Bloomfield BF 0271(21)

Bridge #9

Vermont 102 over the Nulhegan River

Scoping Study

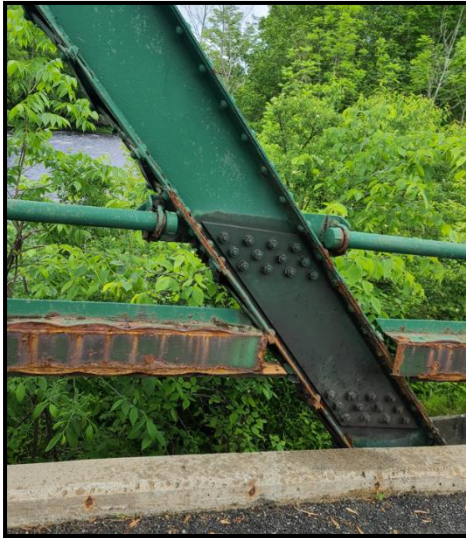
Web plate repairs are present on the end posts at the deck and railing level. These repairs appear to be in good condition, as shown in Figure 1-2.

*Figure 1-2: Typical Repair of End Post
(Top Left)*

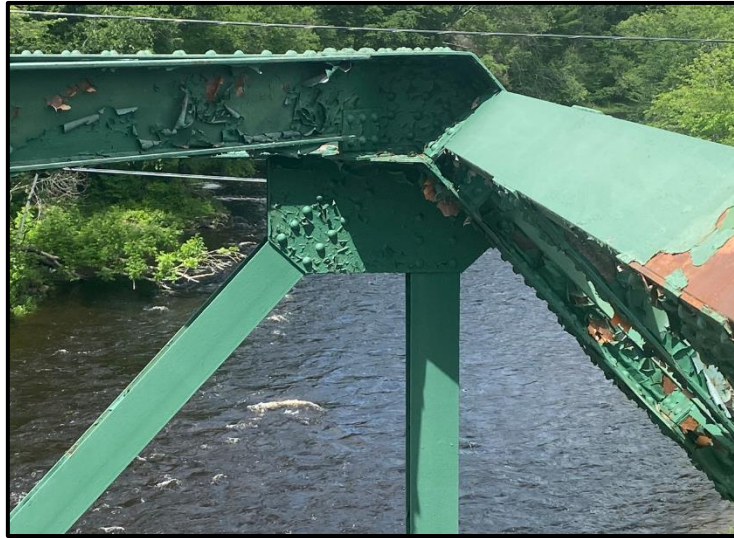
Both trusses are in generally good condition above the deck level. Both the primary and secondary systems need to be cleaned and painted, as failure of the coating system is evident on most members. The existing coating system may contain lead based paint, and cleaning activities will likely require lead abatement. Upper chord gusset plates are relatively thin at 3/8" thickness, but do not show signs of distress. Section losses in both the primary and secondary systems above deck level are localized and generally do not exceed 1/16" of loss, with occasional areas of loss up to 1/8" in thickness. See Figure 1-4.

*Figure 1-4: Typical Condition of Primary and Secondary Systems
Above Deck Level
(Top Right)*

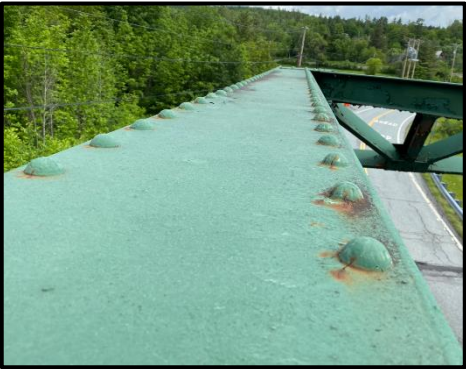
*Figure 1-3: Typical Condition of Top Chord
(Bottom Left)*

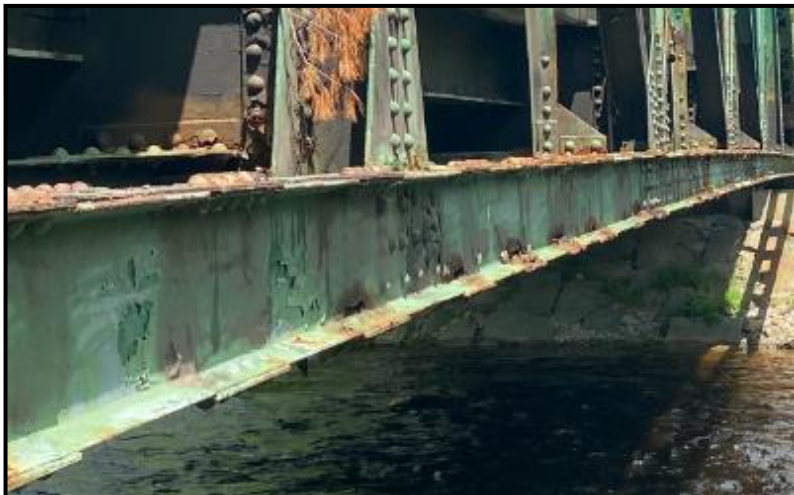
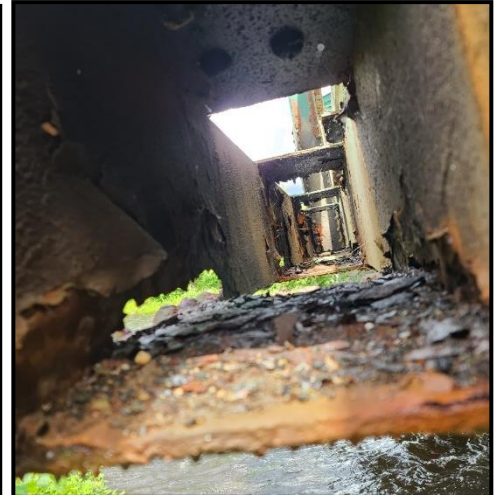
The portions of the web members at and below deck level as well as the bottom chord show more advanced deterioration, with regions of 100% section loss at most batten plate locations on the lower chord. The lower chord gusset plates at the expansion knuckle of the truss are severely deteriorated, with the inner plate on the upstream side severed for the full height, with large areas of full section loss on the downstream side.

Figure 1-5: Typical Deterioration in the Bottom Chord

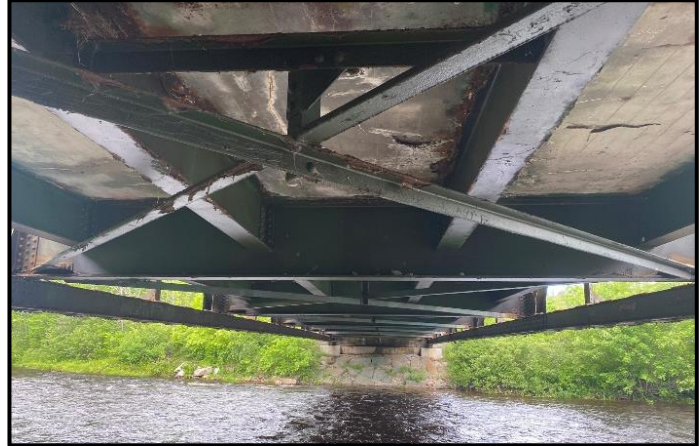
The floor system consists of 2 steel 18"x50WF exterior stringers and 2 21"x59WF interior stringers per bay, with rolled steel 30"x116 WF floor beams at 21'-8" on center. The end floor beams are smaller at 27"x98WF. The lower lateral bracing consists of X bracing with L 3.5"x3.5"x 5/16" single angles supported at midlength, as depicted in Figure 1-6. The lower floor and lateral systems are generally in good condition with the exception of the expansion end bay which is in poor condition (See Figure 1-7). The end floor beam shows evidence of prior plate repairs on the downstream exterior stringer to floorbeam connection on the expansion end, with an approximately 3' long segment of 100% section loss between the web and bottom flange of the floor beam. The lateral bracing at the upstream end connection is fully severed (See Figure 1-8).

Figure 1-6: Typical Floor System Condition

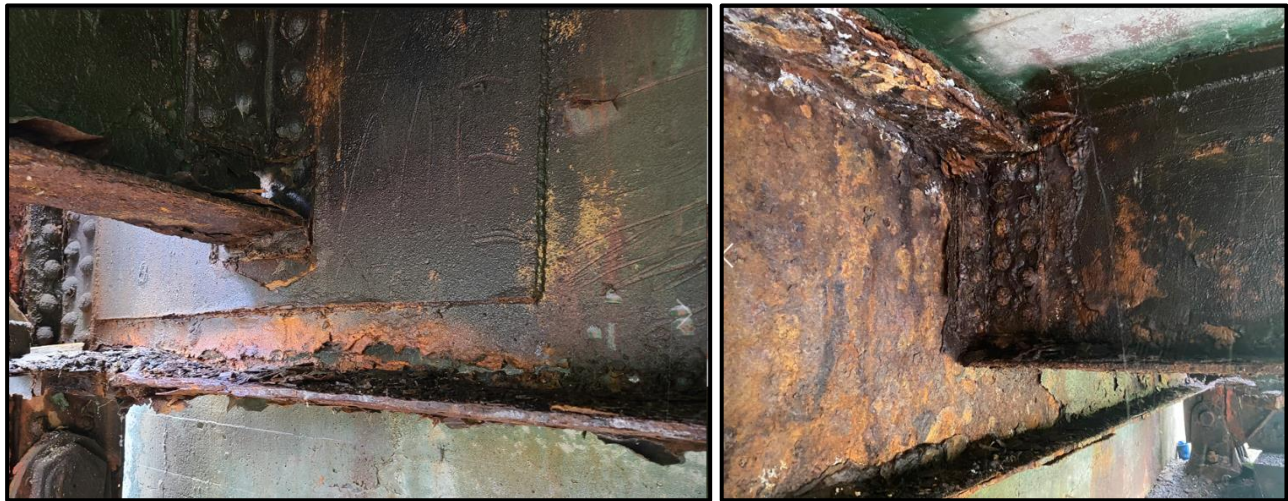
Figure 1-7: Expansion End Floor Beam Condition

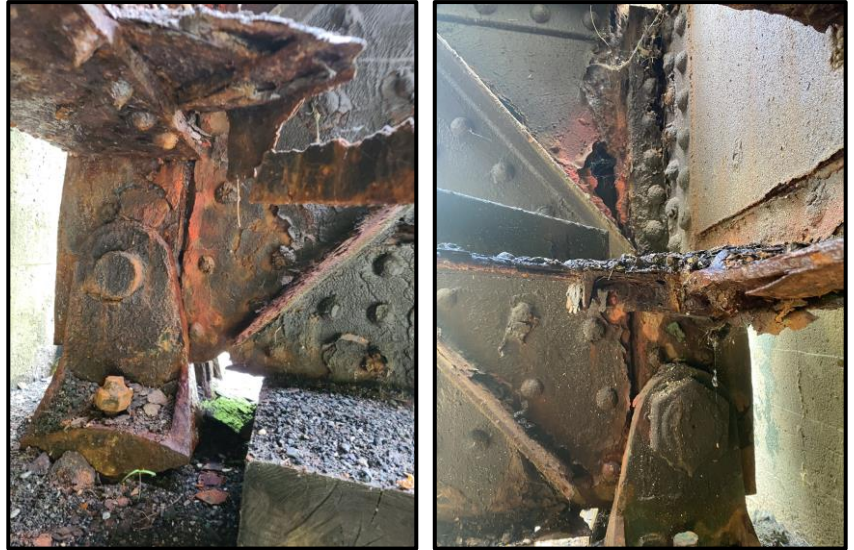
All four truss bearings are cast steel bearings with 4" diameter ASTM A-7-34 steel pins and 4-1.5" diameter straight anchor rods. The fixed shoes at the north end of the bridge are in good condition. Expansion is accommodated by rocker bearings at the south end of the bridge, with an additional two anchors in 3.5" slotted holes for expansion capacity. These bearings show severe deterioration and require replacement, as shown in Figure 1-8.

Figure 1-8: Severe Deterioration of End Bearings, Plates, and Connections

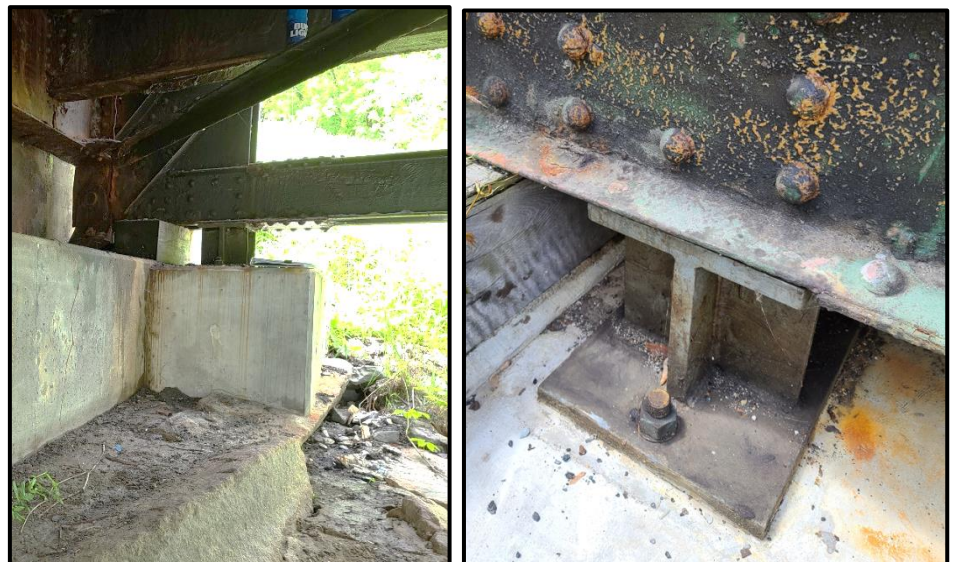
All bearing locations have been temporarily supported by bolster blocks inboard of the pins on new concrete pads supporting the lower chord near at the edge of the gusset. Bolster blocks supports have been poured directly in front of the original bearing seat. The concrete supports and steel bolsters are in good condition as shown in Figure 1-9. Though this temporary solution is not showing signs of distress, it does change the load path of the end post member and the forces in the knuckle plates.

Figure 1-9: South Abutment and Bolsters

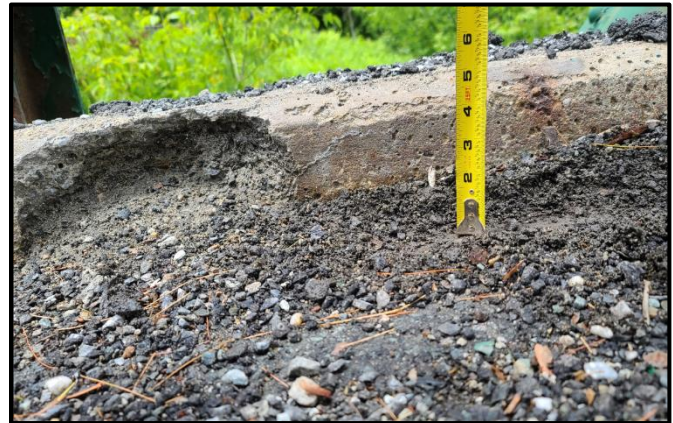
The deck consists of reinforced concrete with an assumed thickness of 10" based on existing plans for a 20' wide roadway. At the time of construction, the concrete was considered class A concrete and the deformed steel bars are designated A15-14. Design curb heights measured 9" from the top of deck surface to top of curb. The curb is shallow with a reveal of approximately 4", indicating a potential for 5" of pavement on the bridge in its current condition, and is spalled in places as shown in Figure 1-10.

Figure 1-10: Spall in Curb

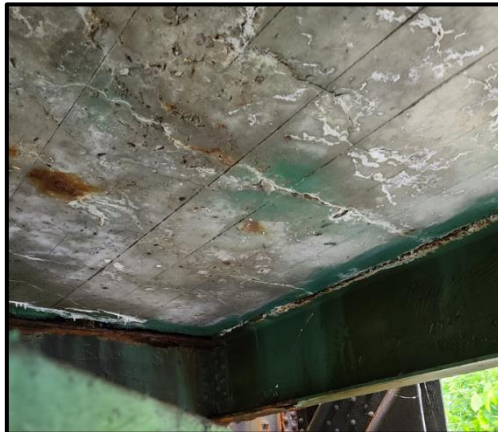
The underside of the deck exhibits numerous cracks, spalls, and areas of minor efflorescence. Rust staining is also visible in places, indicating active corrosion of reinforcement. A typical bay is shown in Figure 1-12, with a more severe spall shown in Figure 1-13. The most significant deterioration tends to occur at the rail post connections on the deck overhang, as shown in Figure 1-11, where large spalls cracking, and efflorescence is visible at the rail post connection. The connection is made by 2 metal studs embedded horizontally in the deck. The embedment is not known, though there is clear evidence of water intrusion.

*Figure 1-13:
Spall in
Underside of
Deck*

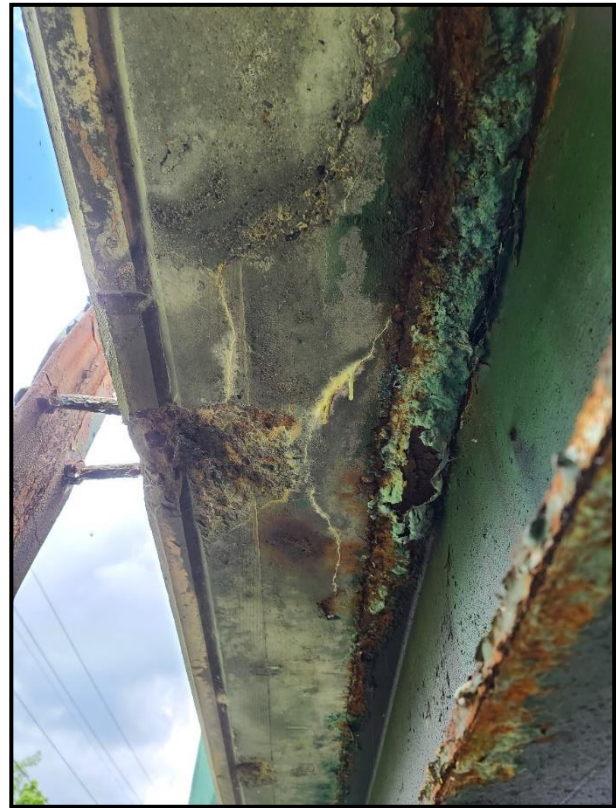
Figure 1-11: Deck Deterioration in Overhang

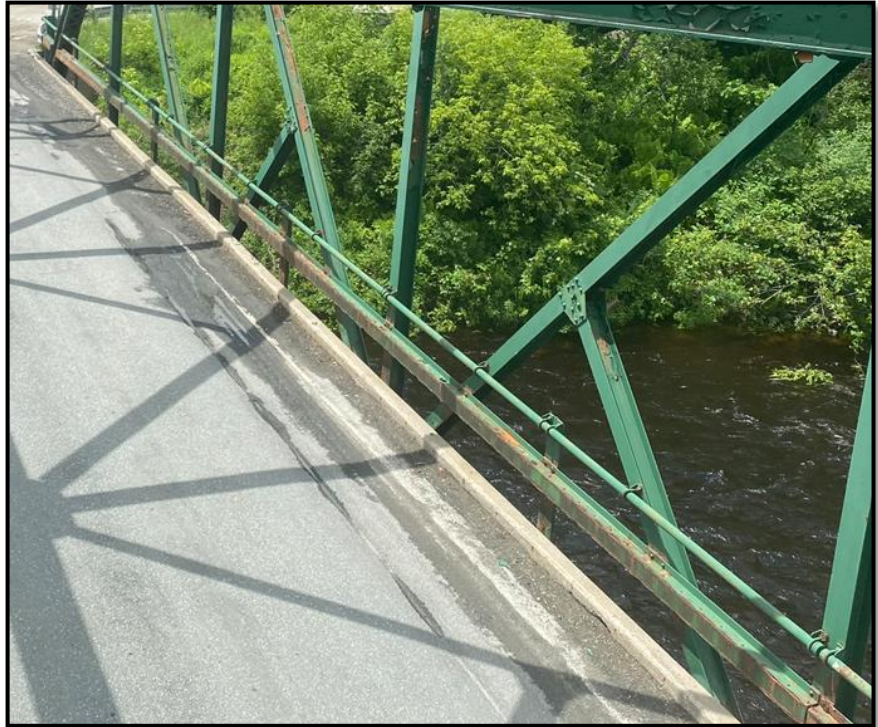
The original railing is still present on the bridge and is attached to the diagonal and vertical members, as well as to posts connected to the bottom chord. The railing consists of a built up section of a 6" channel and two angles to create the low rail and a 2 ½" steel tube top rail. The support posts are built up members consisting of back to back L2x2x5/16" angles with fill and connector plates. The railing is substandard for this class of roadway. The railing and its connections can be seen in Figure 1-14.

Figure 1-14: Aerial View of Roadway, Curb, and Railing

The southbound lane travel surface exhibits rutting and stripping of the pavement due to snowmobile use, as seen in Figure 1-14 above. Pavement is otherwise in fair condition with a few small potholes in the travel surface. The joint at the expansion end is an asphaltic pavement joint that shows measurable deterioration, cracking, and loss of pavement, as shown in Figure 1-16. This allows salt penetration through the pavement layer, which corresponds to the substantial deterioration observed below the deck at this location.

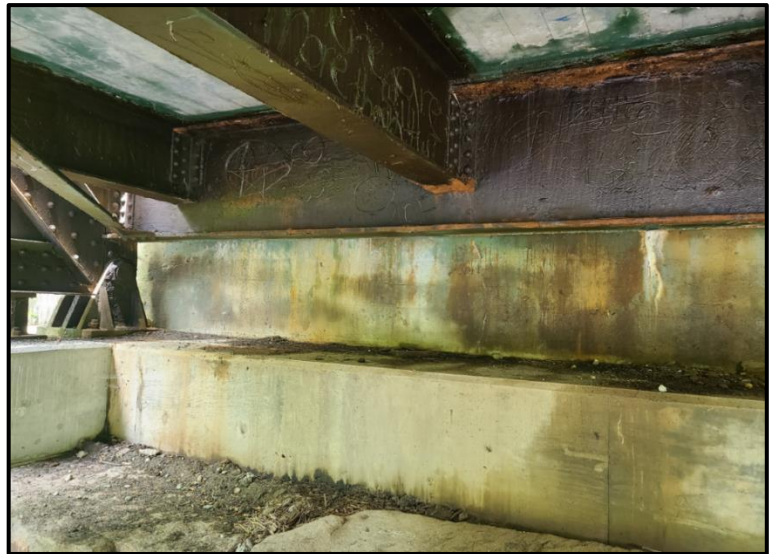
Figure 1-17 shows the typical condition of the abutments, with some staining and minor cracking, with no major spalls in the support areas.

Figure 1-17: North Abutment and End Framing in Good Condition

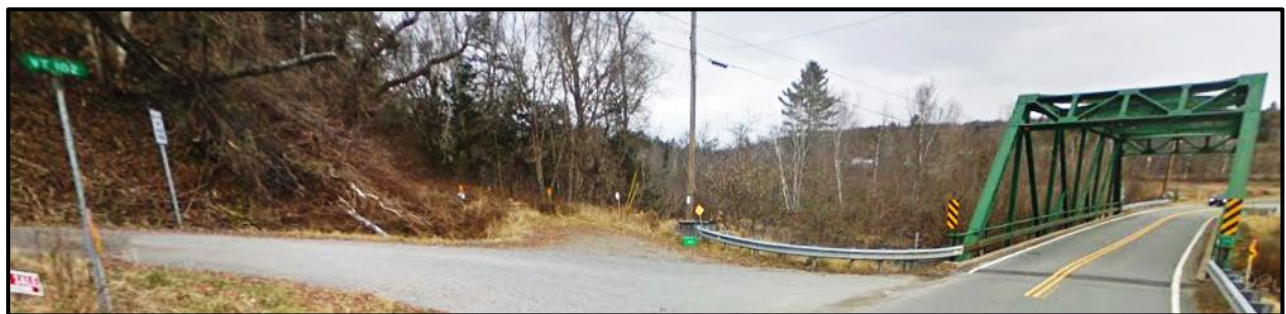
The southerly approach intersects with Patnaude Road just prior to the bridge, with the parking area (4(f) resource) for the canoe trail located at the intersection as shown in Figure 1-18. As such, the approach rail in

Figure 1-18: Southerly Approach and Intersection with Patnaude Road
