**STATE OF VERMONT  
AGENCY OF TRANSPORTATION**

**Scoping Report  
FOR  
Williston BF 5500(19)**

**US Route 2, Bridge 23 over unnamed tributary to Winooski River**

September 10, 2021

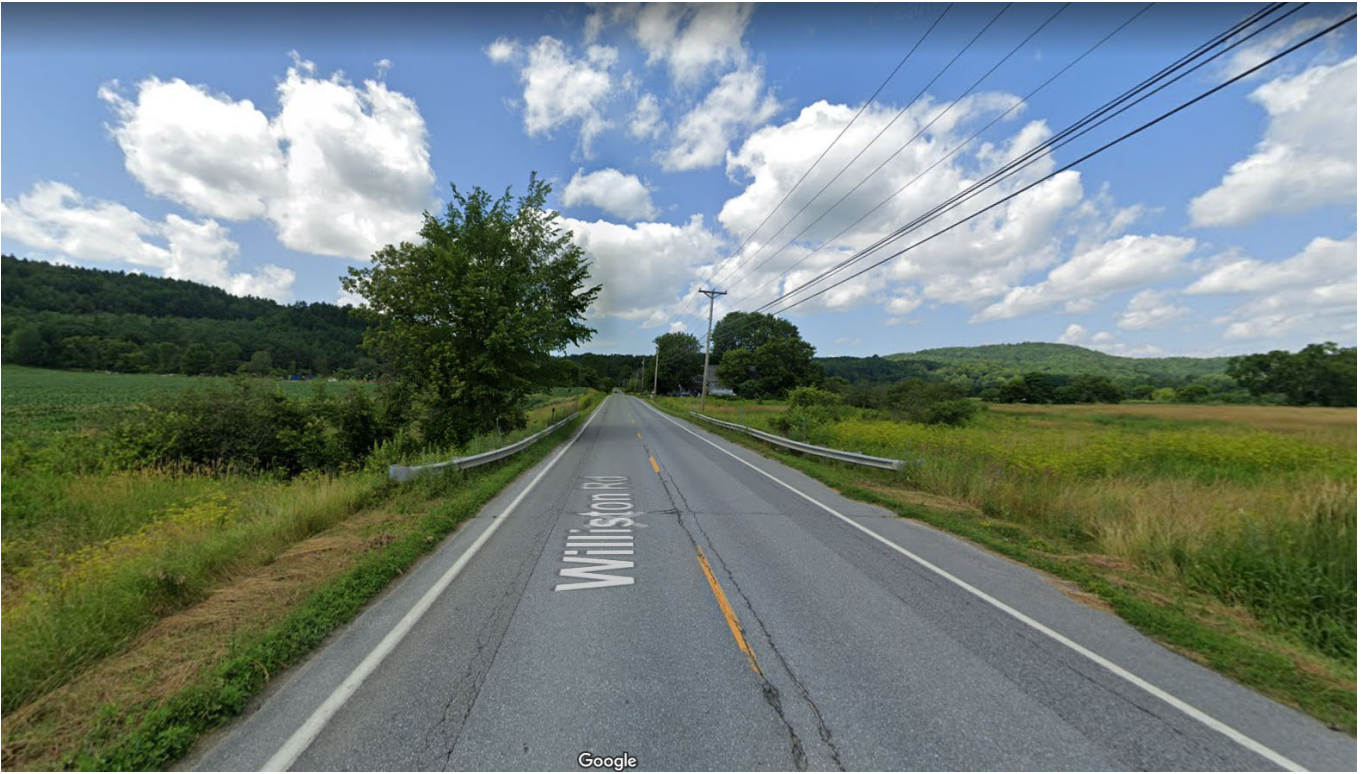
Looking west over Culvert 23

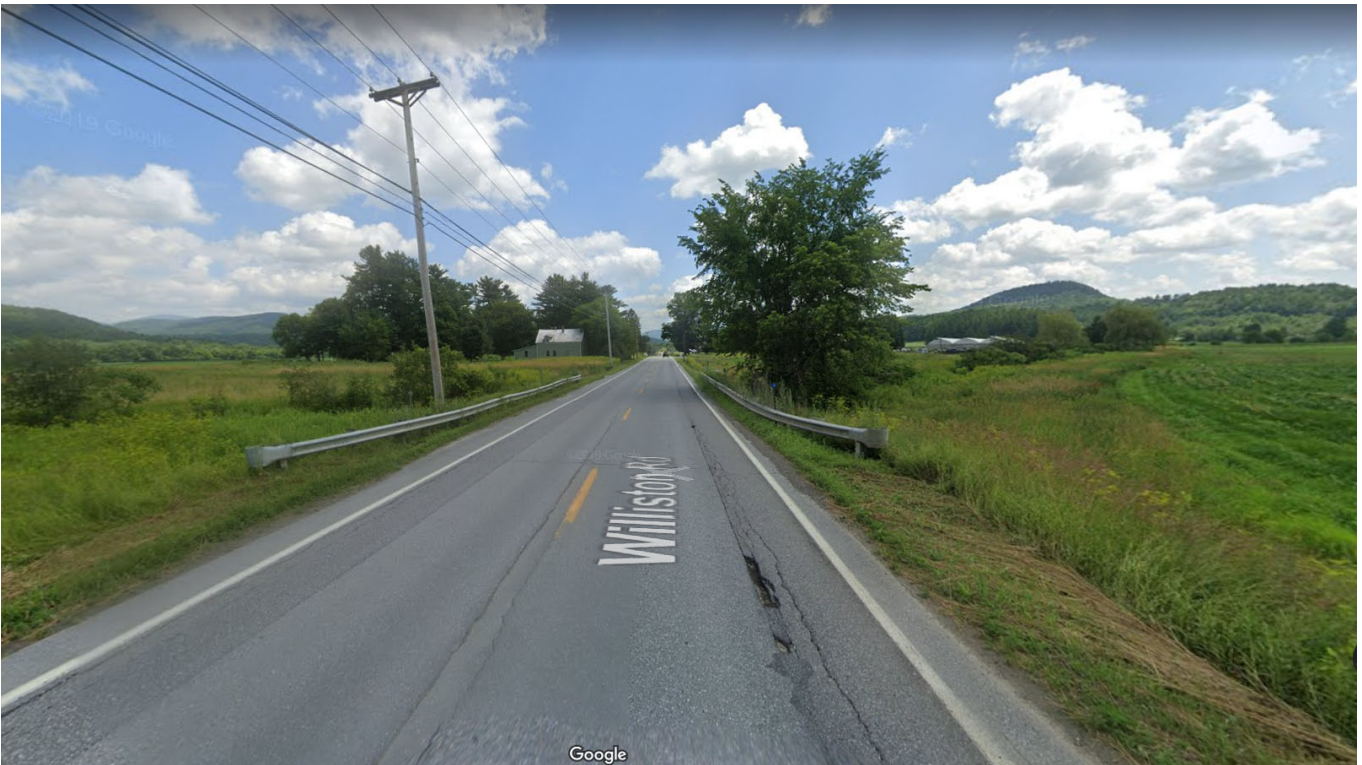
Looking East over Culvert 23

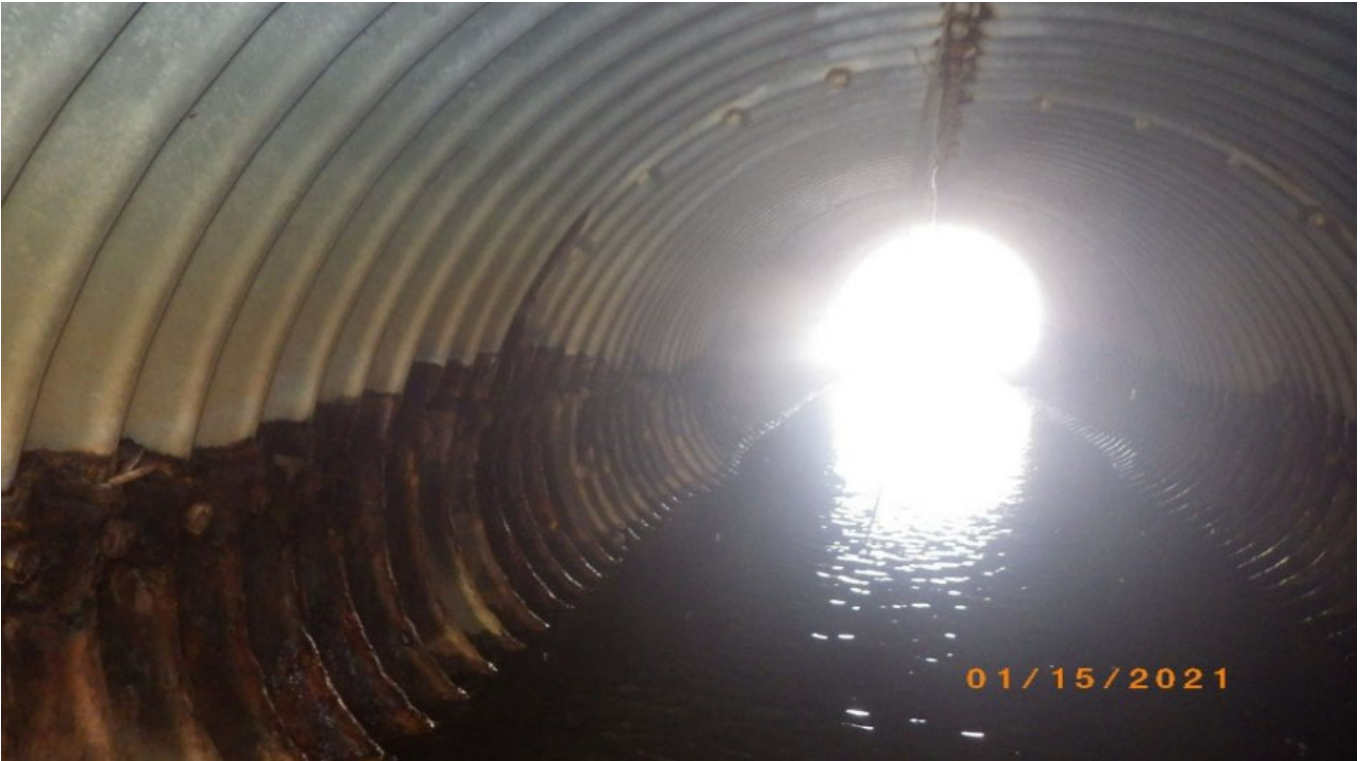
Culvert Barrel

09/22/2020 – Structure is in poor condition and should be sleeved or replaced. Moderate settlement in roadway from barrel crushing and piping occurring. Full length transverse perforations along haunches of barrel. Invert has perforations throughout entire invert. ~MAC/JO

10/28/2016 – Culvert is in very poor condition with the bolt line midway up the culvert sidewalls having heavy deterioration along entire length of culvert. Invert has heavy pitting with large perforation at inlet and outlet with piping occurring. A new culvert is needed or a new sleeve to prevent culvert failure. ~SMP/ABC/JAS

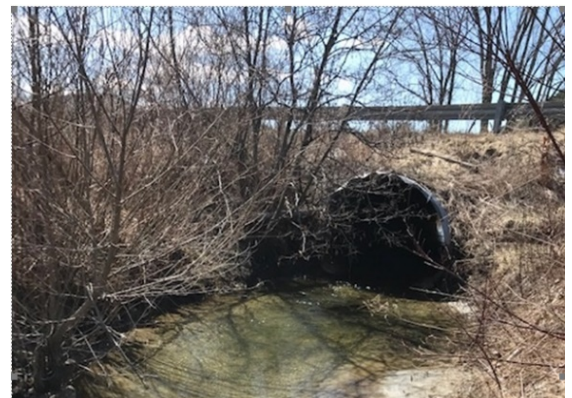
Figure 2 US 2 BR 23 and adjacent wetlands

The current structure (figure 2) is likely to provide aquatic organism passage under most conditions. Bank lines are not present within the structure. If constructed in accordance with AOP guidelines they would likely be achieved. This would allow passage of small terrestrial mammals that may use the riparian zone as movement from habitat blocks.

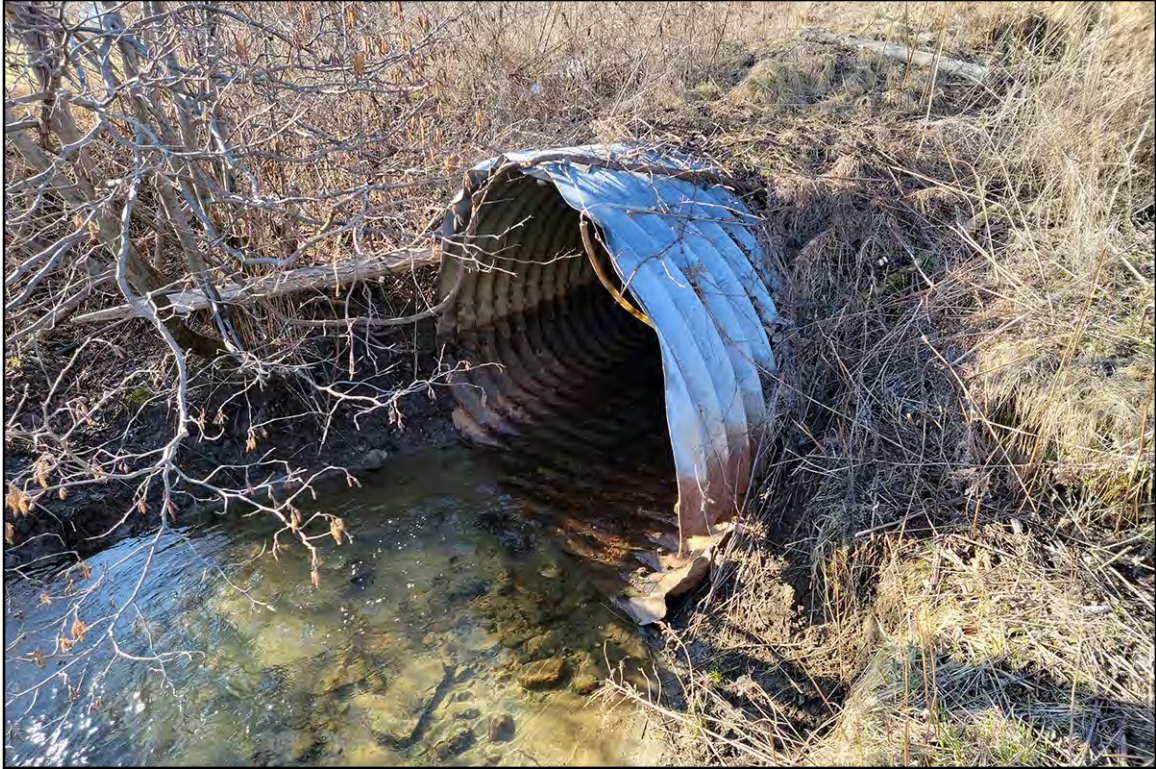
PLATE 1: Built-up Roadway Over East Side of Bridge, View South

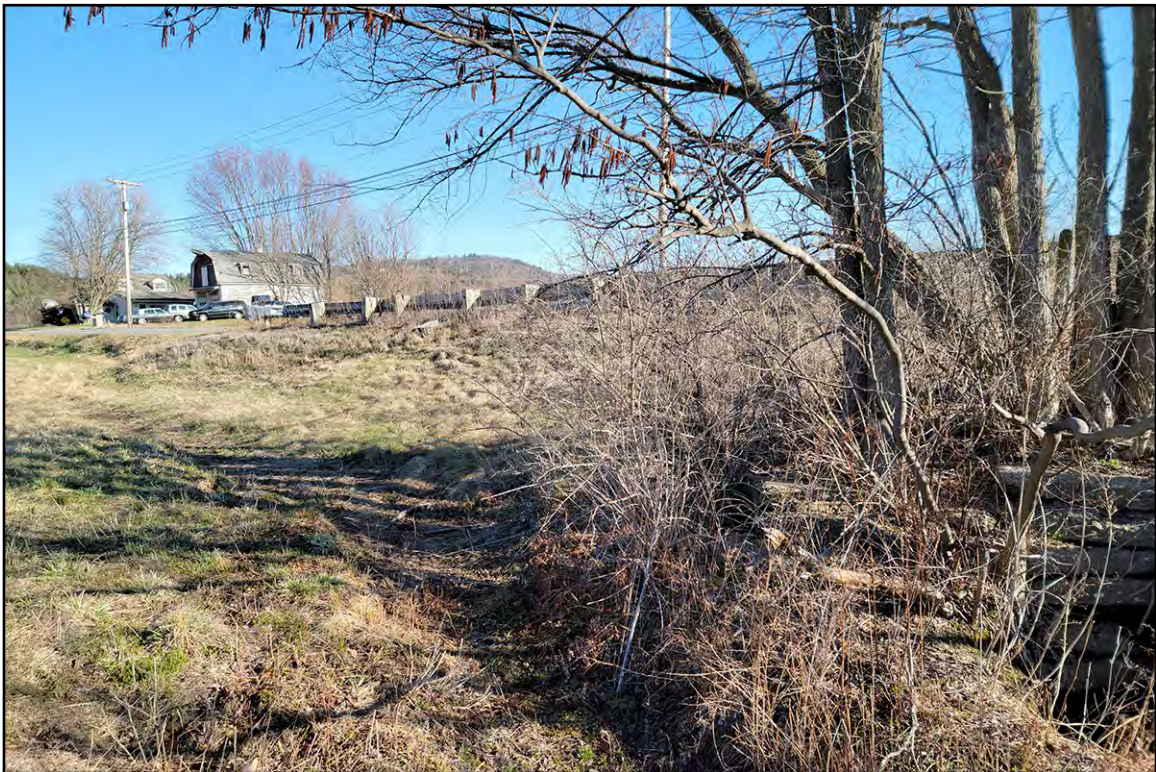
PLATE 2: Built-up Roadway Over West Side of Bridge, View East

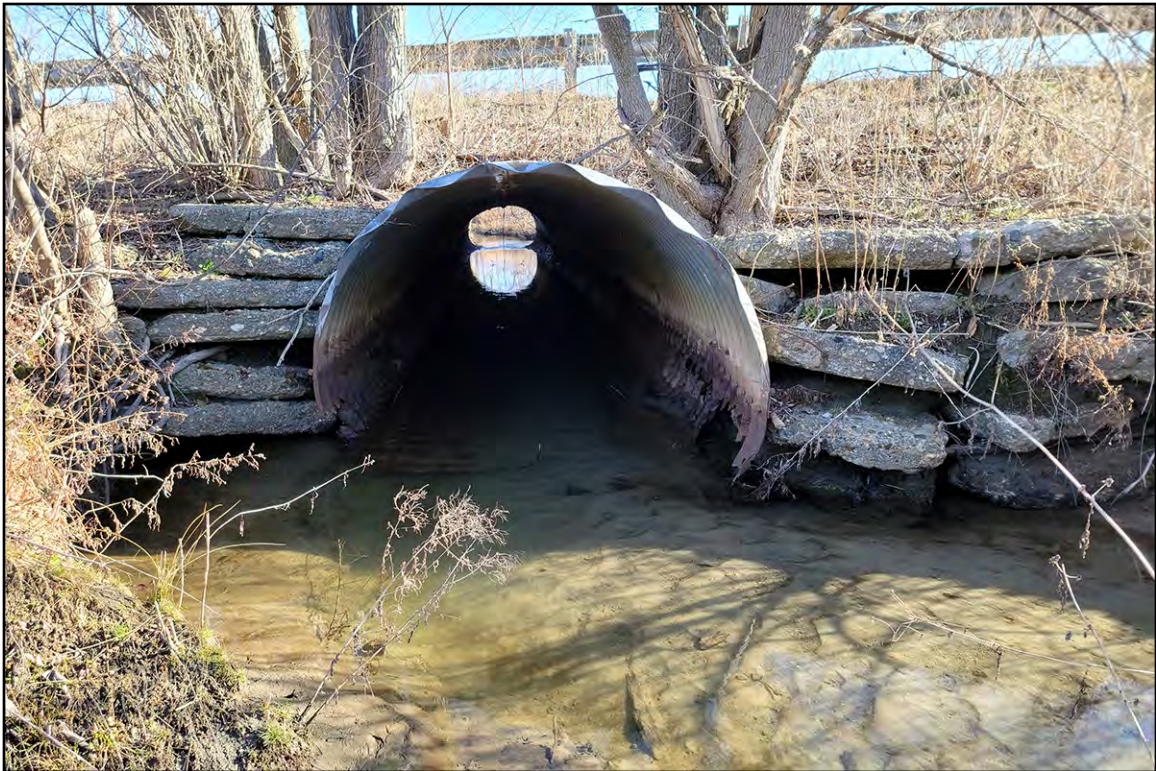
PLATE 3: Built-up Wingwalls of West Side of Bridge, View East

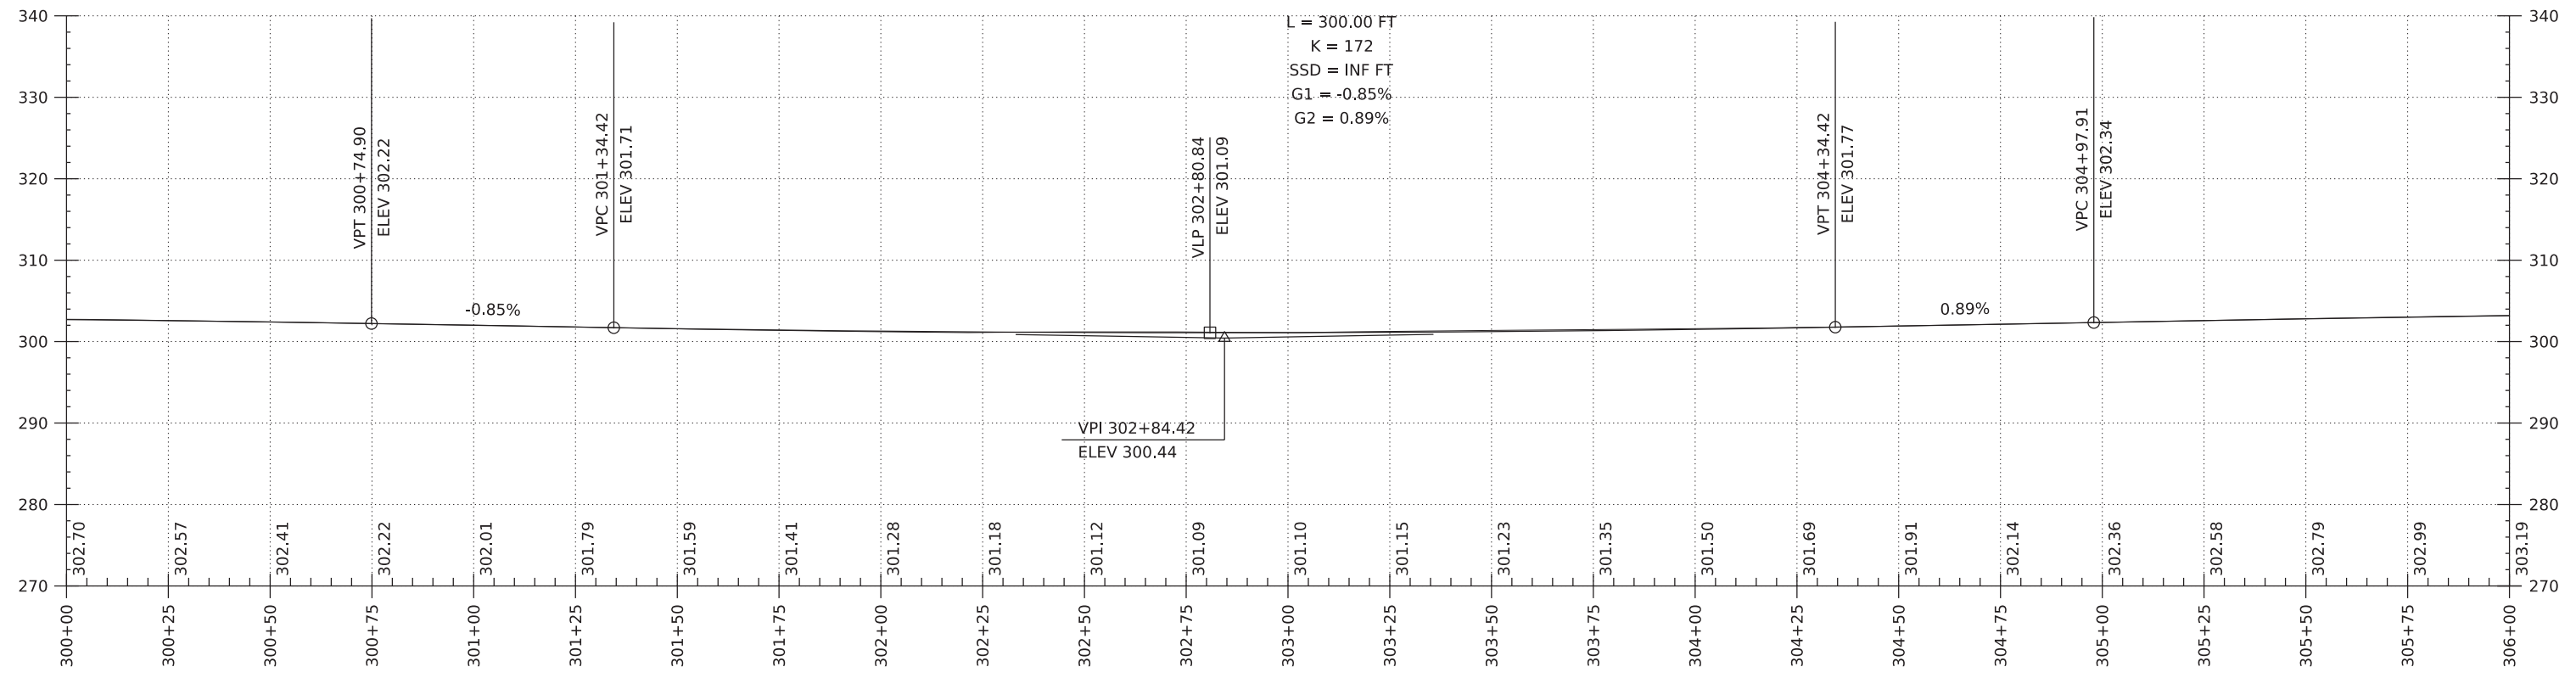
**US ROUTE 2 PROFILE**  
 SCALE: HORIZONTAL 1"=20'-0"  
 VERTICAL 1"=10'-0"

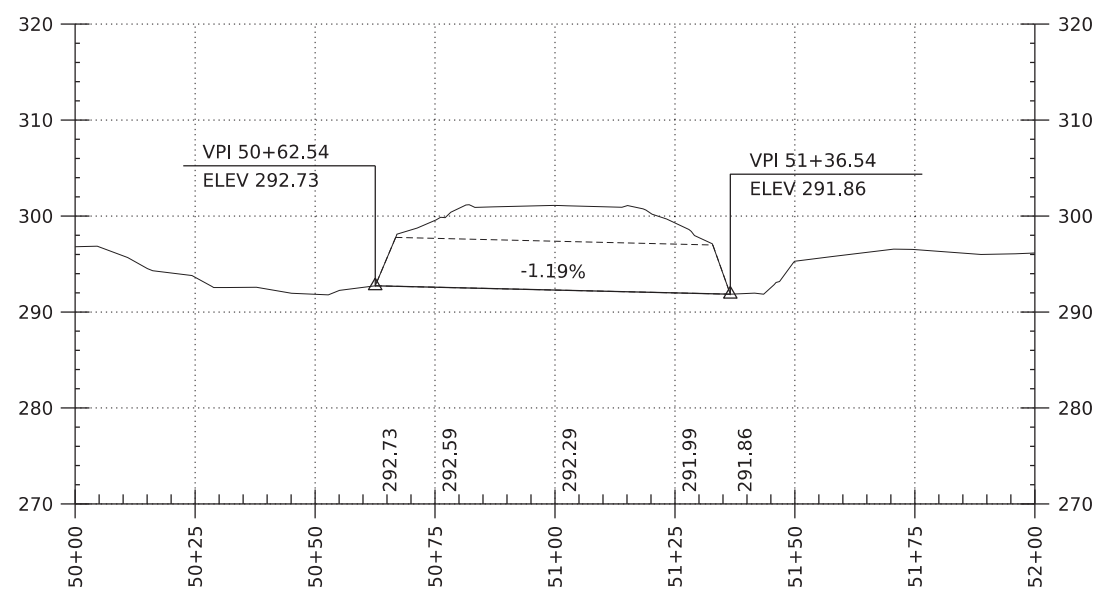
**CULVERT 23 PROFILE**  
 SCALE: HORIZONTAL 1"=20'-0"  
 VERTICAL 1"=10'-0"
