Bradford BF 0113(89)
Alternatives Meeting

US Route 5, Bridge 91 over Waits River October 24, 2024

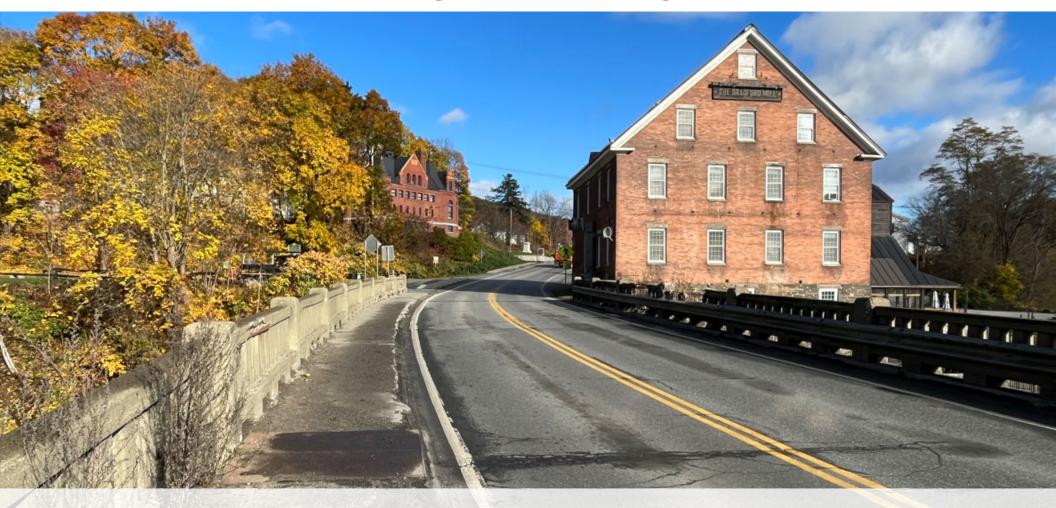
Looking North over Bridge 91

- Roadway Classification Rural Major Collector
- Bridge Type Single Span Two-Girder Bridge
- Ownership State of Vermont
- Constructed in 1939

Traffic - 5000 vpd, 10% trucks

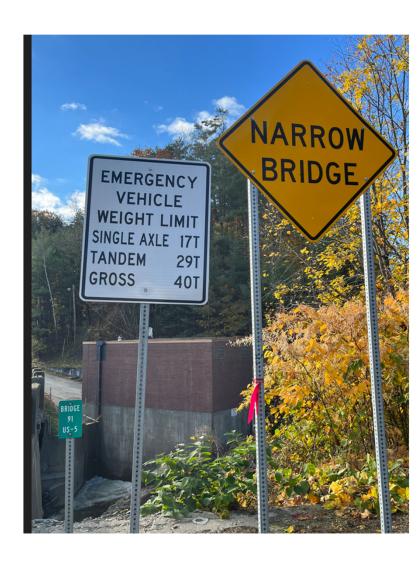
- Geometry
 - Narrow Bridge (32 ft)
 - Narrow Shoulders (1 ft)
- Posted Weight Limit
- Failing Bridge Railing
 - Capped with highway guardrail.
- Bridge 91 Inspection Ratings
 - Deck4 Poor
 - Superstructure6 Satisfactory
 - Substructure5 Fair
 - Channel8 Very Good

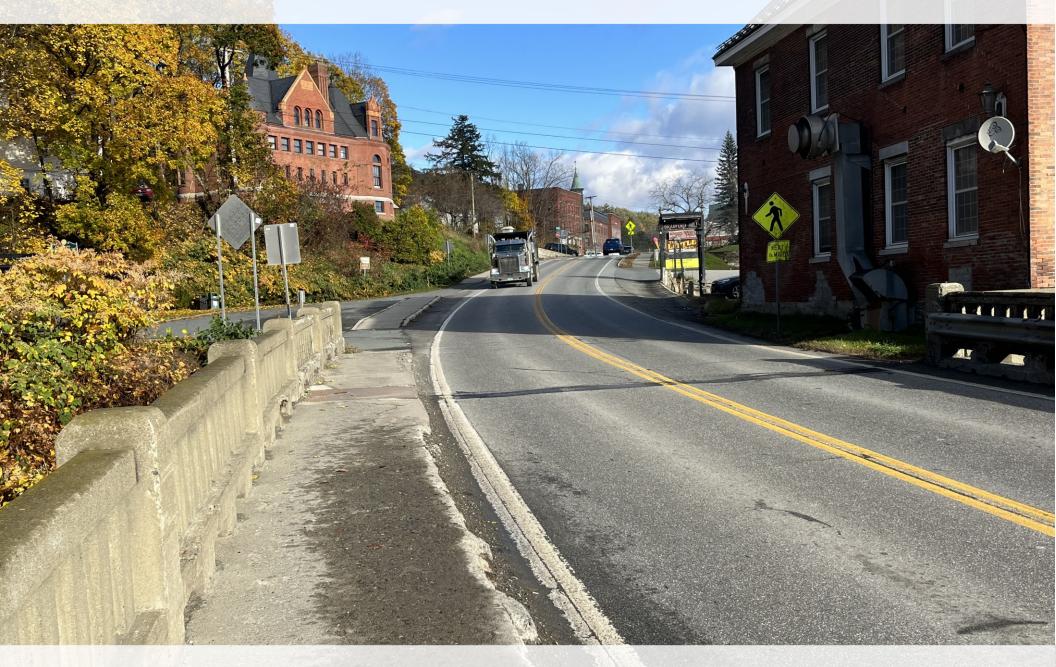
Narrow Shoulders

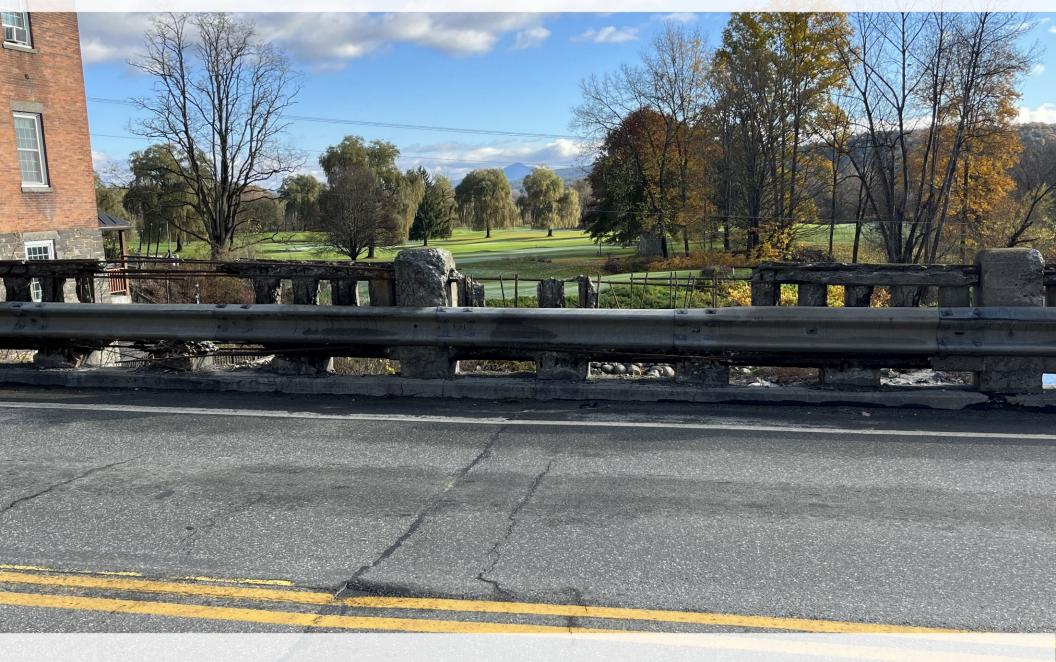
Failing/Obsolete Bridge Rail

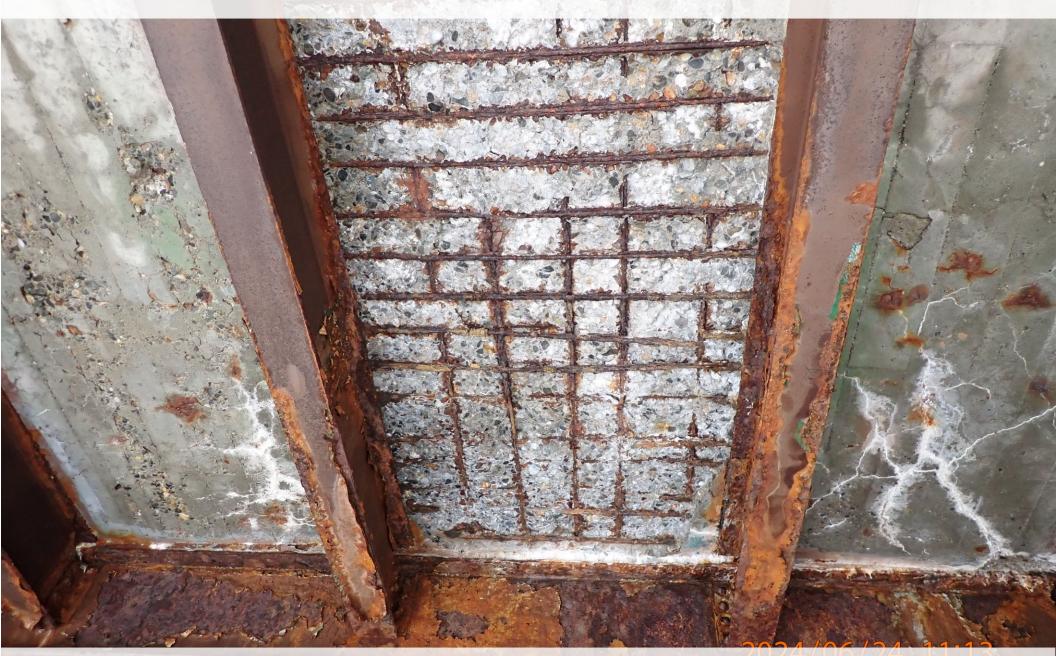
Deck – Spalling Concrete

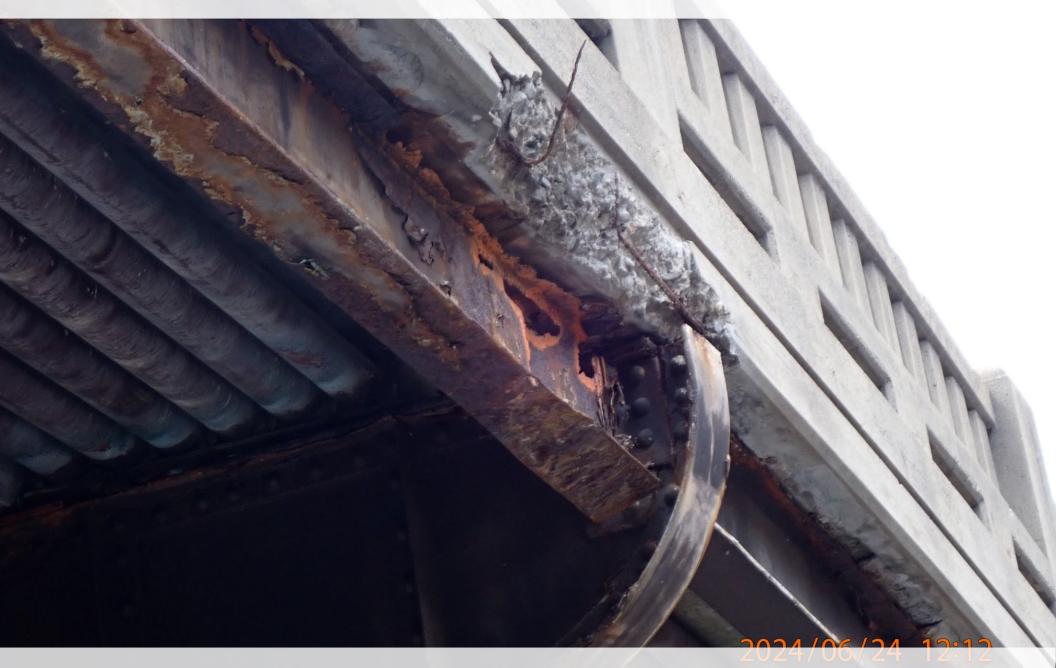
Superstructure – Sidewalk Support Beam

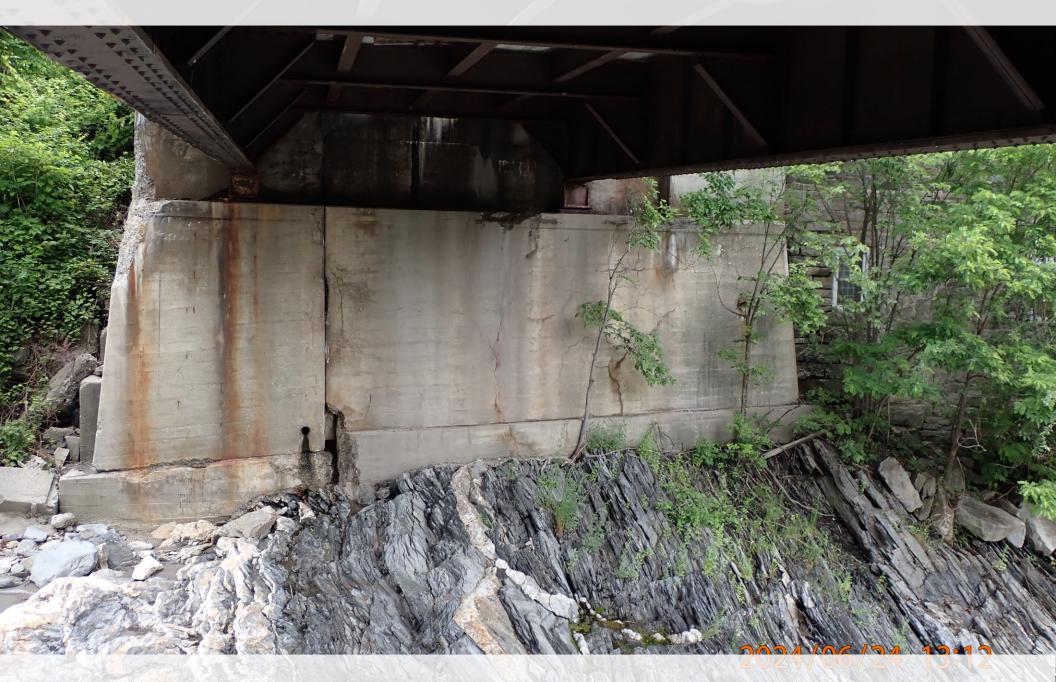
North Abutment

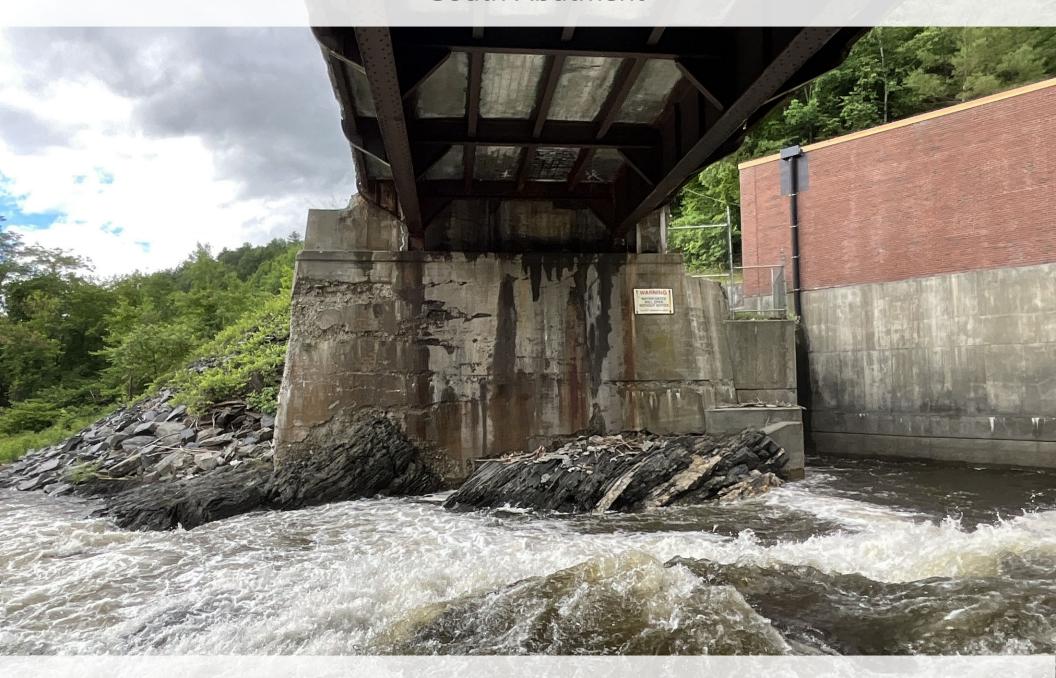
South Abutment

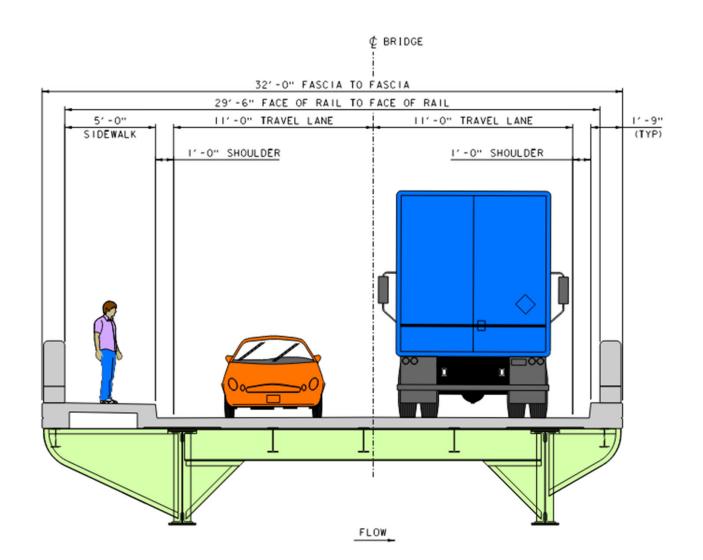
Alternative 1 (No Action)

- Further deterioration resulting in unsafe conditions
- < 10 year lifespan</p>
- Not recommended

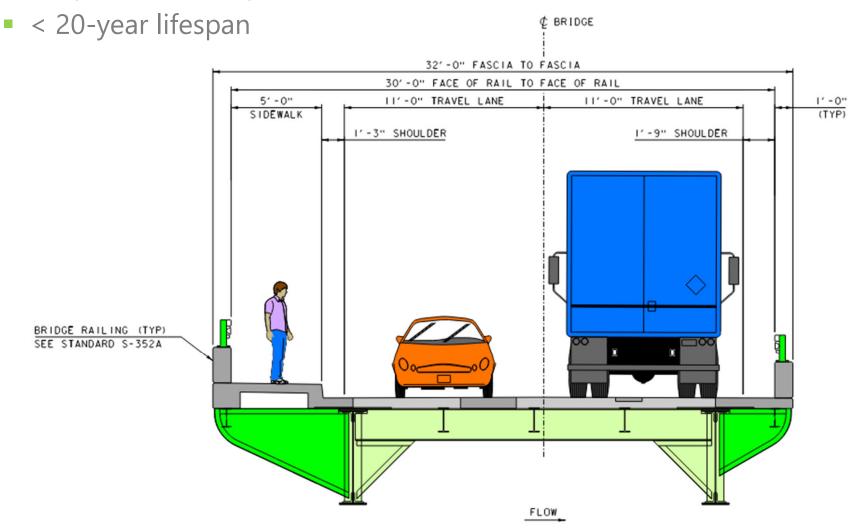
Alternative 2 (Superstructure Repair)

- Replace bridge rail, sidewalk, curb, and support brackets.
- Repair spalling concrete deck and substructure
- Does not improve posted weight limit or shoulder width.
- No permanent impact to abutters and resources.

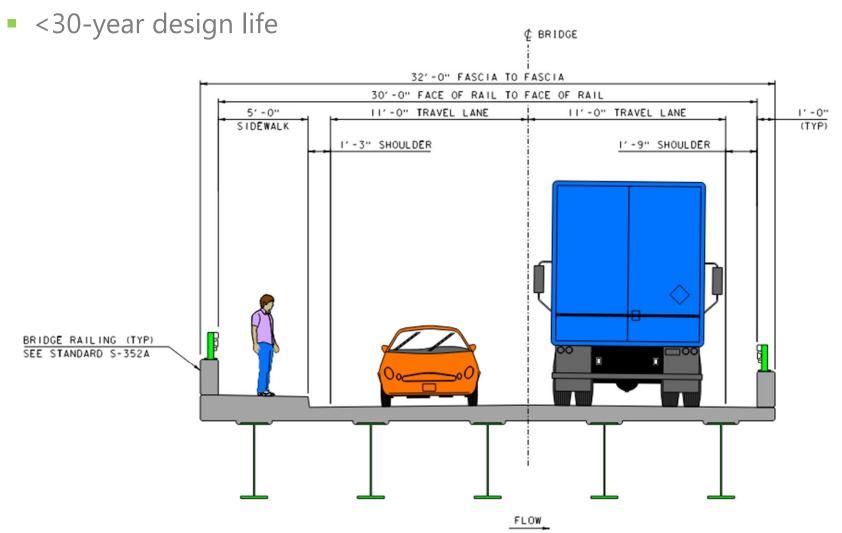
Alternative 3 (Superstructure Replacement)

- New concrete deck and steel superstructure.
- Repair spalling concrete substructure.
- Improves Structural Capacity but does not improve shoulder width.
- No permanent impact to abutters and resources

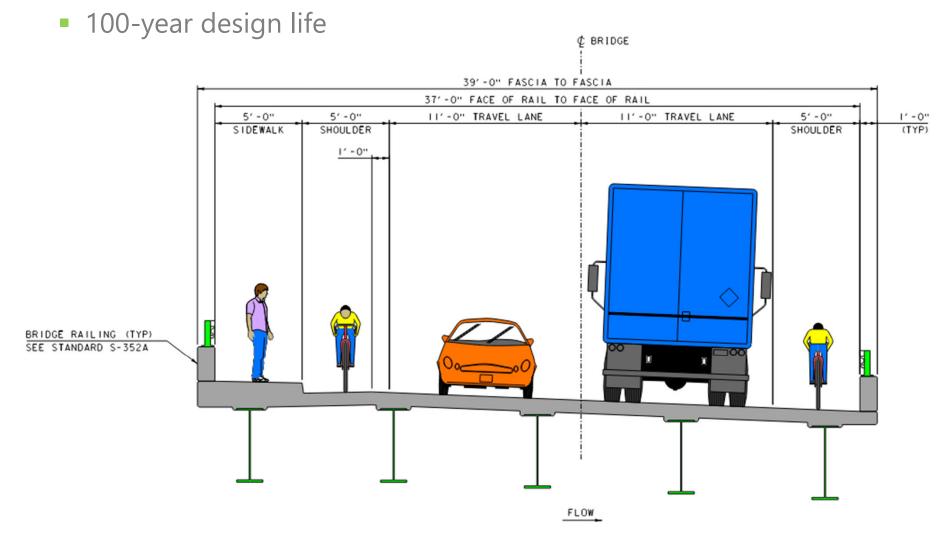
Typical Section – Alternative 4 (Full Bridge Replacement with Sidewalk)

- Meets current standards for structural capacity.
- Provide shoulder widths that meets Vermont State Standards
- Remove all aged concrete.
- Minimal (mostly temporary) impacts to abutters and resources

Alternative #4 – Bridge Replacement

- Lowest construction and life cycle cost based on a 100-year design life.
- Meets current standards for bridge width, shoulder width, and structure capacity.
- Minimizes permanent impacts to abutters compared to Alternative #5

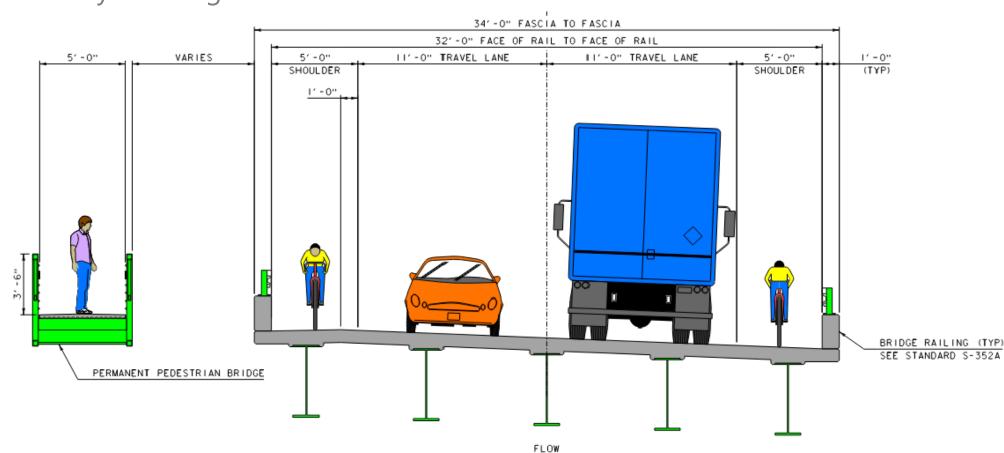
Typical Section – Alternative 5 (Full Replacement w/ Ped Bridge)

- Meets current standards for structural capacity.
- Provide shoulder widths that meets Vermont State Standards
- Permanent Pedestrian Bridge
- Most permanent impacts to abutters and resources.
- Increased construction and life cycle costs (2 bridges)
- 100-year design life

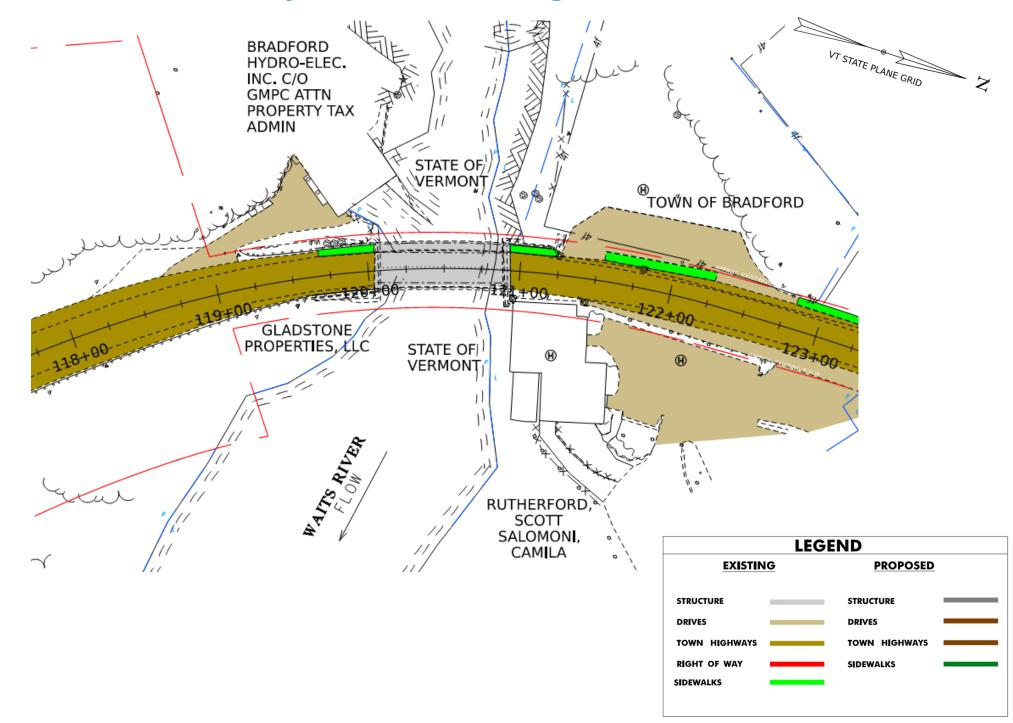
Layout - Existing Conditions

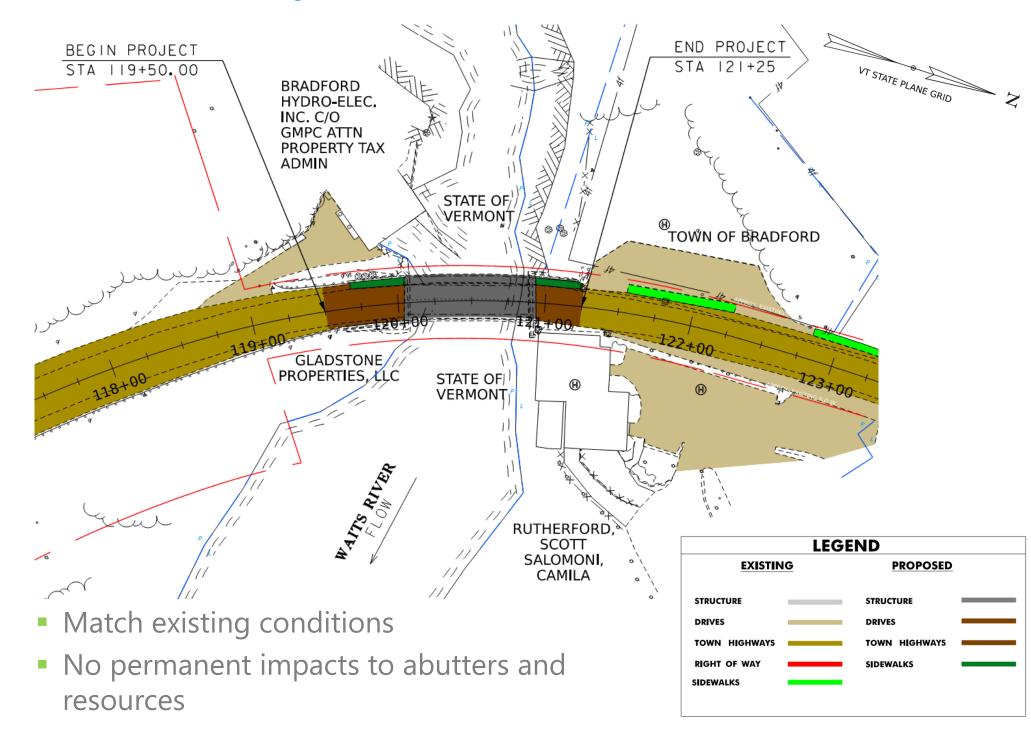
Layout – Alternatives 2 and 3

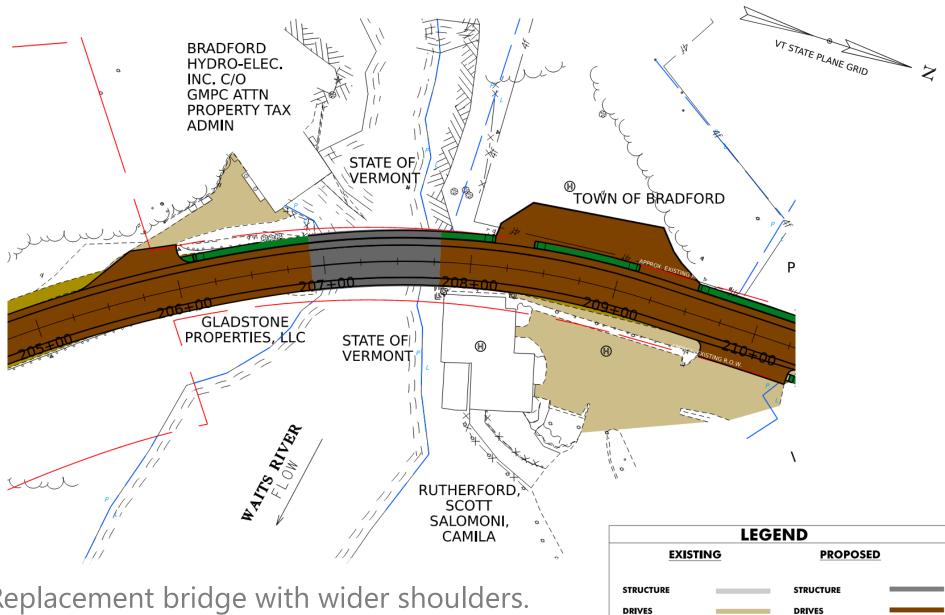
Layout - Alternative 4

- Replacement bridge with wider shoulders.
- Minimizes permanent impacts to abutters and resources.

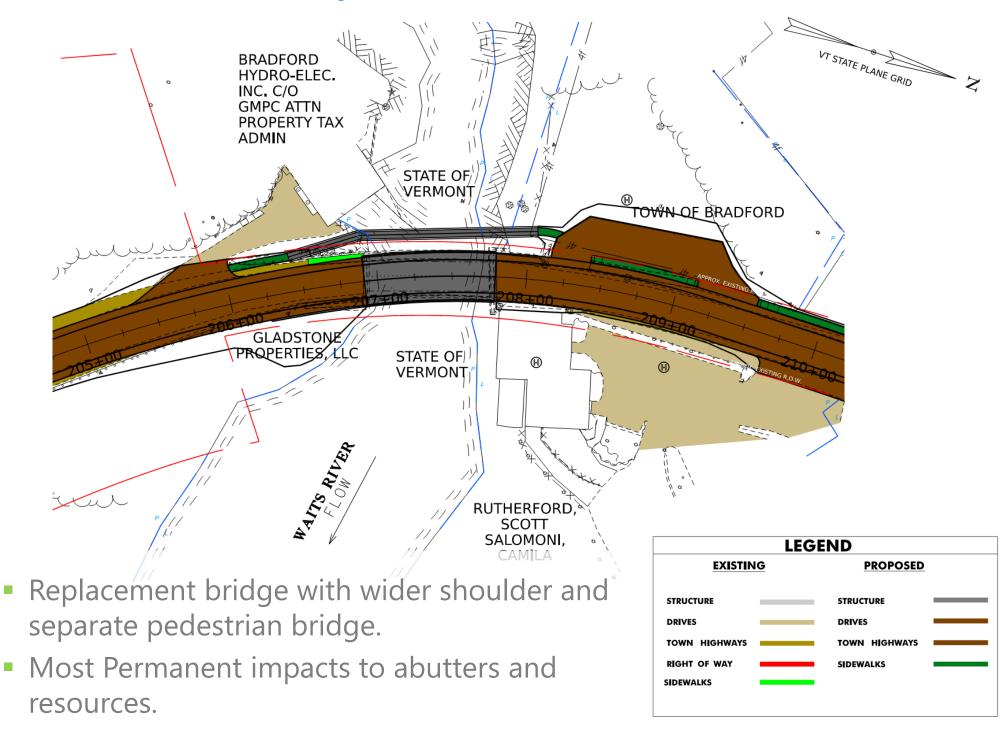
Layout – Alternative 5

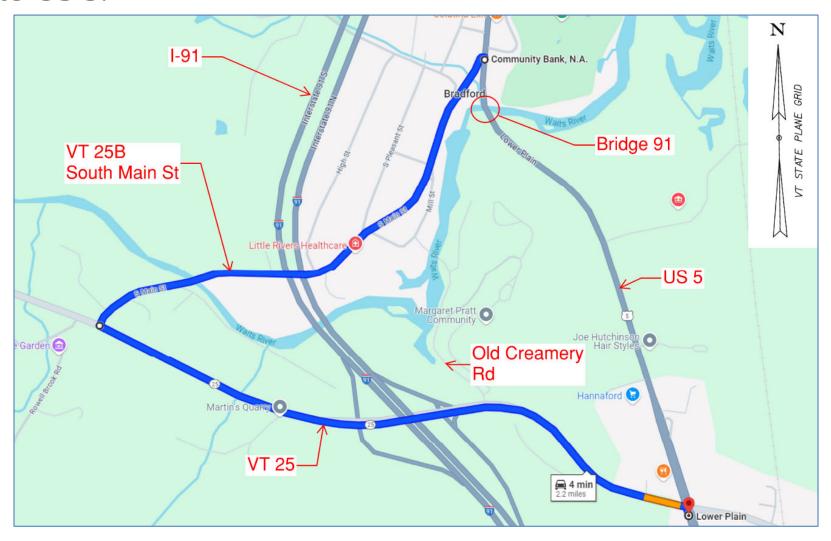
Traffic Control – Detour

Detour Route:

From the intersection of VT 25 and US 5; VT Route 25 to VT 25B/South Main St; VT 25B to US 5.

Through Distance: 1.0 miles
Detour Distance: 2.2 miles

Added Distance: 1.2 miles
