# Ferrisburgh BF 019-4(35) Regional Concerns Meeting

**US Route 7, Bridge 139 over Lewis Creek**

September 17, 2024

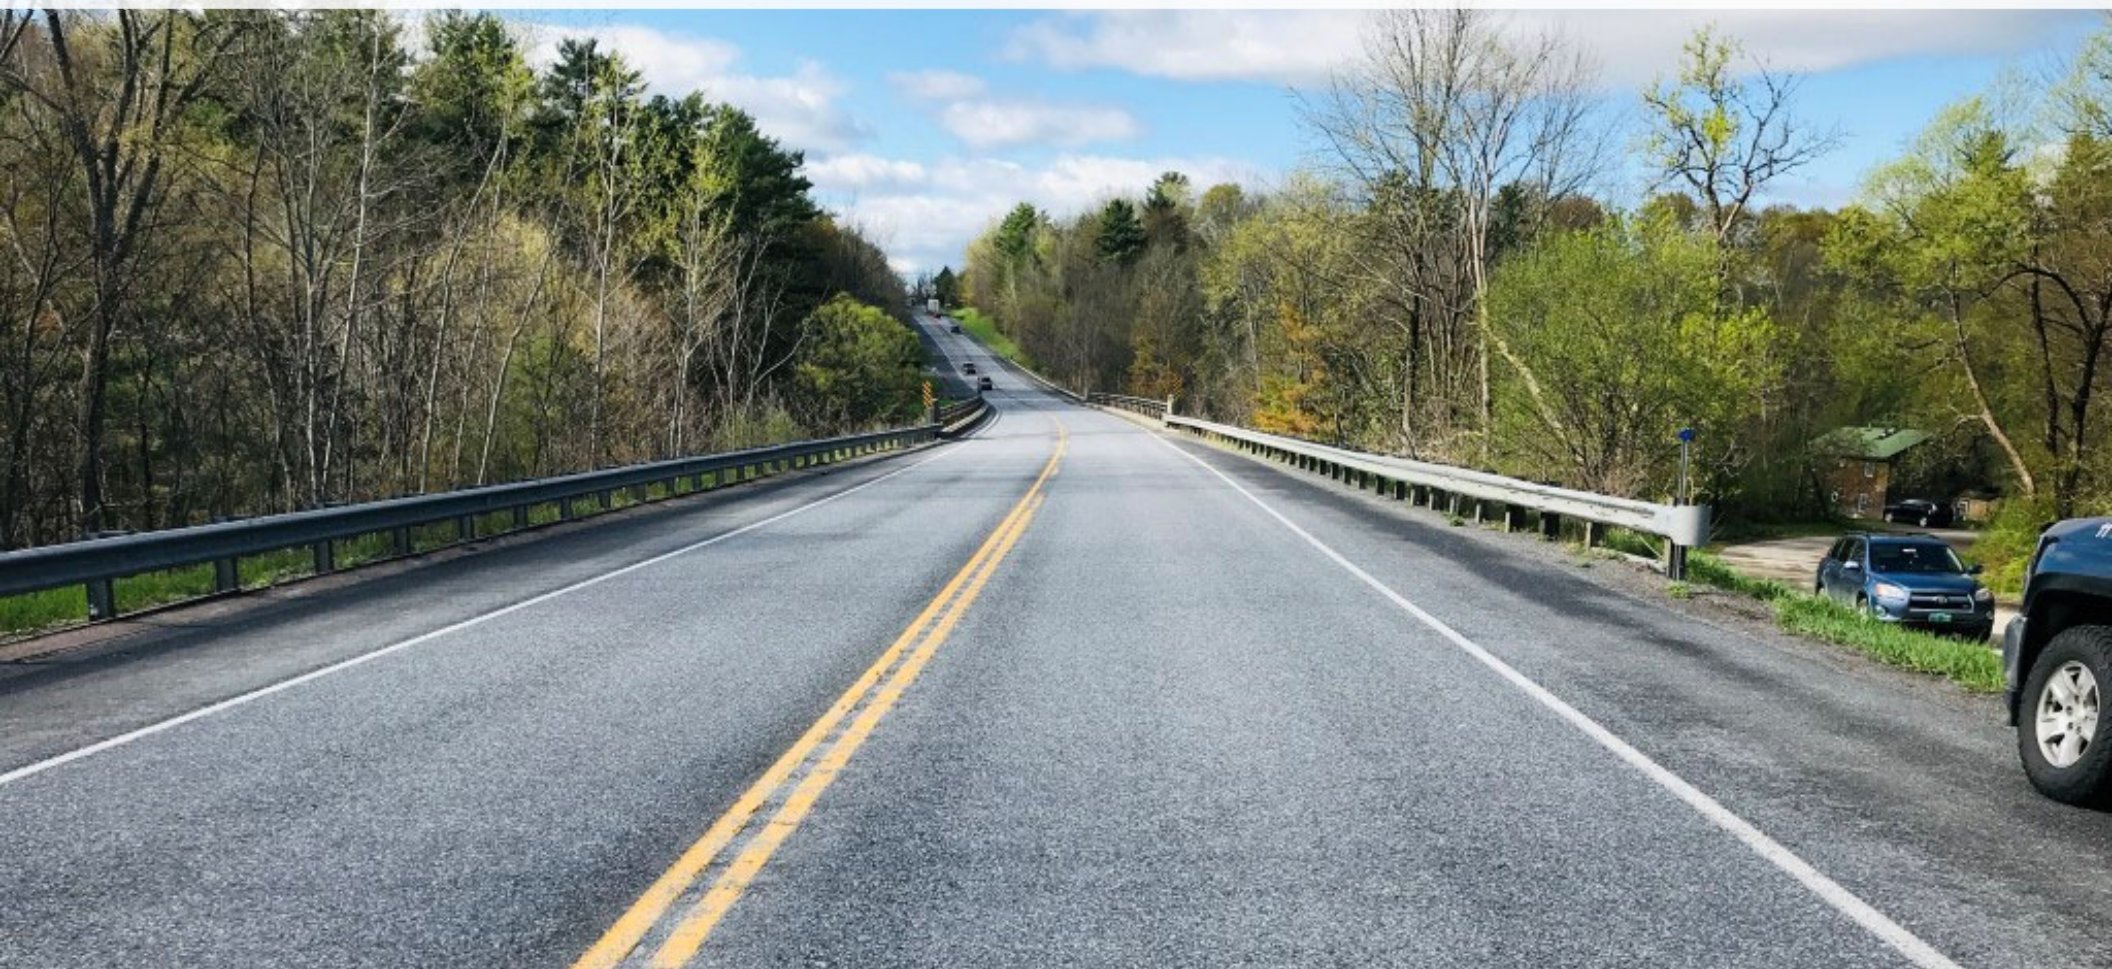
## Looking South over Bridge 139

### Existing Conditions – Bridge 139

- Roadway Classification – Principal Arterial (National Highway System)
- Bridge Type – 3-Span Continuous Rolled Beam Bridge
- Ownership – State of Vermont
- Constructed in 1957

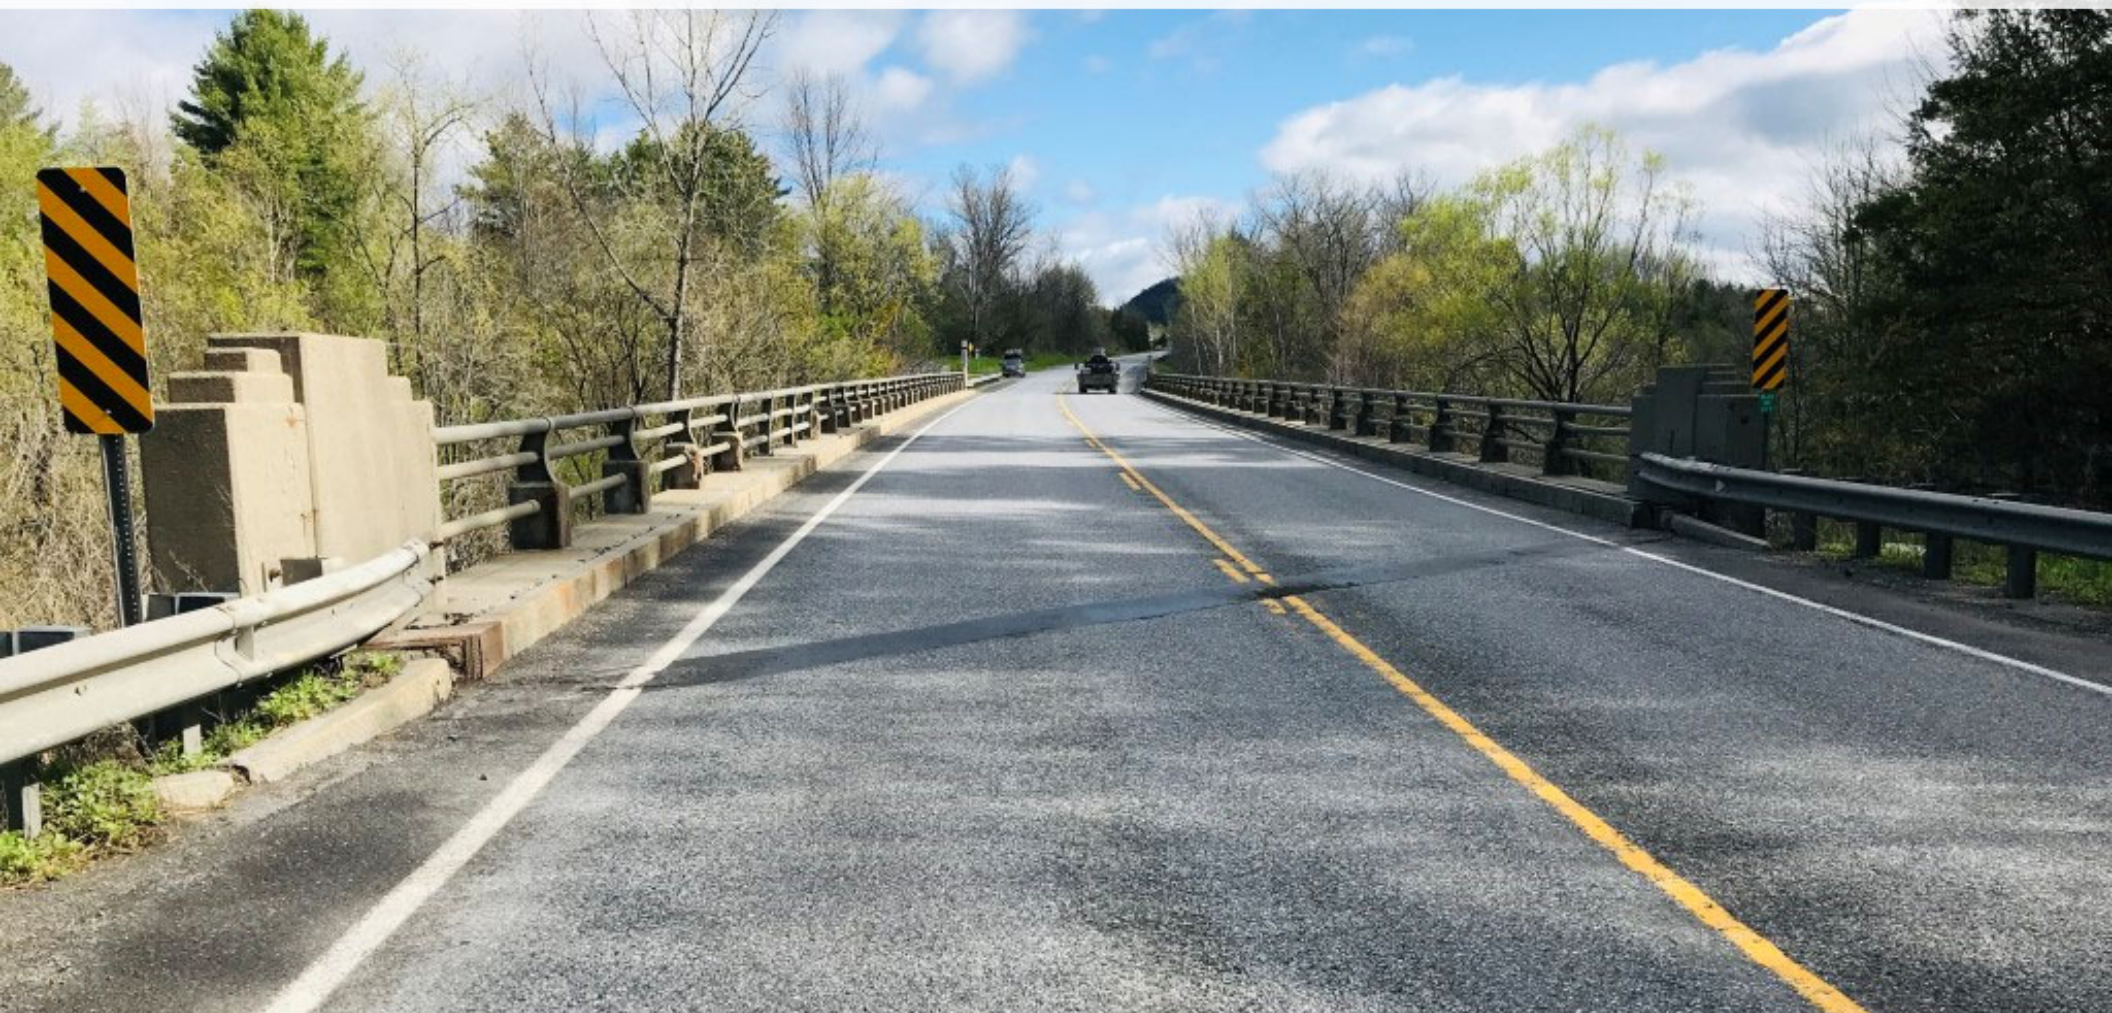
## Looking North over Bridge 139

### Existing Conditions – Bridge 139

- The aerial utilities in the project area are located over 230 feet west of the bridge and will not be in conflict with project work.
- Consolidated has a buried Fiber line in a 4" PVC conduit which hangs off the west side of the bridge which will likely need to be relocated.

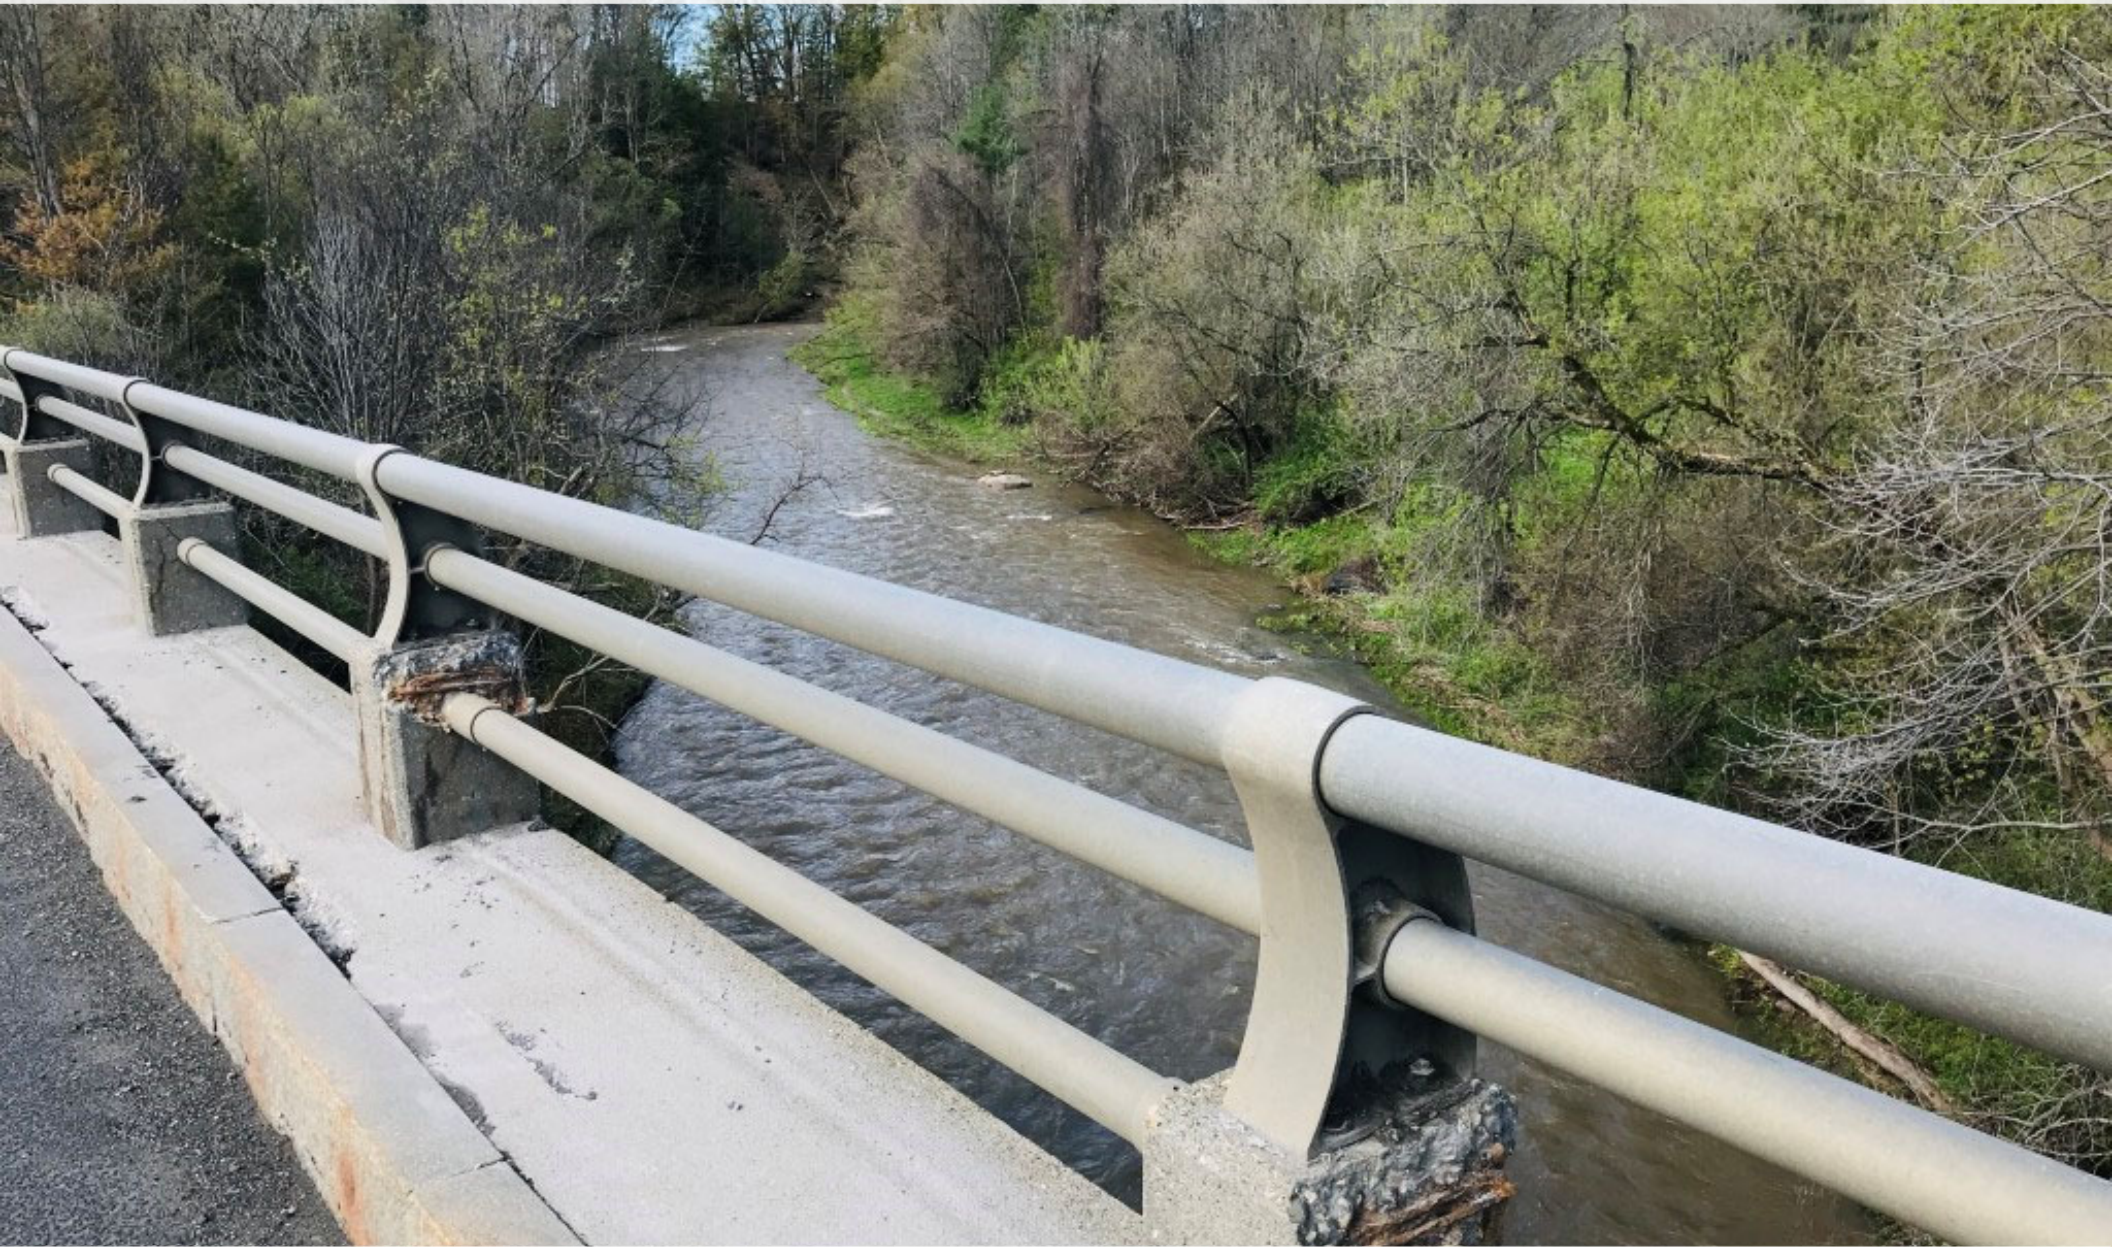
## Obsolete Bridge Rail

# Existing Conditions – Bridge 139

- The reinforced concrete deck is in fair condition with a few areas of spalling that extend the full width of the bays and penetrate up to and beyond the first layer of reinforcing steel. There is also moderate to heavy saturation throughout the deck with efflorescence, varying sized delaminations, and map cracking throughout the fascia.
- The steel girder superstructure is in satisfactory condition with areas of rust scale at the beam ends and scattered small locations along the flanges with minor pitting and section loss.
- The reinforced concrete substructure is in good condition with scattered shrinkage cracks throughout the abutment end walls with light staining and minor saturation.
- The shoulder widths on the bridge are substandard.

## Deck Spalling

### Existing Conditions – Bridge 139 Inspection Ratings

- Deck 5 Fair
- Superstructure 6 Satisfactory
- Substructure 7 Good
- Channel 8 Very Good

- Match existing bridge dimensions and give additional width for bicycles
- Replace with standard railing

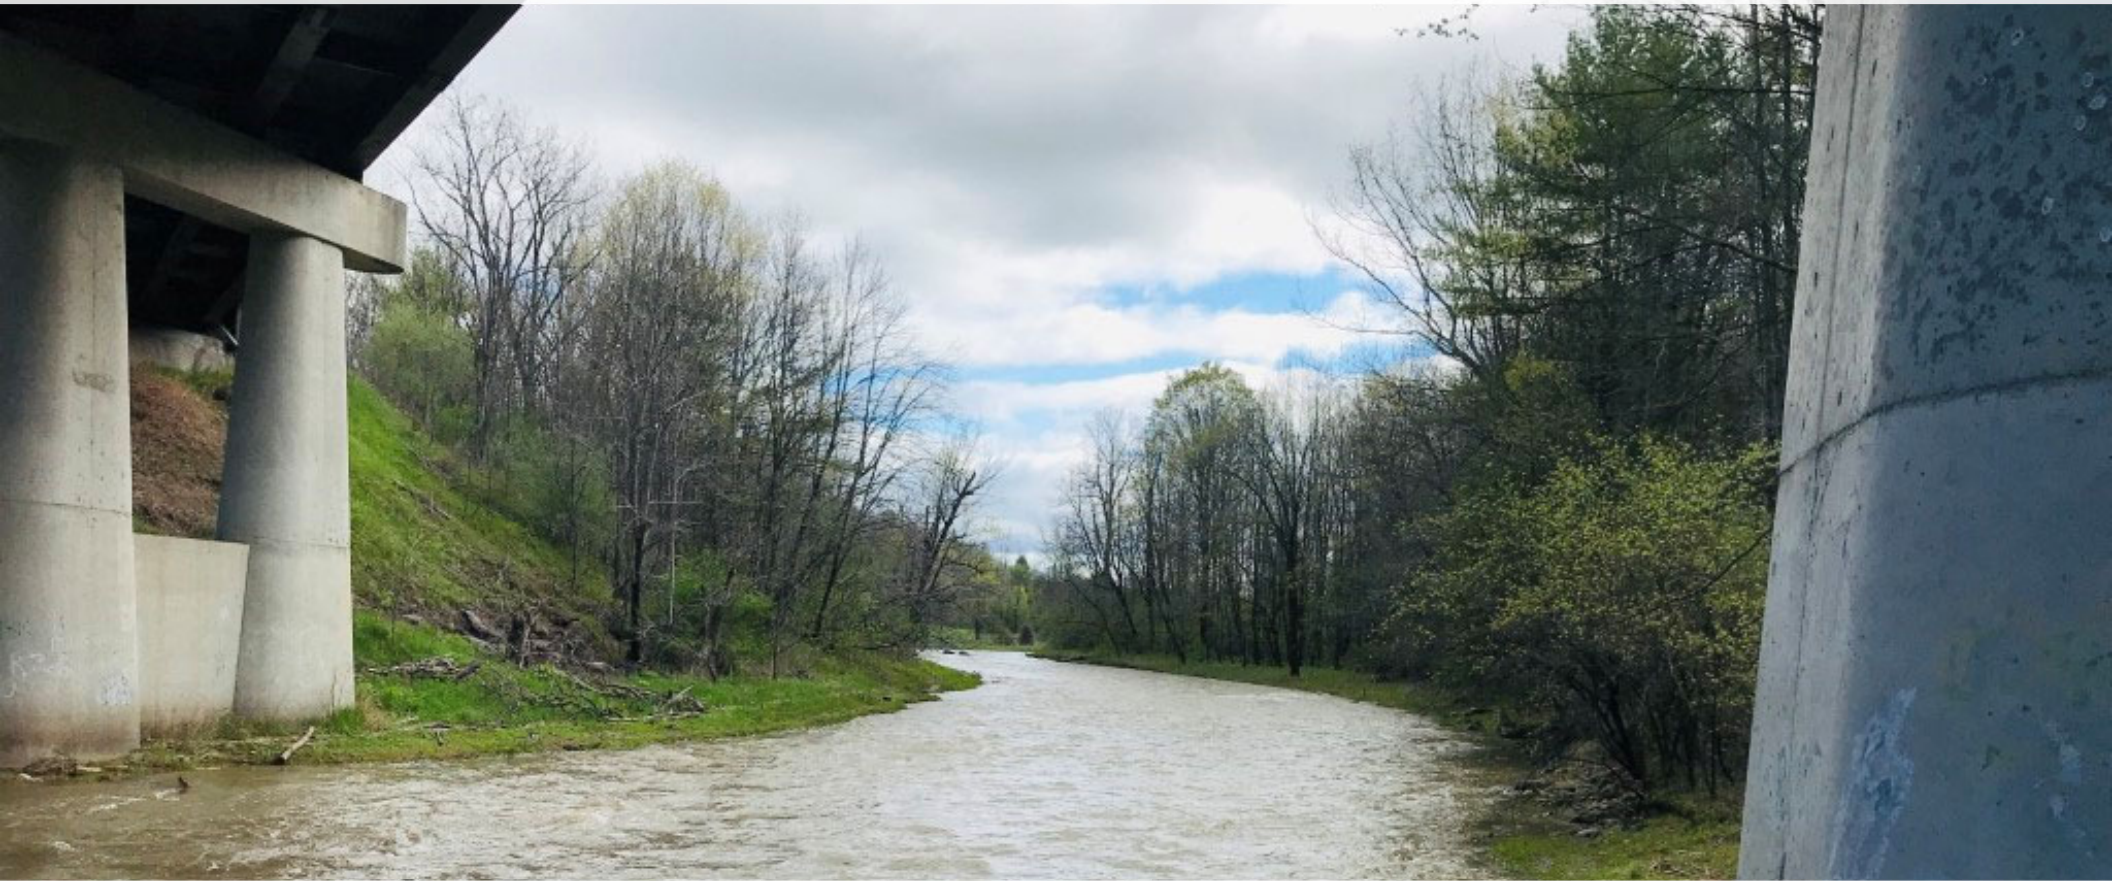
## View Looking East

### Existing Conditions – Bridge 139 Environmental Resources

- Class II Wetlands
- Wildlife Habitat - Site currently passes wildlife
- Federally listed species that have the potential to occur in the project area include the monarch butterfly and northern long-eared bat
- Sensitive for precontact archaeological resources
