AGENCY OF TRANSPORTATION

Wilmington BF 010-1(58) Local Concerns Meeting Structures Engineering Services

June 4, 2024

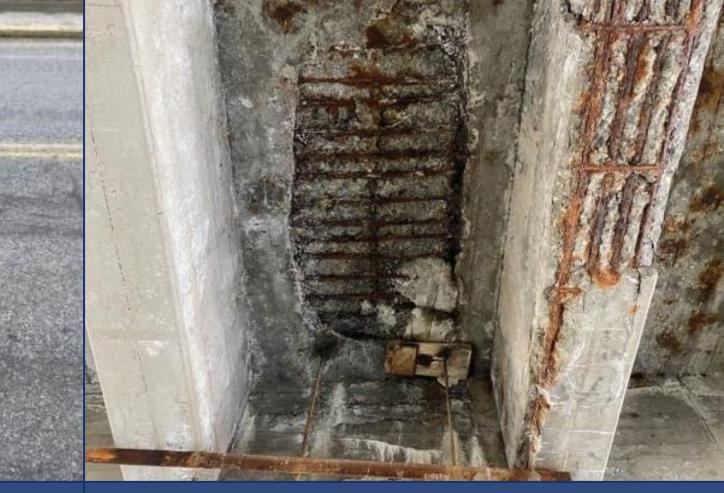
Depression Cracking and Exposed Deck Surface

Probable Full-Depth Deck Hole in Bay 4 with Severe Concrete Spalling and Corroded Reinforcing

The Deck and Superstructure are in **poor condition**. The Substructure is in **fair condition**. **Finding from Inspection on 4/24/24**: possible full depth hole in the deck, triggering a short-term repair.

- Congestion at Rt 9/Rt 100 intersection a notable concern
- Deteriorating concrete throughout, severe deterioration of the deck and tee beams
- Previous deck repairs
