Local Concerns Meeting

Swanton BF 036-1(16)

Bridge 6 – Vermont Route 78 over Missiquoi River

June 10, 2024

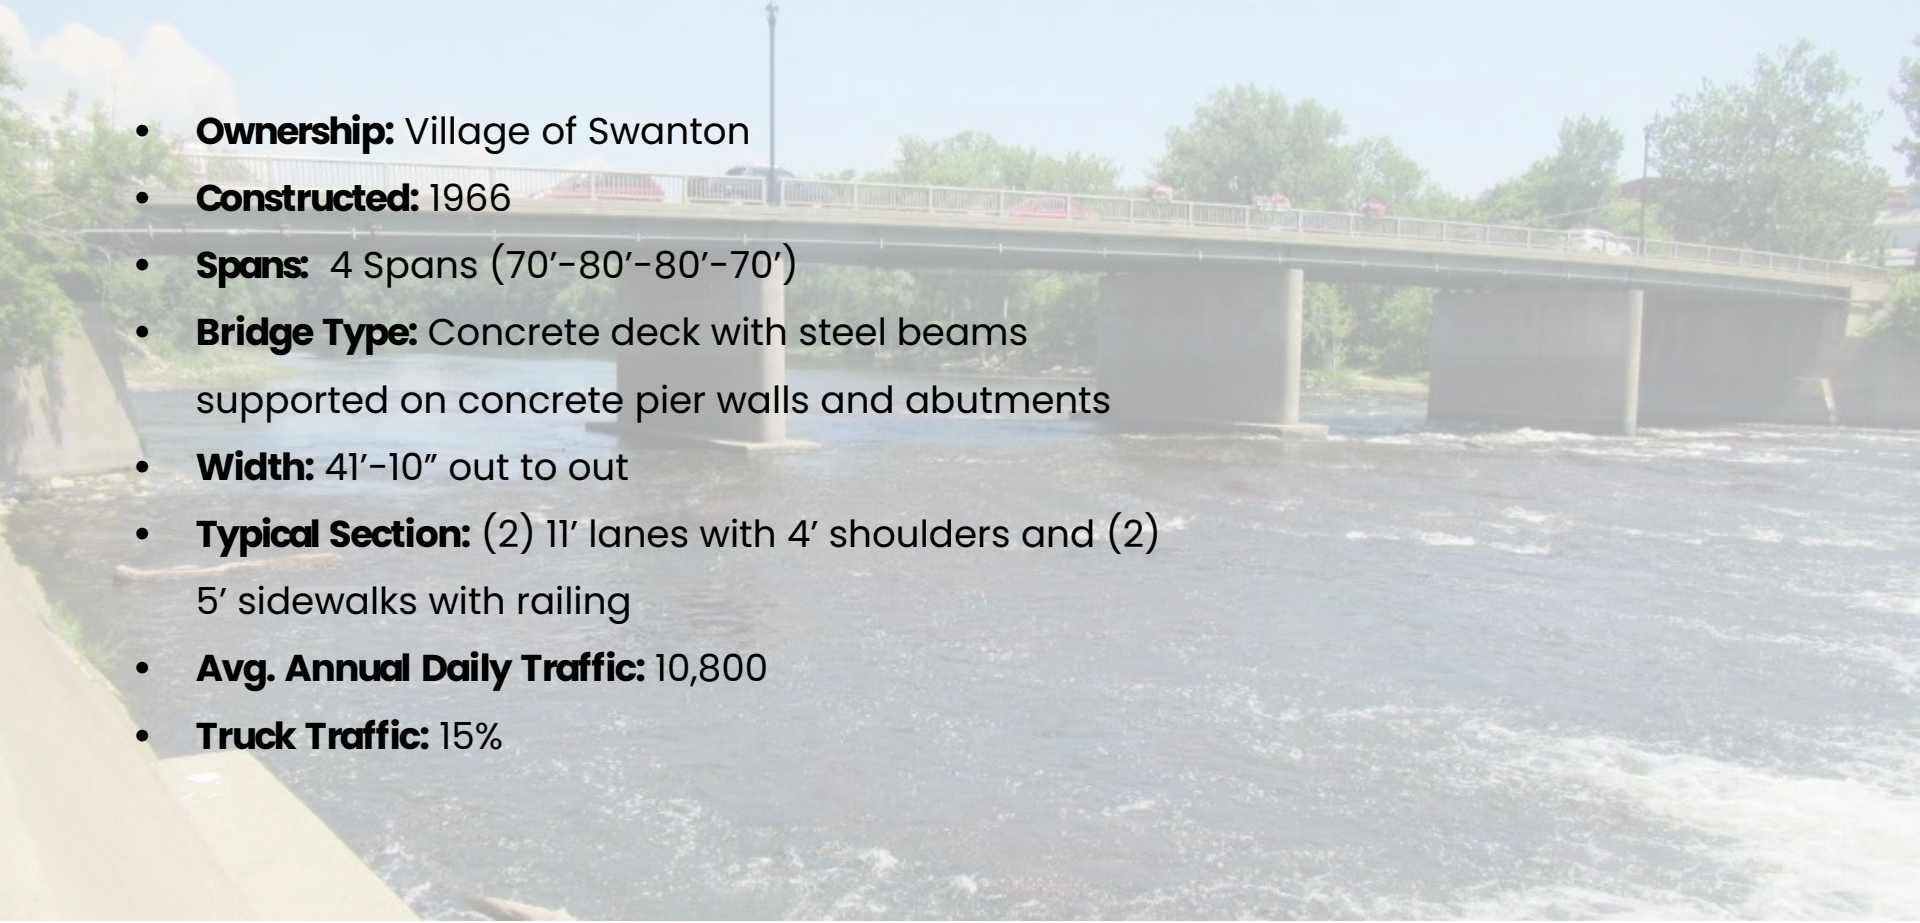
Existing Bridge Information

- **Ownership:** Village of Swanton
- **Constructed:** 1966
- **Spans:** 4 Spans (70'-80'-80'-70')
- **Bridge Type:** Concrete deck with steel beams supported on concrete pier walls and abutments
- **Width:** 41'-10" out to out
- **Typical Section:** (2) 11' lanes with 4' shoulders and (2) 5' sidewalks with railing
- **Avg. Annual Daily Traffic:** 10,800
- **Truck Traffic:** 15%

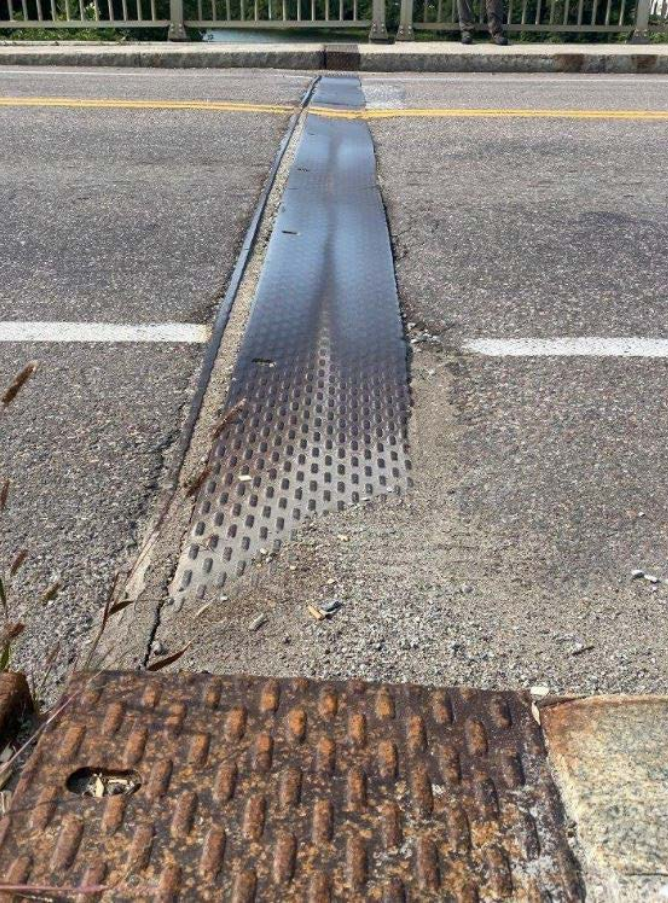
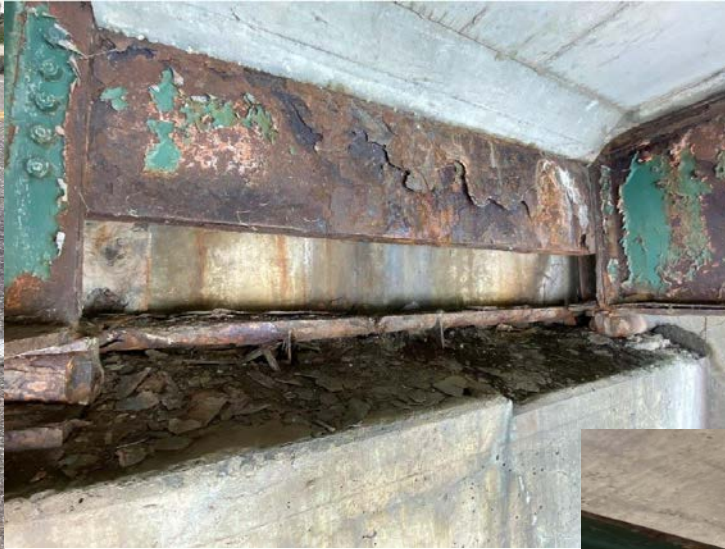
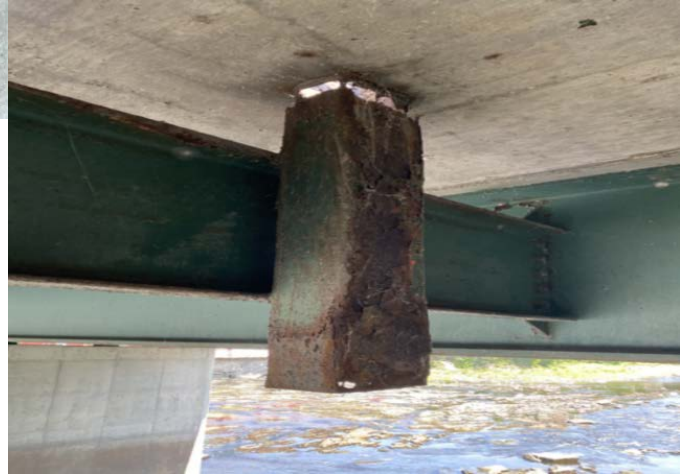
Inspection Findings

Deck Joints
End Diaphragms
Beam Ends
Abutment Seats and
Backwall
Downspouts

- Deck = 6 Satisfactory
- Superstructure = 6 Satisfactory
- Substructure = 6 Satisfactory
- Channel = 8 Very Good

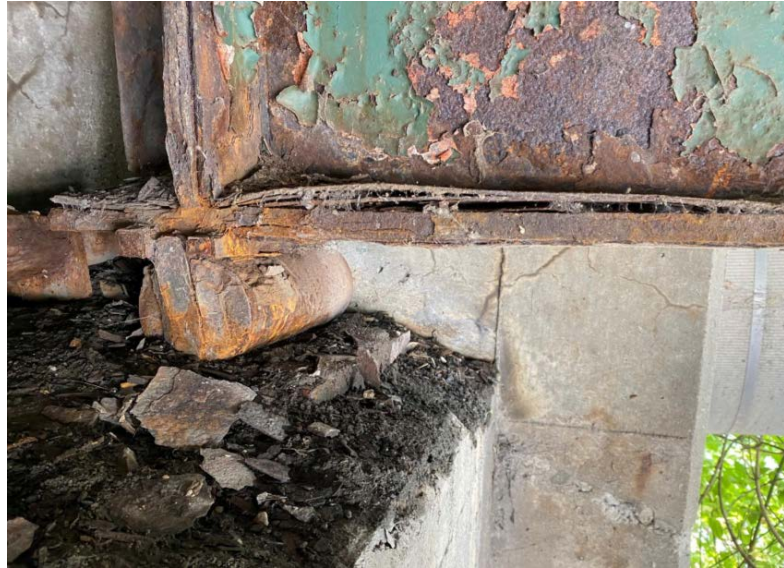
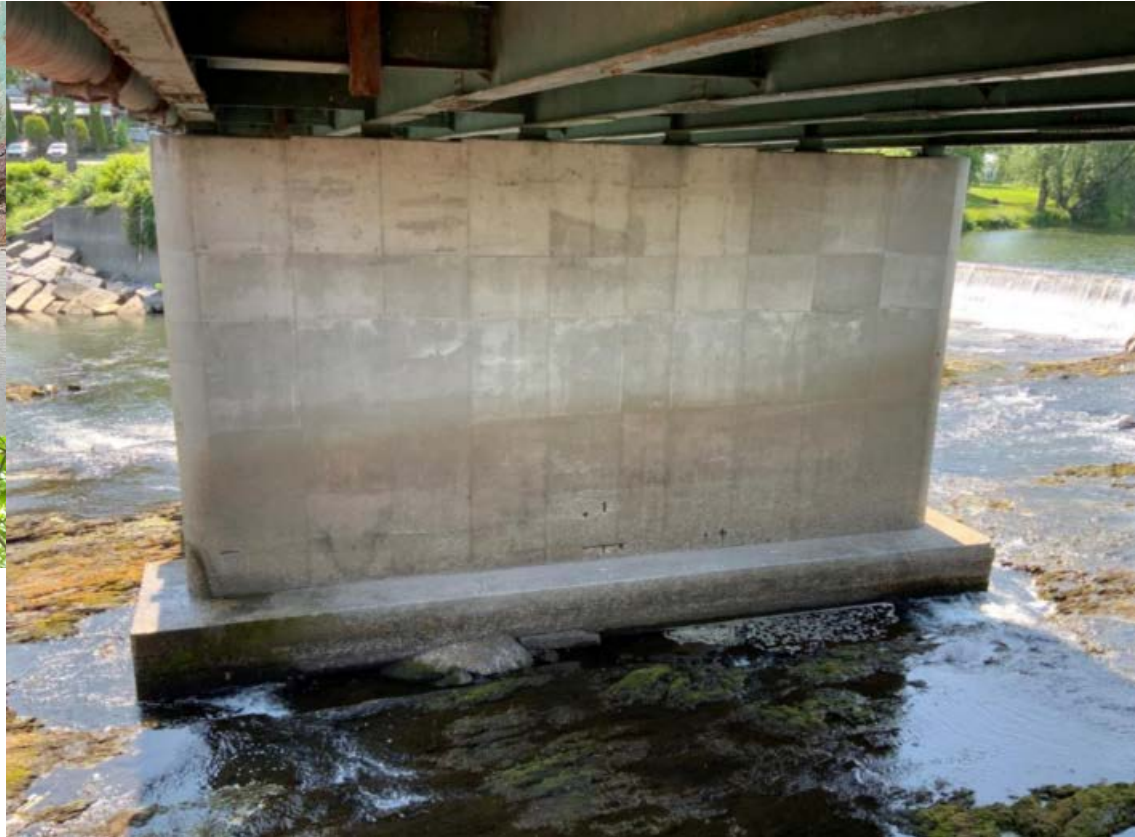
Inspection Findings

Beam Ends
Bearings
Bridge Seat
Pier Walls
