Lincoln BO TRUS(7) Local Concerns Meeting

Town Highway 6 – Bridge 46 over New Haven River

April 1, 2025

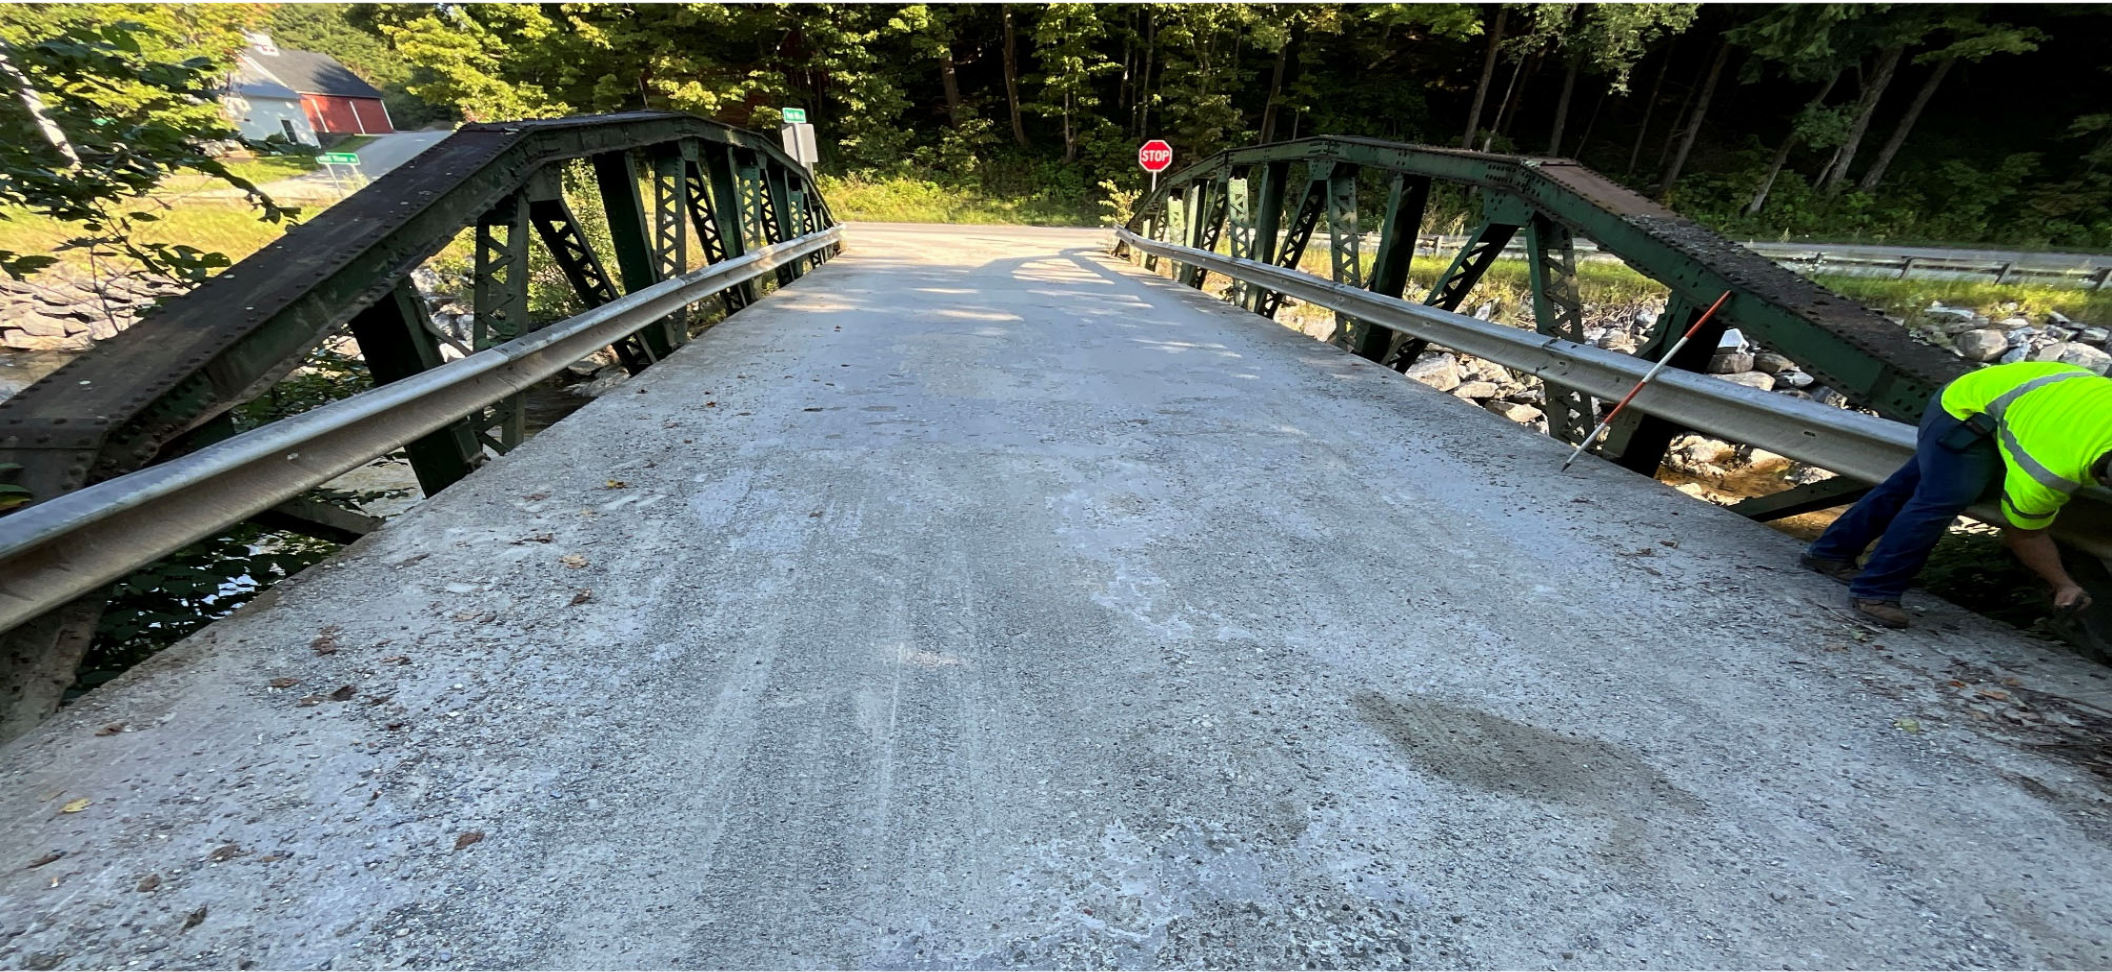
Looking North Towards TH 1

Existing Conditions – Bridge #46

- Roadway Classification – Local Road, Class 3
- Bridge Type – Parker Pony Truss
- Ownership – Town of Lincoln
- Constructed in 1919, reconstructed in 1970

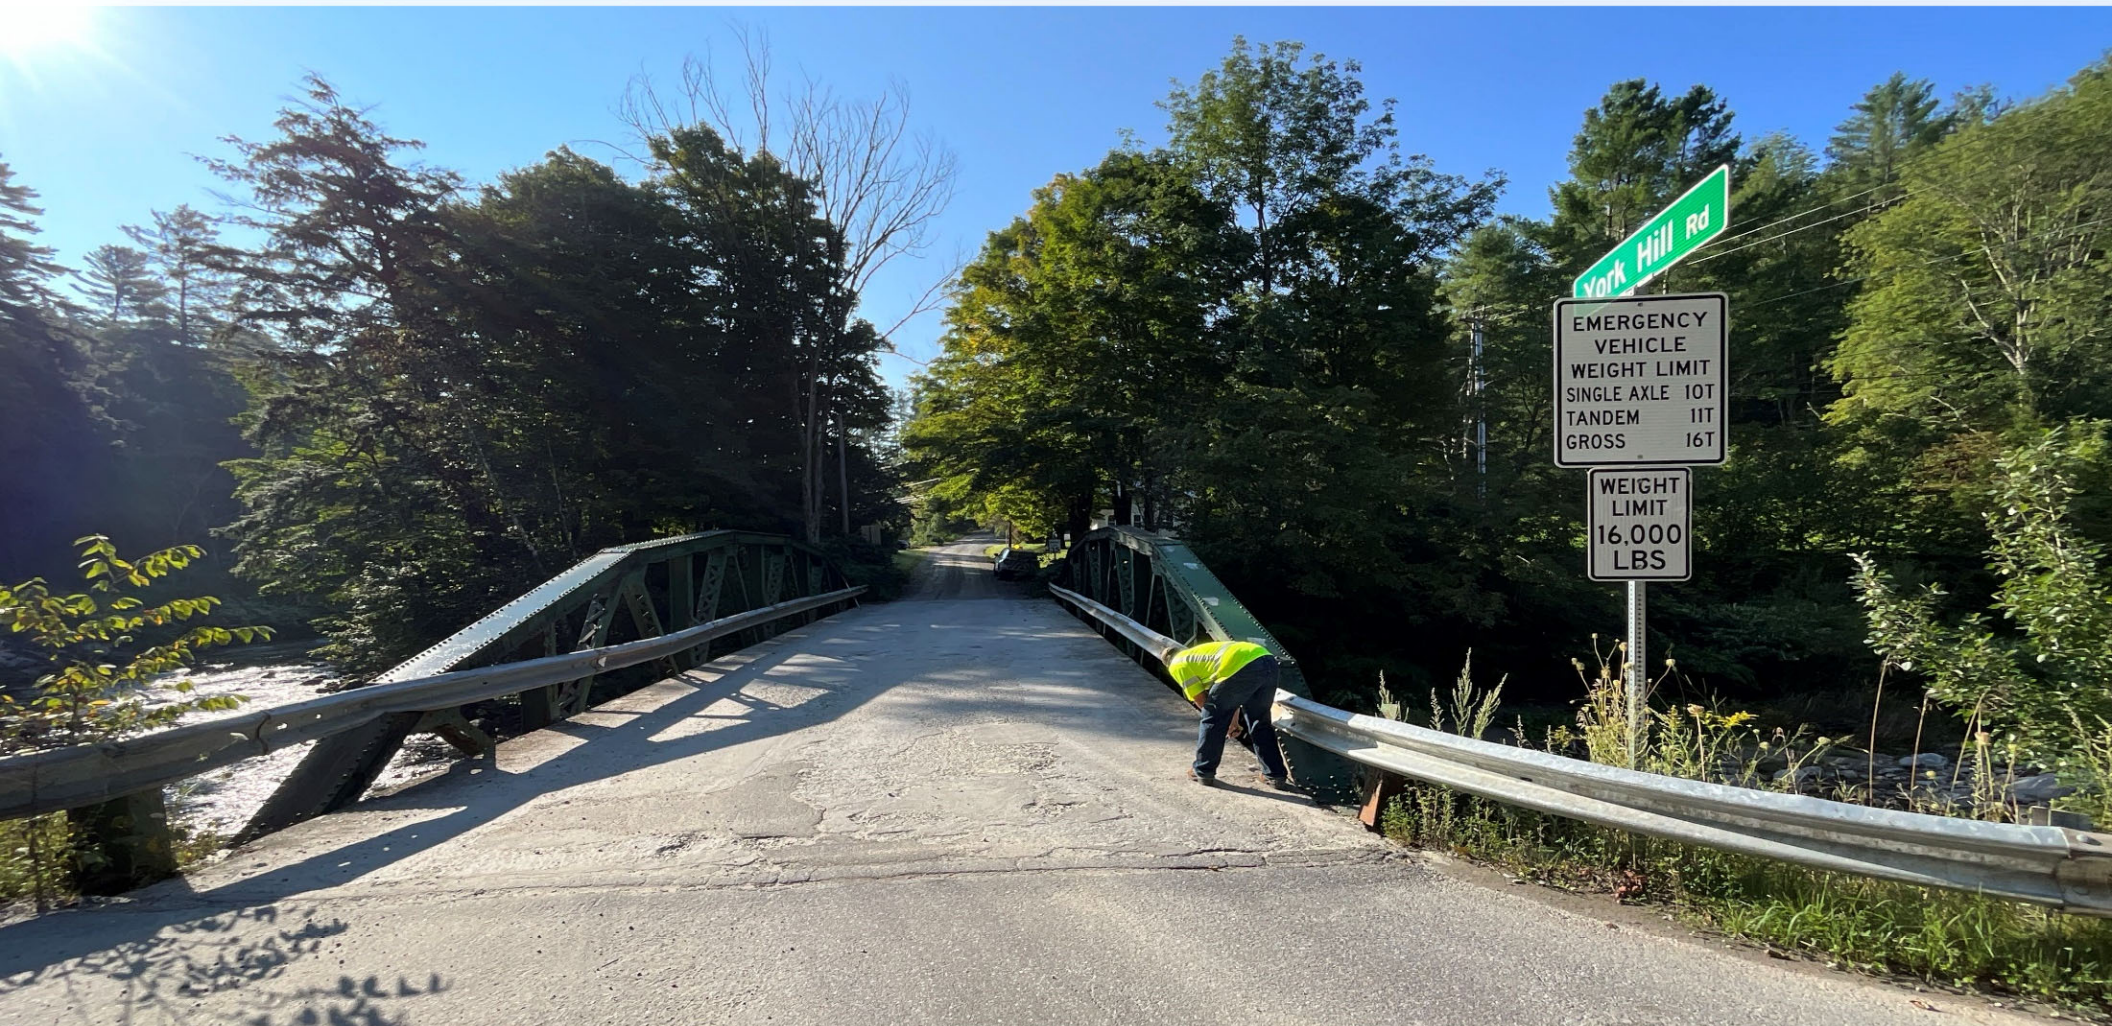
Looking South

Existing Conditions – Bridge #46

- Utilities – Aerial (Green Mountain Power, Comcast, Waitsfield Champlain Valley Telecom)
- Posted for 8 Ton Weight Limit

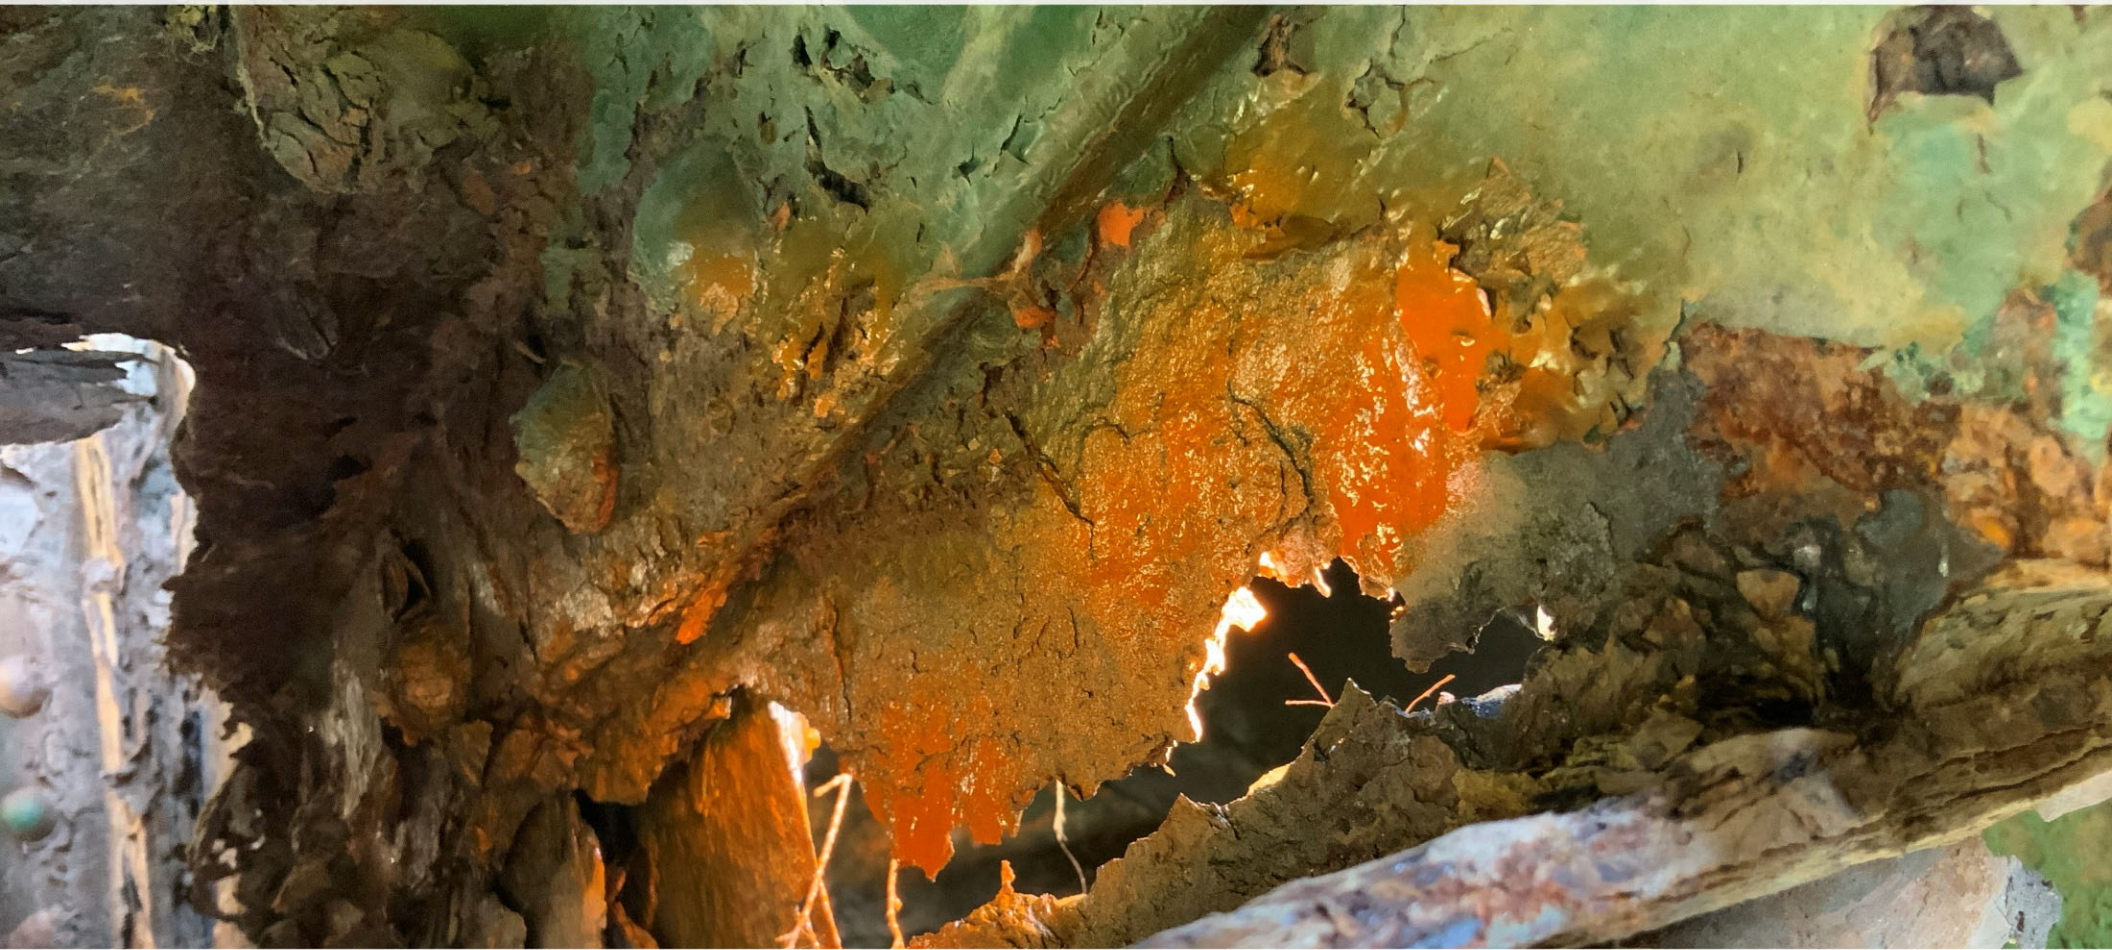
Extensive Corrosion

- The bridge has been getting spot repairs for a decade and the existing steel is showing deterioration. The guardrail is damaged and substandard. The deck needs a new layer of asphalt, preferably with a protective sealant underneath.
- The shoulder width on Bridge 46 and TH 6 is substandard.
- Bridge 46 has substandard freeboard, and the bridge was partially submerged in the 1976, 1998, 2011, & 2023 flood events. The bottom chords should also be washed to remove debris from the flood events.

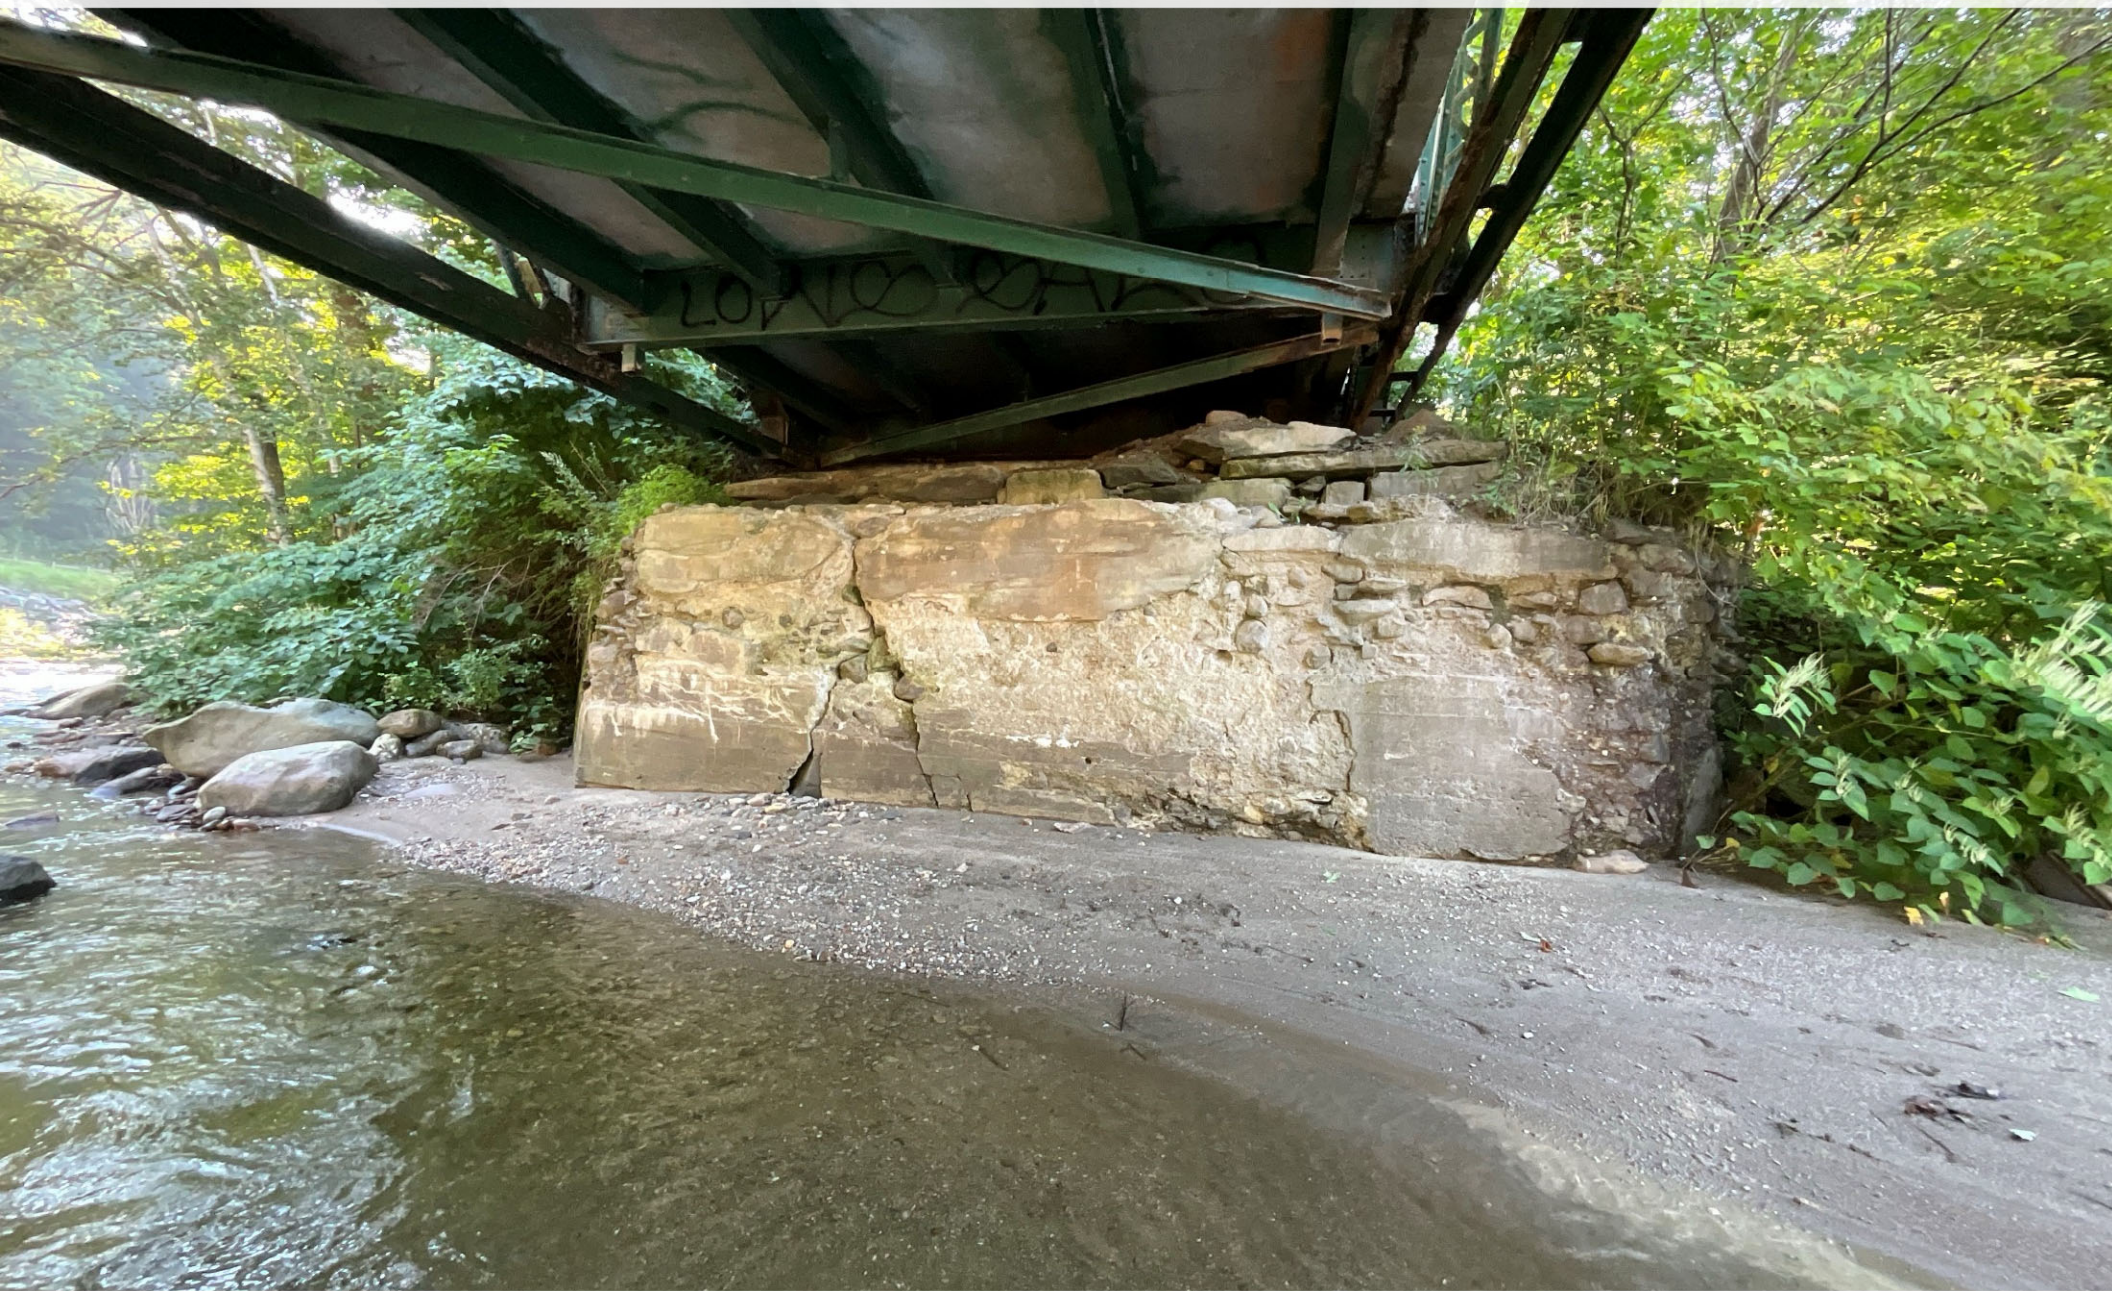
Southern Abutment

- Deck Rating 6 (Satisfactory)
- Superstructure Rating 4 (Poor) – 12-month inspection frequency!
- Substructure Rating 6 (Satisfactory)
- Channel Rating 6 (Satisfactory)

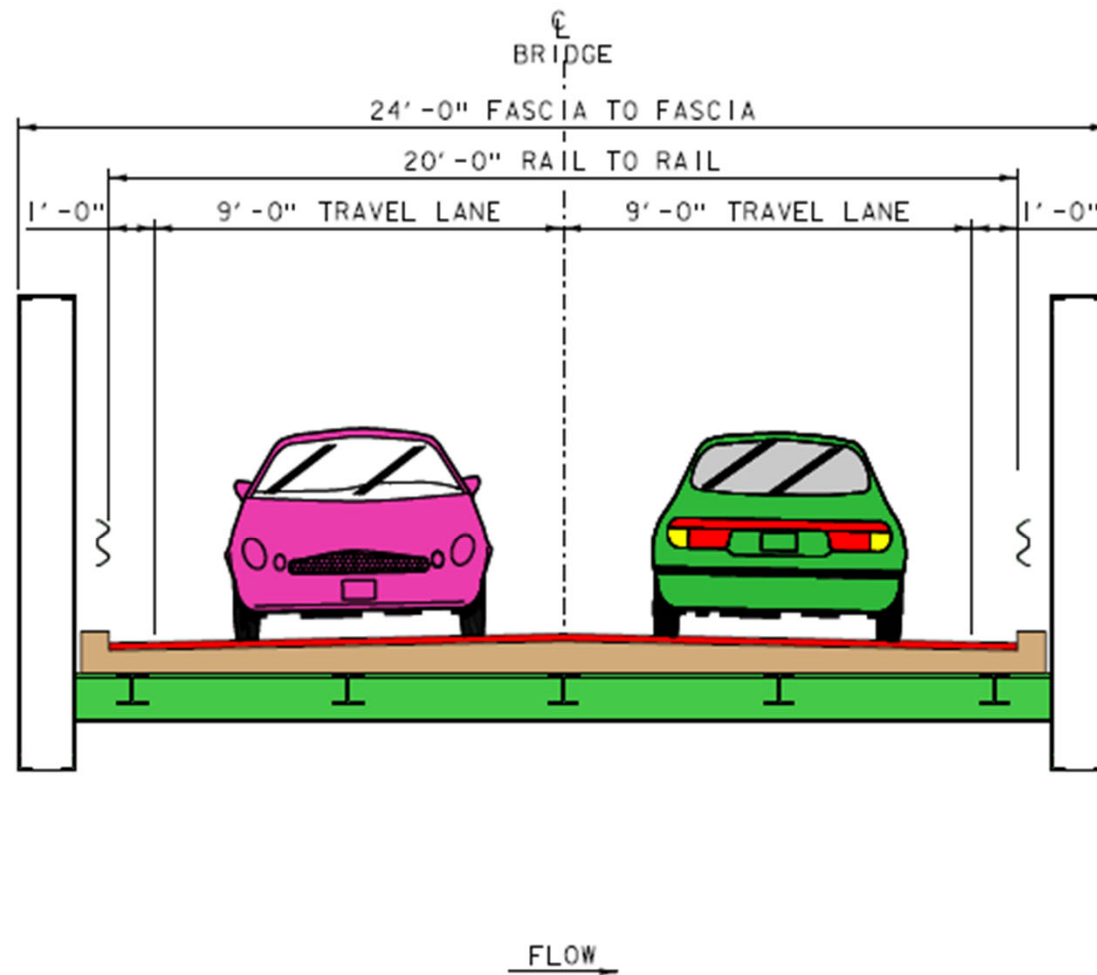
Existing Conditions Typical Section

EXISTING BRIDGE TYPICAL SECTION

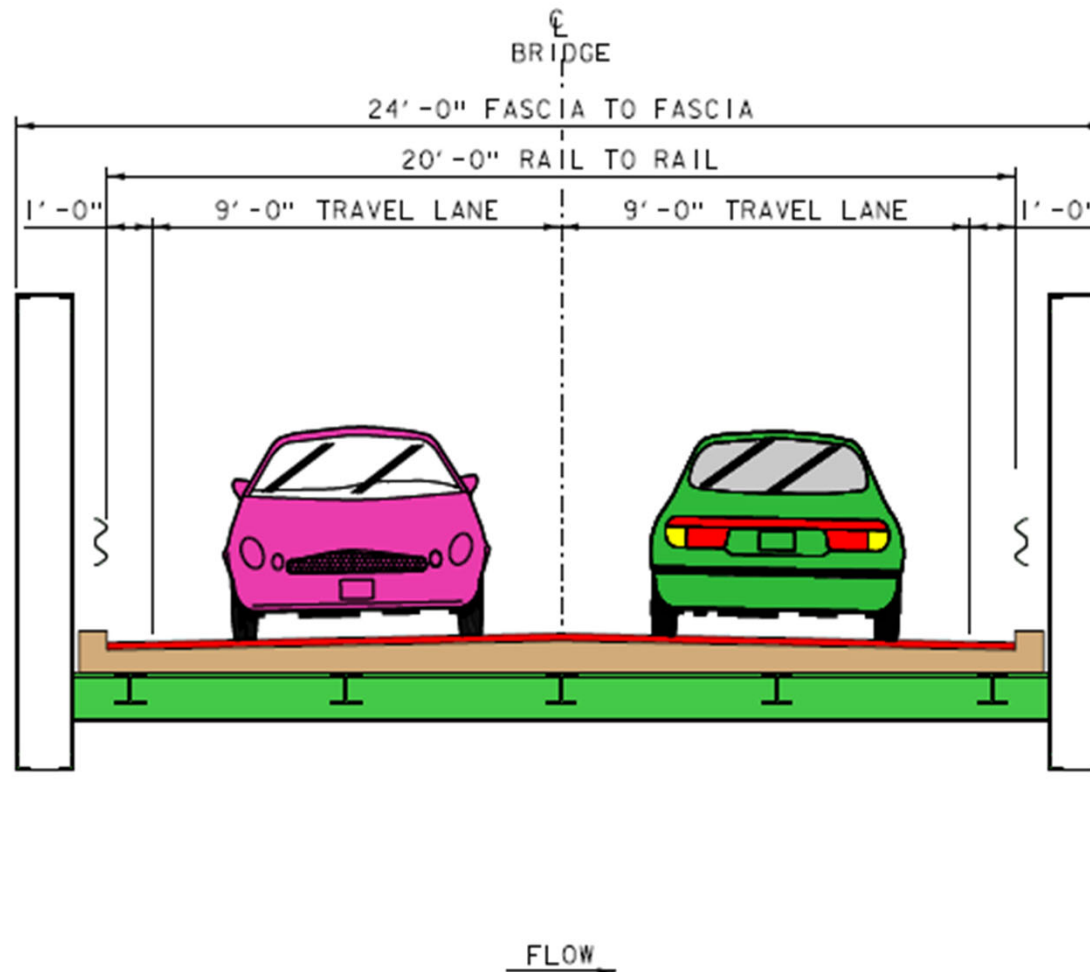
Alternative 1 Typical

EXISTING BRIDGE TYPICAL SECTION

Truss Rehabilitation - Bridge #46

- 9'/1' typical, meets existing

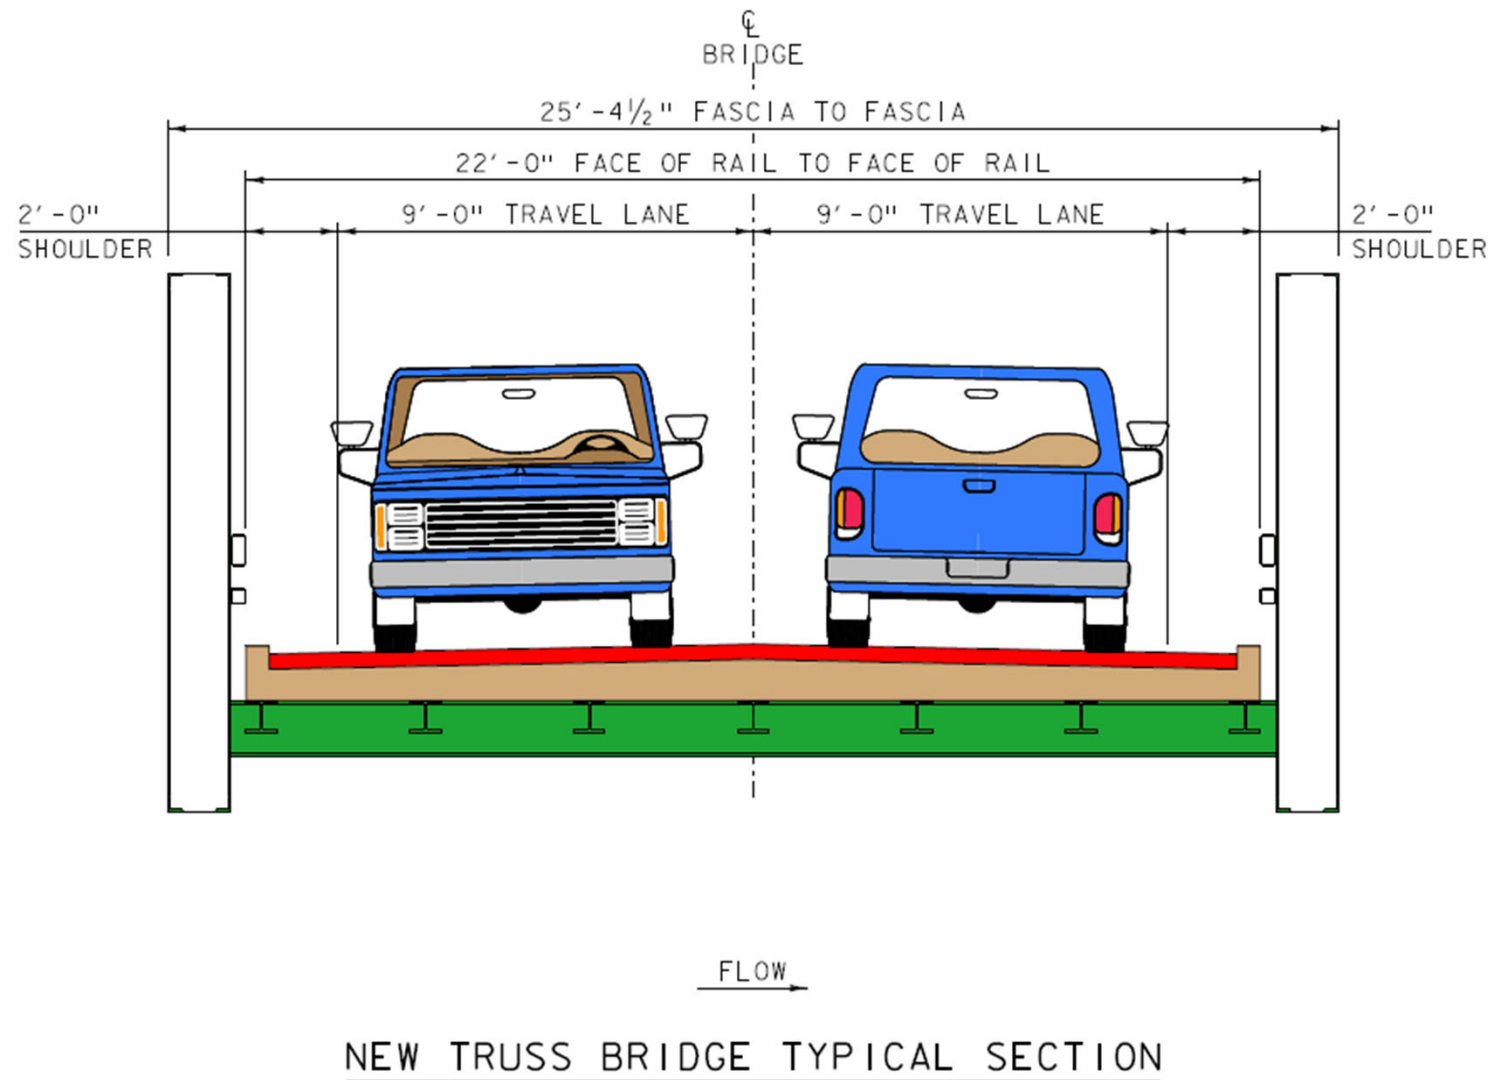
Alternative 2 New Pony Truss Typical

New Parker Pony Truss - Bridge #46

- 9' 1/2' typical

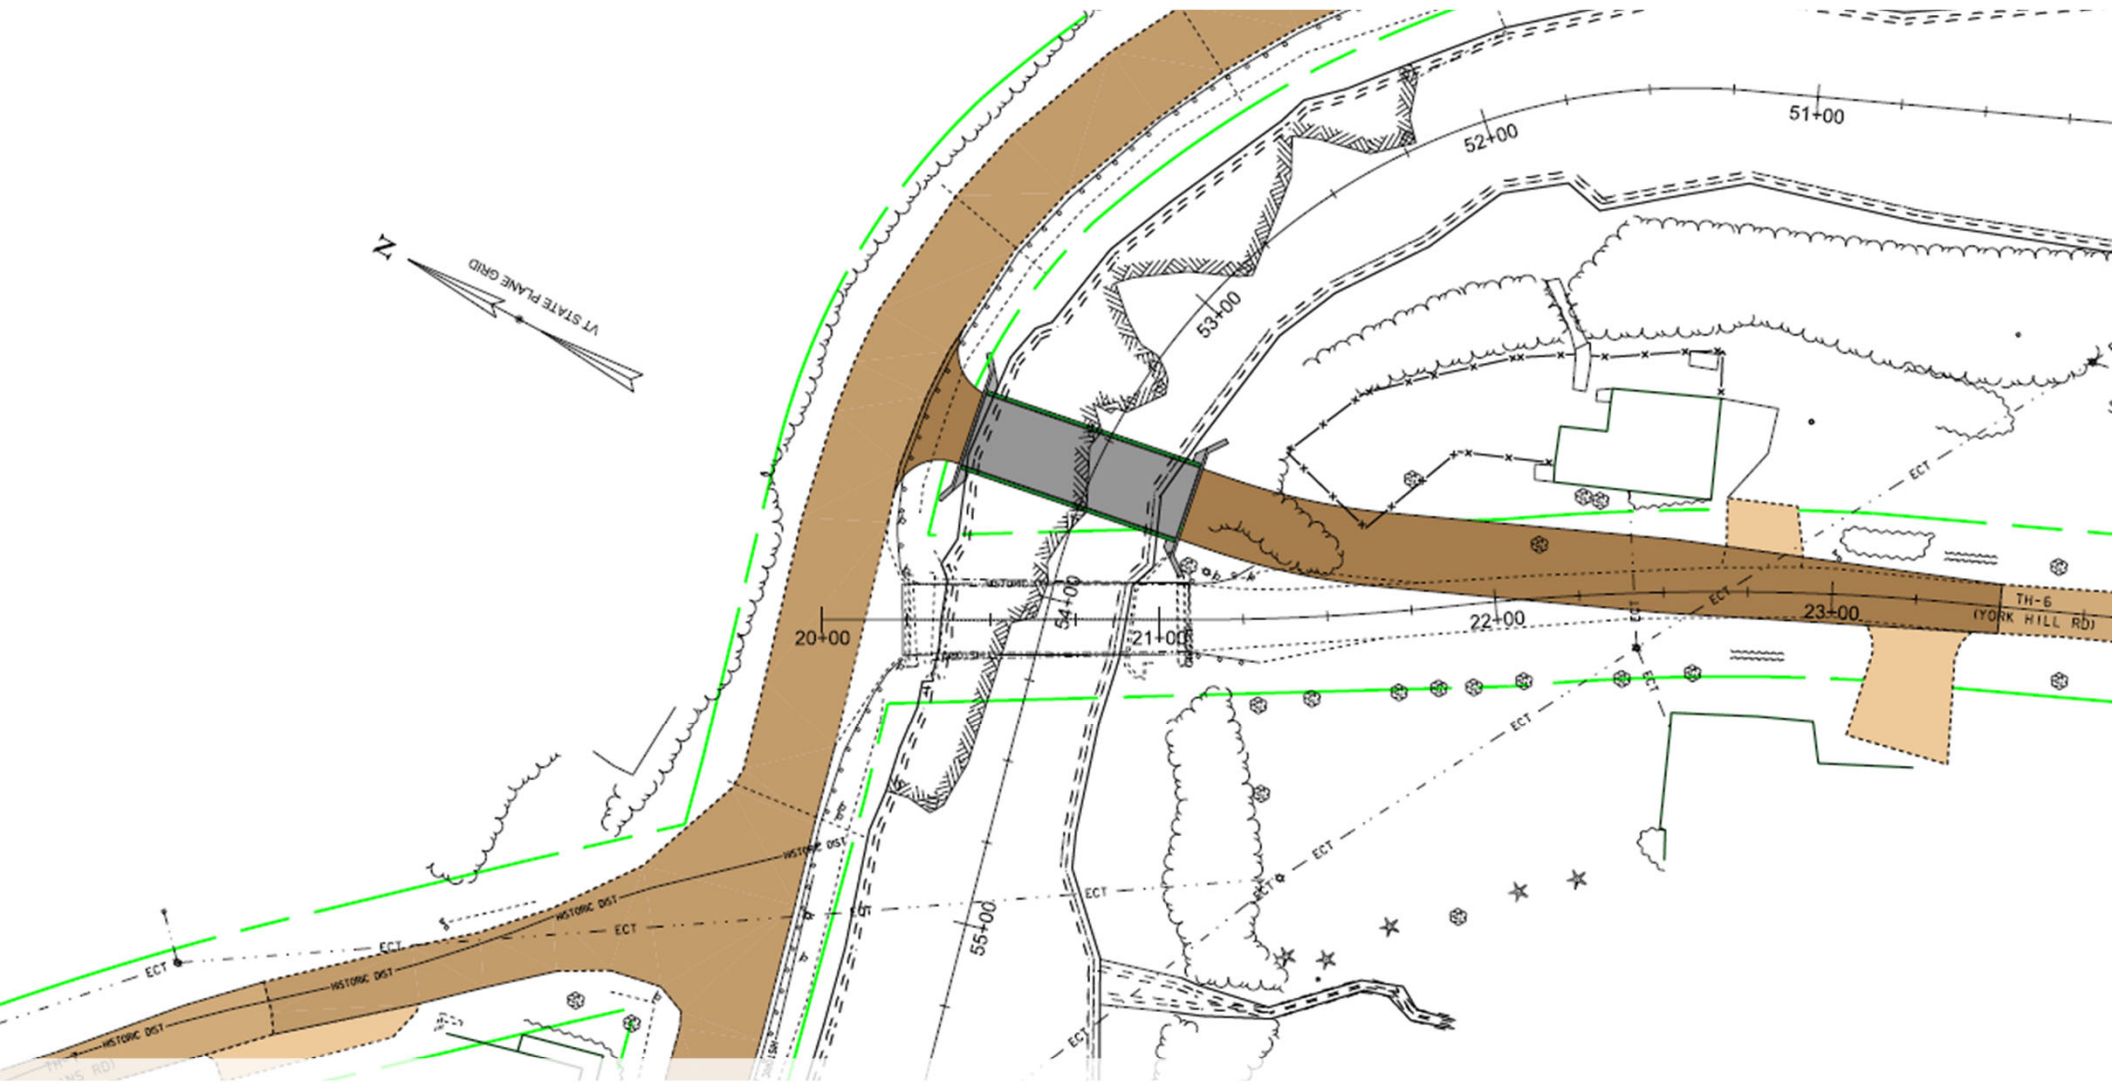
Alternative 2 Off-Alignment Layout

New Parker Pony Truss - Bridge #46

- 75-year design life
- 80' span for improved hydraulics

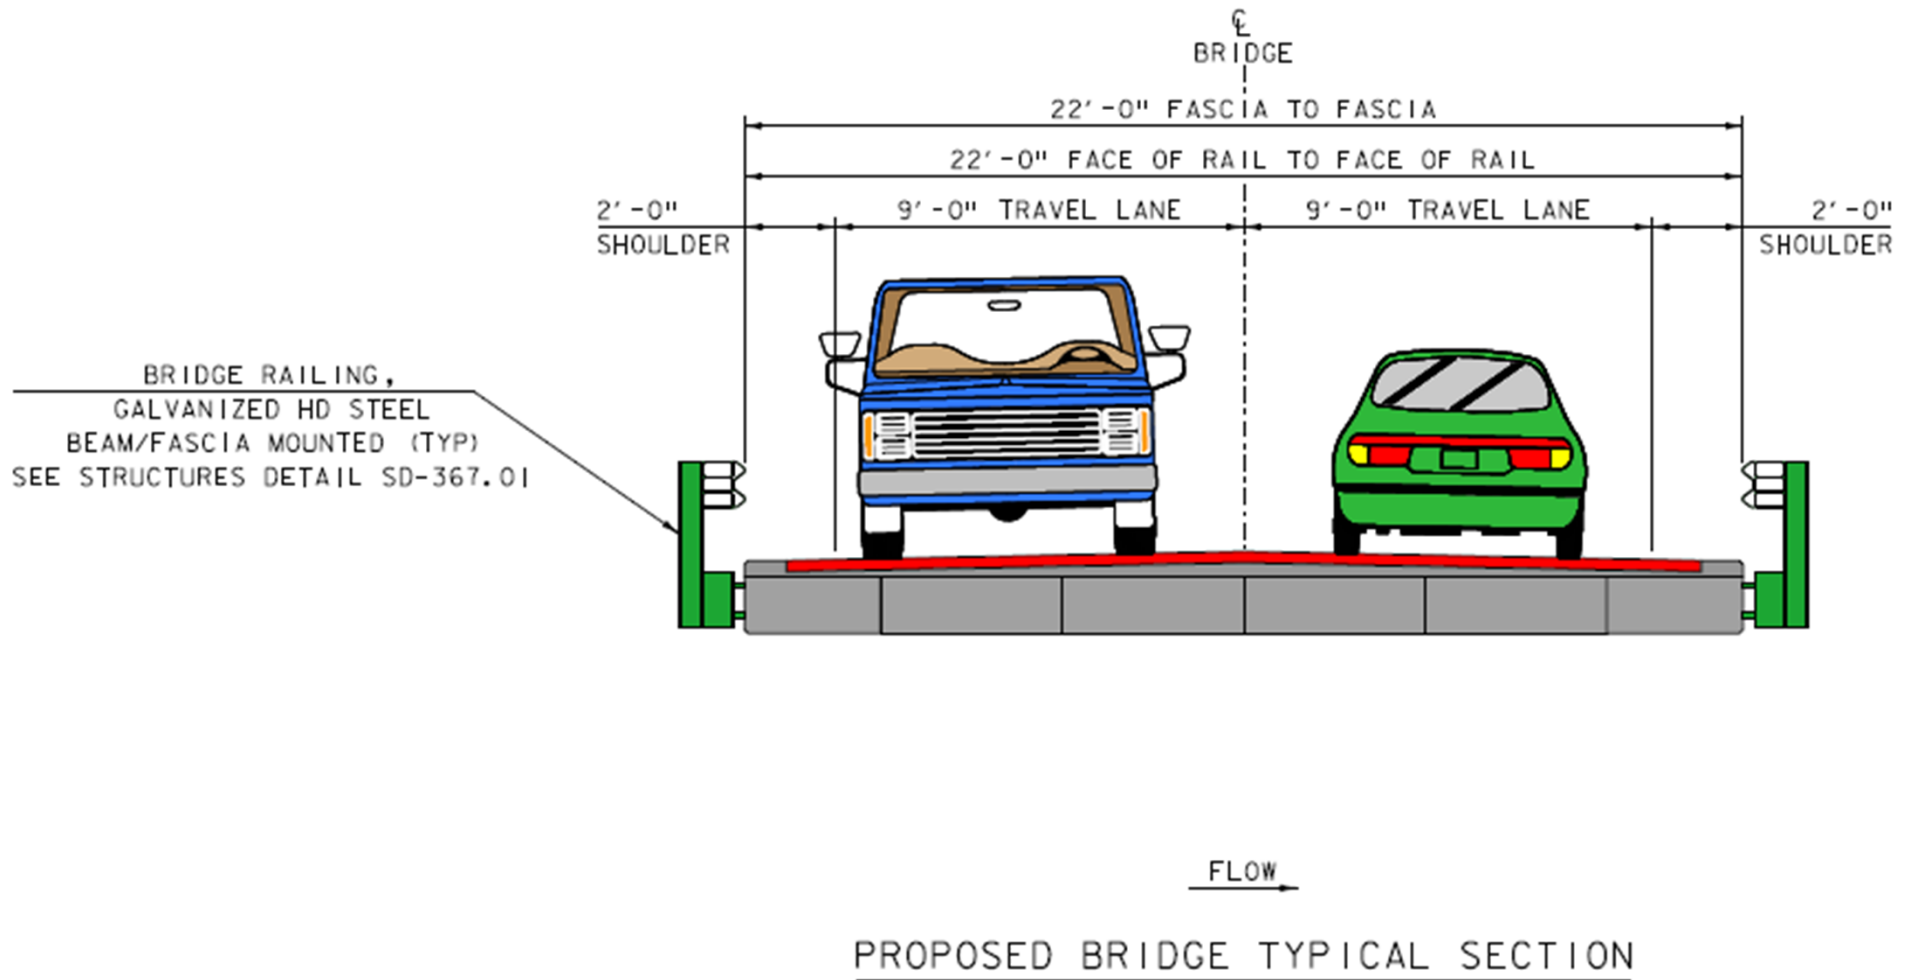
Alternative 3 New Steel Beam Bridge Typical

New Steel Beam Bridge - Bridge #46

- 9'/2' typical

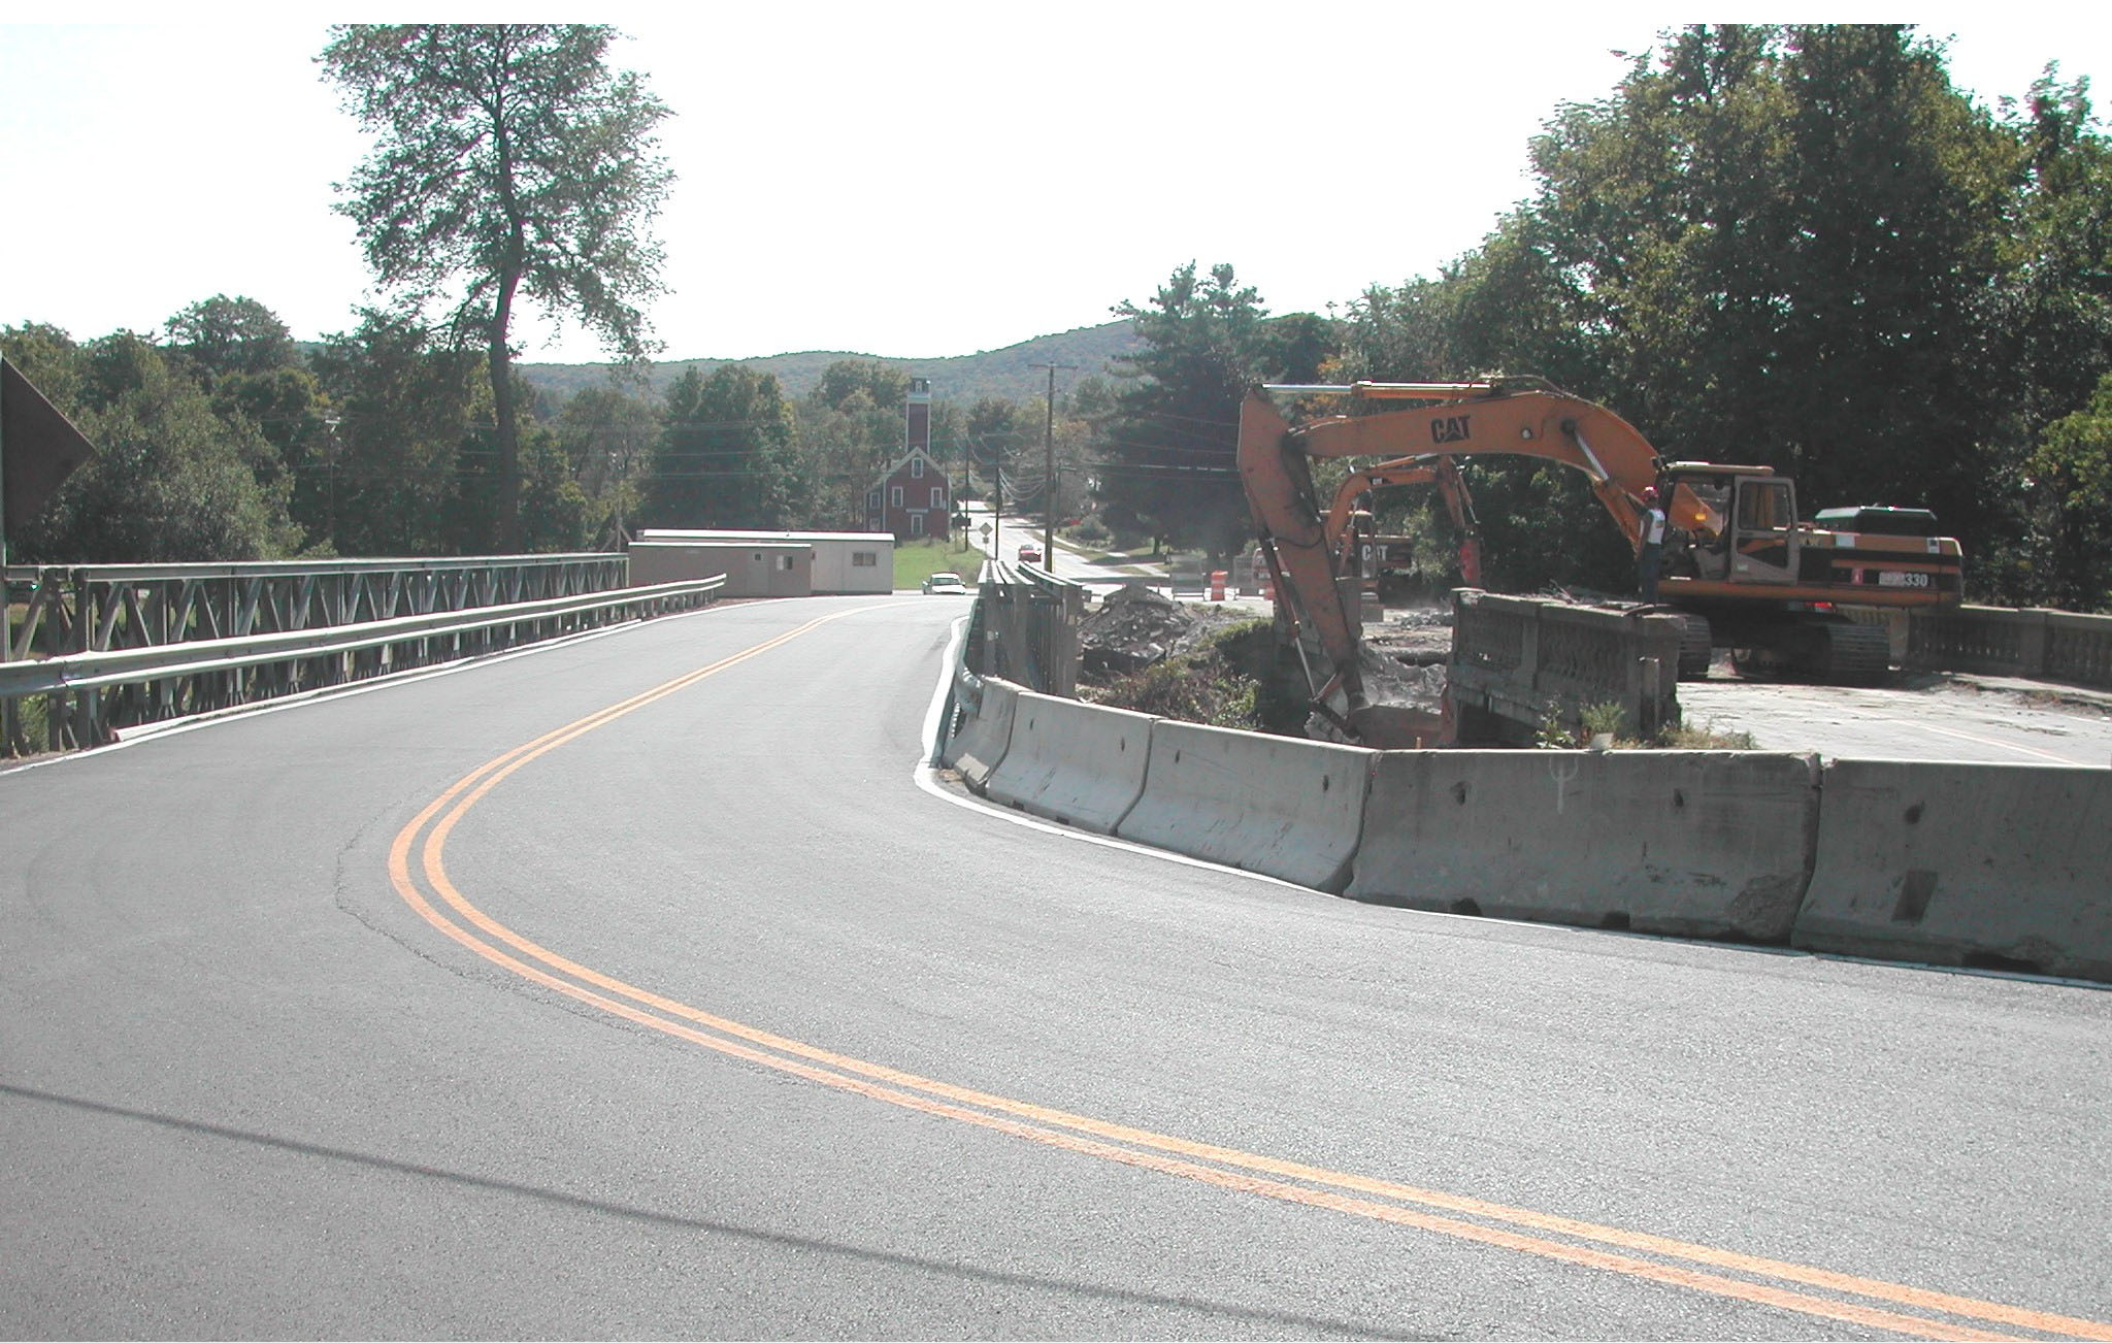
Traffic Control – Detour

- **Regional Detour Route:**

From the intersection of West Hill Rd. and York Hill Rd. - Gove Hill Rd. to West River Rd., and back to the intersection of West River Rd. and West Hill Rd.

- End-to-End Distance: 4.8 miles
- Through Distance: 1.9 miles
- Detour Distance: 2.9 miles
- Added Distance: 1.0 mile

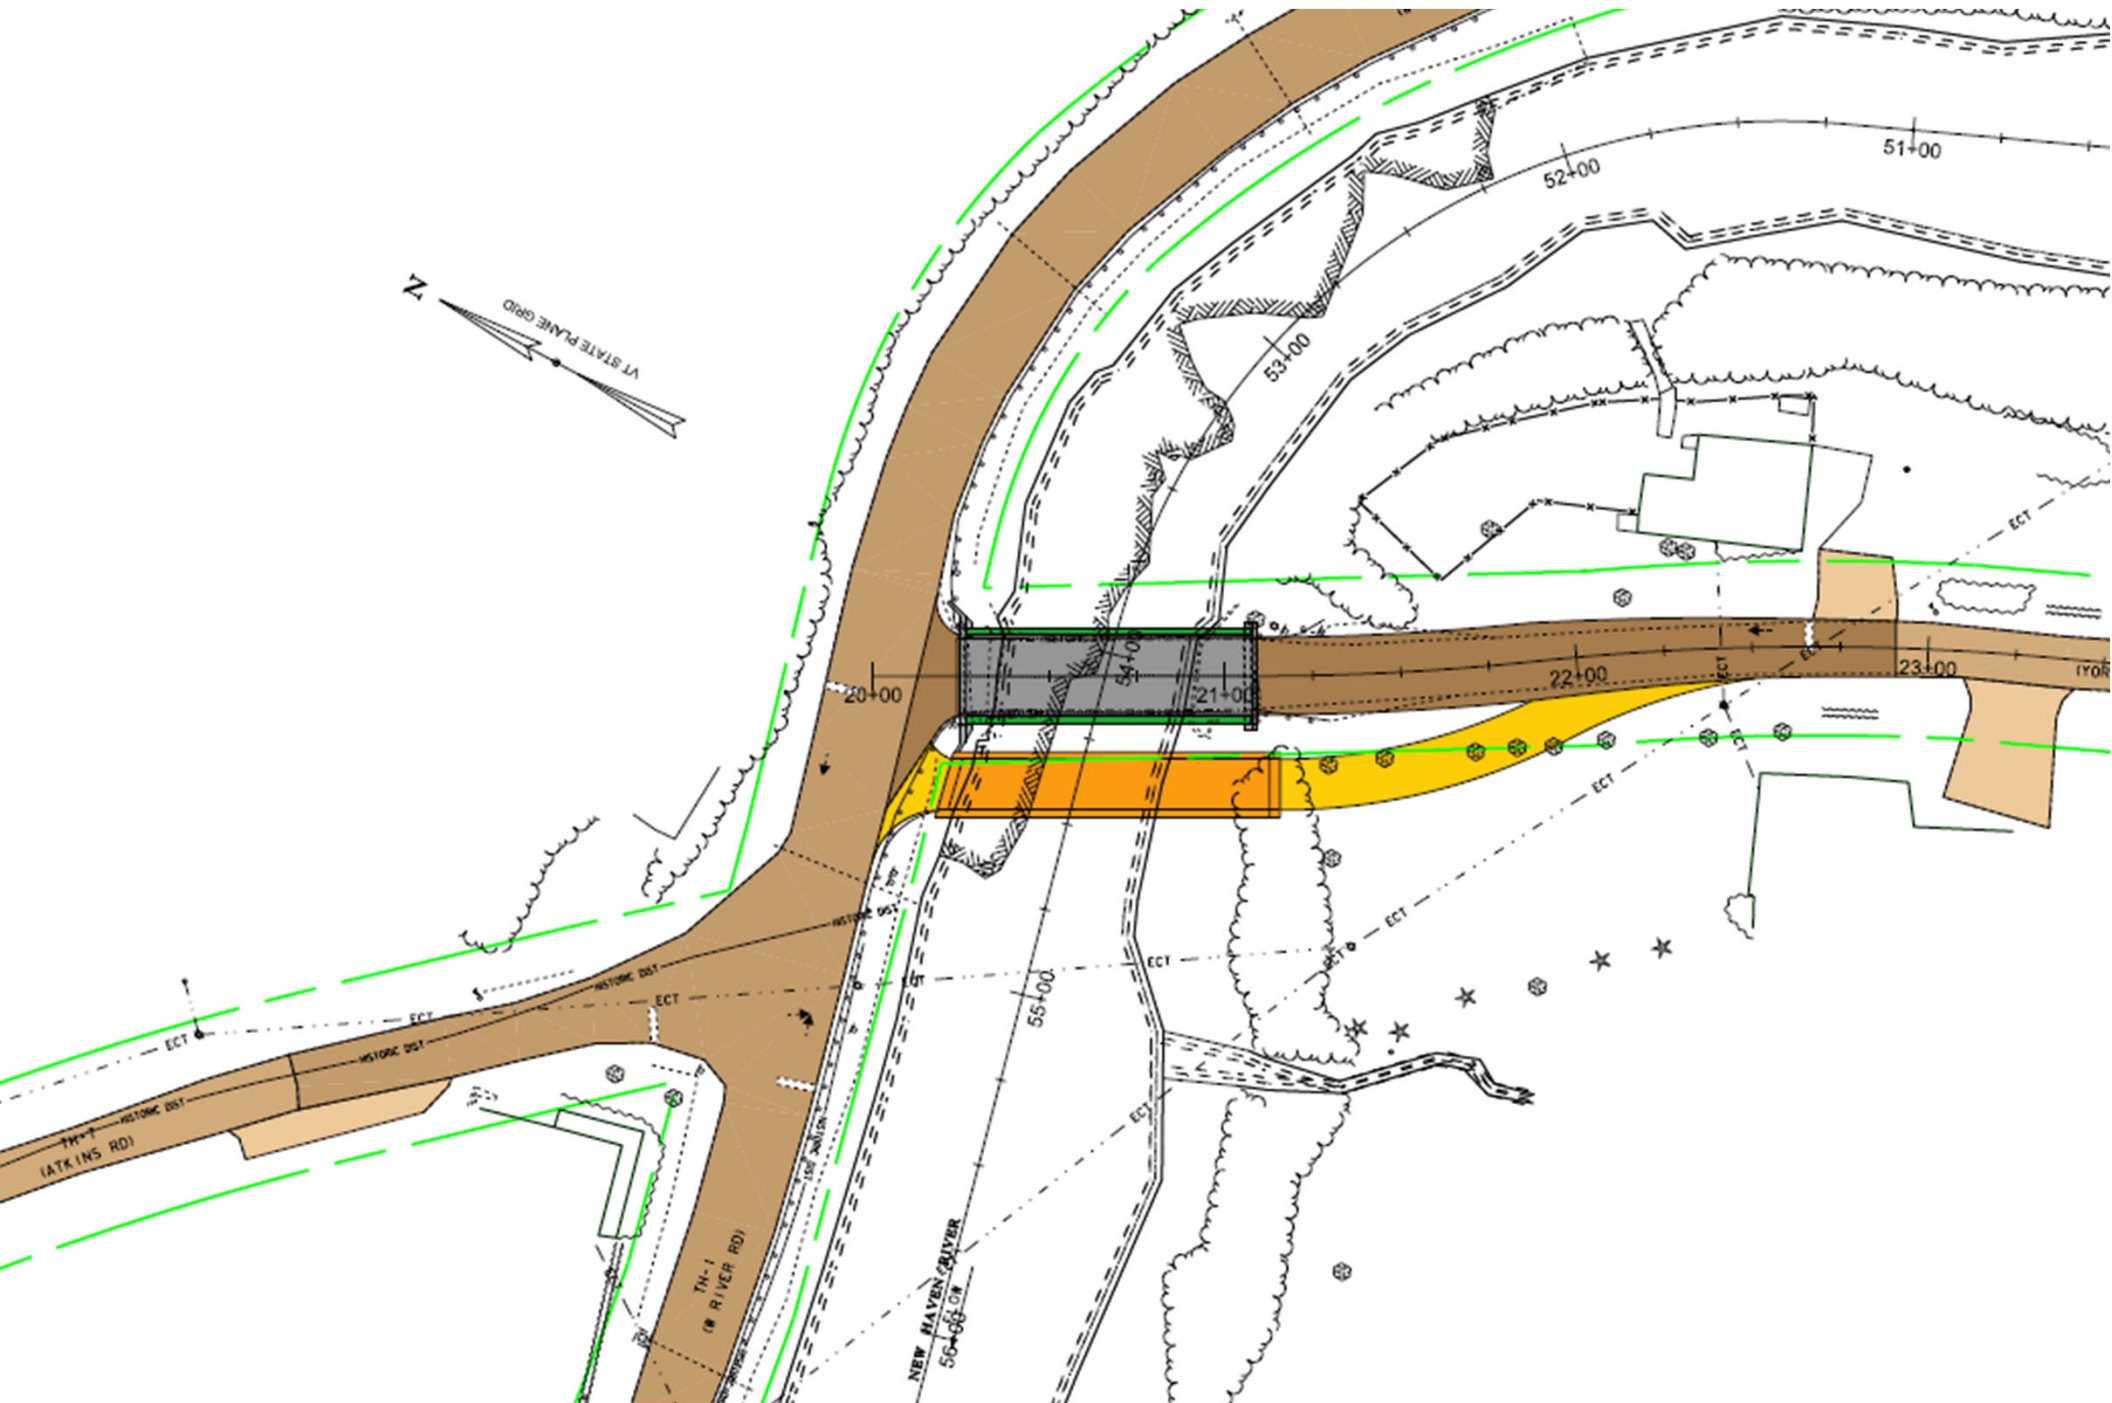
Downstream Temporary Bridge Layout

Temporary Bridge/Roadway

- One Lane Temporary Bridge constructed Downstream
