**STATE OF VERMONT
AGENCY OF TRANSPORTATION**

Scoping Report

Lincoln BO TRUS(7)

Town Highway 6, Bridge 46 over New Haven River

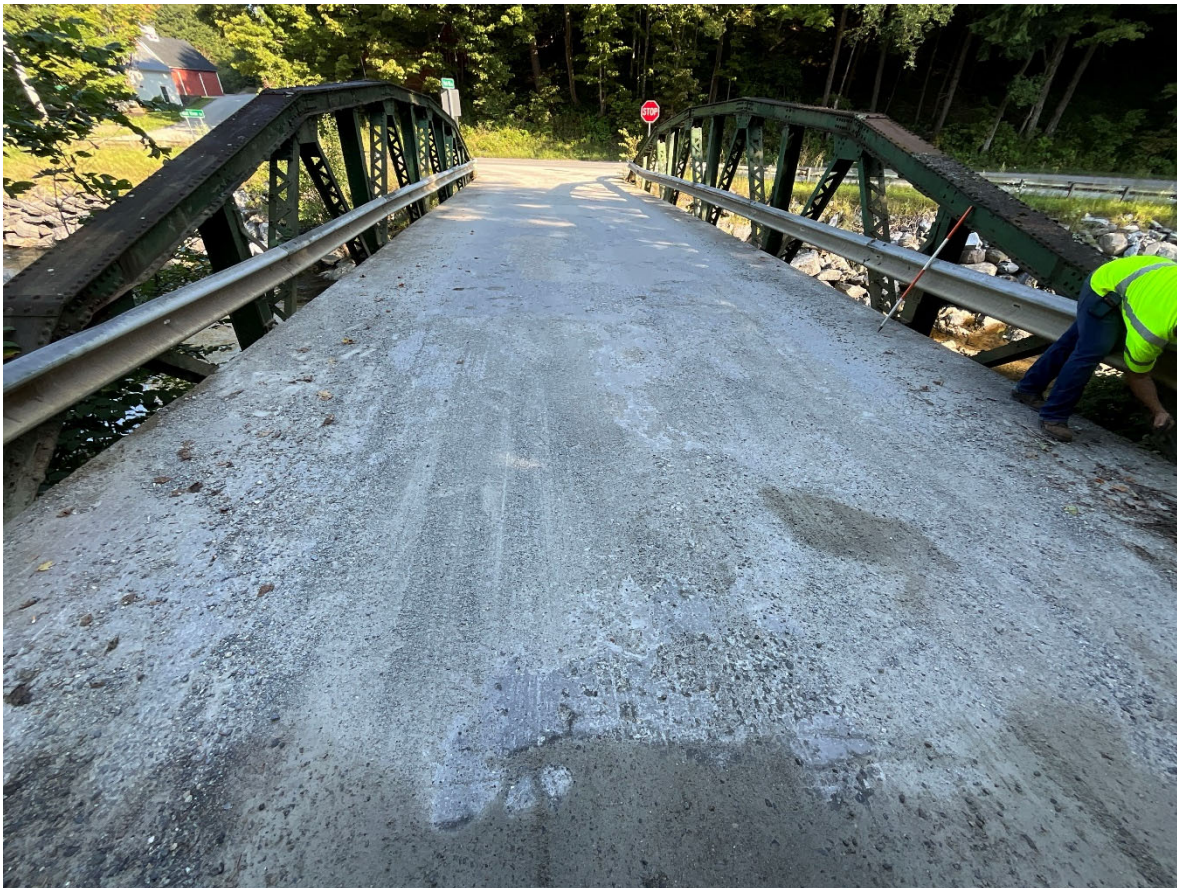
Wearing surface

1. The bridge has been getting spot repairs for a decade and the existing steel is showing deterioration. The guardrail is damaged and substandard. The deck is in need of a new layer of asphalt, preferably with a protective sealant underneath.
2. The shoulder width on Bridge 46 and Town Highway 6 is substandard.
3. Bridge 46 has substandard freeboard and the bridge was partially submerged in the 1976, 1998, 2011, & 2023 flood events. The bottom chords should also be washed to remove debris from the flood events.

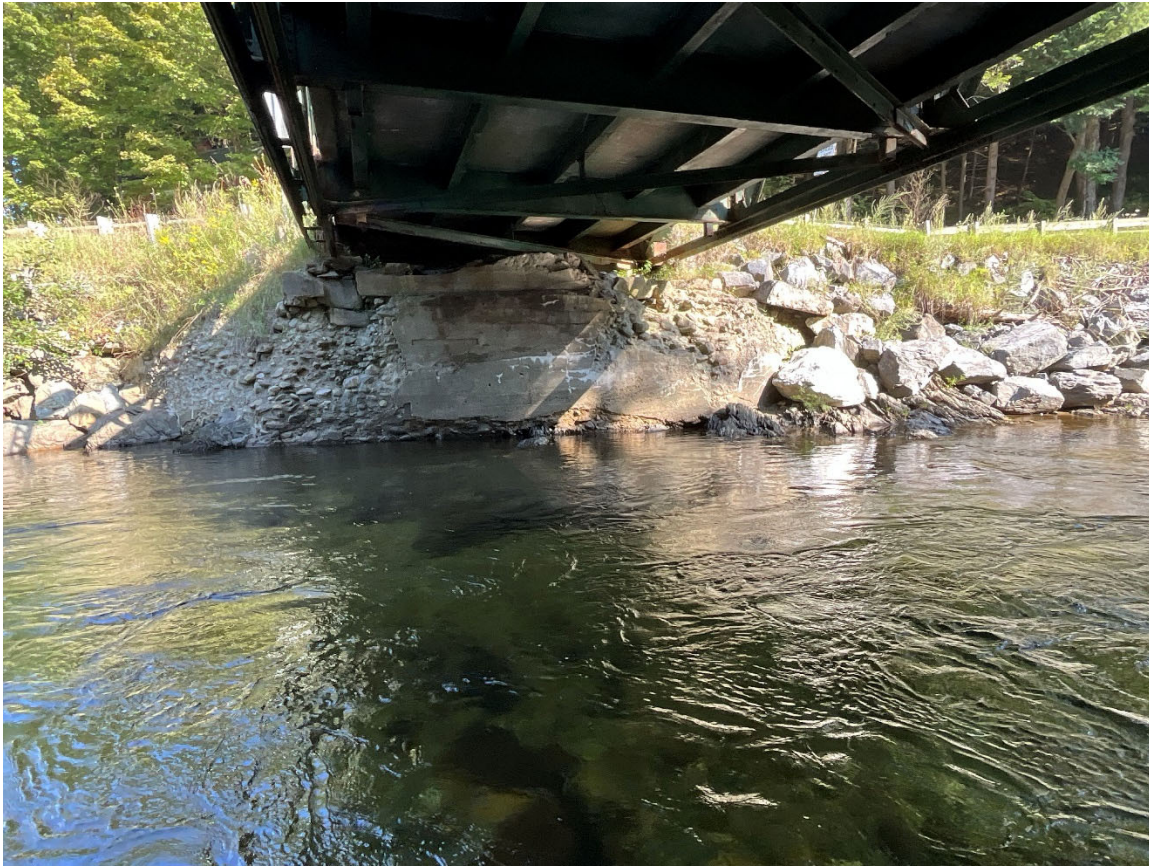
Abutment 1

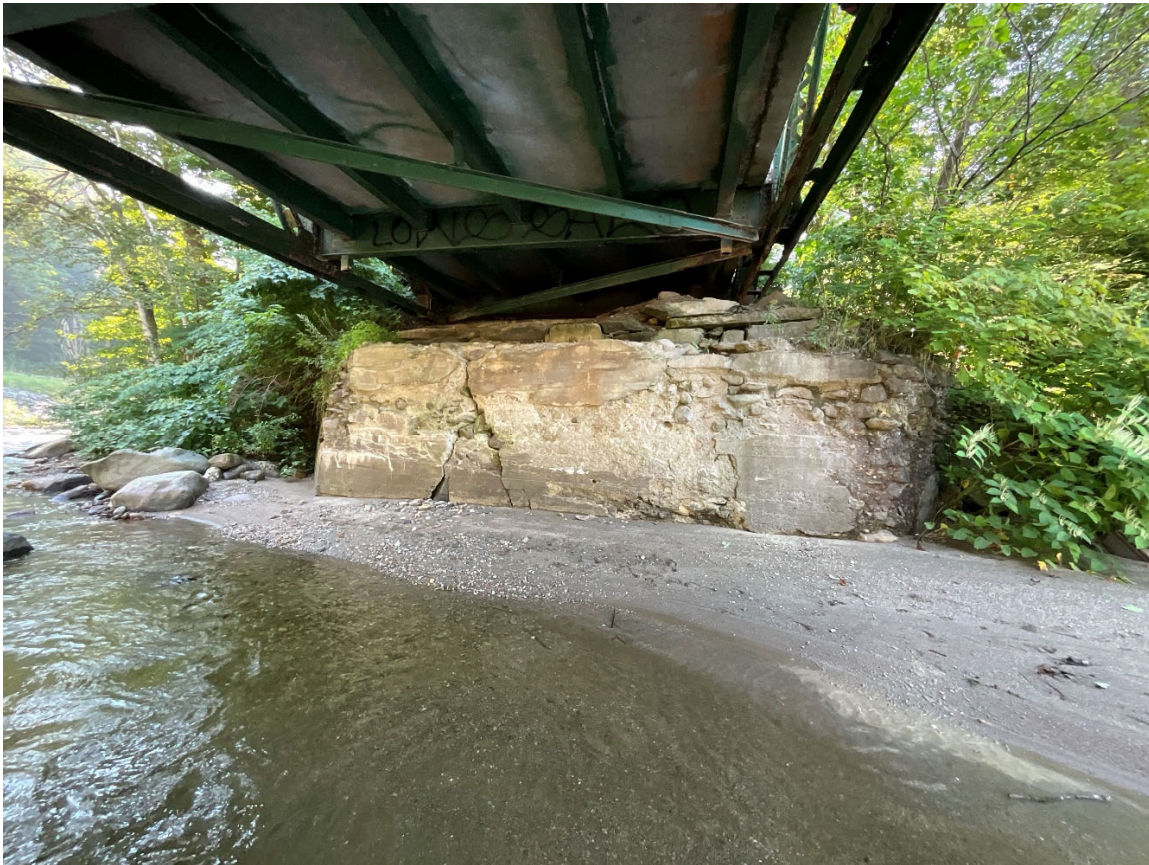
Abutment 2

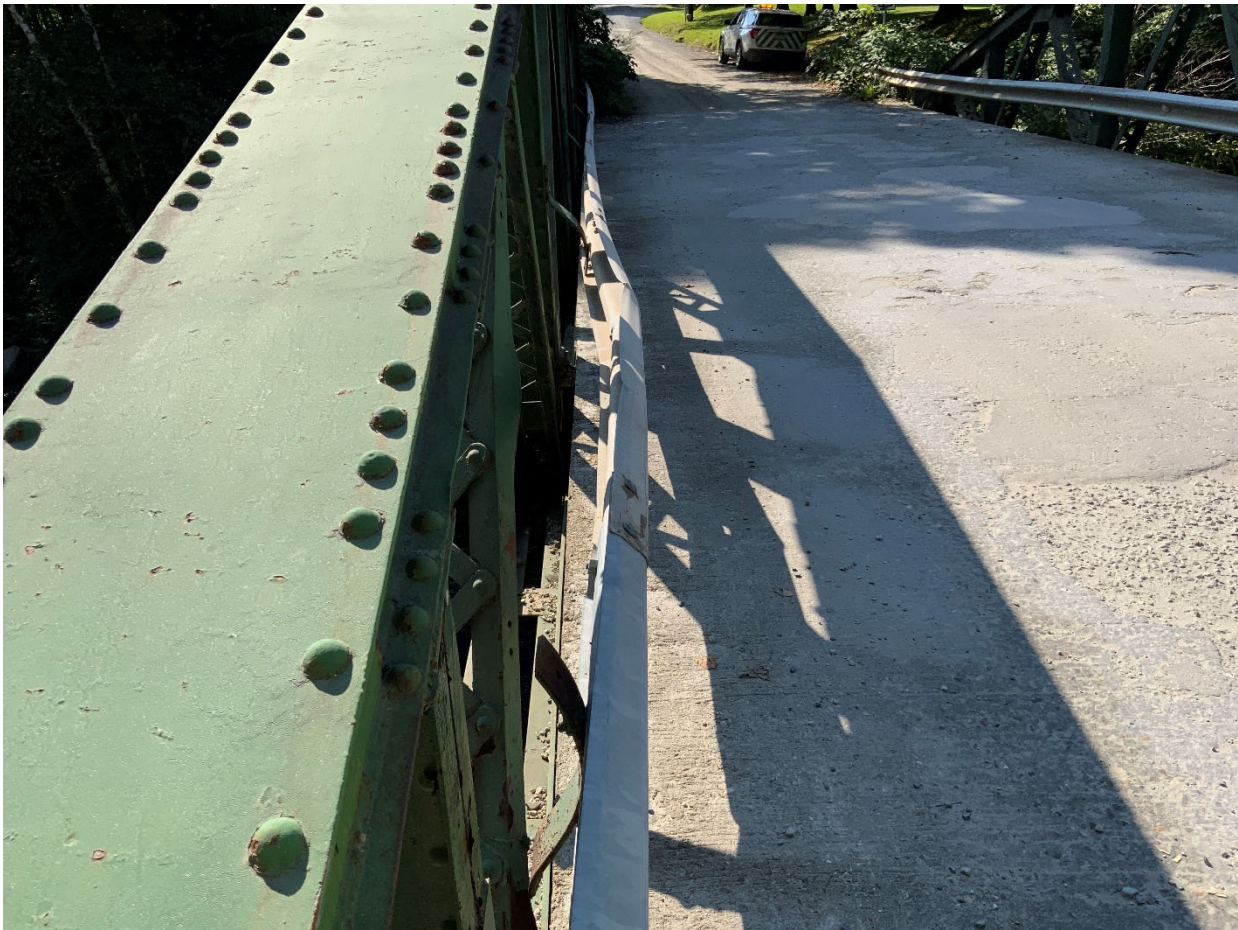
Guardrail damage

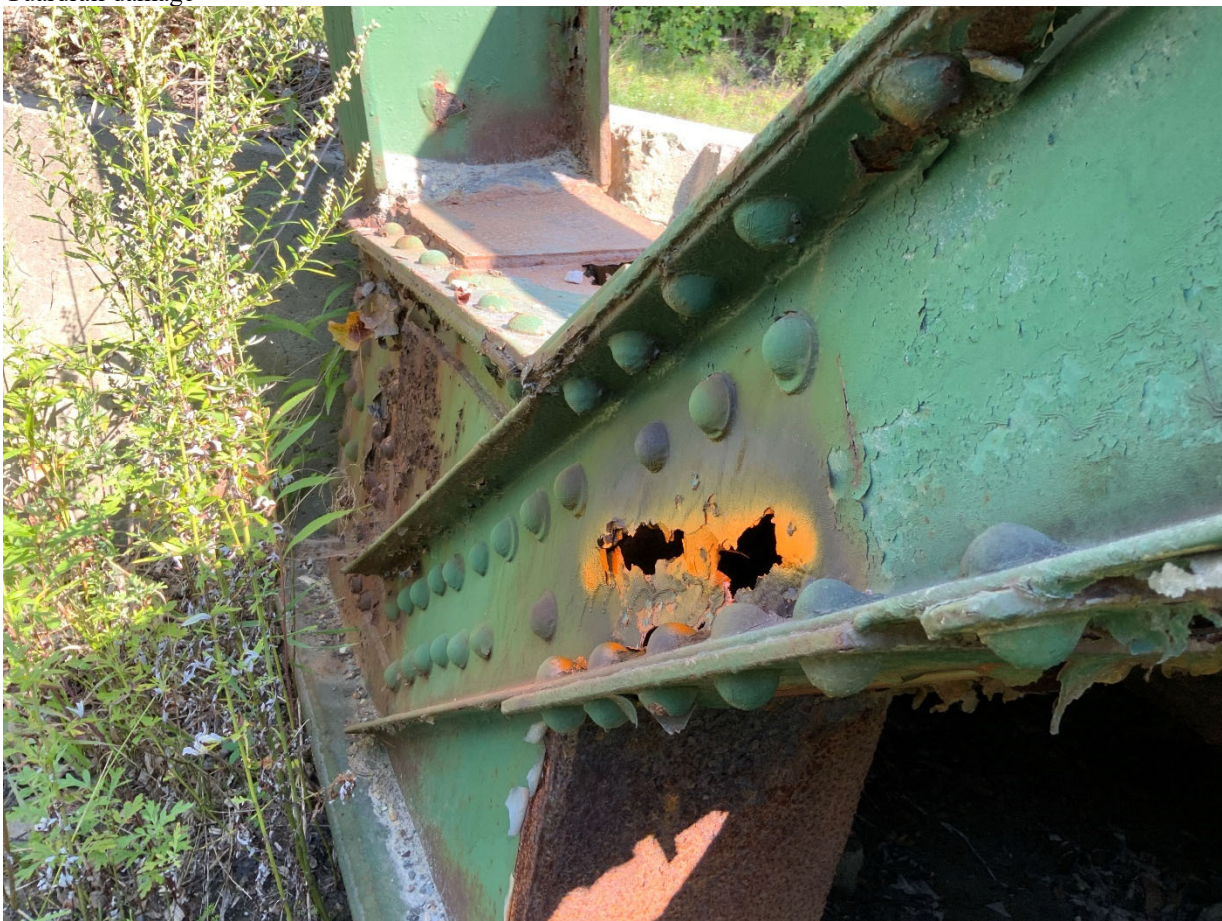
Girder Section Loss

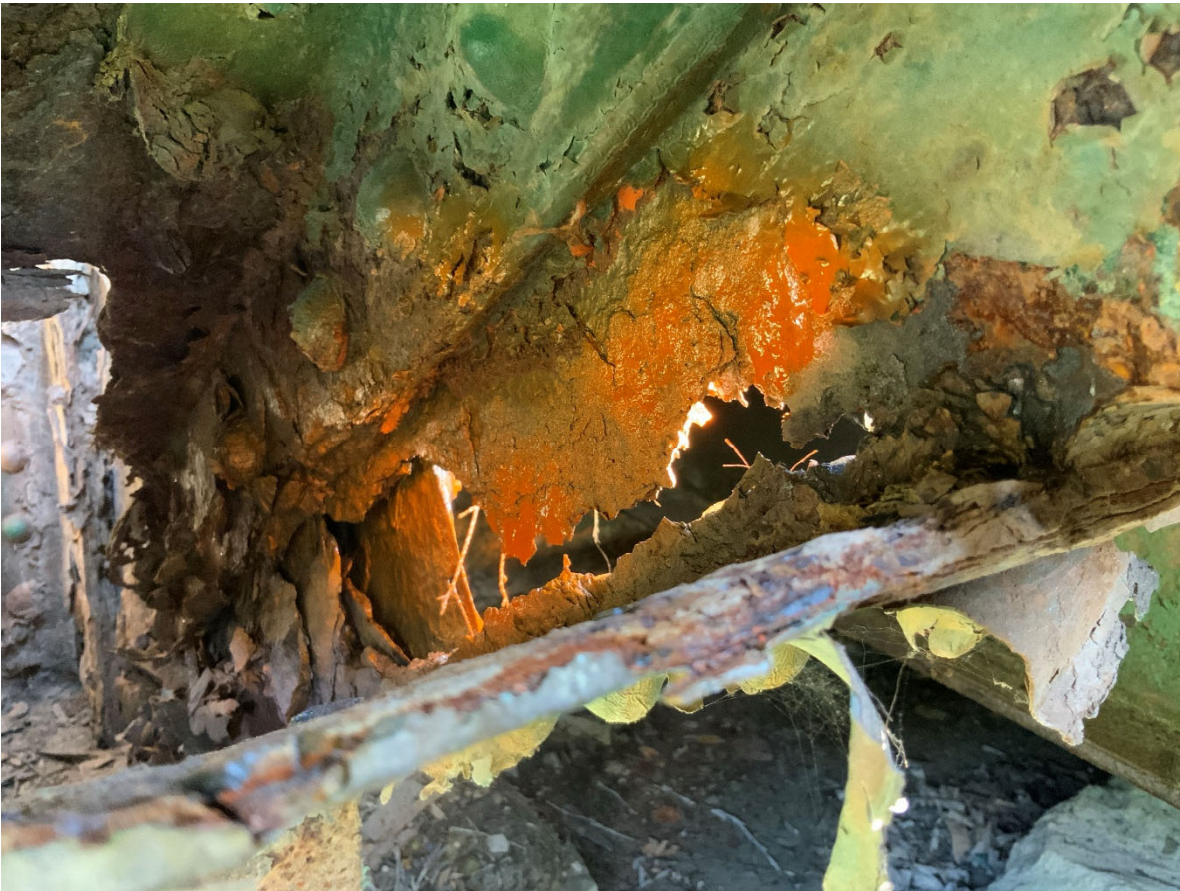
Girder Section Loss

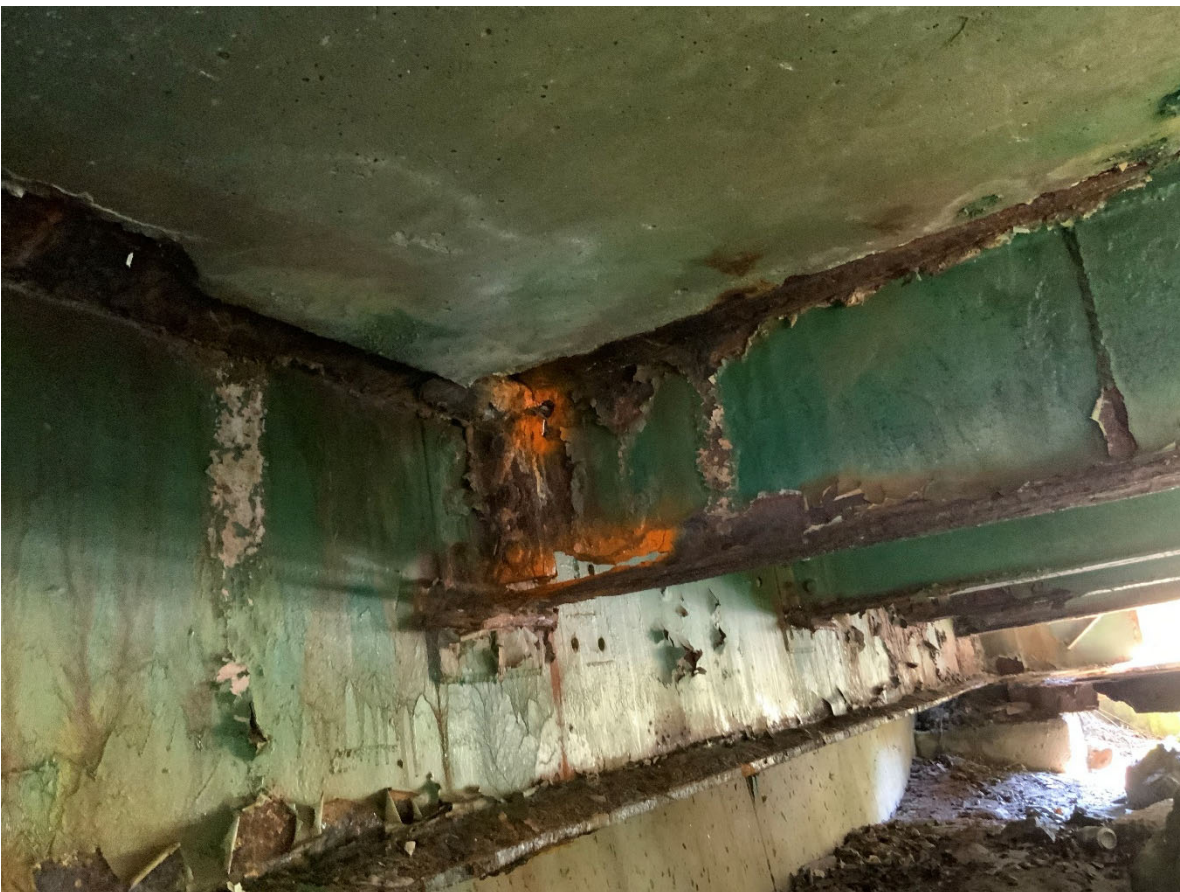
Purlin Section Loss

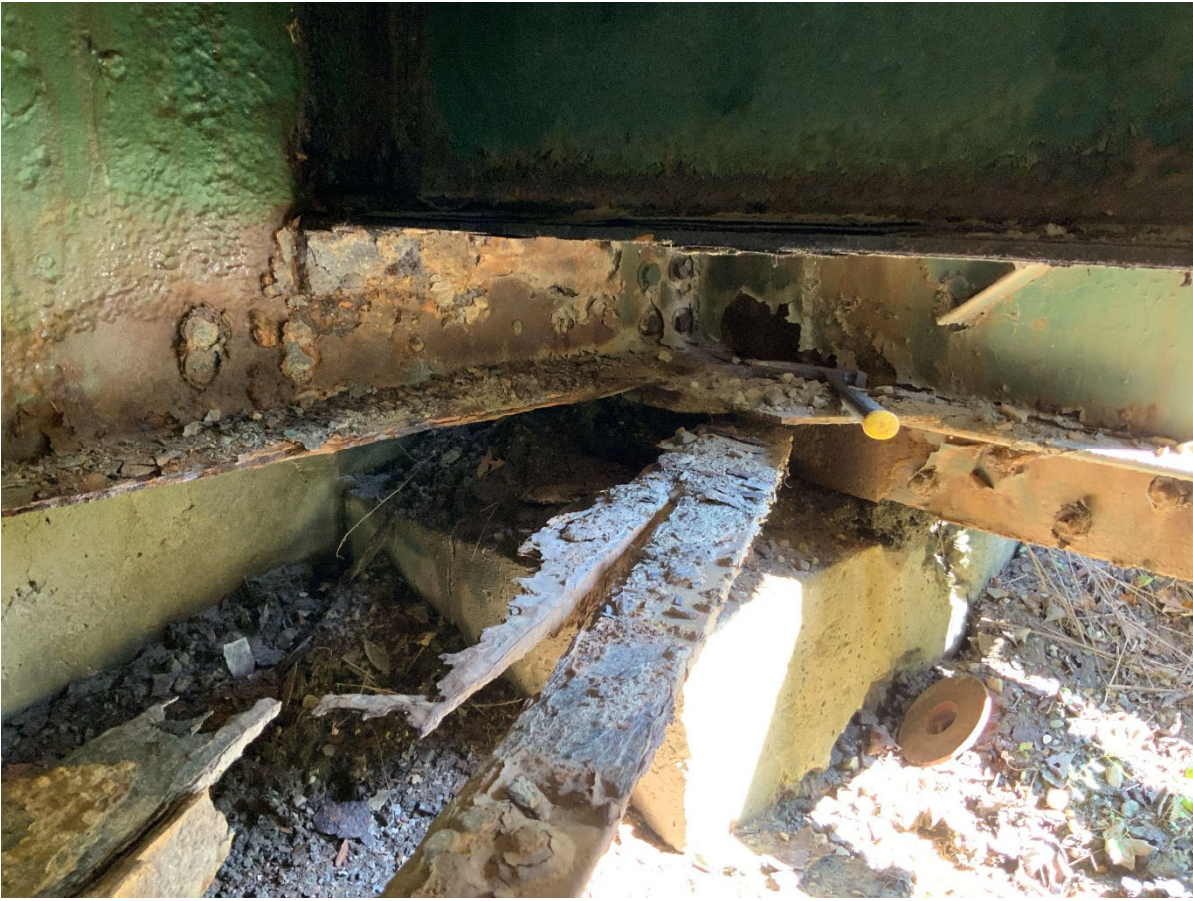
Section Loss

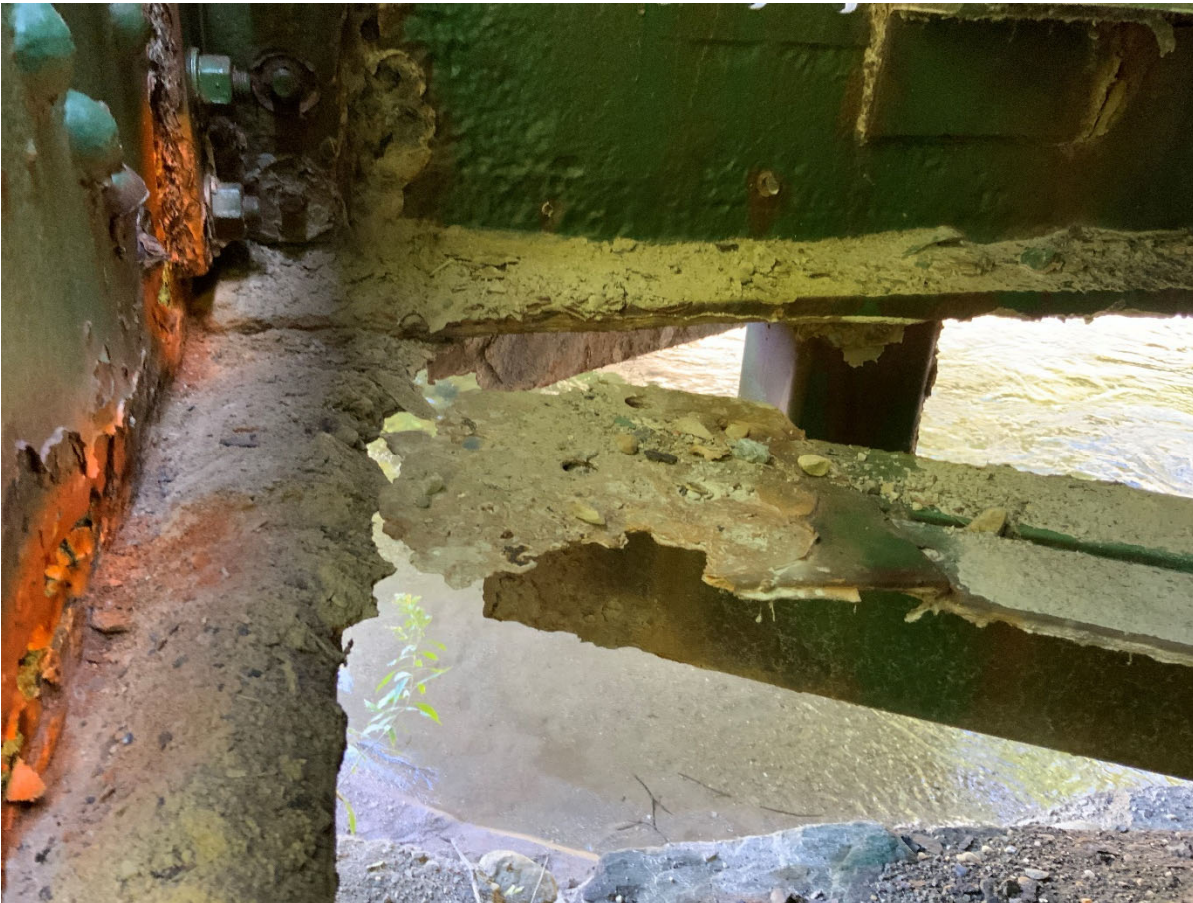
Section Loss / Separation

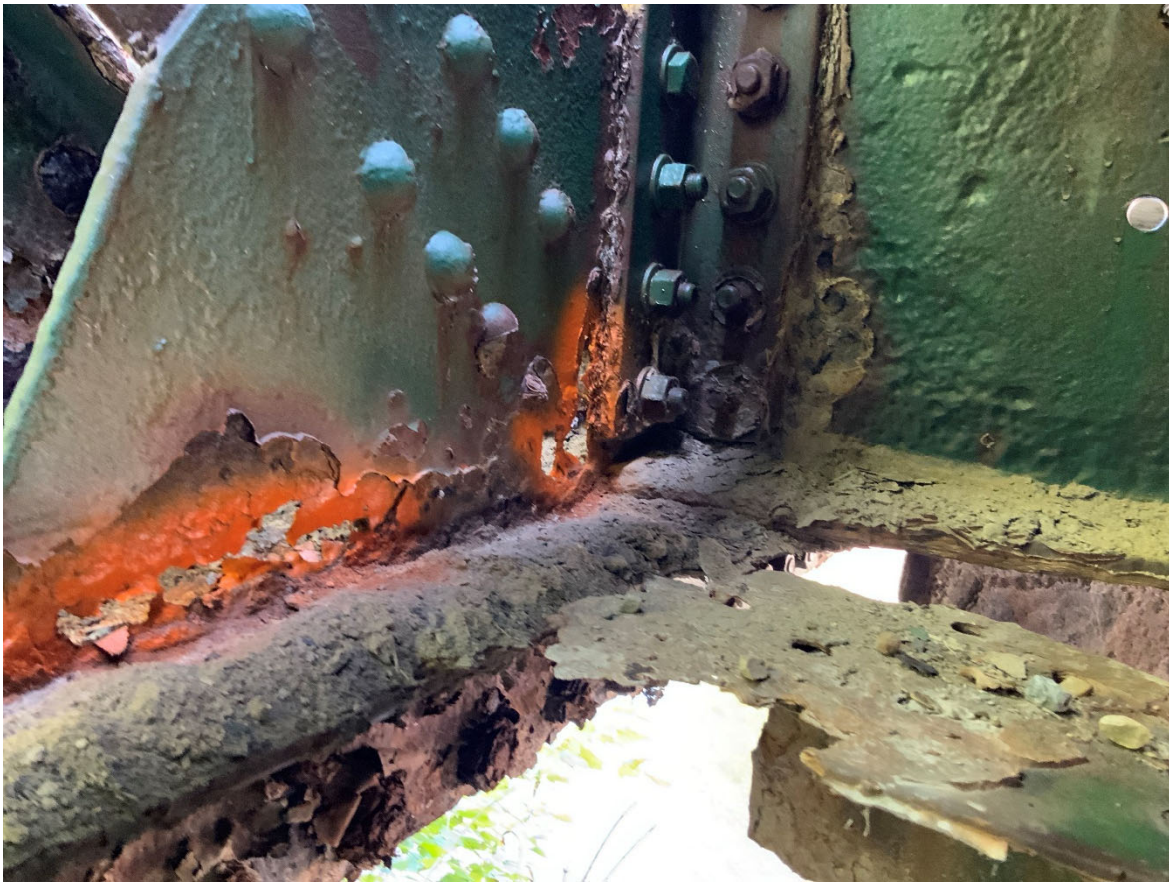
Gusset Plate et al. Section Loss / Separation

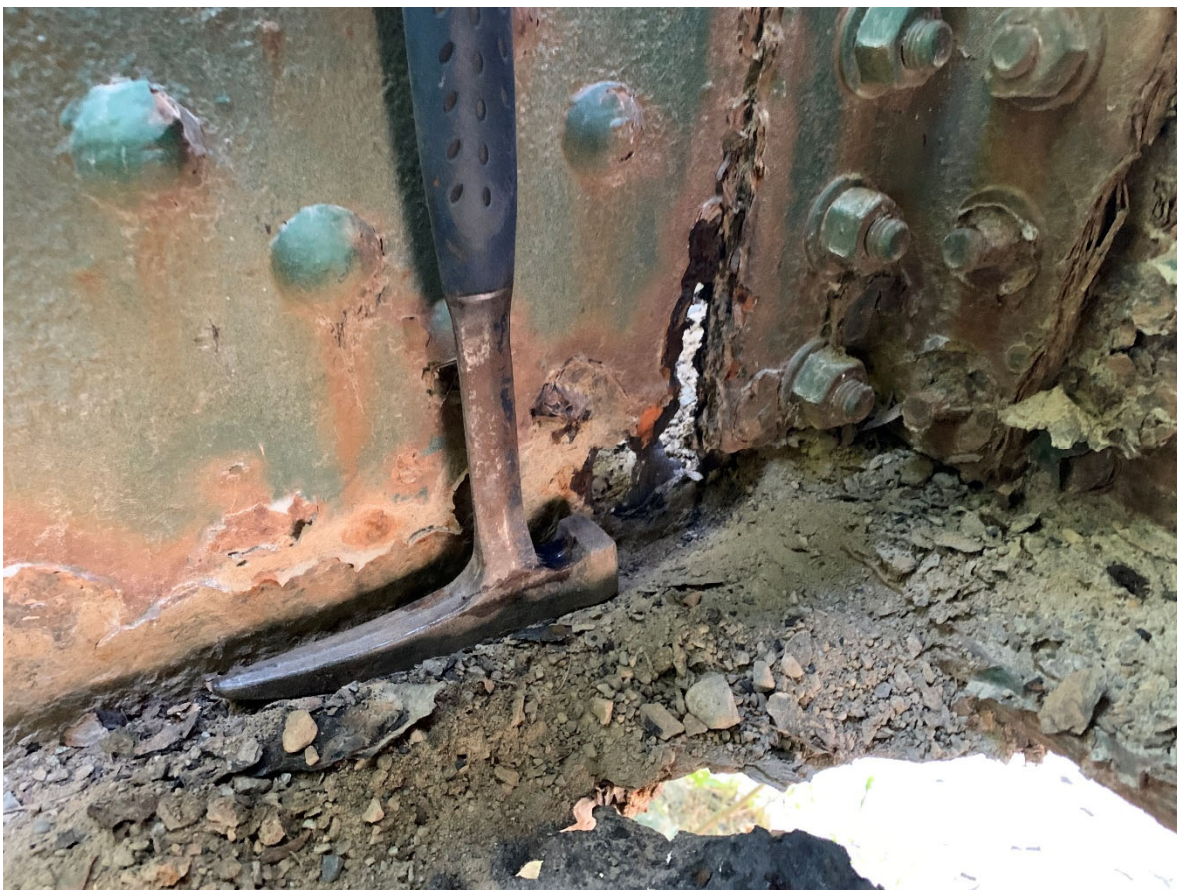
Section Loss

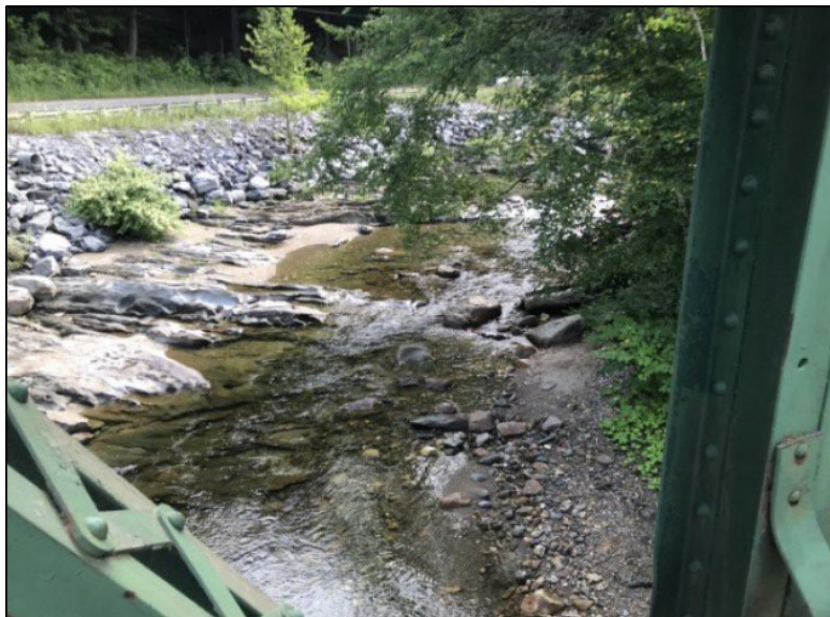
Figure A2: View of upstream river channel. Bedrock outcrops present.

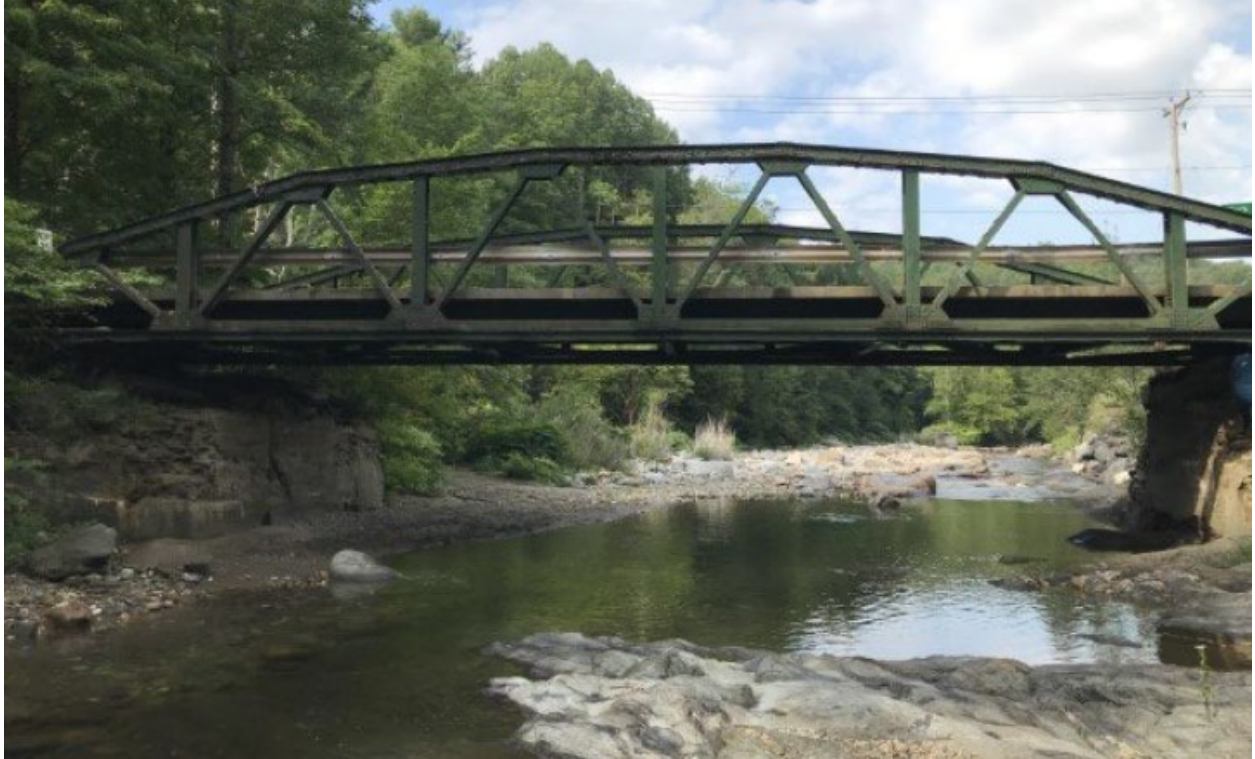
Figure A3: View downstream of river channel. Note lack of bedrock outcrops.

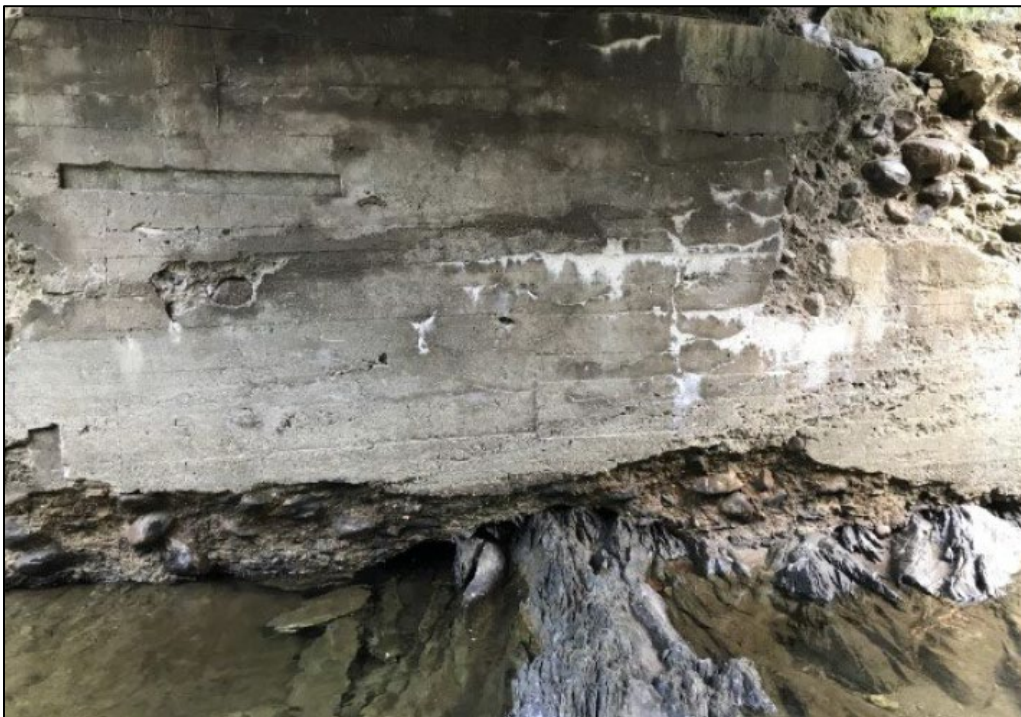
Figure A4: Bedrock exposed under Abutment 2.

The abutment at river right appears to be pinned on bedrock based on bridge inspection photos. If the existing abutments are being considered for replacement, a final scour depth can be calculated at Final Plans utilizing boring information.

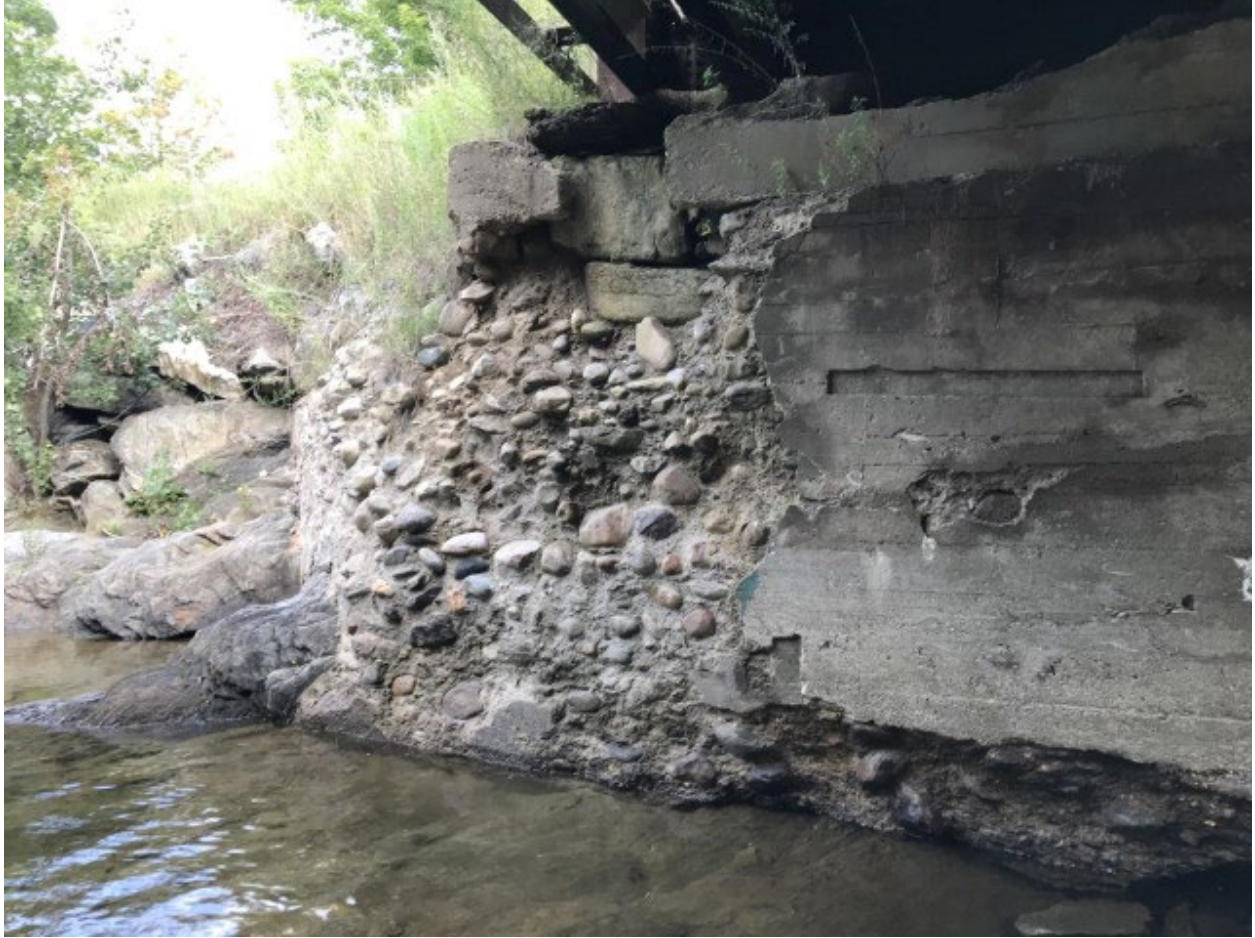
Figure A5: *View of Abutment 1 and bedrock exposed running under abutment.*

No record plans were available; however, the existing substructures appear to be shallow spread footing abutments placed on abutments for a previous bridge. The earlier abutments are gravity walls placed on exposed bedrock. Any new bridge would likely have spread footing abutments placed on bedrock. Additional borings and bedrock probes should be taken early in the design phase to verify the in-situ conditions and choose the most appropriate substructure type. The preliminary geotechnical report can be found in Appendix F.

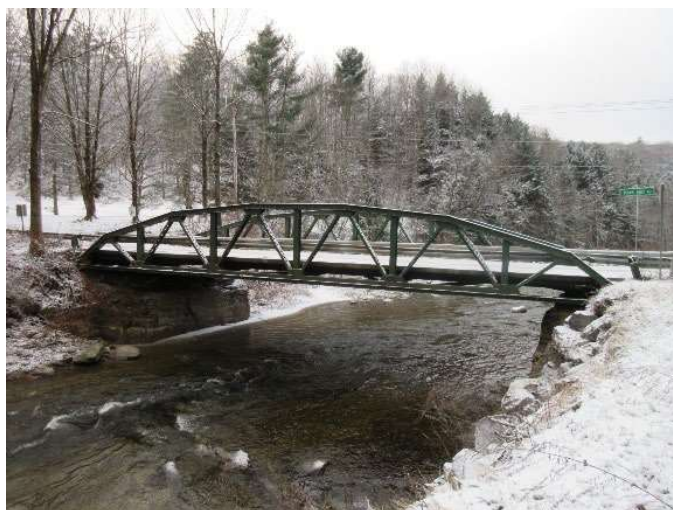
This single-span, riveted Parker pony truss bridge is 85 feet long with an approximately 21-foot-wide concrete deck carrying one lane of York Hill Road over New Haven River. The bridge is composed of seven top polygonal chords braced with five vertical beams with alternating, latticed bracing. The vertical beams have steel guardrails running their entire lengths. The concrete substructure is supported by longitudinal I-beam girders with lateral and diagonal bracing. The latter bracing mimics the vertical members of the polygonal sections. The approaches are anchored into concrete and fieldstone abutments.

According to historic sites and structures survey form, the bridge was likely moved to the current site in 1963, replacing the former bridge (VDHP 1990). The bridge is in generally poor condition aside from the deck which exhibits minor scaling, patching, cracking, and efflorescence staining. The superstructure, particularly the lateral bracing, floor beams, and stringers feature extensive section loss, thinning, holes, and disconnection. The abutments and end walls show signs of wide cracking with minor scaling on the pedestals.

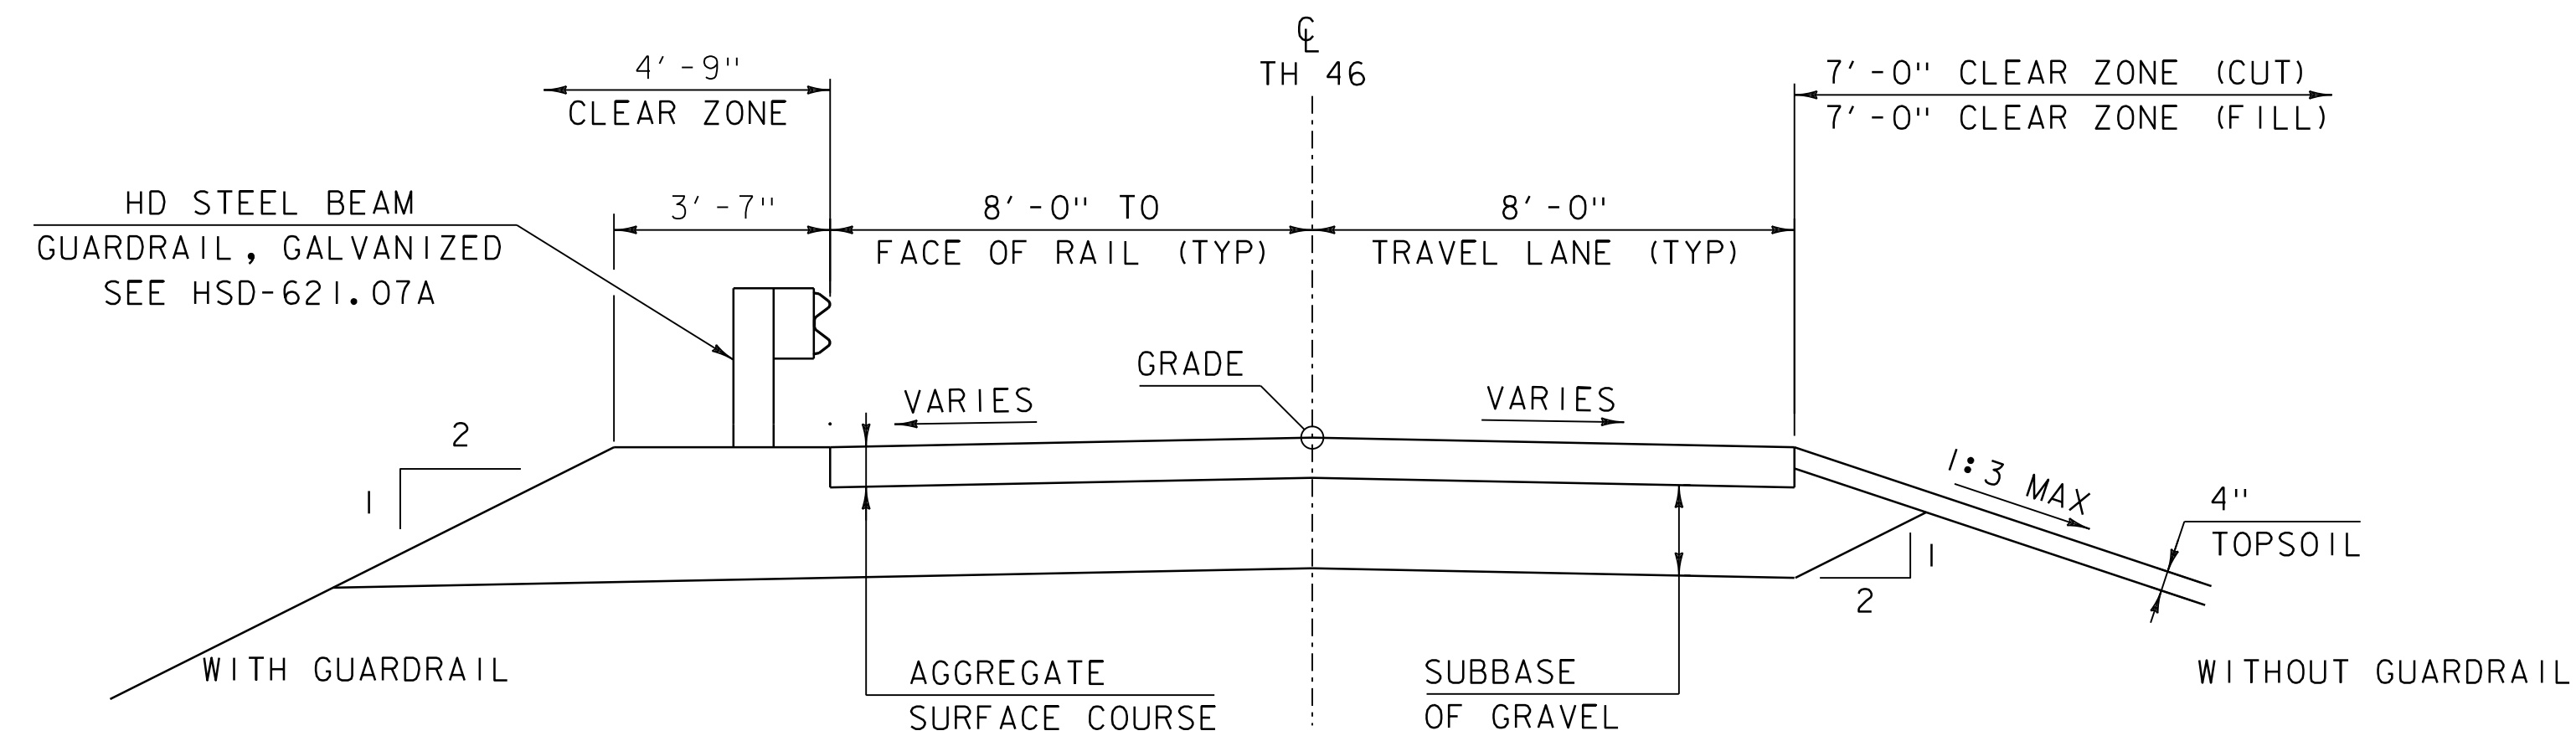
EXISTING TH 46 TYPICAL SECTION
SCALE $\frac{3}{8}$ " = 1'-0"

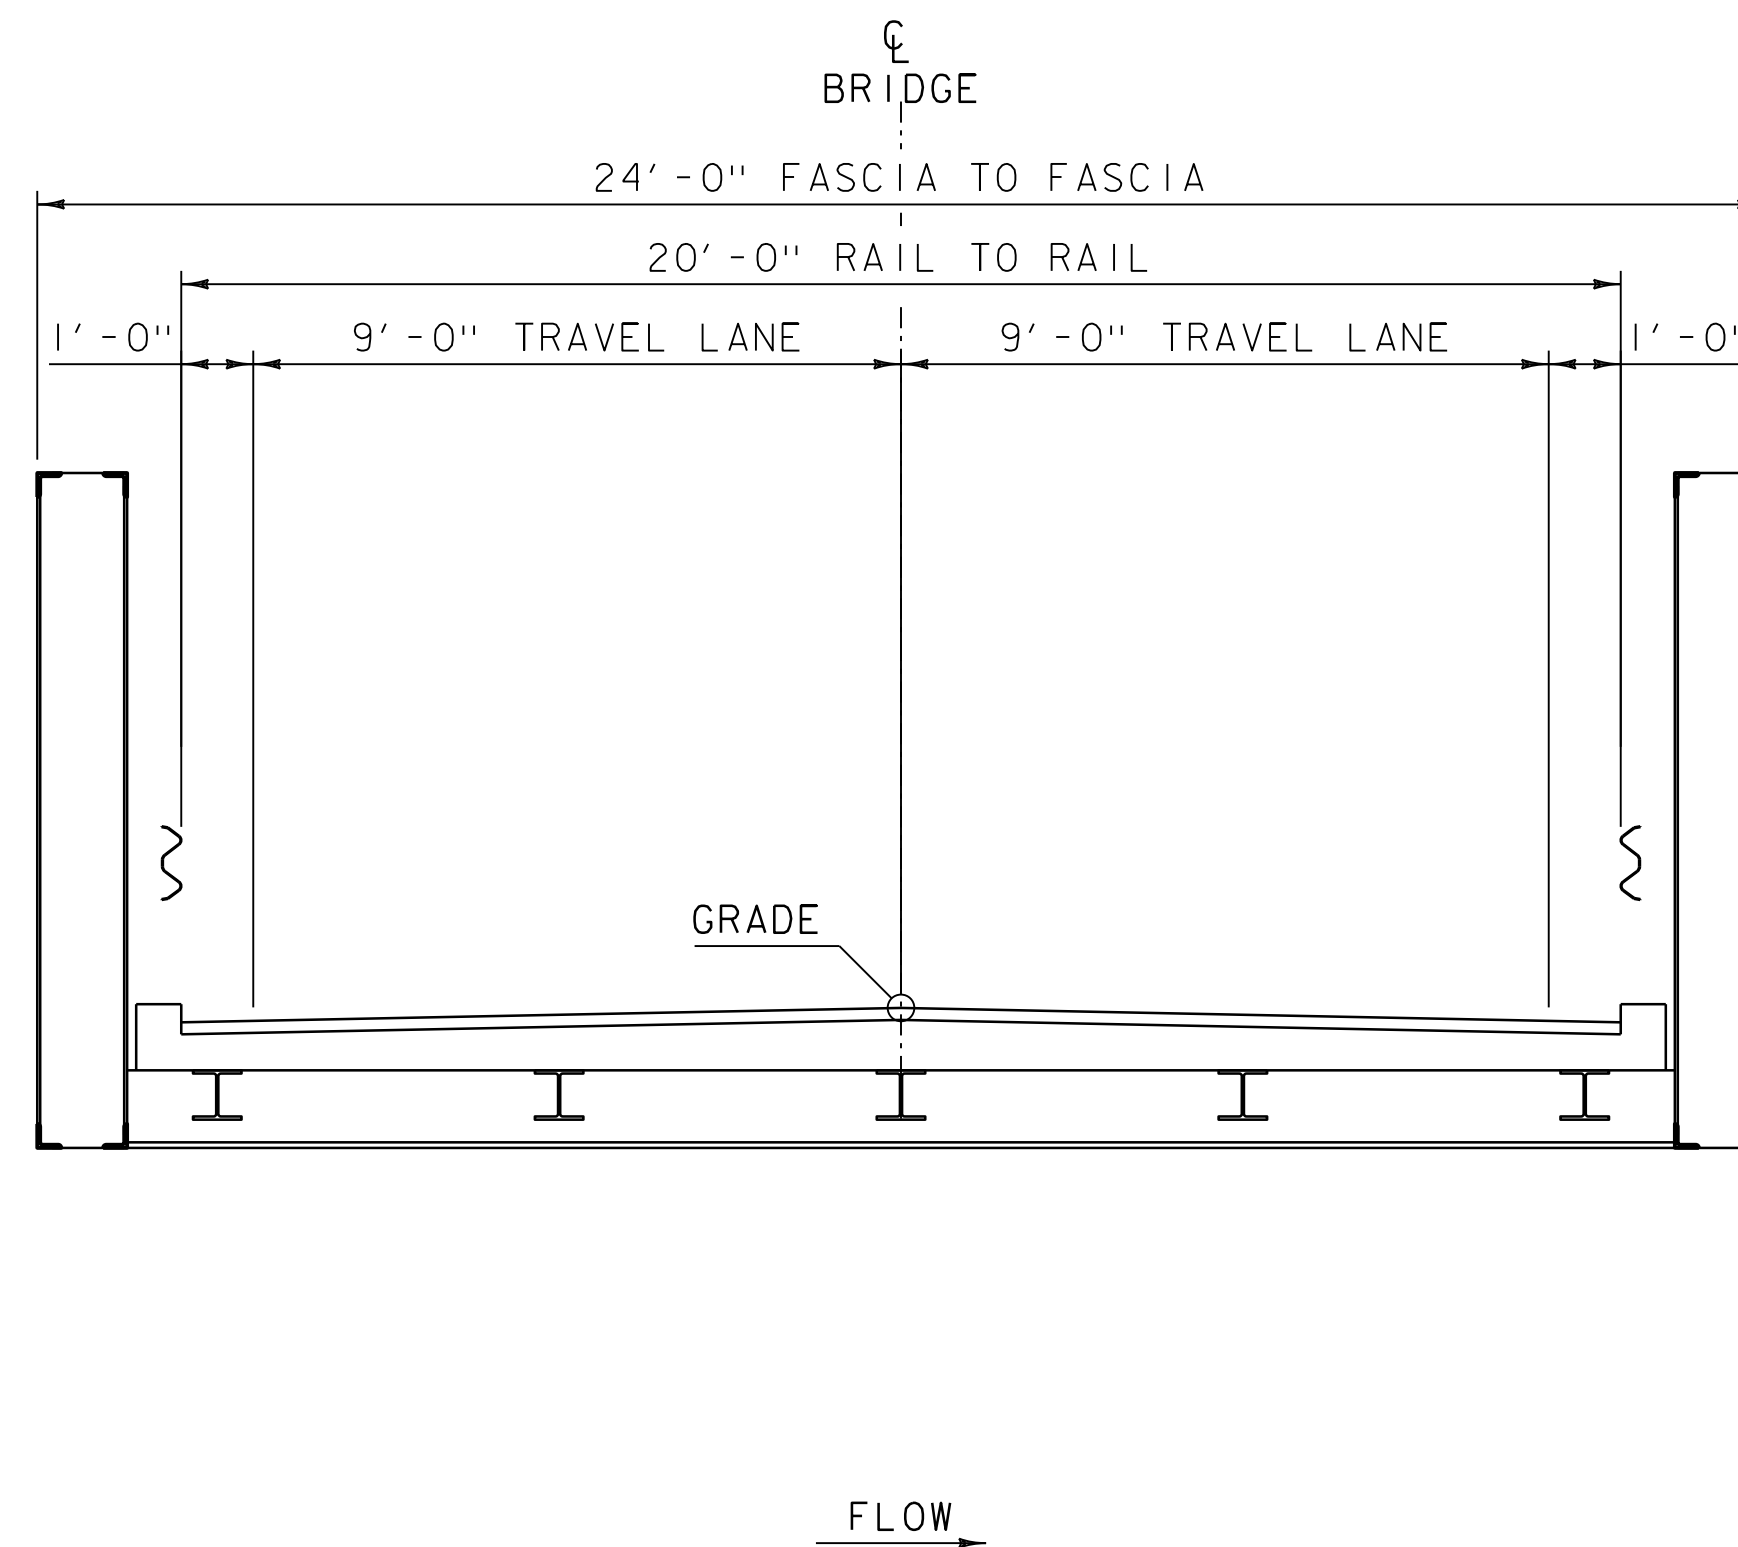
EXISTING BRIDGE TYPICAL SECTION
SCALE $\frac{3}{8}$ " = 1'-0"

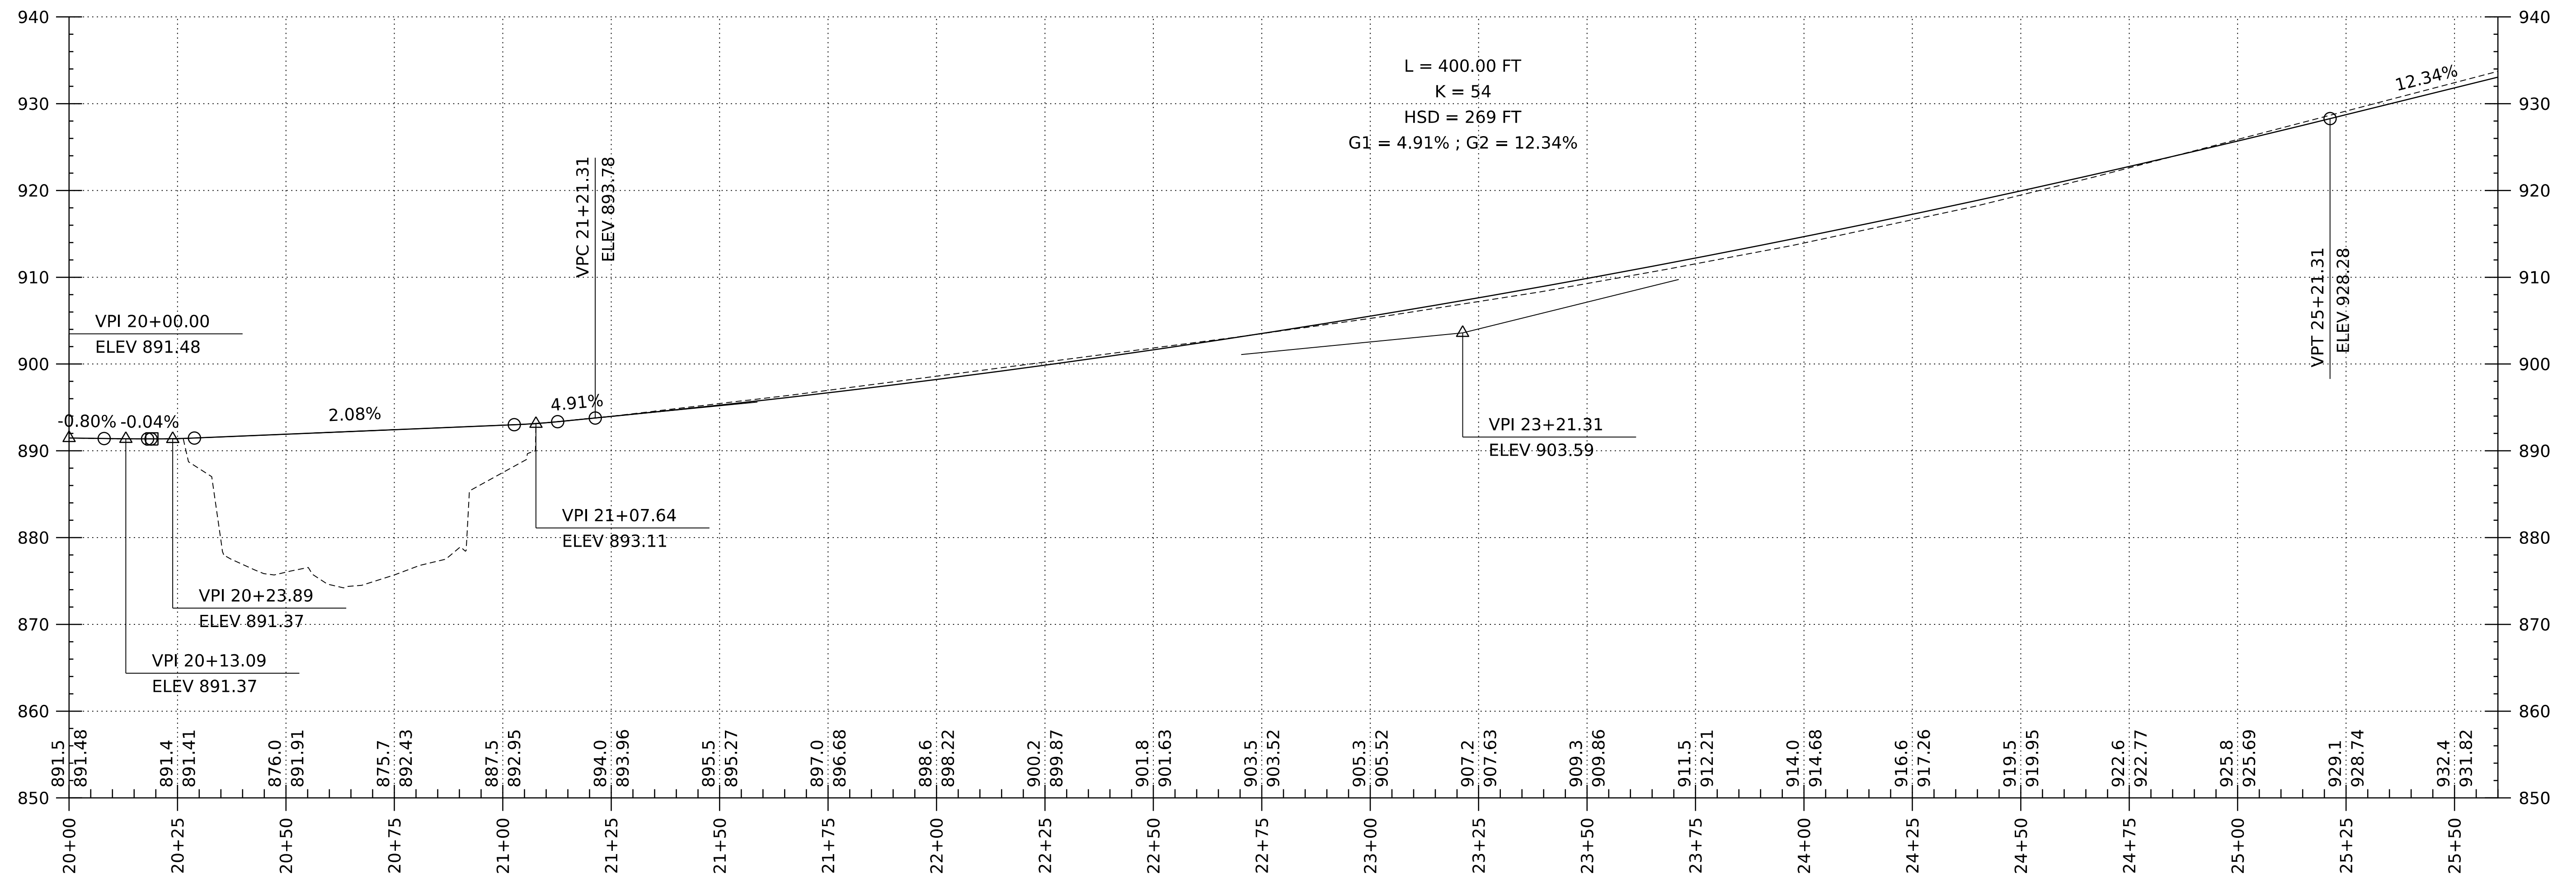
TOWN HIGHWAY 6 (YORK HILL RD) PROFILE
