**STATE OF VERMONT
AGENCY OF TRANSPORTATION**

Scoping Report

Lincoln BO TRUS(7)

Town Highway 6, Bridge 46 over New Haven River

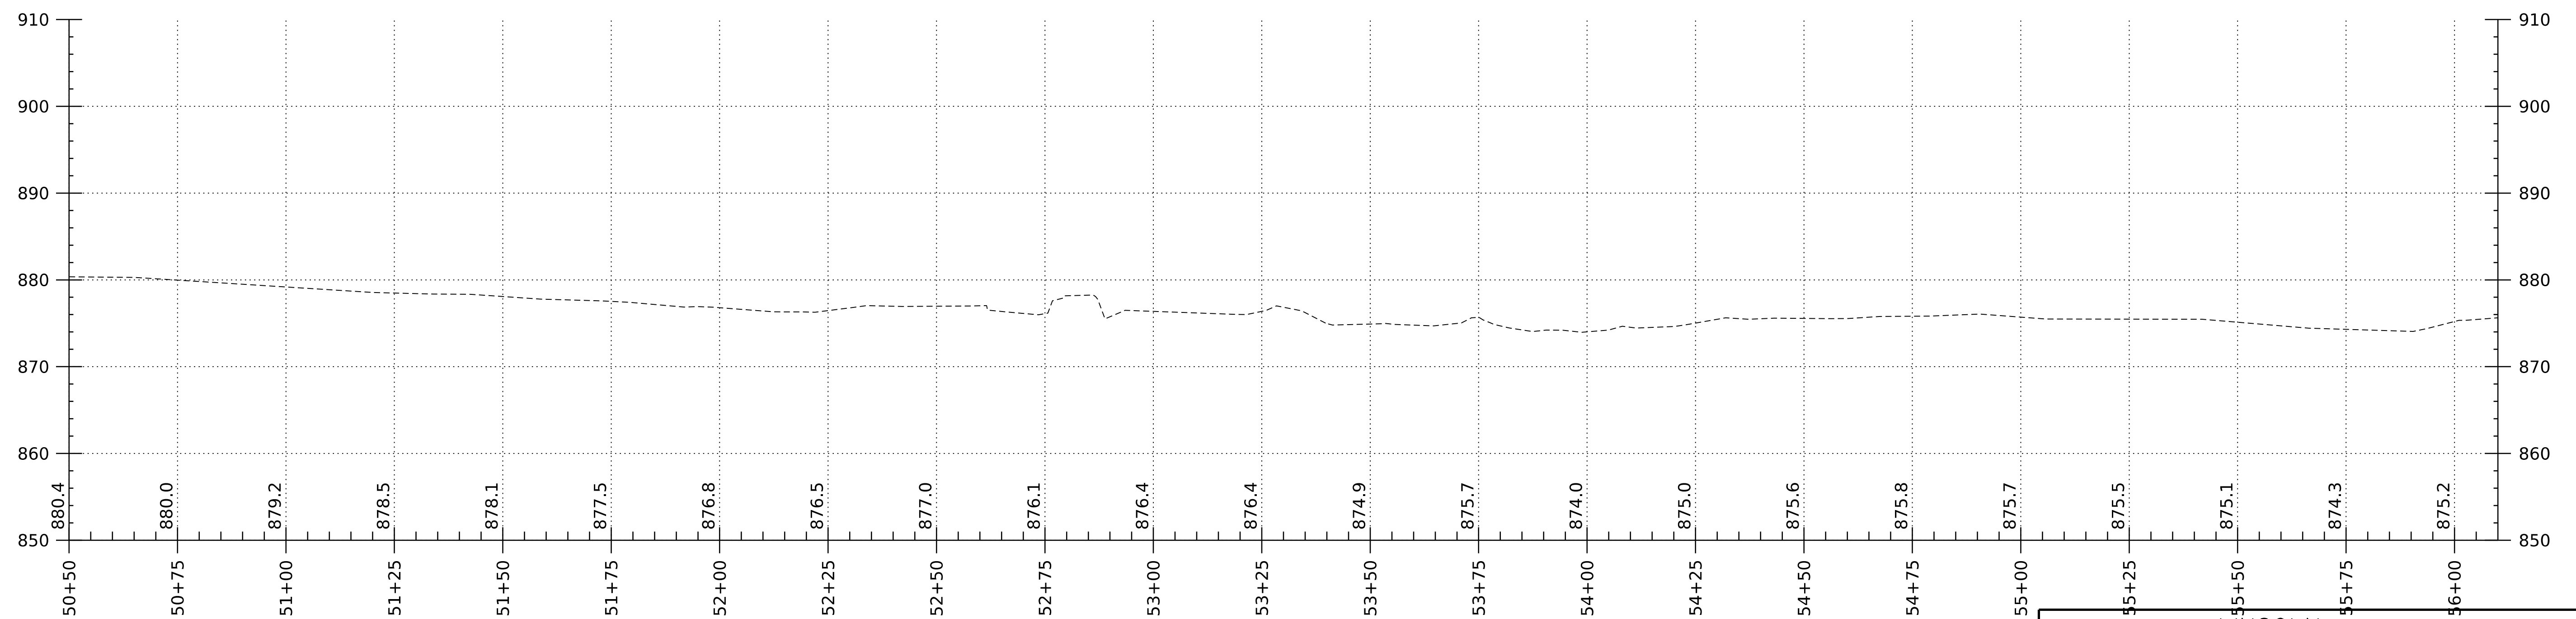
CHANNEL PROFILE

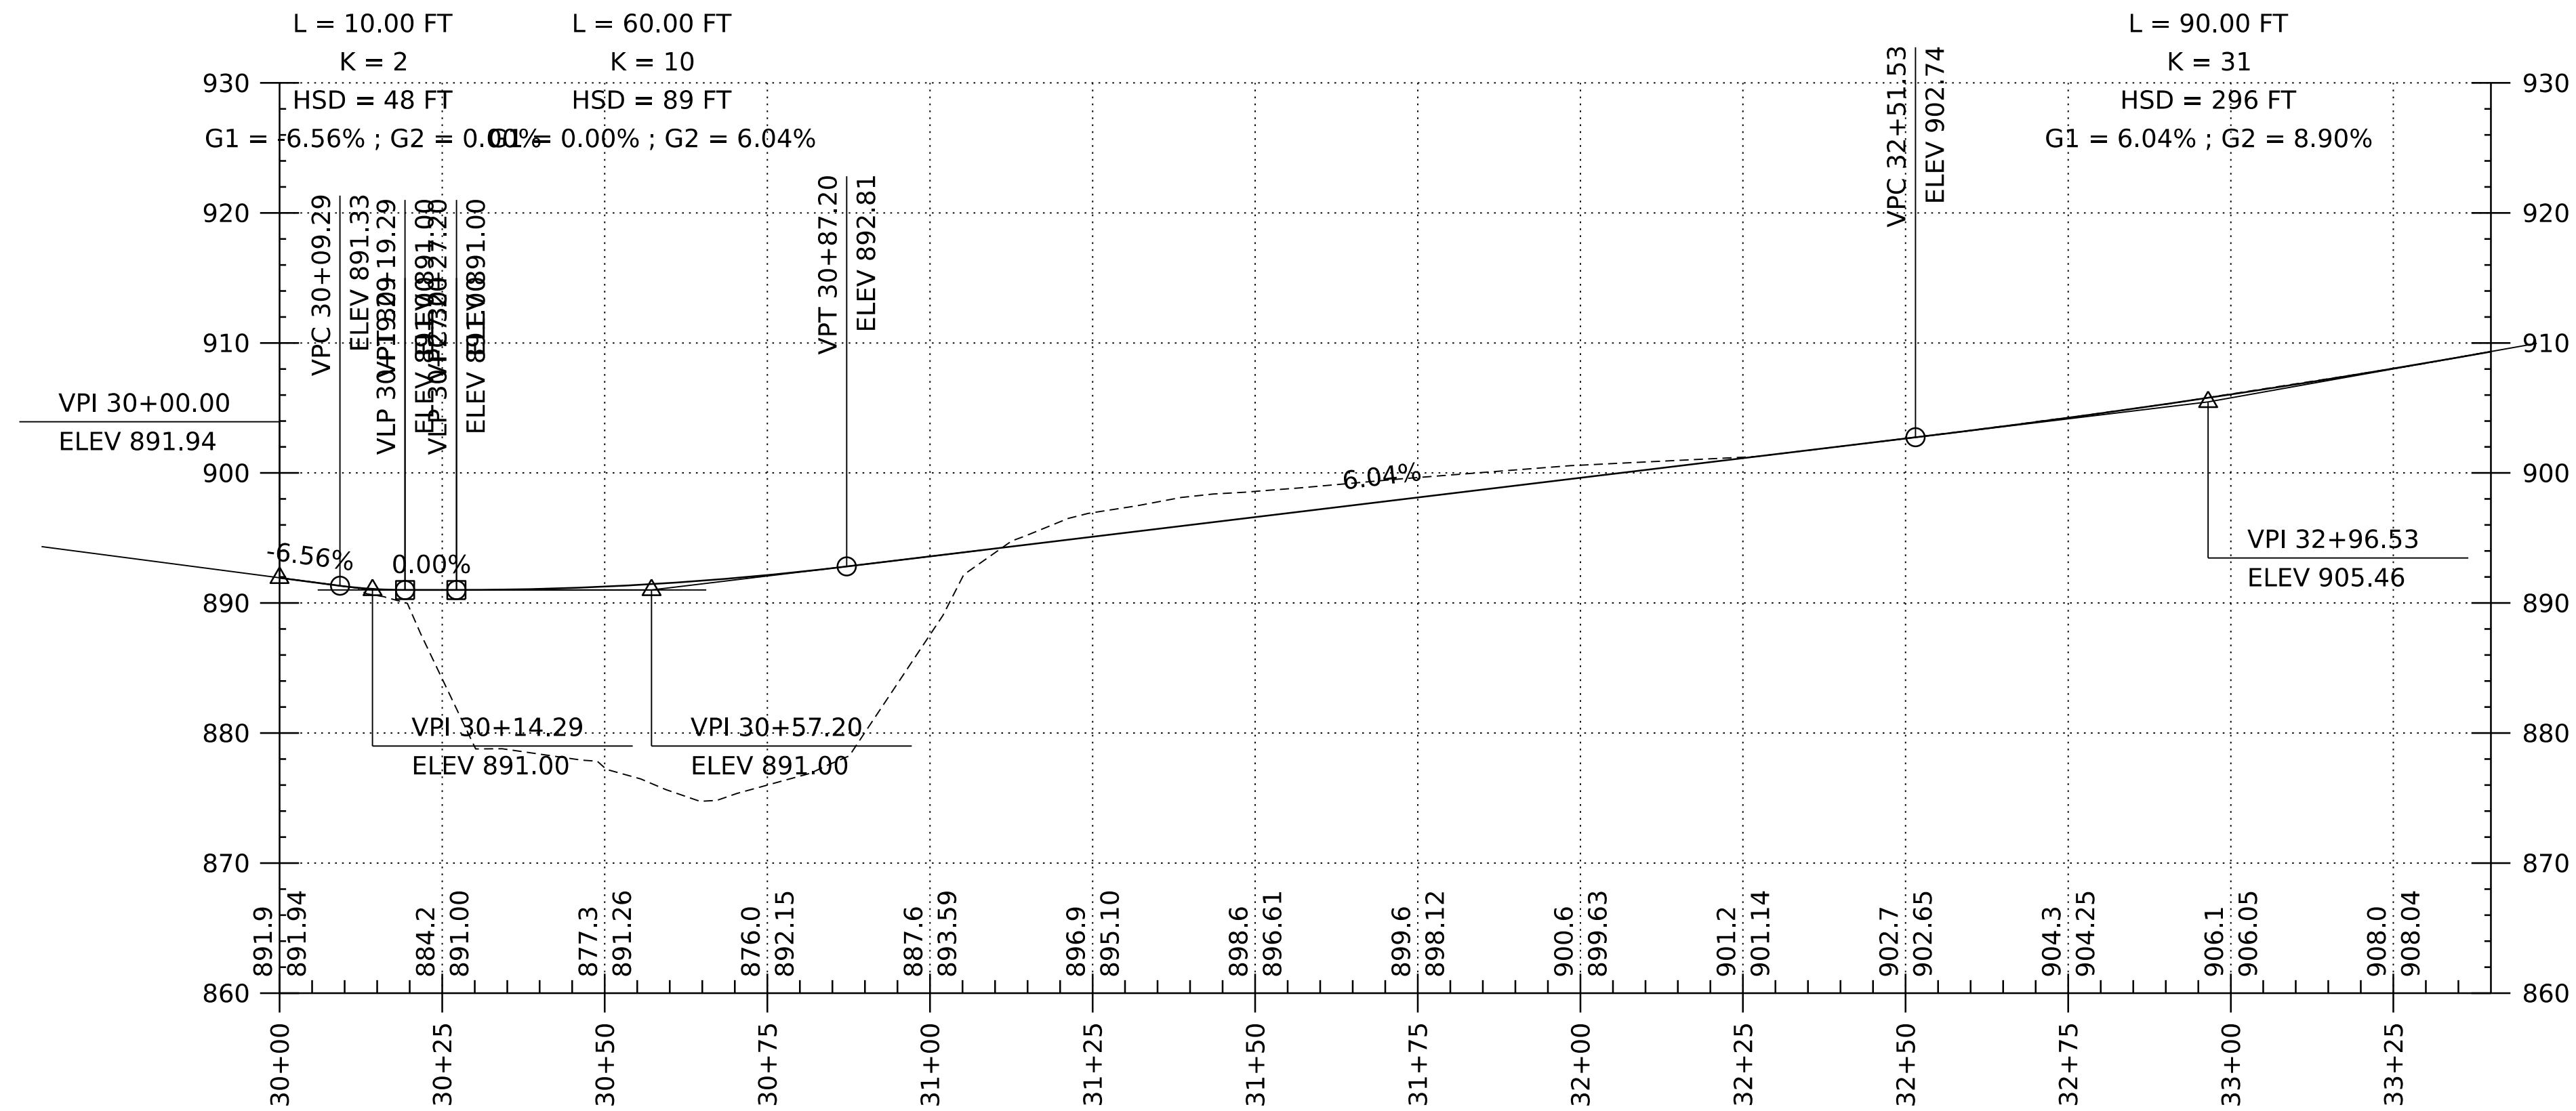
OFF ALIGNMENT ALTERNATIVE TOWN HIGHWAY 6 (YORK HILL RD) PROFILE

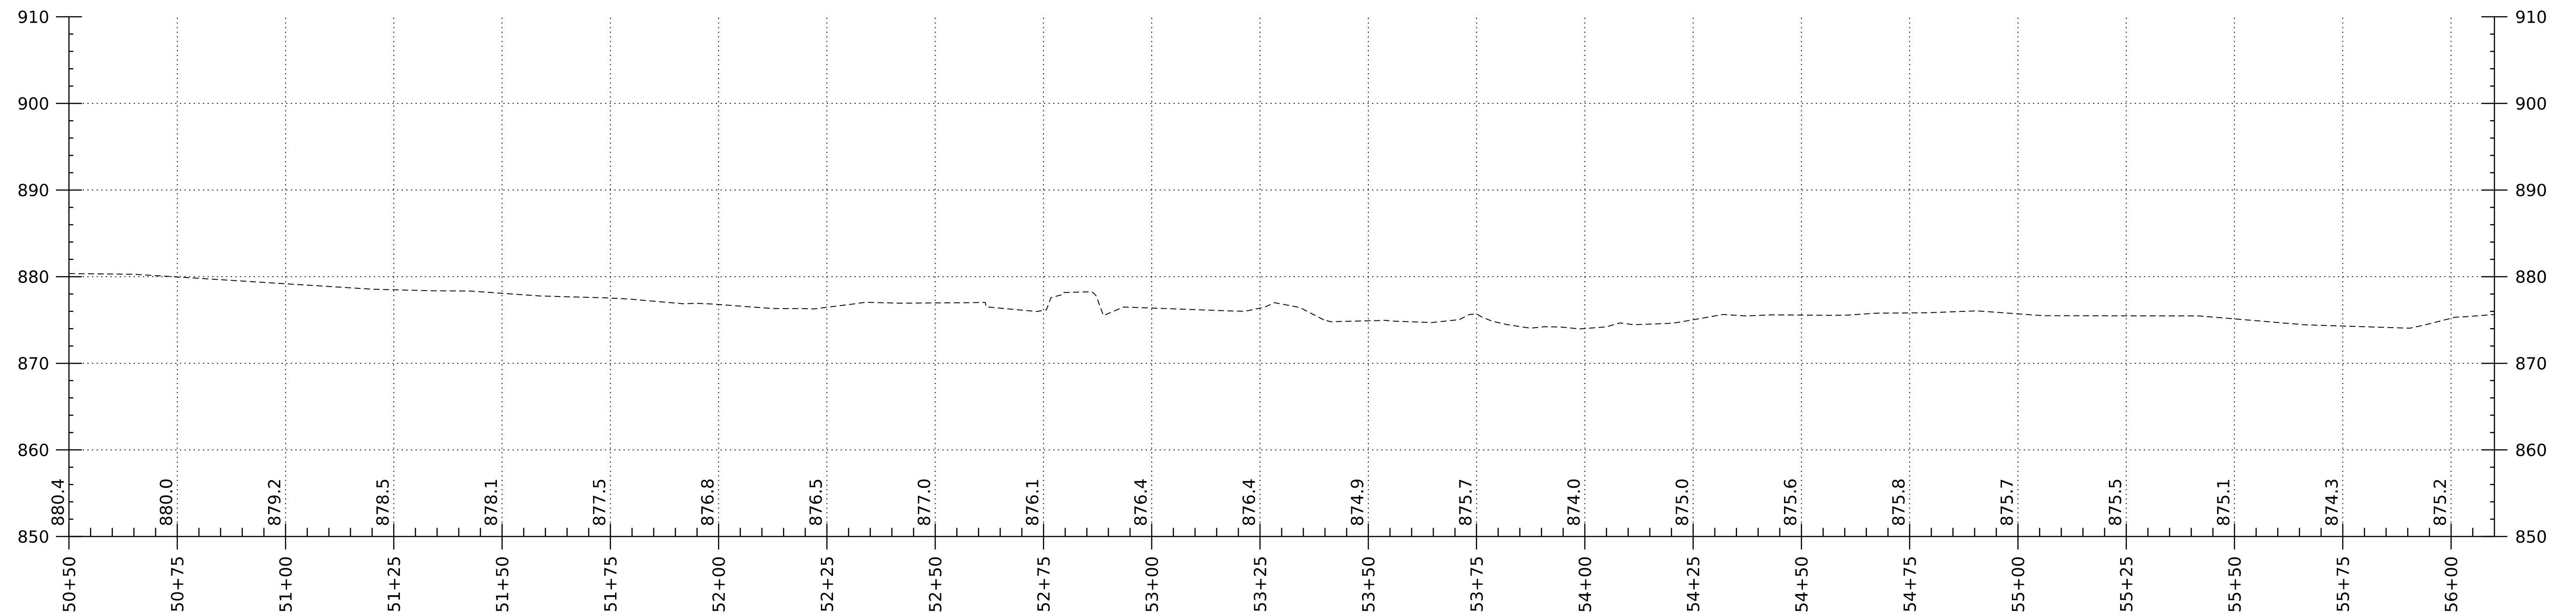
CHANNEL PROFILE

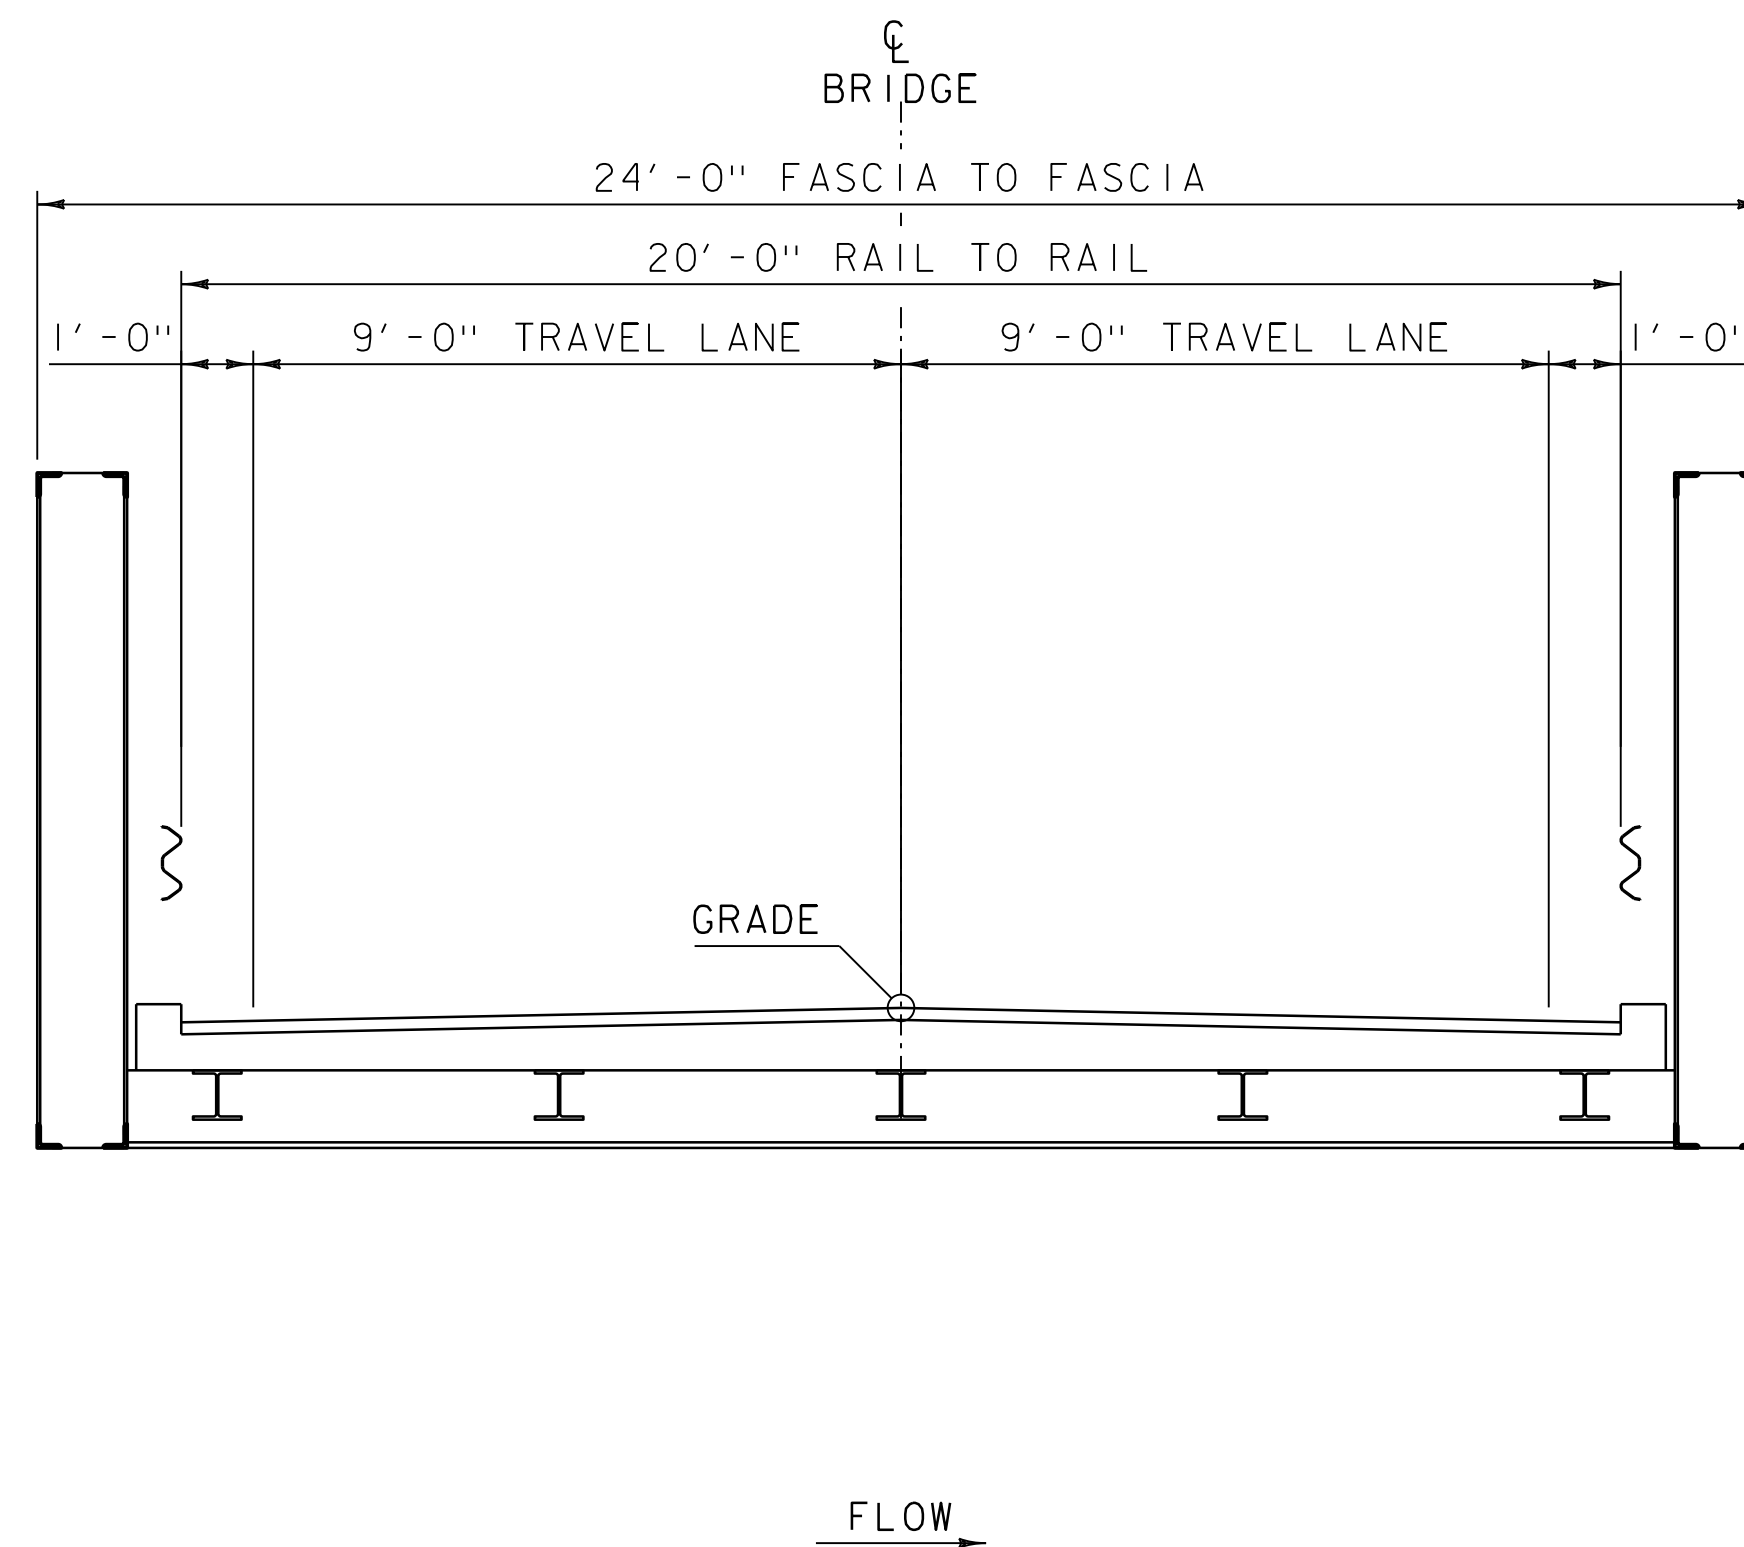
PROPOSED BRIDGE REHABILITATION TYPICAL SECTION
SCALE $\frac{3}{8}$ " = 1' - 0"

A truss rehabilitation would include repairs to the pony truss and abutments and replacement of the deck and floor system. The project would consist of the following:

- Removing the existing pony truss for cleaning, repair or replacement of deteriorated members, strengthening of members, and repainting. Containment of lead paint and environment protection would be required.
- Replacing the existing bridge seats and backwalls and placing the rehabbed truss on new bearings is recommended. Extensive concrete repair or replacement of the abutments should be evaluated in design. If the abutments are fully reconstructed, the removal of the previous bridges remaining abutments will provide additional hydraulic clearspan.
- Constructing a new floor system (floor beams, stringers, and lateral bracing), and deck.

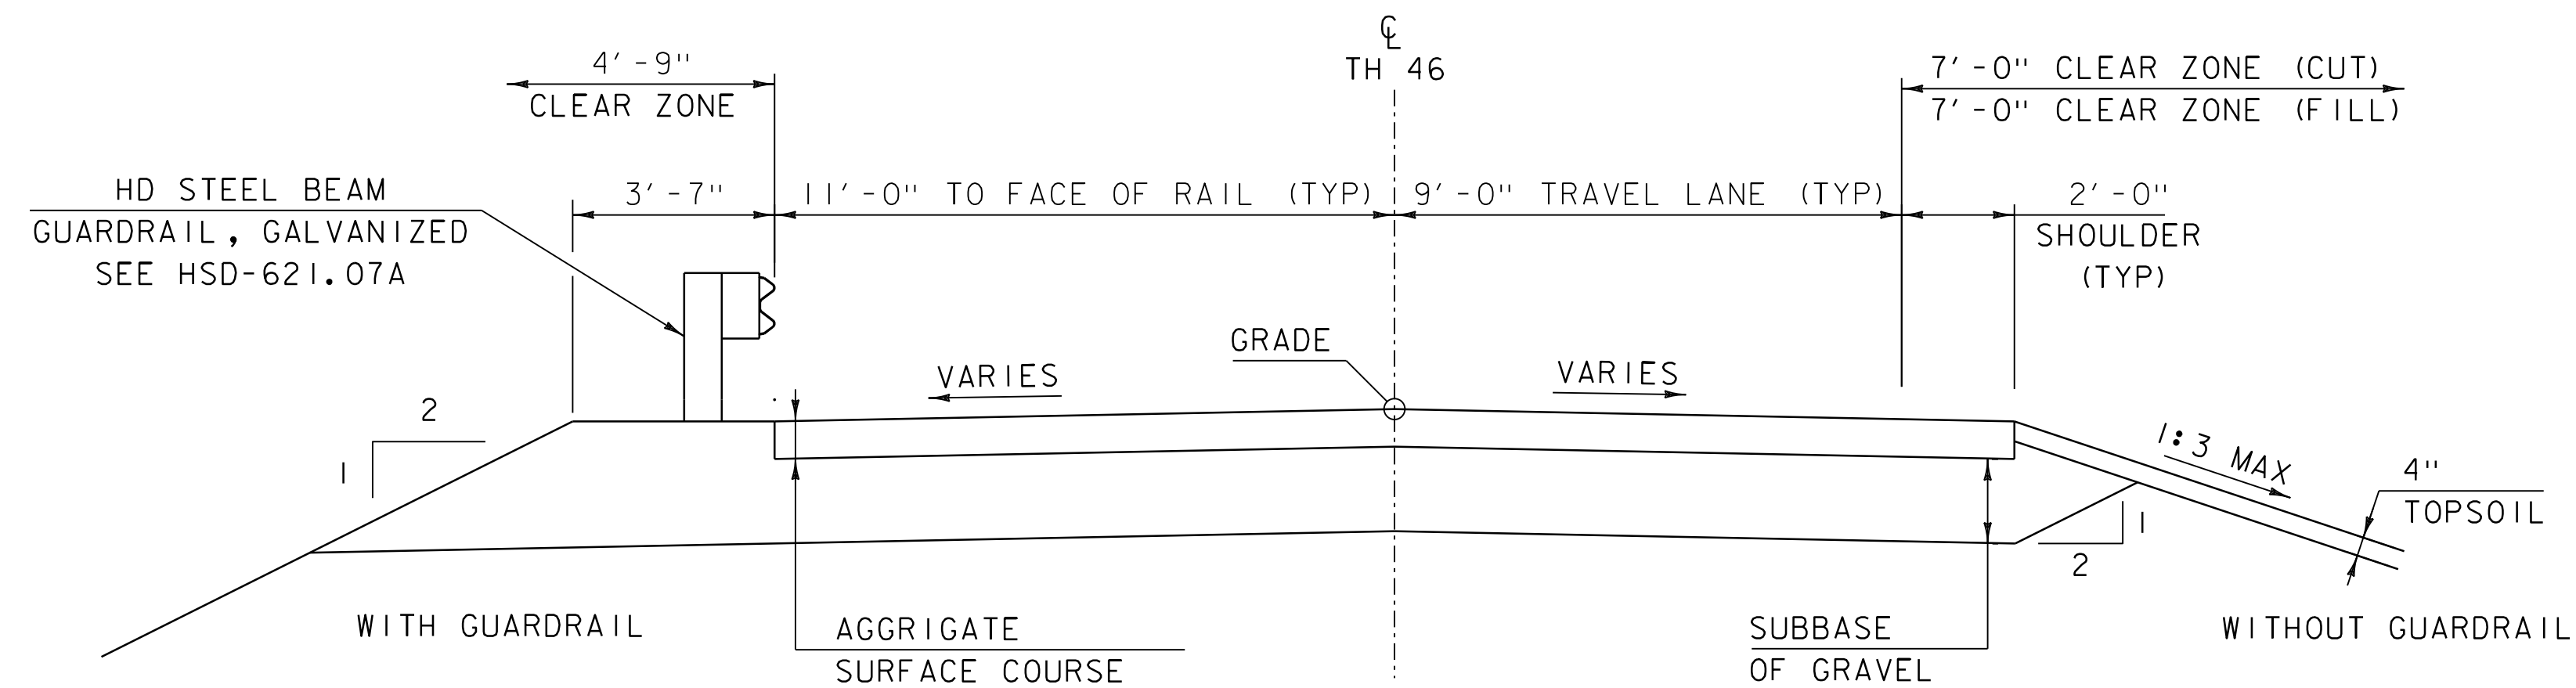
PROPOSED TH 46 TYPICAL SECTION
SCALE $\frac{3}{8}" = 1'-0"$

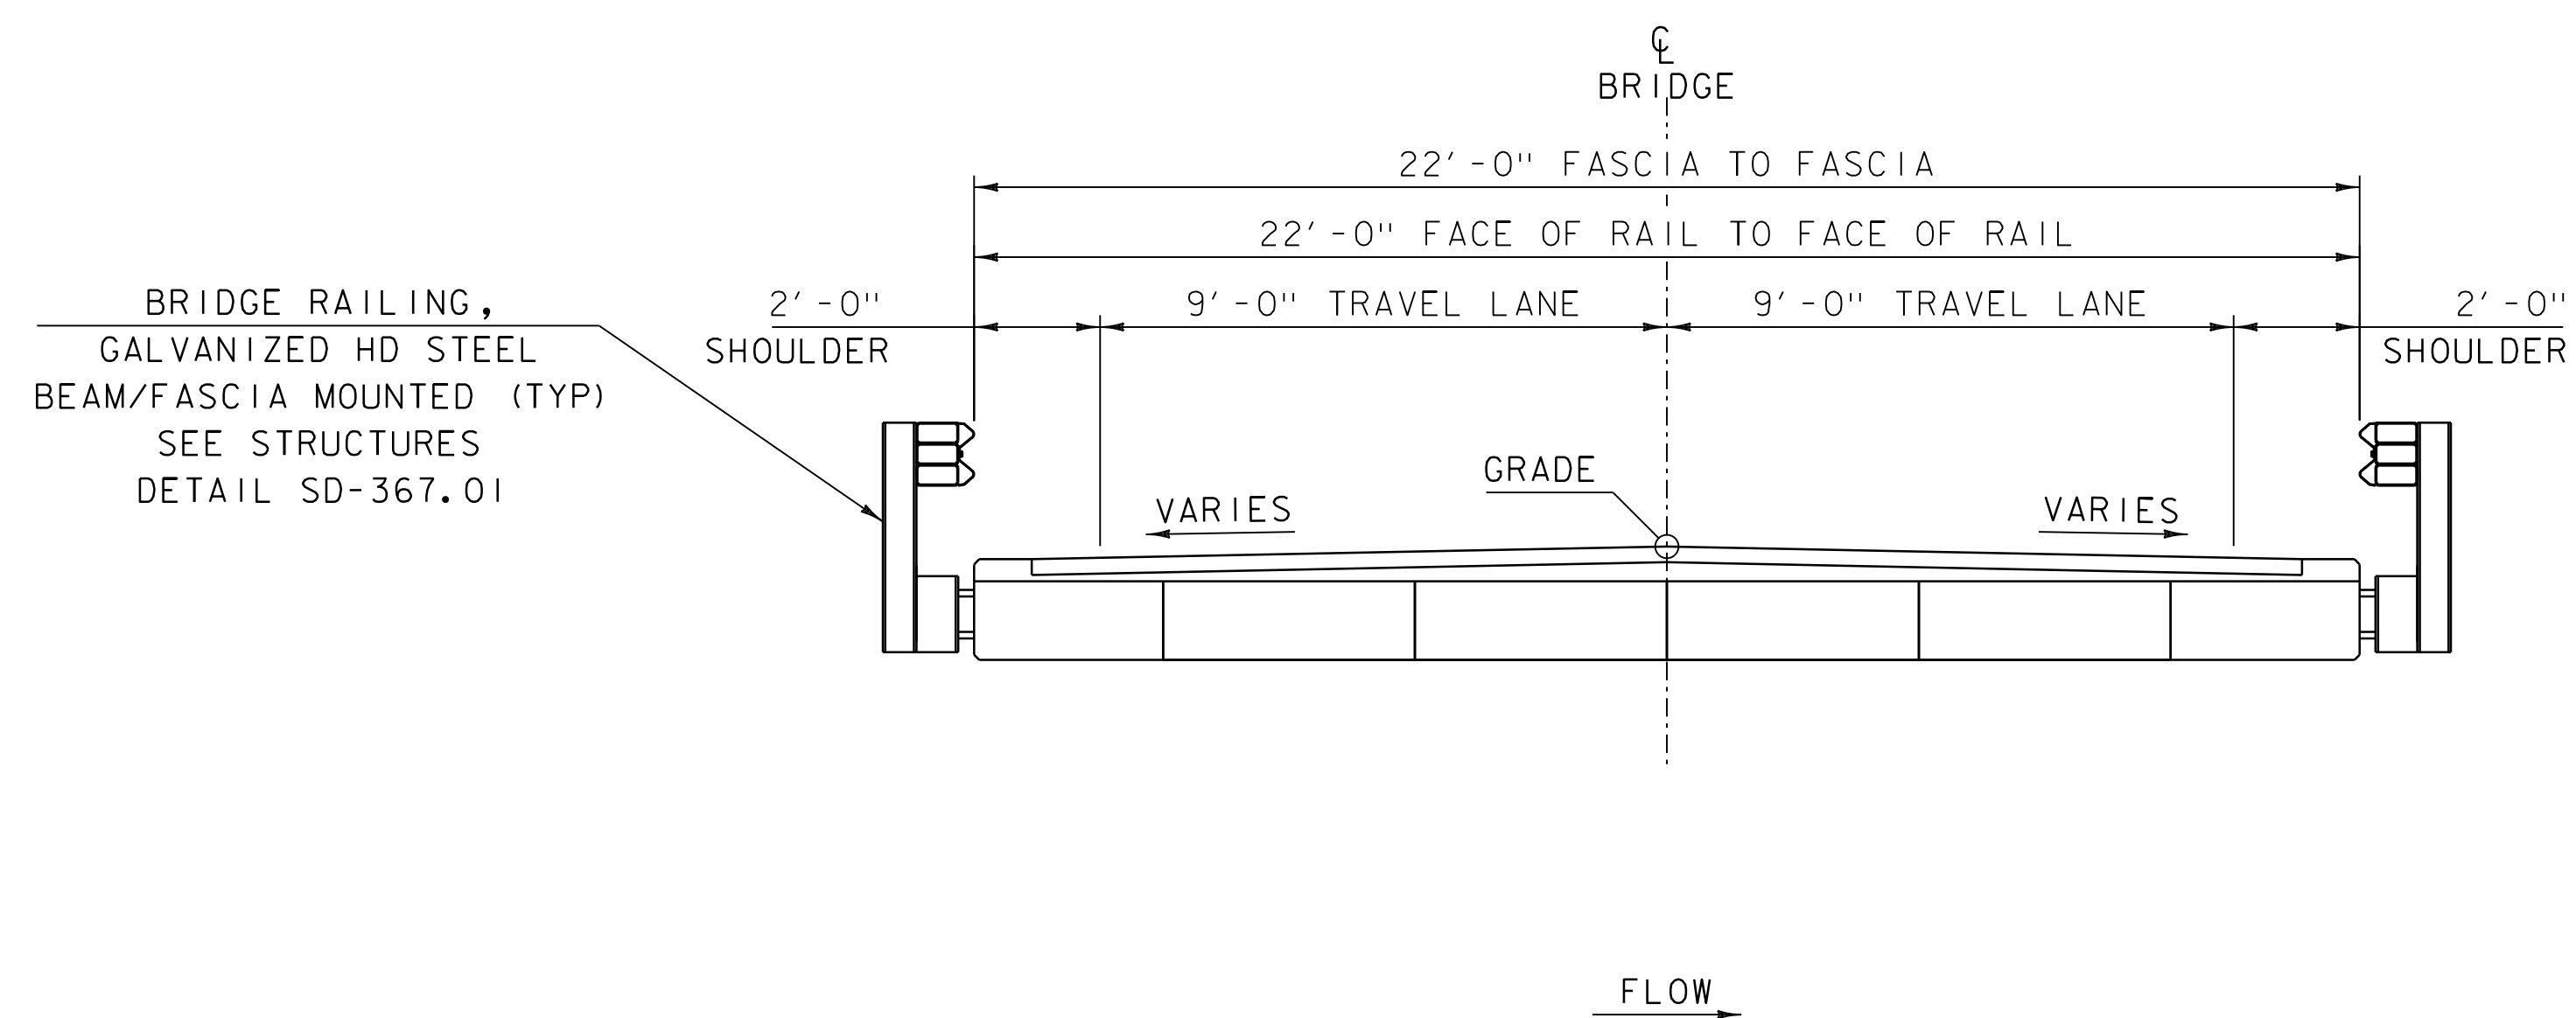
PROPOSED BRIDGE TYPICAL SECTION
SCALE $\frac{3}{8}" = 1'-0"$
