Wallingford BF 0133(18) Project Introduction Meeting

VT Route 155 – Bridge 15 over Mill River

April 3, 2023

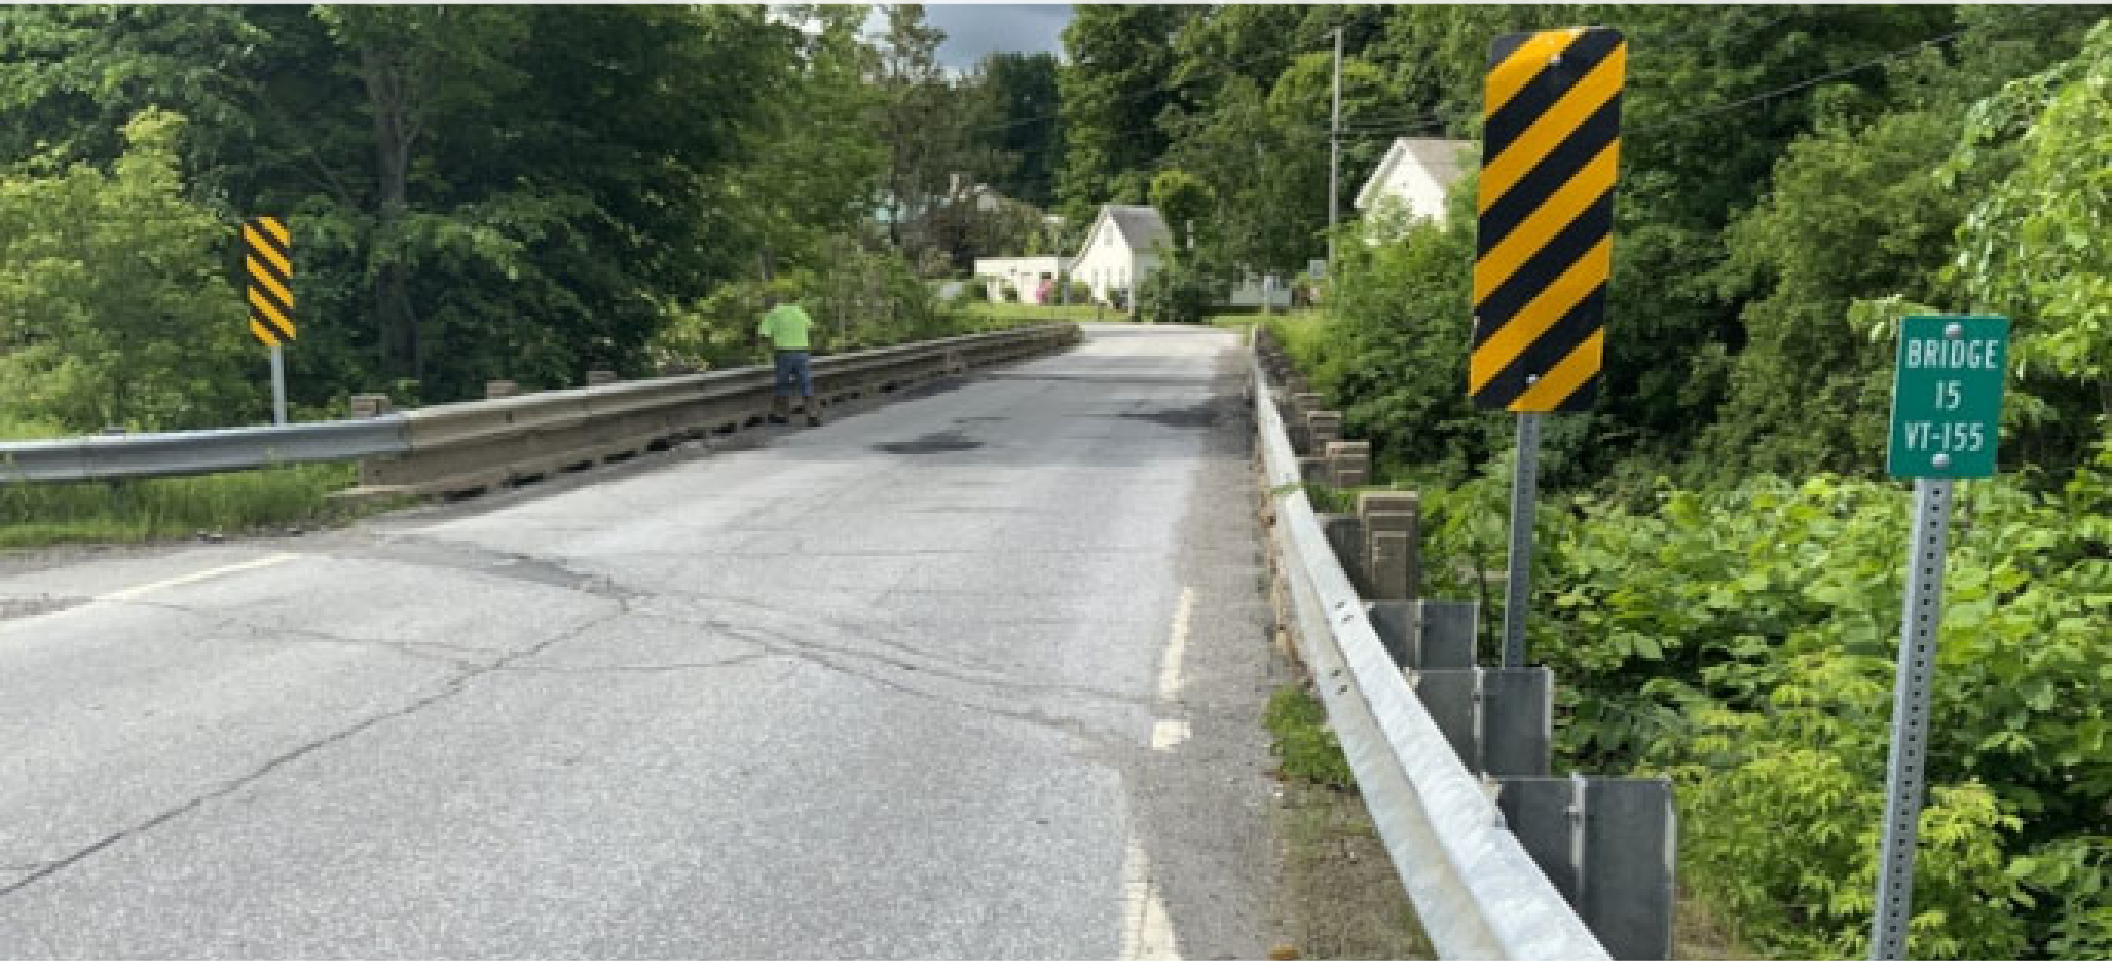
Looking South

Existing Conditions – Bridge #15

- Roadway Classification – Rural Minor Collector
- 180' long 2-Span Rolled Beam Bridge
- Ownership – State of Vermont
- Constructed in 1940

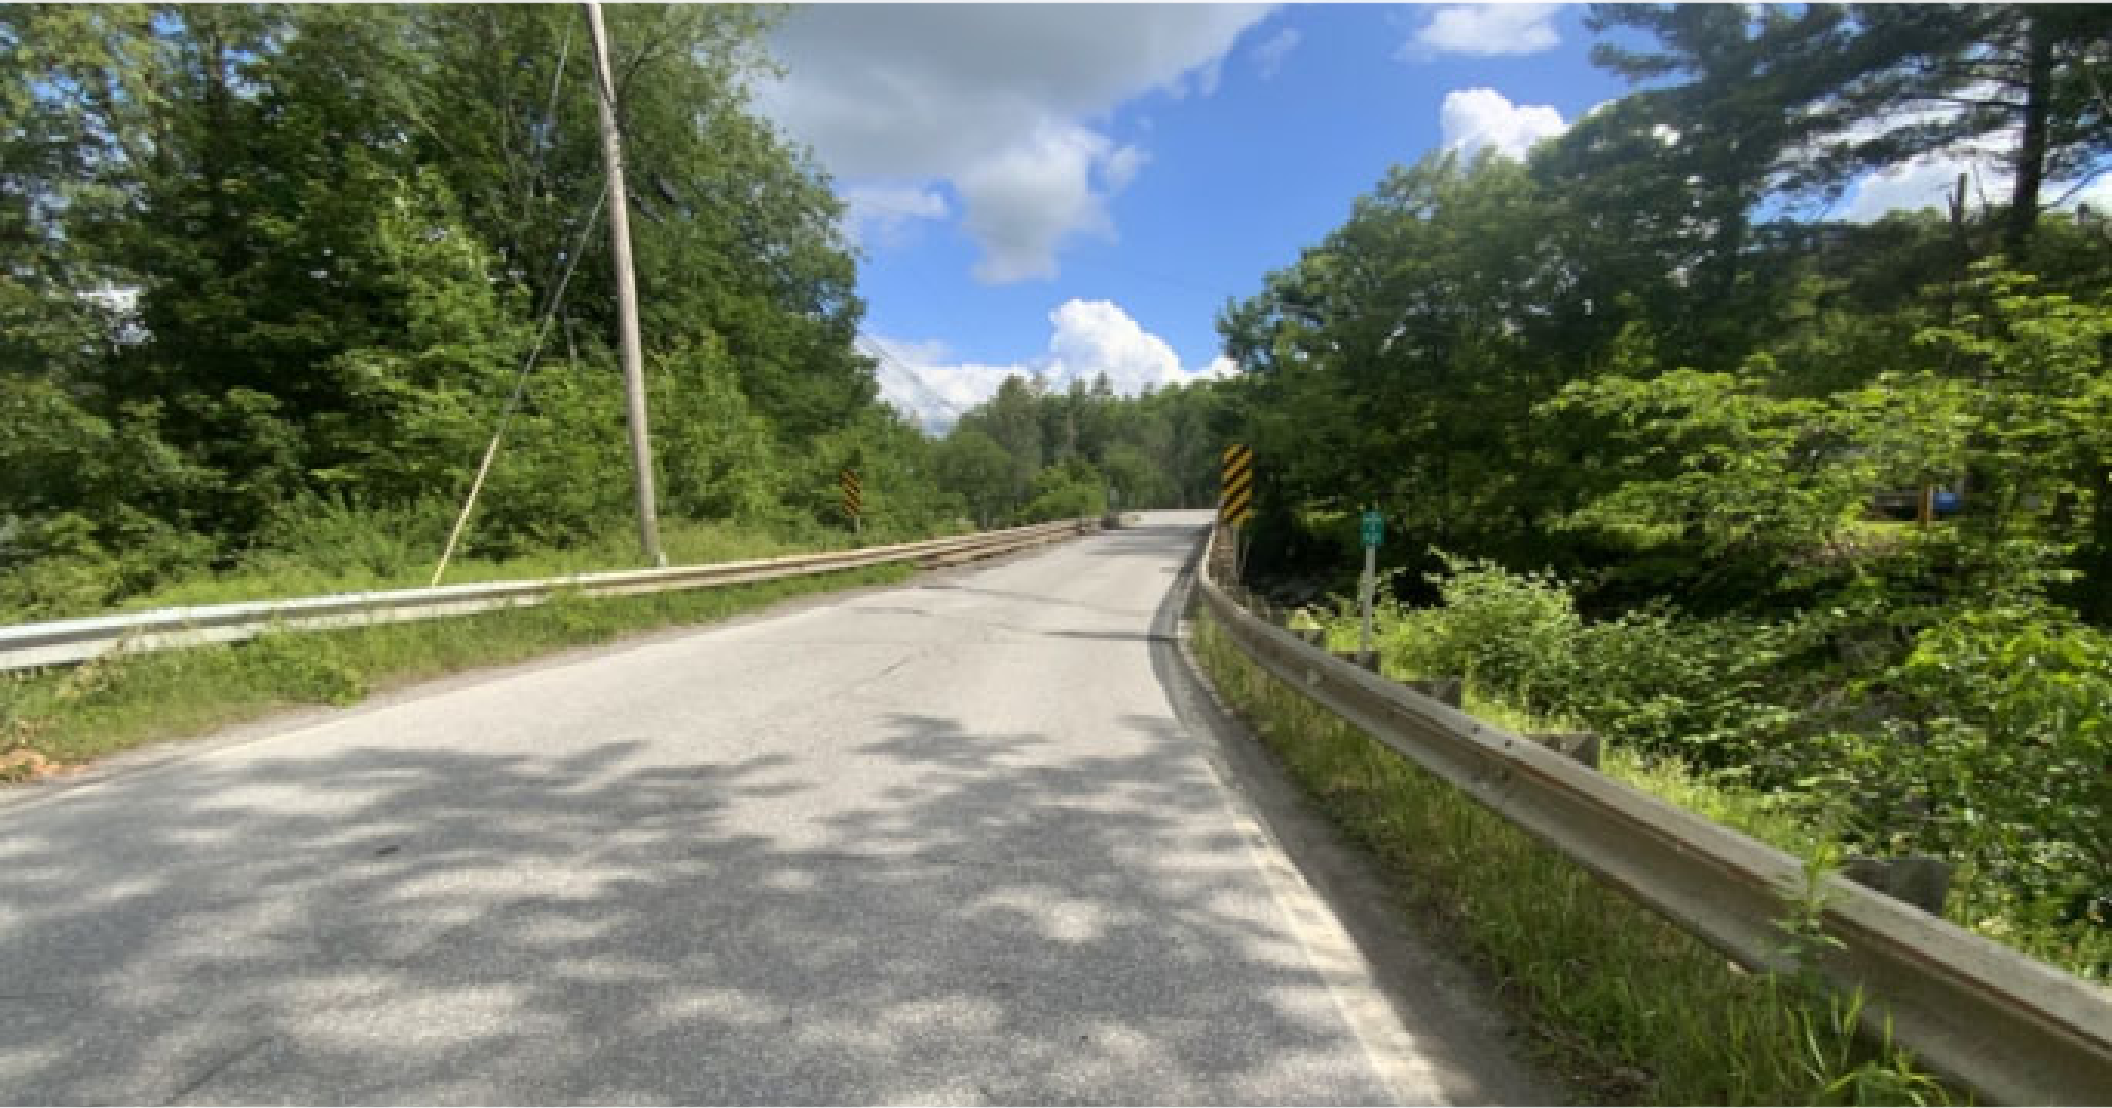
Looking North

Existing Conditions – Bridge #15

- Public Utilities – Aerial Utilities
- Municipal Utilities?

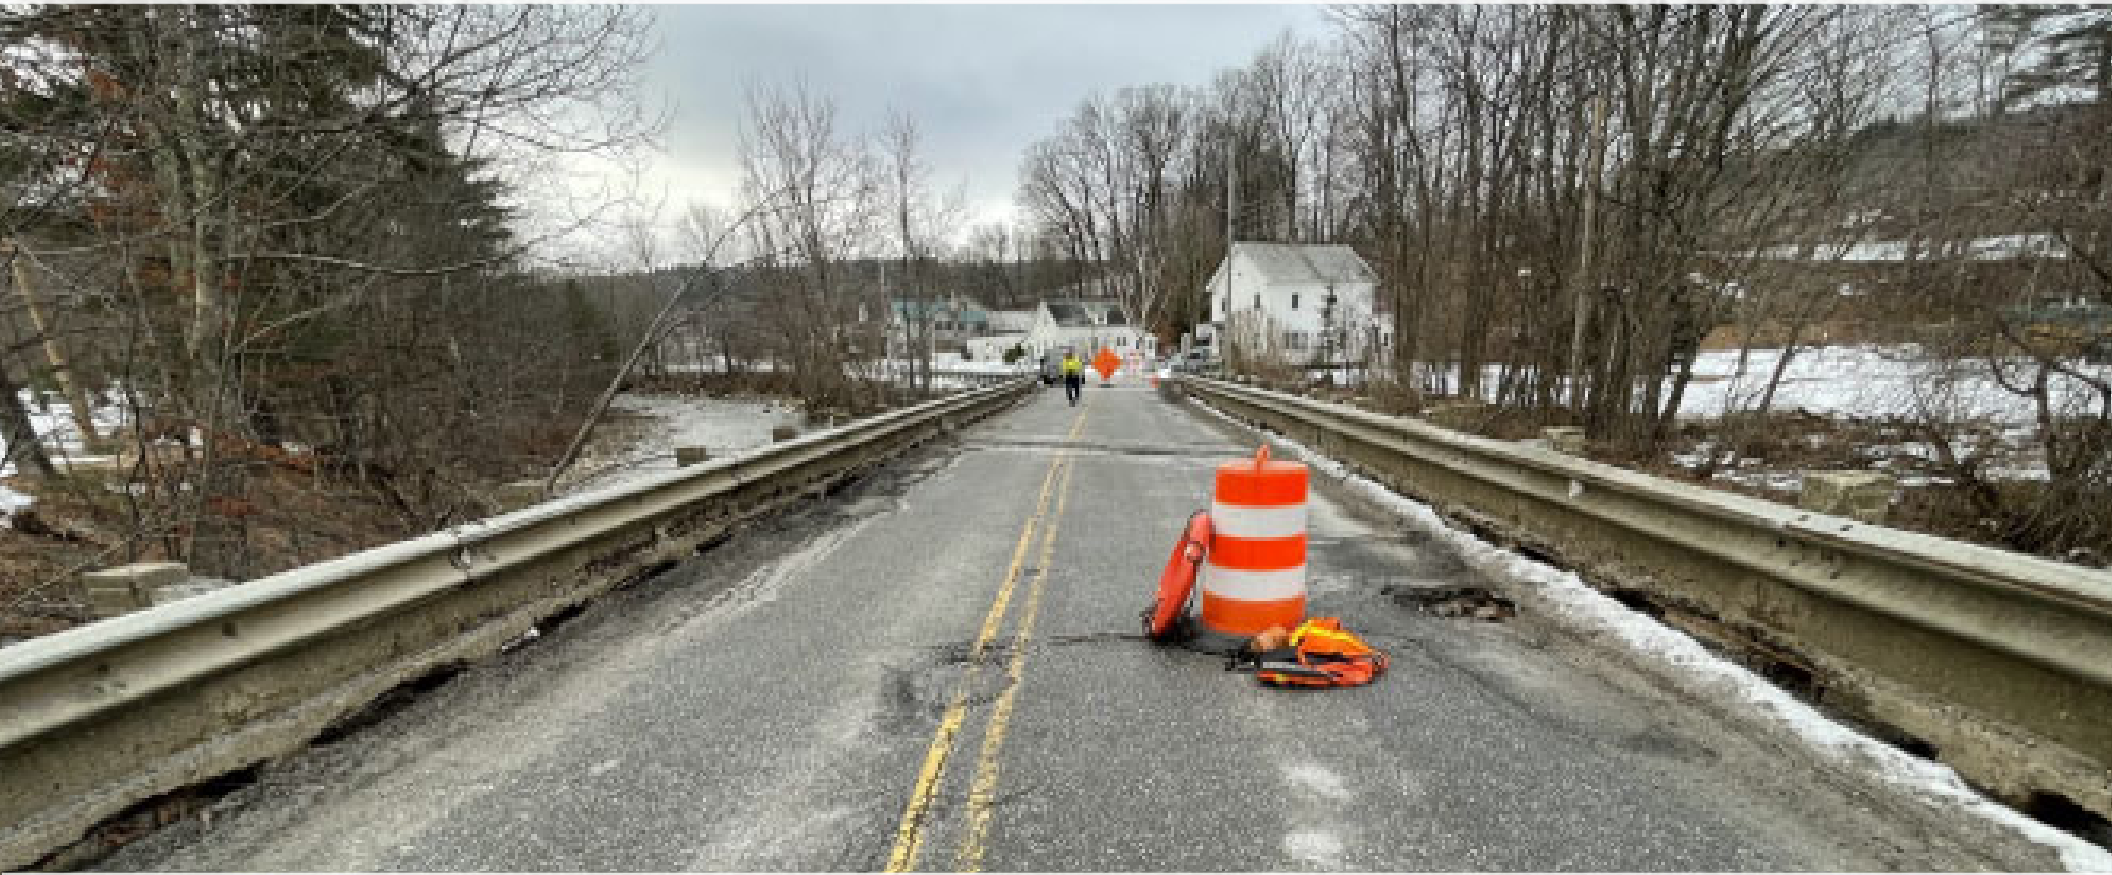
Bridge Inspection Report Ratings

Existing Conditions - Bridge #15

- Deck Rating 4 (Poor)
- Superstructure Rating 5 (Fair)
- Substructure Rating 5 (Fair)
- Channel Rating 6 (Satisfactory)

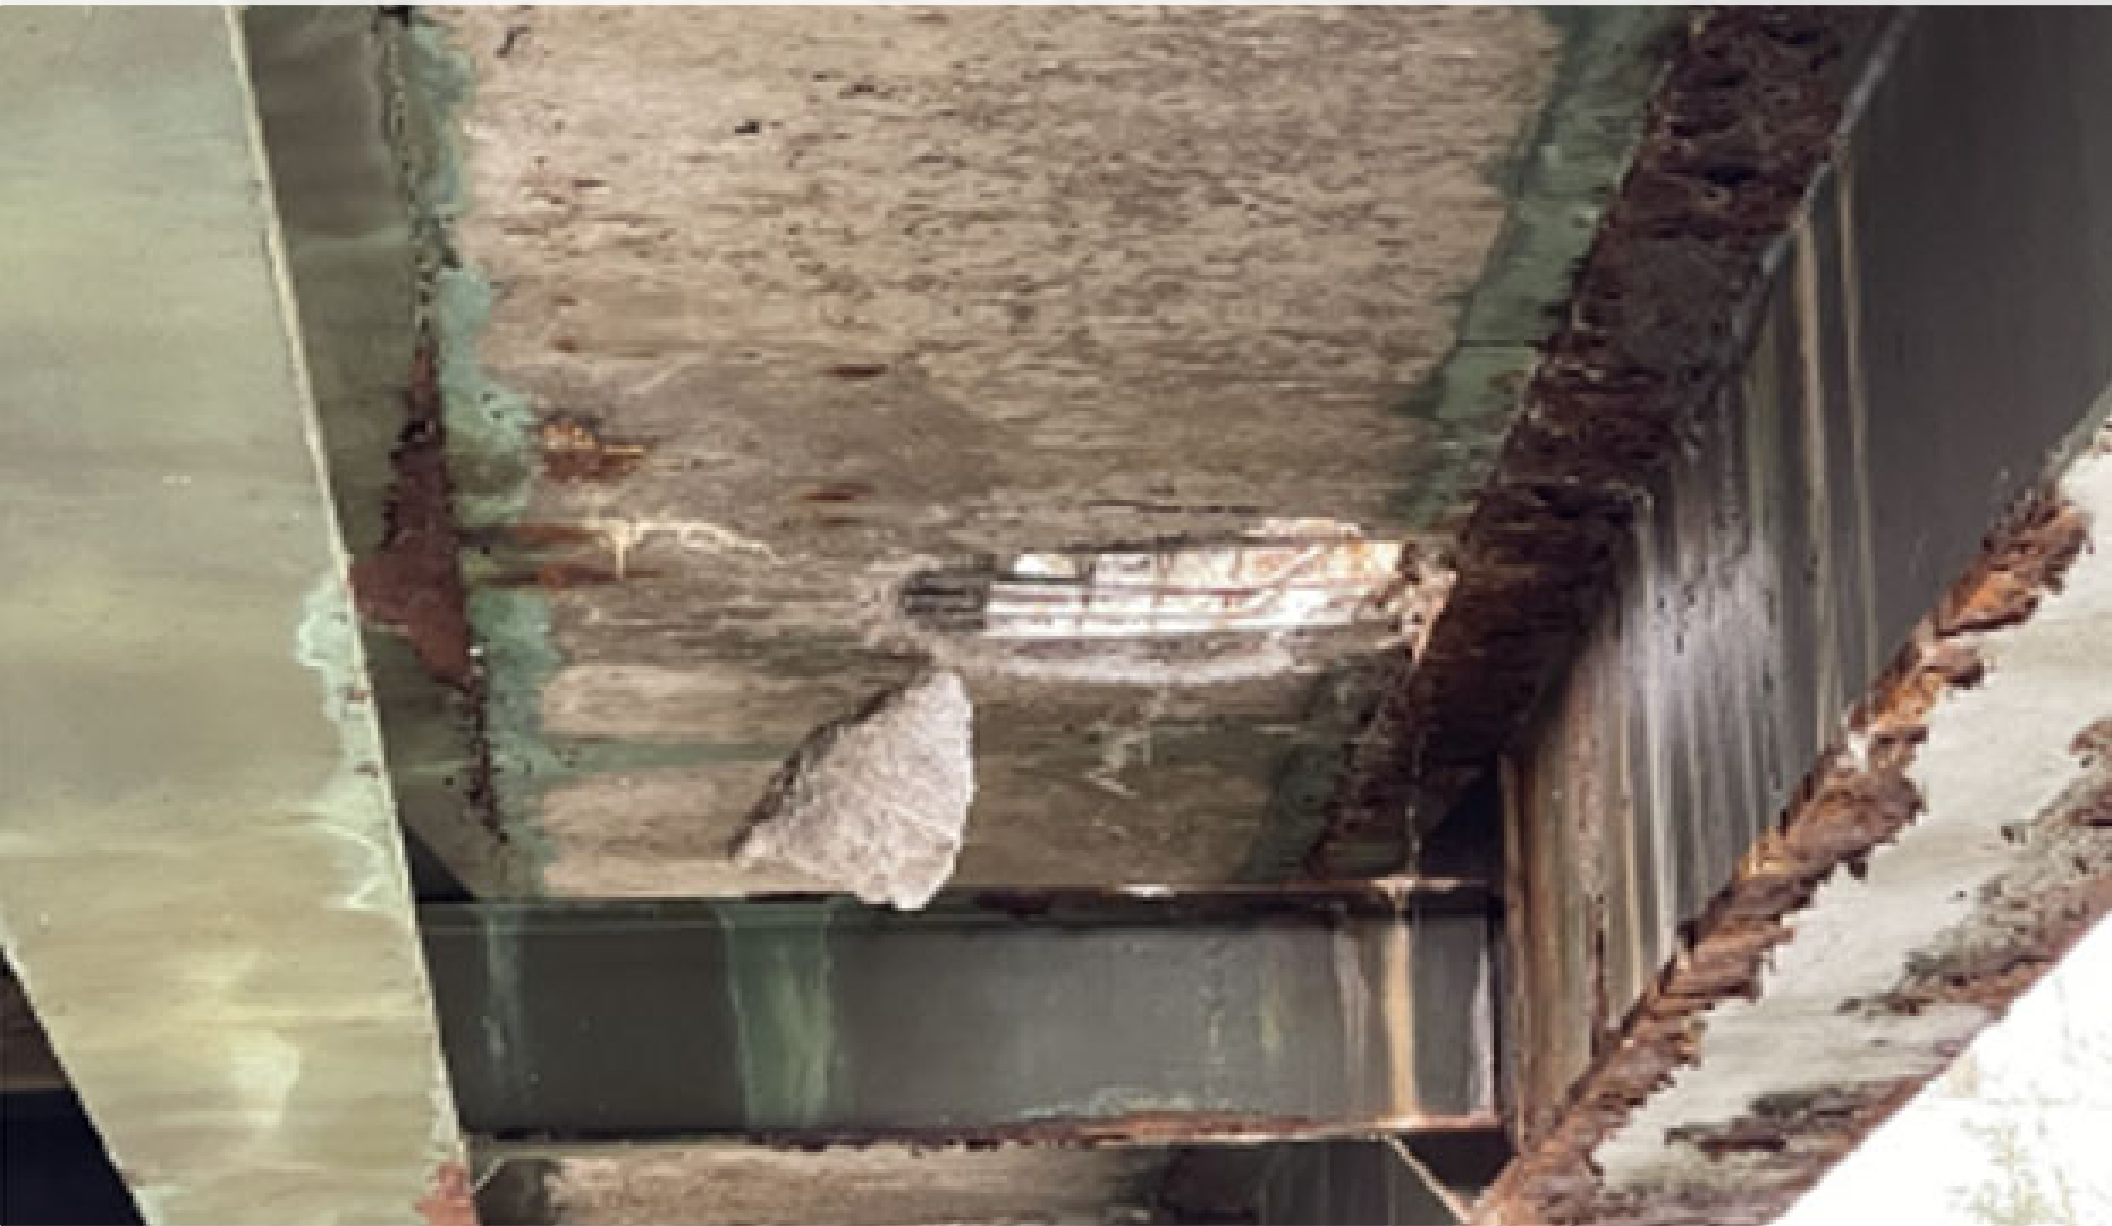
Full Depth Pop Out

- Issue: Full depth hole formed in the VT Route 155 south bound lane on 1/7/2023. The bridge was closed until further discussions.
- Background: Our bridge inspection team was notified of a full depth hole that had developed on this structure. Due to safety concerns the structure was closed (1/7/2023) by district forces until further investigation was performed and discussions had. Bridge inspection was on site the morning of Monday, 1/9/2023. This inspection noted advancement in deterioration and the 3.5ft x 2.5ft hole with soft concrete surrounding the area of concern. Deteriorated concrete was noted and appears extensively throughout the deck. Also noted substantial concrete deterioration along the curb line and around the open wind slots. Due to the 1940's design of the structure with wind slots contributing to the advanced deterioration in the fascia it has now extended beyond the exterior bays and is progressing into some interior bay sections. Deck rating dropping from 5 to 4.

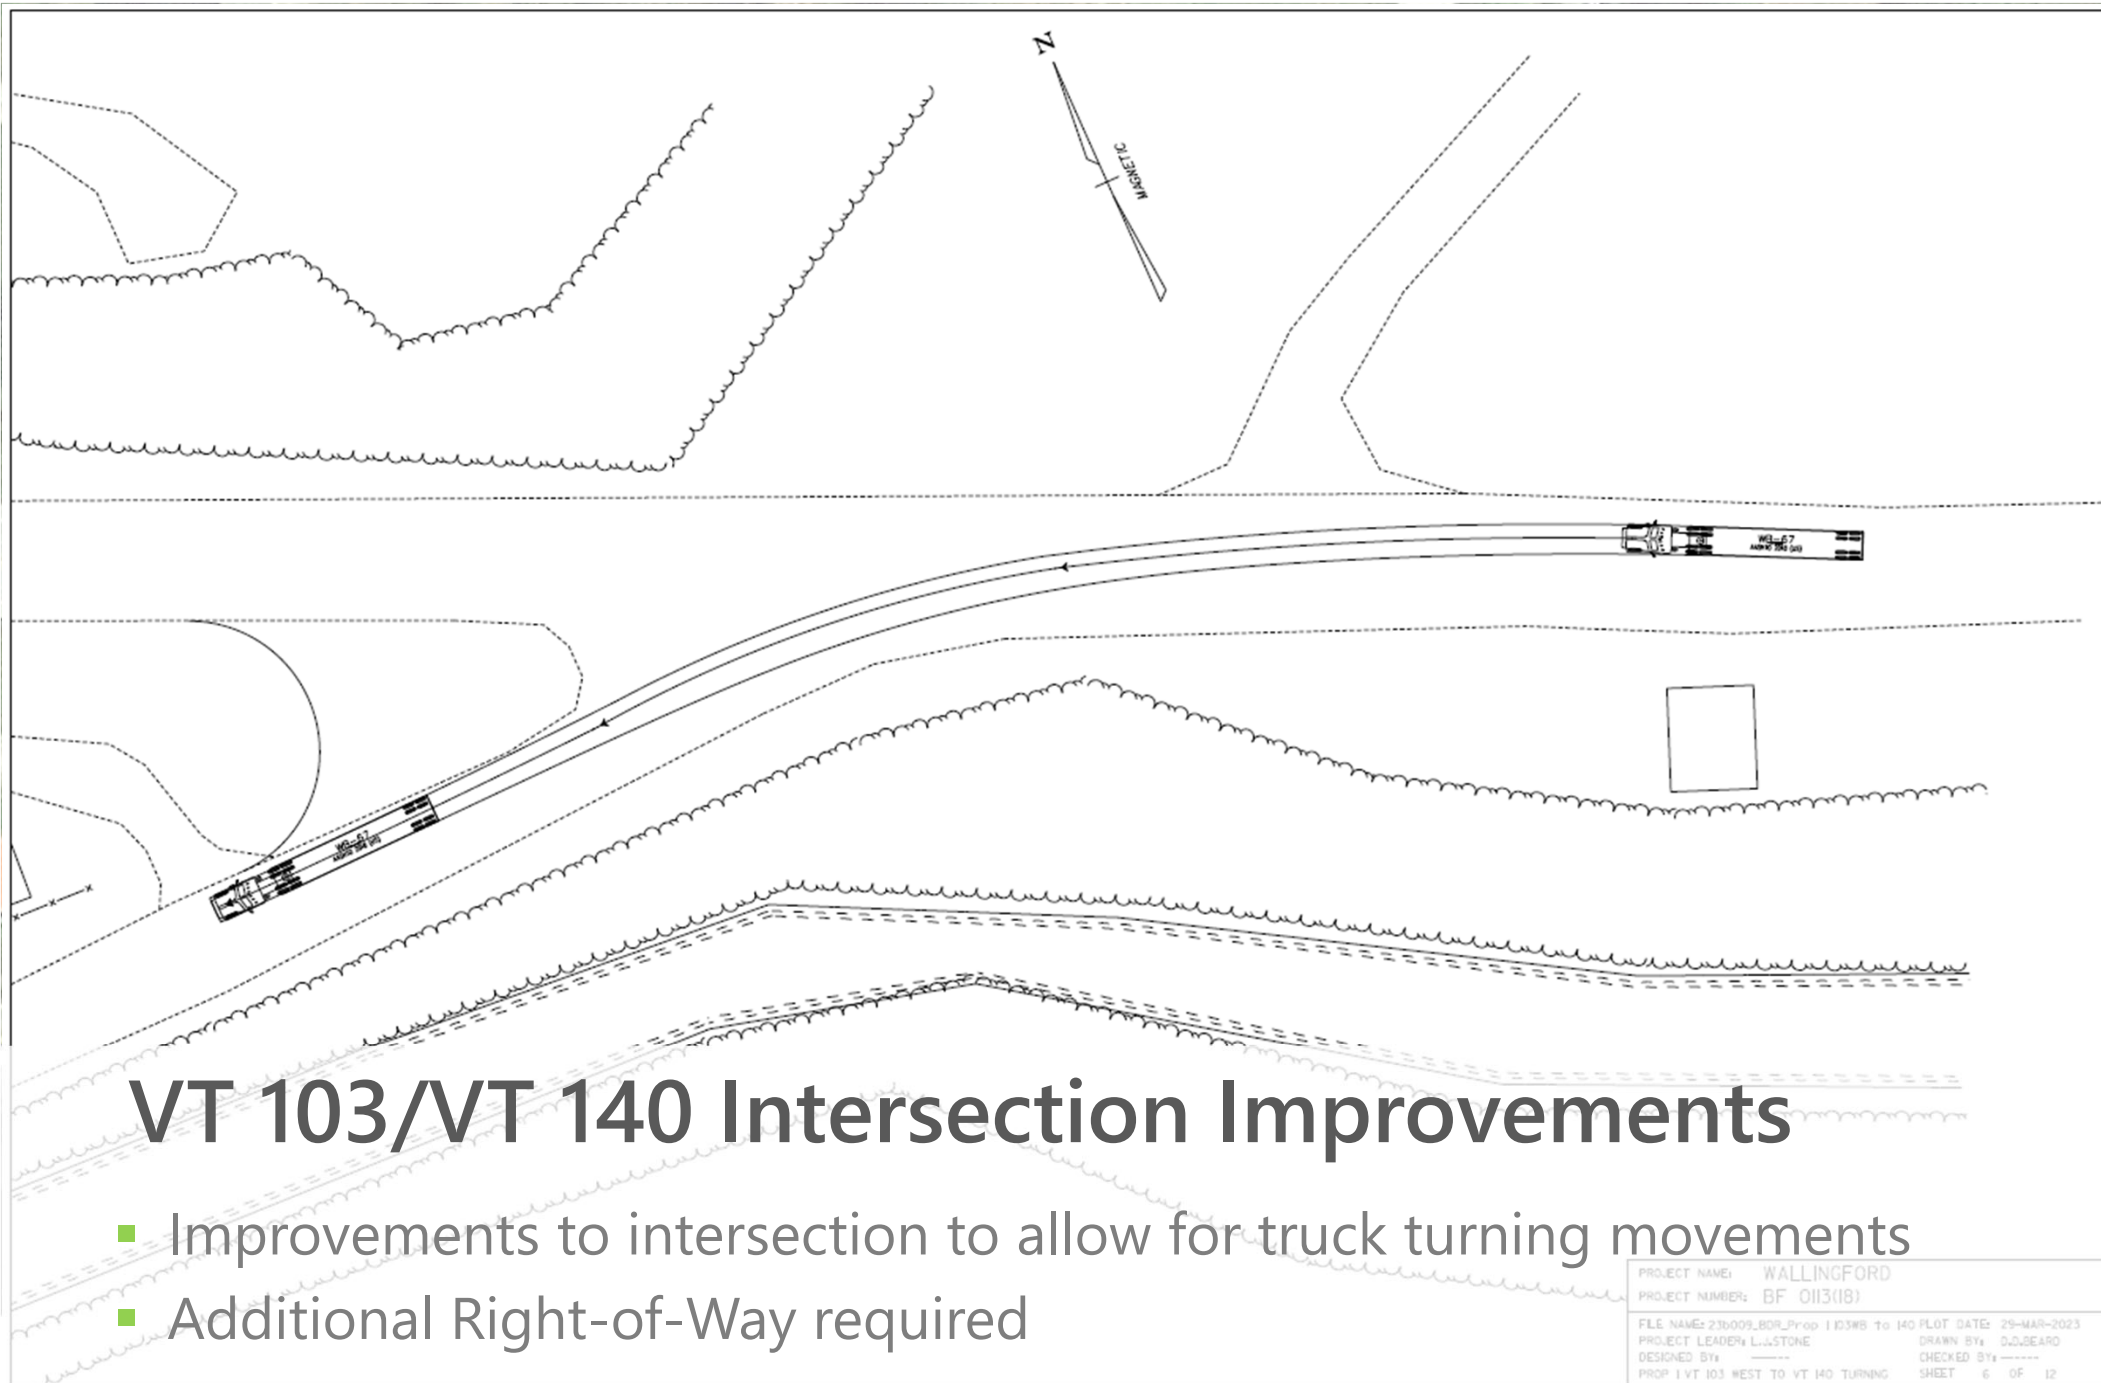
Proposed: VT 103 West to VT 140 Turning Movement

- Improvements to intersection to allow for truck turning movements
- Additional Right-of-Way required
