Wallingford BF 0133(18)
Public Informational Meeting
VT Route 155 – Bridge 15 over Mill River

January 20, 2026

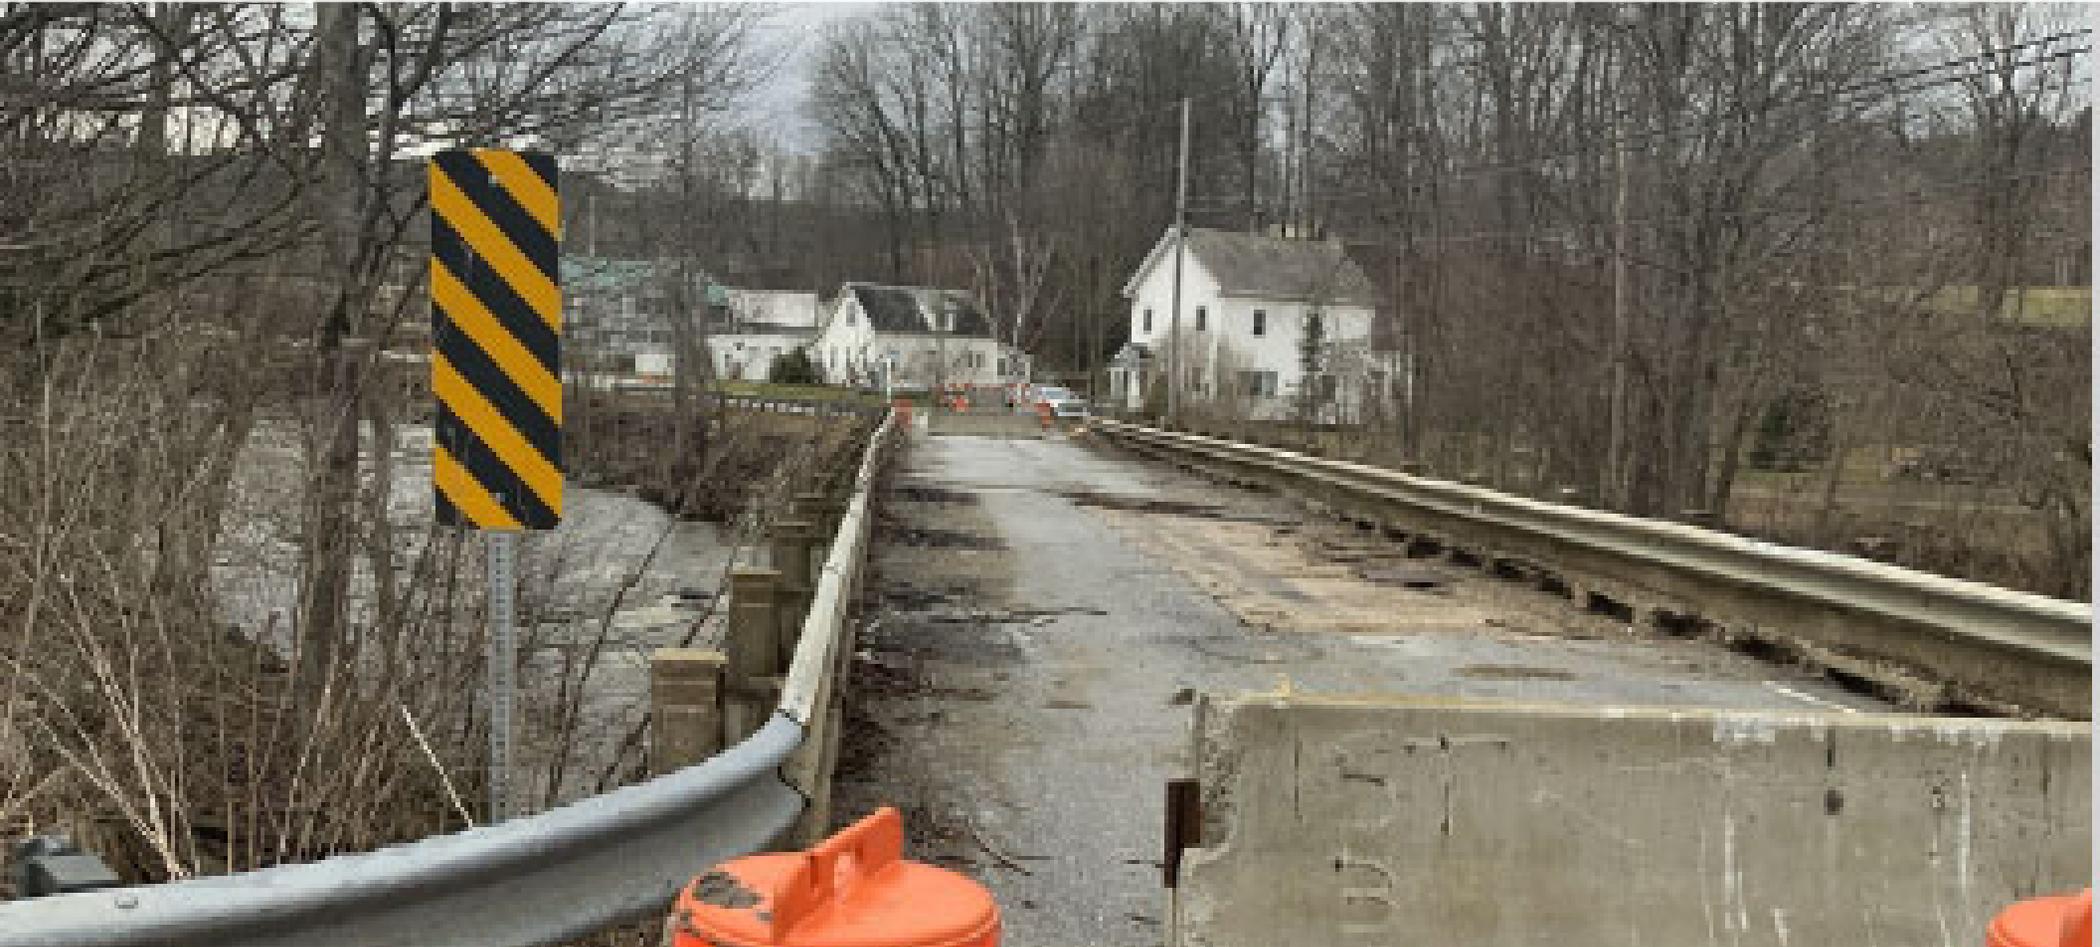
Looking South

- Roadway Classification – Rural Major Collector
- Bridge Type – Two Span Rolled Beam Bridge
- Ownership – State of Vermont
- Constructed in 1940

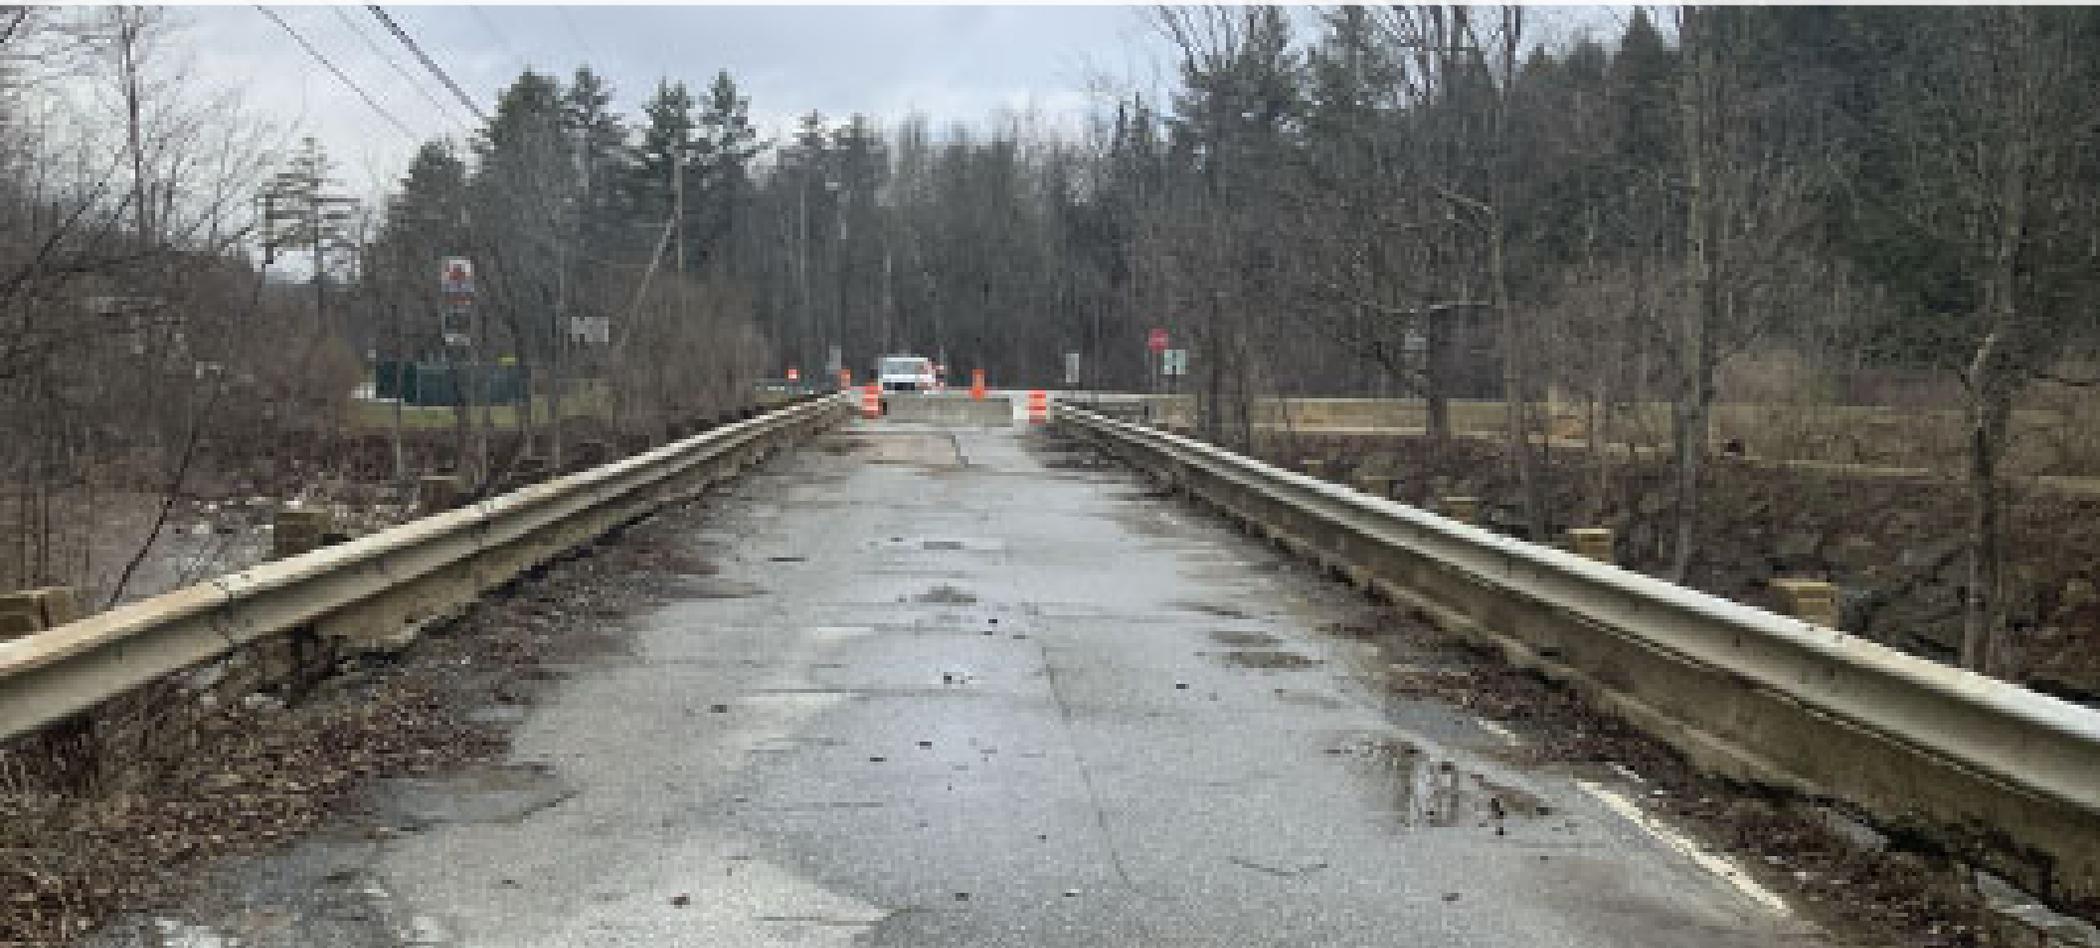
Looking North

- Utilities – Aerial (Green Mountain Power, Consolidated Communications, Comcast, Vt. Telephone Company, Inc.)
- Utilities – Underground (Vt. Telephone Company)
- Utilities – Municipal (None)

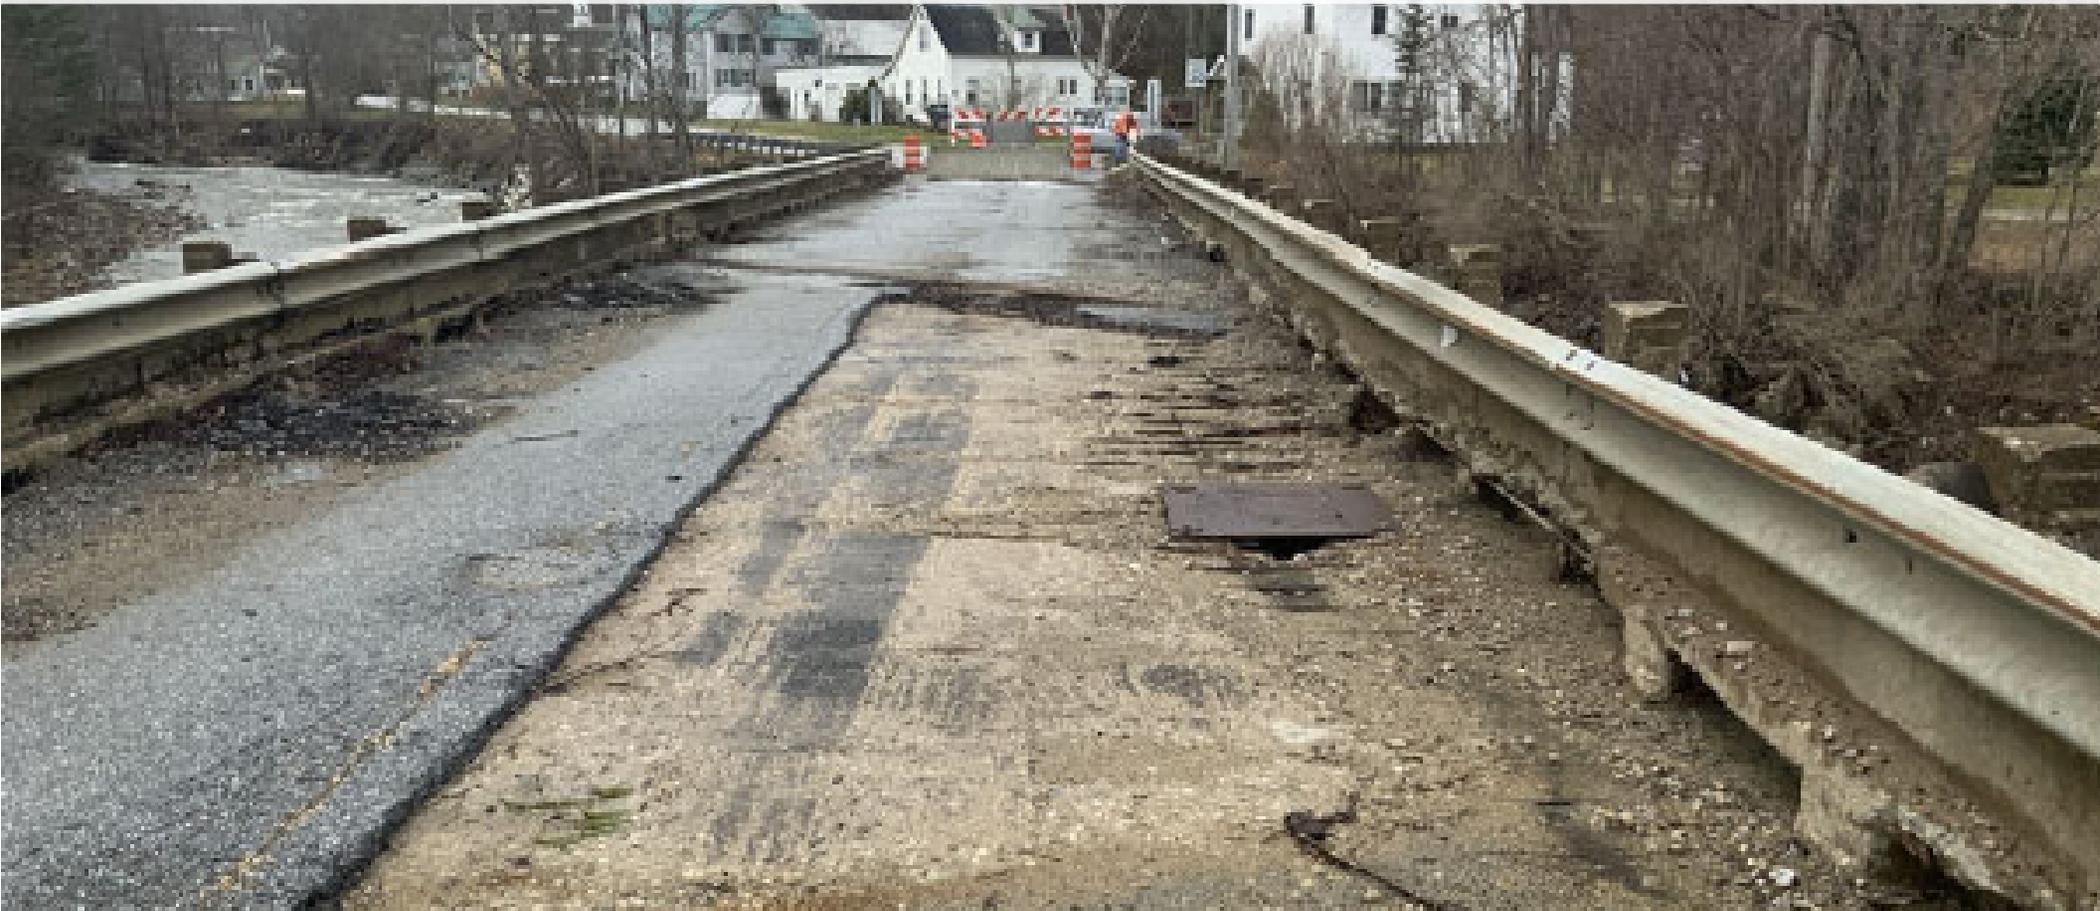
Bridge Inspection Report Ratings

- Deck Rating 4 (Poor)
- Superstructure Rating 5 (Fair)
- Substructure Rating 4 (Poor)
- Channel Rating 5 (Fair)

- Advancement in deterioration with a 3.5ft x 2.5ft hole with soft concrete surrounding the area of concern. Deteriorated concrete appears extensively throughout the deck. There is substantial concrete deterioration along the curb line and around the open wind slots. Due to the 1940's design of the structure with wind slots contributing to the advanced deterioration in the fascia it has now extended beyond the exterior bays and is progressing into some interior bay sections. The stringers have section loss at exterior beam ends and at the pier.

- The substructure is in poor condition. Both abutments have cracking and staining, and abutment 1 has exposed rebar along the southwest corner. The bearing area is undermined 50%.

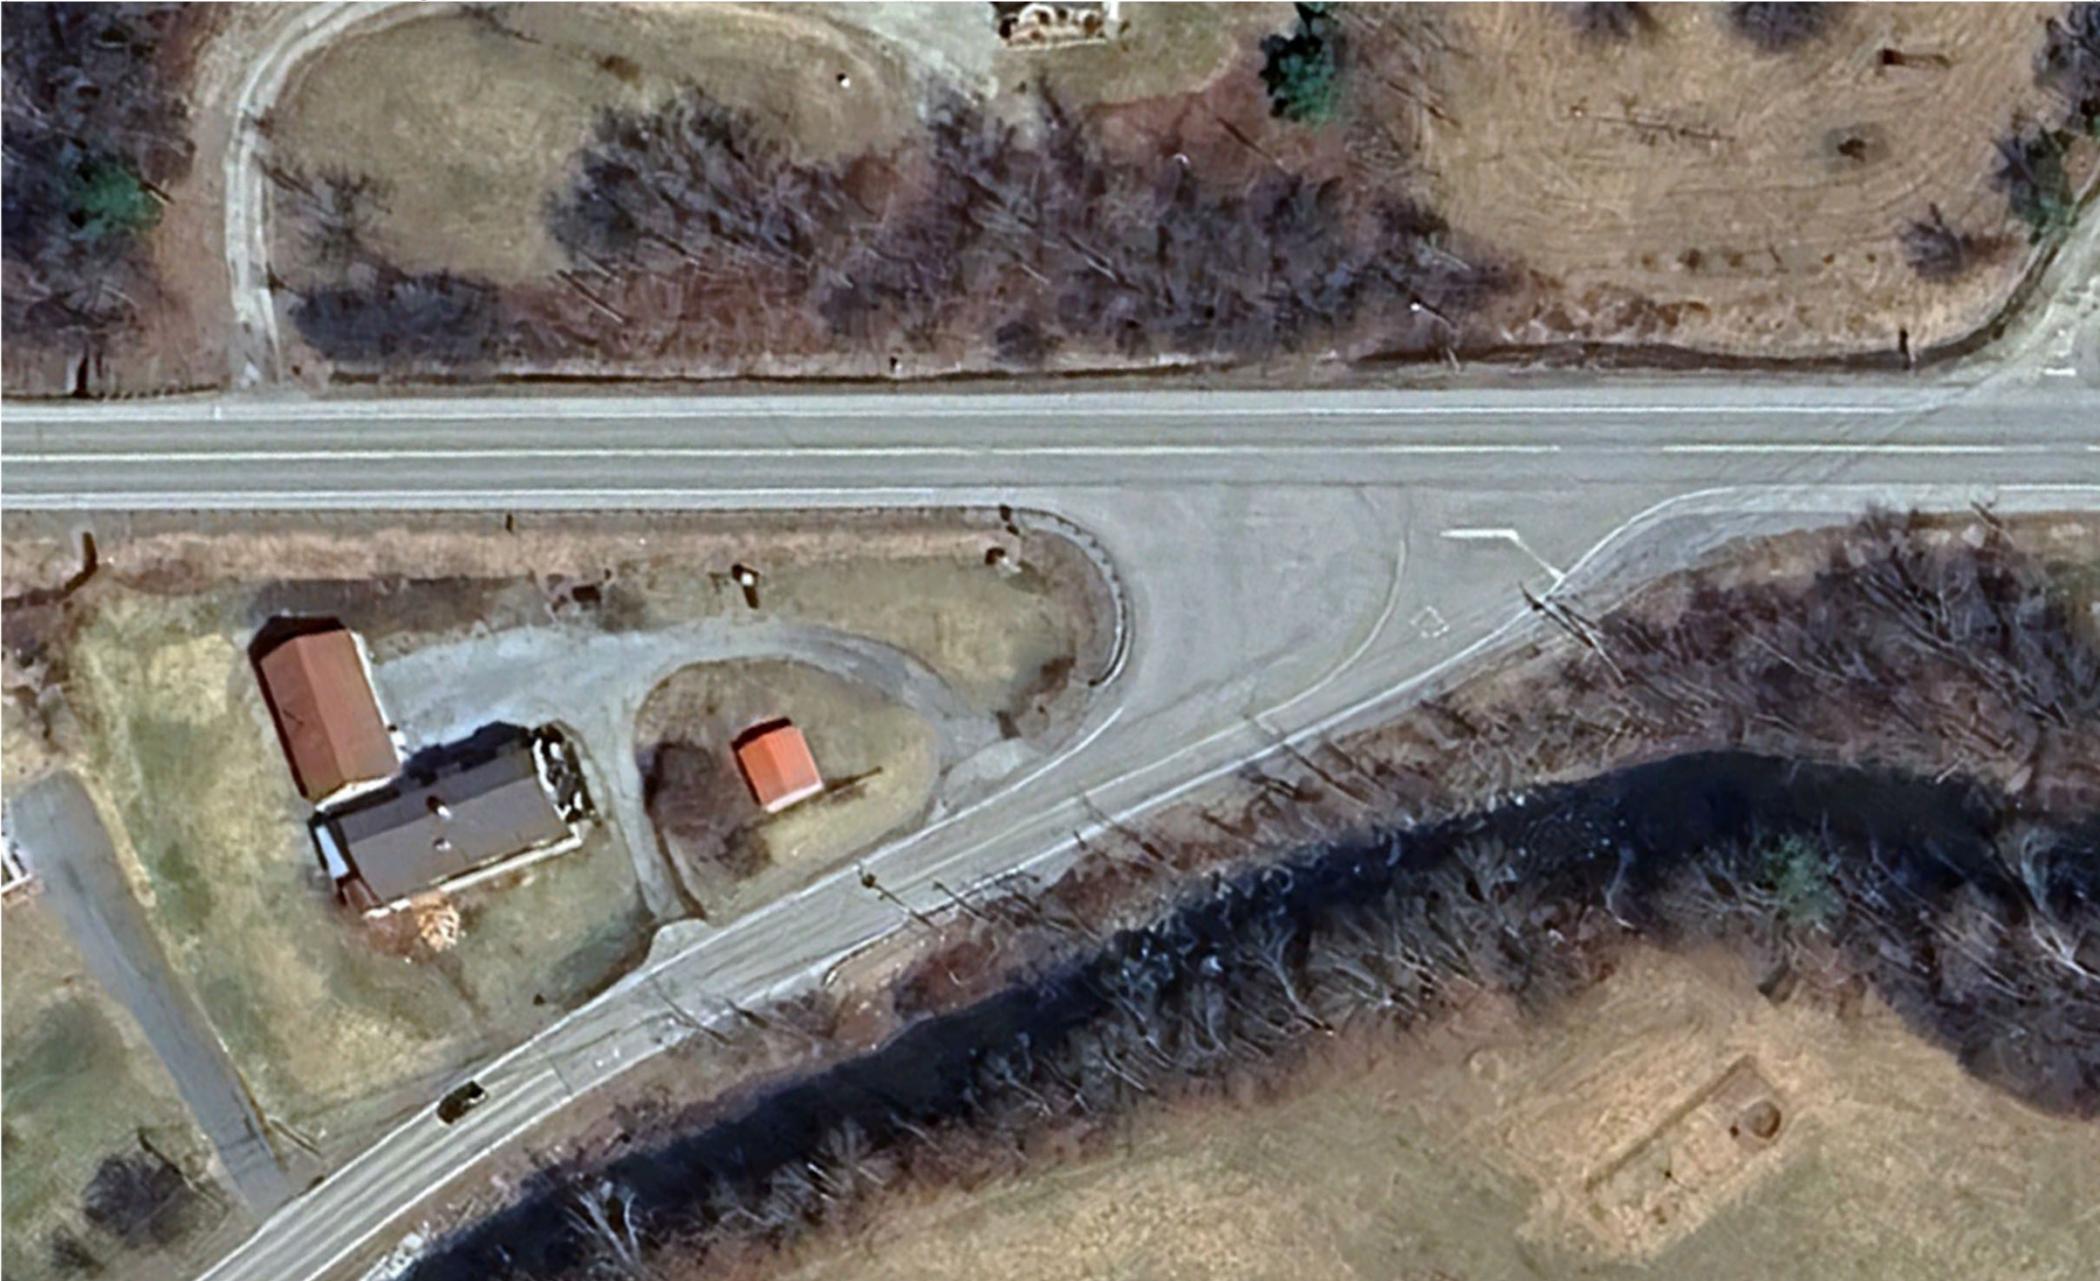
- Improvements to the intersection to allow for truck turning movements were completed in 2023
