Killington NH CULV(120)
Regional Concerns Meeting
US ROUTE 4, BRIDGE 28 OVER KENT BROOK

February 12, 2024

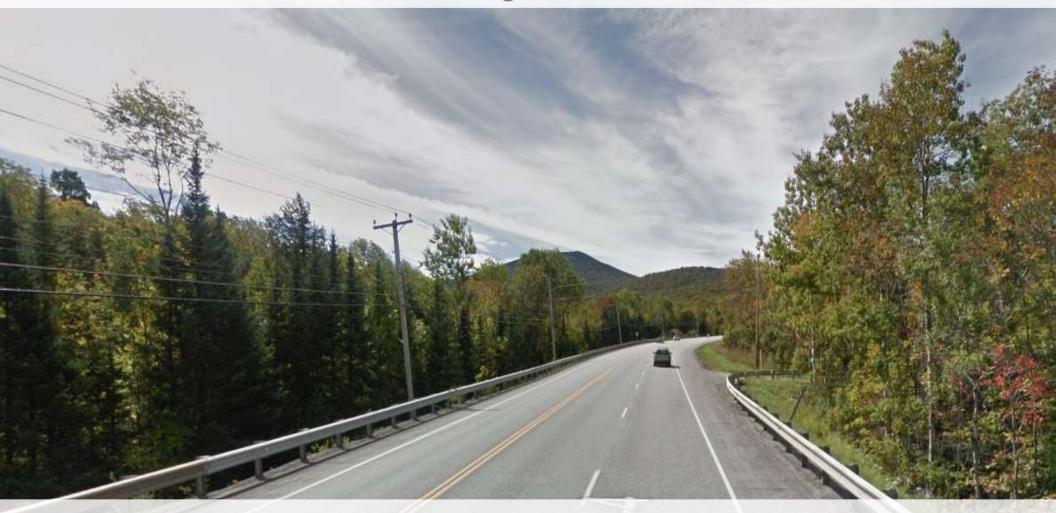
Looking Southwest

Existing Conditions – Bridge #28

- Roadway Classification Principal Arterial (NHS)
- Bridge Type 11 ft Span Corrugated Galvanized Multi Plate Pipe (CGMPP)
- Ownership State of Vermont
- Constructed in 1948

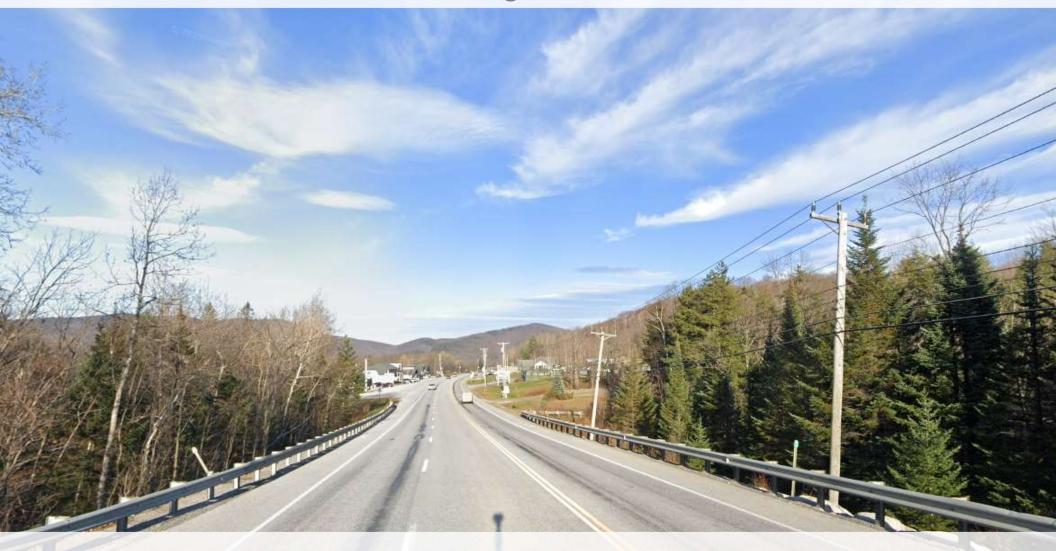
Looking Northeast

Existing Conditions – Bridge #28

- Aerial utilities (electric, communications, fiberoptic, and telephone) run parallel to US4 on the southeast side
- Underground municipal utilities (sewer) run parallel to US4 on the northwest side

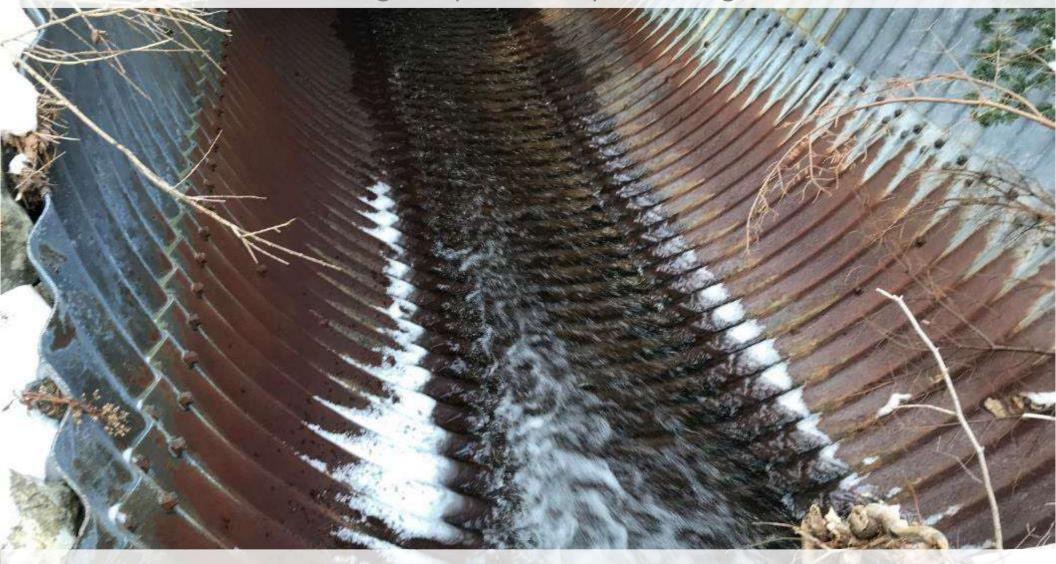
Bridge Inspection Report Ratings

- The culvert is in poor condition. The culvert has heavy rust scale along the exposed top edge of the rust line with deep pitting and moderate to heavy section loss. Scattered perforations of smaller sizes run throughout the pipe which have produced visible piping causing a noticeable minor drop in the water line along this area.
- The existing culvert does not meet the measured 30-foot bank full width of Kent Brook.
- US Route 4 has substandard shoulder widths along the US Route 4 corridor through the project area.

Existing Conditions - Bridge #28

- Culvert Rating 4 (Poor)
- Channel Rating 6 (Satisfactory)

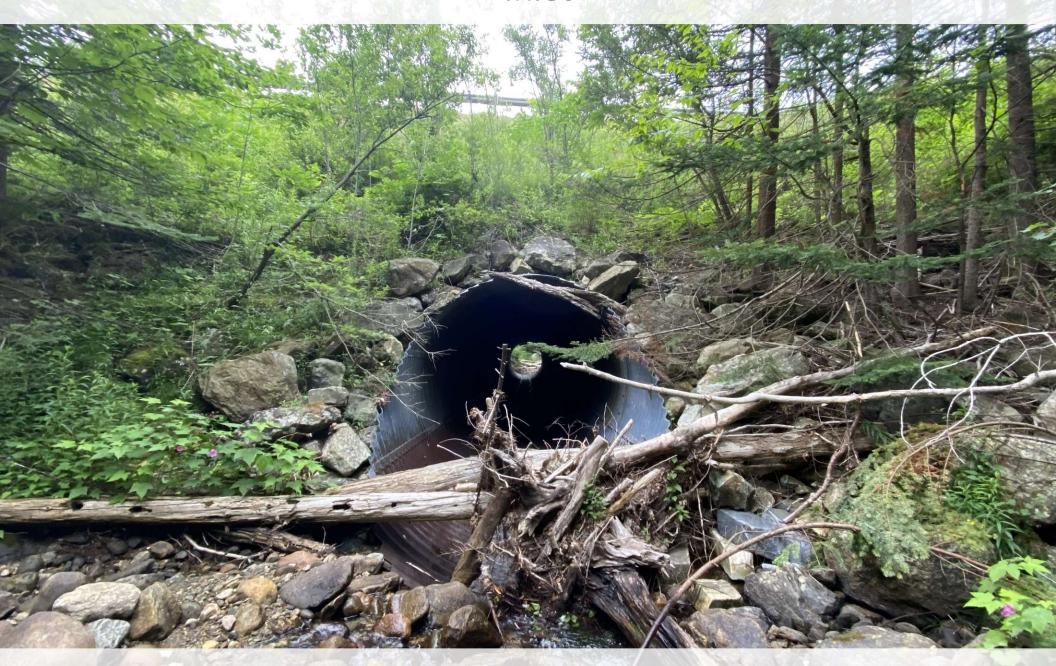
Inlet

Existing Conditions - Bridge #28

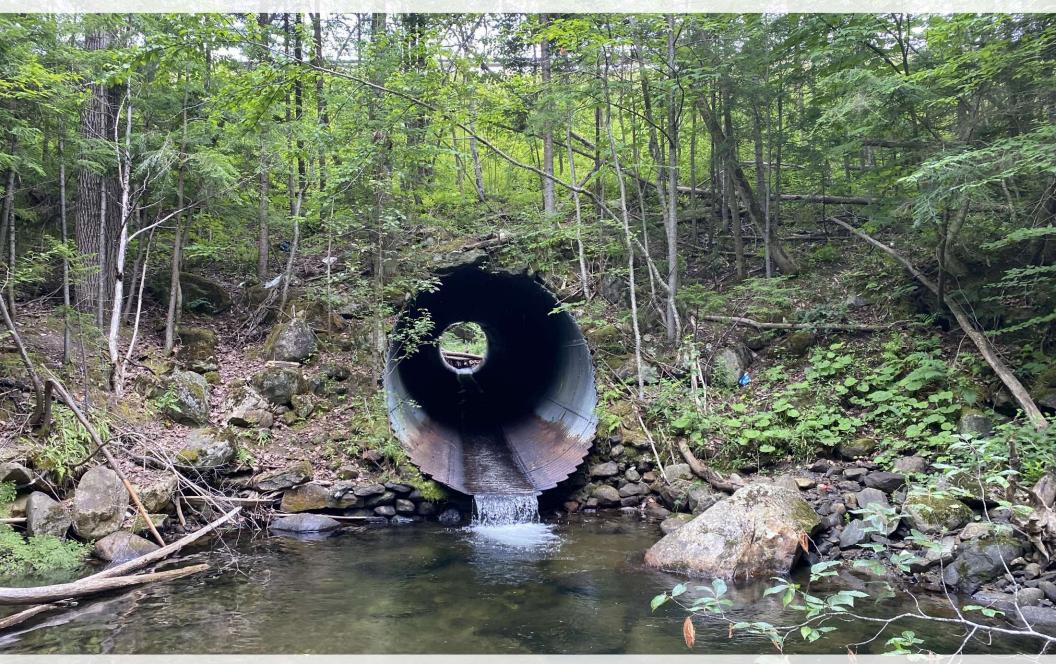
Outlet

Existing Conditions - Bridge #28

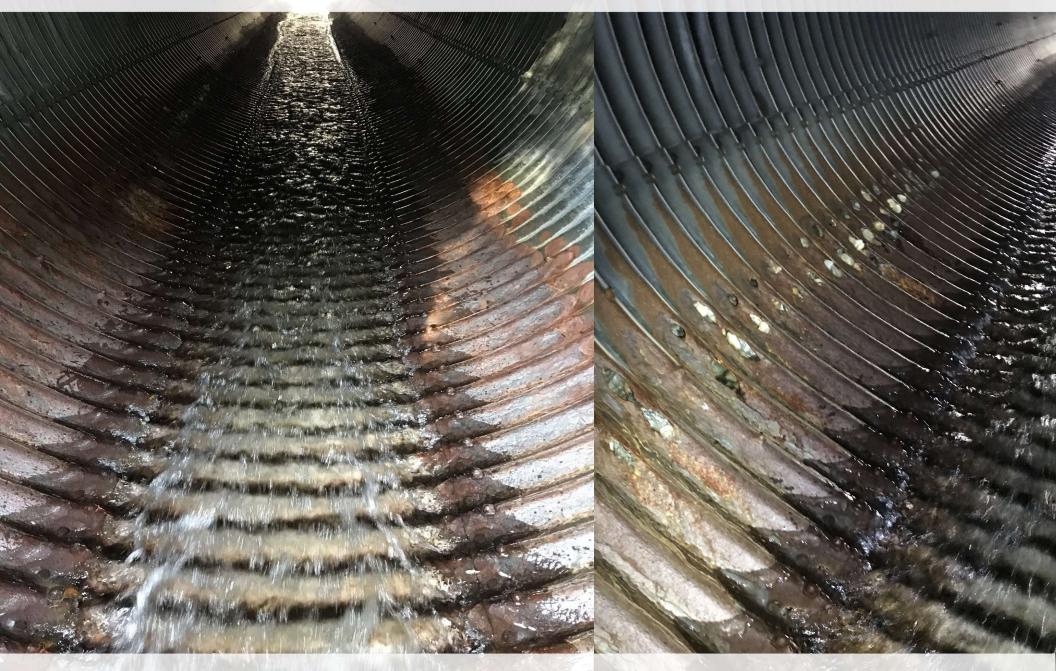
Rusted and Perforated Invert

Existing Conditions - Bridge #28
