Public Information Meeting

BRIDGE 19-5 and BRIDGE 19-7 OVER UNNAMED BROOKS ALONG U.S. ROUTE 7 IN SUNDERLAND

September 30, 2024

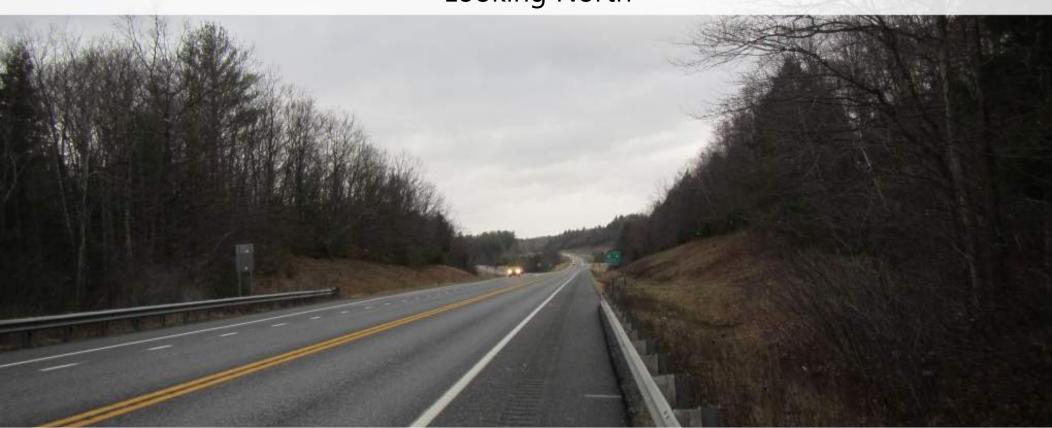
Looking North

- Roadway Classification Principal Arterial, National Highway System
- Bridge Type 7-foot Span Corrugated Galvanized Metal Plate Pipe (CGMPP)
- Culvert Length: 120 feet
- Fill Over Culvert: 10 feet
- Ownership State of Vermont
- Constructed in 1979

- The culvert is in fair condition. There is heavy rust scaling, pitting, and large perforations scattered along the culvert barrel. The invert haunches throughout the structure have heavy rust scaling, pitting and large perforations scattered along the barrel length.
- Culvert does not meet stream equilibrium standard of 14' for bank full width

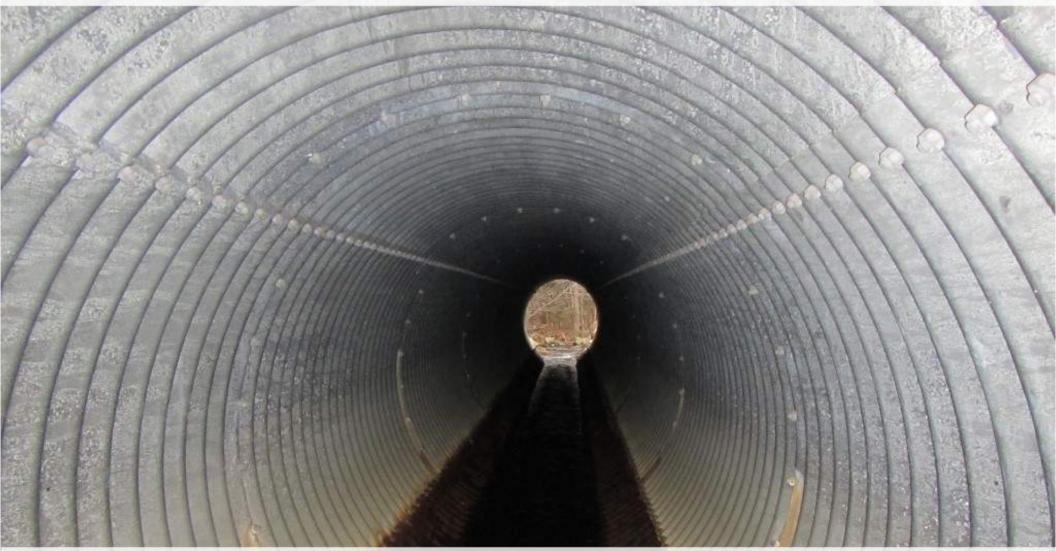
Bridge Inspection Report Ratings

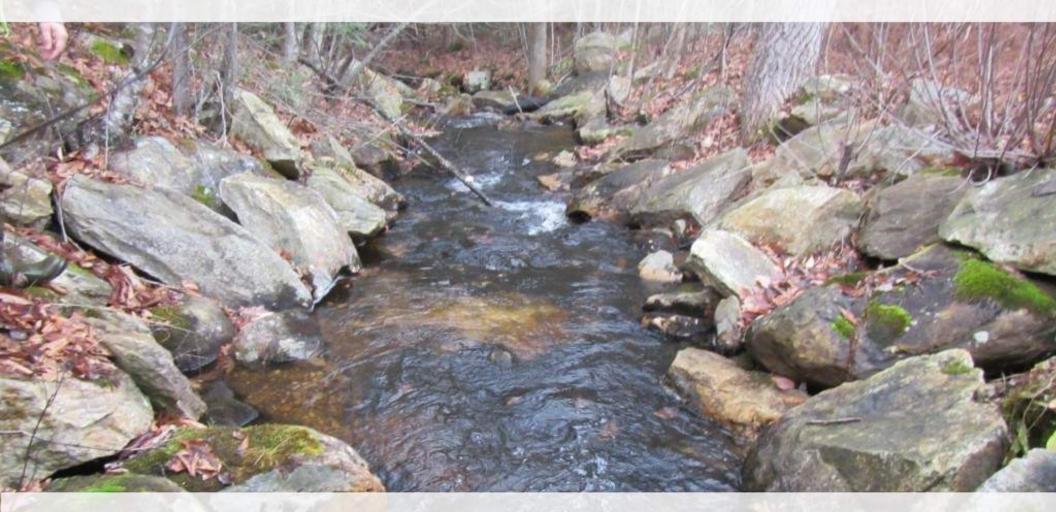
Looking Downstream (West) - Resources

- Within the Northern Long Eared Bat's (NLEB's) habitat range.
- Wildlife Habitat Bridge 19-7 was identified as being a "top priority for wildlife passage" categorization for habitat, and also as having "prime fish habitat" category under the Aquatic Organism Passage (AOP) analysis

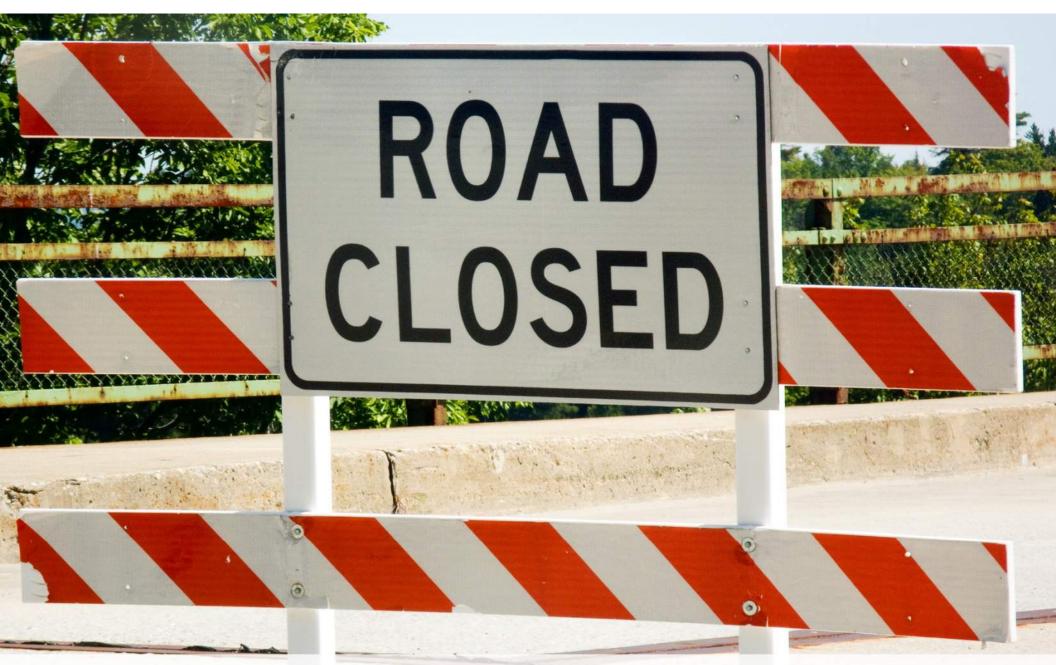
Full-Road Closure

• Off-site Detour via VT Route 7A; signage and temporary signals by the State

- Existing intersections are stop controlled; incorporating temporary signals will reduce delay and minimize safety concerns
- During full-closure, vehicles are routed from US 7 to VT 7A:
 - Diverted 280 veh. in AM peak hour
 - Diverted 350 veh. in PM peak hour
- With temporary signals, intersections will operate at a similar level of service to the existing condition
- Temporary Signal Locations:
 - VT 7A & VT 313
 - VT 7A & VT 67
 - VT 7A & US 7 Ramps
