Castleton STP CULV(123)
Regional Concerns Meeting
VT ROUTE 4A, BRIDGE 9 OVER UNNAMED BROOK

March 25, 2024

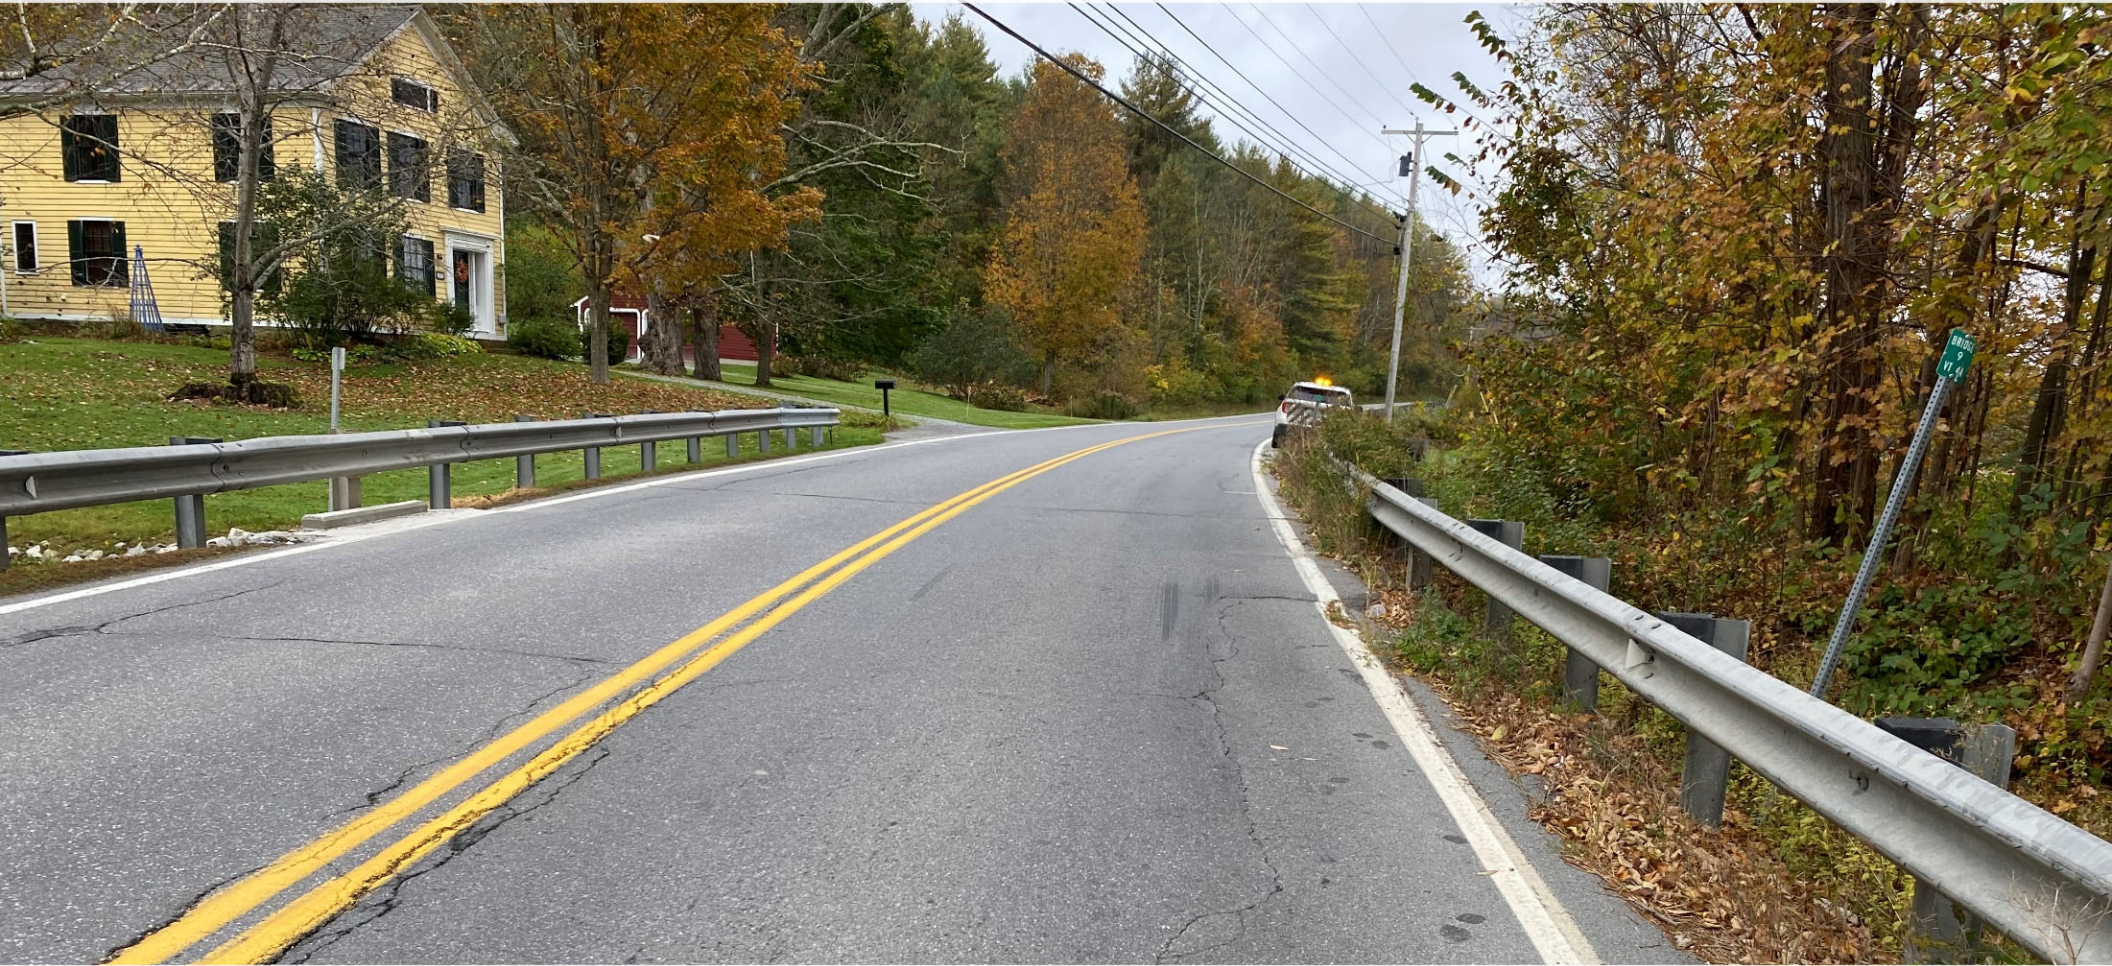
Looking West

Existing Conditions – Bridge #9

- Roadway Classification – Rural Major Collector
- Bridge Type – Reinforced Concrete Box
- Ownership – State of Vermont
- Constructed in 1927

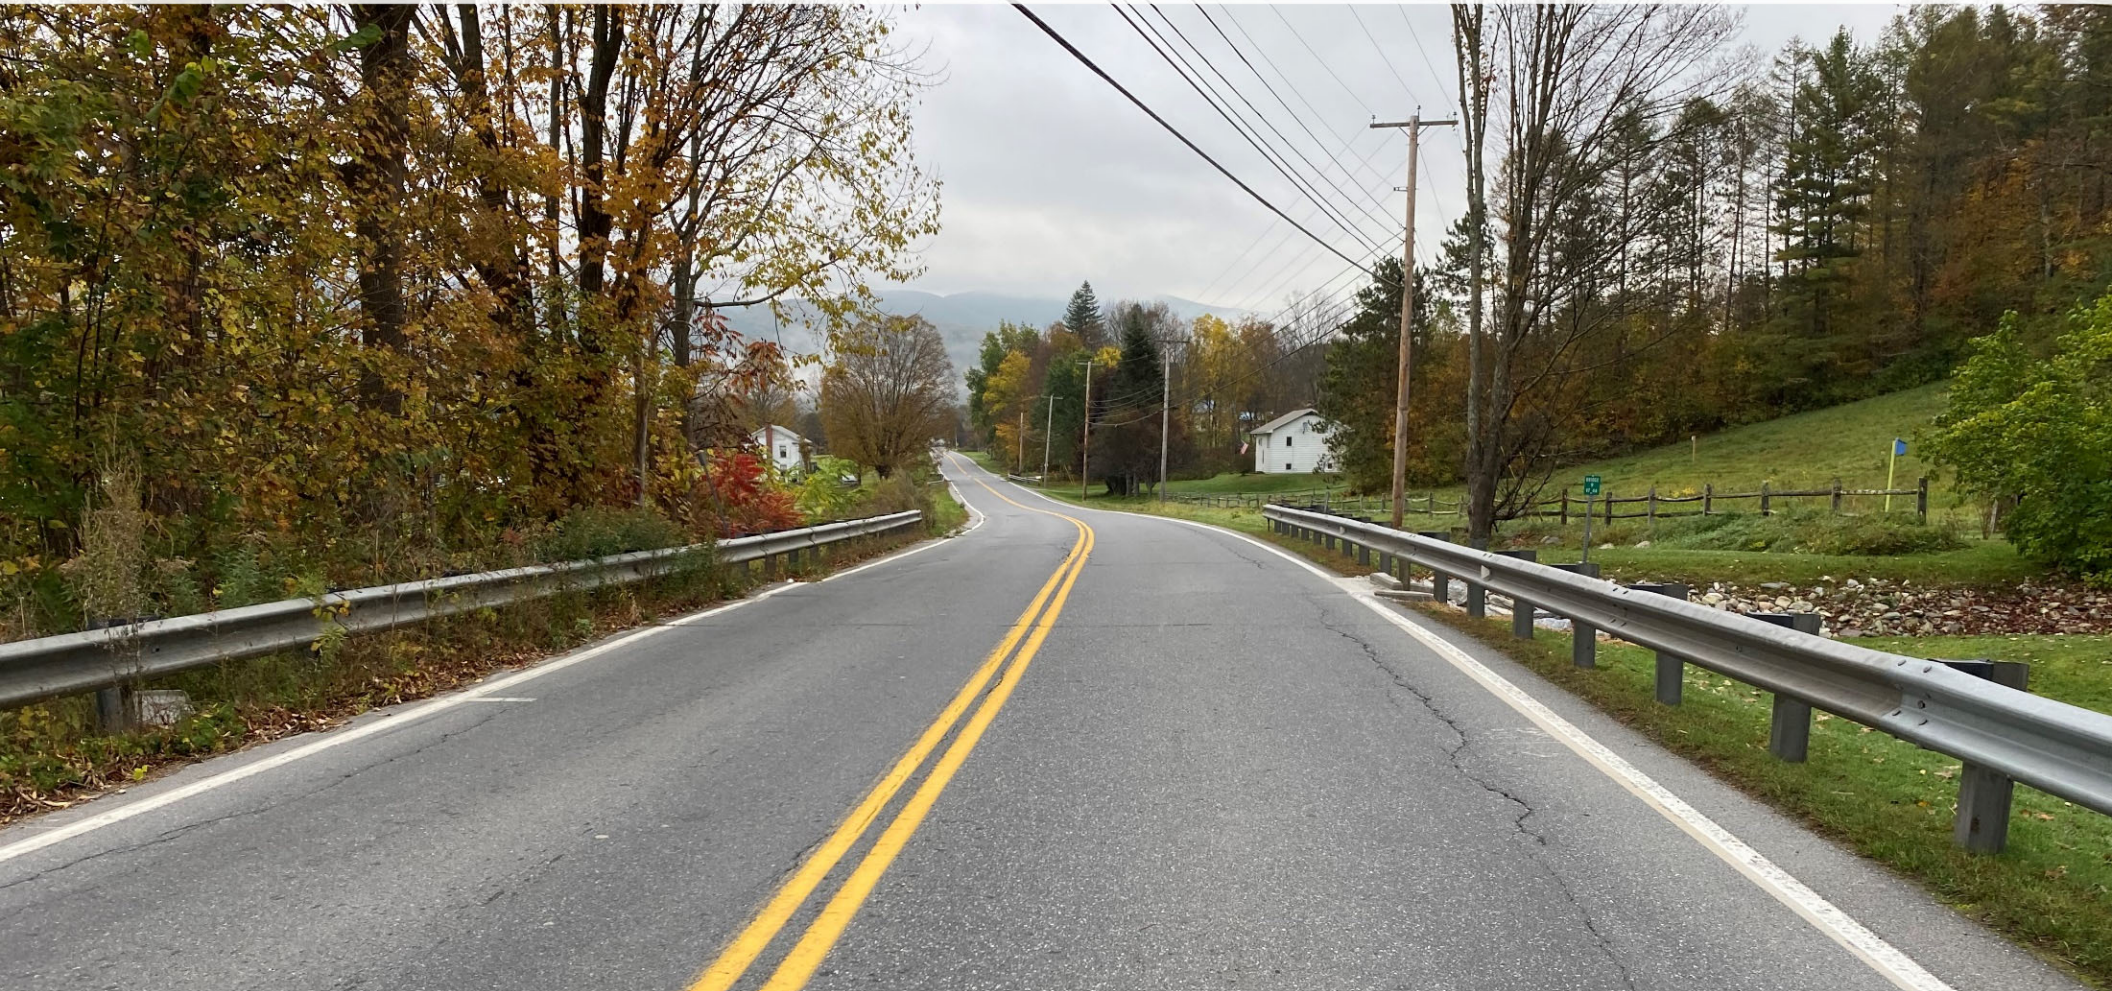
Looking East

Existing Utilities – Bridge #9

- Aerial utilities, owned by Green Mountain Power (Three & Single Phase), Comcast, Consolidated Communications, and FirstLight Fiber.
- It is anticipated that overhead utilities will need to be relocated for replacement of the culvert.

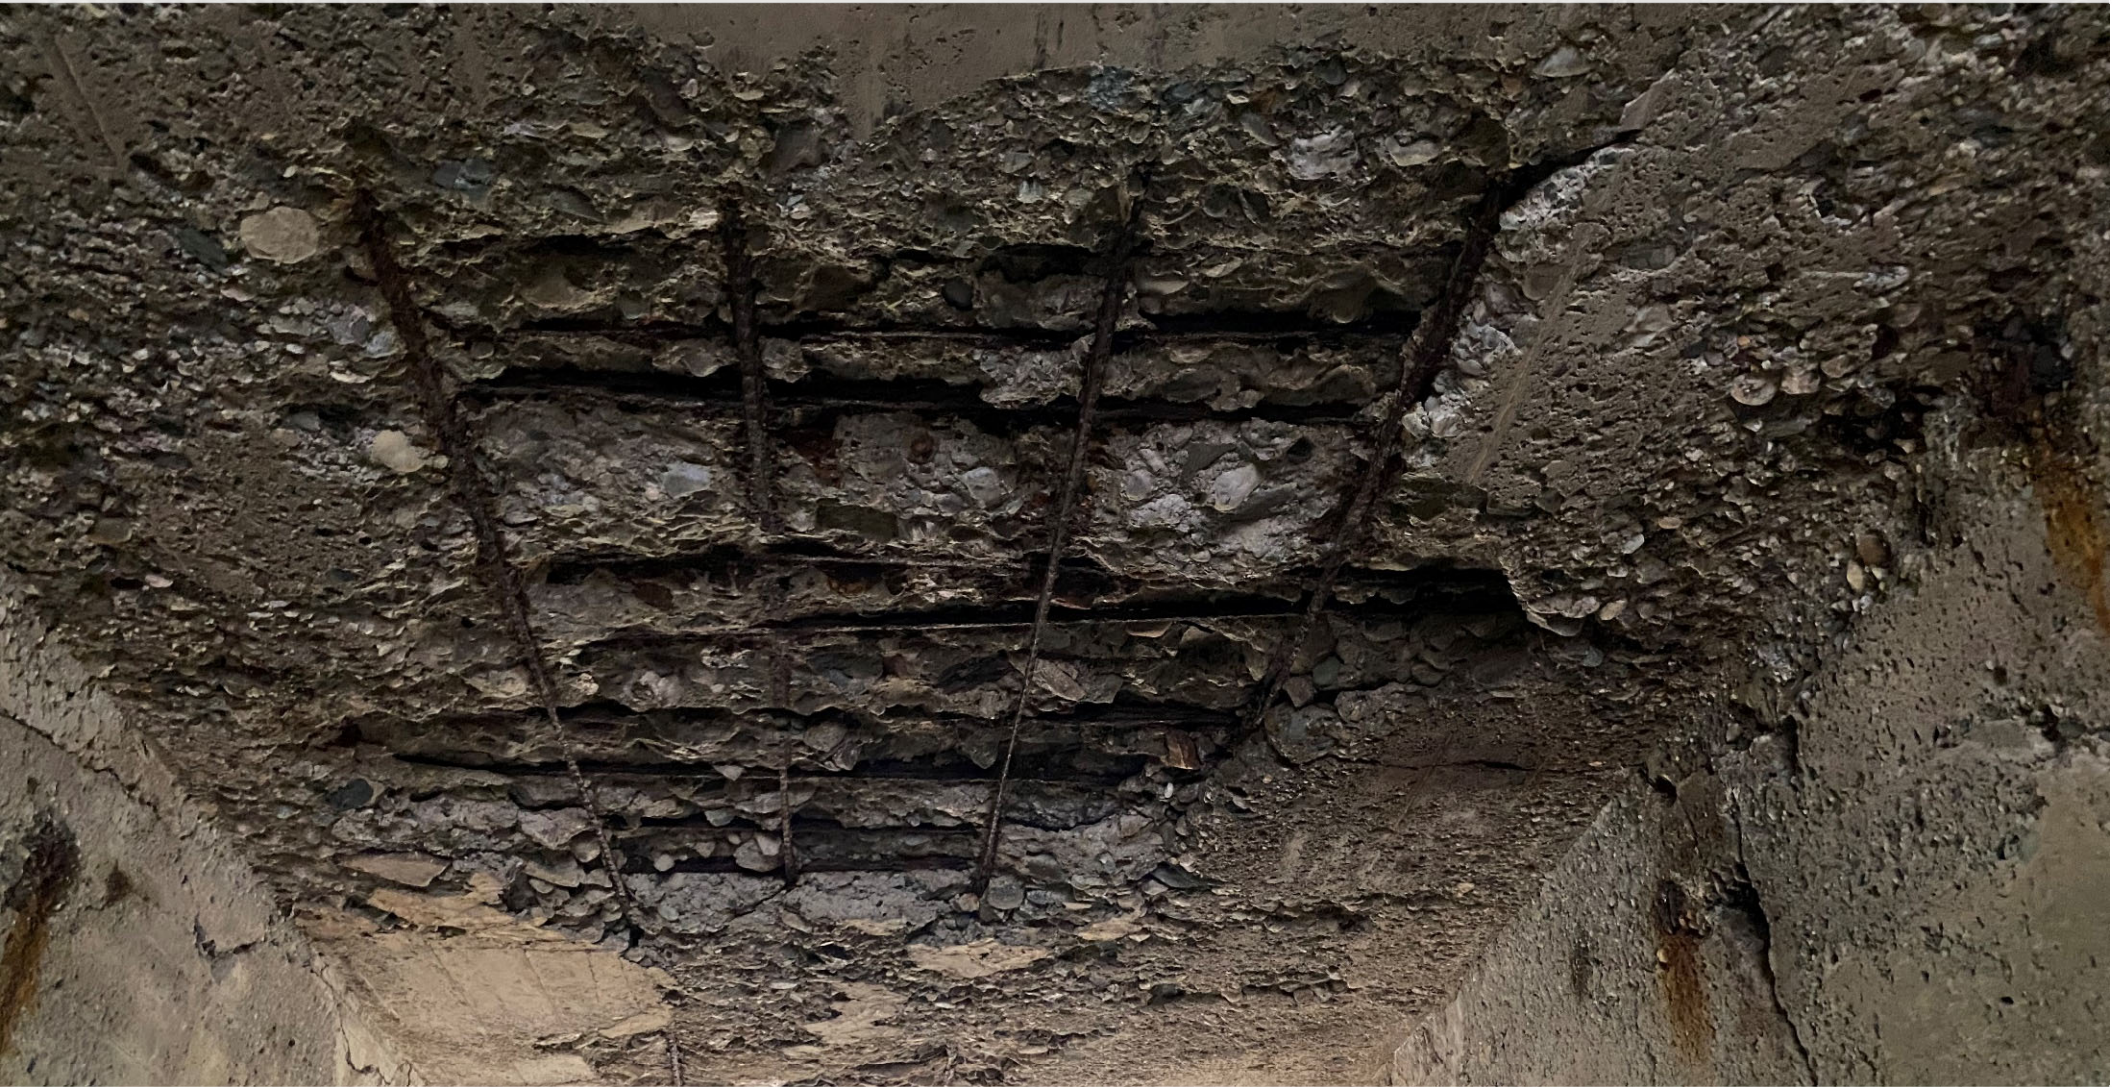
Bridge Inspection Report Ratings

Existing Conditions - Bridge #9

- Culvert Rating 4 (Poor)
- Channel Rating 6 (Satisfactory)

- The culvert is in poor condition. There are delaminations and cracks throughout the culvert.
- The existing culvert does not meet the calculated or measured bank full width.
- The existing culvert does not meet the headwater depth for the design or check storm. During the check storm, the roadway is calculated to be overtopped.
- The stream is intermittent, flashy, and laden with sediment.
- The stream channel has curves at the inlet and outlet, these cause slowing of the stream and deposition of sediment within and downstream of the culvert. This deposition reduces the carrying capacity of the culvert, increasing the frequency of overtopping.
- The shoulder width over the culvert does not meet the minimum standards.

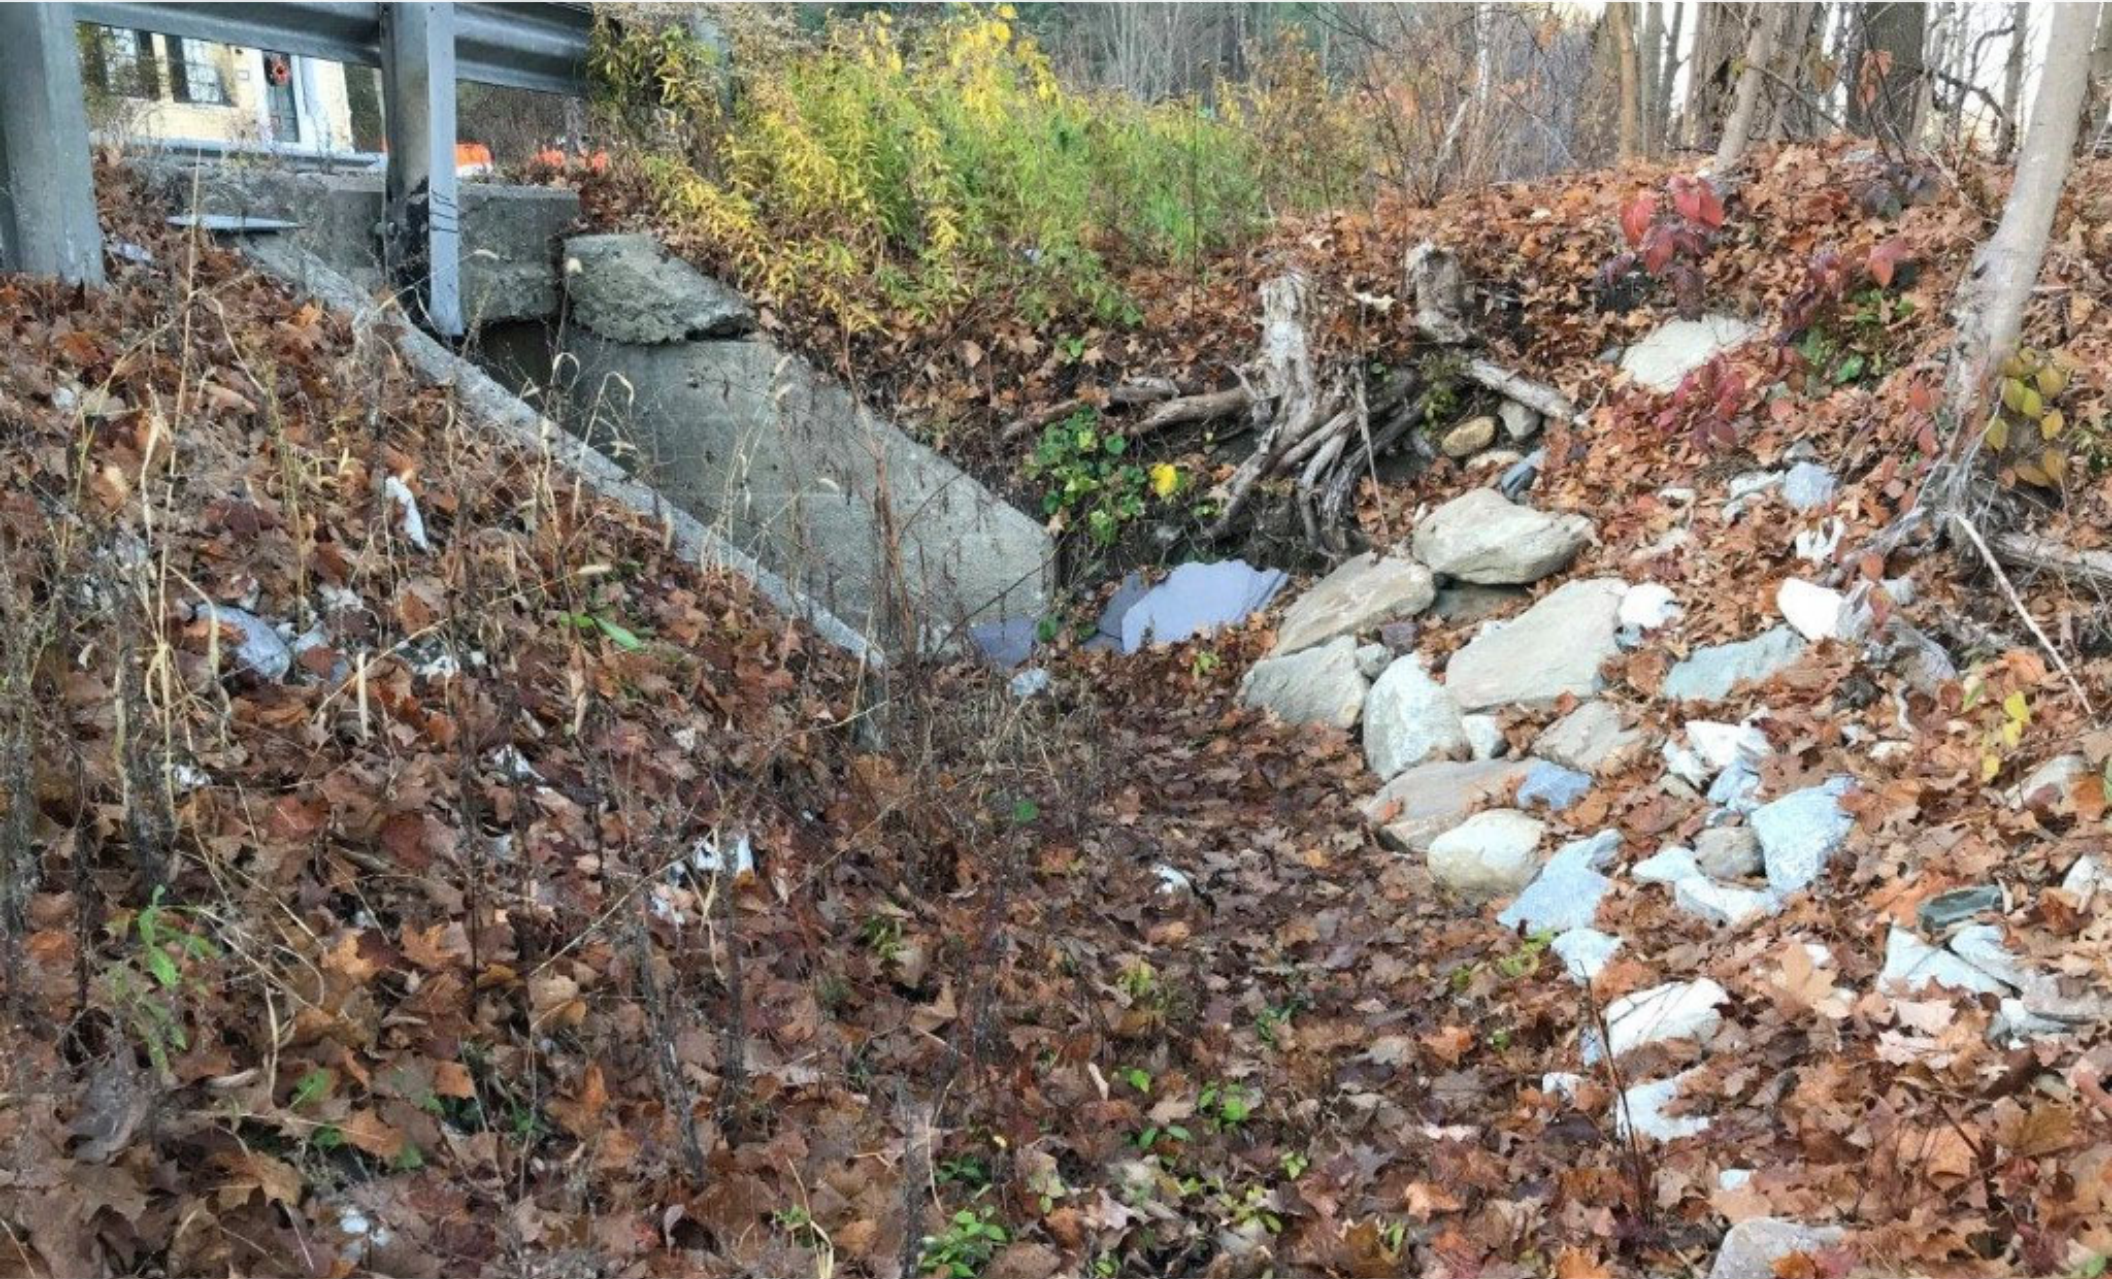
Looking at Outlet

Existing Conditions - Bridge #9

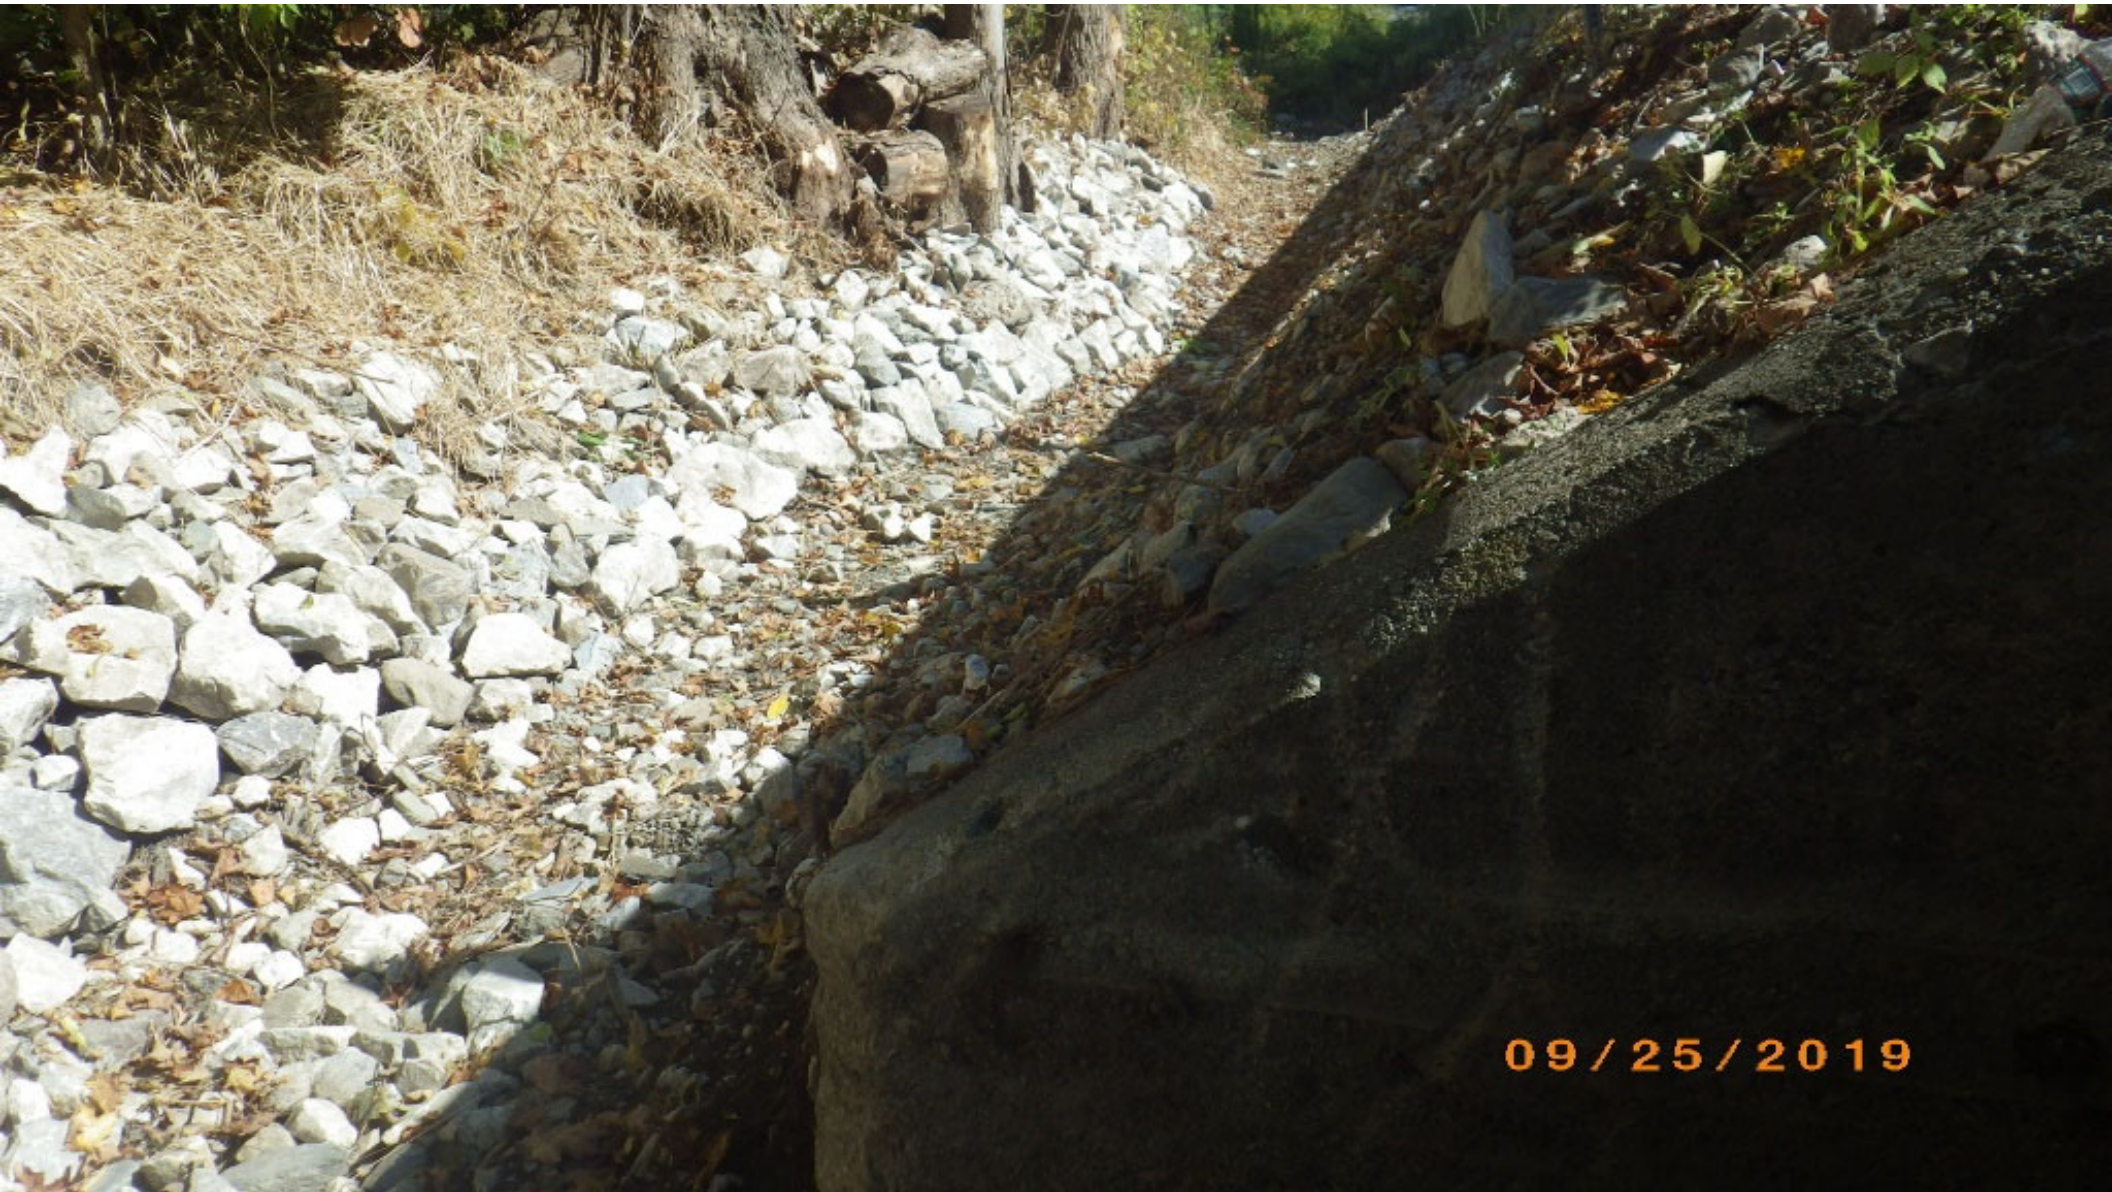
Looking Downstream (Northeast)

Existing Conditions - Bridge #9

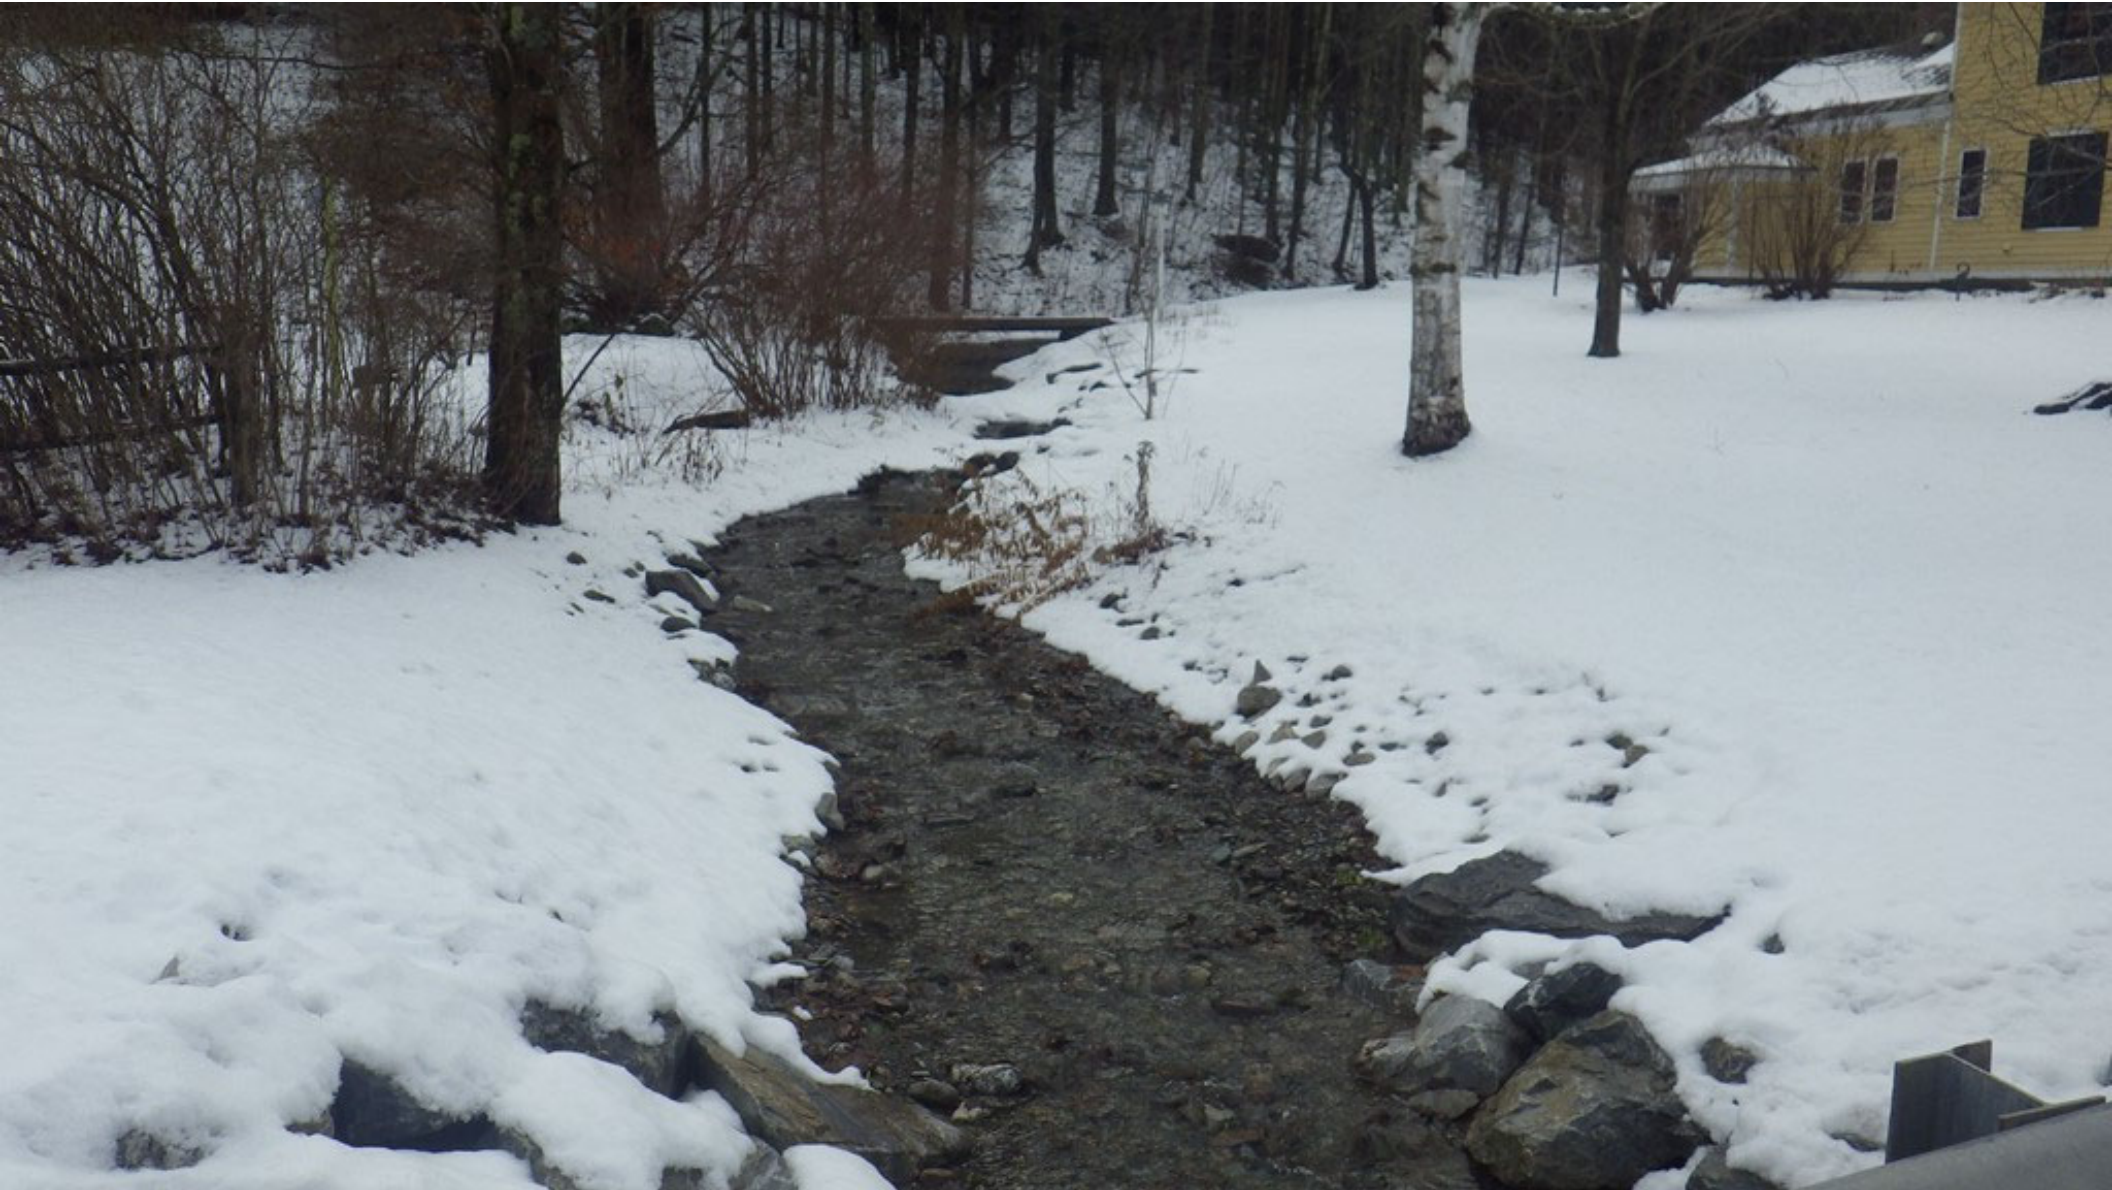
Looking Upstream (South)

Existing Conditions - Bridge #9

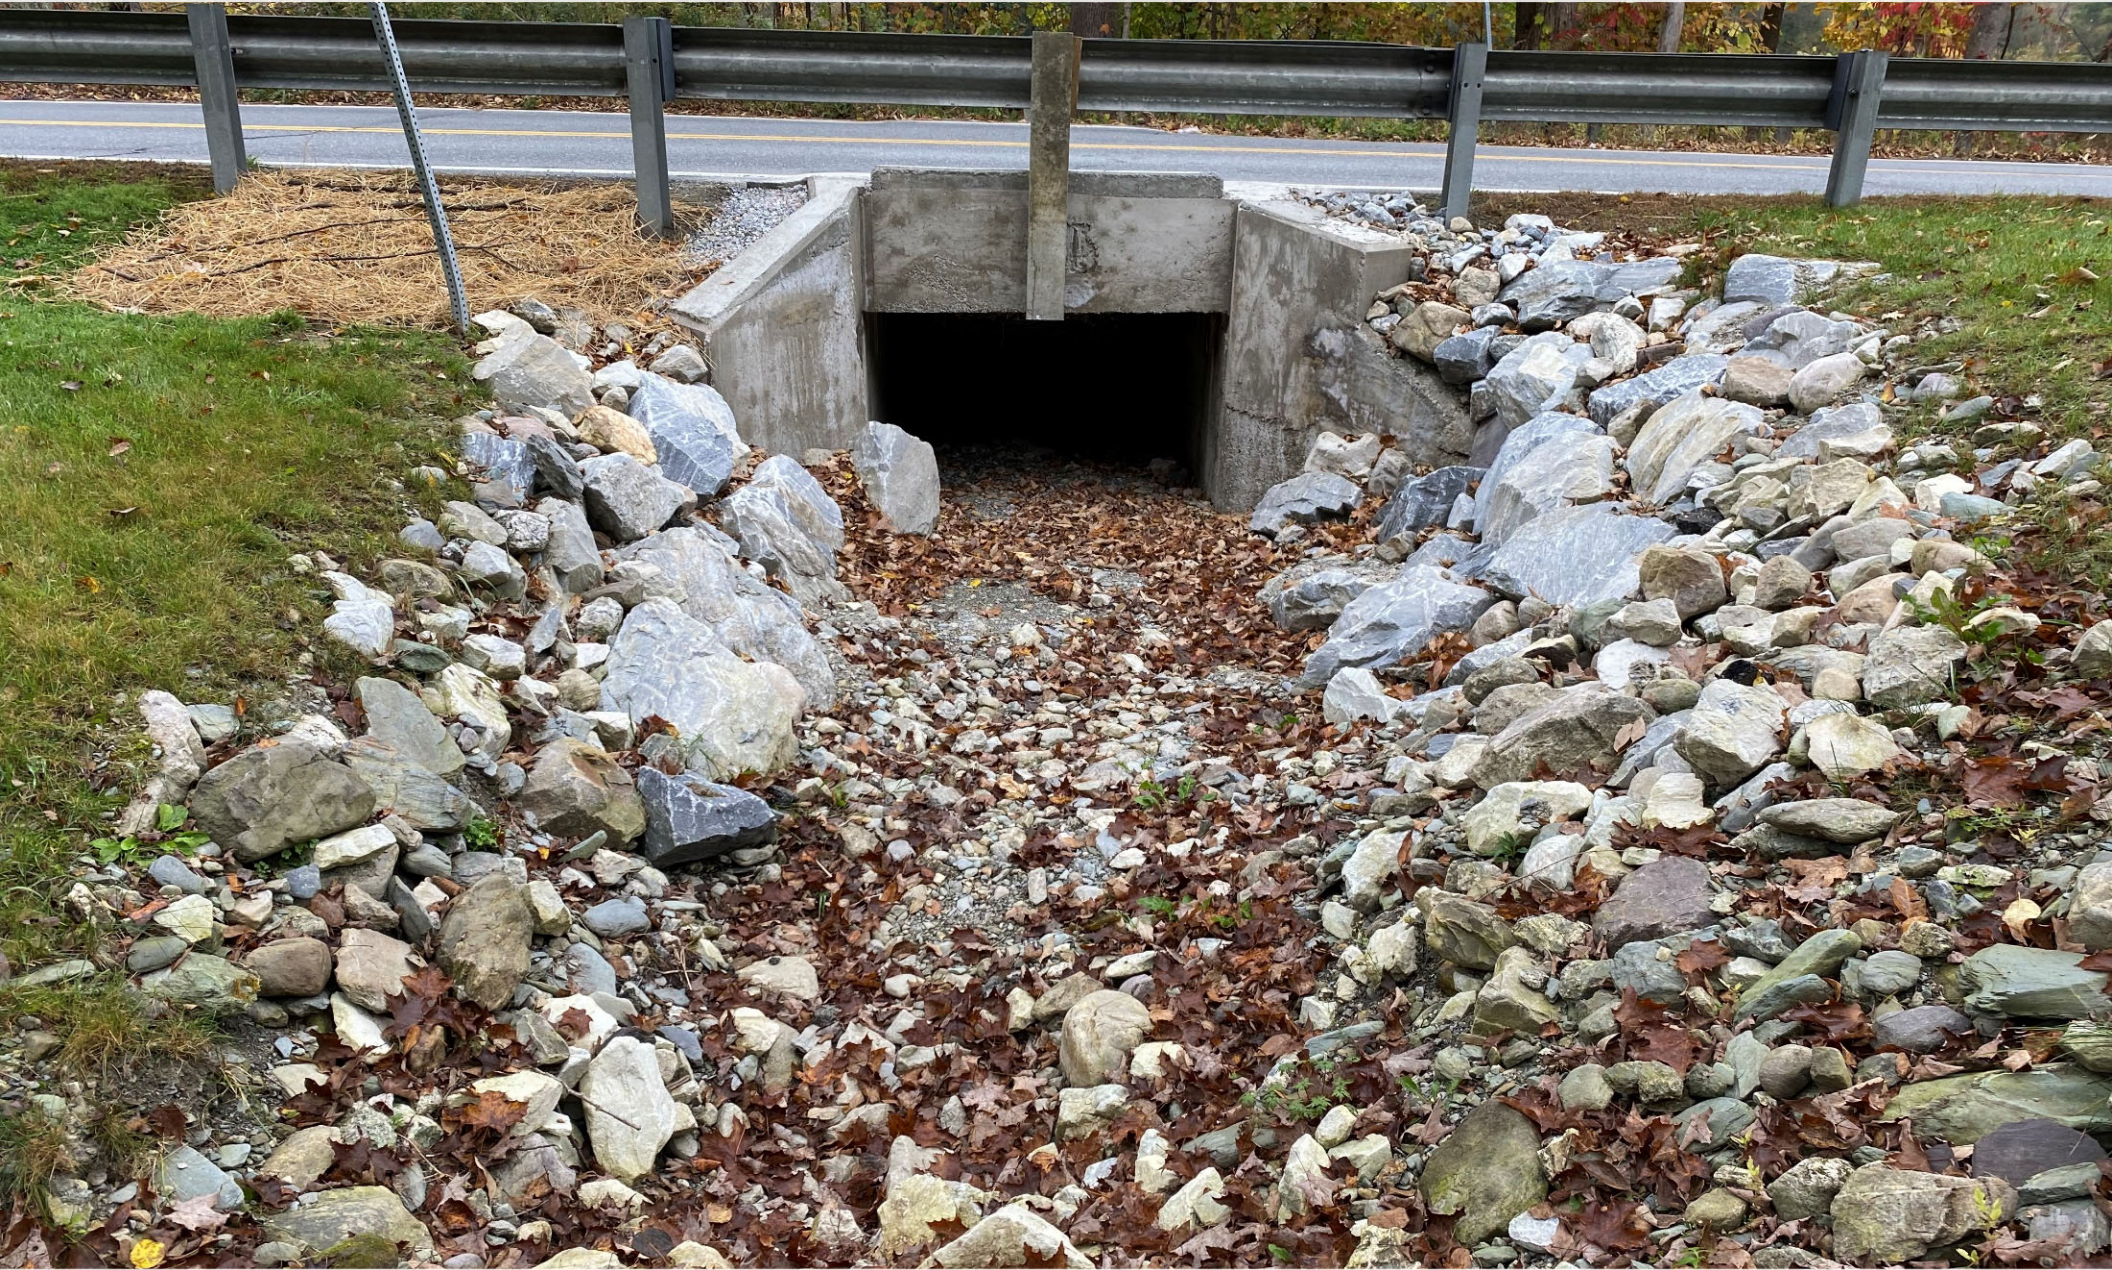
Inlet

Existing Conditions - Bridge #9

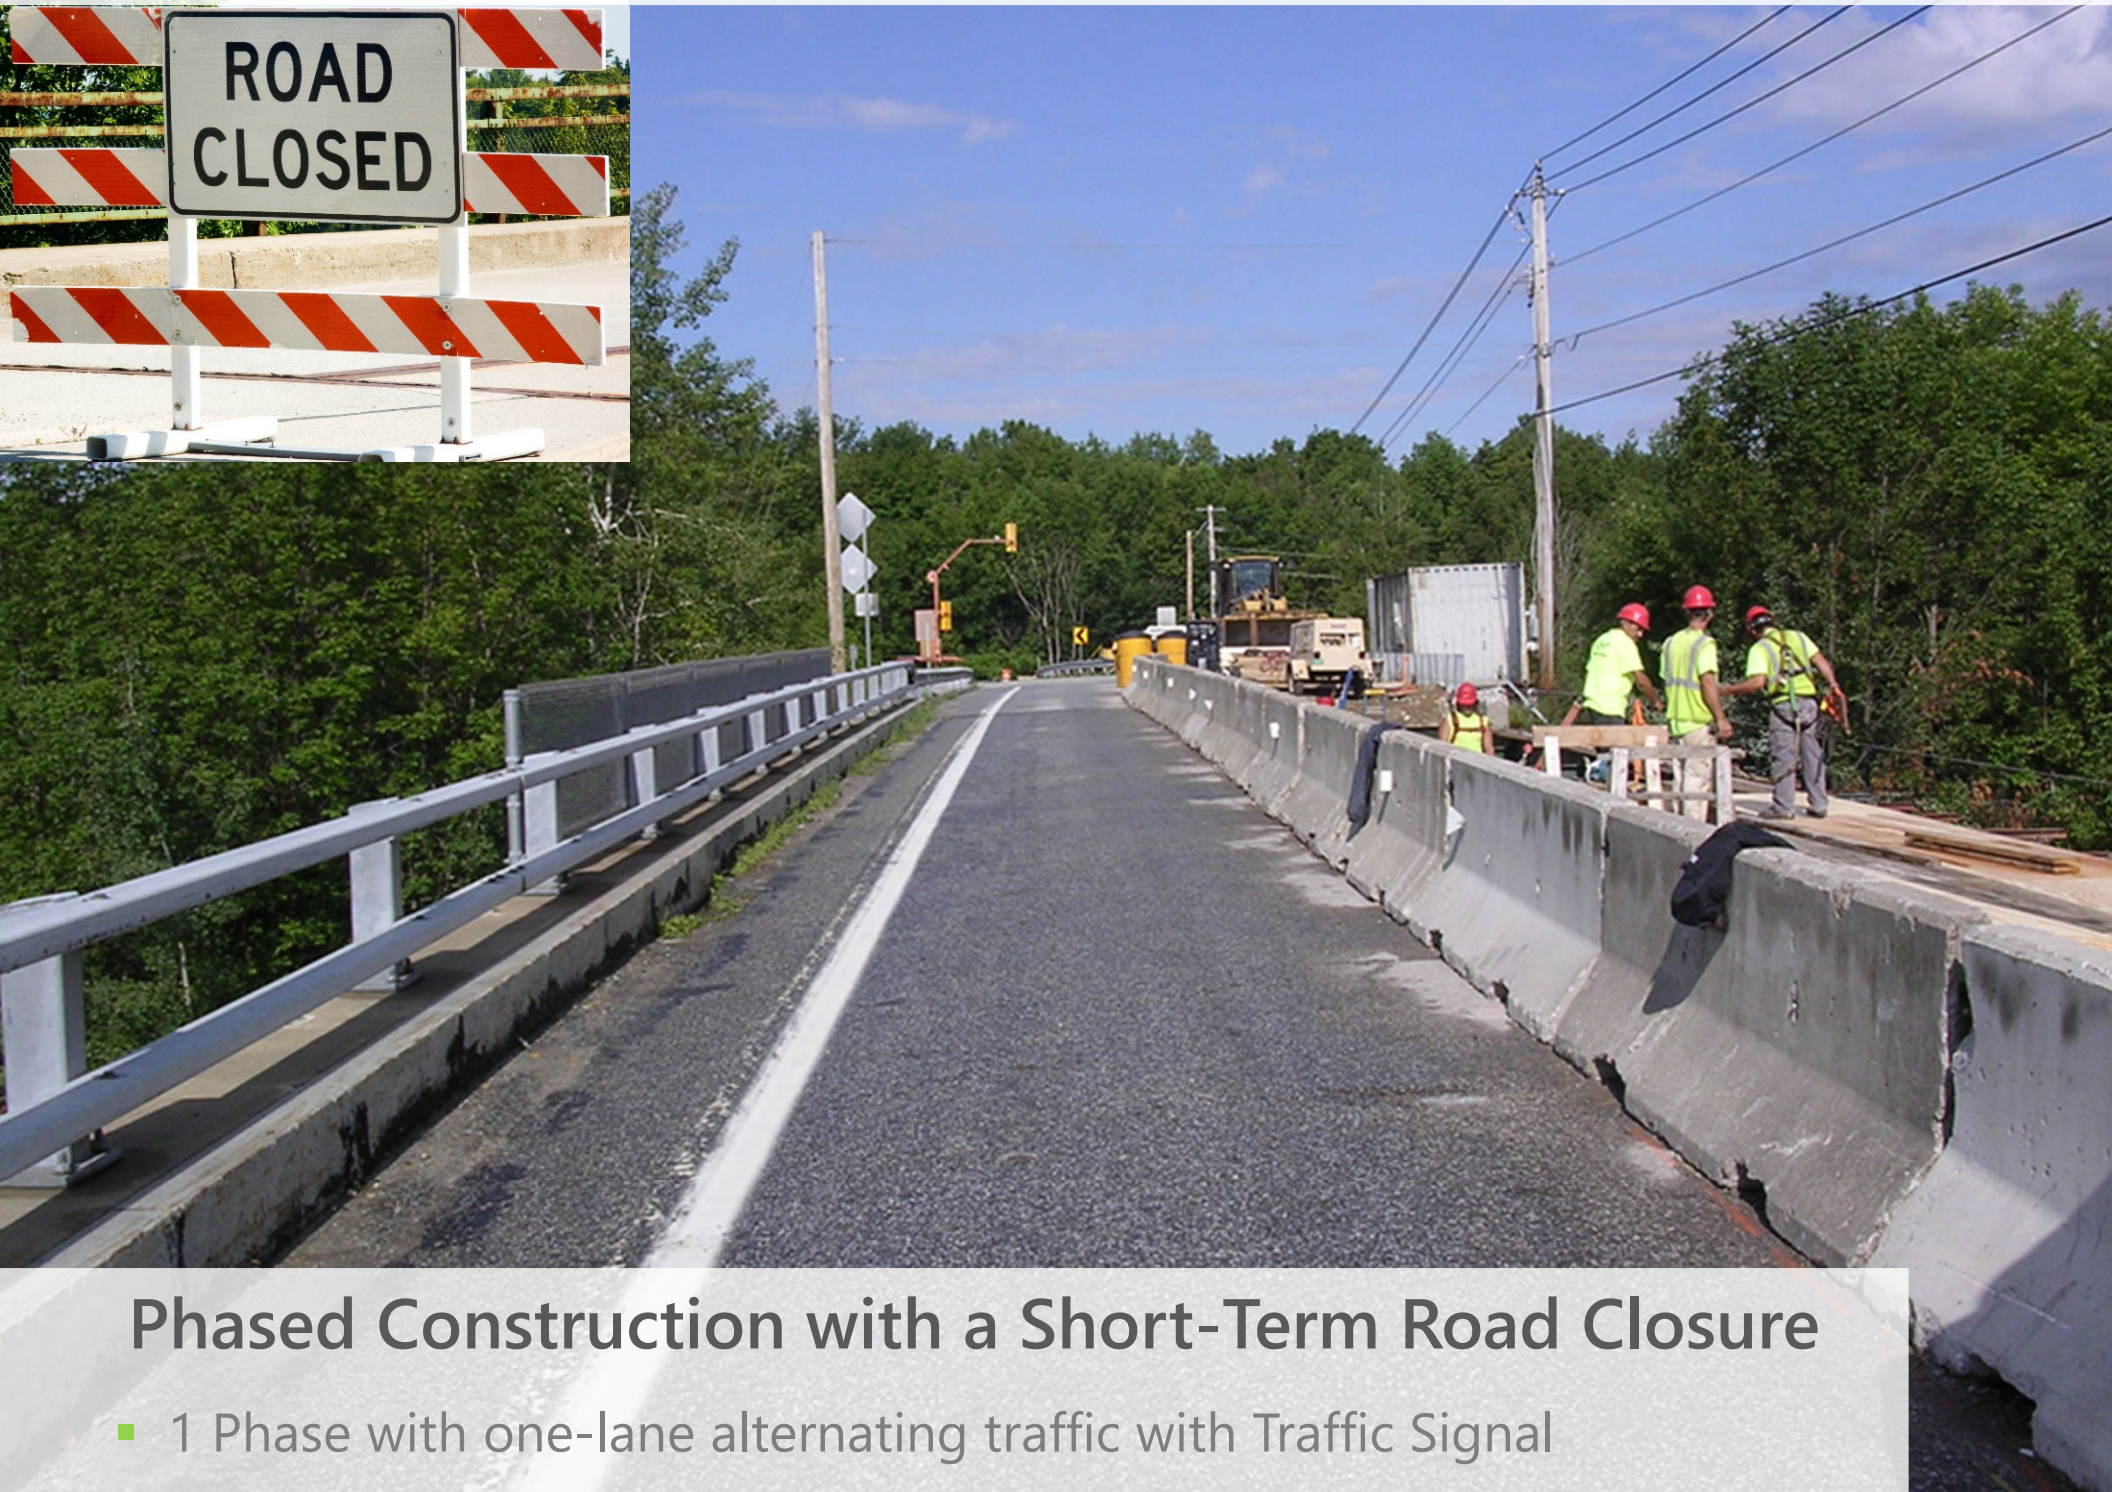
Phased Construction with a Short-Term Road Closure

- 1 Phase with one-lane alternating traffic with Traffic Signal
