**STATE OF VERMONT  
AGENCY OF TRANSPORTATION**

**Scoping Report**

**STATEWIDE - SOUTHWEST STP CULV(91)**

**VT ROUTE 30, BRIDGE 58A OVER DRAINAGE CULVERT**

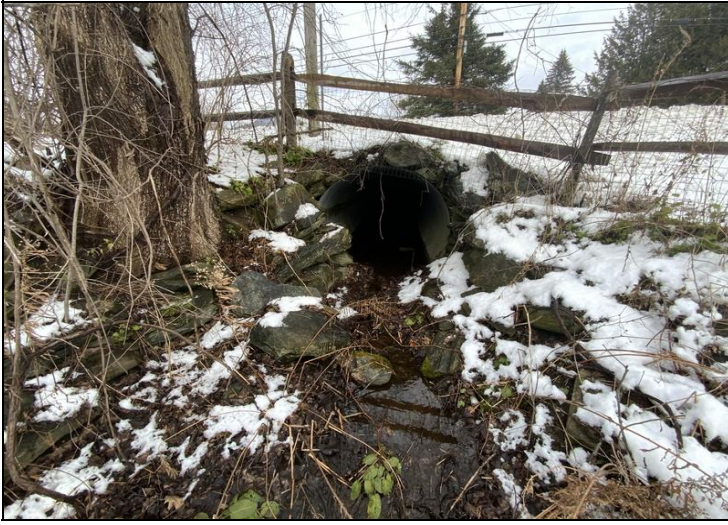
Outlet

**Comment:** Areas of freckled rust and minor rust staining throughout. The the splice connections and sides of the pipe near the center have scattered small areas of heavy rust scale with deep pitting and minor to moderate section loss. The north side has scattered large perforations as well measuring 1'- 2' in diameter allowing some loose fill to fall through. The grated drop inlet and surrounding retaining concrete blocks are undermined 6"- 1' vertically and penetrating 3'+/-.

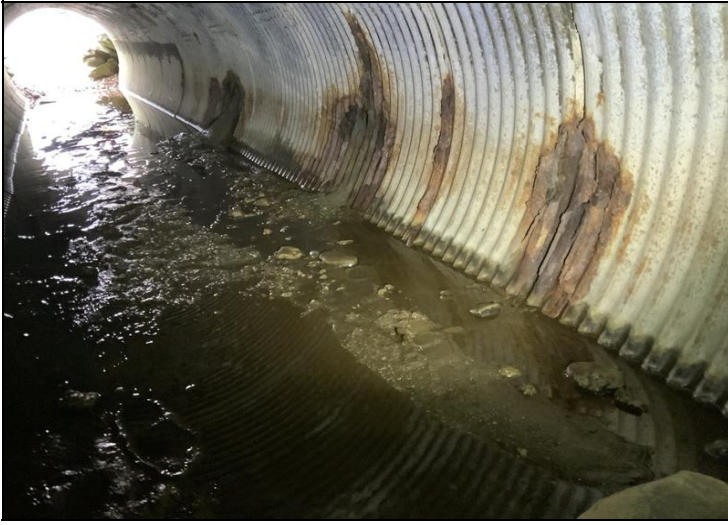
North side

07/07/2009 – Culvert is in fair to poor condition with holes in the north side of the pipe in places. This structure is now used for a drainage ditch. Culvert will need replacing in the near future ~ DCP

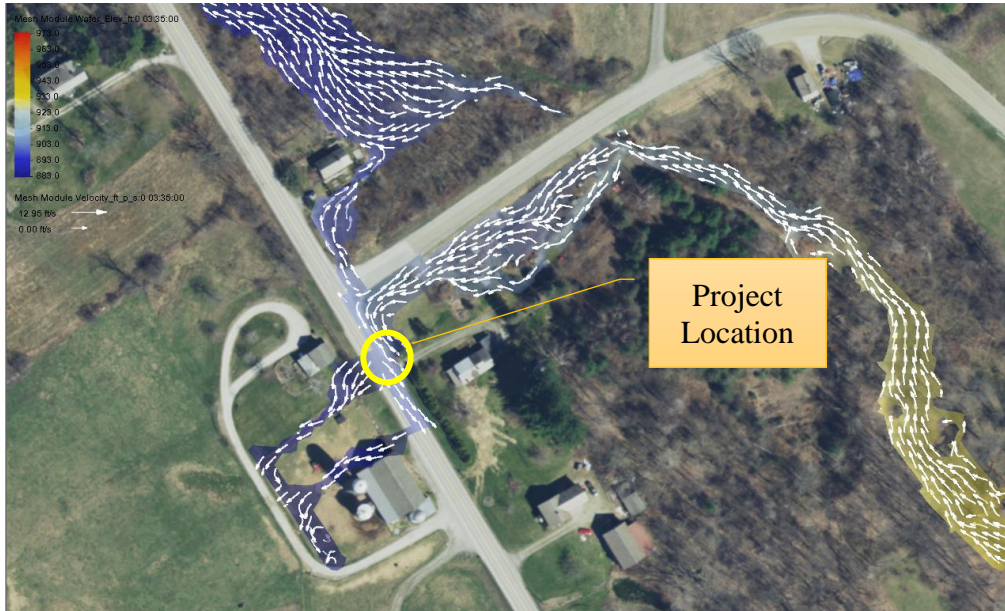
The proposed crossing was sized to convey the flow if the drop inlet was removed. This decision was made because based on preliminary modeling, there appears to be potential for bypassing and overtopping as shown in Figure 1.

*Figure 1 – 50yr Flood Flow Path*

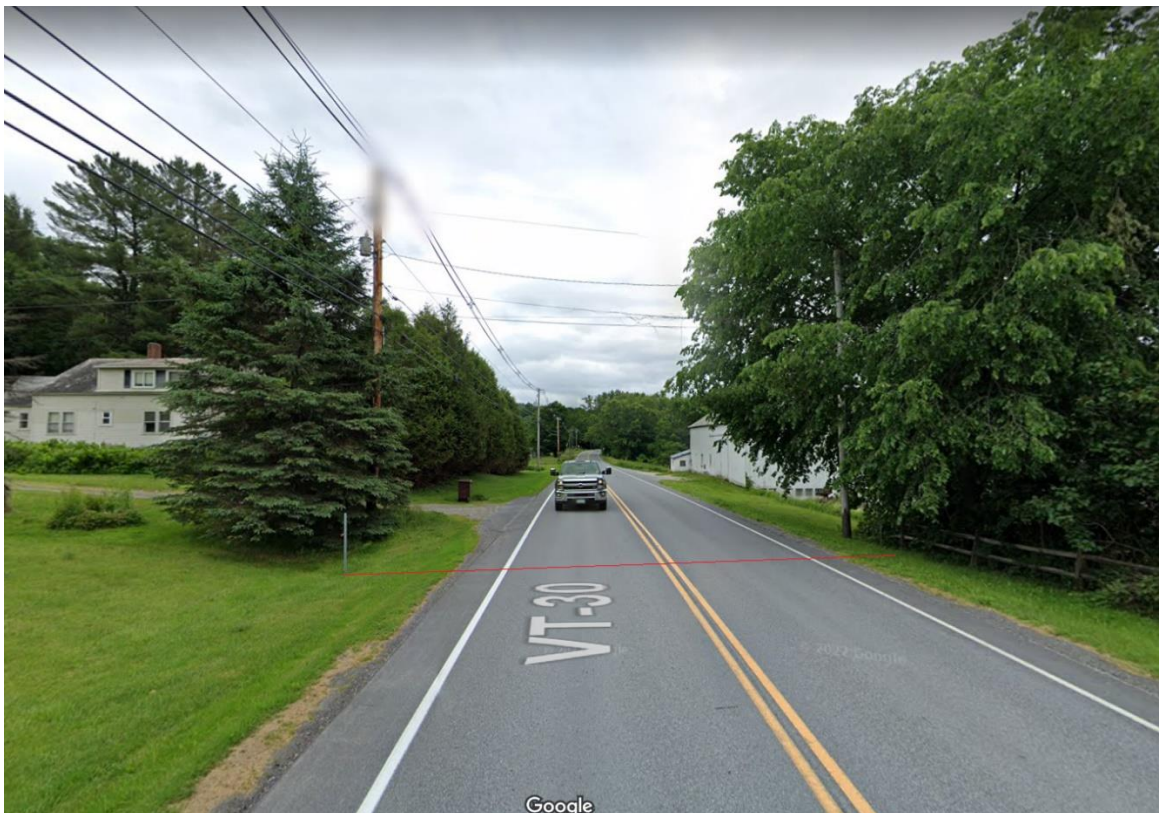
**Figure 1:** *Overhead Utilities over the North End of the Culvert and Crossing VT-30*

A site investigation was not conducted by Geotechnical Section staff however photos from inspections and satellite imagery were reviewed to evaluate the feasibility of boring operations and assess general site conditions as they relate to the proposed project. Overhead utilities run along the north/east side of VT 30 in the location of the culvert and cross the road just south of the culvert. The subsurface investigation can be adjusted to avoid the overhead utilities and still evaluate the subsurface conditions in this location. If additional information is needed, additional drilling techniques could be utilized or the use of geophysical methods can be implemented here. The overhead utilities can be seen in Figure 1 with the approximate location of the culvert marked.

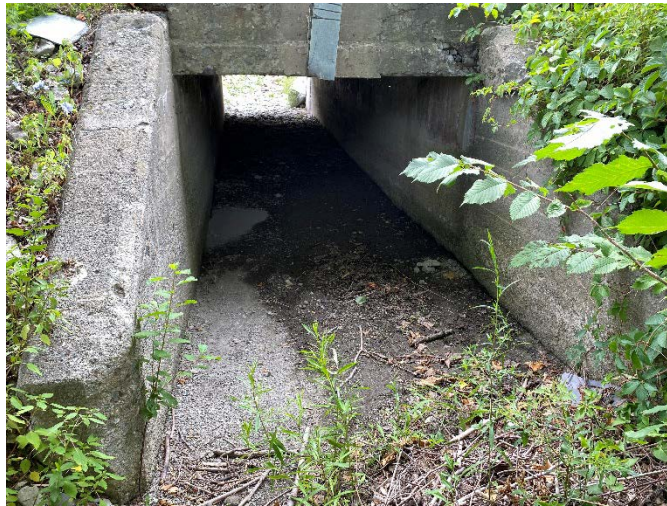
Photo 1. View looking south through the **BR 9** culvert under VT-4A in Castleton. Stantec, July 18, 2022

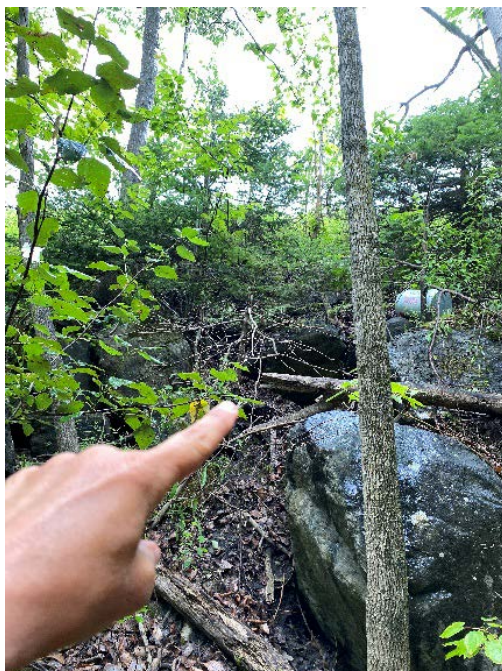
Photo 8. A view looking generally south towards US-4 and the assumed approximate location of the upgradient/inlet end of the **BR 28** culvert (culvert not found in field, appears to have been buried by fill, debris, organic material, other). Stantec, July 18, 2022.

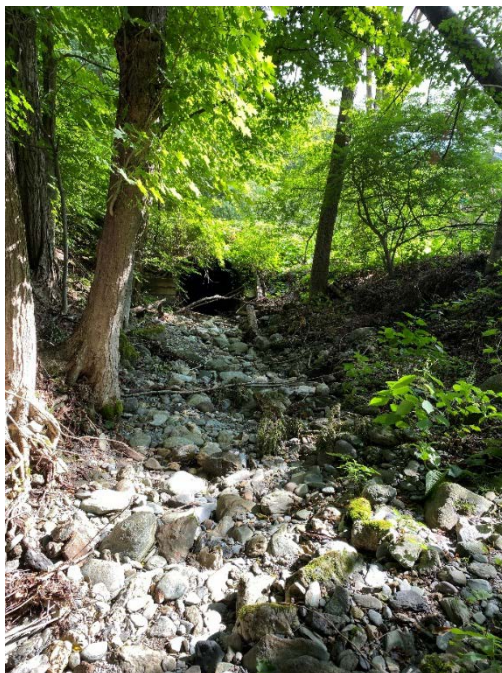
Photo 15. Photo view looking north towards the inlet of **BR 61** where it crosses VT-30. Photo view shows culvert dry streambed conditions and some evidence of dynamic channel with exposed roots on mature trees. Stantec, July 19, 2022.

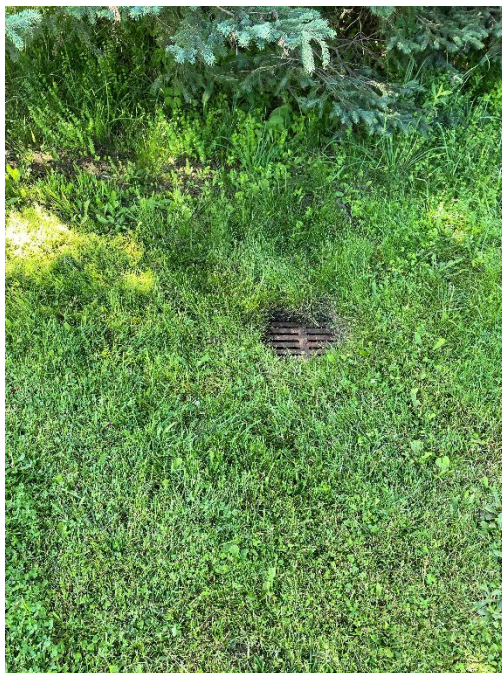
Photo 17. Photo view looking at the inlet of the **BR 58A** culvert structure in Rupert where it crosses VT-30. Culvert inlet is on the north side of VT-30 within a mowed/maintained lawn area. Stantec, July 19, 2022.

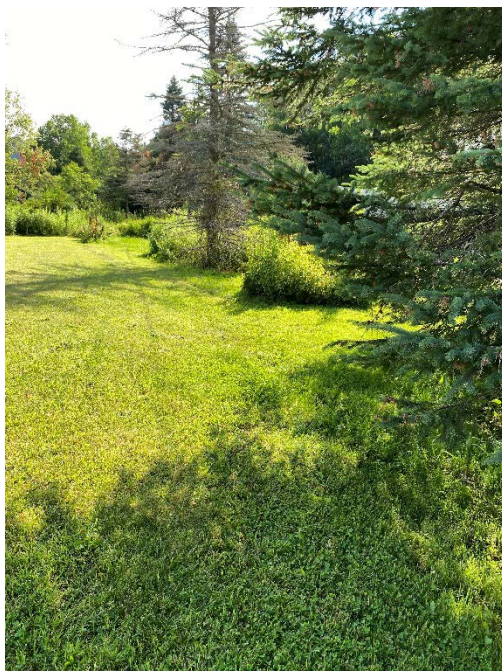
Photo 18. A view looking north from the inlet (north) end of **BR 58A**. Photo view shows edge of wetland area in the background (within tall herbs/shrubs), beyond the limits of the investigation area. Stantec, July 19, 2022.

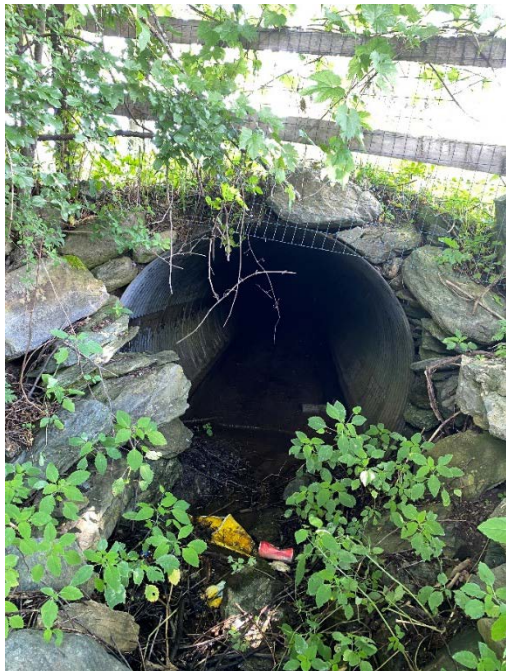
Photo 19. Photograph taken looking generally north at the outlet end of **BR 58A** where Stream BR58A-S1 flows generally south. Stantec, July 19, 2022

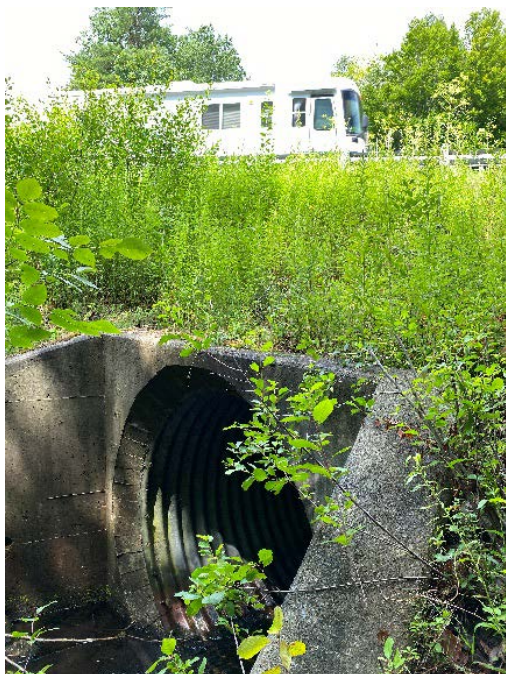
Photo 20. A view looking generally south at the culvert inlet of **BR 19** where Stream BR19-S1 flows into the crossing structure towards its confluence with Fayville Branch, crossing under US-7 in Sunderland. Stantec, July 19, 2022.

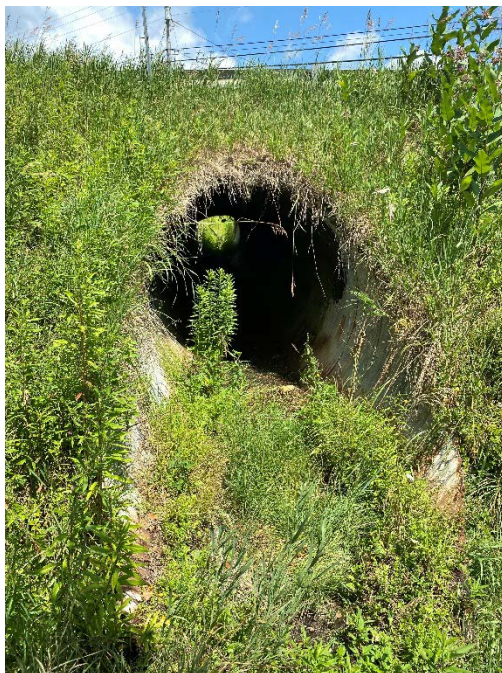
Photo 23. Photo view looking generally north (upgradient) at the outlet end of **BR 25** where it crossed VT-11 in Londonderry. Stantec, July 19, 2022.

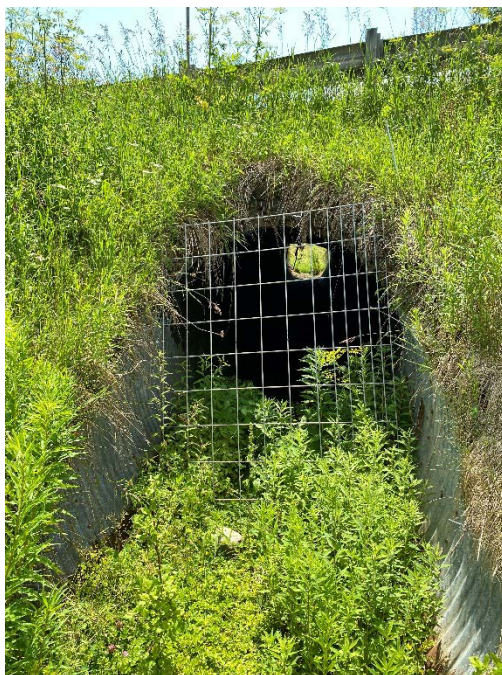
Photo 25. Photo view looking generally south (downgradient) at the inlet end of **BR 25** where it crosses under VT-11 in Londonderry. Stantec, July 19, 2022.

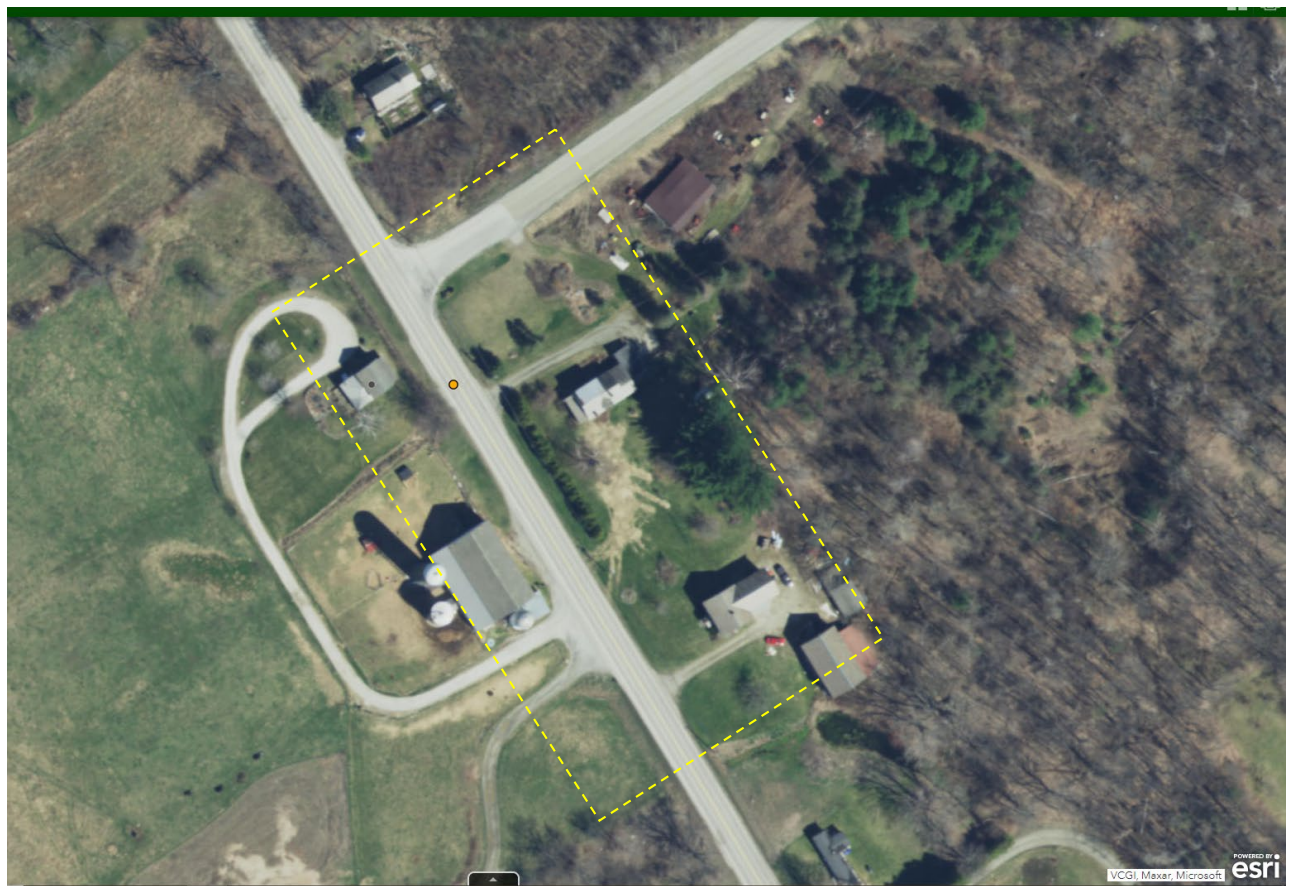
Figure 8. Survey area at Bridge 58.A in Dorset, near 4343 Vermont Route 30.

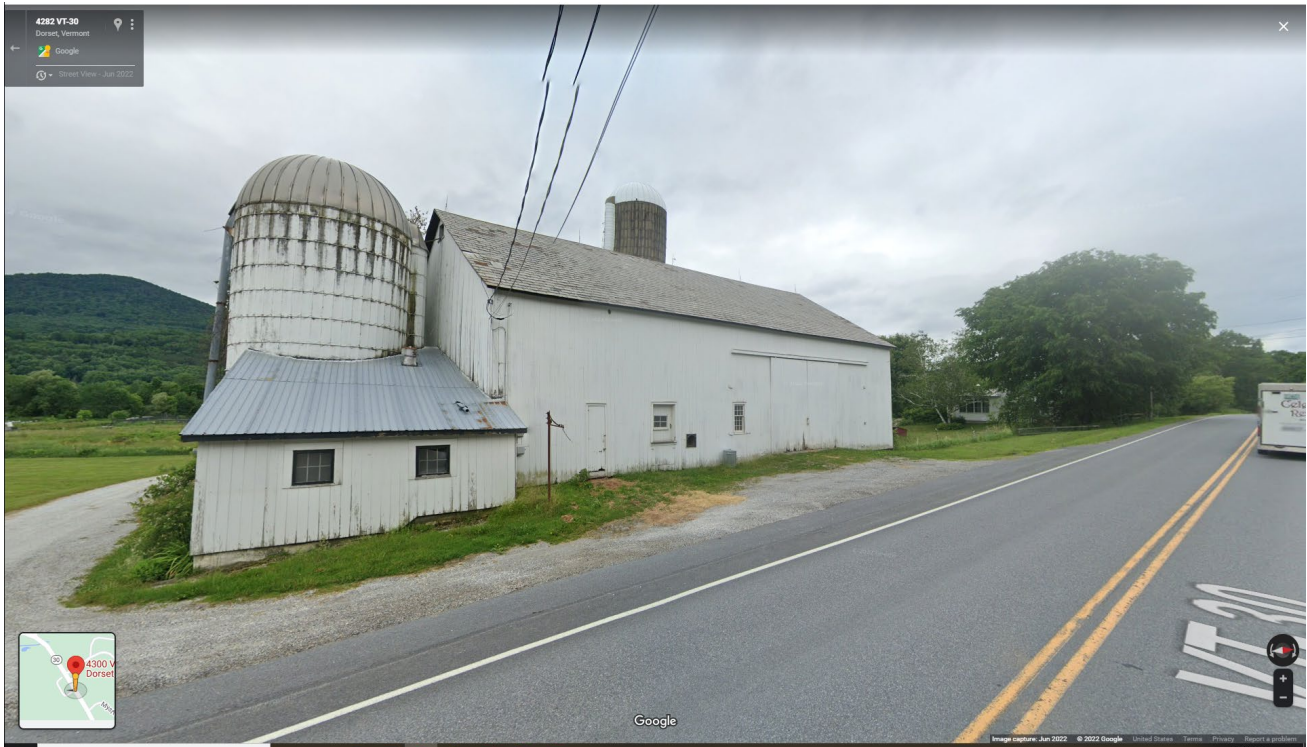
Figure 9. Potentially National Register-eligible farm complex near Br. 58A in Dorset at 4343 Vermont Route 30.

- A potentially **National-register eligible farmstead** was identified within a likely project **APE at 4299 and 4343 Vermont Route 30** (*Figure 9*). Further research, including better images of the farmhouse, is necessary to make a more definitive determination; however, this complex should be considered historically significant during project design. Section 4(f) review might be necessary if easements are required from the parcel associated with the farm complex.
- Although over 50 years of age, Bridge 58A is a common example of its type and does not possess the historic significance necessary for inclusion in the National Register.

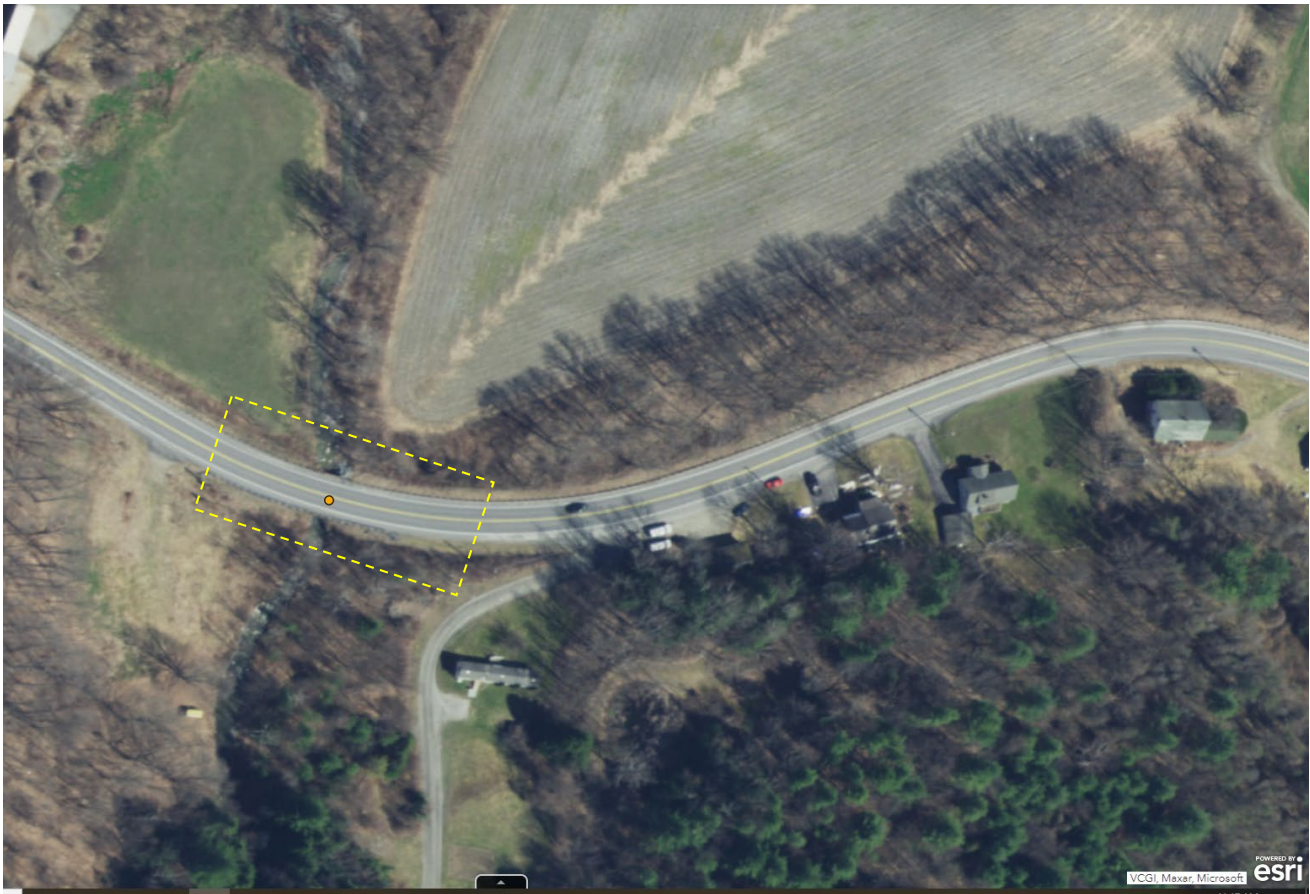
Figure 11. Survey area at Bridge 14 in Ira on Vermont Route 30.

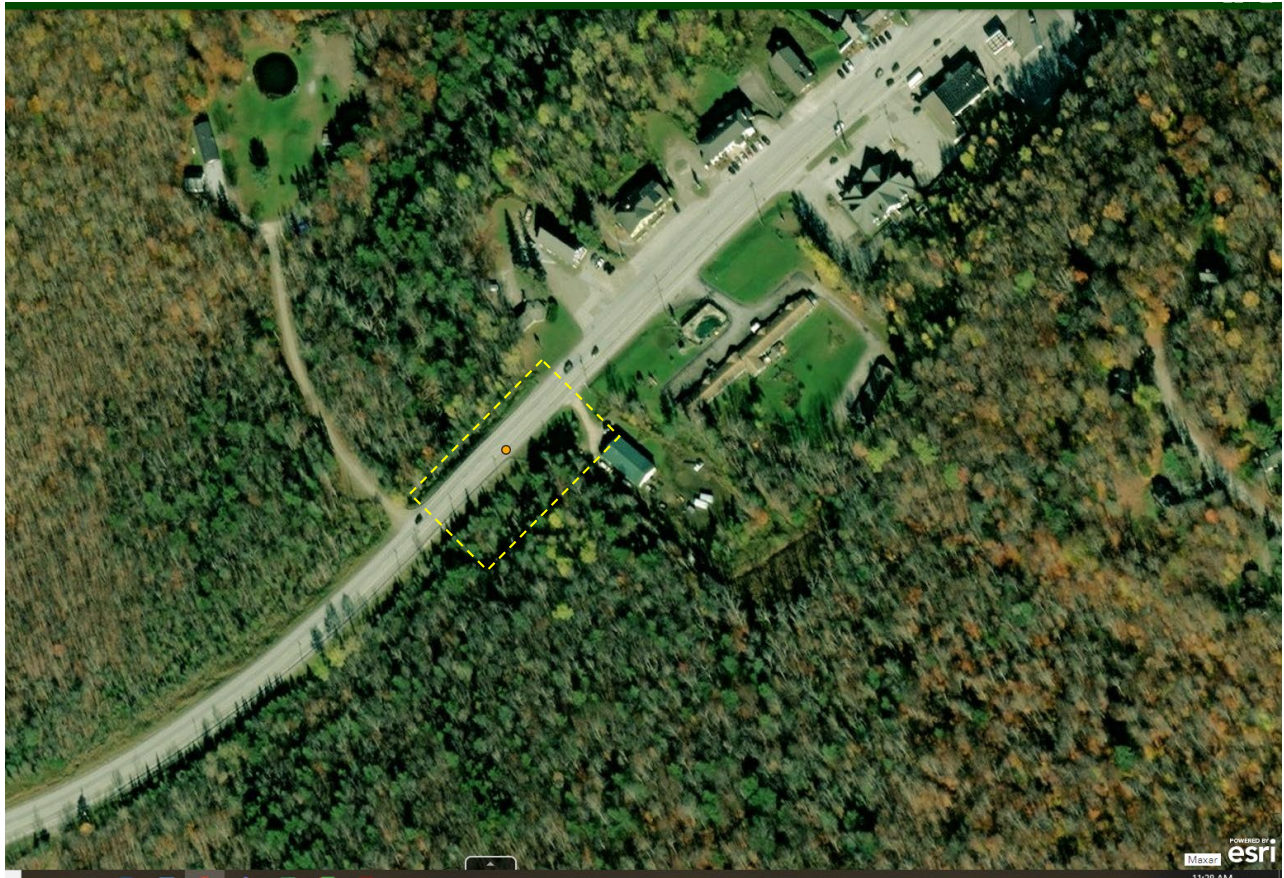
Figure 13. Survey area at Bridge 28 in Killington on US Route 4.

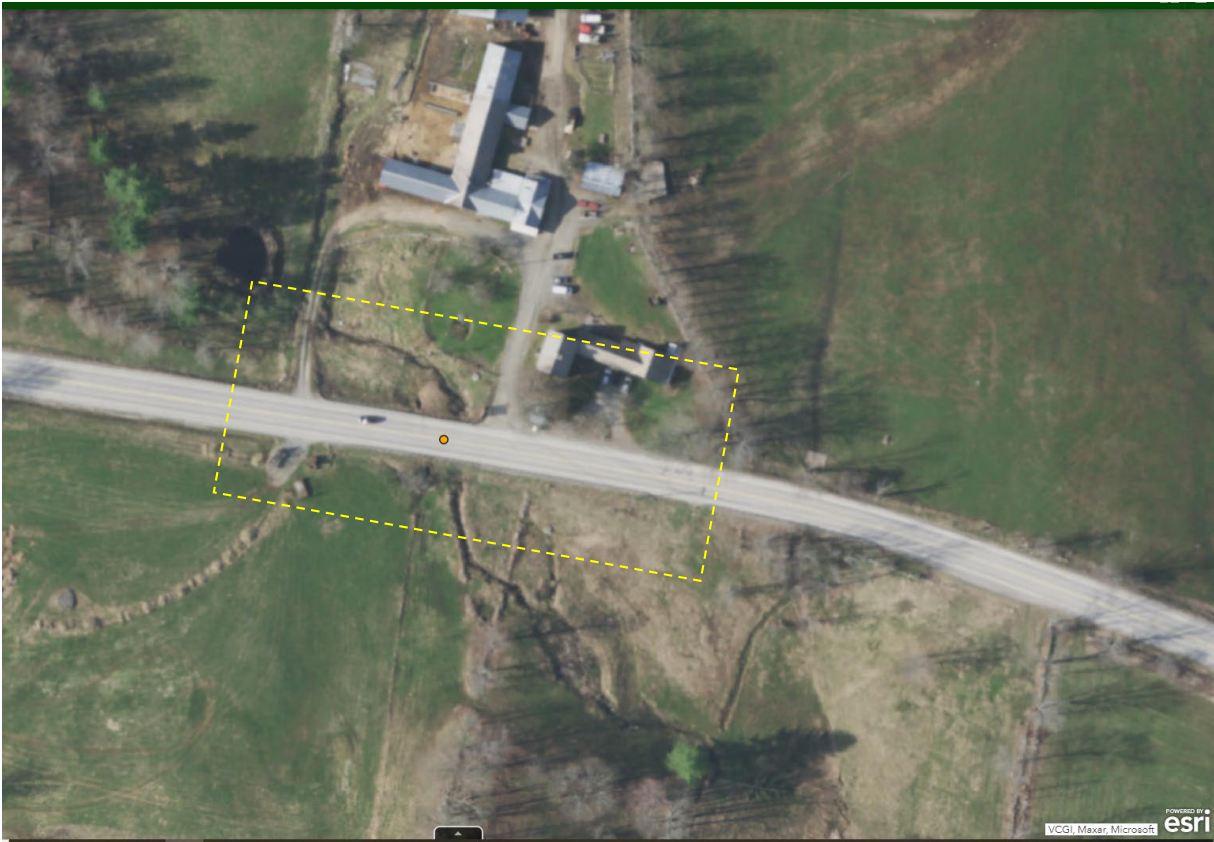
*Figure 15. Survey area at Bridge 25 in Londonderry on Vermont Route 11.*

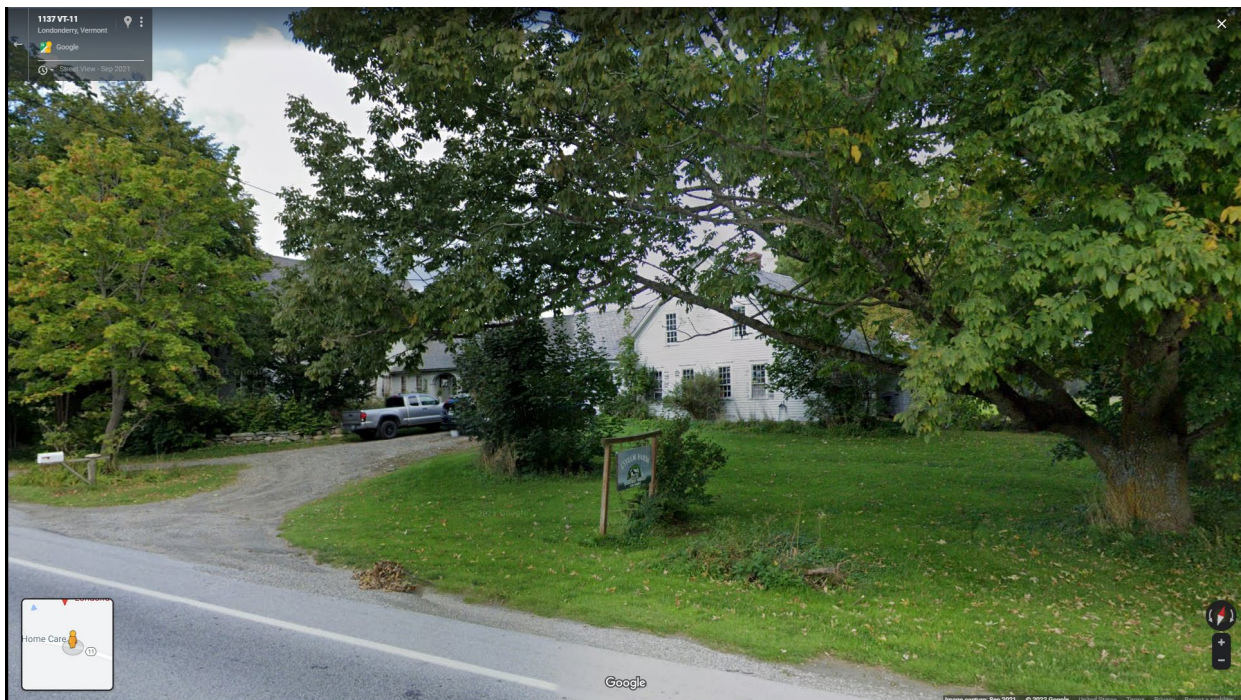
*Figure 16. Potentially National Register-eligible farm complex at 825 Vermont Route 11 in Londonderry (Taylor Farm).*

- A potentially **National-register eligible farmstead** was identified within a likely project **APE at 825 Vermont Route 11 (Taylor Farm) in Londonderry** (*Figure 16*). Further research, including better images of the farmhouse, is necessary to make a more definitive determination; however, this complex should be considered historically significant during project design. Section 4(f) review might be necessary if easements are required from the parcel associated with the farm complex.
- Although over 50 years of age, Bridge 25 is a common example of its type and does not possess the historic significance necessary for inclusion in the National Register.

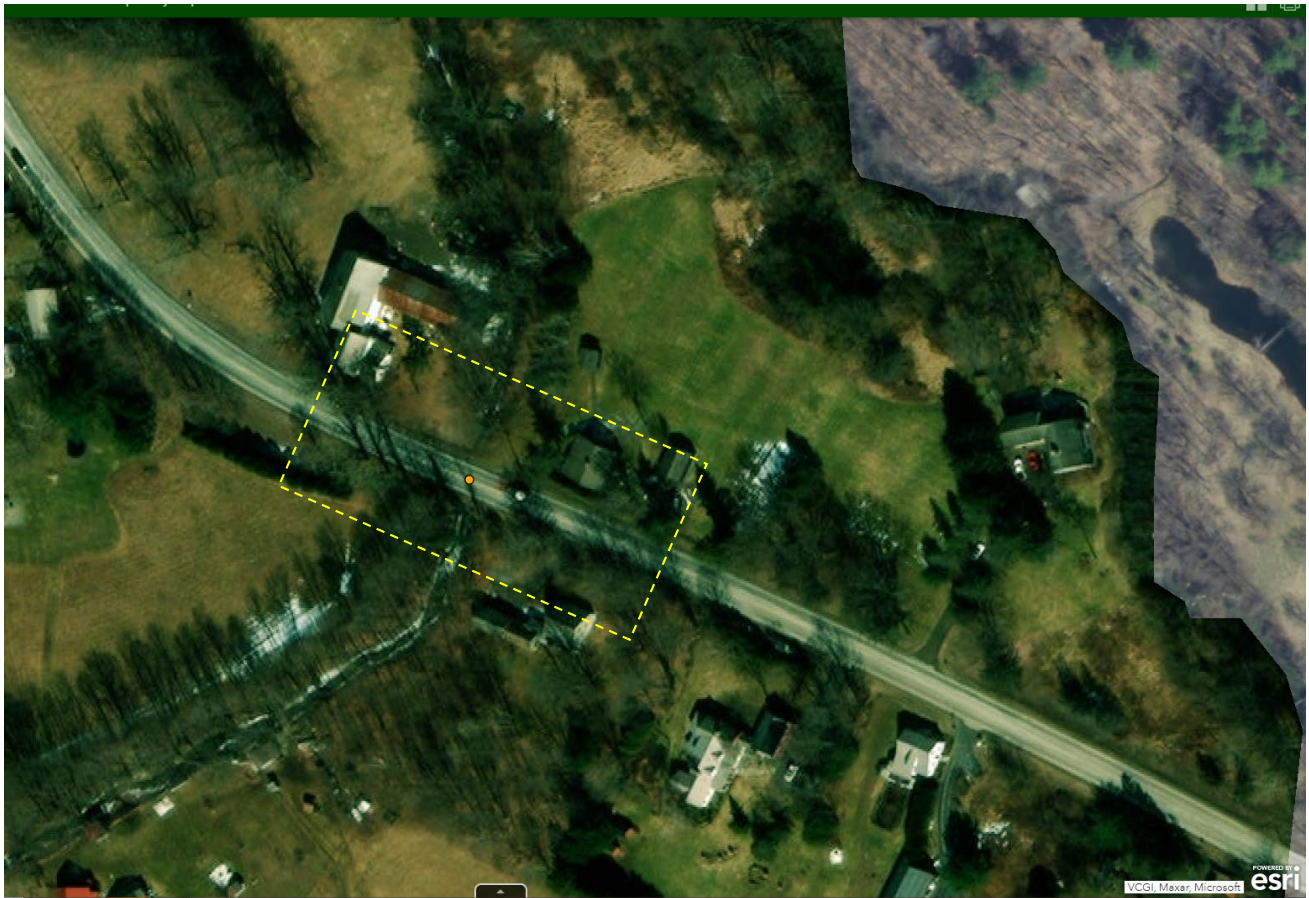
Figure 18. Survey area at Bridge 25 in Londonderry on Vermont Route 11.

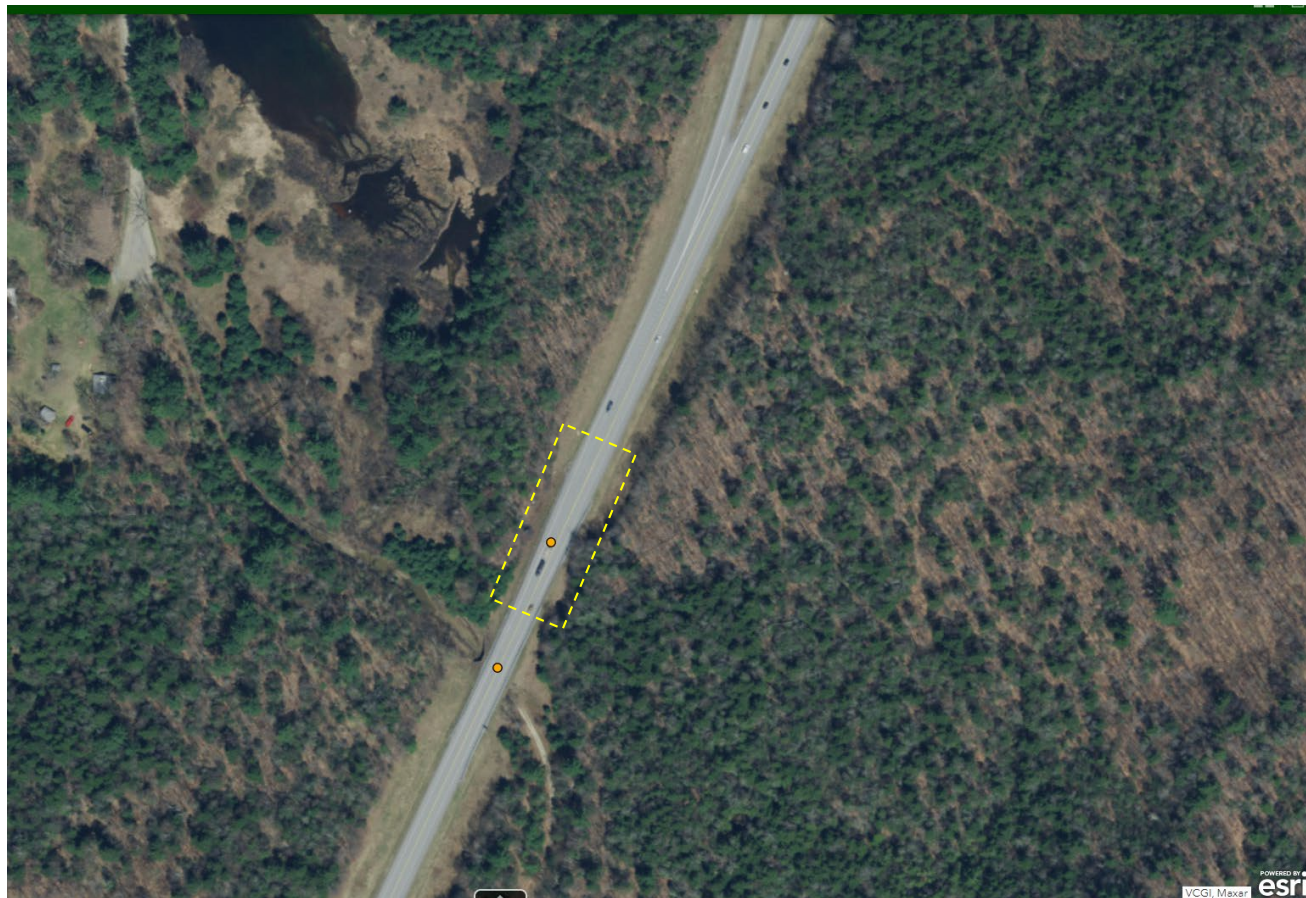
Figure 22. Survey area at Bridge 19-7 in Sunderland on US Route 7.
