Waterbury BO 1446(40)
Bridge #36
Scoping Study
Project Definition
Stowe Street over Thatcher Brook

6/24/21

Stantec Consulting Services (Stantec)
55 Green Mountain Drive
South Burlington, VT 05403

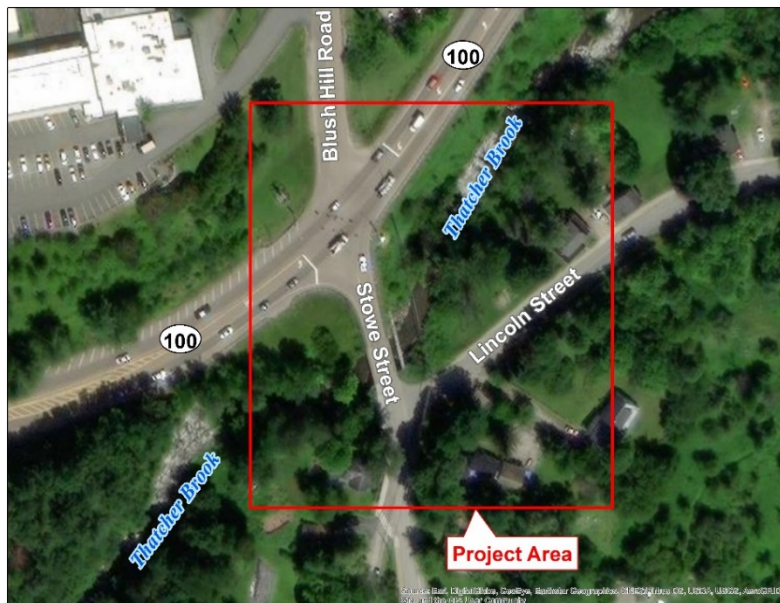
Figure 1 Project Location Plan

The project area is centered around Bridge 36, where Stowe Street passes over Thatcher Brook. The project area also includes the intersection of VT 100 / Stowe Street and Stowe Street / Lincoln Street, as shown in Figure 1.

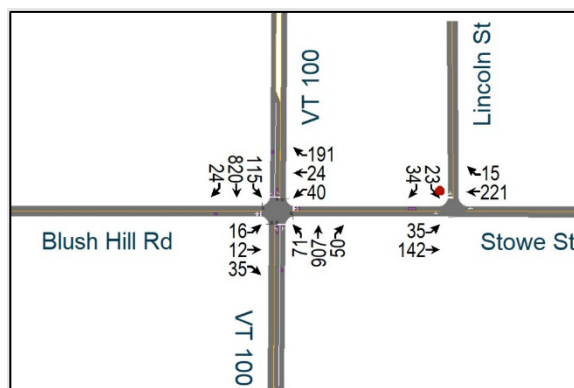
Figure 4 Existing 2020 PM

Turning movement counts (TMCs) were collected by the Vermont Agency of Transportation (VTrans) at VT 100/Stowe Street in July 2016. These volumes were adjusted to 2020 by Stantec using an annual growth factor of 1.02 per the VTrans Continuous Traffic Counter Report (The Redbook) based on 2016 traffic data. Stantec collected TMCs at Lincoln St/Stowe Street in November 2020. These volumes were adjusted to account for the reduced traffic volumes due to the COVID pandemic, using a factor of 1.2 per discussions with VTrans, to approximate pre-COVID traffic volumes. This 20% increase is based on a VTrans comparison of data collected by Automated Traffic Signal Performance Measures (ATSPMs) during Indigenous Peoples Day weekend in 2020 vs 2019. Volumes were balanced between both intersections, displayed in Figures 3 and 4.

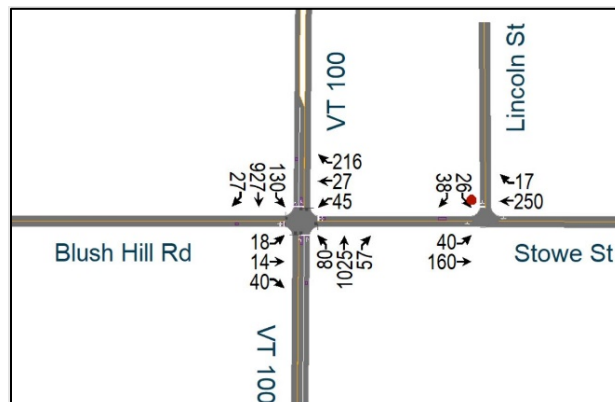
Figure 10 Future 2045 PM

Future traffic conditions for the year 2045 (25-year horizon) were determined by adjusting 2020 volumes to 2045 using a growth factor of 1.13, per the VTrans Continuous Traffic Counter Report (The Redbook), based on 2020 traffic data. Future 2045 volumes are displayed in Figures 9 and 10. No known specific land use development projects were identified.

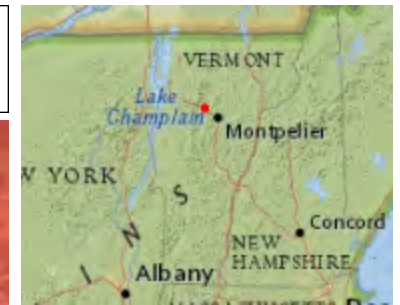
ANR Map

Project Area reviewed by Stantec's Environmental Scientist - initially flagged as Class 1 wetland

Tom - I visited the Waterbury Stowe Street Bridge project site on June 27, 2018 to verify the location of wetlands upstream of the project area. These wetlands are not mapped on the ANR database but were mapped as part of the Broadreach/Colbyville project. Based on my site visit, the wetlands mapped on Figure 3 in that report are a bit over-generous – the actual wetlands do not extend downstream (toward the bridge) as far as shown on the sketch. However, even as mapped, the bridge is located outside of the 50-foot buffer to these wetlands. Attached is a revised Figure 3 showing my estimate of the wetland boundary.
