# Using Remote Data Collection to Identify Bridges and Culverts Susceptible to Blockage During Flooding Events

UVM Transportation Research Center

UVM Spatial Analysis Lab

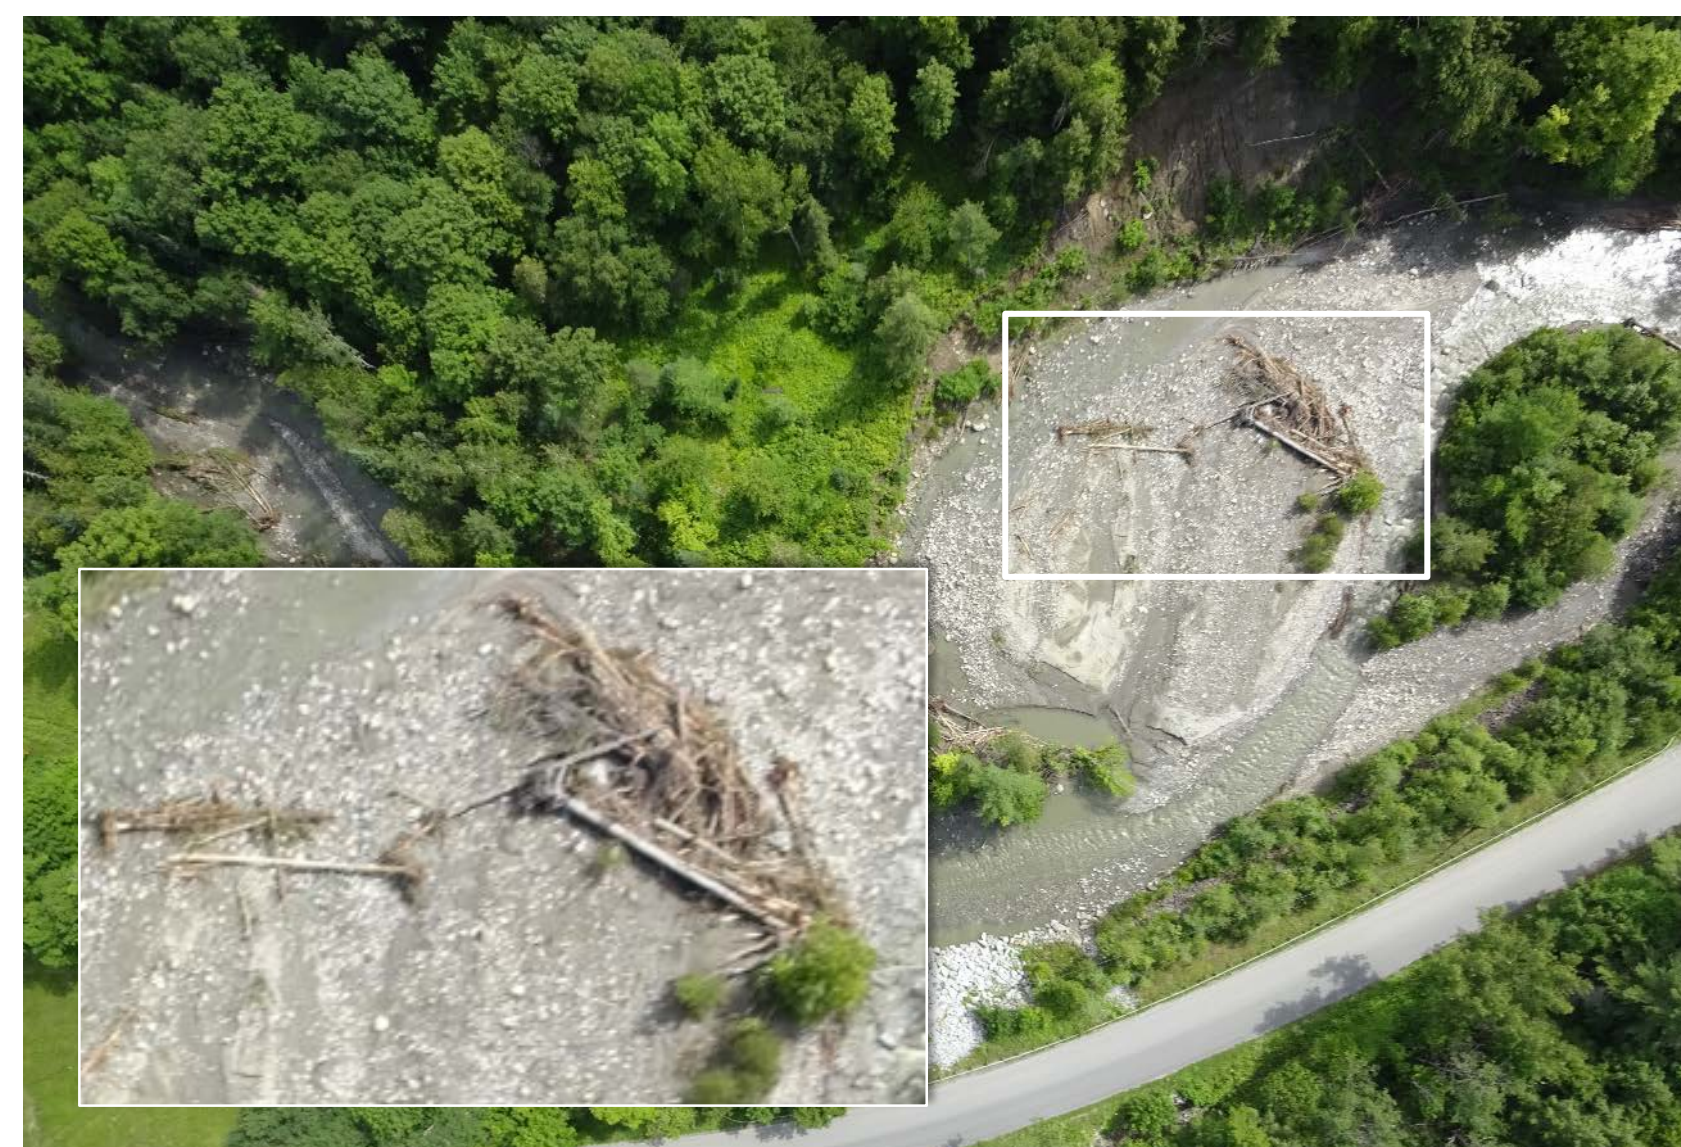
LWD pile identification in Great Brook

The UAV imagery was used to identify the size of each LWD pile and its distance upstream from the crossing structure at each of the 5 test sites. The modified inverse distance upstream (MIDU) was then calculated to identify high-risk locations by weighting the inverses of the distances upstream for the LWD piles based on their size:

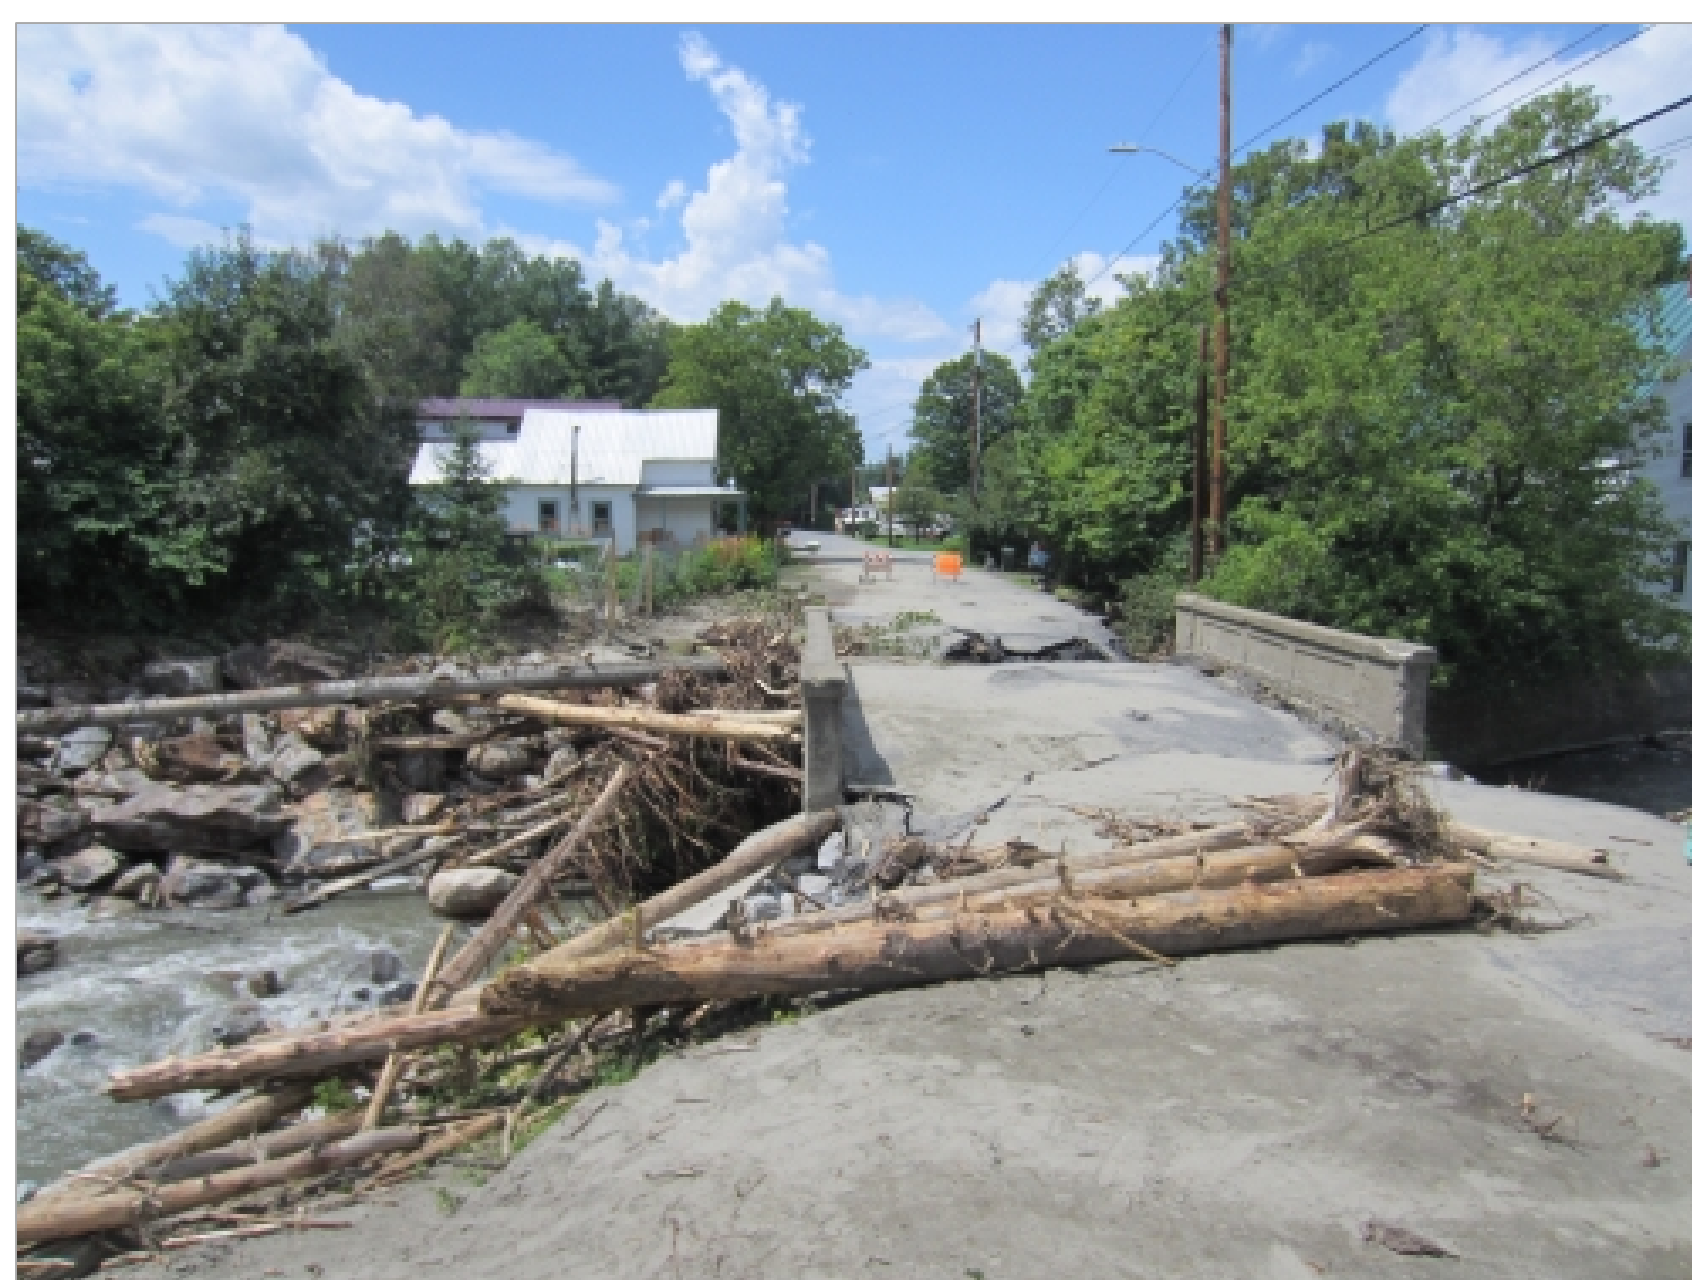
Damage caused by debris blockage of a crossing structure
