### 2022 School Facilities Inventory Report

Facility Name: **CENTRAL VERMONT SU | NORTHFIELD MIDDLE/HIGH SCHOOL | 37 CROSS STREET, UNIT2+3, NORTHFIELD 5663 - Combination (6 thru 12) - Main Building**

March 29, 2022

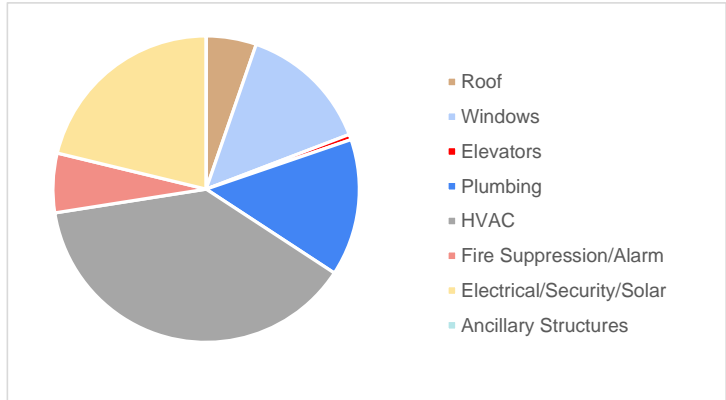
#### Relative Asset Values

Value of Assets/GSF **\$103.70**

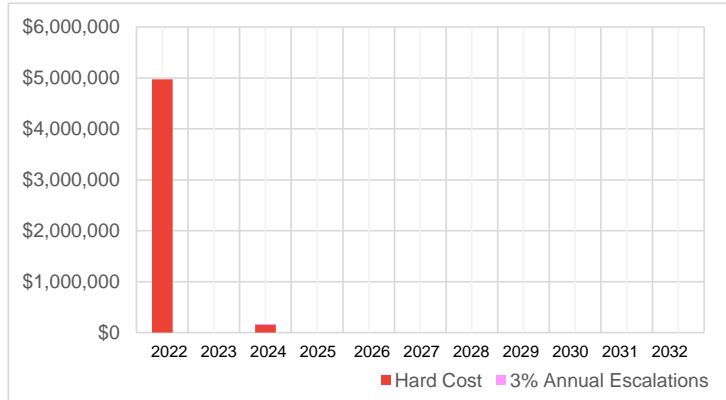
#### Projected Capital Planning Cash Flow

<b>Projected Capital Planning Cash Flow</b>	The estimated replacement costs of systems as they expire annually.
<b>Facility Condition Index (FCI)</b>	The cost -weighted depleted value of the building compared to the total value of all its systems; overall percent of building useful life consumed by years in service.
<b>Total Value of Assets</b>	The total estimated replacement cost of all the assets listed in the form.
<b>Value of Assets per GSF</b>	The Total Value of all Assets in the form divide by the Gross Square Footage (GSF) of the building.
<b>Facility Condition Index (FCI) Compared to Portfolio</b>	The Facility Condition Index (FCI) of the building overlayed on the chart of FCI's for all buildings in the portfolio. Indicated by a red line in the chart.
<b>Calculated Remaining Useful Life( C-RUL)</b>	The current number of remaining years a system may be expected to perform in designed service.

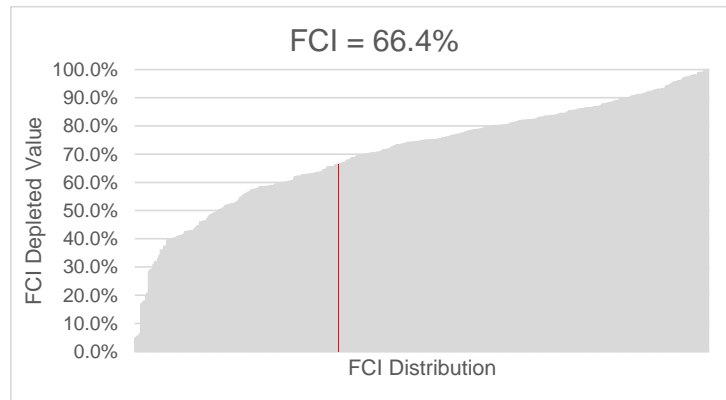
#### Facility Condition Index (FCI) Compared to Portfolio

School Type **Combination (6 thru 12)**  
 Building Identification **Main Building**  
 Stories **2**  
 Building Area **85000 (Gross Square Footage - GSF)**  
 Year Constructed **1975**  
 Year of Last Major Renovation **N/A**  
 FCI (Depleted Value) **66.4%**
