FY17 Vermont Better Roads Grant Application

Project Name: Salvas Road Erosion Control

Road Name: Salvas Road TH #: 21 Structure # (if applicable): _____

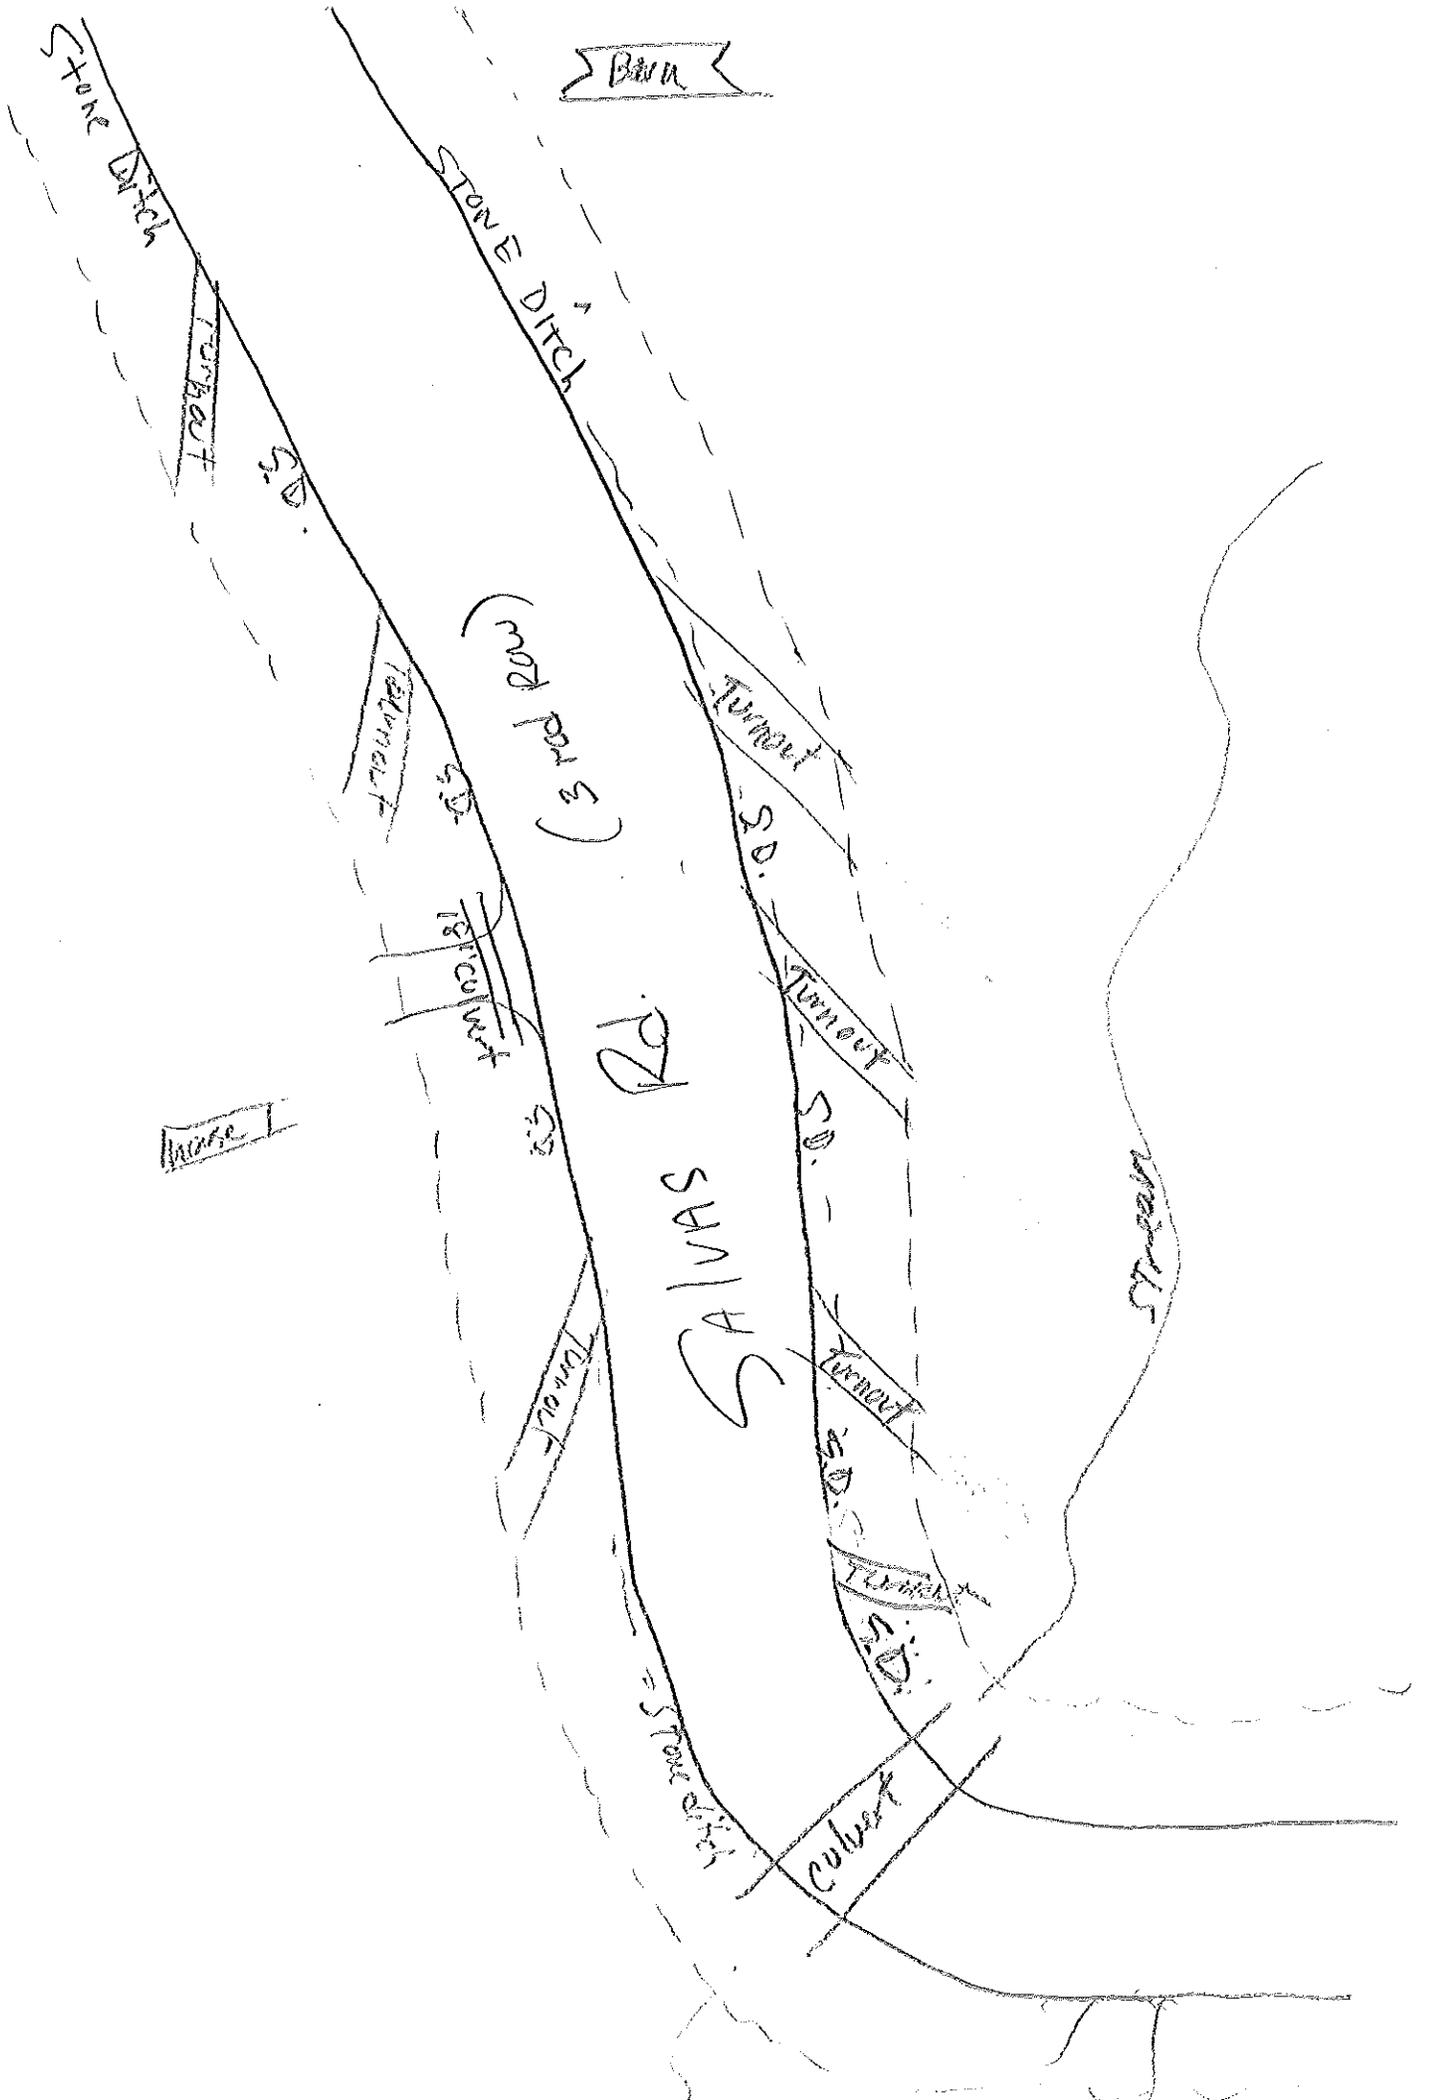
SALVAS Rd.

Culvert

Stone Ditch

Turnout 50.

Turnout

Work will be to add turn outs and stone lined ditches on both sides of aprox. 700' of roadway, starting at the top of the road & working downhill. This is part 1 of a 2-part project: the lower portion of the road is currently part of a FEMA disaster recovery project slated to be completed summer 2016. Since the upper portion of the road feeds the downhill 'FEMA project' portion, this grant would enable us to complete the road.
