# Vermont Better Roads Grant Program Application

Town/Organization: Town of Strafford

Project Name: Old City Falls Slope Stabilization

**RE: Strafford, bridge #27 on TH #6 (Class 3) over Old City Brook**

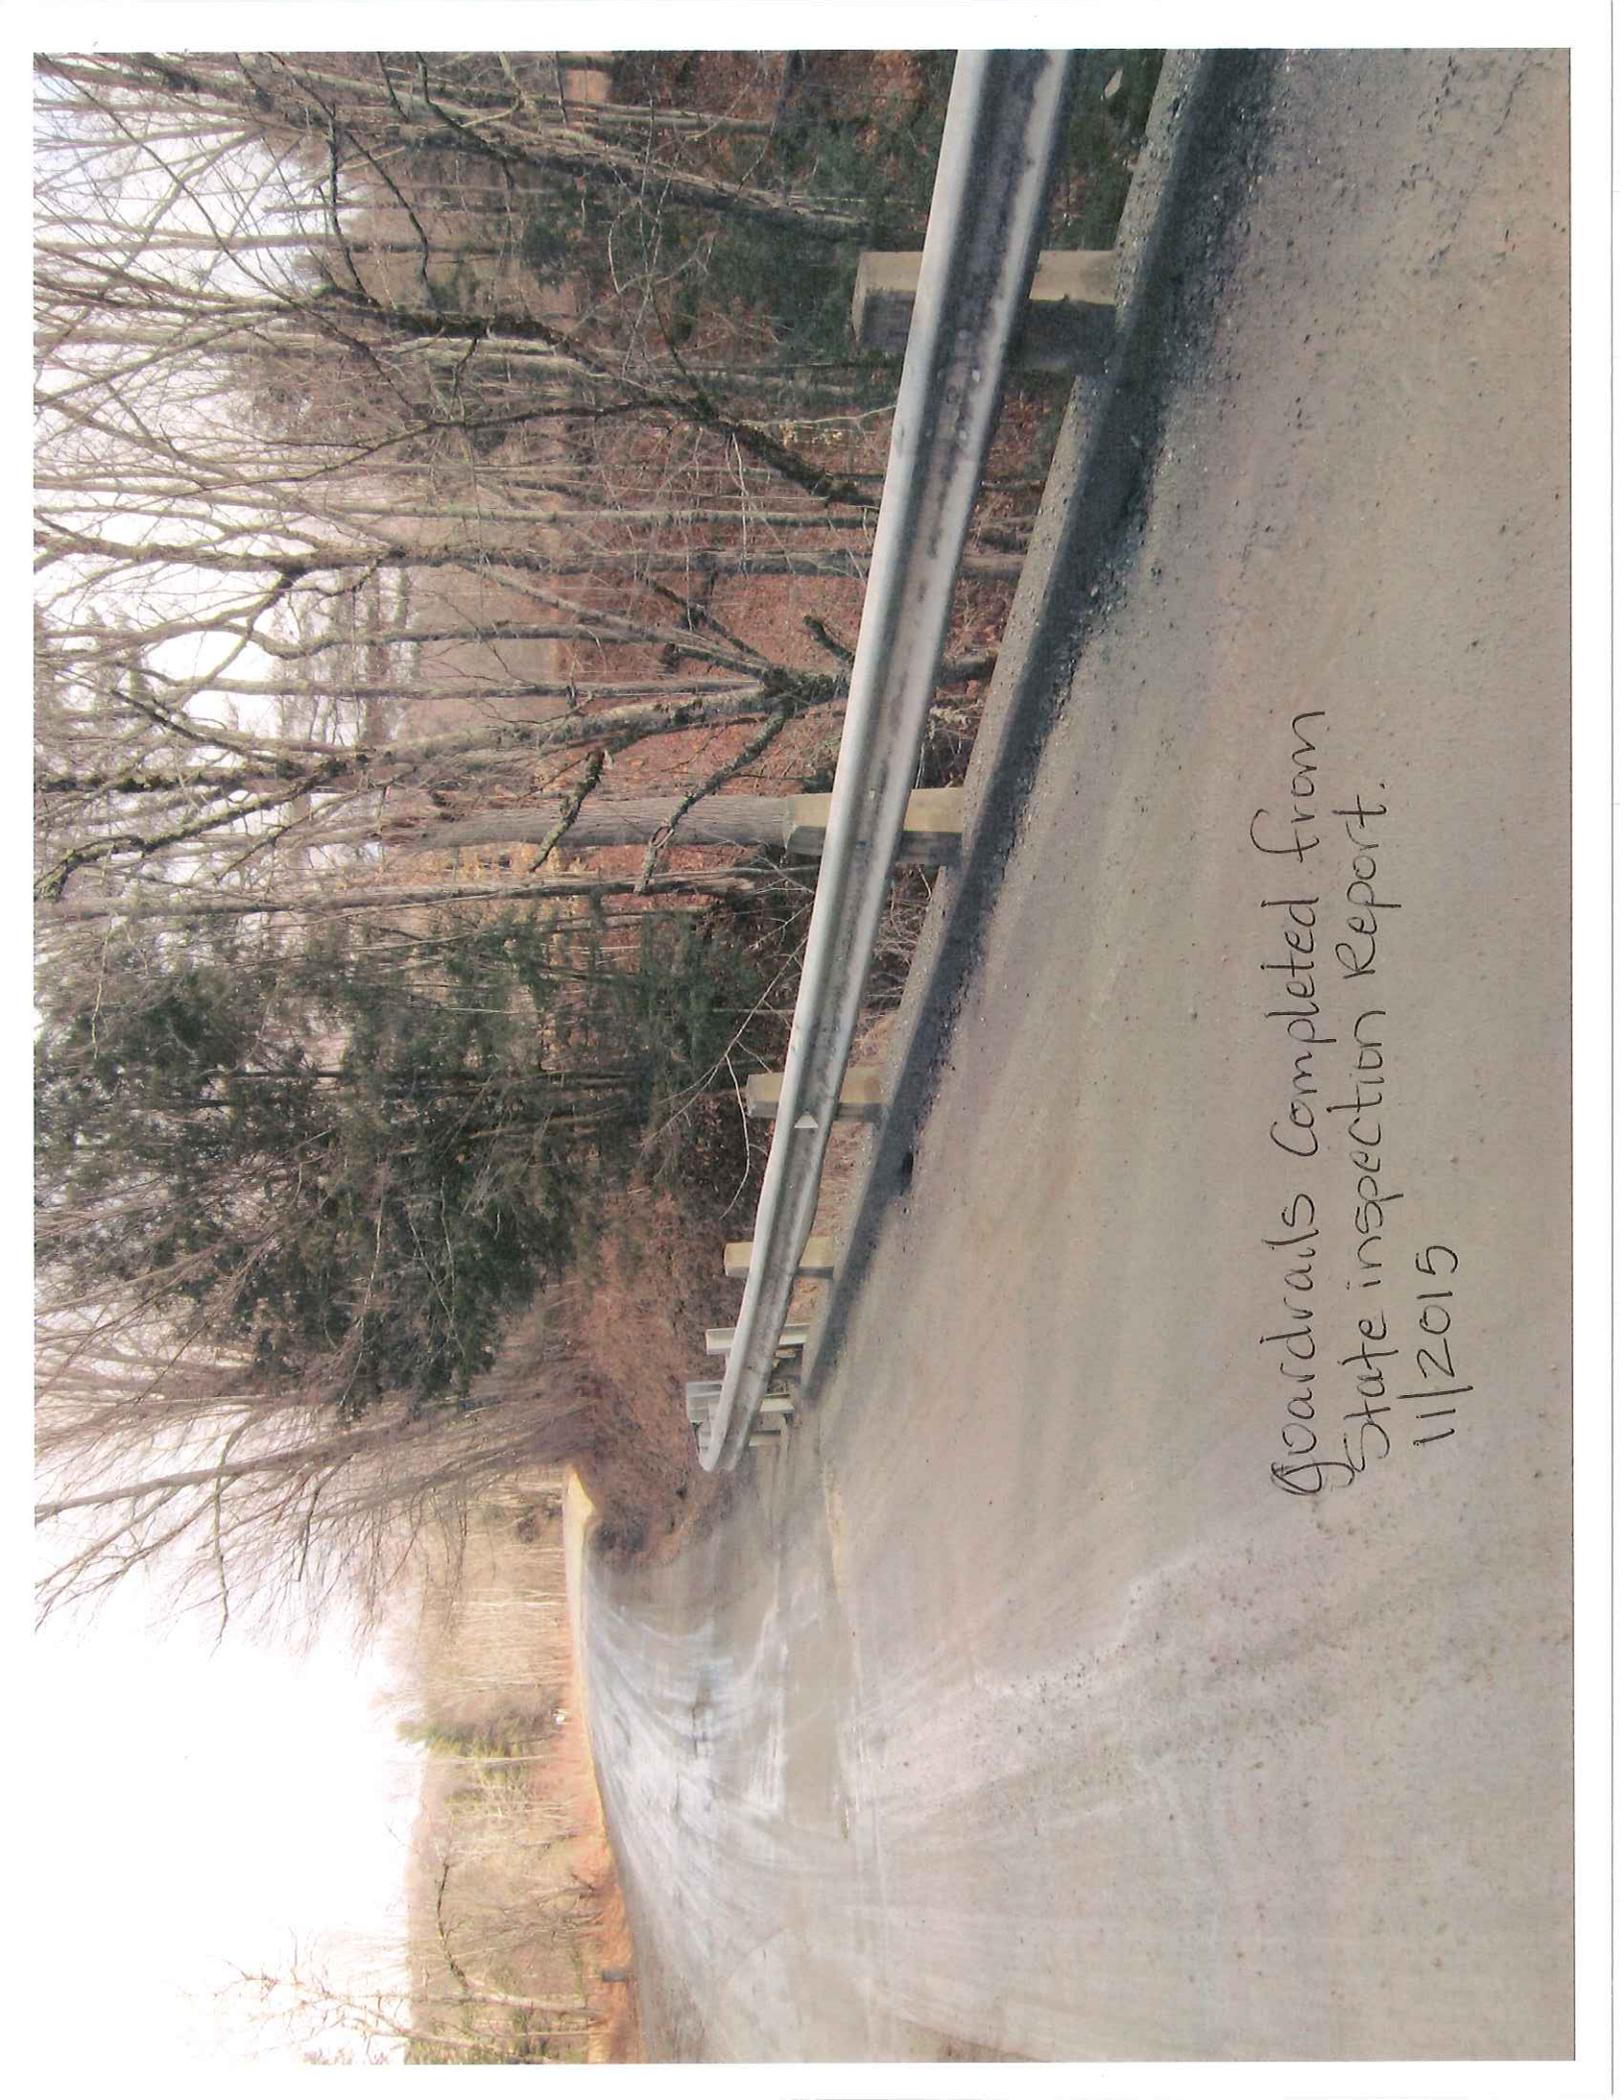
Guardrails Completed from  
State inspection Report.  
11/2015

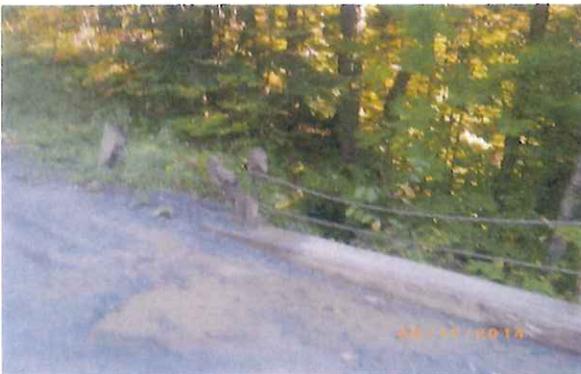
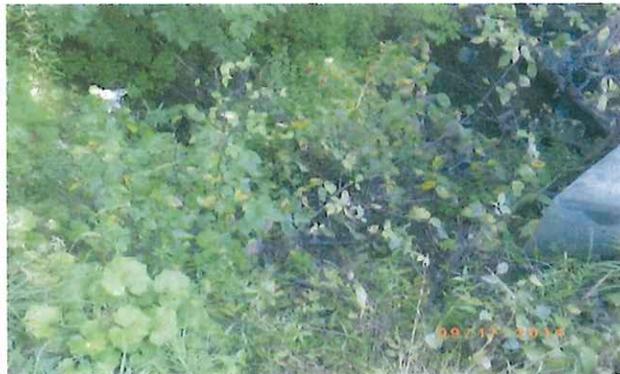
- The approach's cable rails lie on the ground due to failed timber posts and has caused the bridge rail to sag. There is also a broken out concrete post over the upstream end of abutment 1.
- The upstream embankment at abutment 1 has heavy erosion due to road runoff.

Based on these findings it is recommended that the bridge and approach guardrail be replaced to meet standards. Also new approach guardrail posts be installed and repairs made to the broken out bridge post over abutment 1.

The upstream embankment at abutment 1 should have anti erosion protection installed.
