Bicycle & Pedestrian Scoping Study *along Route 100 in Dover, VT*

Dover STP BP14(16)

DRAFT
Submitted to the
Town of Dover
Vermont

Project No. 1570021

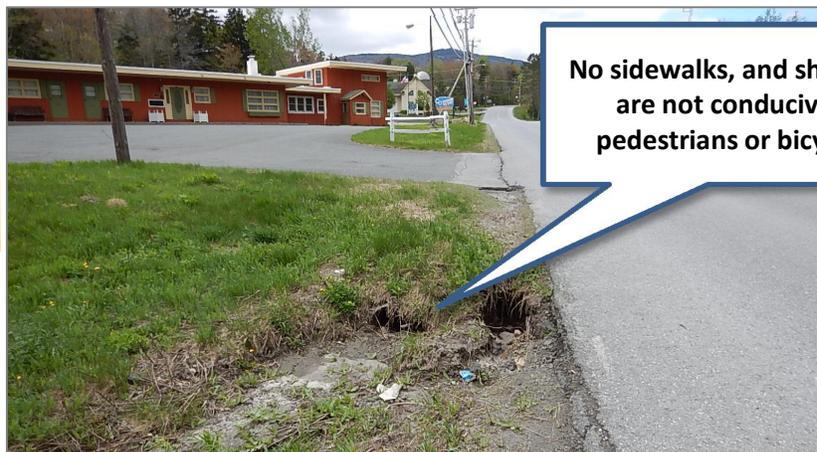
- 4) Pedestrians and bicyclists using the bridge over the North Branch of the Deerfield River are more vulnerable to conflicts with automobiles because of the narrow shoulder on both sides of the bridge. The horizontal curvature causes automobiles to sometimes veer onto the shoulder area as they travel across the bridge.

What are the roadway typical sections along this corridor? Specifically, here at the bridge? "Narrow Shoulder" is too

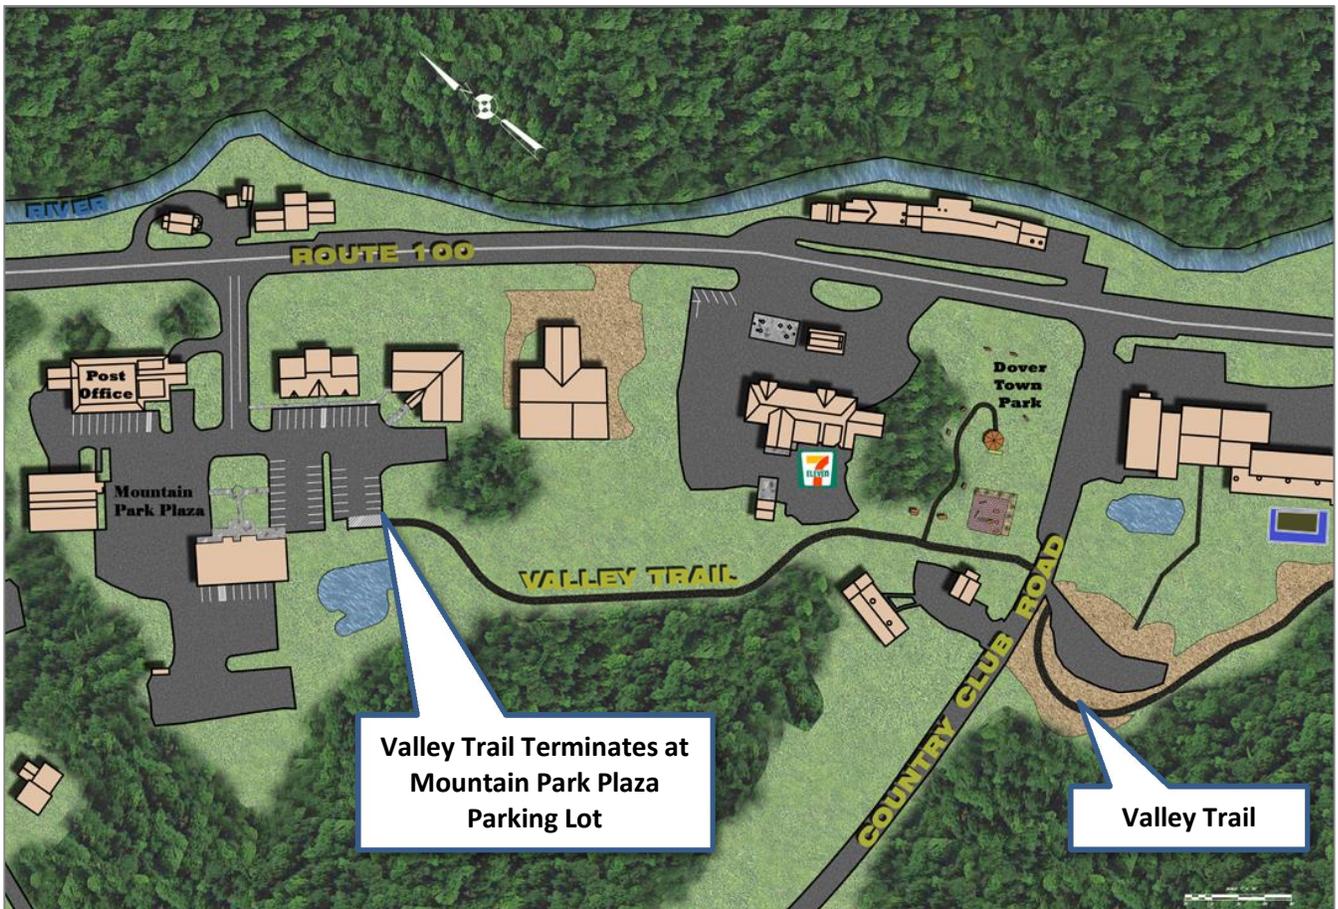
The location of the Valley Trail and its terminus in the shopping center parking lot results in potential users being disconnected from businesses and other activities along Vermont Route 100. In many instances, potential users are unaware that the trail terminates in the shopping center parking lot. There is no clear definition of the trail terminus, and no information identifying the end of the trail at the parking lot.

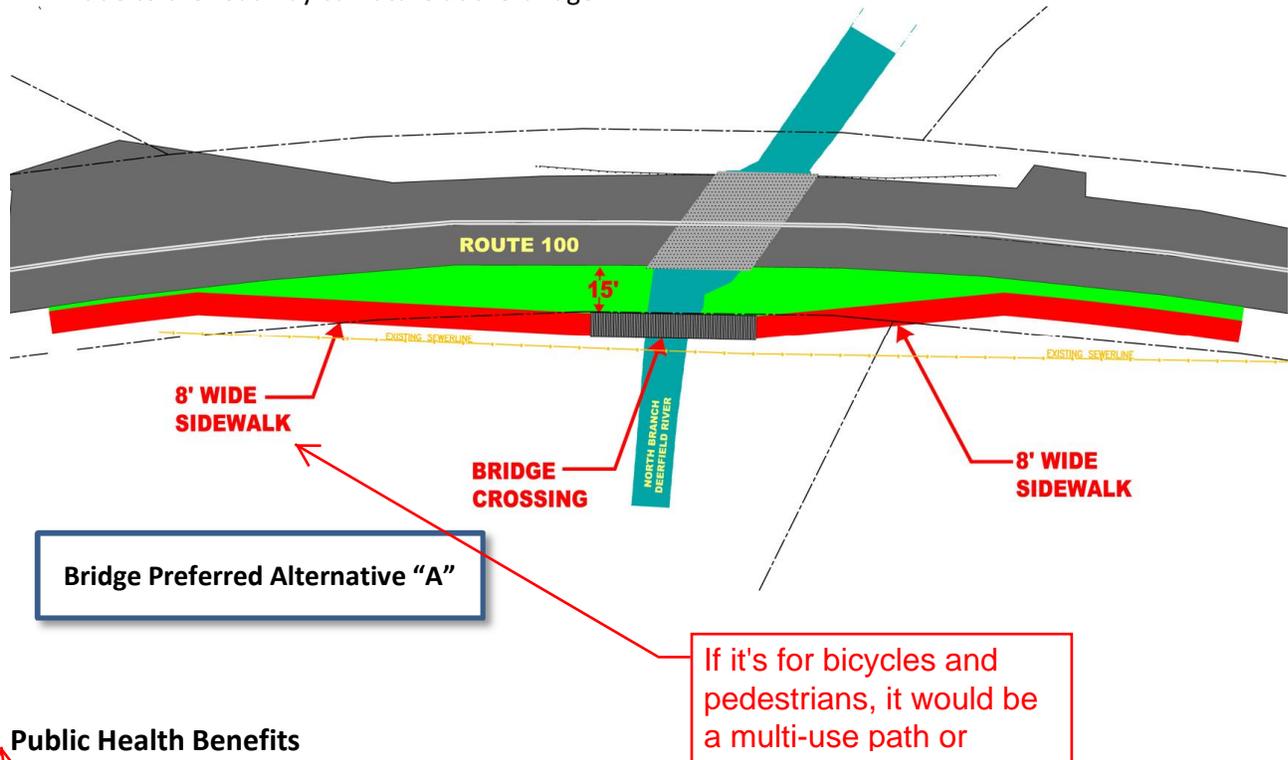
- 6) Completion of the bridge rehabilitation/replacement project for Bridge B59 would include a dedicated pedestrian and bicycle bridge separated from the Vermont Route 100 highway bridge. This improvement would significantly improve pedestrian and bicyclist safety at this crossing of the North Branch of the Deerfield River. Presently, pedestrians and bicyclists along VT Route 100 must navigate the bridge using the narrow shoulder which is oftentimes occupied by automobiles due to the roadway curvature at the bridge.

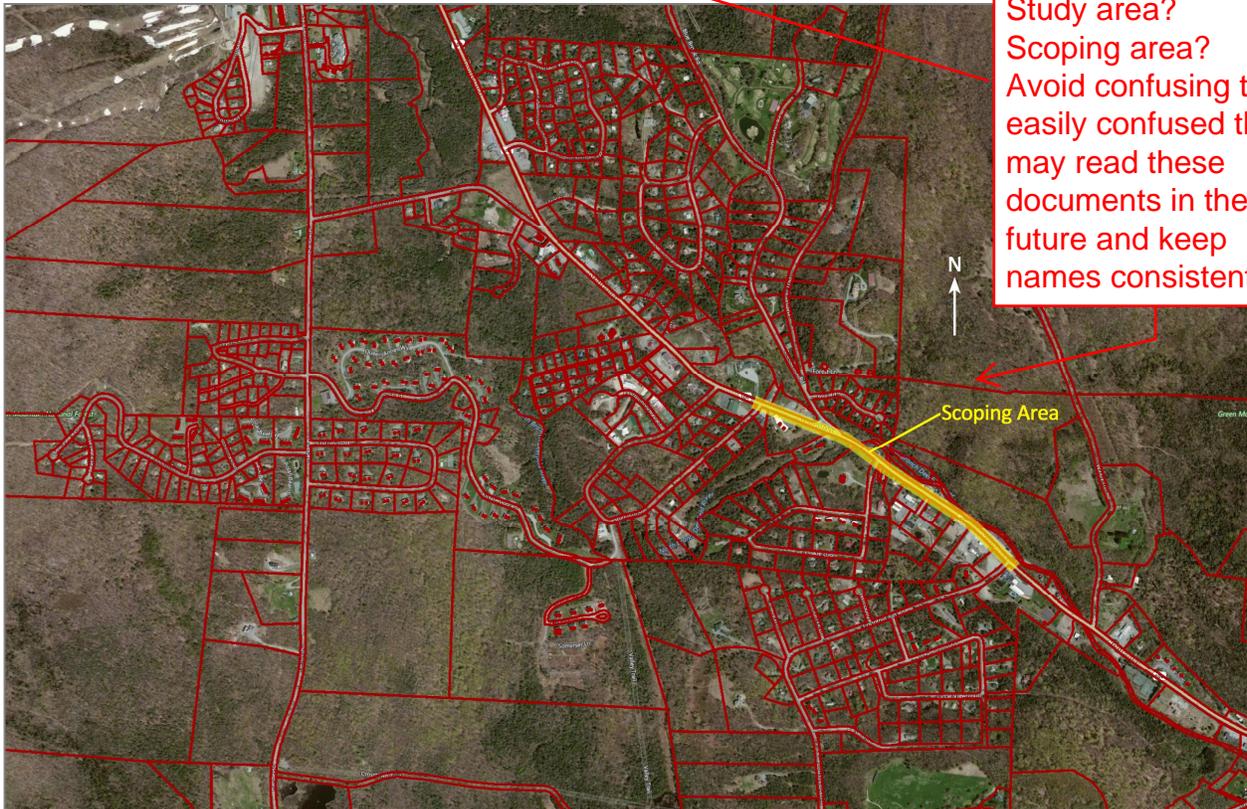
There are approximately 18 business properties located within the east and west sides of the study area. In addition, there are approximately 75 residential housing units located on both sides within the study area, with a higher concentration on the westerly side. There are additional businesses and a considerable number of residential housing units located both North and South of the study area along Vermont Route 100. Pedestrian and bicycle traffic is generated from both within and directly outside of the study area. There are additional bicyclists and pedestrians traveling into the study area from homes and businesses north and south of the study area.

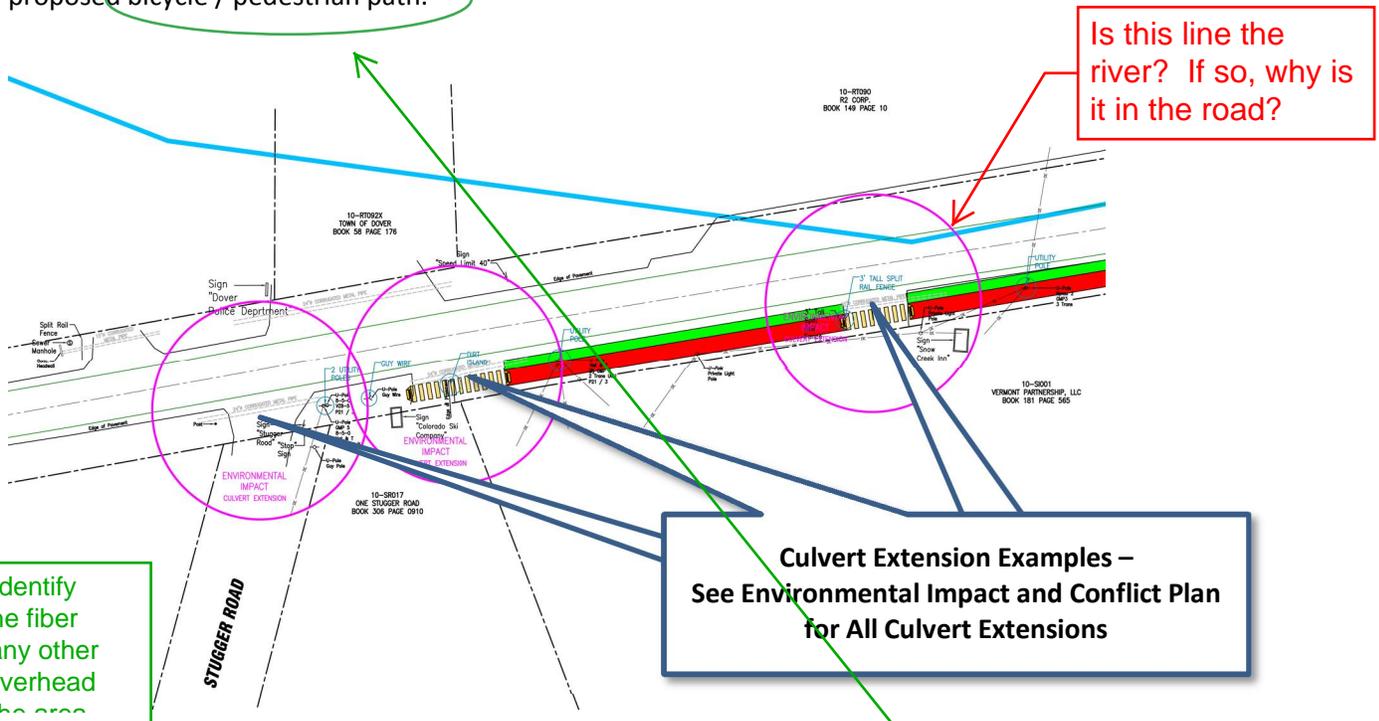
The constraints on the westerly side of Vermont Route 100 roadway consist mostly of cross culverts that would need to be extended beyond their current end points. There are also several driveway culverts that potentially might have to be moved further away from the edge of pavement to allow space for the proposed bicycle / pedestrian path.

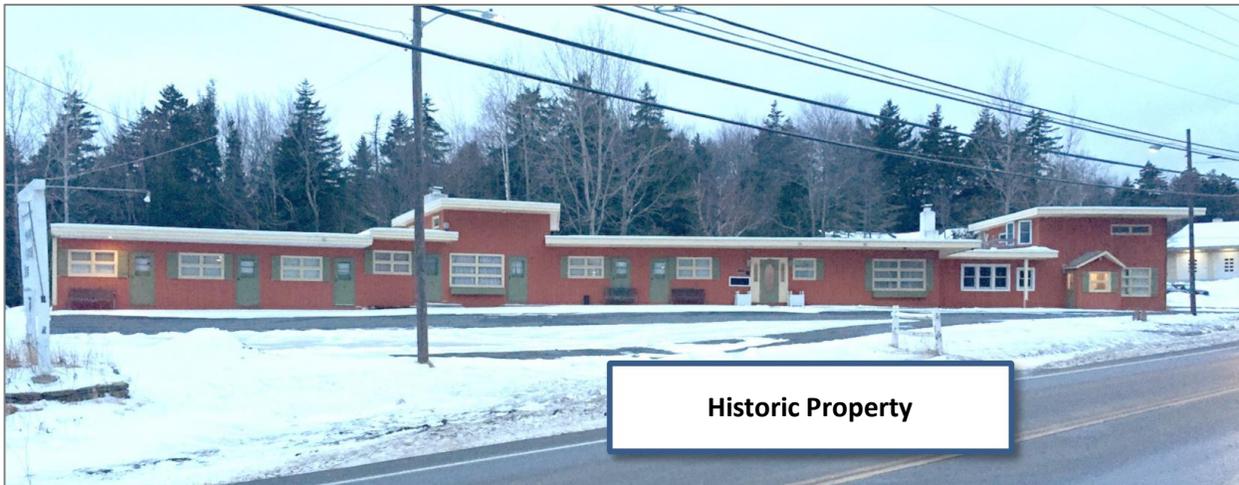
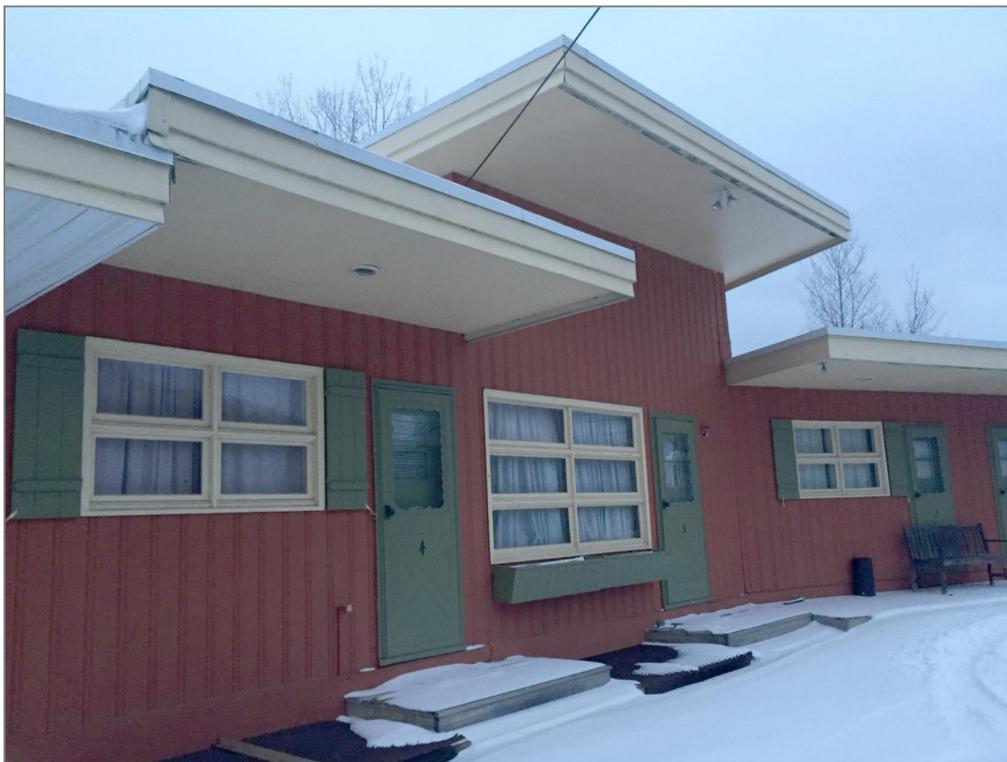
At the northerly end of the study area on the west side, there is a historic property. At the front of the property are several utility poles that would be located very close to a pedestrian/bicycle path if it were to be constructed on the west side of Route 100. The viability of relocating the poles onto the historic property should be investigated further to assure that that relocation is acceptable. The relocation would not affect the building, but only grassed or possibly paved areas in front of the building.

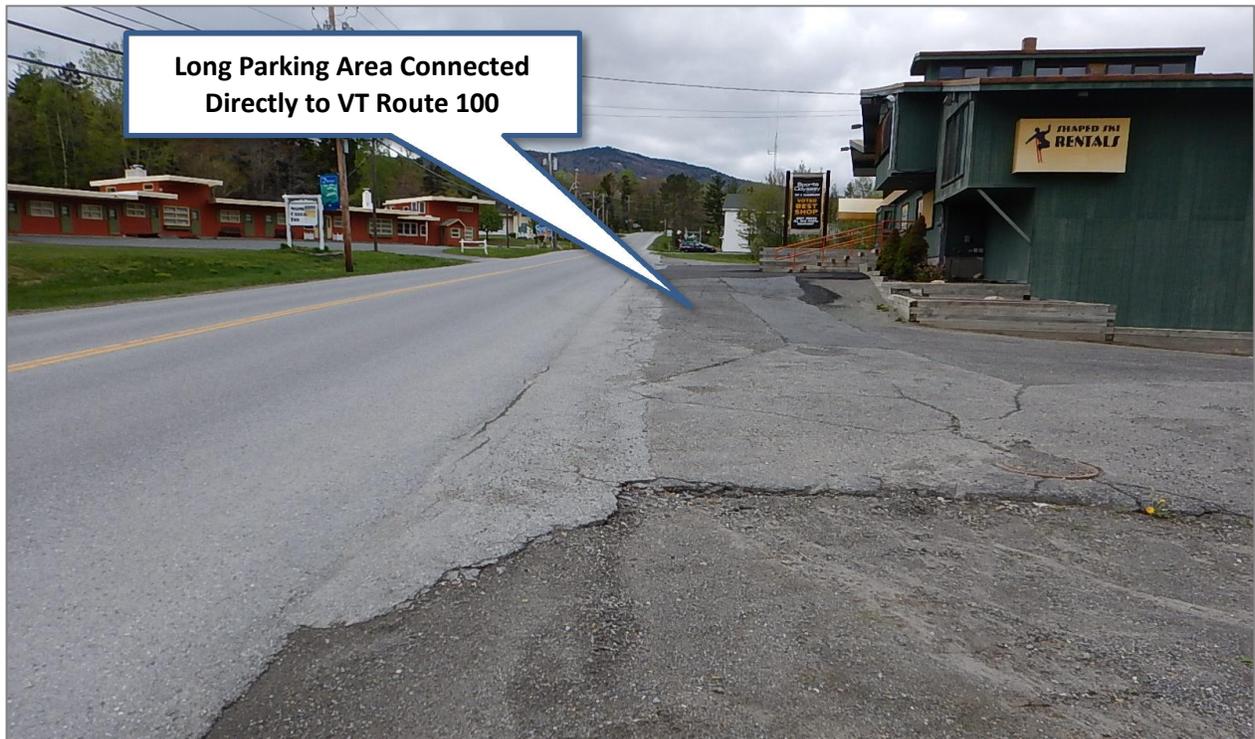
Continuing along the easterly side, north of Blue Brook Road, are two commercial properties whose parking spaces lie between the face of the buildings and the Route 100 pavement. One of the properties has a parking lot that is approximately 400 feet wide. Traversing across this paved area with a sidewalk/bike path without reconfiguring the pavement between the building and the roadway would be less than desirable because of the high potential for pedestrian/vehicular conflicts. ← solution?

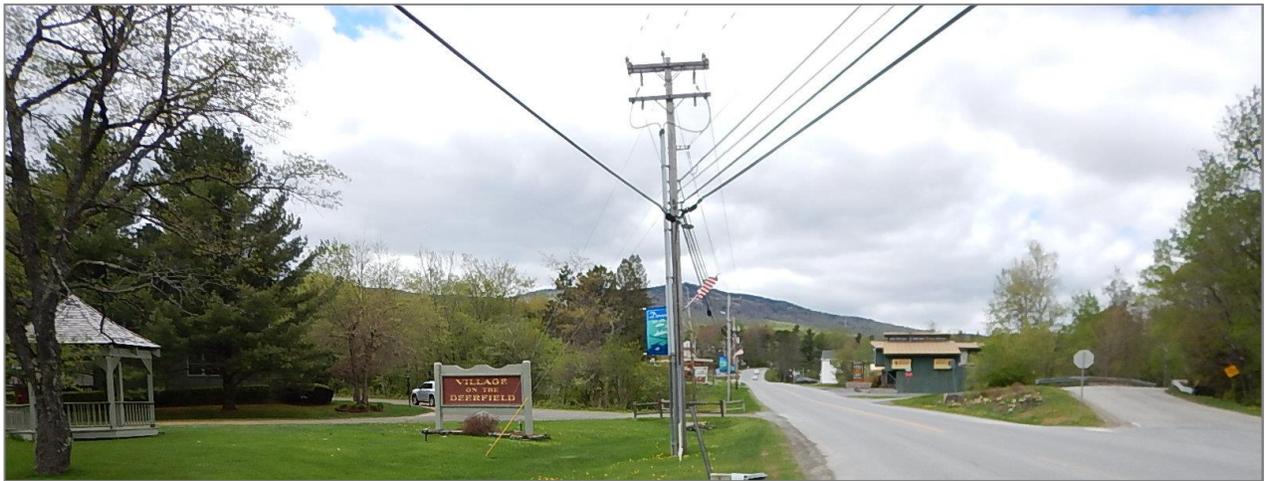
Overhead wires run parallel with Vermont Route 100 and are located on both the easterly and westerly side of the road. If the sidewalk/bike path were constructed on the westerly side, there would be seven utility poles impacted. On this side, there is sufficient space to relocate the poles and still keep them within the Route 100 right-of-way.

If the path were constructed on the easterly side, there would be three utility poles impacted.

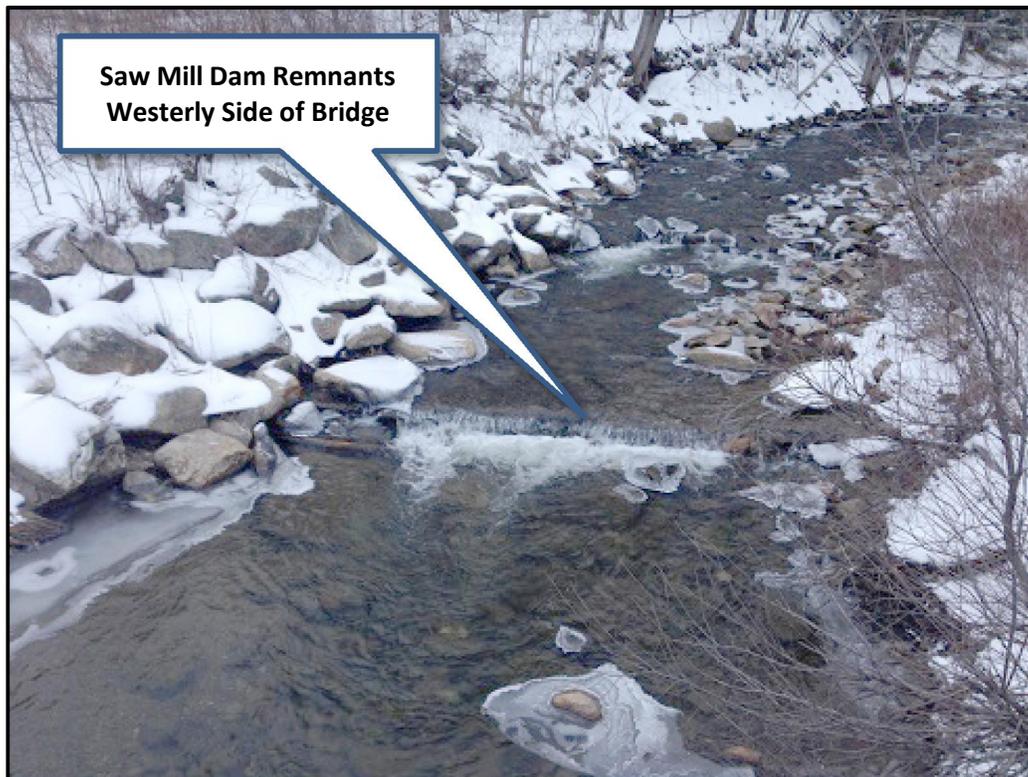
At some point in time, it appears that the upper portion of the dam was removed so that normal river flows could resume. By such action, the area of impoundment was depleted. What remains today appears to be the foundation (or footing) of the original dam, with runoff making a short fall over the remaining footing.

Where the proposed path alignment and pedestrian bridge will pass in very close proximity to the dam, additional archaeological investigation is recommended to document this feature. In addition, it is recommended that the exact position and size of the remnant dam be field located by survey, and the information imported into the base plan.

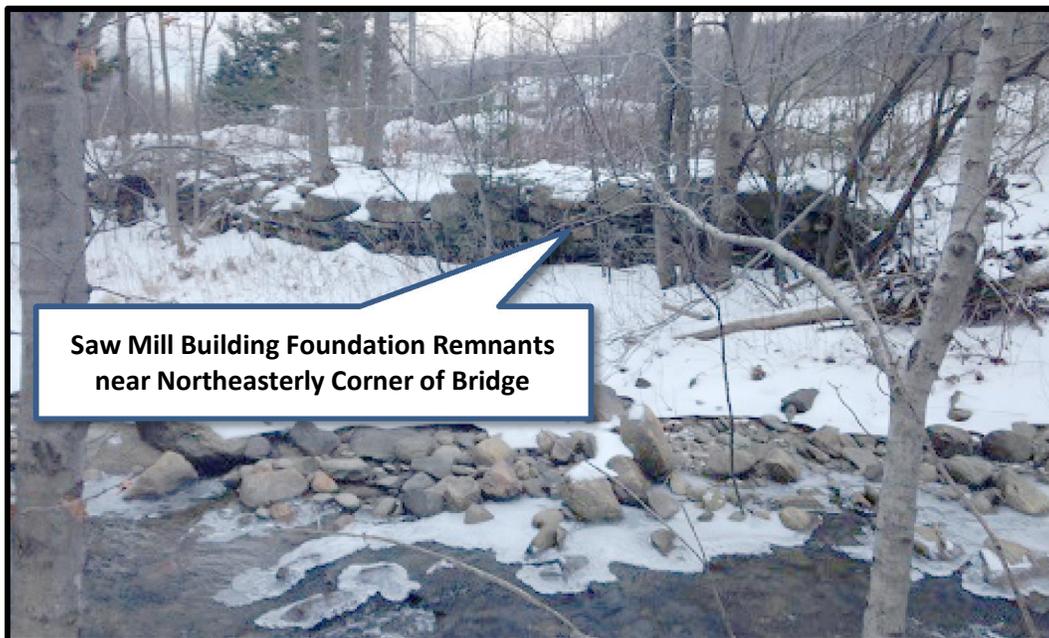
Easterly Side (downstream) of BR59

The exact location (position) of the old building foundation is less critical at this point, unless a decision is made to construct the new path on the east side. Should this occur, then additional study and survey would be warranted.

Monadnock Archeological Consulting identified remnants of an old sawmill in the vicinity of the vehicular bridge (BR59) over the North Branch of the Deerfield River. On the westerly side are visible remnants of an old dam, and on the easterly side, evidence of the old sawmill building foundation. Photos of each side were provided in the archaeology report.

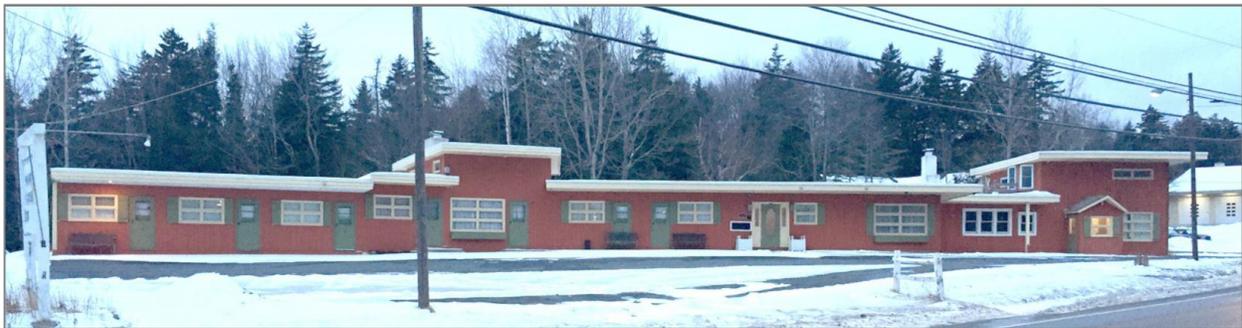
The exception, and the only property in the Area of Potential Effect (APE) we recommend to be considered eligible for the National Register, is Building No. 9 from the attached orthophotos and photo sheets. The Snow Creek Inn building has projecting roofs, vertical siding, and wooden windows, and dates to ca. 1960. It is one of the few remaining intact ski motels constructed in the years after Mt. Snow was developed in 1954 to serve ski tourists.

Effects to the historic Inn structure (Building No. 9) will be minor, comprising linear conversion to multimodal path of part of the green strip that separates the driveway from RT 100. Traffic will not be moved closer to the road, a green strip will be maintained between the new path and road, and the path and green strip will be modified as required to accommodate the utility poles in their existing locations. As a result, the impacts to Building No. 9 are not considered adverse. In summary, this project qualifies for a finding of No Adverse Effect for above-ground historic properties provided the stipulations detailed in this letter are followed.

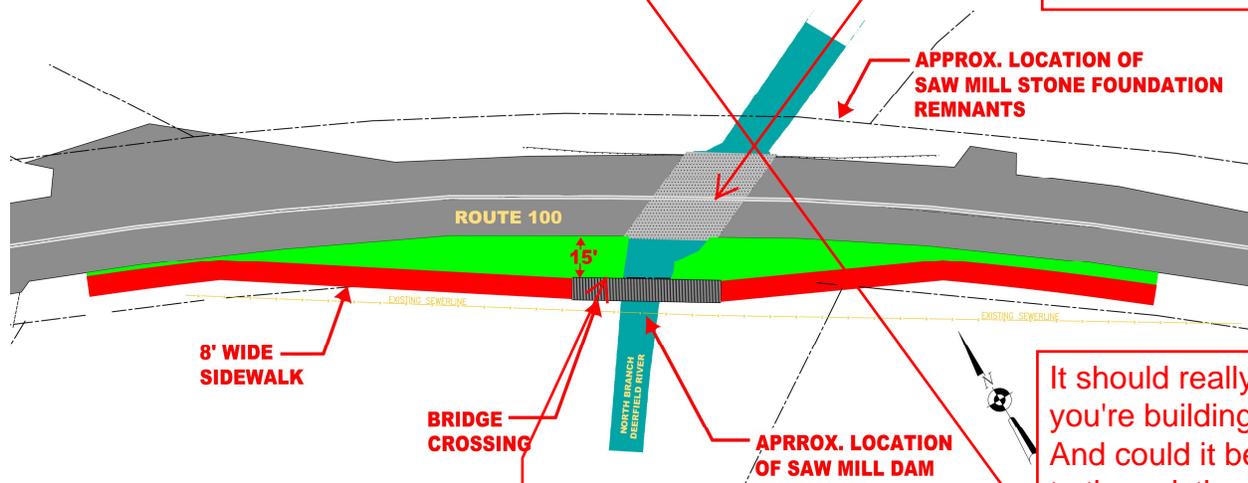
This alternative proposes to construct a **new 8-foot wide (stand-alone) pedestrian bridge** approximately **15 feet westerly of the existing roadway bridge**.

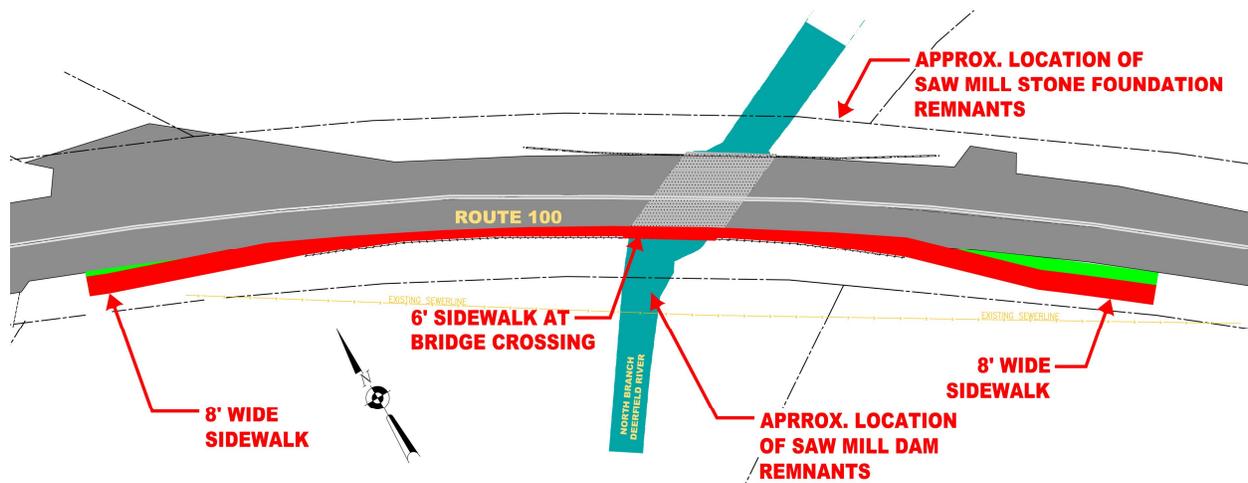
This alternative proposes to **utilize a 6-foot wide sidewalk that is constructed on the west side of a new vehicular bridge** replacement.

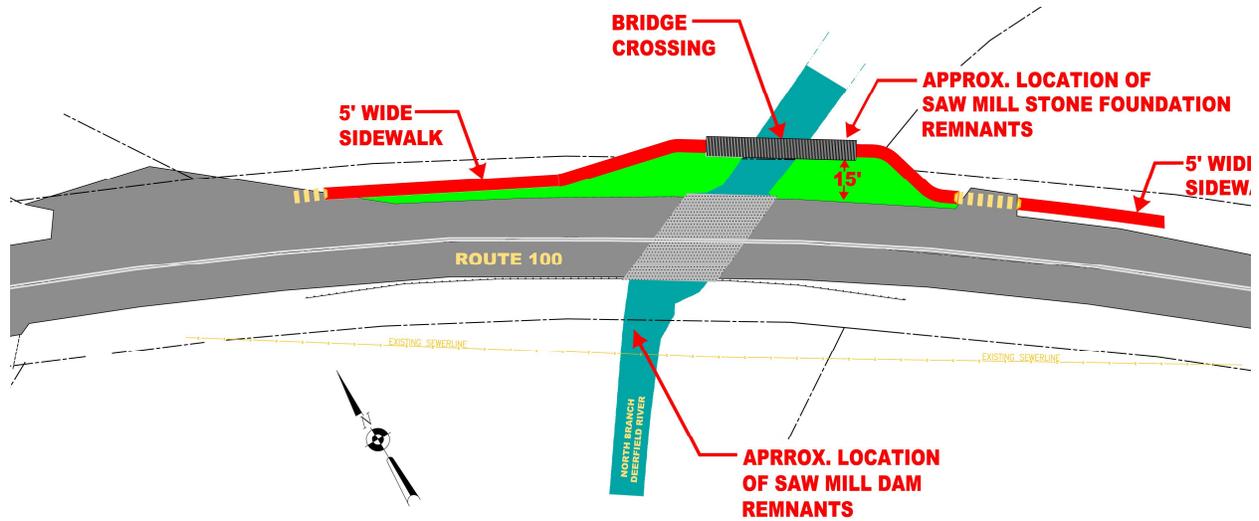
Bridge Alternative C

This alternative proposes to construct a **new 8-foot wide (stand-alone) pedestrian bridge**, offset approximately **15 feet easterly of the existing roadway bridge**.

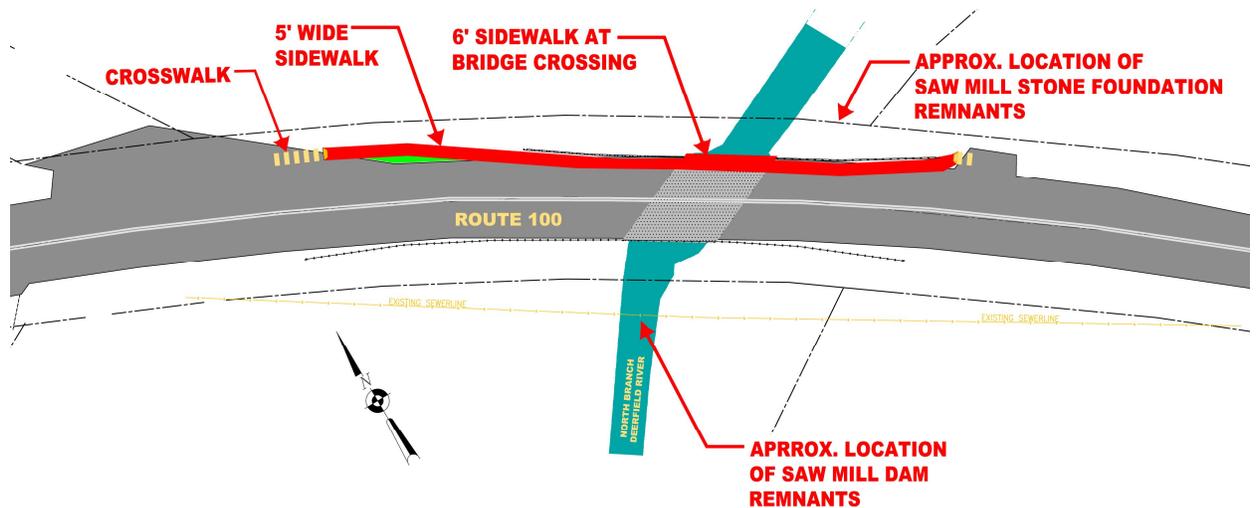
Bridge Alternative D

This alternative proposes to **utilize a 6-foot wide sidewalk that is constructed on the east side of a new vehicular bridge** replacement.

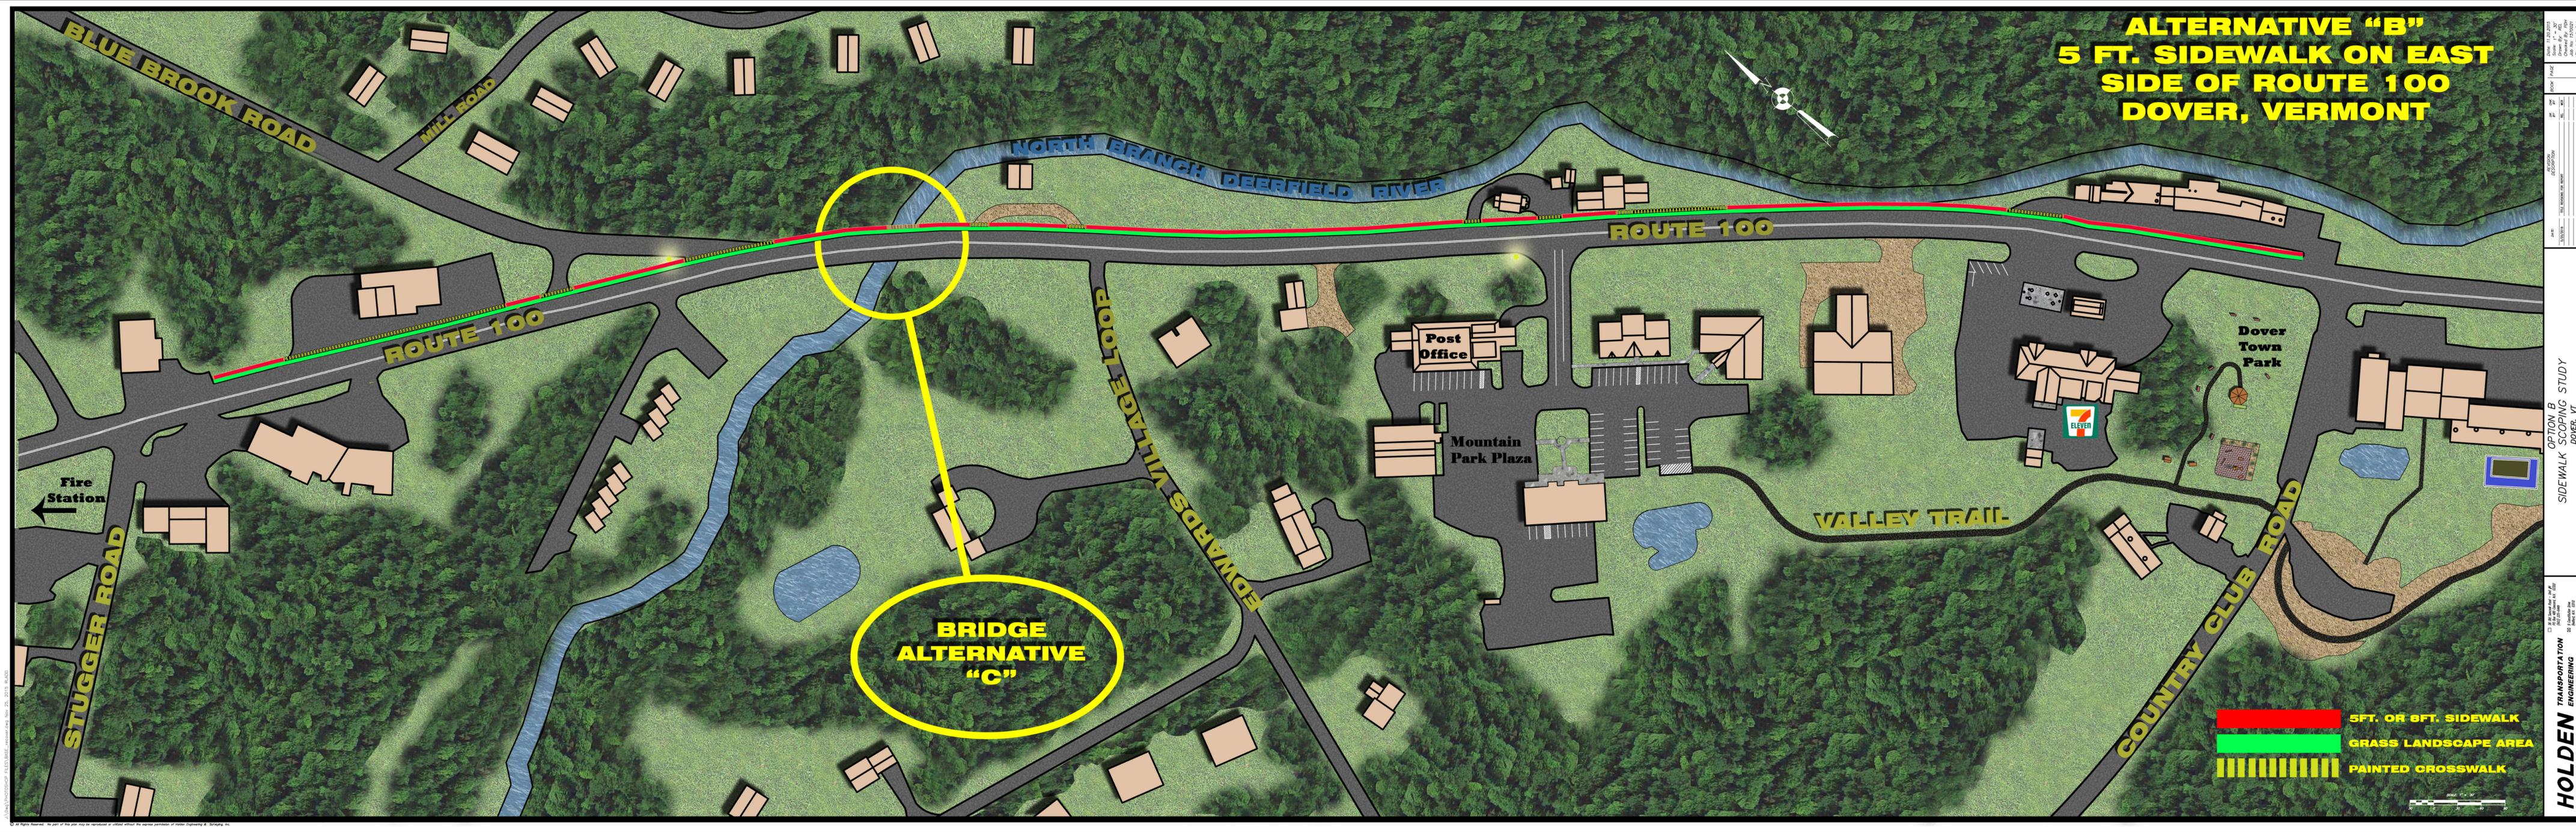
ALTERNATIVE "B" 5 FT. SIDEWALK ON EAST SIDE OF ROUTE 100 DOVER, VERMONT

- 5FT. OR 8FT. SIDEWALK
- GRASS LANDSCAPE AREA
- PAINTED CROSSWALK

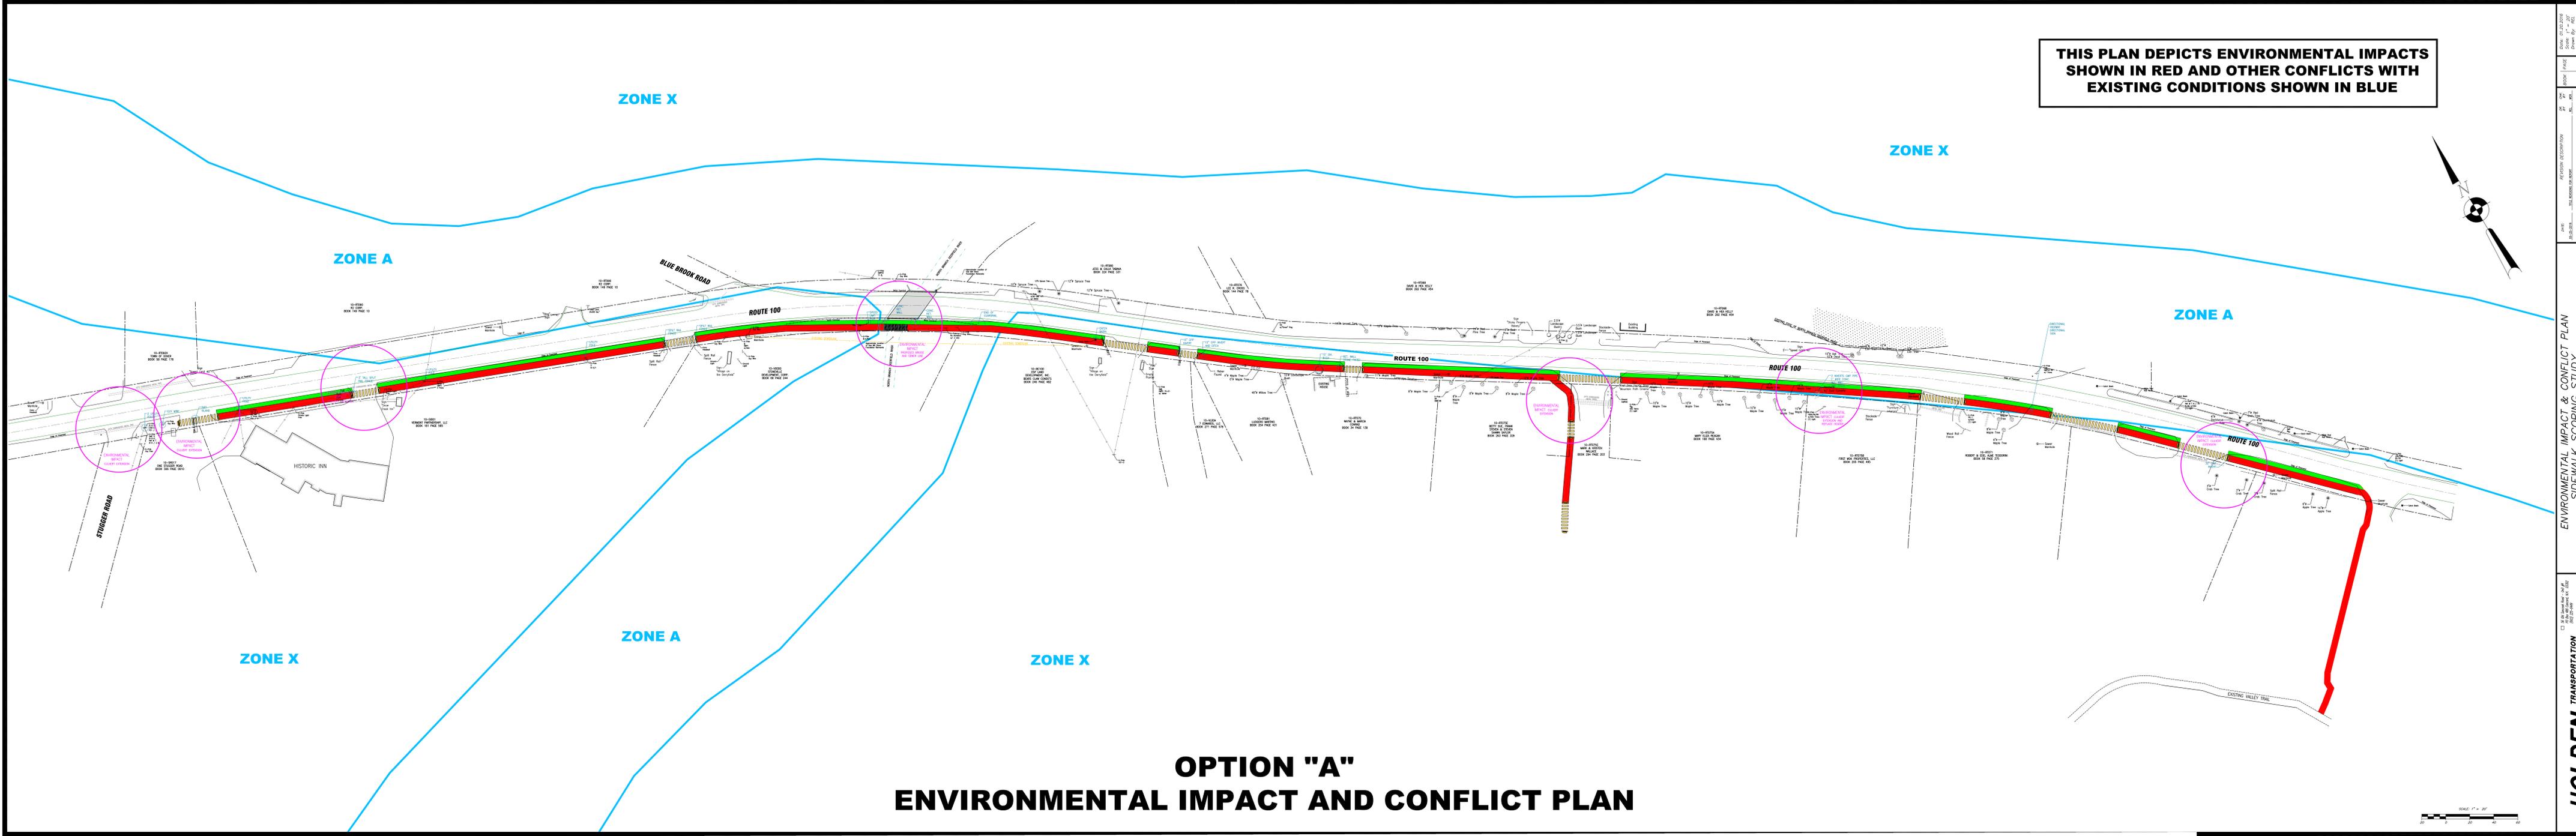
OPTION "A" ENVIRONMENTAL IMPACT AND CONFLICT PLAN

THIS PLAN DEPICTS ENVIRONMENTAL IMPACTS SHOWN IN RED AND OTHER CONFLICTS WITH EXISTING CONDITIONS SHOWN IN BLUE

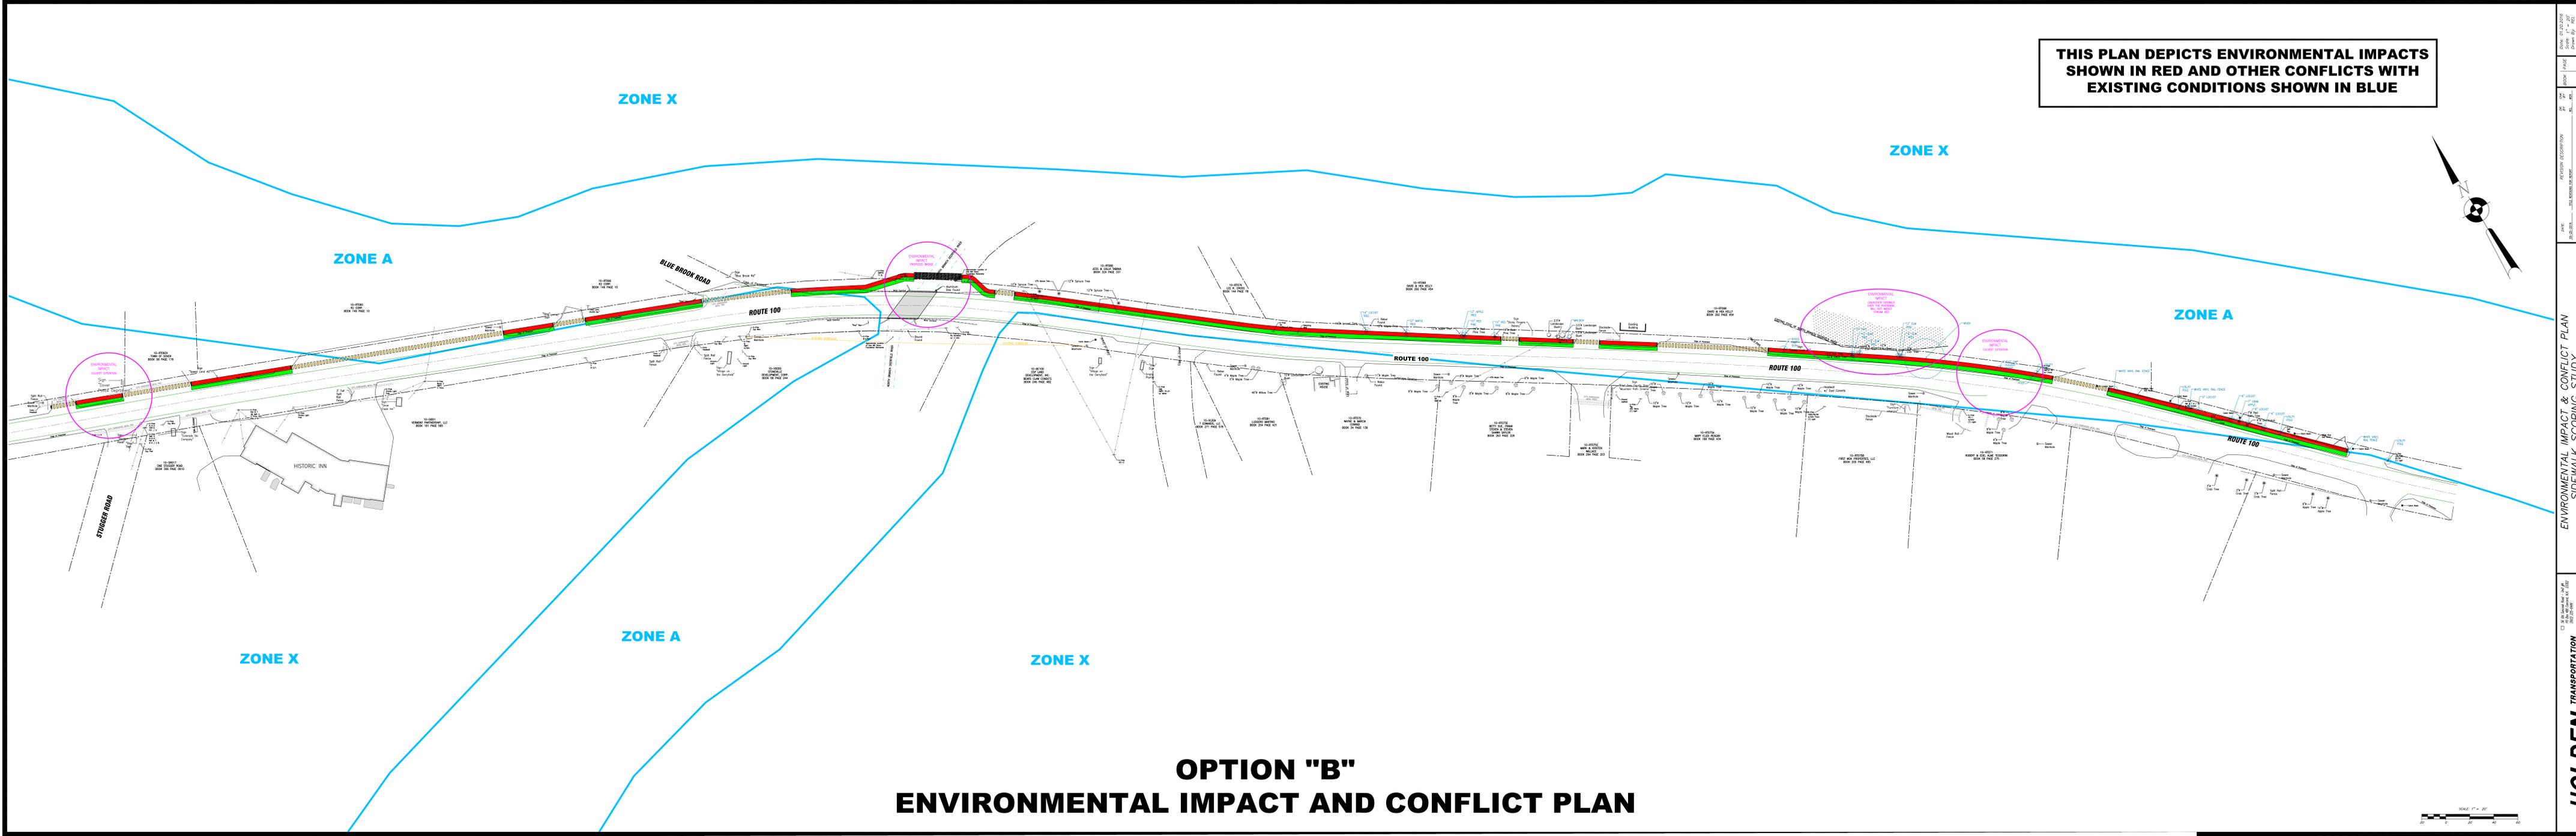
OPTION "B" ENVIRONMENTAL IMPACT AND CONFLICT PLAN

THIS PLAN DEPICTS ENVIRONMENTAL IMPACTS SHOWN IN RED AND OTHER CONFLICTS WITH EXISTING CONDITIONS SHOWN IN BLUE

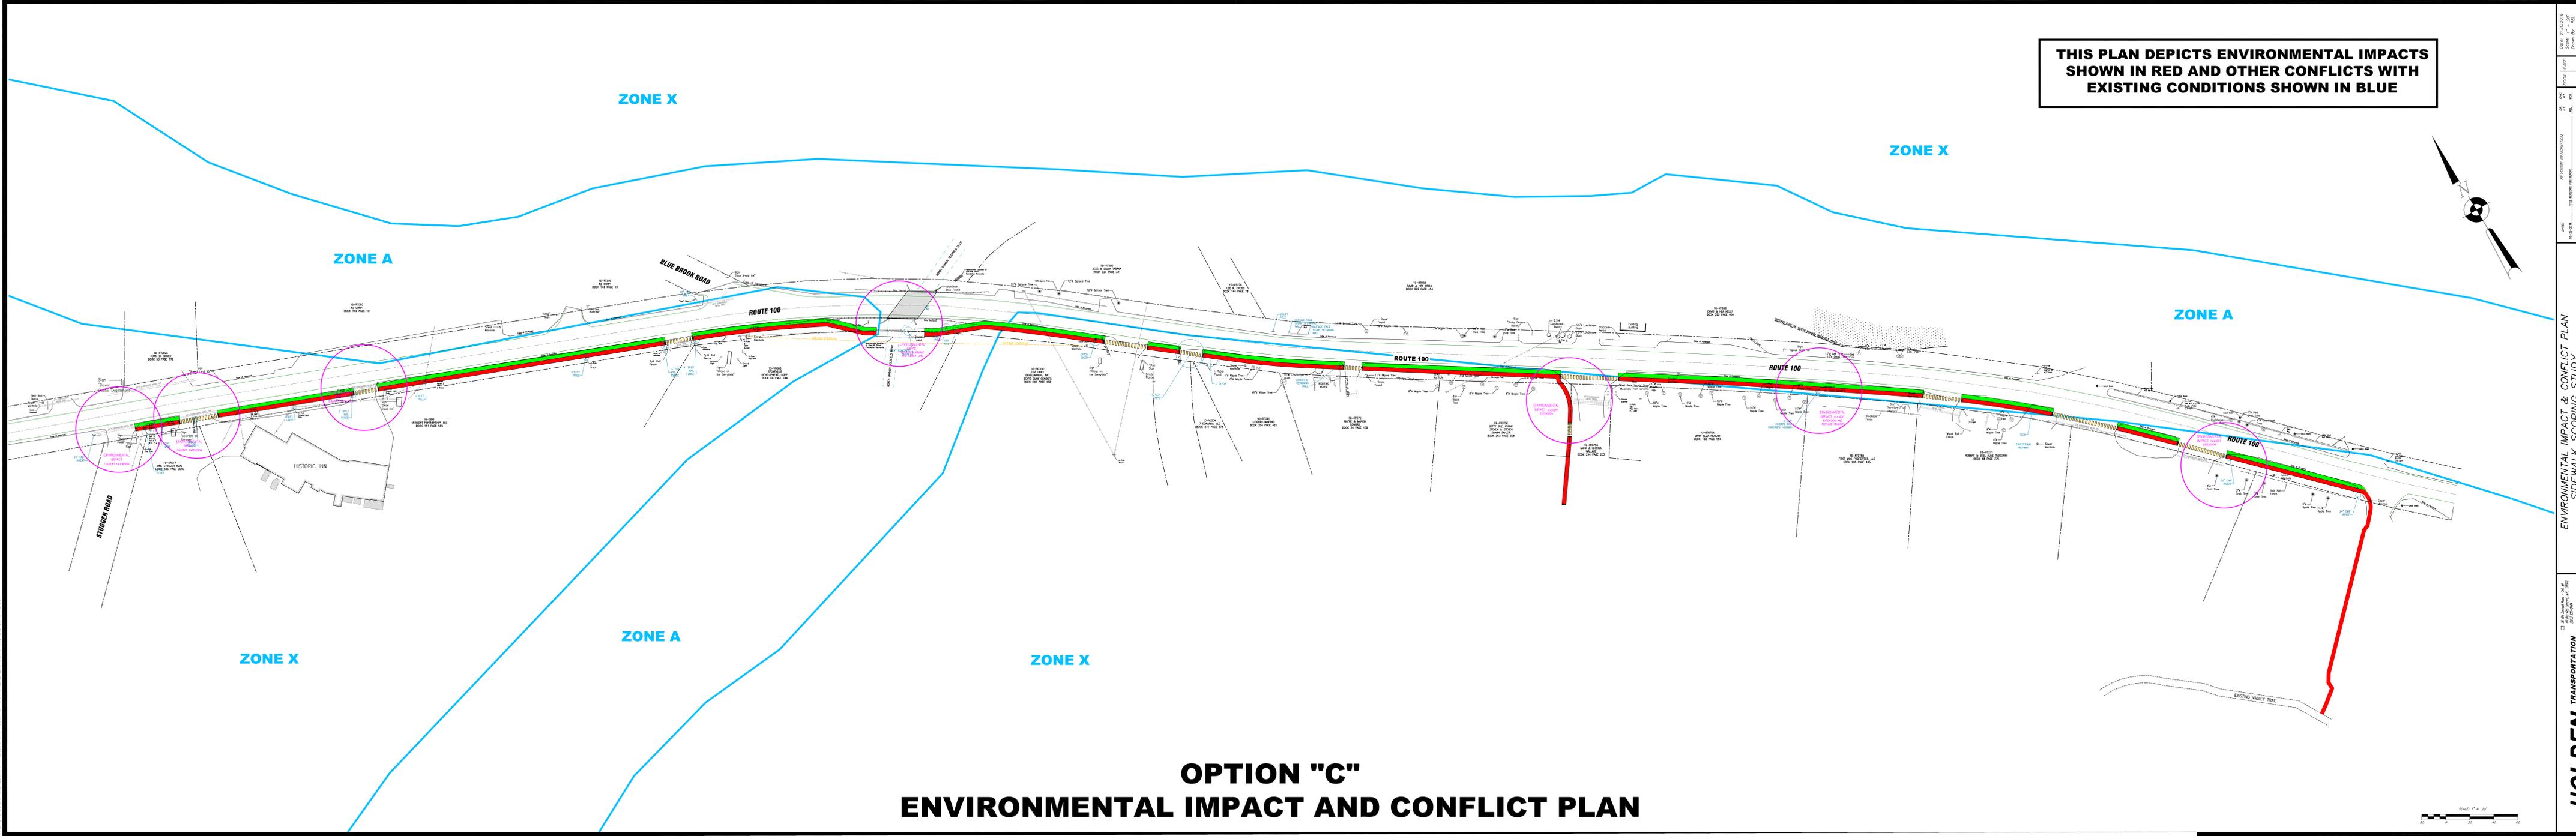
OPTION "C" ENVIRONMENTAL IMPACT AND CONFLICT PLAN

THIS PLAN DEPICTS ENVIRONMENTAL IMPACTS SHOWN IN RED AND OTHER CONFLICTS WITH EXISTING CONDITIONS SHOWN IN BLUE
