Bicycle & Pedestrian Scoping Study *along Route 100 in Dover, VT*

Dover STP BP14(16)

DRAFT
Submitted to the
Town of Dover
Vermont

Project No. 1570021

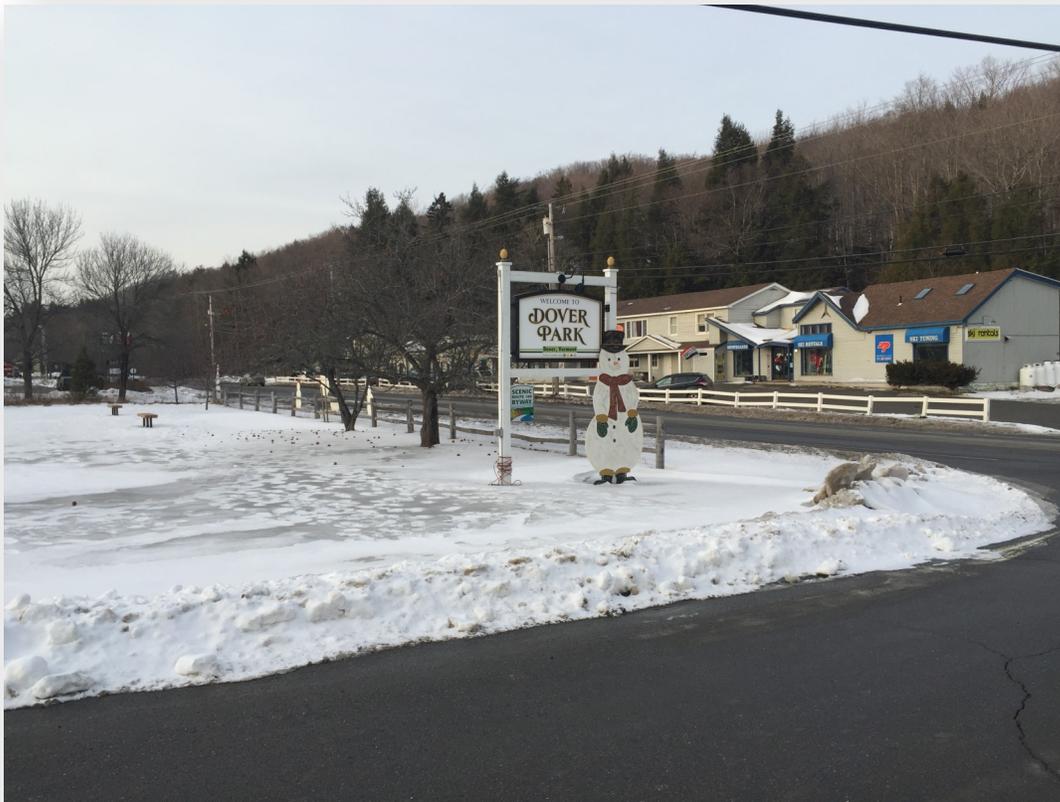
Resource No. 1, Dover Municipal Park, southwest corner of RT 100 and Country Club Road, qualifies as a Section 4(f) property—recreational resource.

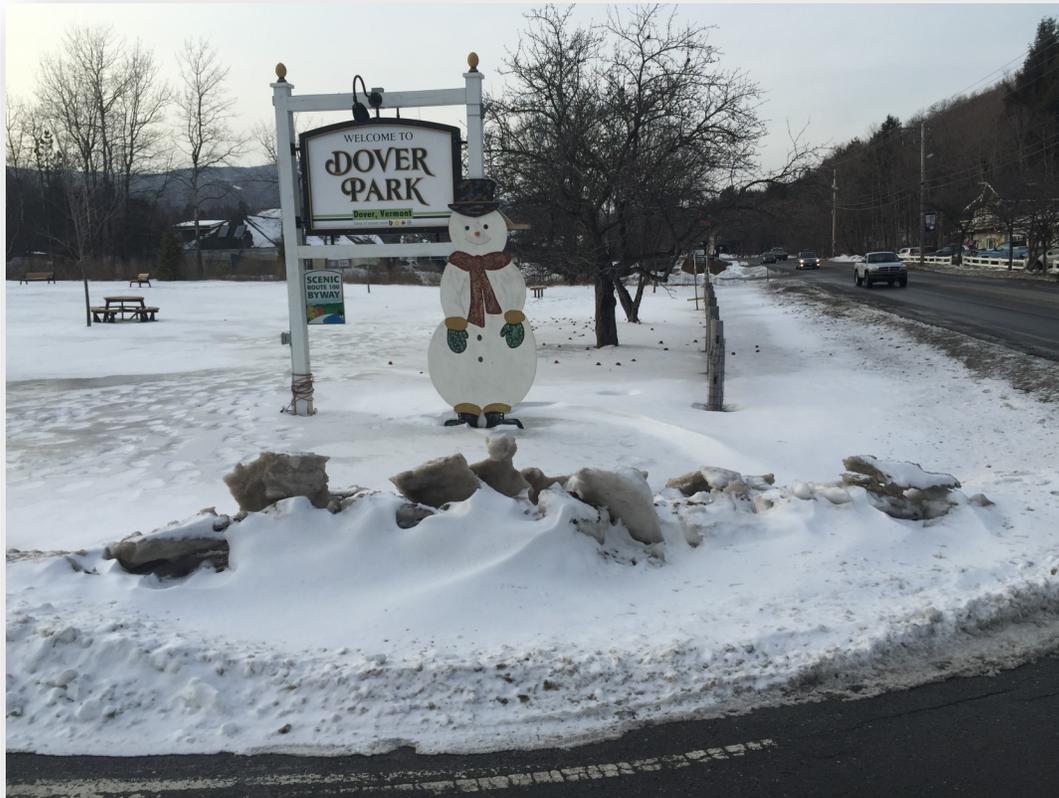
Resource No. 1: Looking north up RT 100. The sidewalk will be constructed between the wood fence and road, resulting in no encroachment and no impacts on this Section 4(f) resource.

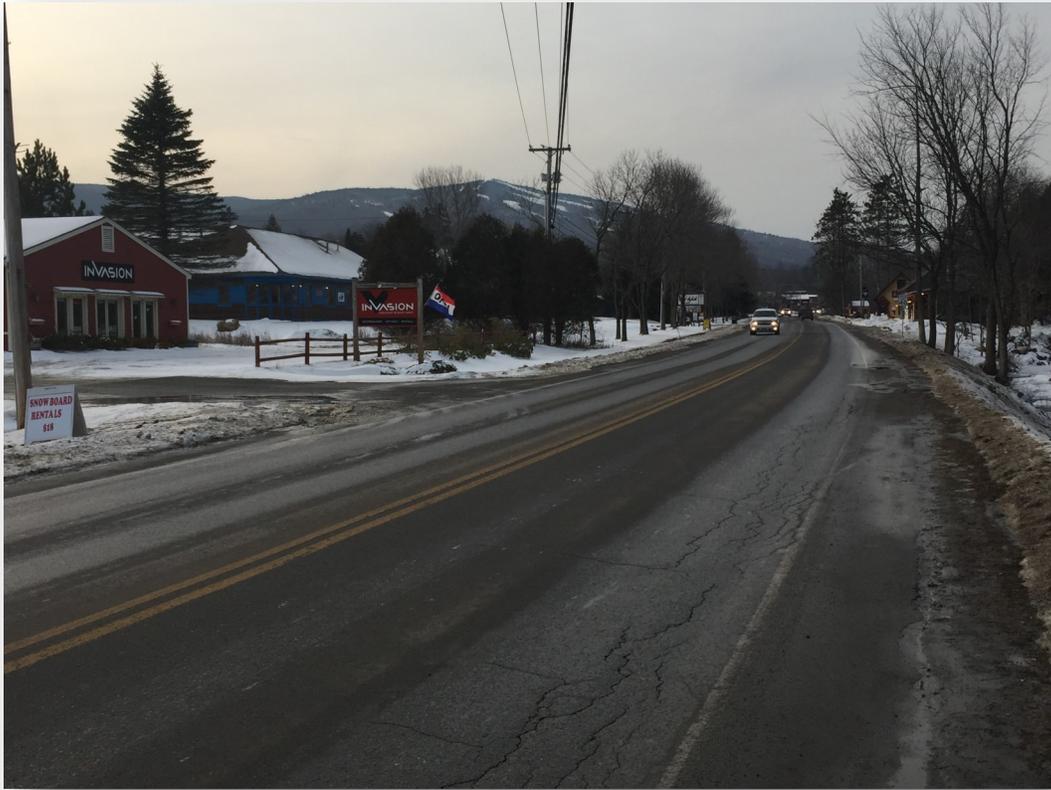
Looking north from Building No. 3. Sidewalk will be constructed on the south (left) side of RT 100

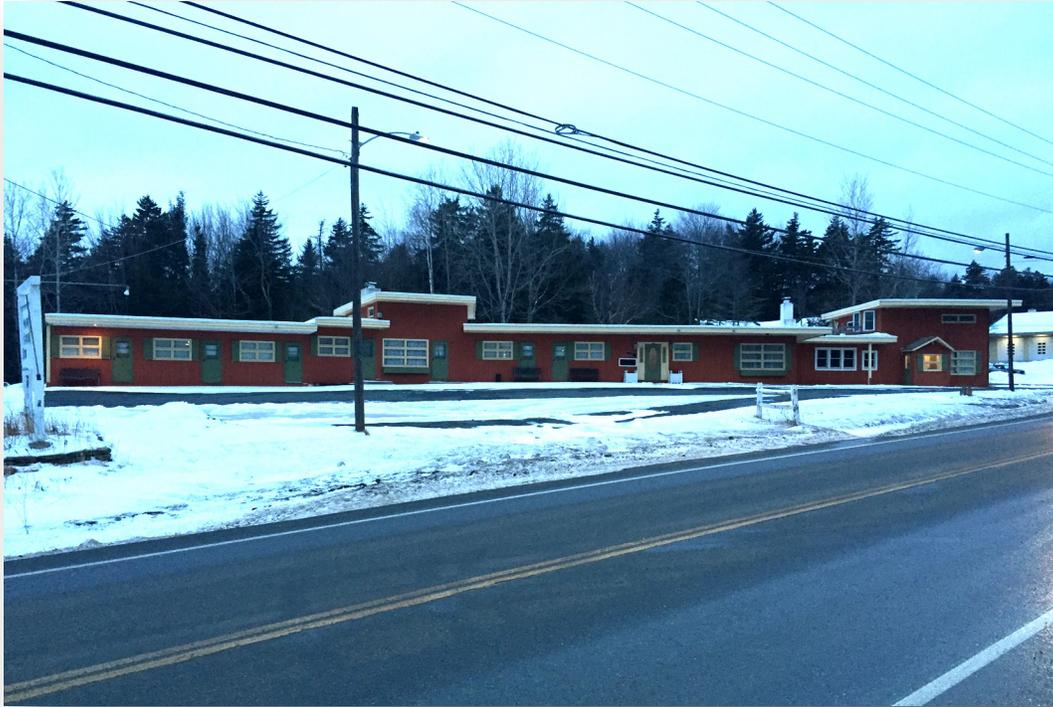
Building No. 9, ca. 1960 was constructed soon after Mt Snow was developed in 1954. The building is considered individually eligible for the National Register

The exception, and the only property in the APE we recommend to be considered eligible for the National Register is Building No. 9 from the attached orthophotos and photo sheets. The Snow Creek Inn building has projecting roofs, vertical siding, and wooden windows, and dates to ca. 1960. It is one of the few remaining, intact ski motels constructed in the years after Mt. Snow was developed in 1954 to serve ski tourists.

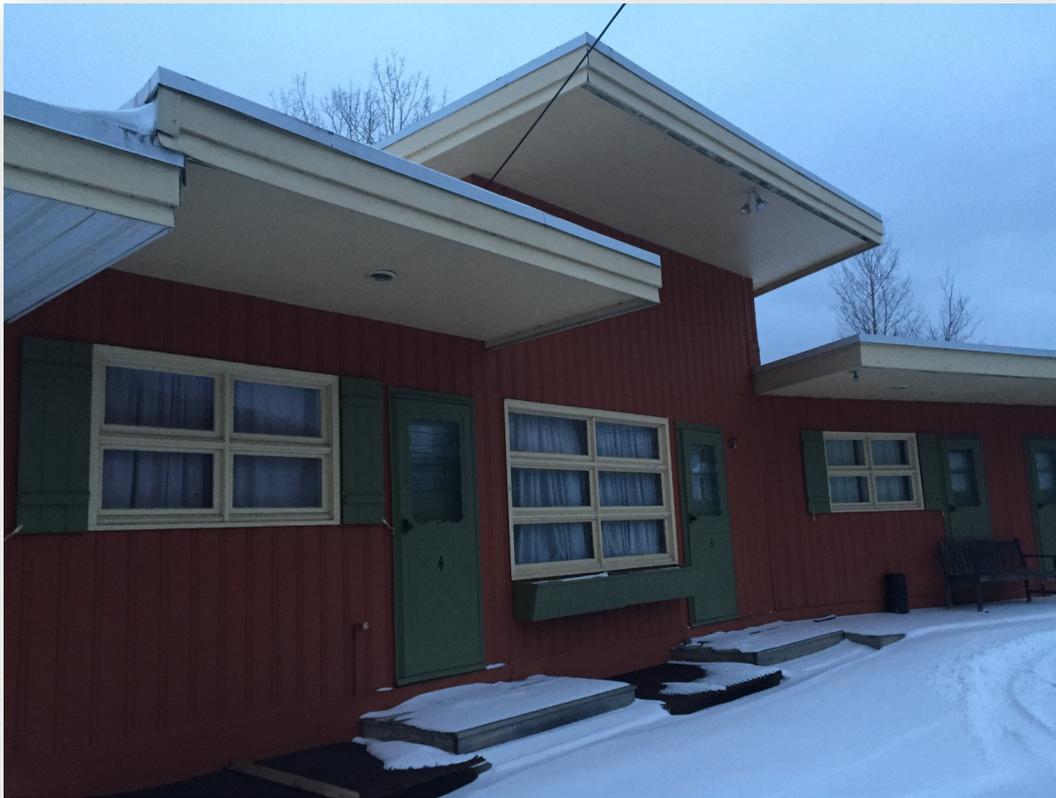
Building No. 9 detail: wood windows, vertical siding, cantilevered canopy roofs

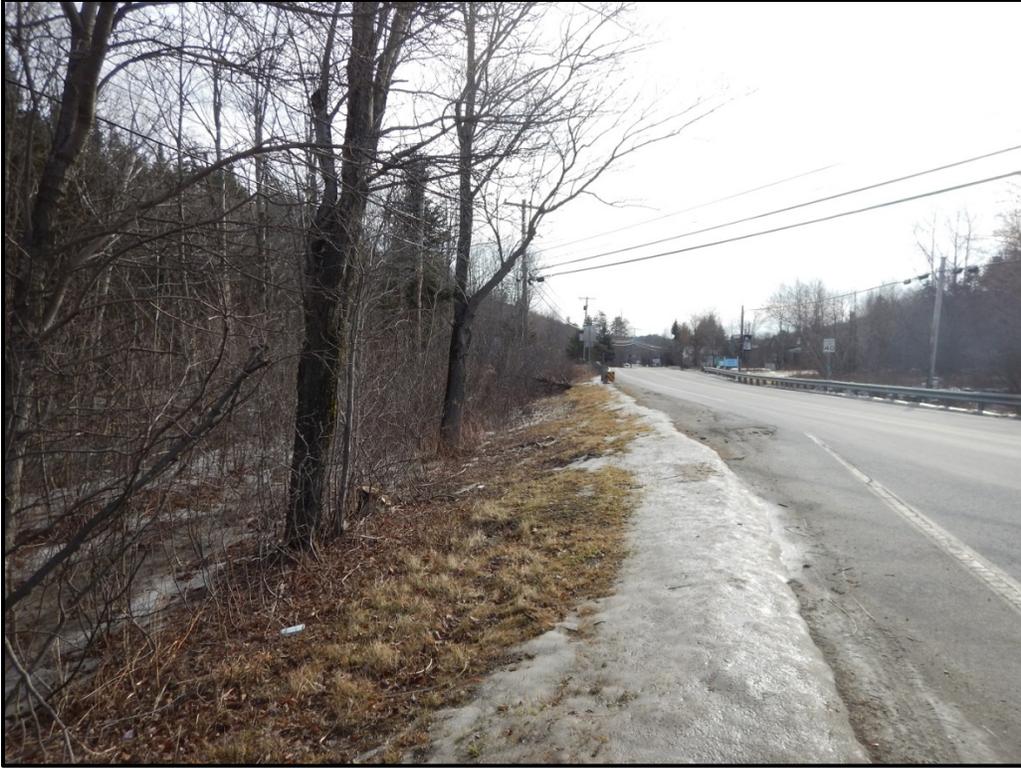
Plate 4. View Southeast Toward Bridge over Deerfield River, Showing Sloping Road Margin

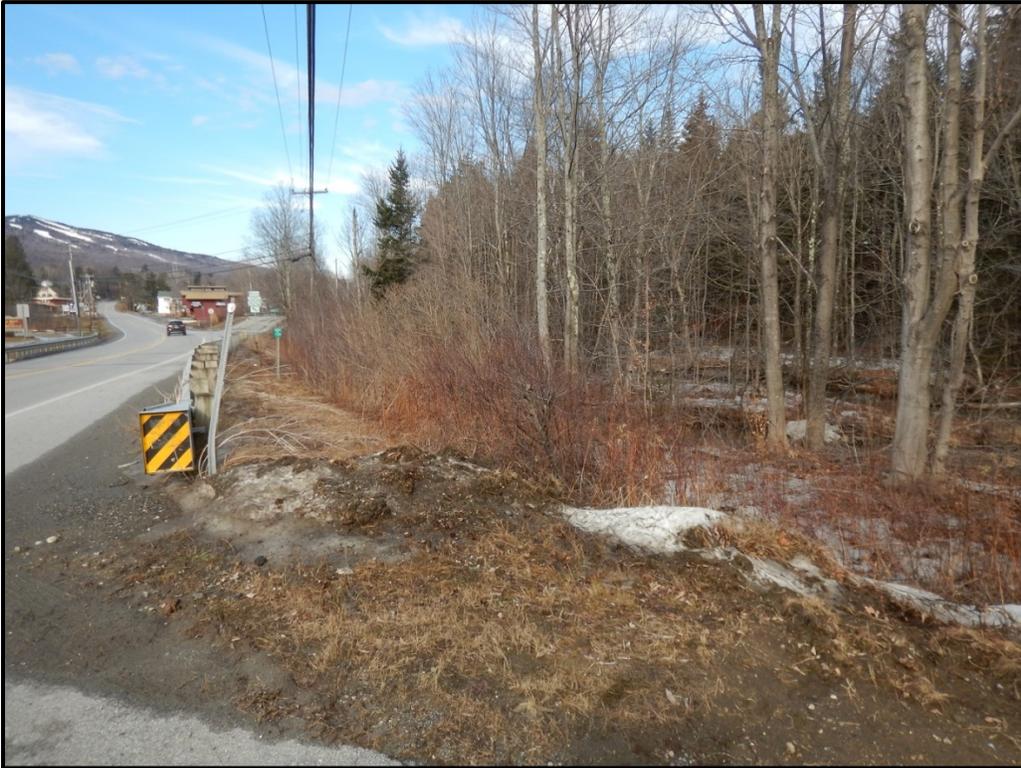
Plate 5. View Northwest of Bridge Over Deerfield River, Showing Low-Lying Terrain

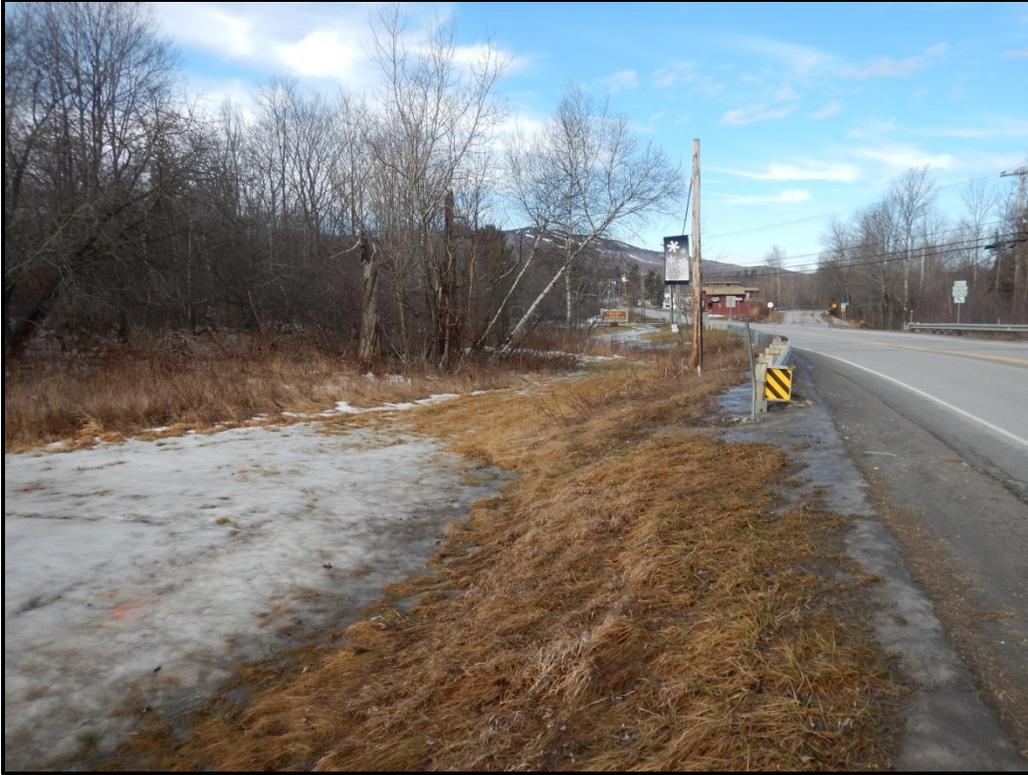
Plate 6. View Northwest Toward Bridge, Showing Low-Lying Terrain on South Side of Road

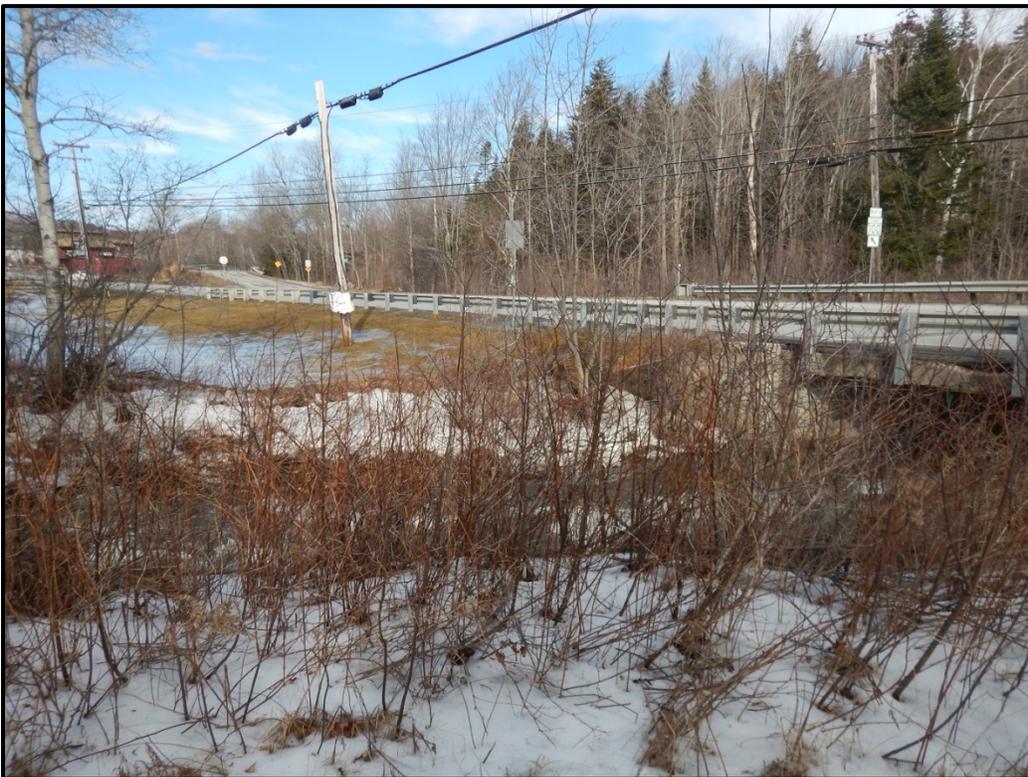
Plate 7. View North Toward Bridge, Showing Low-Lying Terrain on South Side of Road

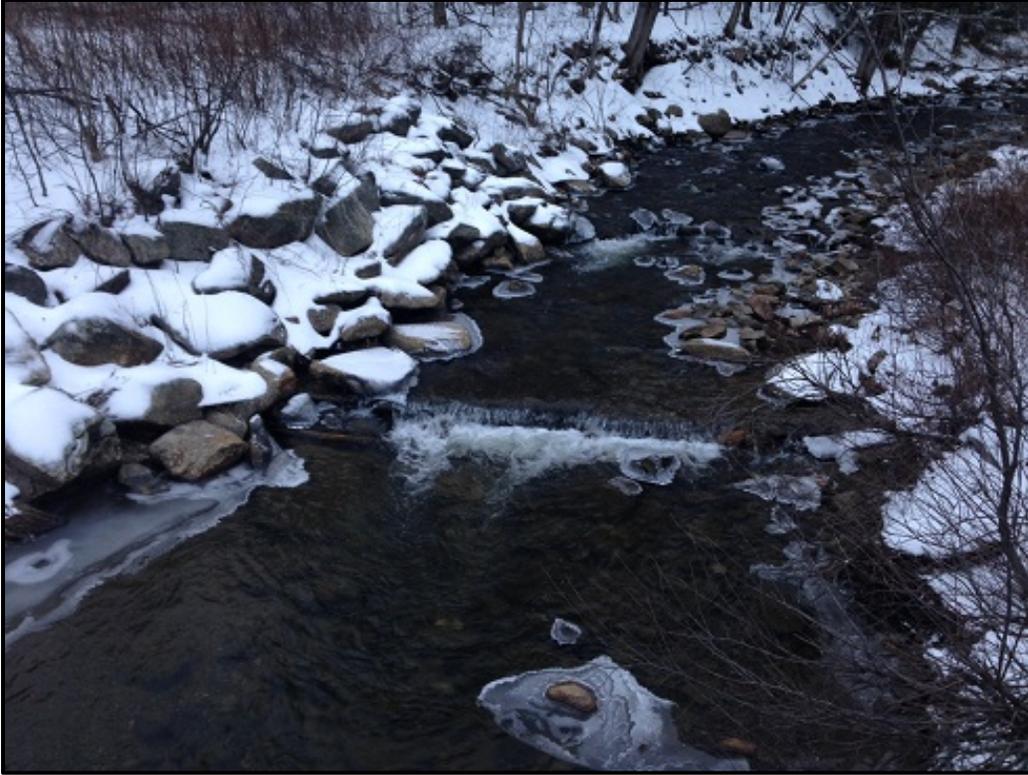
Plate 8. View West from Deerfield River Bridge of Historic Dam Remnant

Historic maps (Figures 3-5) indicate the project area was a lightly settled area on the outskirts of West Dover village. A single historic site was noted during the visual inspection, consisting of a dry-laid stone foundation wall and associated stone dam north and west of the Rt. 100 bridge over the Deerfield River (Plates 8, 9). The stone wall is approximately six feet high and thirty feet long. A sawmill is depicted at this location on the 1856 map of Dover (Figure 3). As noted above, the area of the river crossing has undergone extensive disturbance. While there may have been intact archaeological deposits here, it is unlikely that the sawmill has any intact features or stratigraphy, and the features themselves appear to be outside the Area of Potential Effect for the project, as each of the four proposed bridge designs will place the pedestrian/bicycle route on or immediately adjacent to the bridge at this location. However, to prevent inadvertent impacts to this resource, it is recommended that these features be marked off with flagging and avoided during construction.

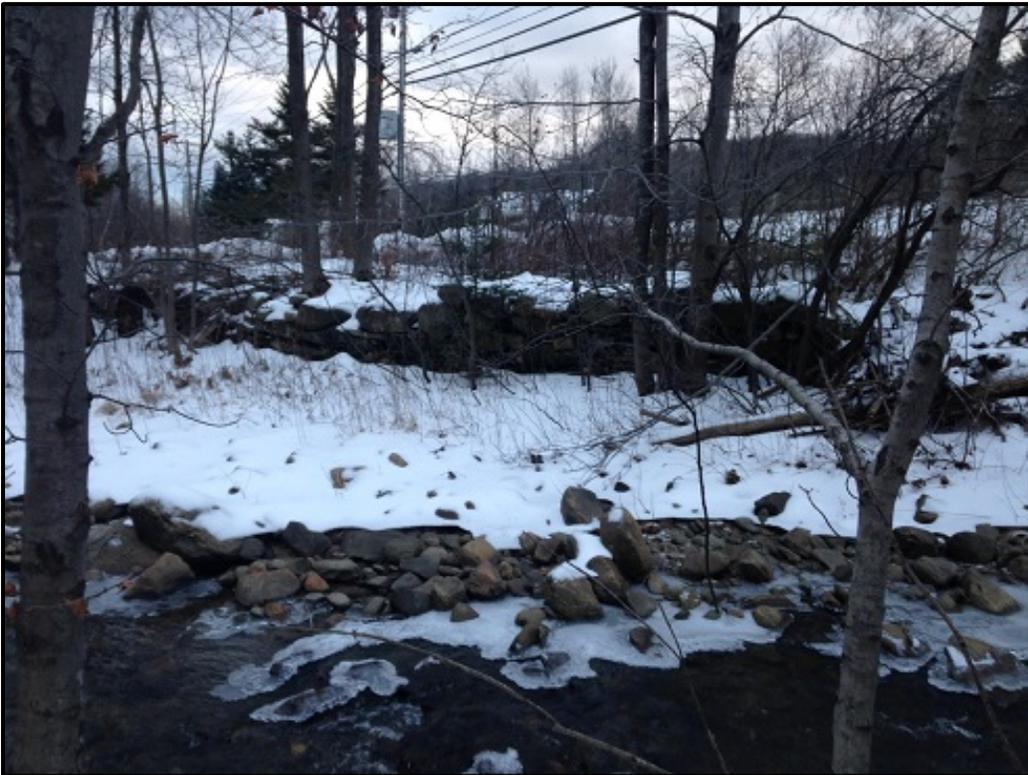
Plate 9. Sawmill Foundation Northeast of Bridge, View Northeast

Monadnock Archeological Consulting identified remnants of an old sawmill in the vicinity of the vehicular bridge (BR59) over the North Branch of the Deerfield River. On the westerly side are visible remnants of an old dam, and on the easterly side, evidence of the old sawmill building foundation. Photos of each side were provided in the archaeology report.
