Weathersfield

Vermont Route 131 Bridge 15 over Mill Brook

Weathersfield STP 0146(16)

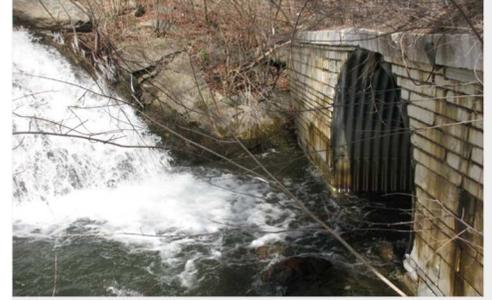
Upstream Waterfall and Stone Headwall

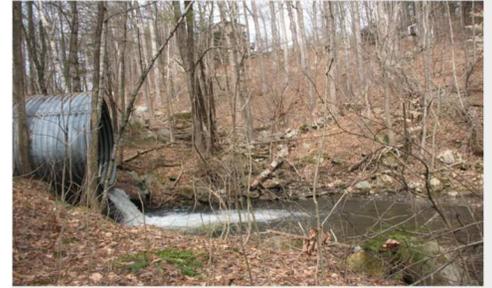
Outfall

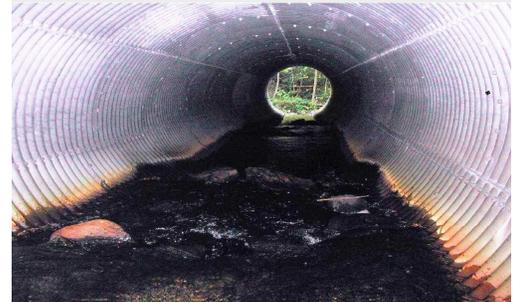
Interior Condition

The Weathersfield Bridge 15 project includes the repair of the existing 11 ft. dia. multi-plate pipe culvert. The culvert currently has a rating of 5, "Fair" and has cracking along the bolt line. The culvert was installed in 1959 and is 114 ft. in length. There are signs that the culvert is deforming or squashing. There are no known roadway deficiencies in the project area.
