# Richford, VT- Sutton, PQ

## VT 105A, Bridge 3

### Richford-Sutton Bridge 3 – BHF 0814(1)

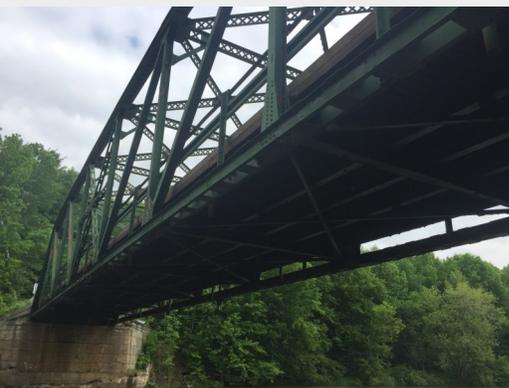
*Existing Bridge Elevation View*

The Richford-Sutton Bridge 3 project will rehabilitate the existing bridge over the Missisquoi River, which has deteriorating components in the deck, superstructure, and substructure elements. The existing bridge is a two-span structure built in 1929, with the first span being a 51-ft steel rolled beam structure and the second span being a 151-ft steel truss. The bridge spans over the border between the United States and Canada, with approximately 80% in the United States and 20% in Canada. The existing approach span has substantial corrosion to the metal grid deck, rusting of the beams, and concrete cracking in the skeletal abutment. The truss span also has significant deterioration of the metal grid deck, as well as truss components with section loss in need of repair or replacement. Currently the bridge is posted for a weight limit of 5 tons.

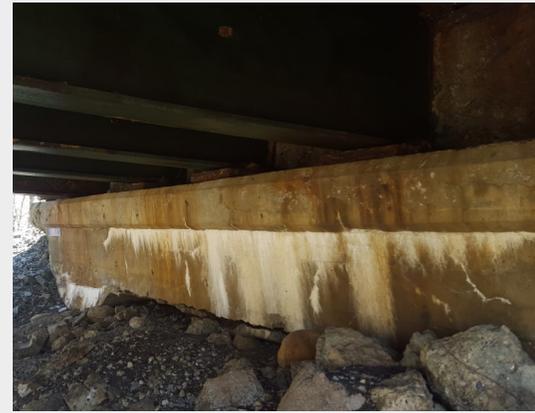
Poor Condition of Abutment #1

The rehabilitation project will consist of the replacement of the entire approach span with a new partial-filled grid deck system supported by new steel rolled beams. A new abutment on piles will also be installed at the south end of the bridge. The existing truss span will be rehabilitated with a new partial-filled grid deck system and new steel members will replace significantly deteriorated members. The remaining truss will be cleaned and painted. The rehabilitation will also include substructure repair work to the existing pier and abutment at the north end of the bridge. The bridge will have two, ten-foot travel lanes with new bridge rail to improve the safety on the bridge.

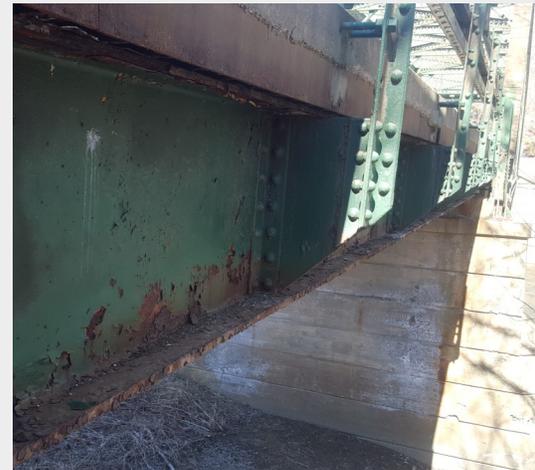
Deterioration of the Approach Span Beams

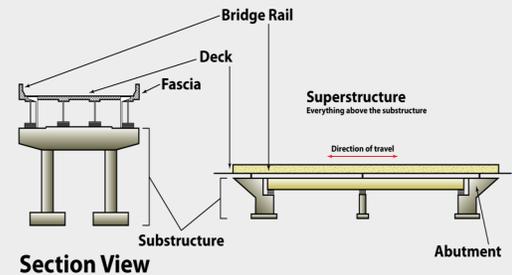
Section View

Generic Bridge Element Description
