Lincoln - BRF 0188(8) – Bridge 19
TH1 over New Haven River

Scoping Report

Lincoln Bridge #19 Replacement
Lincoln, Vermont
Historic Resource Identification and Preliminary Findings of Effect
December 2010

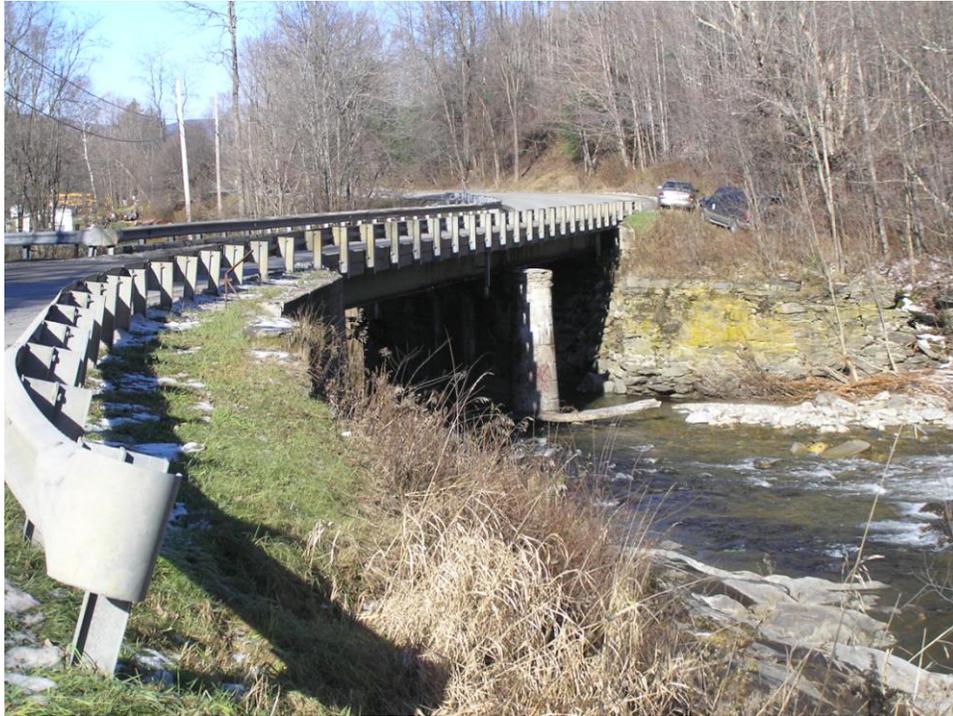
1. Looking north at east side of Bridge #19 and laid up stone ruins at right.

Laid Up Stone Foundations-To the northeast of the existing bridge are a series of large laid up stone foundations along the river bank that may be mill ruins and/or abutments from an earlier bridge. The ruins are not eligible for the National Register as above ground structures. They may have significance as historic archeological resources and will be addressed by Hartgen Archeological Associates in their report for this project.

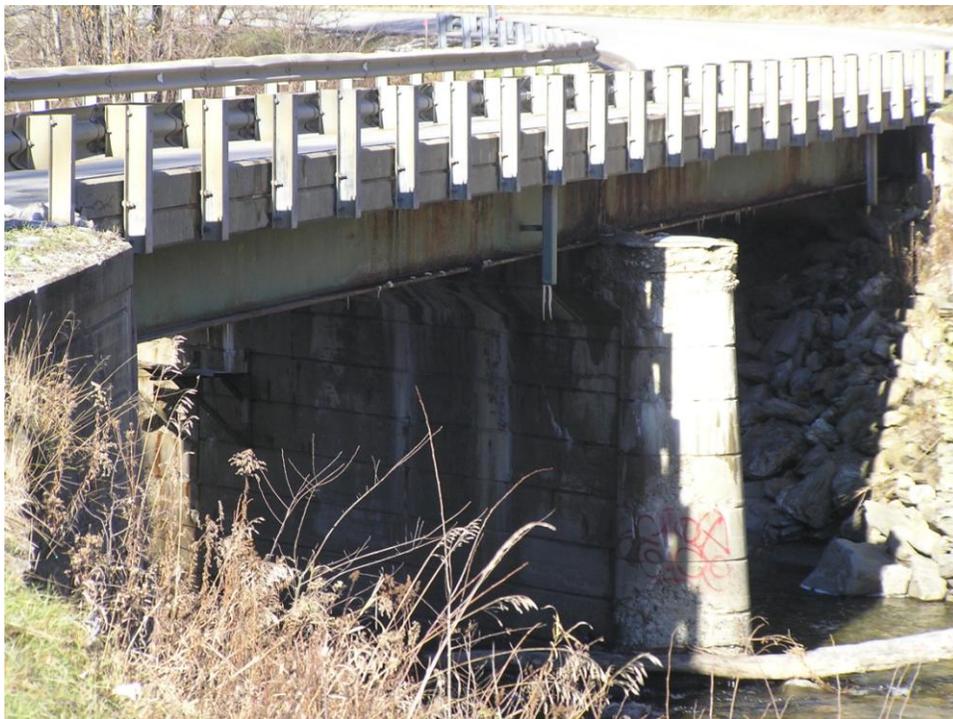
2. Looking north at scored pier without conical cap, steel I-beams, concrete deck curbing, and replacement guard rails on east side of bridge.

The existing bridge, set on a tangent, is 128 feet long, and has two spans of 64' with a 21.3 foot curb to curb width. The bridge is composed of five rusted, scaling steel I-beams that carry a scored, reinforced concrete deck with concrete curbs. A modern steel guard rail lines both sides of the concrete deck. The bridge underwent substantial reconstruction in 1978 receiving a new concrete deck, curbing, and guard rails. The bridge rests on reinforced concrete abutments. The southern abutment rests on ledge and is more substantial in size and has a broad, scored wingwall on the southeast side. There is substantial riprap at the base of the northern abutment. The bridge is carried by a scored, tapered reinforced concrete pier that originally had conical concrete caps that were removed in the 1978 reconstruction. The pier and abutments are set on a 45 degrees skew. The concrete is severely spalling and has lost the smooth facing on many components in many locations. Areas of the deck, pier and abutments have lost fabric completely.

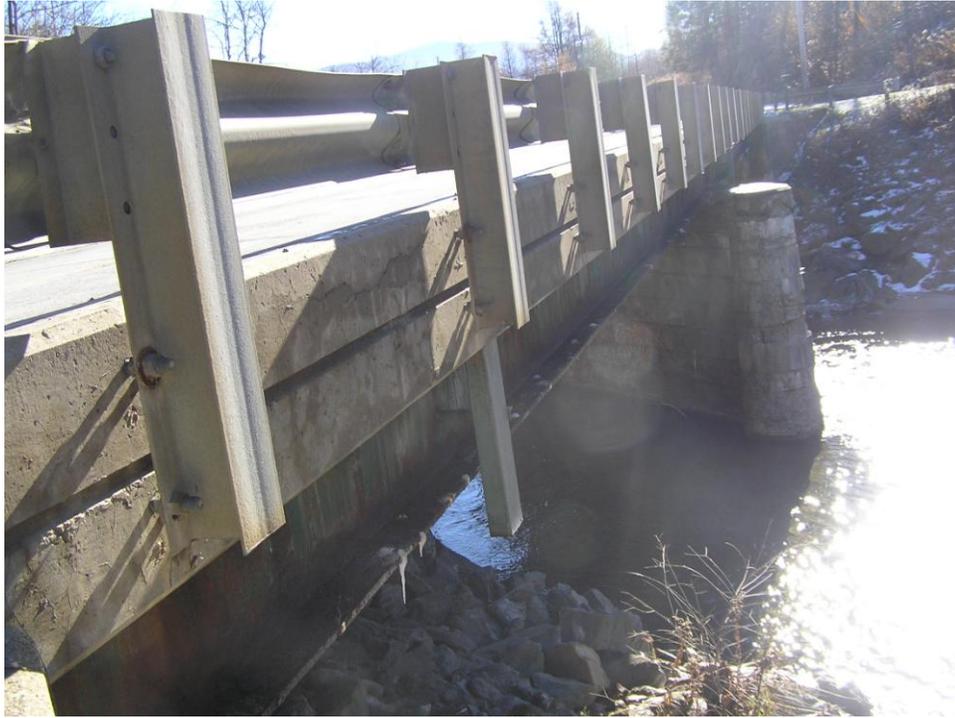
3. Looking south at concrete deck and replacement steel guard rail on west side of bridge.

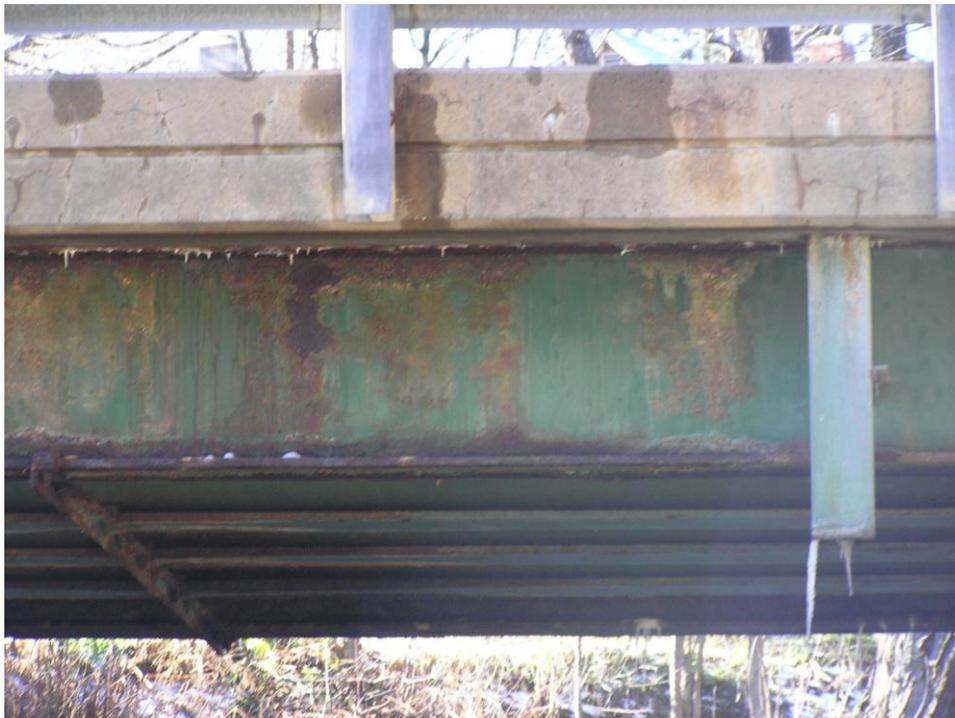
4. Looking east at steel I-beam stringers and replacement concrete deck on west side.

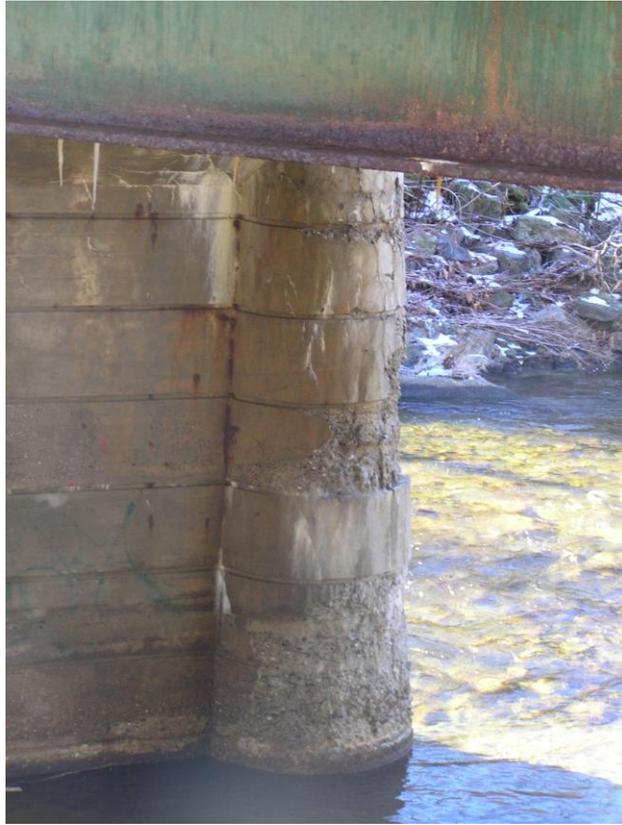
5. Looking west at deterioration on west pier and rusted stringer on east side.

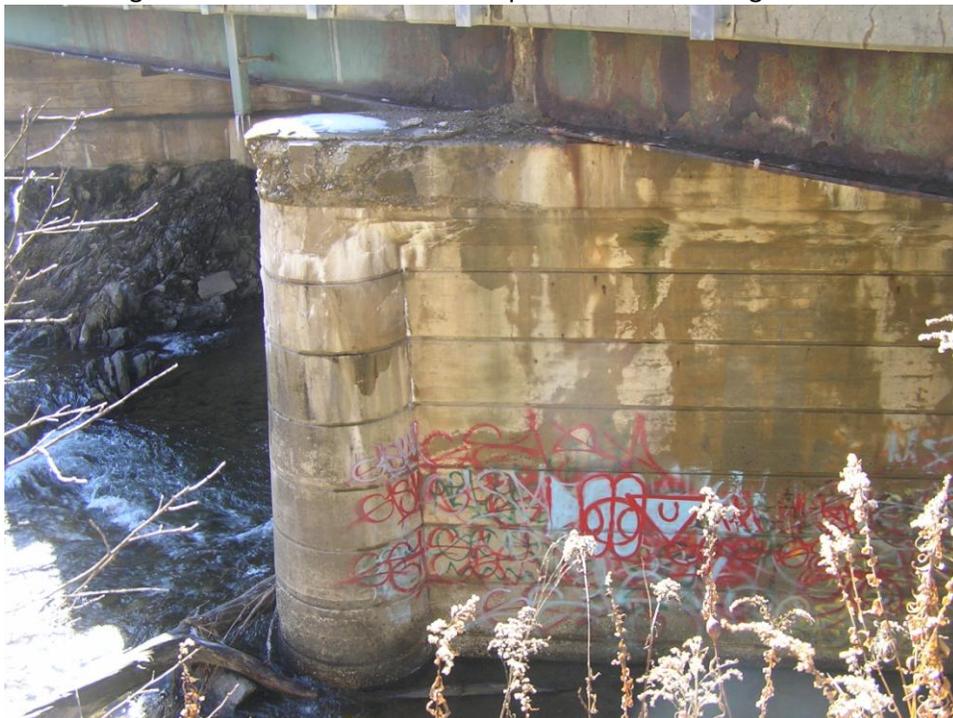
6. Looking south at deteriorated east pier and rusted stringer.

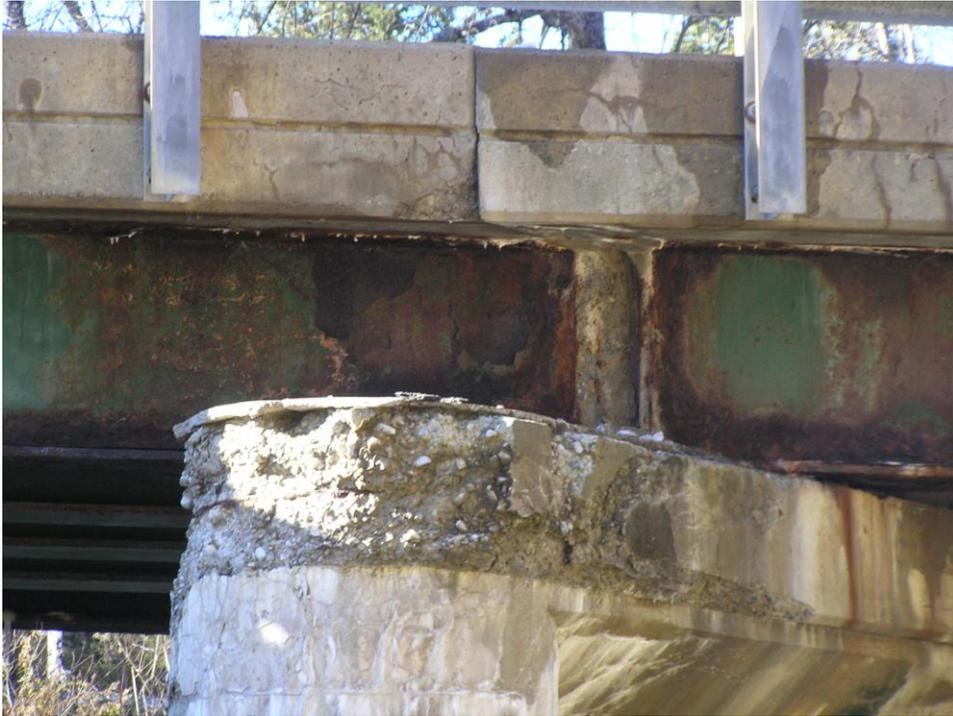
7. Looking west at deteriorated concrete on east pier and rust and scaling on steel I-beams.

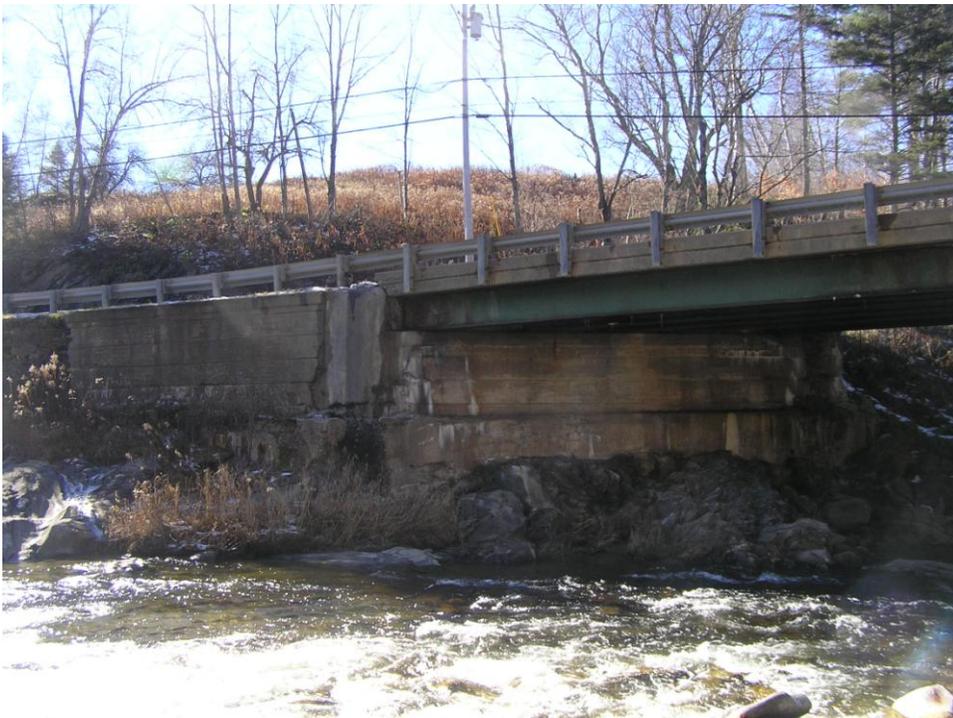
8. Looking southwest at east side of south abutment and bridge.

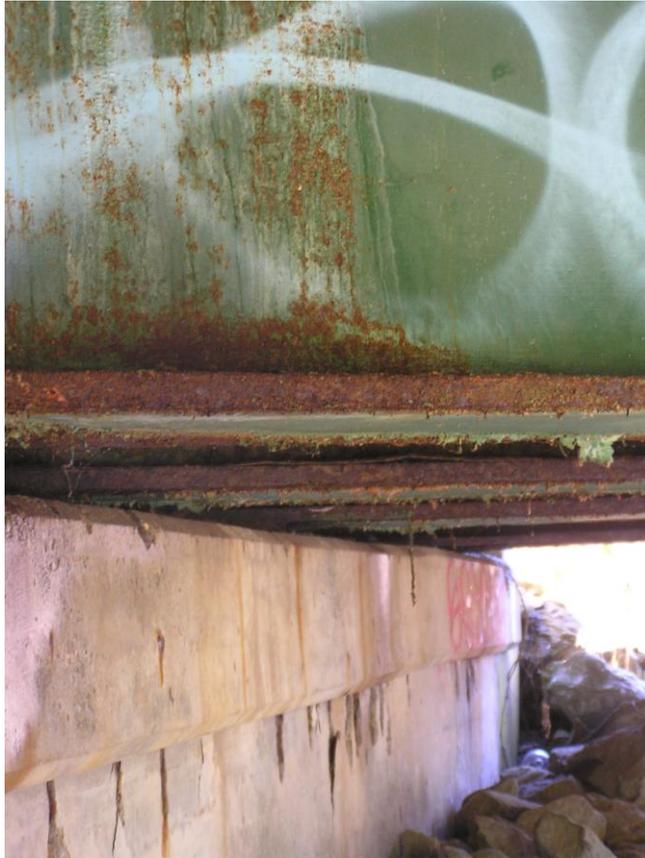
9. Looking east at north abutment and stringers.

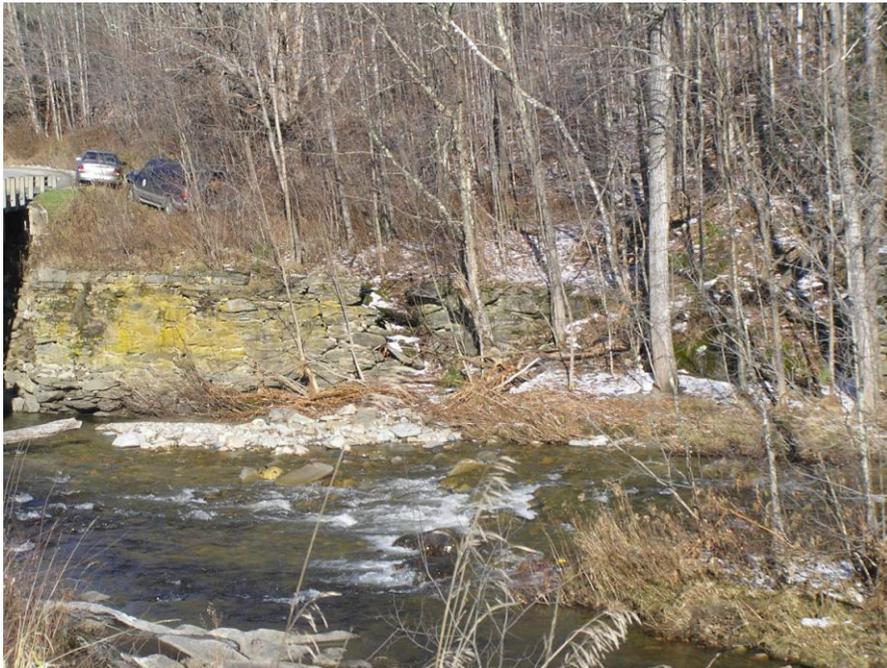
10. Looking north at ruins adjacent to east side of bridge.

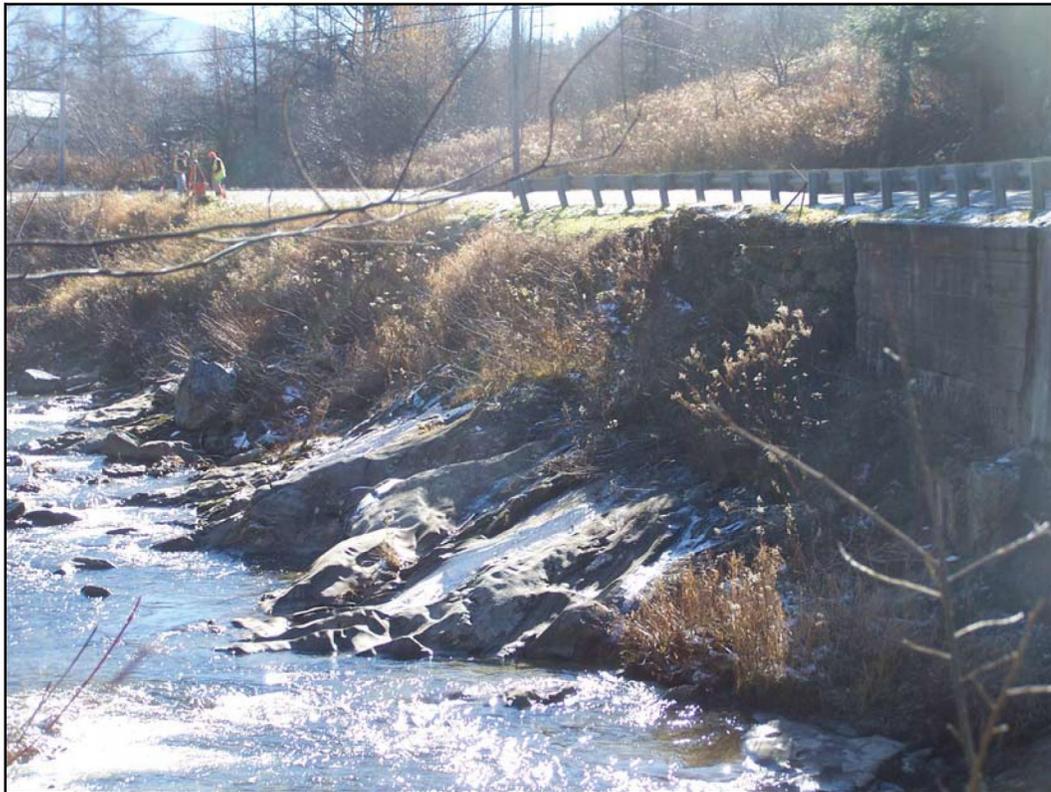
Photo 1. Steep slope, exposed bedrock, and the stone bridge abutment are visible on the southeast corner of the bridge. View is to the south.

The southeast quadrant of the bridge is characterized by the presence of bedrock and slope down to the river. A portion of the dry-laid stone bridge abutment is visible under the roadbed at this locale (Photo 1). Bedrock and steep slope are also present southwest of the bridge, as well as a 19th-century residence located on a small level elevated terrace (Photo 2). Northwest of the bridge, there is steep slope down into the river channel, where there is exposed bedrock, as well as large stones, most likely originating from an earlier stone bridge abutment (Photo 3). The landform to the northeast of the bridge is characterized by uphill slope to the north, and downhill slope to the river to the south.

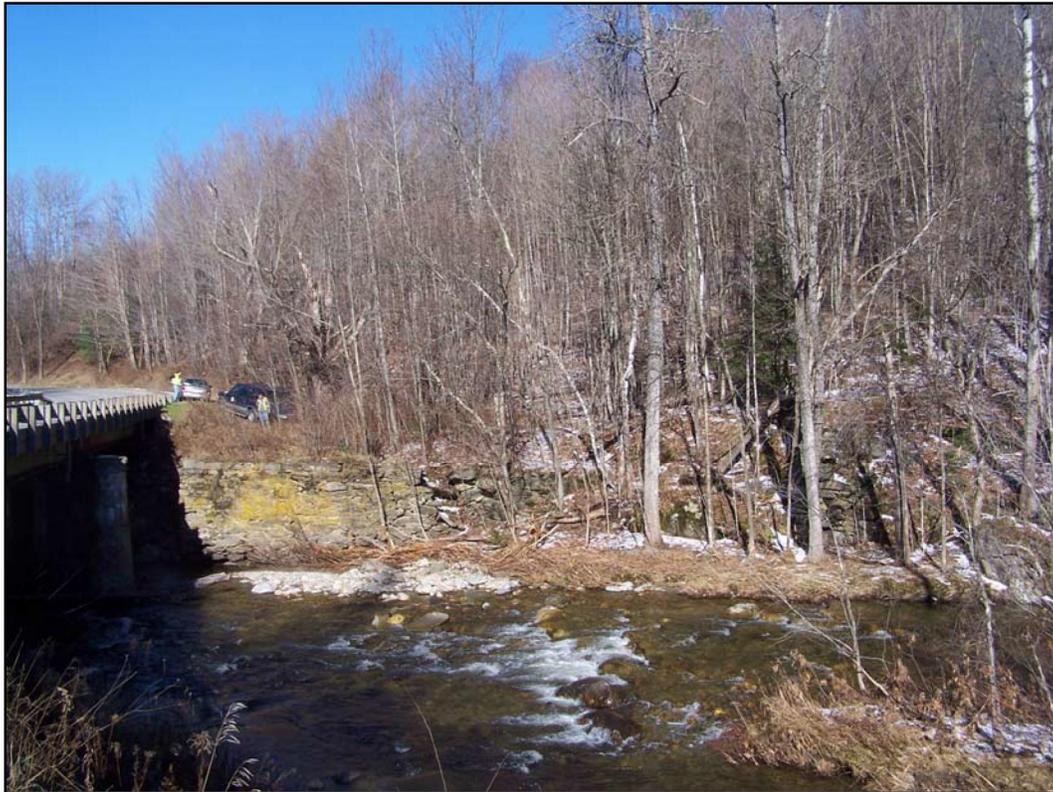
Photo 4. An overview of the area and features located northeast of the bridge.
View is to the north.

An extensive intact portion of an earlier stone bridge abutment is evident directly east of the present extant bridge (Photo 4). The base of the stone abutment is built on top of a very thin terrace situated a few feet above the water level (at the time of the site visit). The bridge which had been situated on top of this stone abutment was seriously damaged in the devastating floods of 1927 (Floyd Hall, personal communication). The stone construction of this abutment indicates masterful masonry work, with tightly laid cut stone capped with large finished stone slabs (Photo 5).

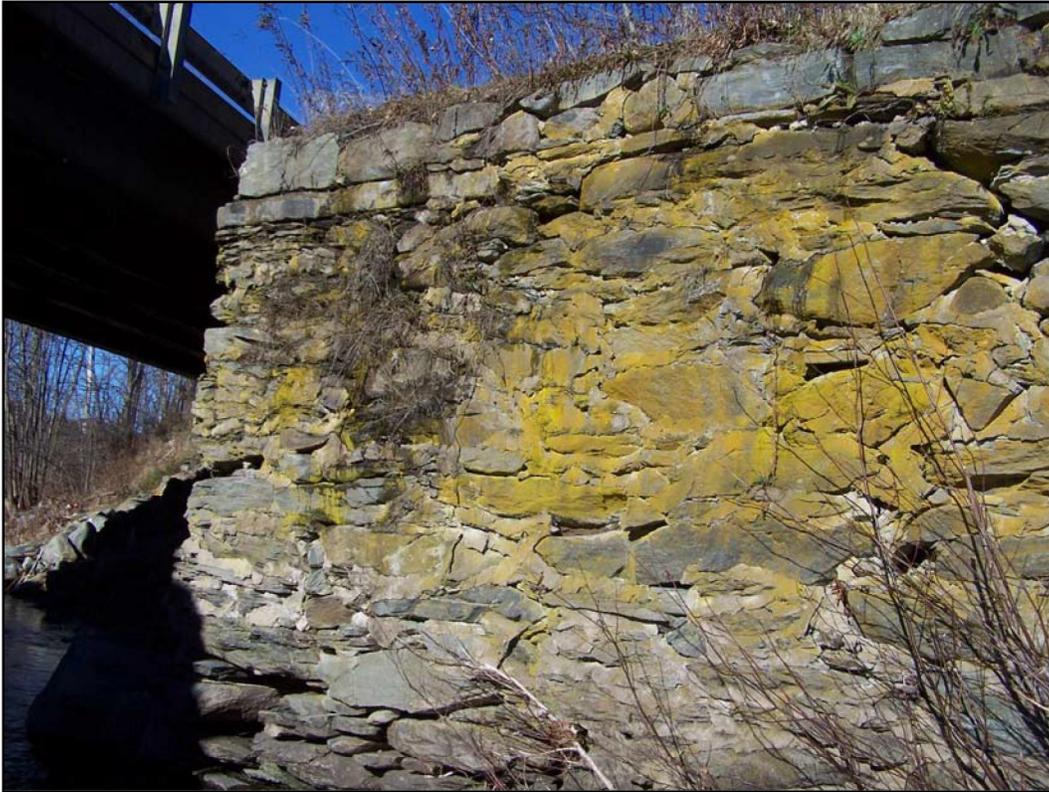
Photo 5. The stone abutment from the bridge which washed away in the 1927 flood is visible on the left. The stone column feature is located further to the right. View is to the north.

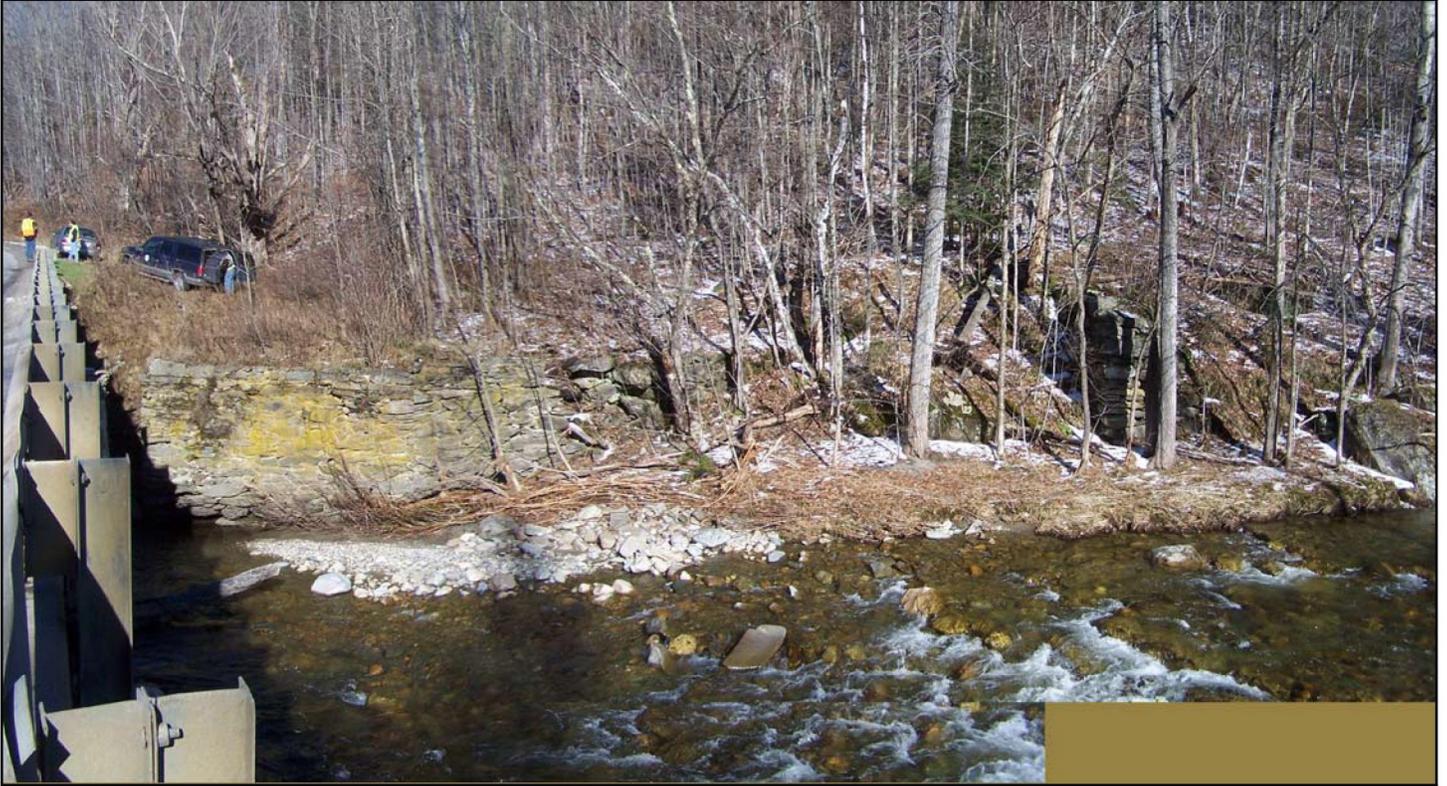
Photo 6. Photo shows a close-up view of the southwest corner of the stone column feature.
View is to the northeast.

Further to the east of the abandoned stone bridge abutment is a stone column which was built on the same small terrace above the river (Photo 6). The dry-laid stone column is constructed of large rounded cobbles, as well as cut stone, as evidenced by the presence of a drill hole (Photo 7). This feature appears to be relatively intact, and mostly complete - with a finished west side (face) and south side, joined at a 90 degree angle (Photo 8). The construction of this feature differs greatly from the adjacent 19th-century bridge abutment (Photo 5). The drylaid stone column was constructed directly onto a bedrock outcrop. The builder of this feature made use of large boulders as well cut stone, suggesting a more expedient type of construction. The definite function of this feature is unclear.

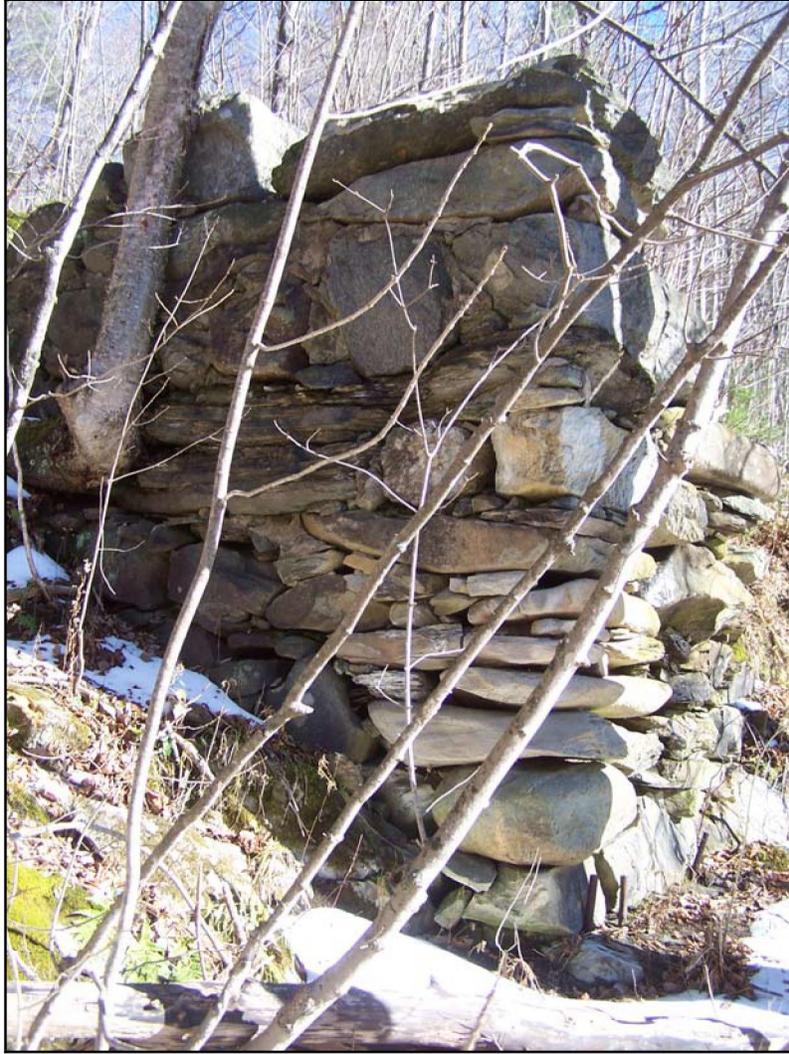
Photo 7. Photo shows a close-up view of a cut stone block with drill hole located in the stone column feature. View is to the northwest.

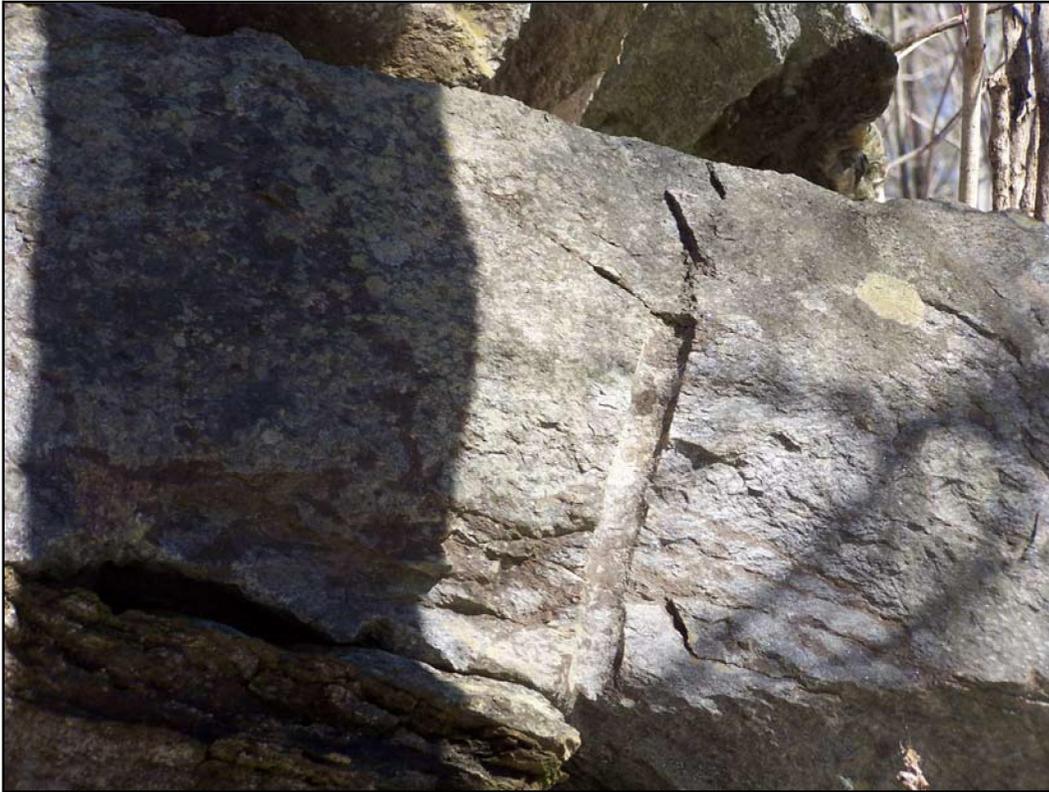
Photo 8. Photo shows a close-up view of the stone materials and masonry technique associated with the earlier stone bridge abutment. View is to the north.

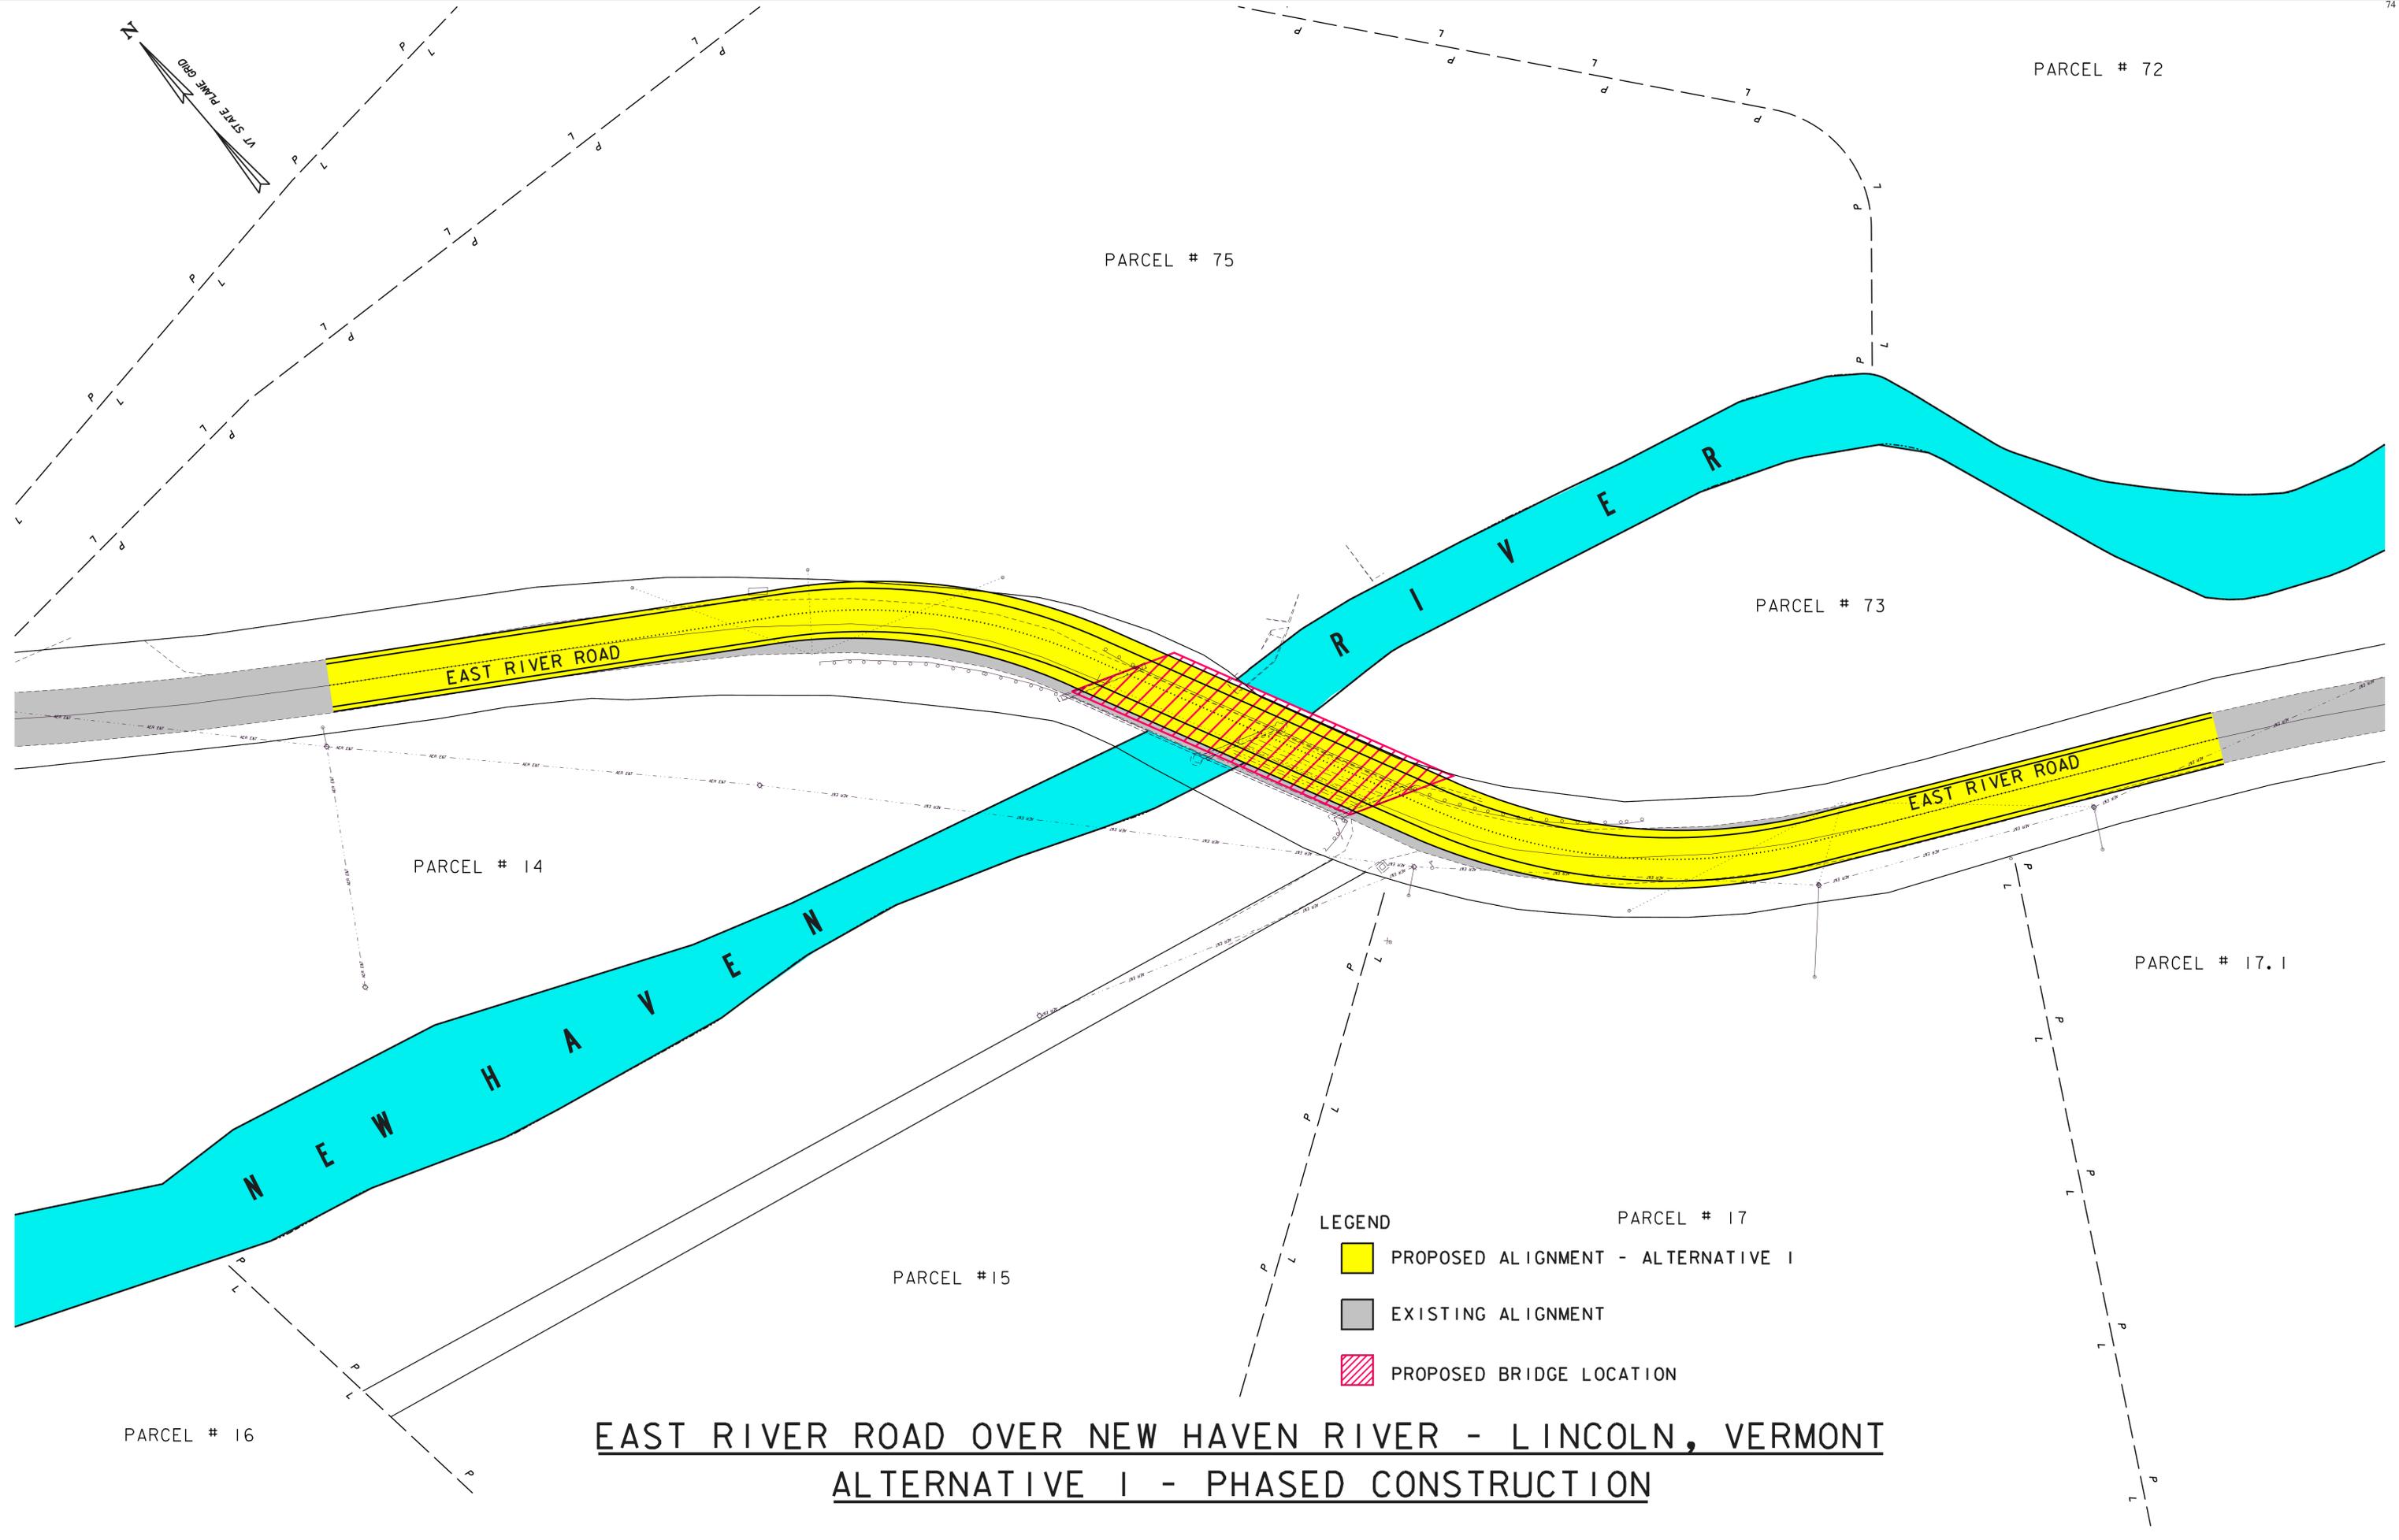
EAST RIVER ROAD OVER NEW HAVEN RIVER - LINCOLN, VERMONT
ALTERNATIVE I - PHASED CONSTRUCTION

- PROPOSED ALIGNMENT - ALTERNATIVE I
- EXISTING ALIGNMENT
- PROPOSED BRIDGE LOCATION

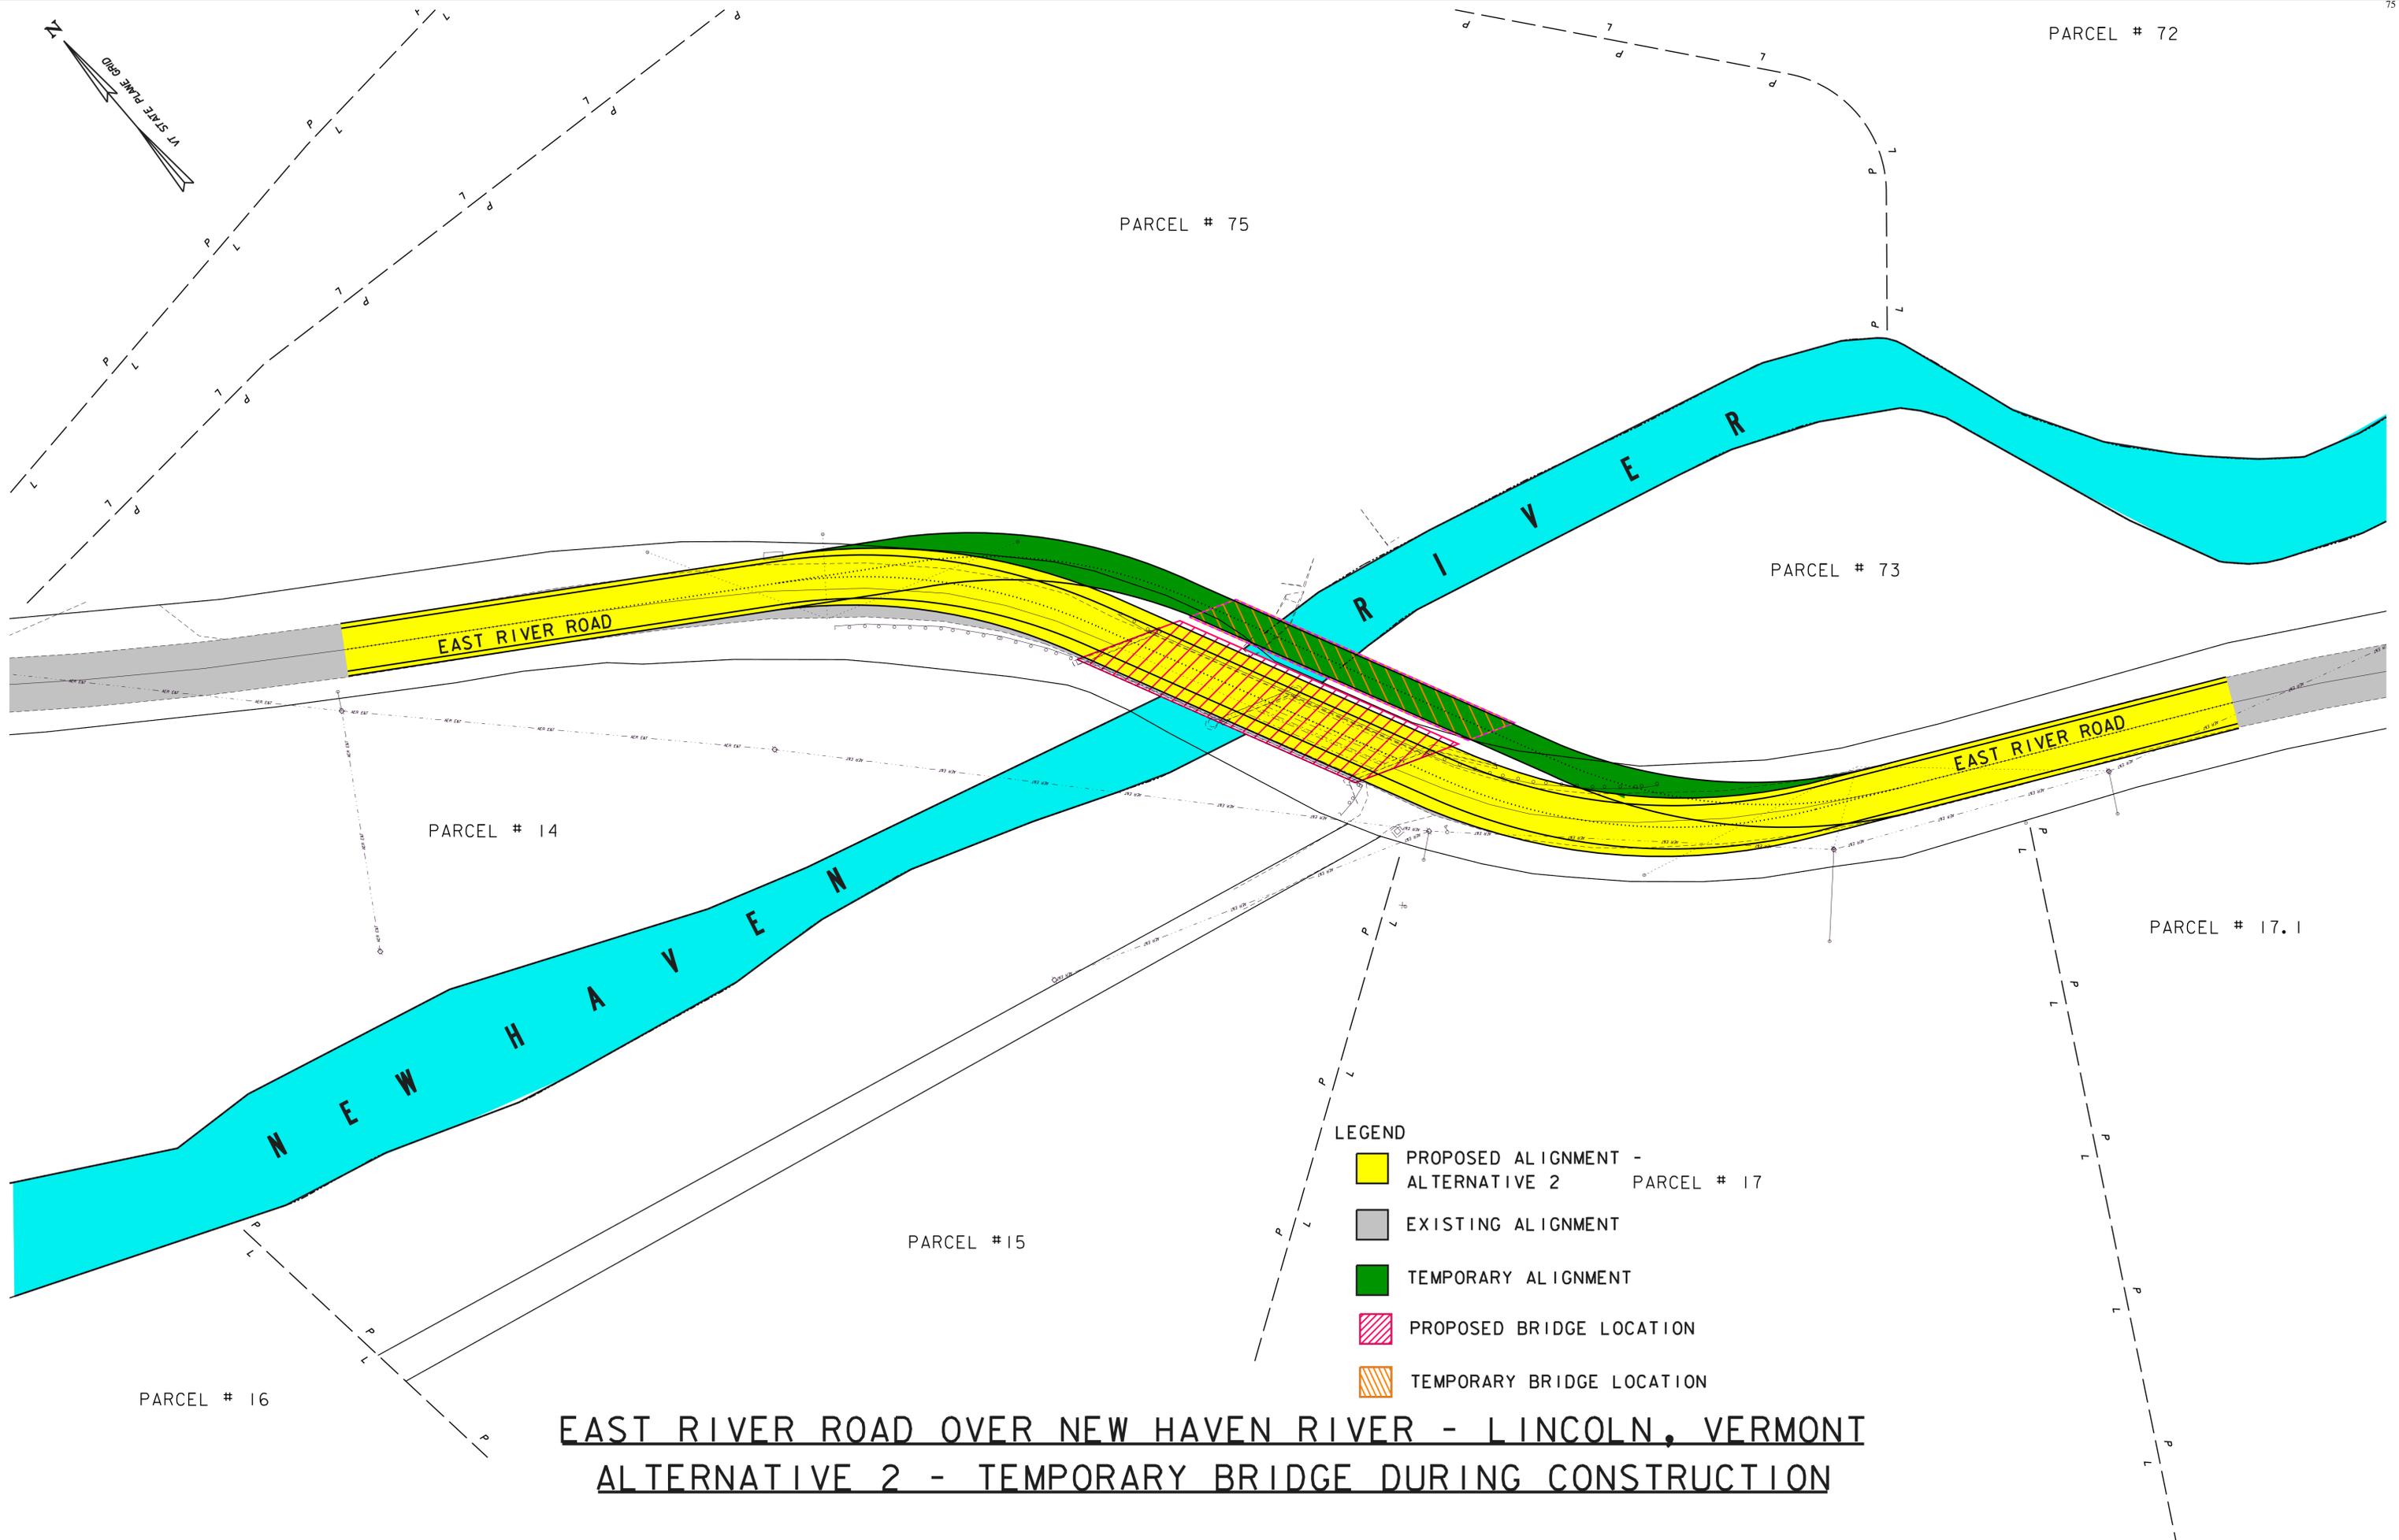
EAST RIVER ROAD OVER NEW HAVEN RIVER - LINCOLN, VERMONT
ALTERNATIVE 2 - TEMPORARY BRIDGE DURING CONSTRUCTION

- LEGEND
- PROPOSED ALIGNMENT - ALTERNATIVE 2
 - EXISTING ALIGNMENT
 - TEMPORARY ALIGNMENT
 - PROPOSED BRIDGE LOCATION
 - TEMPORARY BRIDGE LOCATION
