Lincoln - BRF 0188(8) – Bridge 19
TH1 over New Haven River

Scoping Report

Lincoln Bridge #19 Replacement
Lincoln, Vermont
Historic Resource Identification and Preliminary Findings of Effect
December 2010

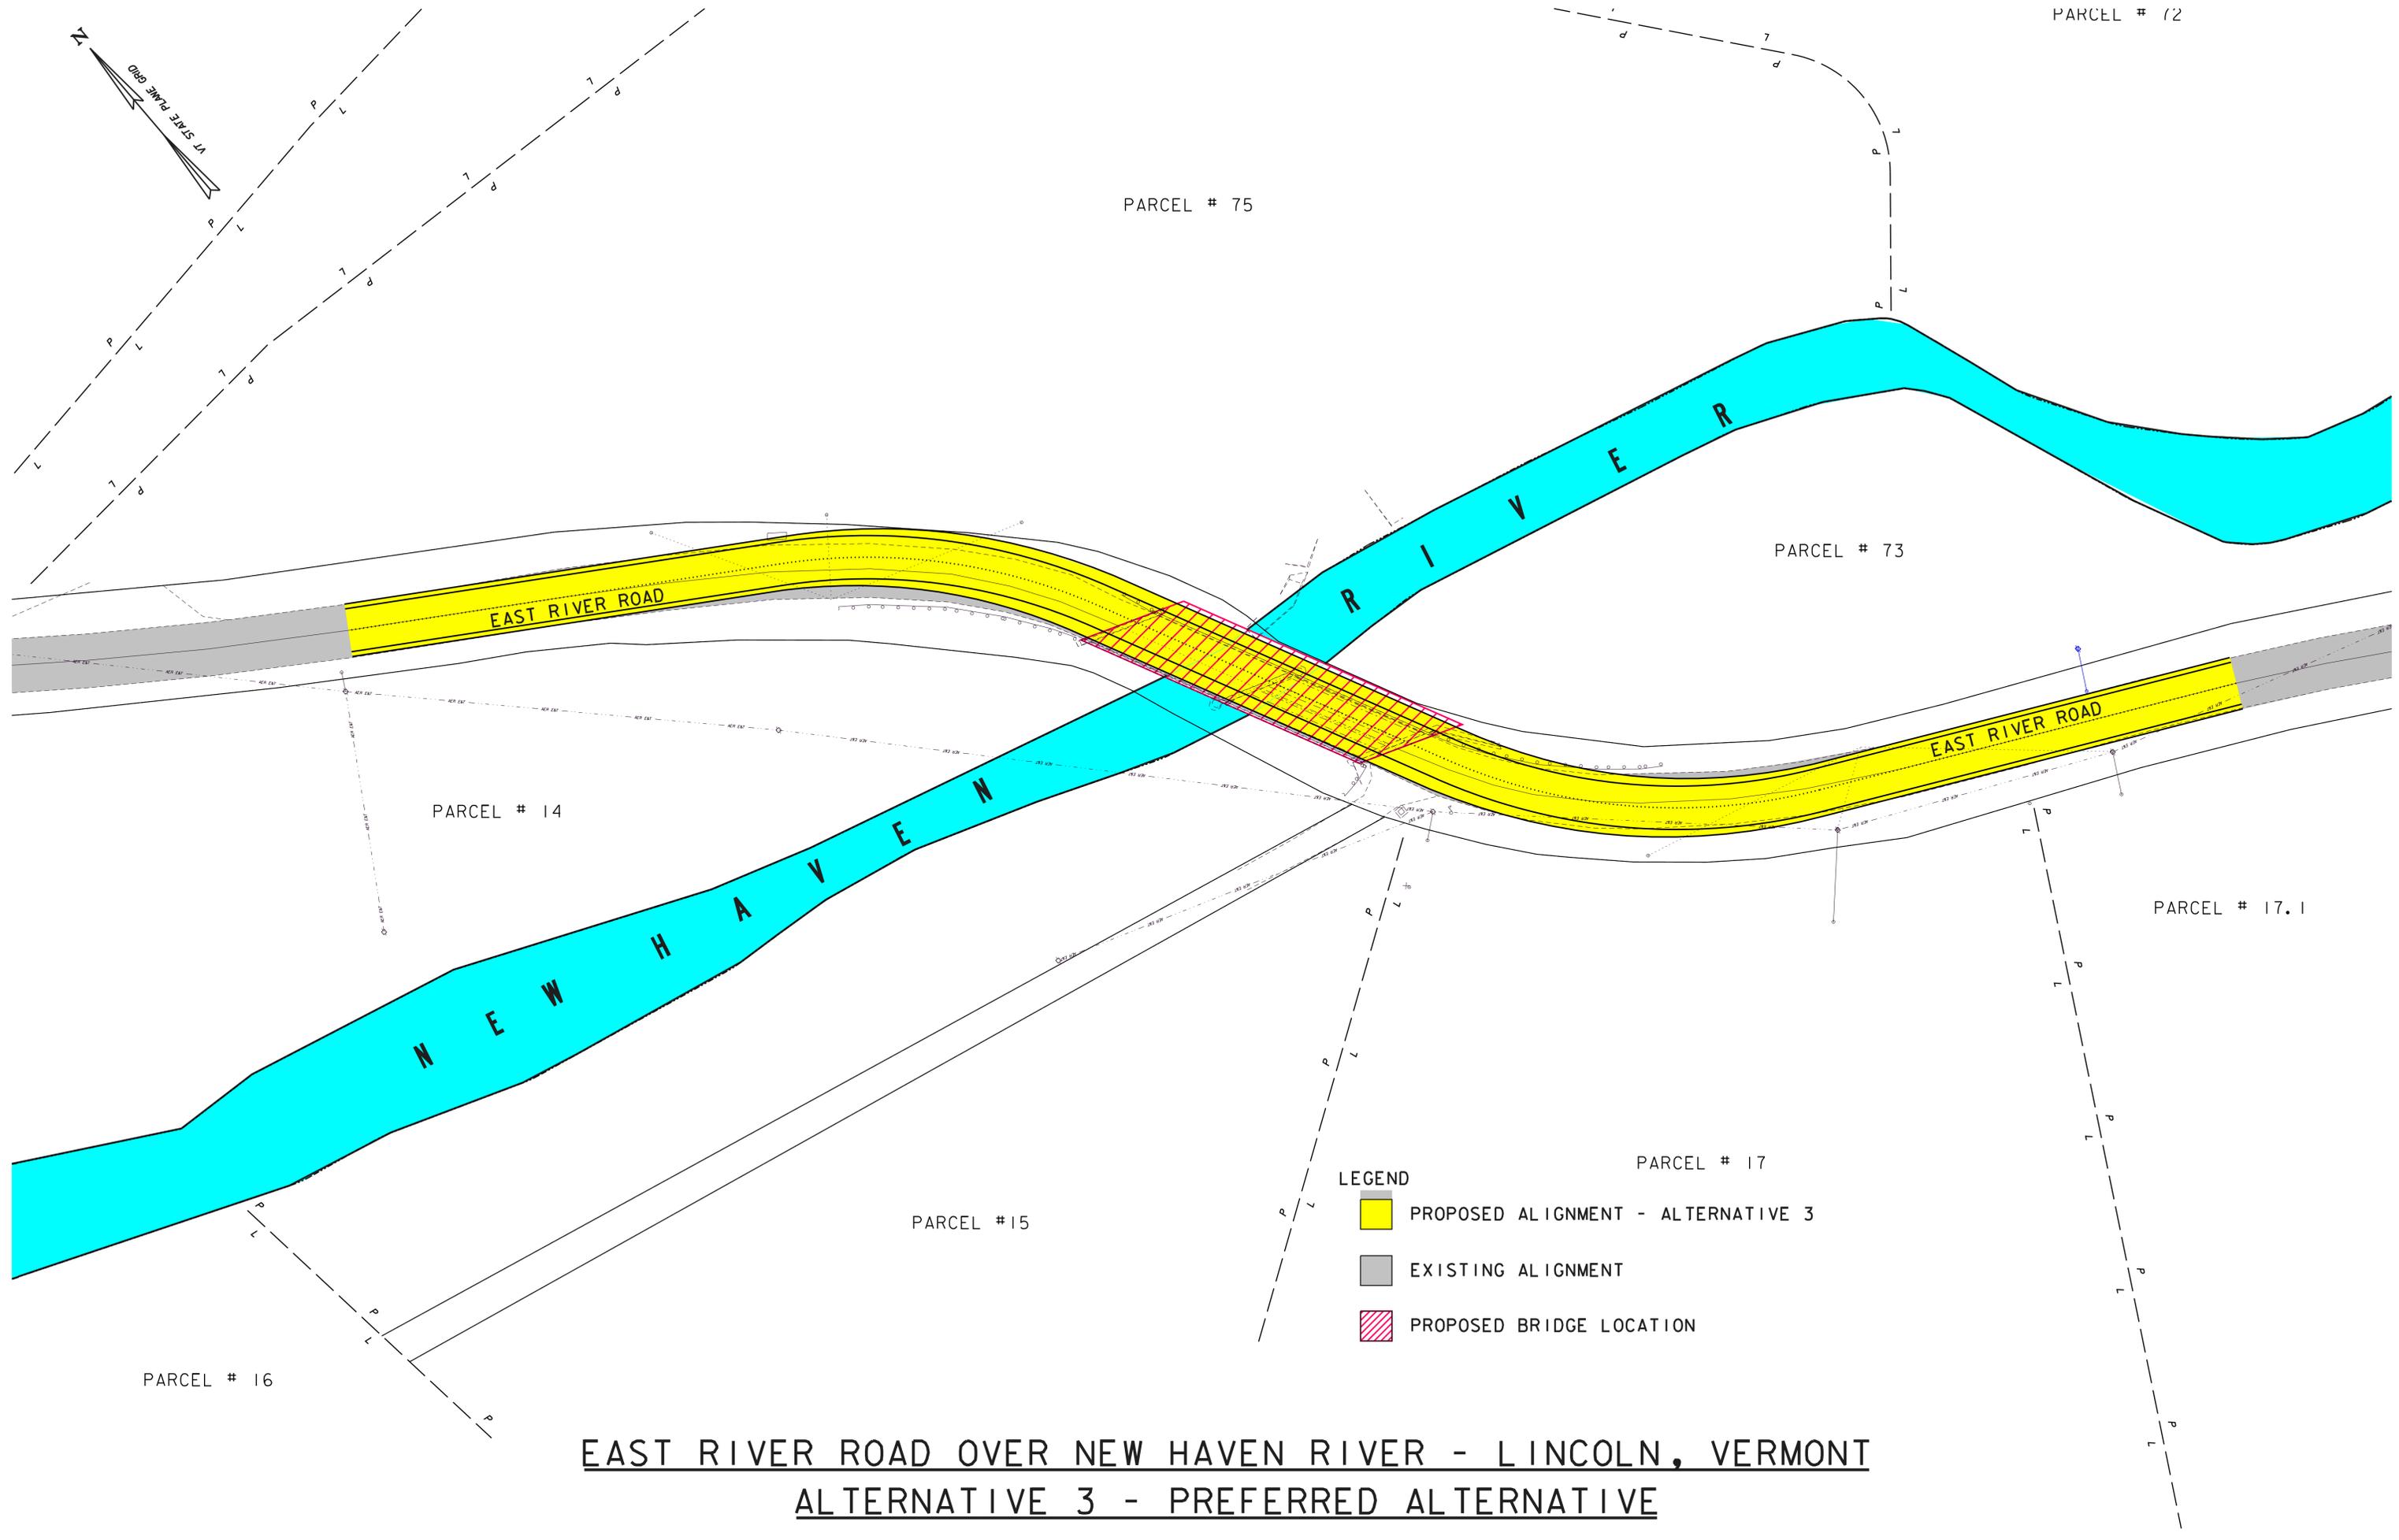
EAST RIVER ROAD OVER NEW HAVEN RIVER - LINCOLN, VERMONT
ALTERNATIVE 3 - PREFERRED ALTERNATIVE

- LEGEND**
- PROPOSED ALIGNMENT - ALTERNATIVE 3
 - EXISTING ALIGNMENT
 - PROPOSED BRIDGE LOCATION

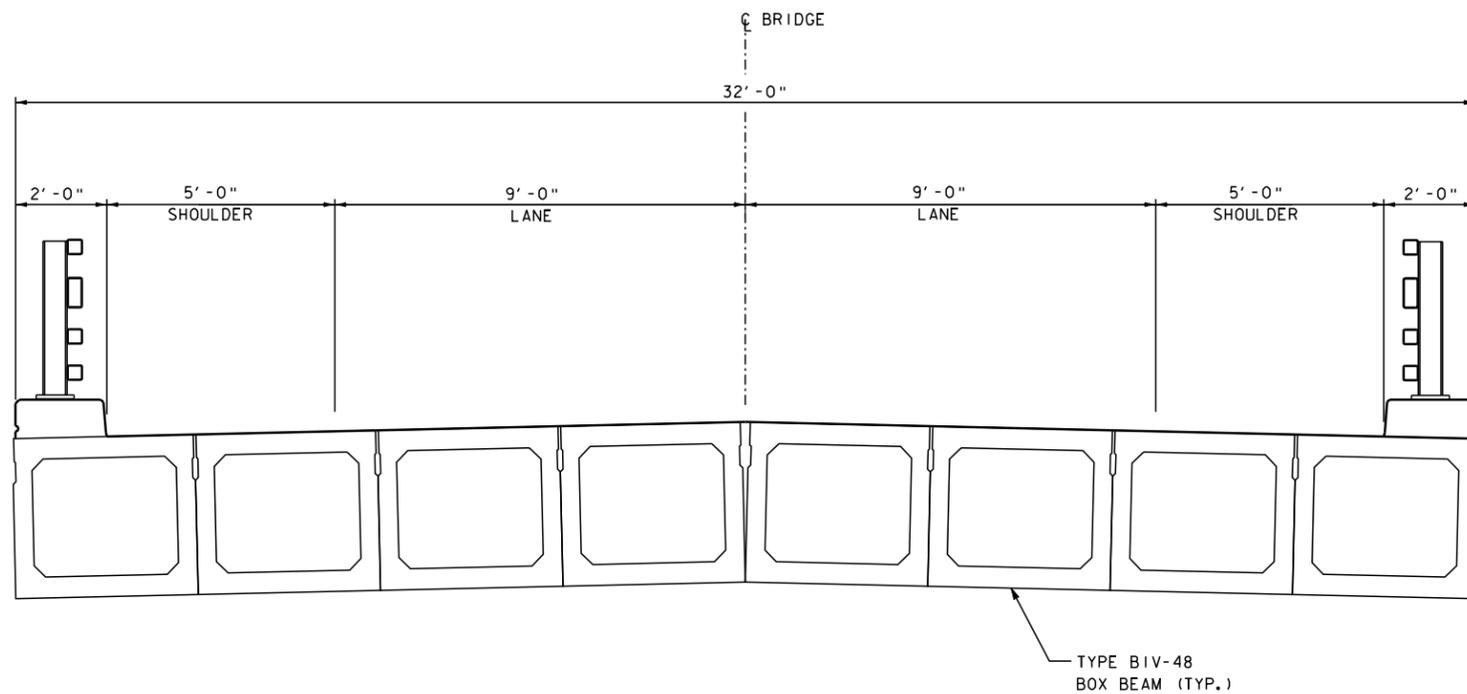
PROPOSED DECK SECTION (PRECAST CONCRETE BOX BEAM OPTION)

SCALE: 1/2" = 1'-0"
