**STATE OF VERMONT  
AGENCY OF TRANSPORTATION**

**Scoping Report**

**Calais BHF 037-2(12)  
VT 14, Bridge 77 over the Kingsbury Branch**

December 13, 2012

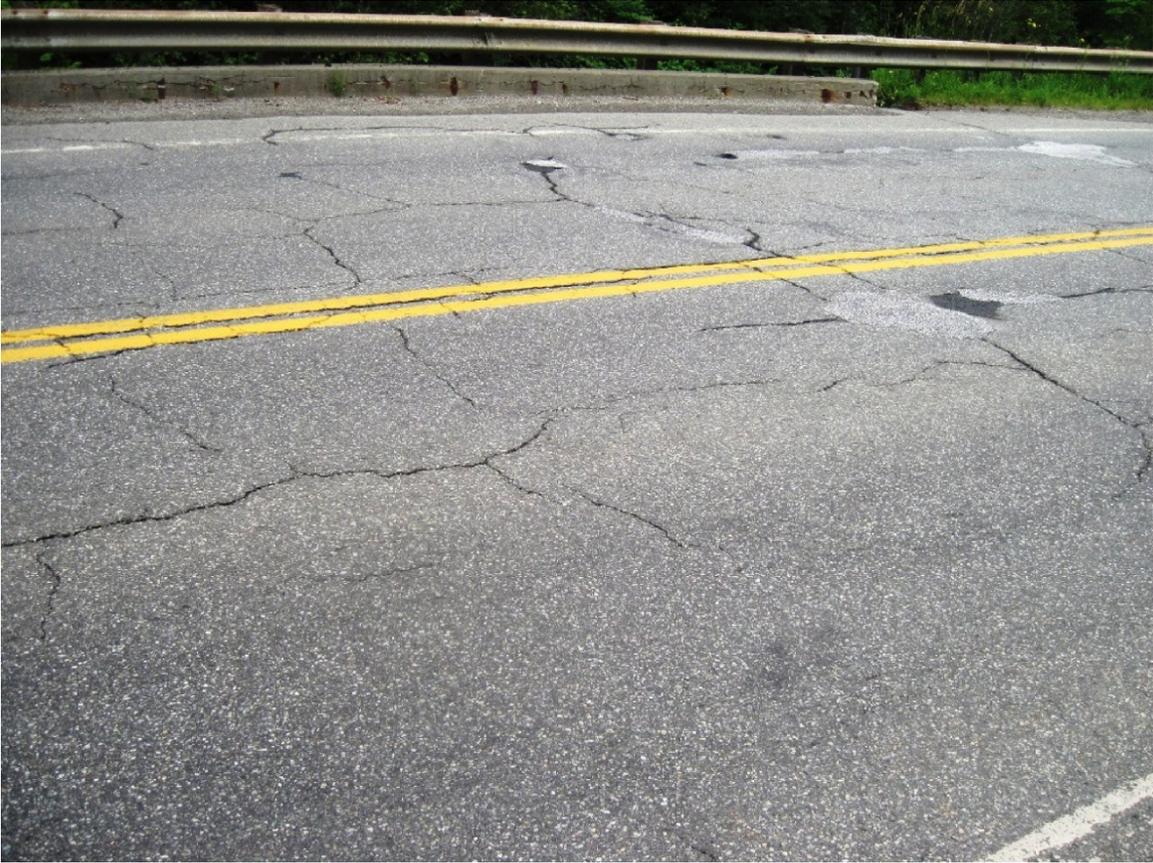
Pavement Distress due to Deck Deterioration

1. The original central bays of the deck are in poor condition and the original T-Beams show significant deterioration as well.
2. The existing bridge railing does not meet the current standard.
3. The existing bridge does not meet the standards with regards to the vertical grade, vertical sag curve, and stopping sight distance.
4. The existing bridge does not meet the hydraulic standard.

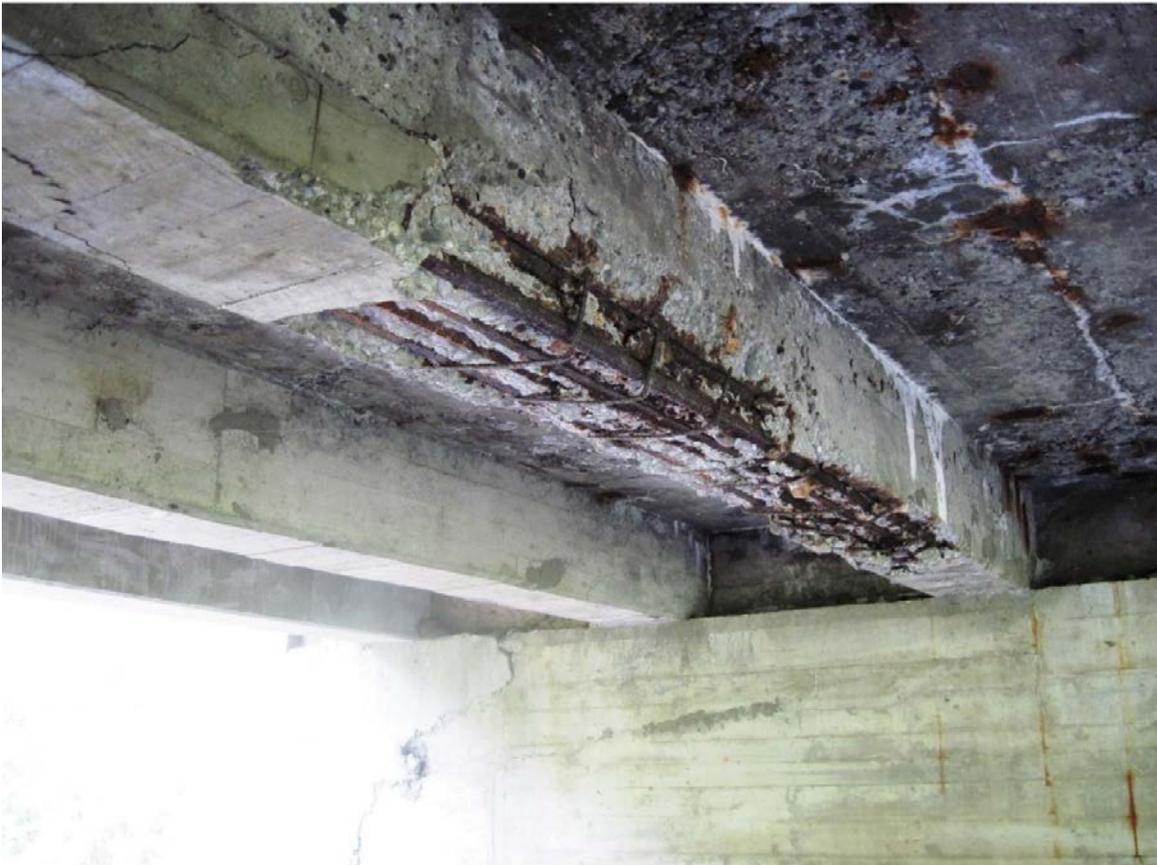
Deck and Superstructure Deterioration

07/18/2011 – Deck and superstructure have some advanced contamination and or deterioration and are rated as fair at this time. Bridge would be a good candidate for reconstruction with prestressed concrete superstructure components within the next 10 years. ~ MJ/DK

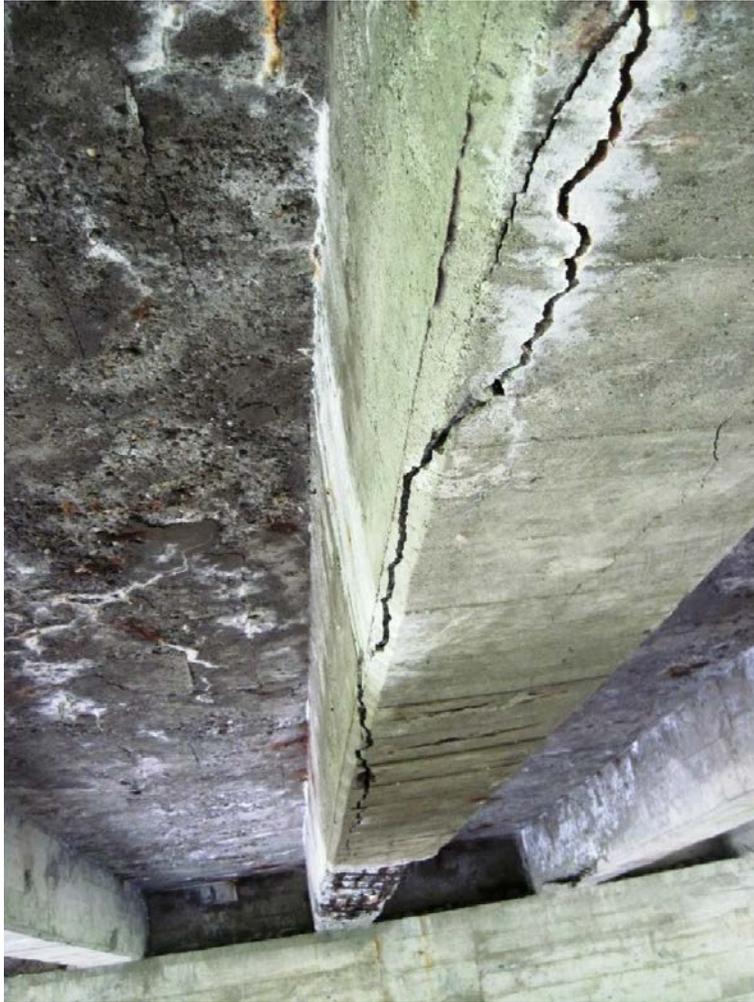
Additional T-beam and Deck deterioration

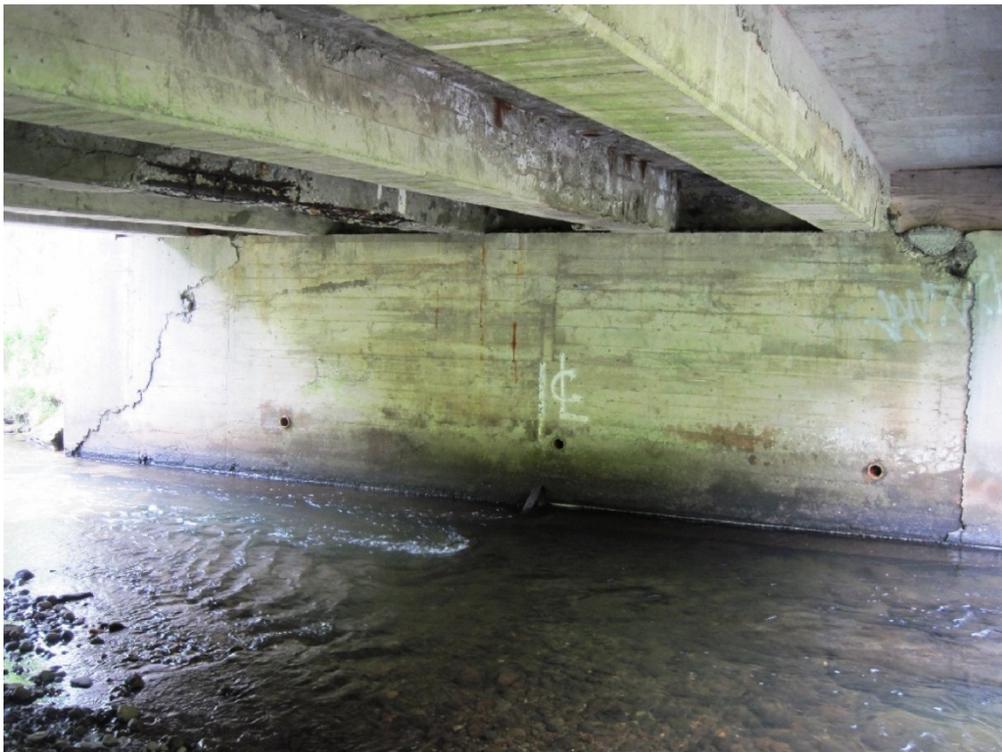
Substructure Patching

The main issue with this bridge is the deteriorated state of the deck and superstructure. Because the deck acts integrally with the superstructure and they are both in equally bad shape, it would be easiest and cheapest to replace the entire superstructure with new precast concrete NEXT beams. There are several cracks and deteriorated sections in the substructure which could be patched during a rehabilitation project.

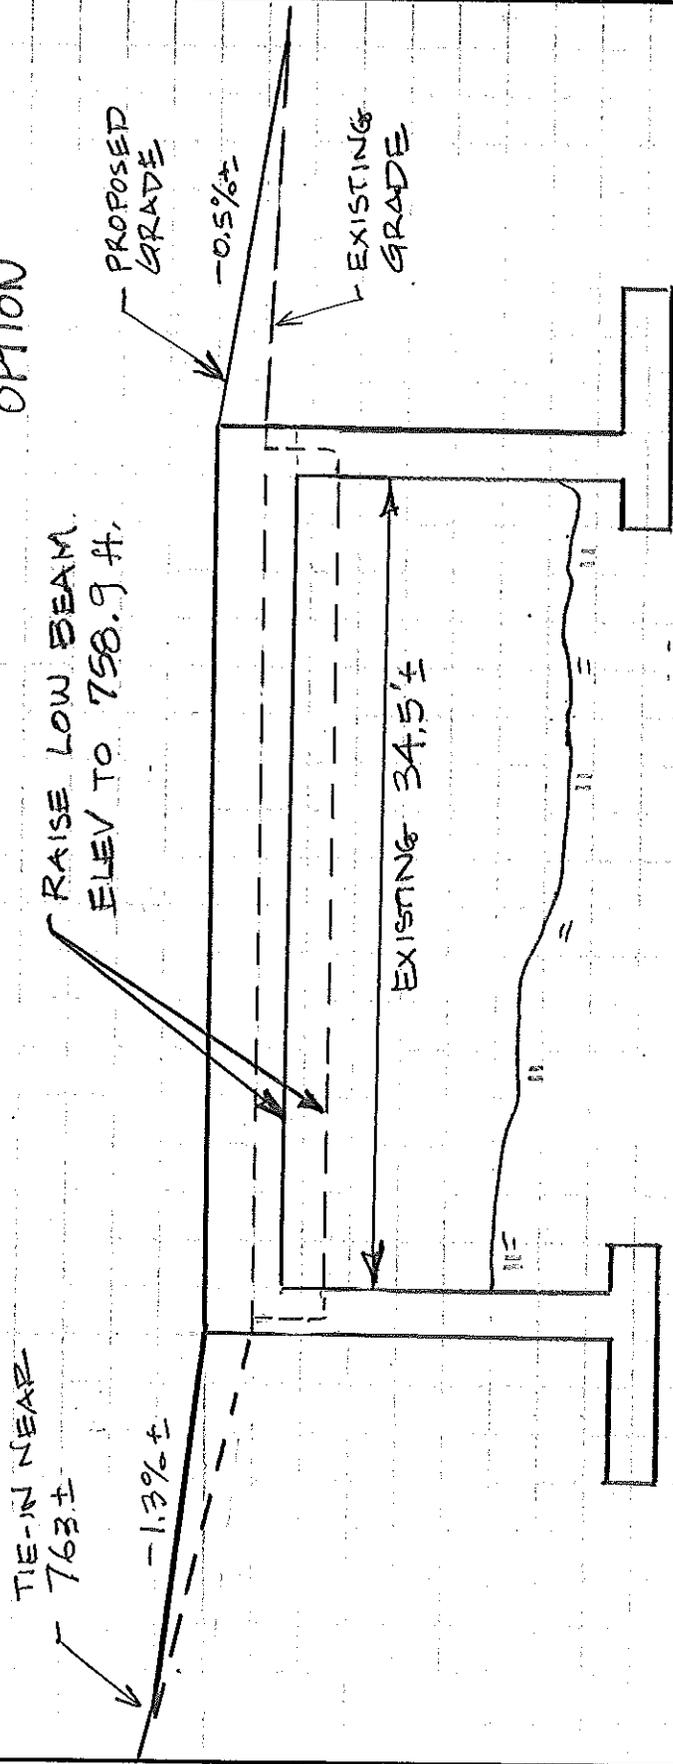
ALTERNATE  
OPTION

NOTE: RE-USE EXISTING  
ABUTMENTS AND MODIFY  
TO RAISE BRIDGE  
SEAT AND TOP OF  
BACK WALL.

An additional alternative was also reviewed as part of the hydraulic analysis which re-used the existing abutments to lower the construction costs. However, these abutments would need to be modified by raising the bridge seats/low beam elevation and adjusting the roadway grades. The recommended alternate option would raise the low beam elevation to an elevation of 758.9 feet (approximately 1.7 feet) to allow the  $Q_{50}$  design event to pass through the structure. For this shorter term solution to be possible, an analysis of the ability to raise the bridge seats on the existing abutments needs to be performed. Furthermore, it should be noted that this short term option does not provide any additional scour protection from the existing conditions and the stream will continue to have a constriction at the downstream end of a large bend.

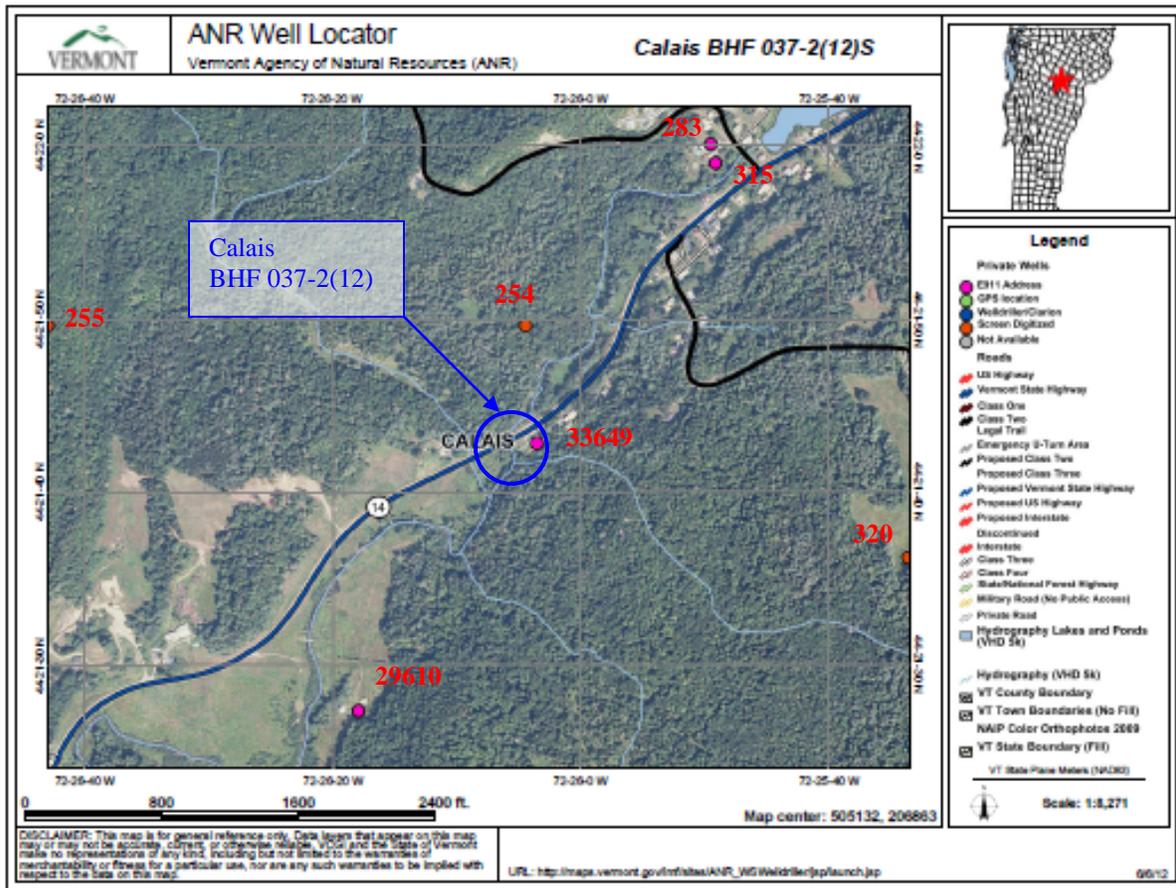
Figure 2: ANR Well Locations near Bridge 77 – VT 14 in Calais, VT

recorded on the logs is provided by field personnel with unknown qualifications, and as such, should only be used as an approximation. Surrounding well logs were examined for depths to bedrock and soil strata. Well locations are shown in Figure 2 and a summary of the specific wells used to gain information on the subsurface conditions are presented in Table 1. The two closest wells, wells No. 254 and 33649 are located between 150 and 675 ft from the project location.

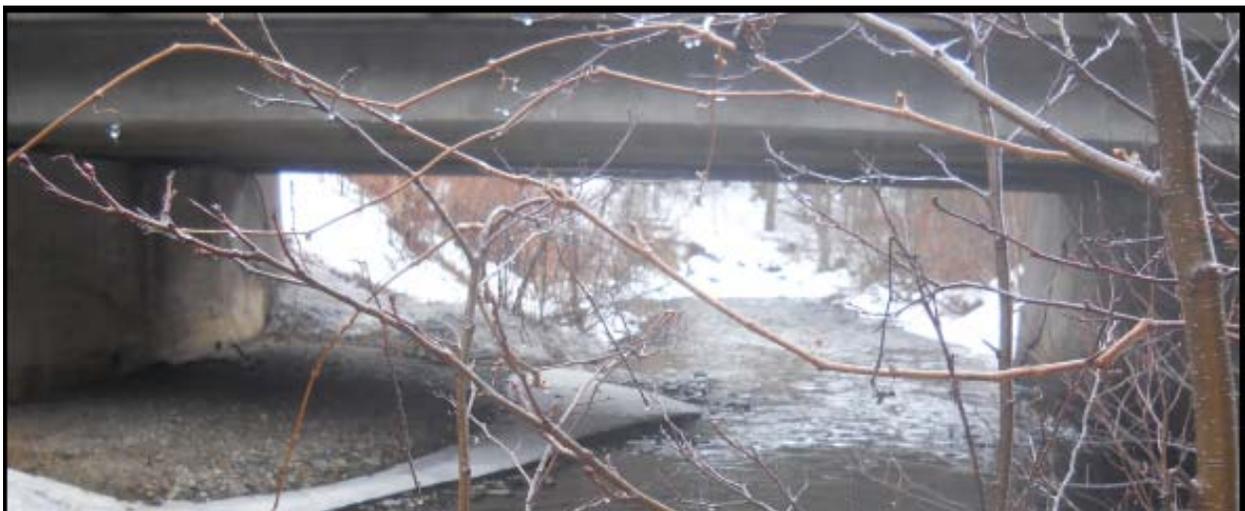
Figure 3: Bridge 77 Elevation View

The existing bridge is a 38 ft long, straight single span structure. The current grade difference between the abutments is negligible. The bridge is located at a bend in the river and the channel seems to be migrating south towards the southern abutment, see Figure 3. Consideration of the migration of the stream should be given, which may result in an increase in the overall superstructure length.

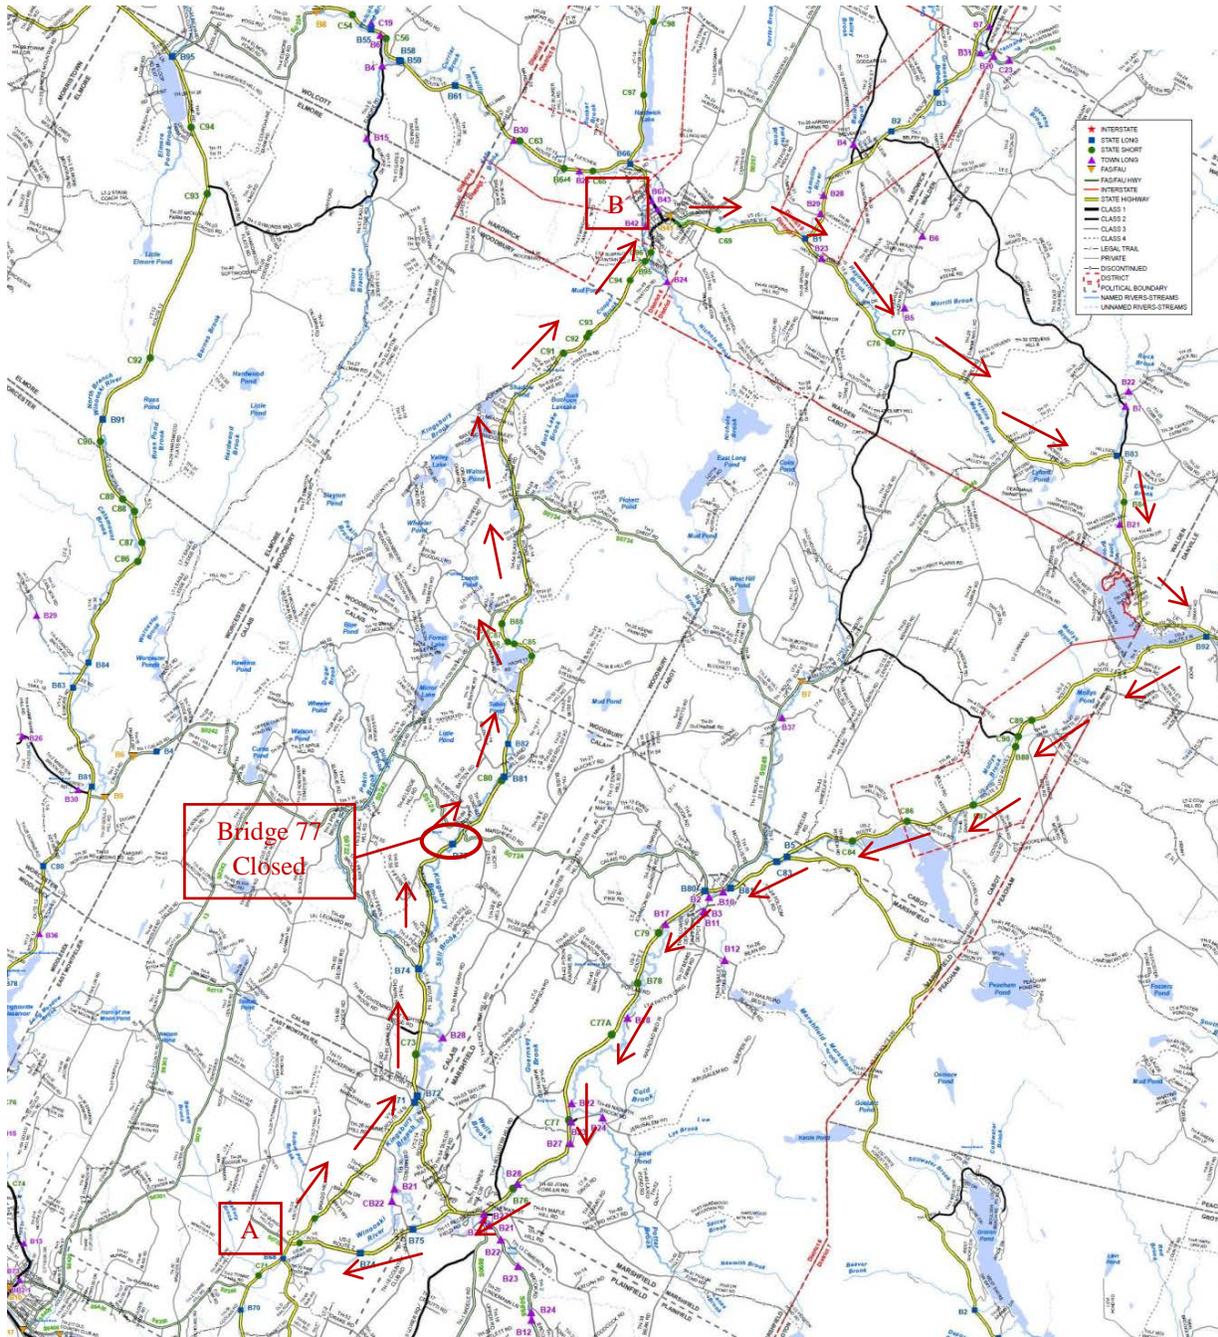
Proposed Detour:

Detour Route: VT 14 to VT 15 to US 2 to VT 14.

A-B Through Distance: 19.5 miles

End to End Distance: 51.9 mile

This option would close the section of VT 14 near the bridge to through traffic for a limited time during construction. The detour would utilize VT 15 and US 2 to circumvent the closed section of VT 14. This detour adds approximately 12.9 miles for through traffic.

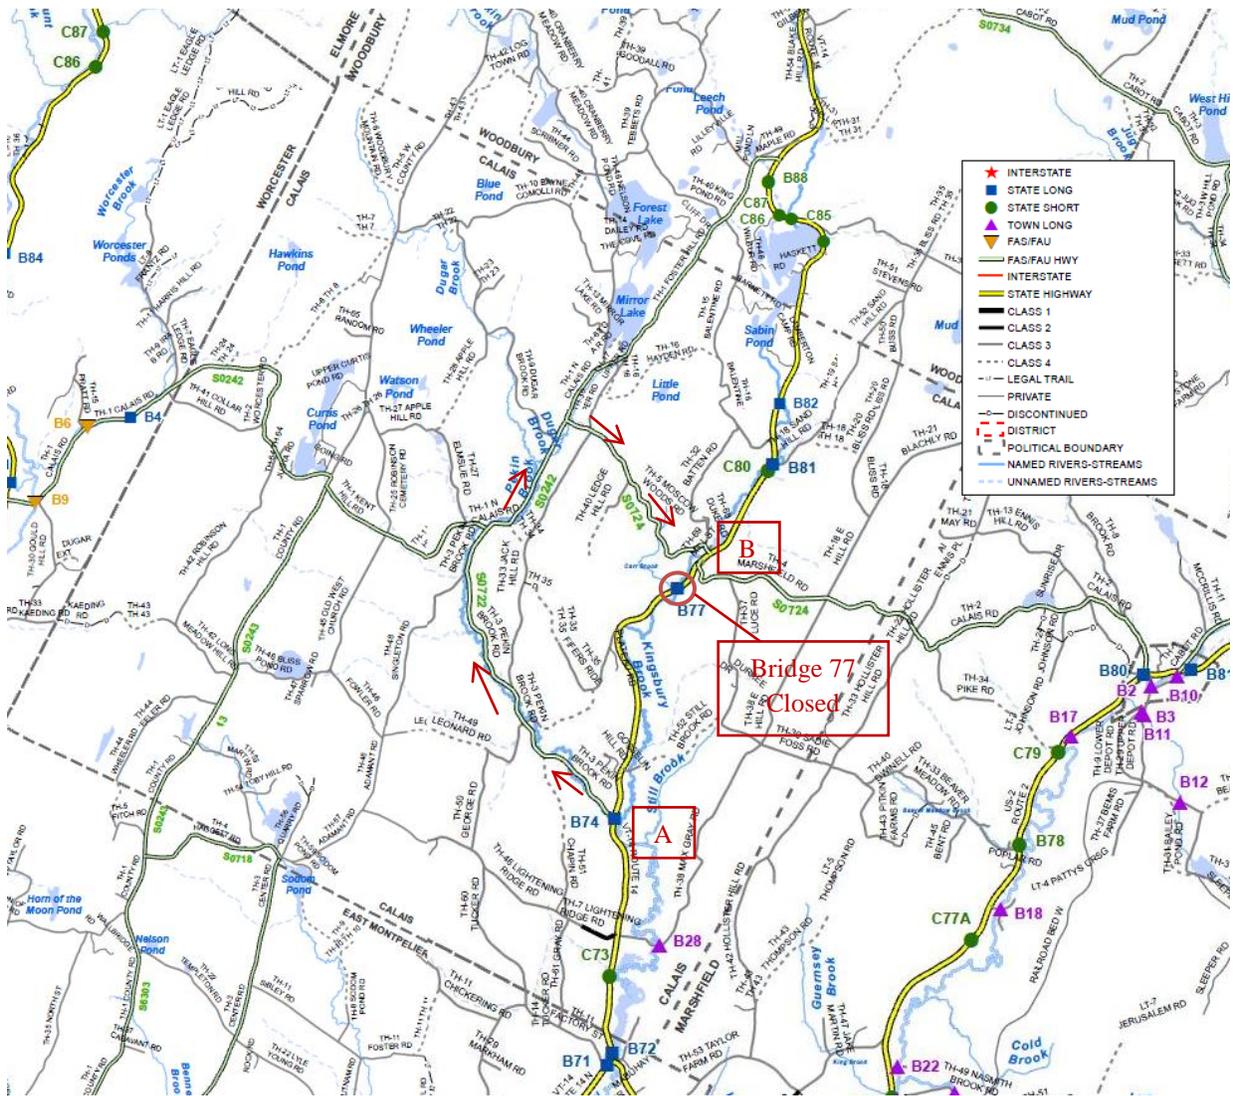
Local Bypass Route Option 1:

Bypass Route: VT 14 to Pekin Brook Rd. (TH 3) to North Calais Rd. (TH 1) to Moscow Woods Rd. (TH 5) to VT 14.

A-B Through Distance: 2.7 miles

End to End Distance: 7.9 miles

1. Local Bypass Route 1: Max Gray Rd to Luce Rd to Marshfield Rd adding 0.9 miles.
2. Local Bypass Route 2: Pekin Brook Rd to North Calais Rd to Moscow Woods Rd adding 3.6 miles.

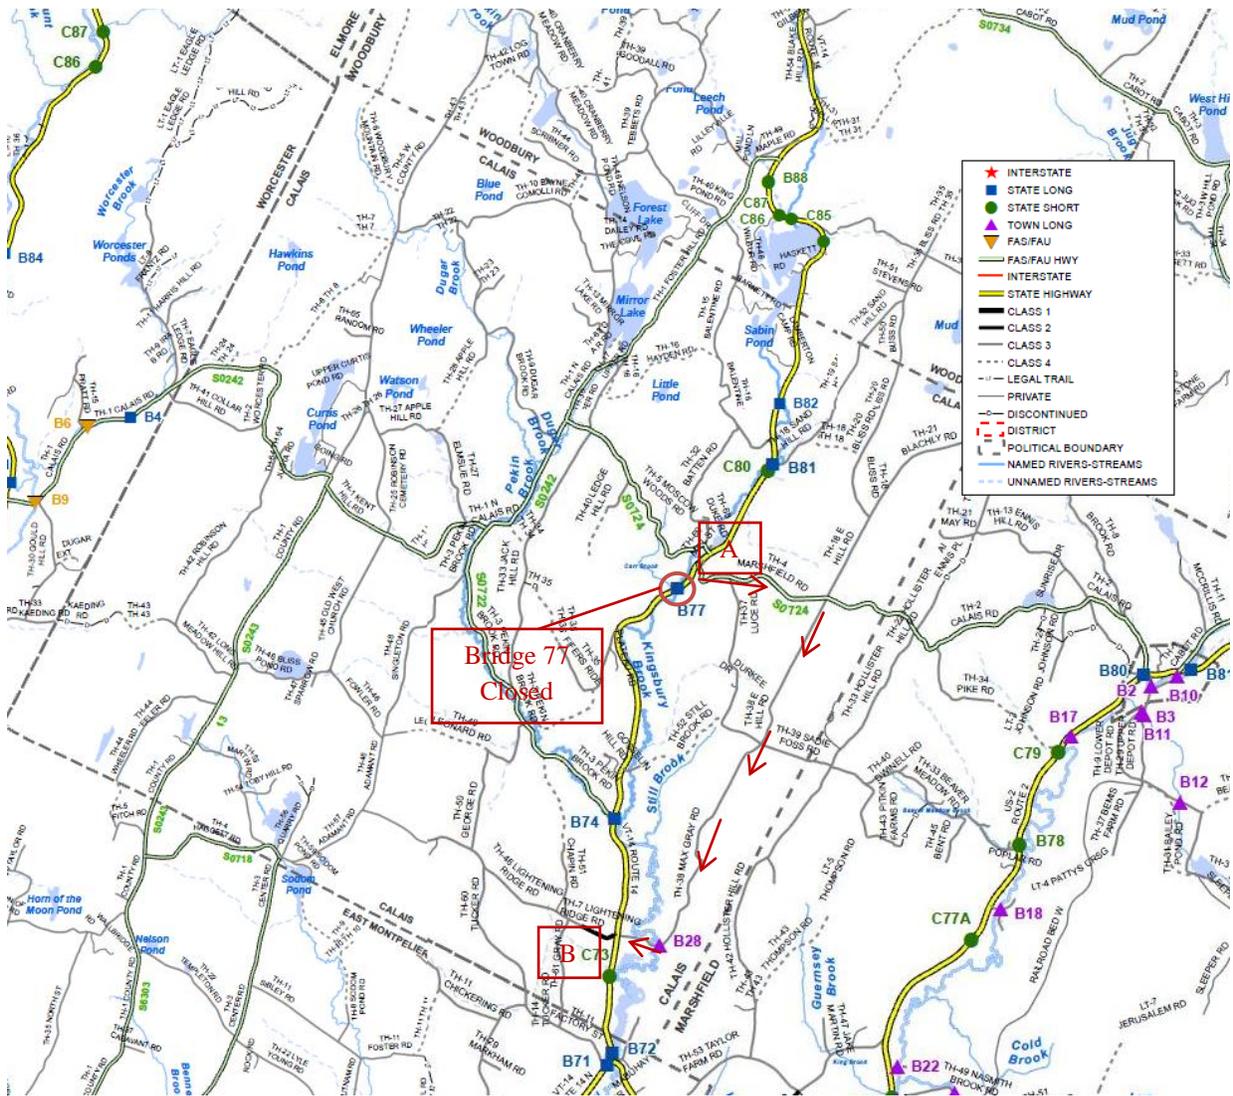
Local Bypass Route Option 2:

Bypass Route: VT 14 to Marshfield Rd. (TH 4) to East Hill Rd. (TH 39) to Max Grey Rd. (TH 39) to VT 14.

A-B Through Distance: 3.6 miles

A-B Bypass Distance: 5.3 miles

End to End Distance: 8.9 miles

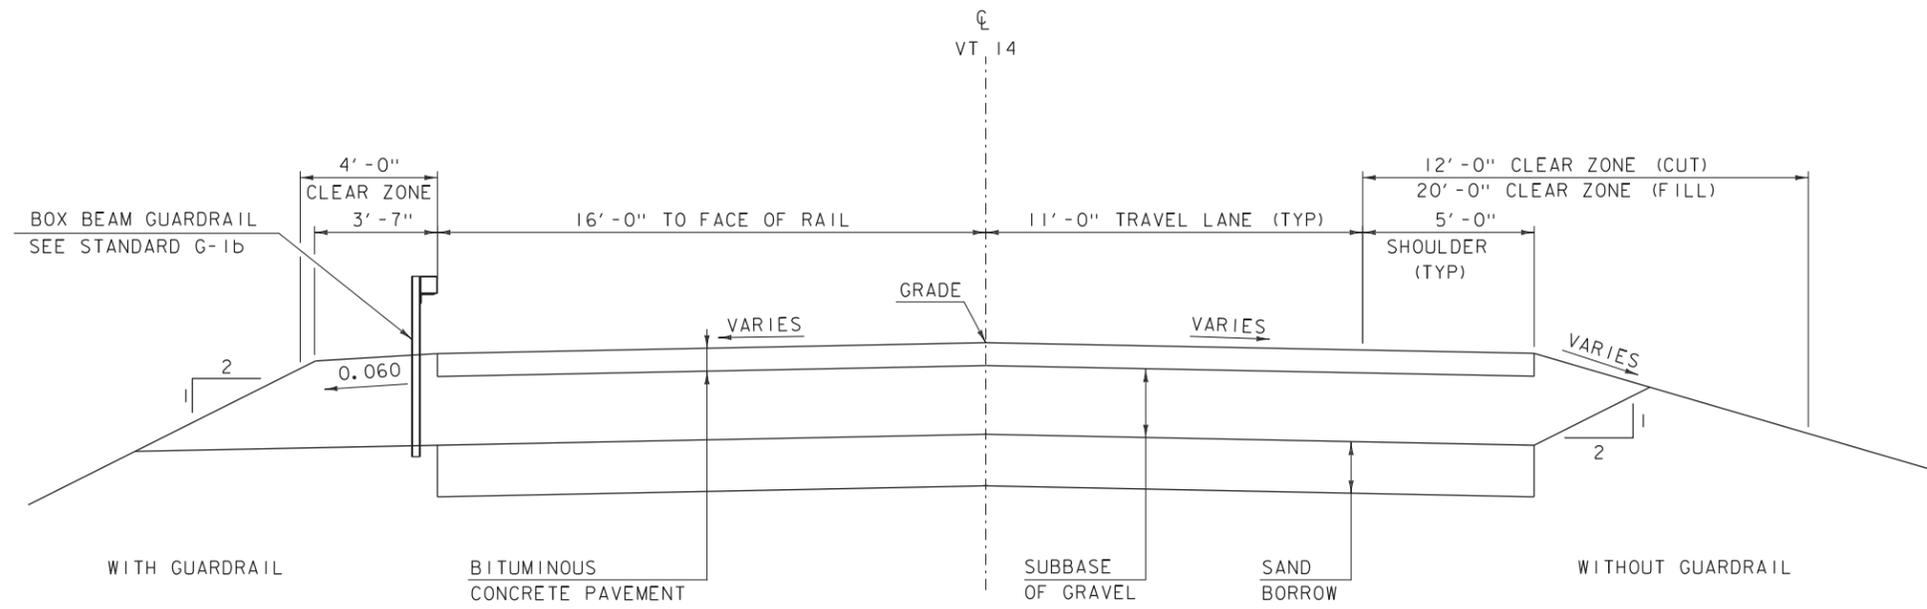
**PROPOSED VT 14 TYPICAL SECTION**

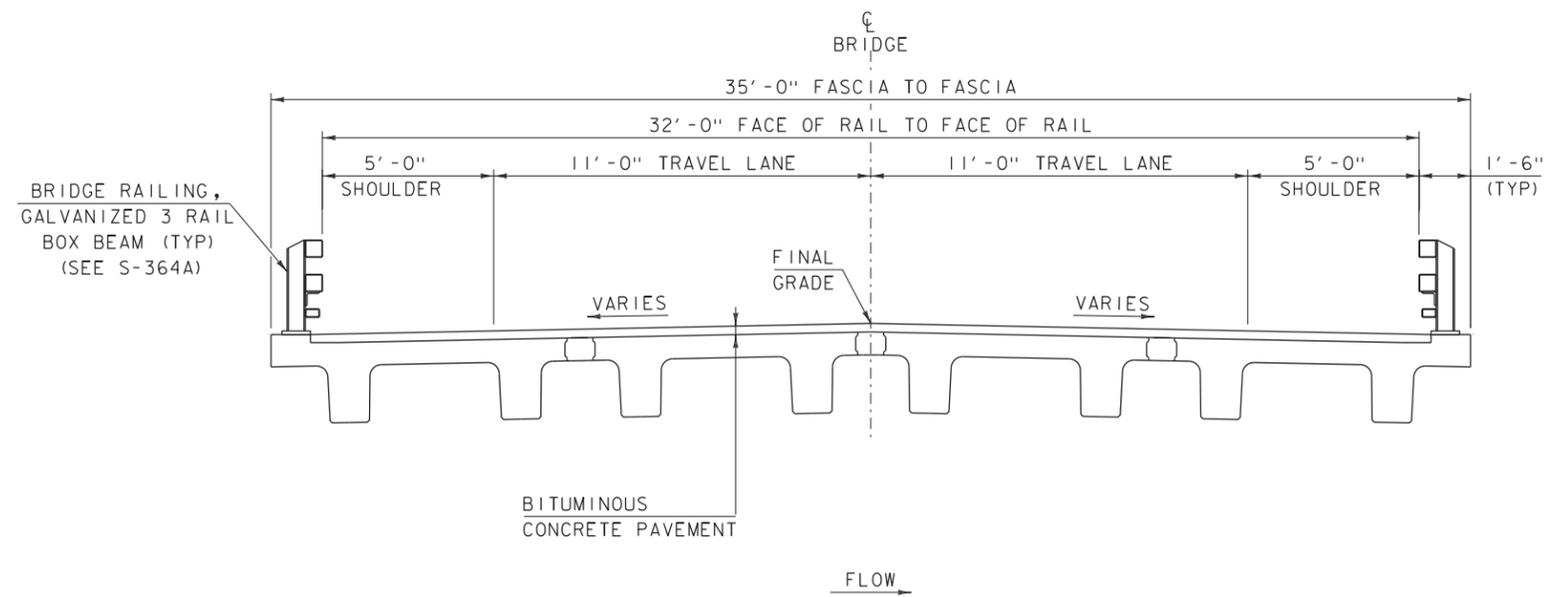
**PROPOSED BRIDGE TYPICAL SECTION**

NOTE: SUPERSTRUCTURE NOT DESIGNED.  
NEXT 28D SHOWN FOR EXAMPLE

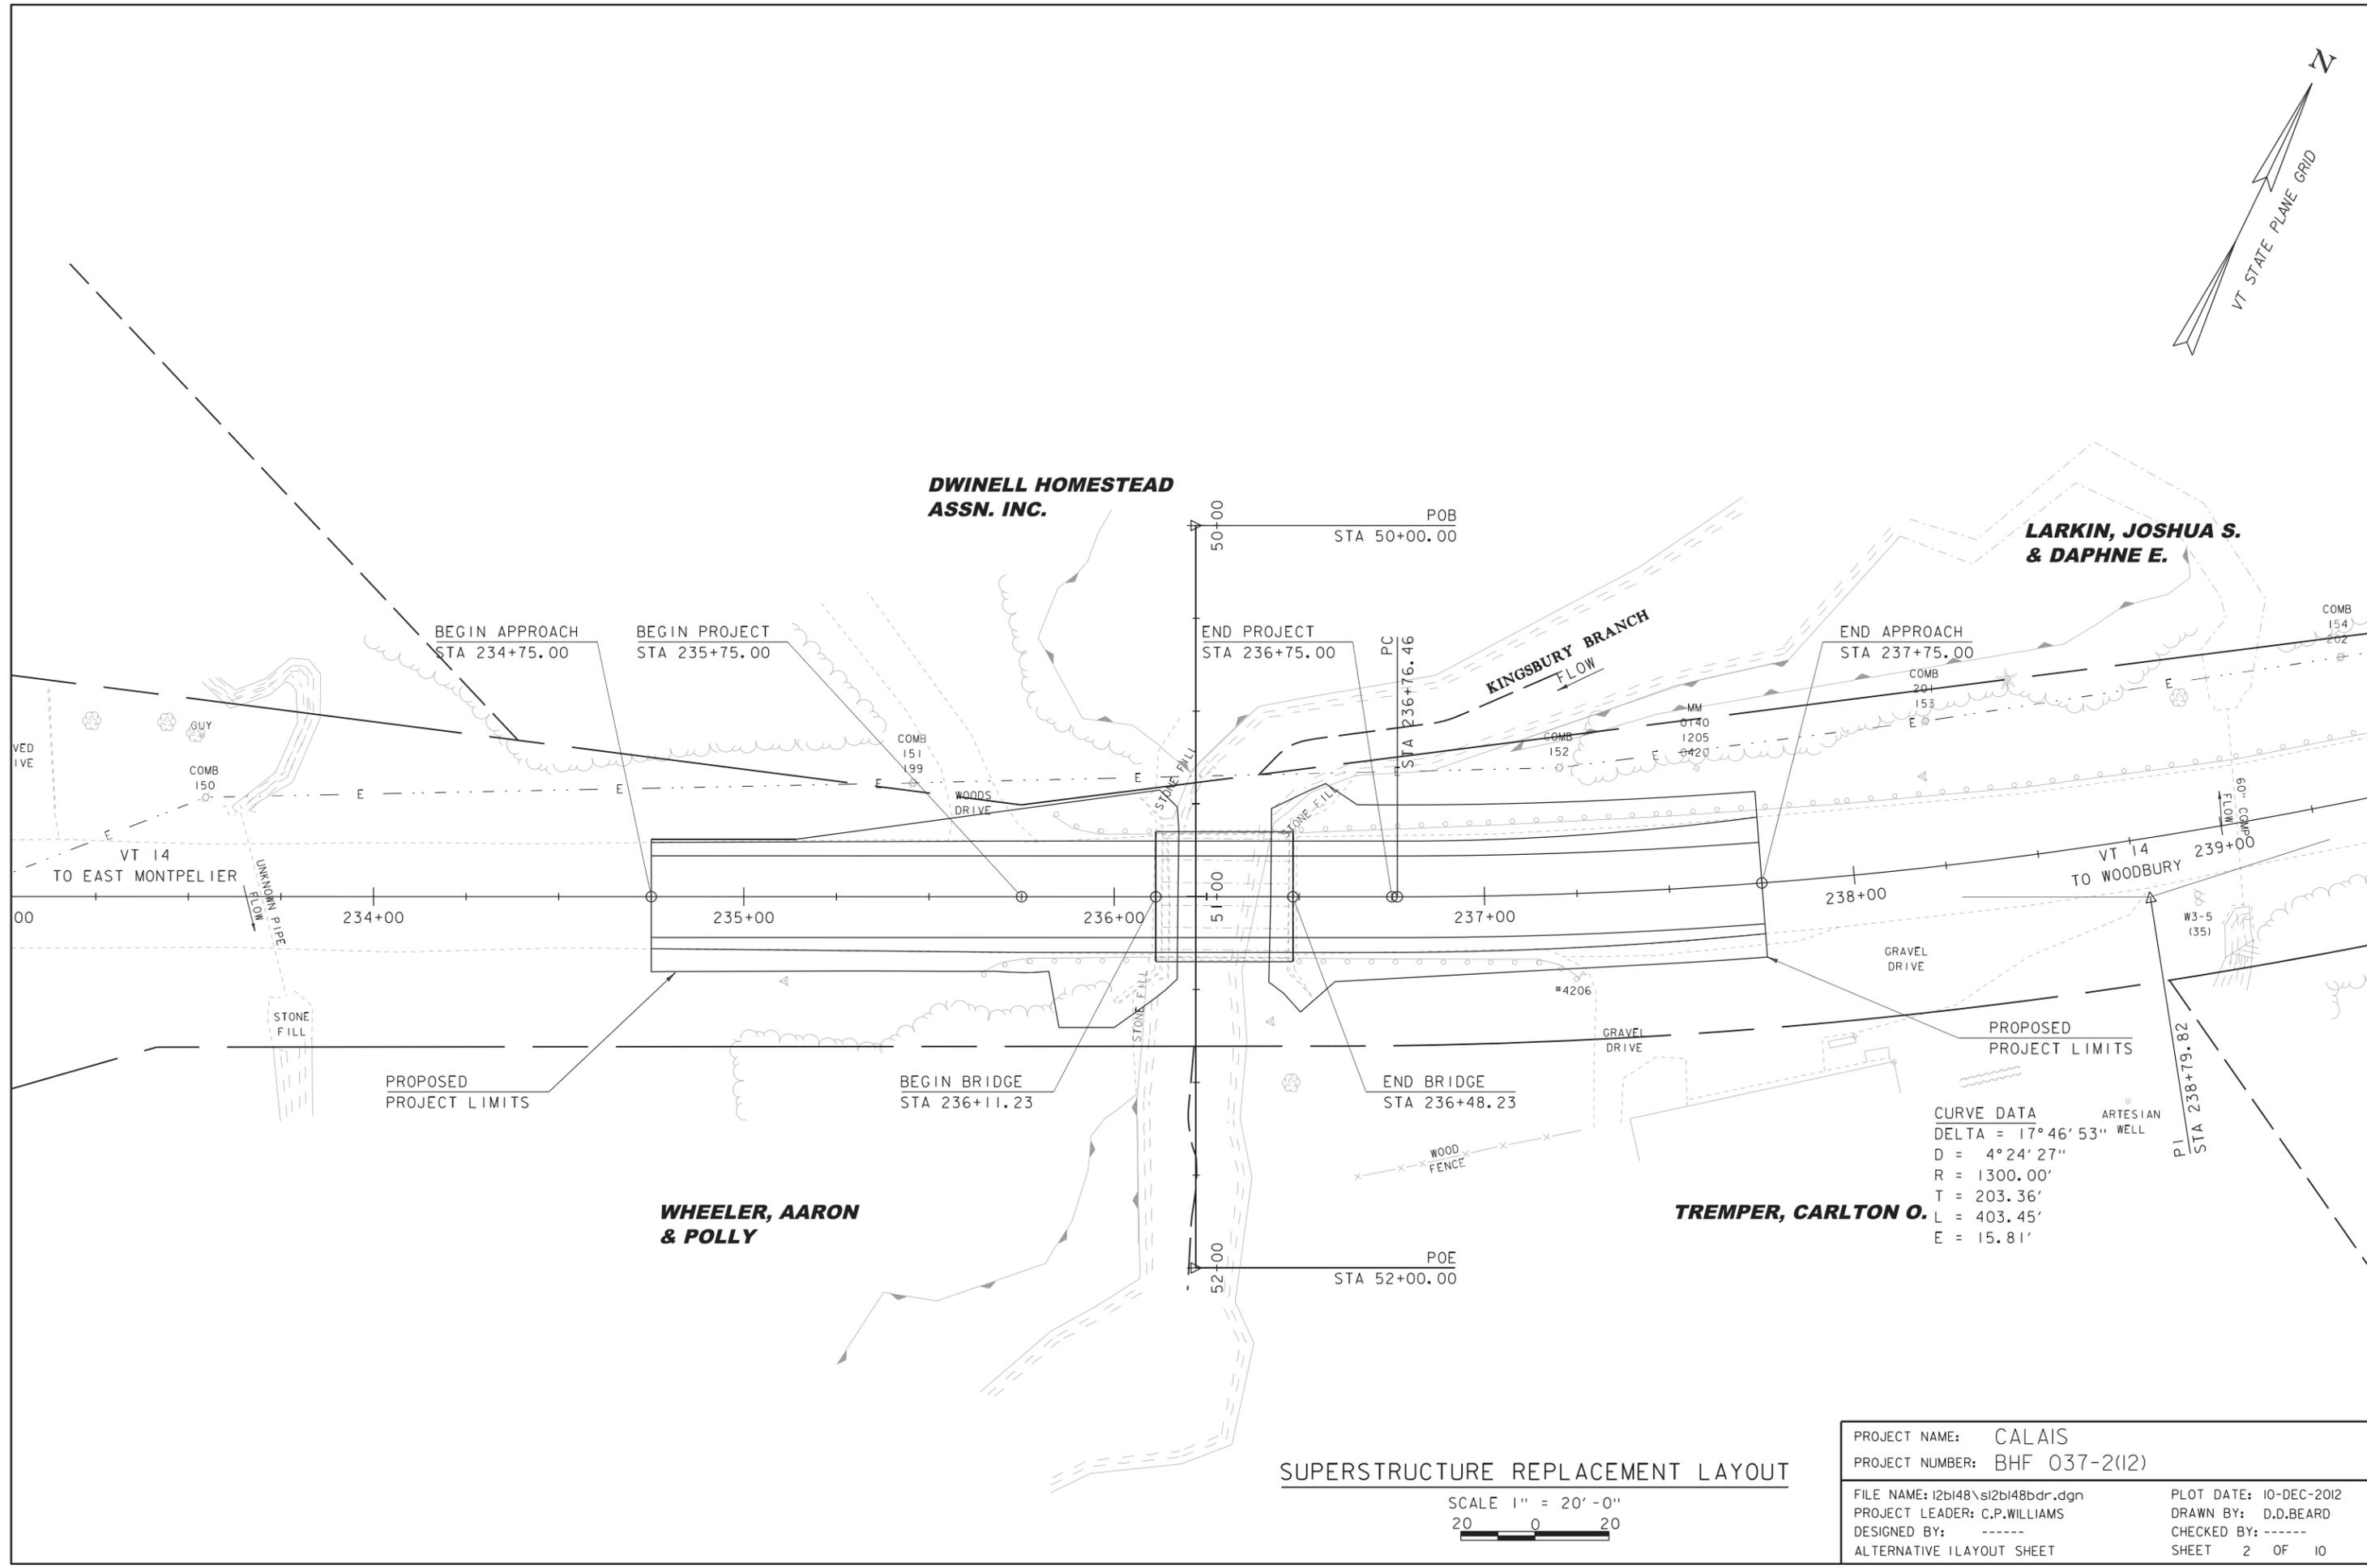
**SUPERSTRUCTURE REPLACEMENT LAYOUT**

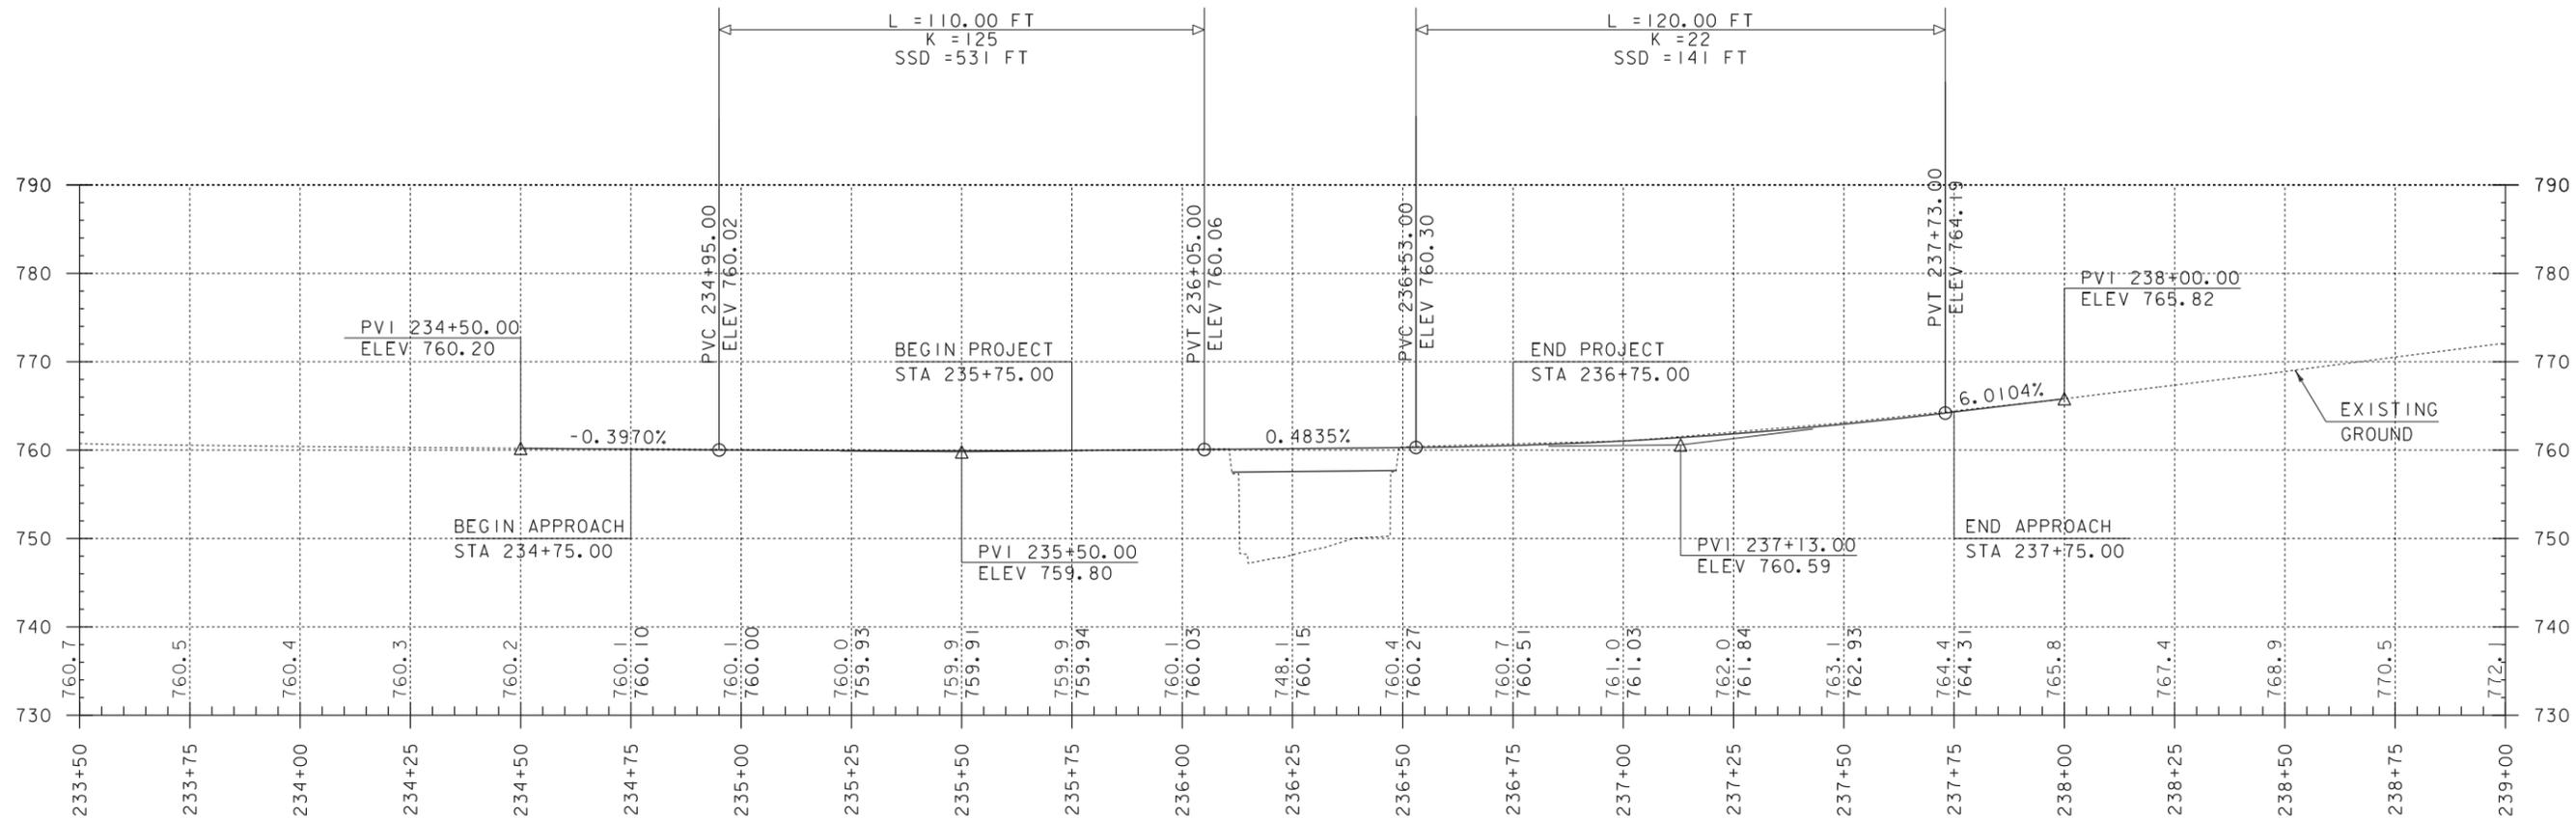
VT RT 14 SUPERSTRUCTURE REPLACEMENT PROFILE

GRADES SHOWN TO THE NEAREST HUNDREDTH ARE FINISH GRADE ALONG  $\phi$

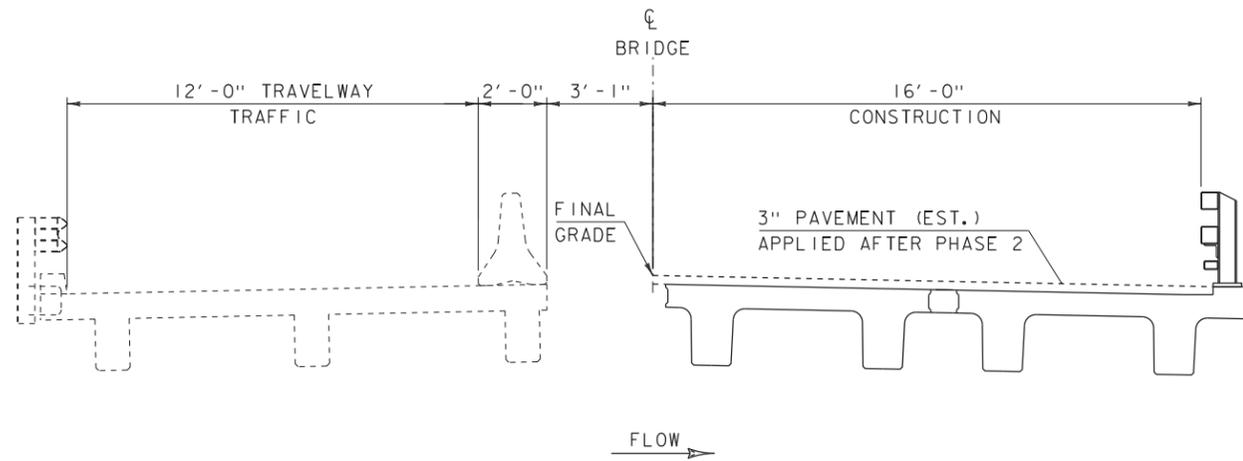
SUPERSTRUCTURE REPLACEMENT PHASE #1 TYPICAL SECTION

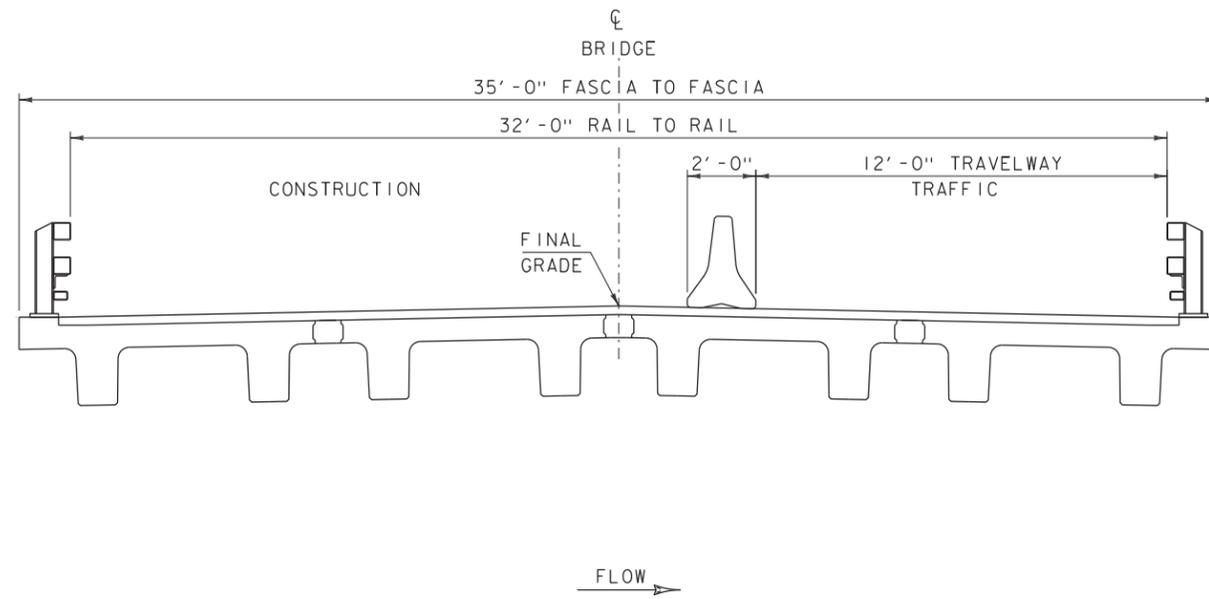
SUPERSTRUCTURE REPLACEMENT PHASE #2 TYPICAL SECTION
