**STATE OF VERMONT  
AGENCY OF TRANSPORTATION**

**Scoping Report**

**Calais BHF 037-2(12)  
VT 14, Bridge 77 over the Kingsbury Branch**

December 13, 2012

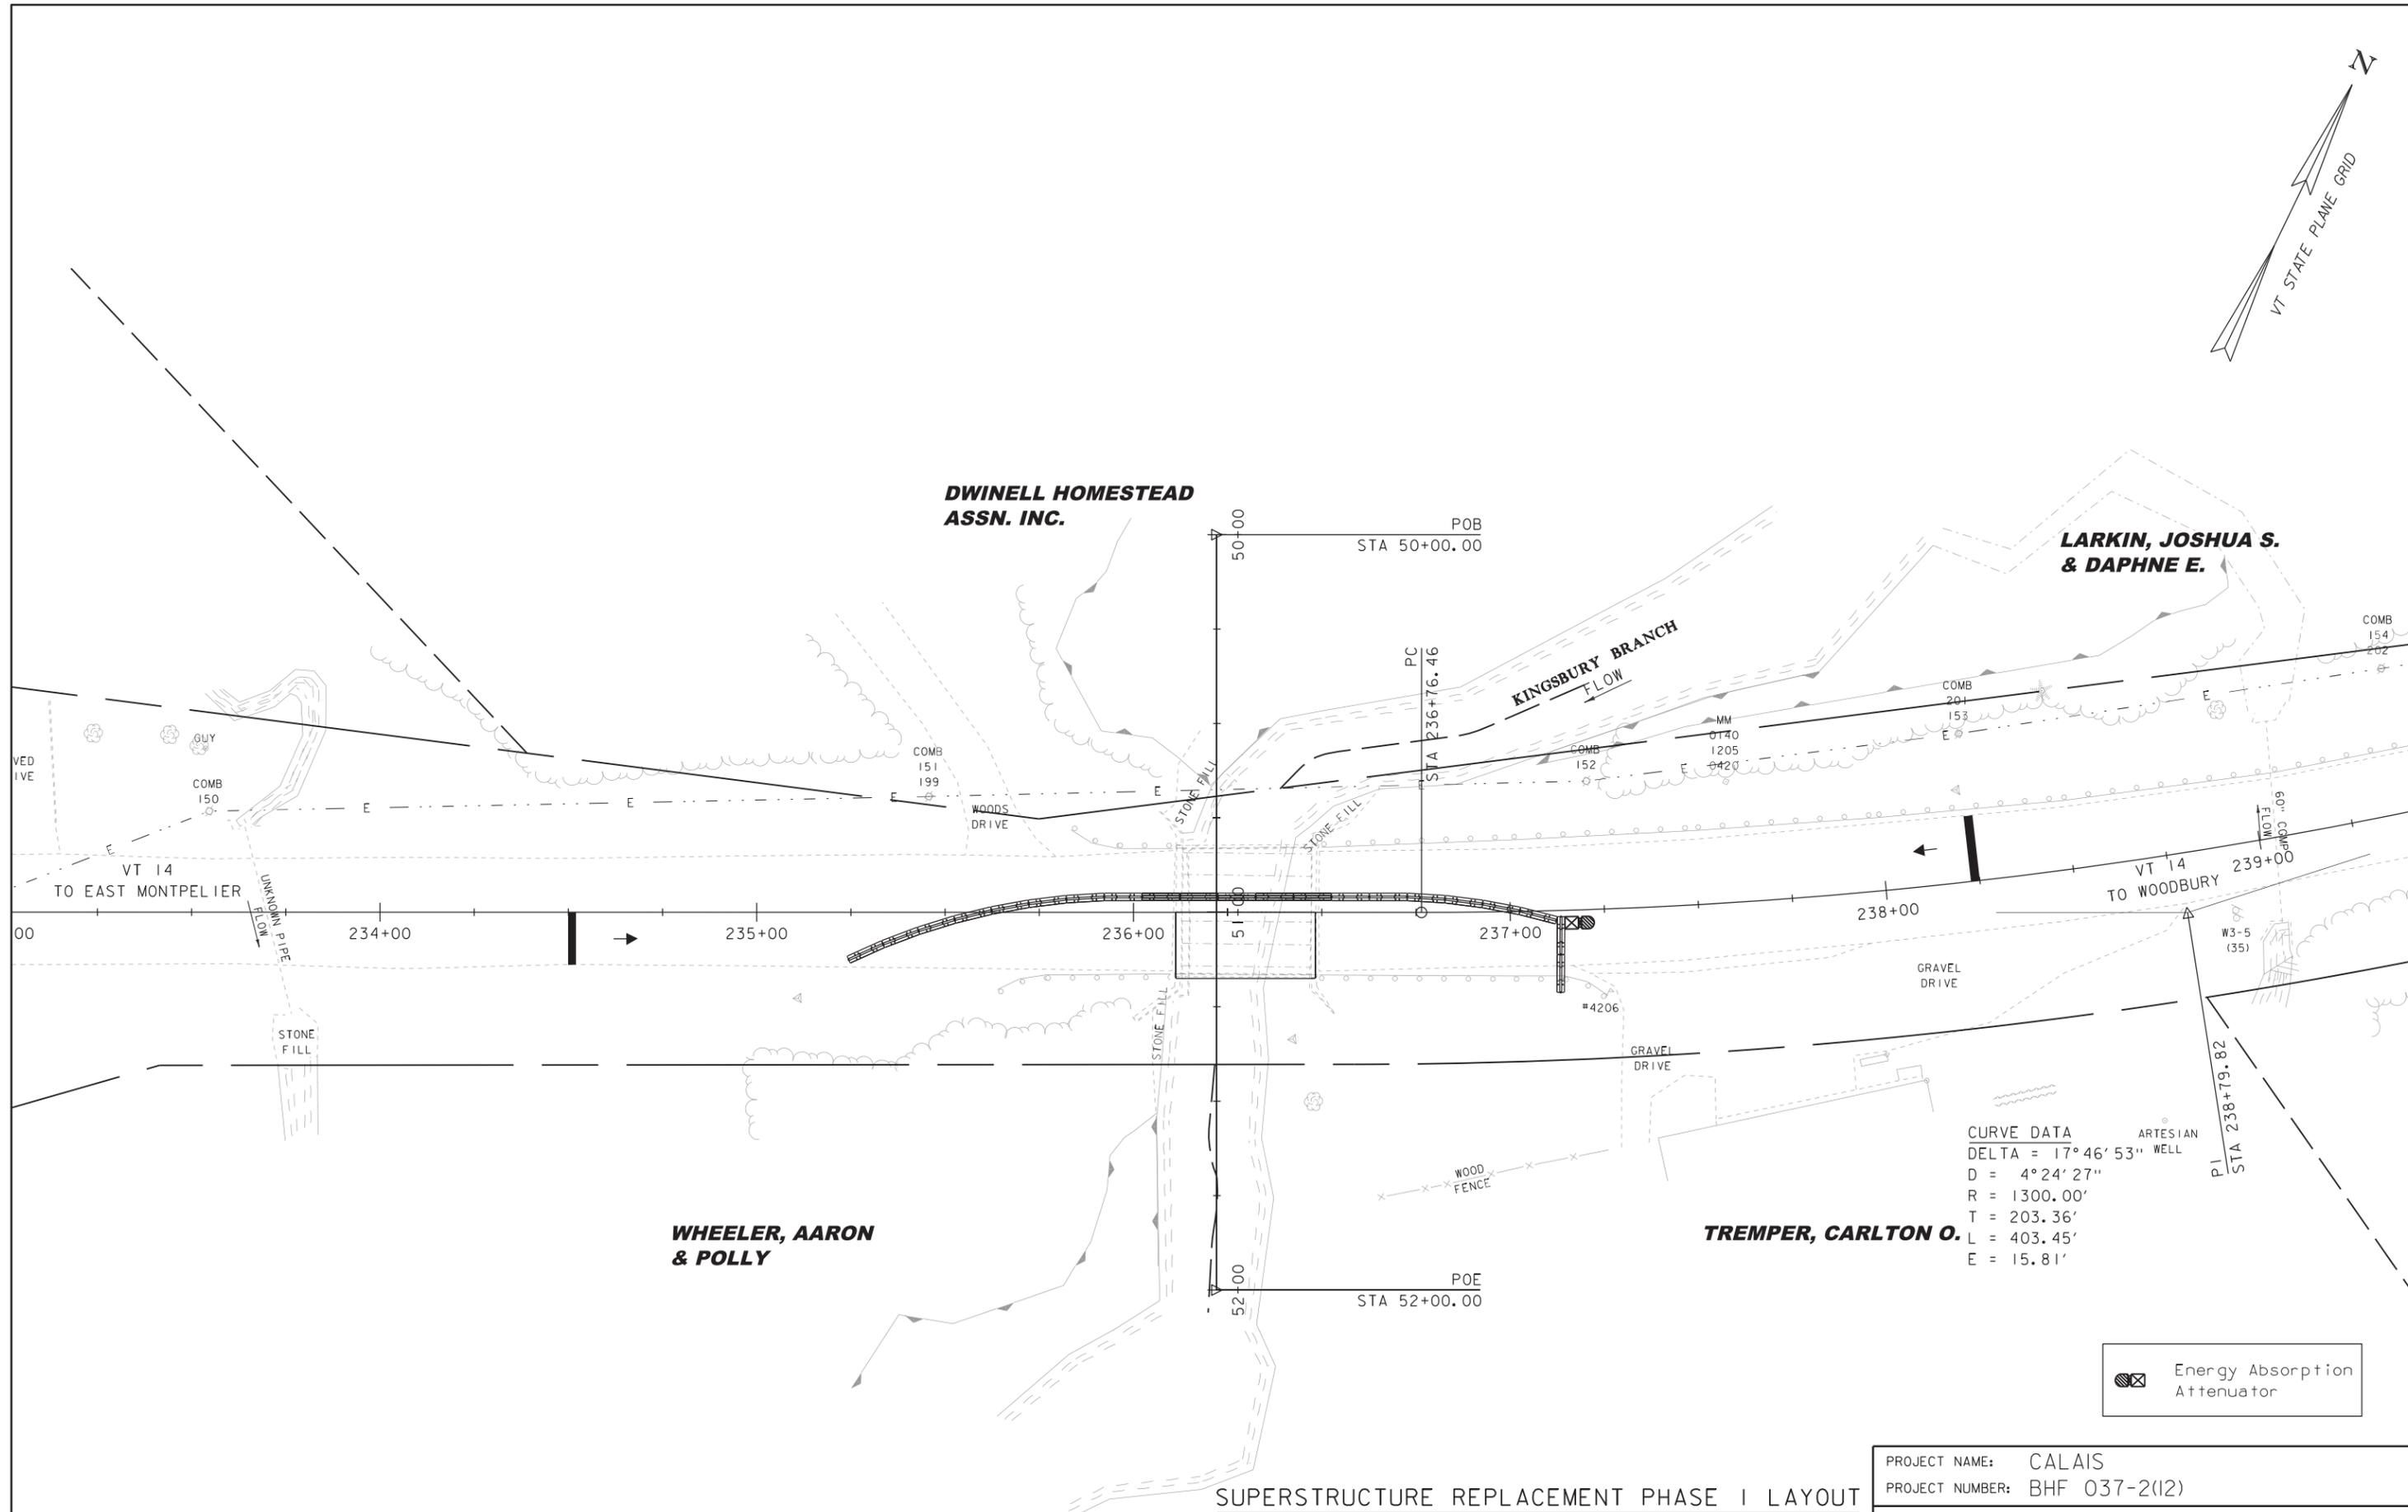
CURVE DATA  
 DELTA = 17° 46' 53"  
 D = 4° 24' 27"  
 R = 1300.00'  
 T = 203.36'  
 L = 403.45'  
 E = 15.81'

**SUPERSTRUCTURE REPLACEMENT PHASE I LAYOUT**

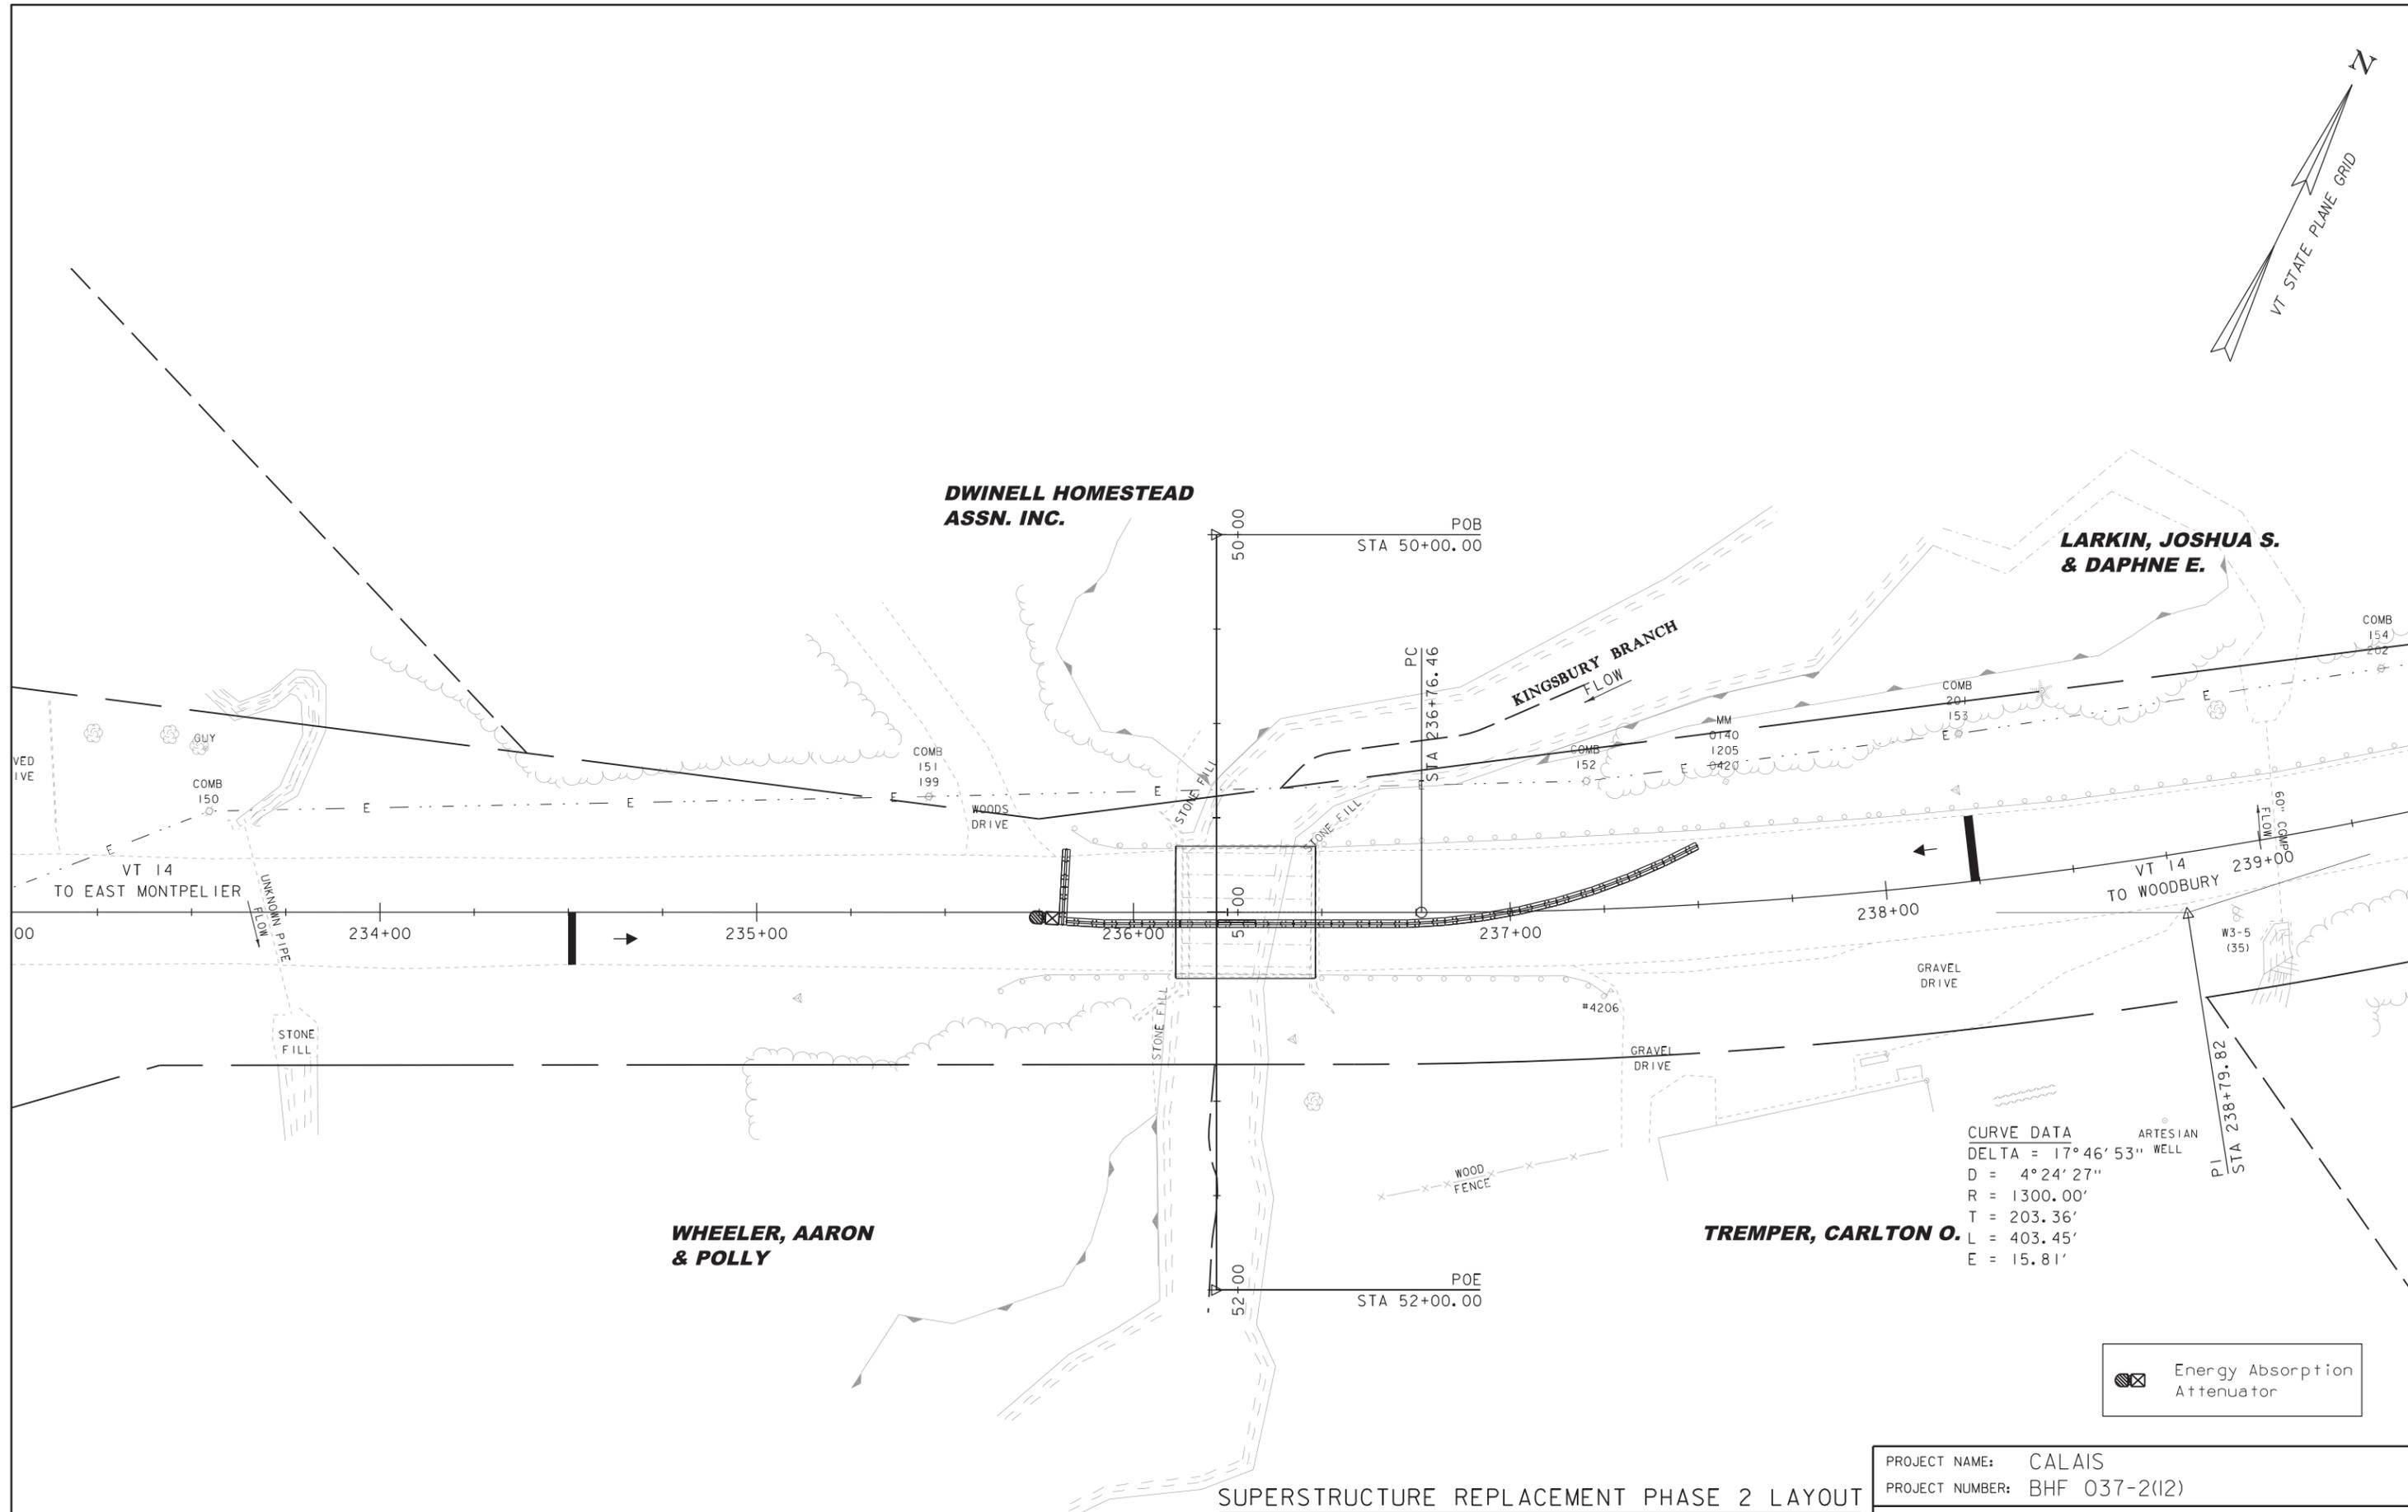
CURVE DATA  
 DELTA = 17° 46' 53"  
 D = 4° 24' 27"  
 R = 1300.00'  
 T = 203.36'  
 L = 403.45'  
 E = 15.81'

**SUPERSTRUCTURE REPLACEMENT PHASE 2 LAYOUT**

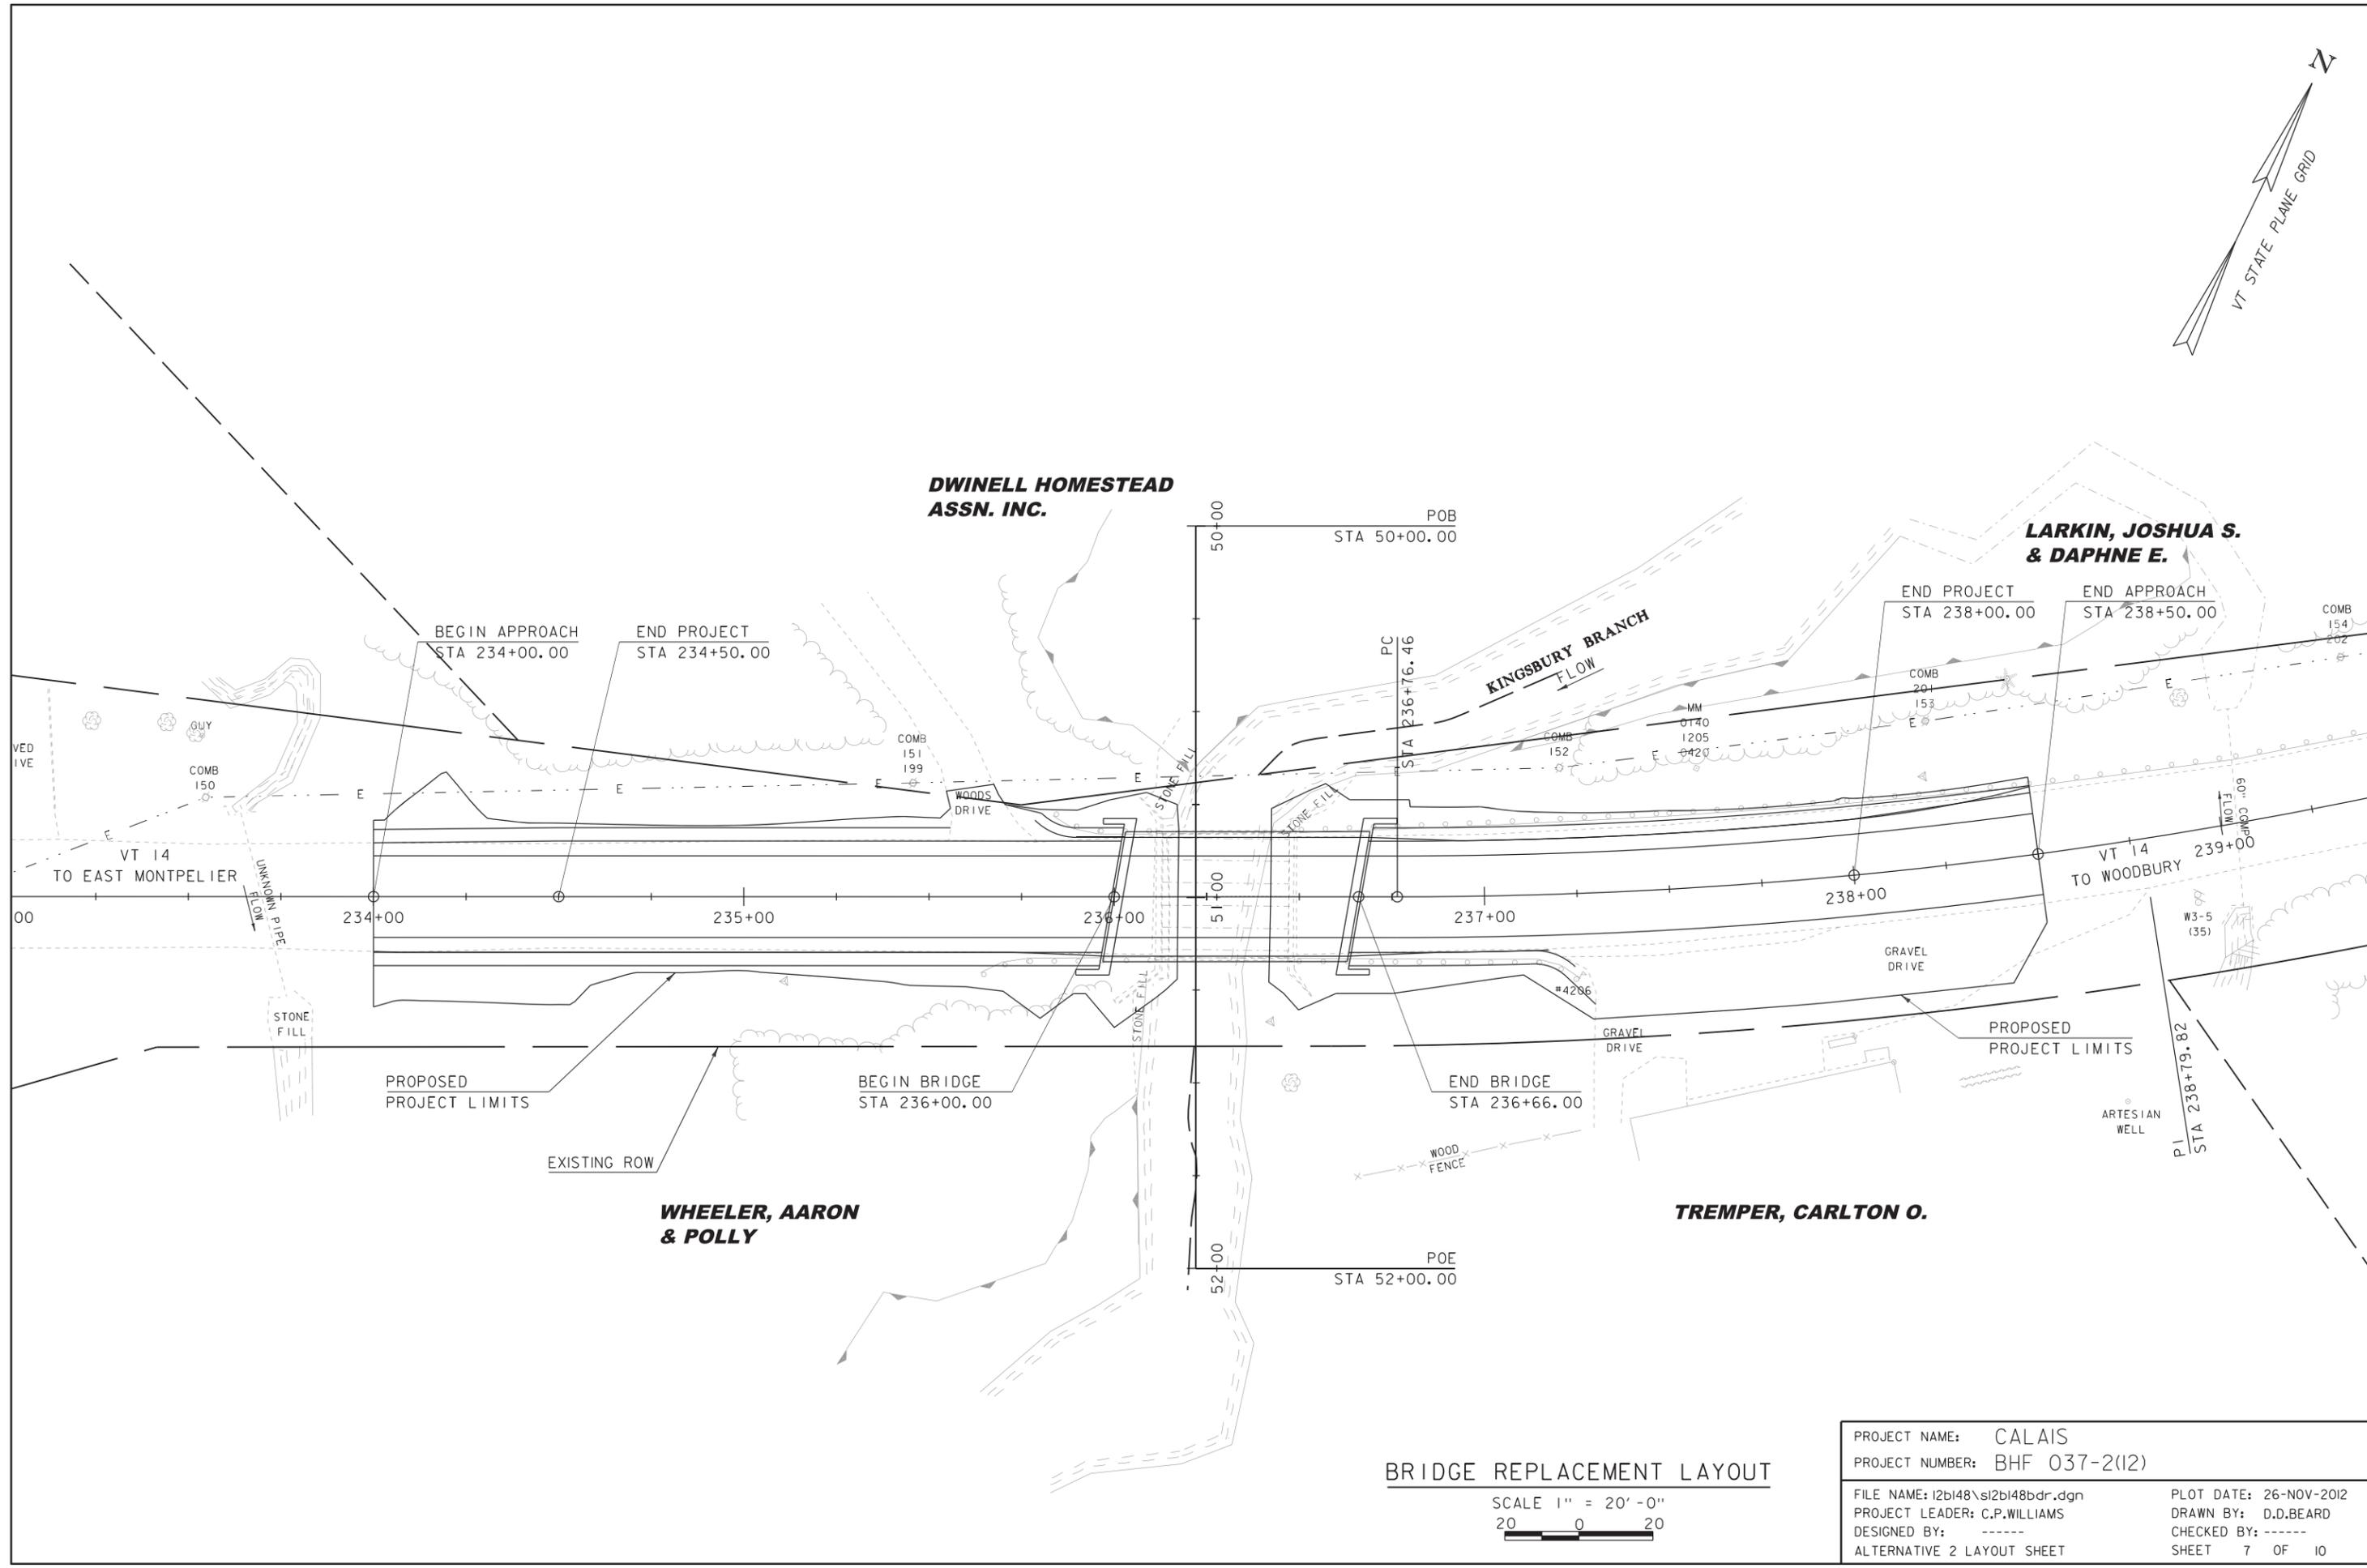
**BRIDGE REPLACEMENT LAYOUT**

Since both the hydraulics report and the input from the Town of Calais identified hydraulic issues at this structure, any replacement option should meet the recommended hydraulic criteria for this location. This would involve creating a wider opening and raising grade of the road. A new 66' single span bridge on integral abutments skewed 10° to the road will meet the requirements at this location. Raising the grade in order to meet the hydraulic criteria will necessitate obtaining temporary rights to match in to the field drive on the southwest corner of the site. No additional permanent rights should be required for this option. This alternative will meet all of the issues identified as addressable for this project.

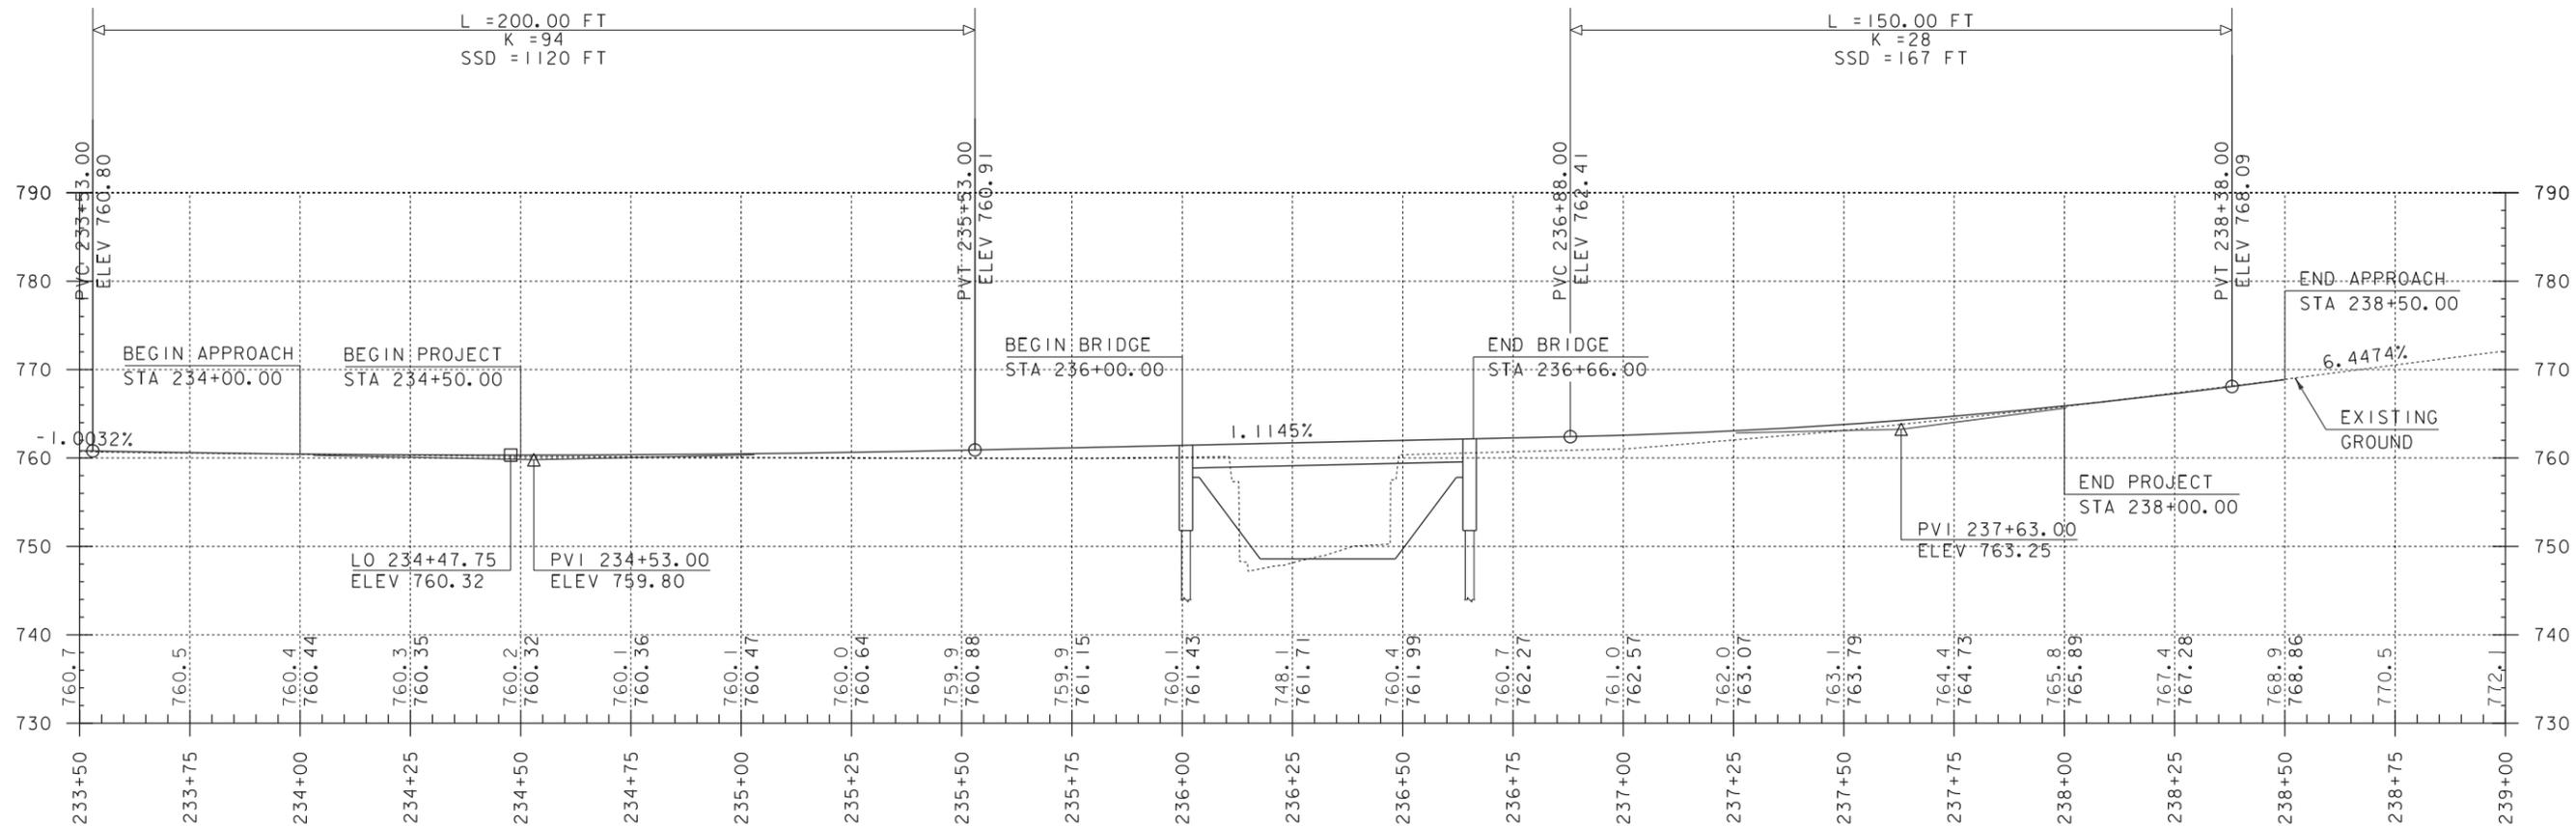
**VT RT 14 BRIDGE REPLACEMENT PROFILE**

GRADES SHOWN TO THE NEAREST HUNDREDTH ARE FINISH GRADE ALONG  $\phi$

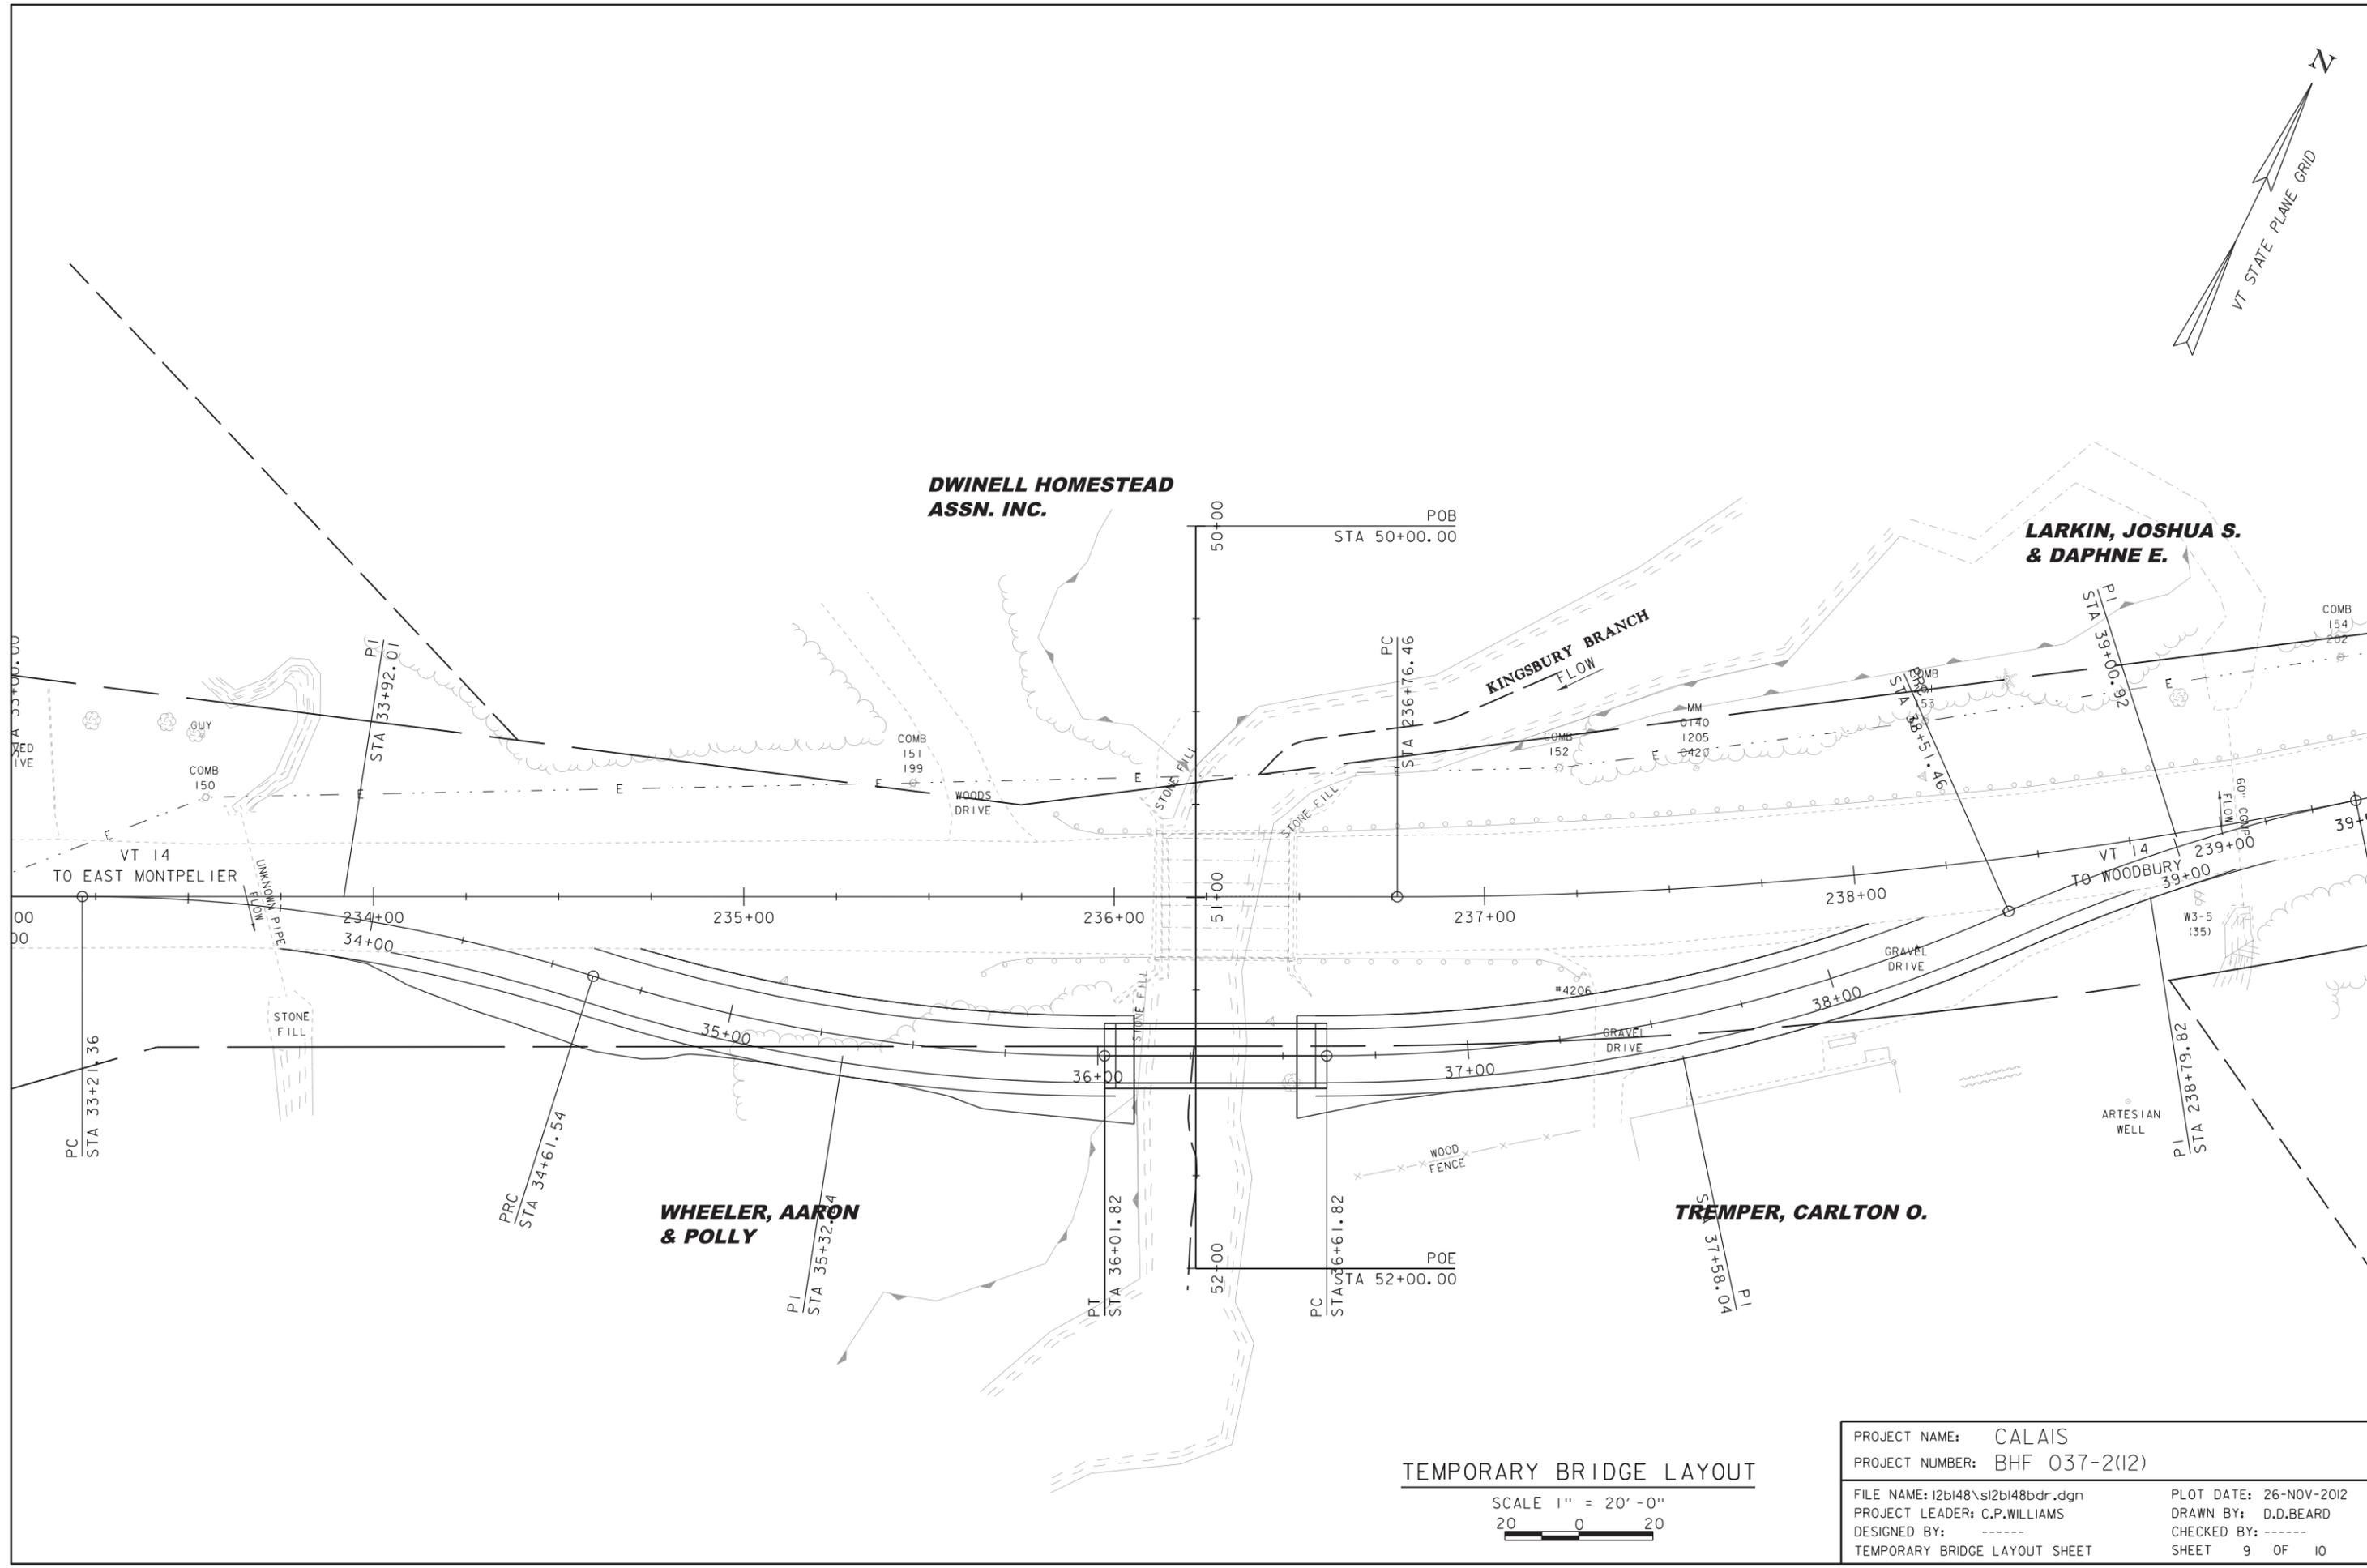
PROJECT NAME: CALAIS	PLOT DATE: 26-NOV-2012
PROJECT NUMBER: BHF 037-2(12)	DRAWN BY: D.D.BEARD
FILE NAME: I2bI48\sl2bI48bdr.dgn	CHECKED BY: -----
PROJECT LEADER: C.P.WILLIAMS	SHEET 9 OF 10
DESIGNED BY: -----	
TEMPORARY BRIDGE LAYOUT SHEET

Based on the length of the bridge and the traffic volumes at this location, a one lane two-way temporary bridge with traffic signals would be an appropriate choice for this location. Because the river closely parallels the road on the northwest side of the project, a temporary bridge would ideally be located on the eastern (downstream) side of the bridge.

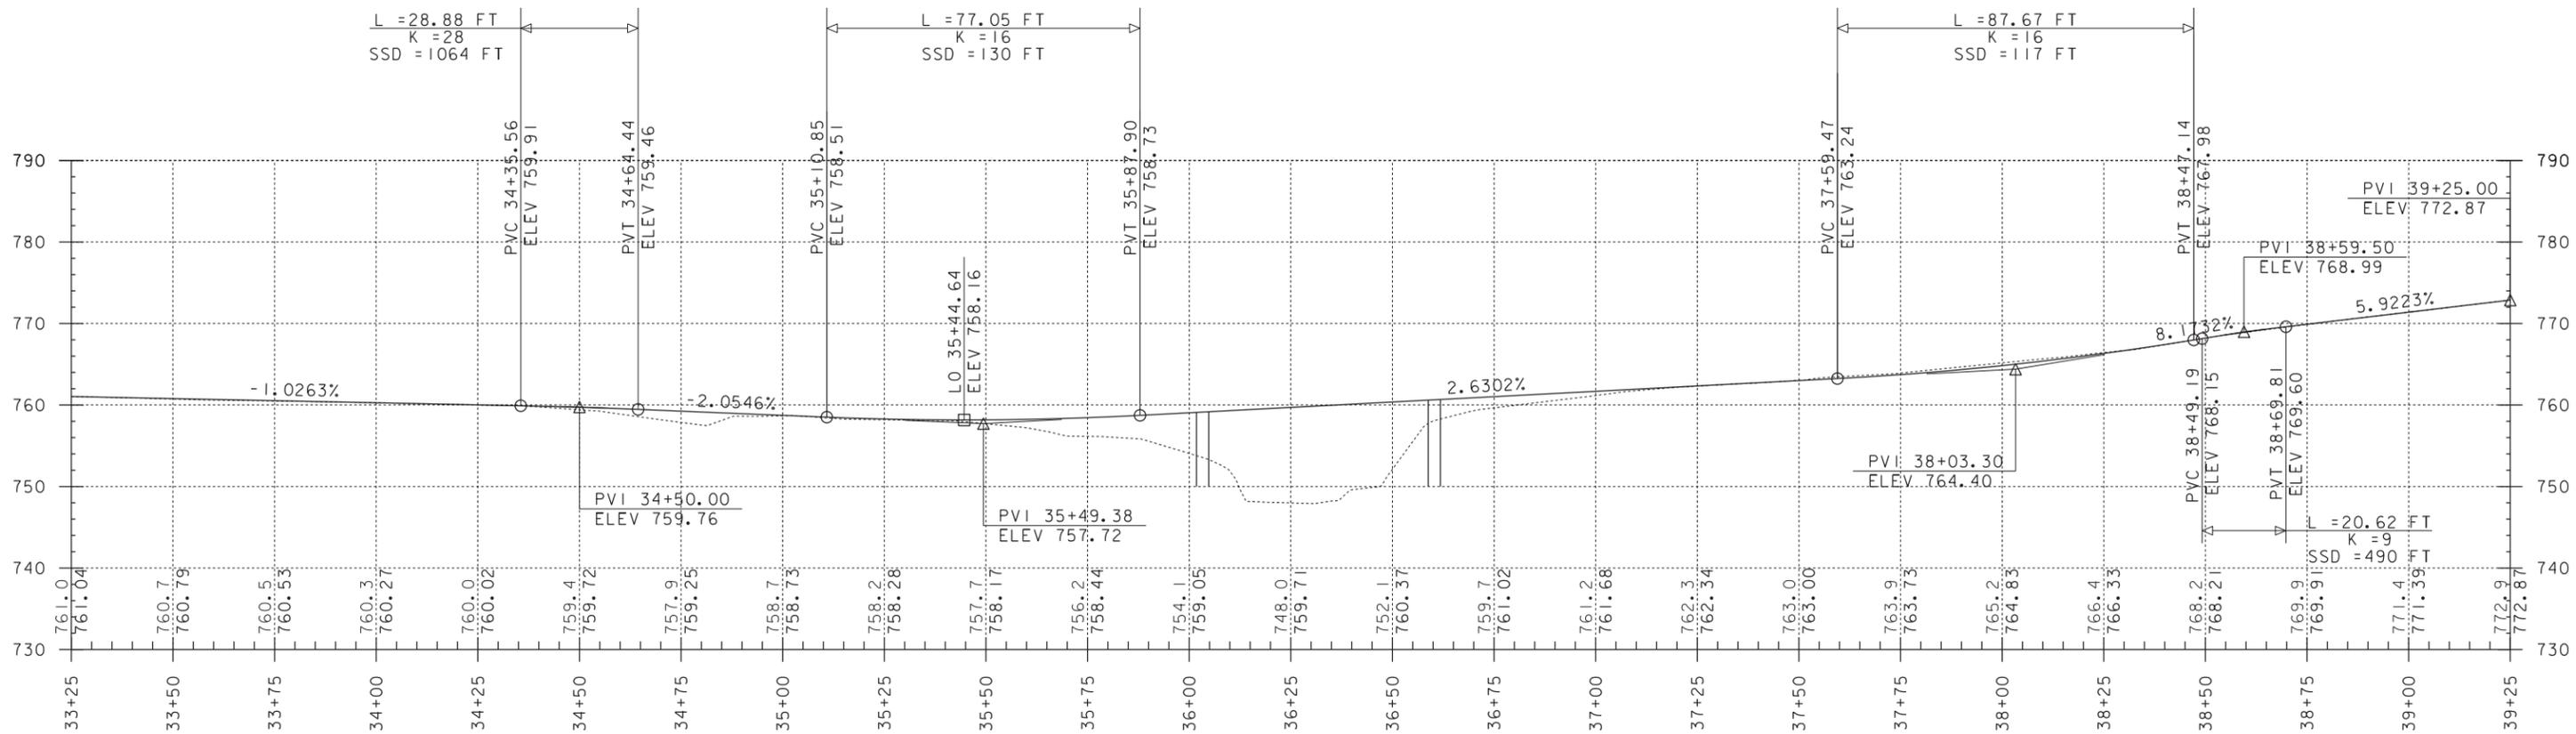
TEMPORARY BRIDGE PROFILE

GRADES SHOWN TO THE NEAREST TENTH ARE EXISTING GROUND ALONG  $\phi$
