**STATE OF VERMONT  
AGENCY OF TRANSPORTATION**

**Scoping Report**

**Chelsea BHF 0169(9)**

**VT ROUTE 110, Bridge #9  
OVER THE FIRST BRANCH OF THE WHITE RIVER**

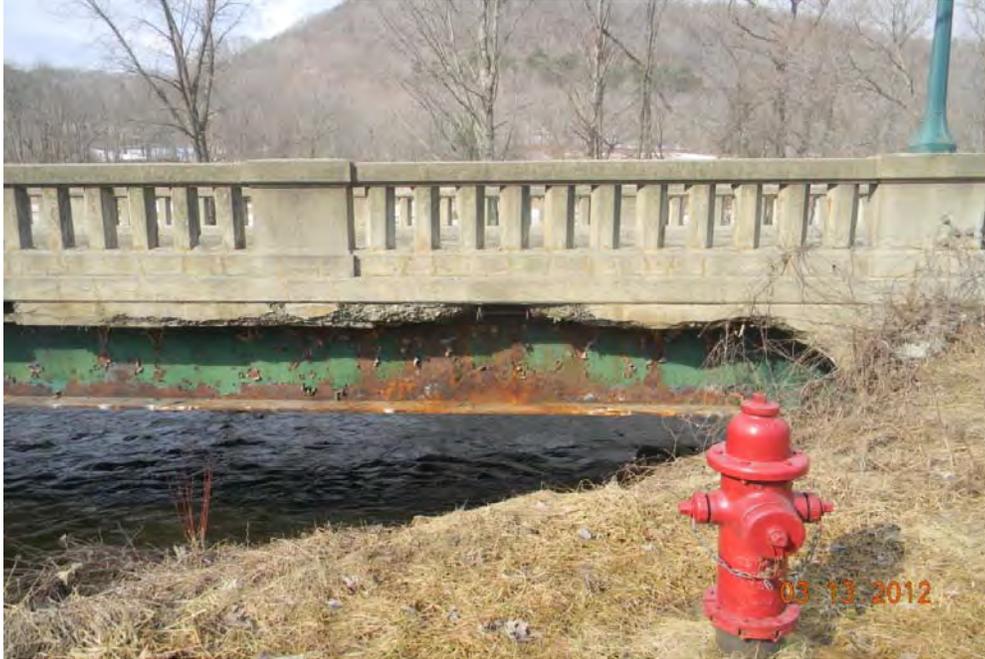
Deteriorated Concrete Deck and Steel Beam Surface Corrosion

1. The deck is in poor condition with a rating of 4 (Poor) in the latest inspection report. There is presently a steel plate covering holes in the deck, which rocks under traffic loads, making it impossible to maintain smooth pavement.
2. The bridge does not meet the hydraulic standard.
3. The width of the bridge deck is substandard.
4. The transition from approach guardrail to bridge guardrail and the approach guardrail ends do not meet the current standard. Additionally, the approach guardrail ends do not meet the current standard.

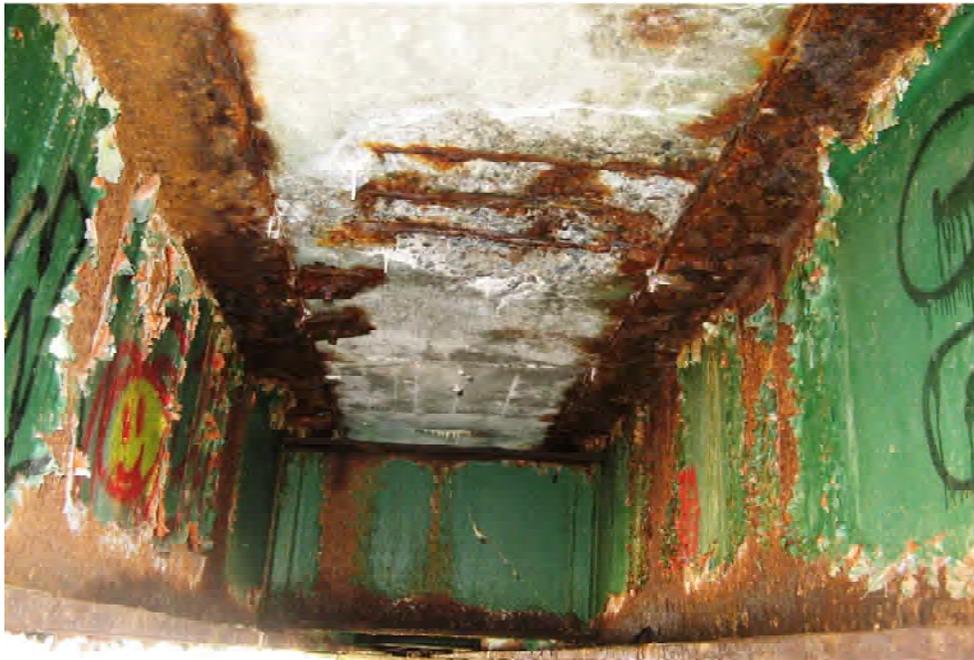
Deteriorated Concrete Deck and Steel Beam Surface Corrosion

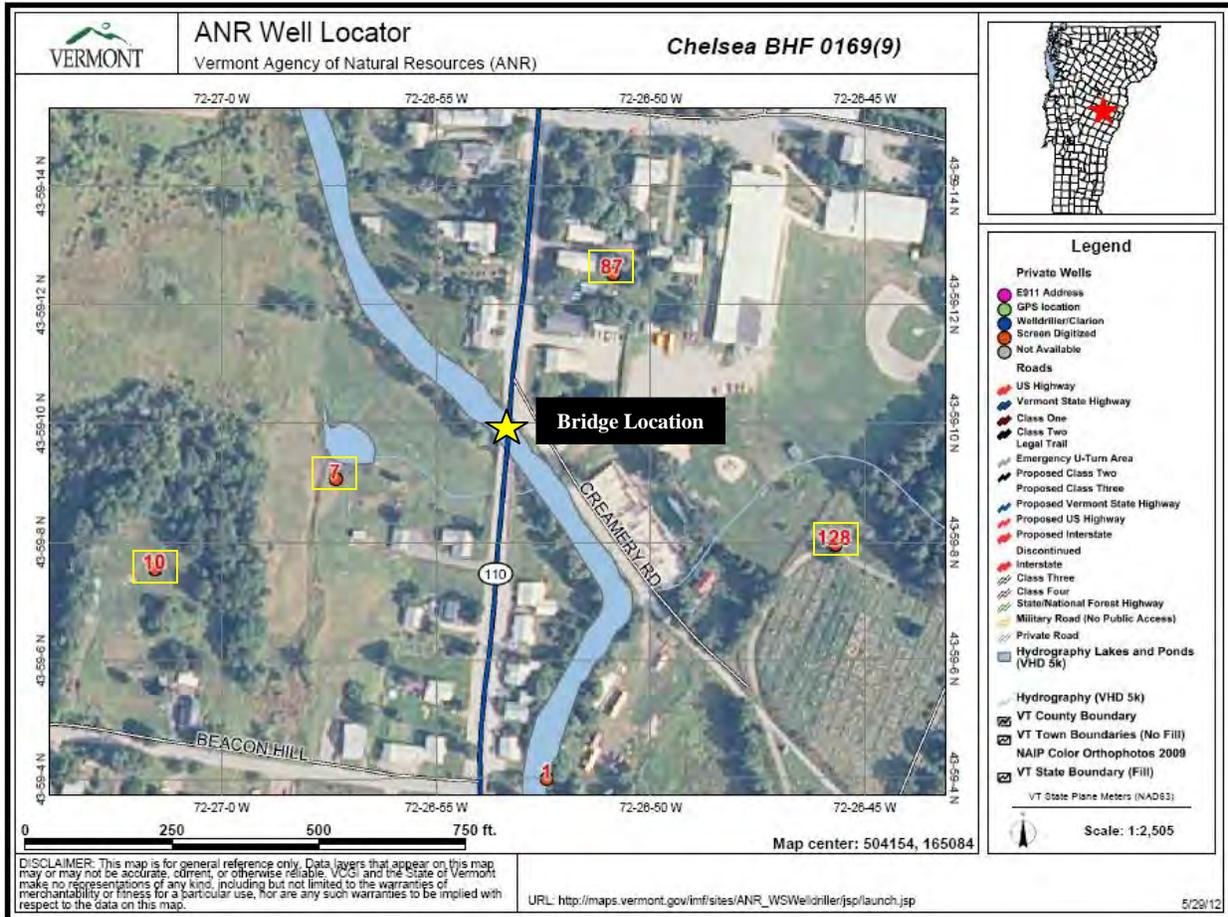
Figure 1. Site map with well locations.

The ANR provides published water well logs, which were referenced with data from wells that were within a 625 foot radius. The data provided an estimated depth to bedrock and soils types expected to be encountered on the site. It should be noted that this information is dependent upon field data collection by various unknown personnel and therefore provides only an approximation of the field conditions. The corresponding well locations are highlighted in Figure 1.

Four wells were identified within the 625 foot radius from the bridge site. The bedrock and overburden information for each well is listed in Table 1.

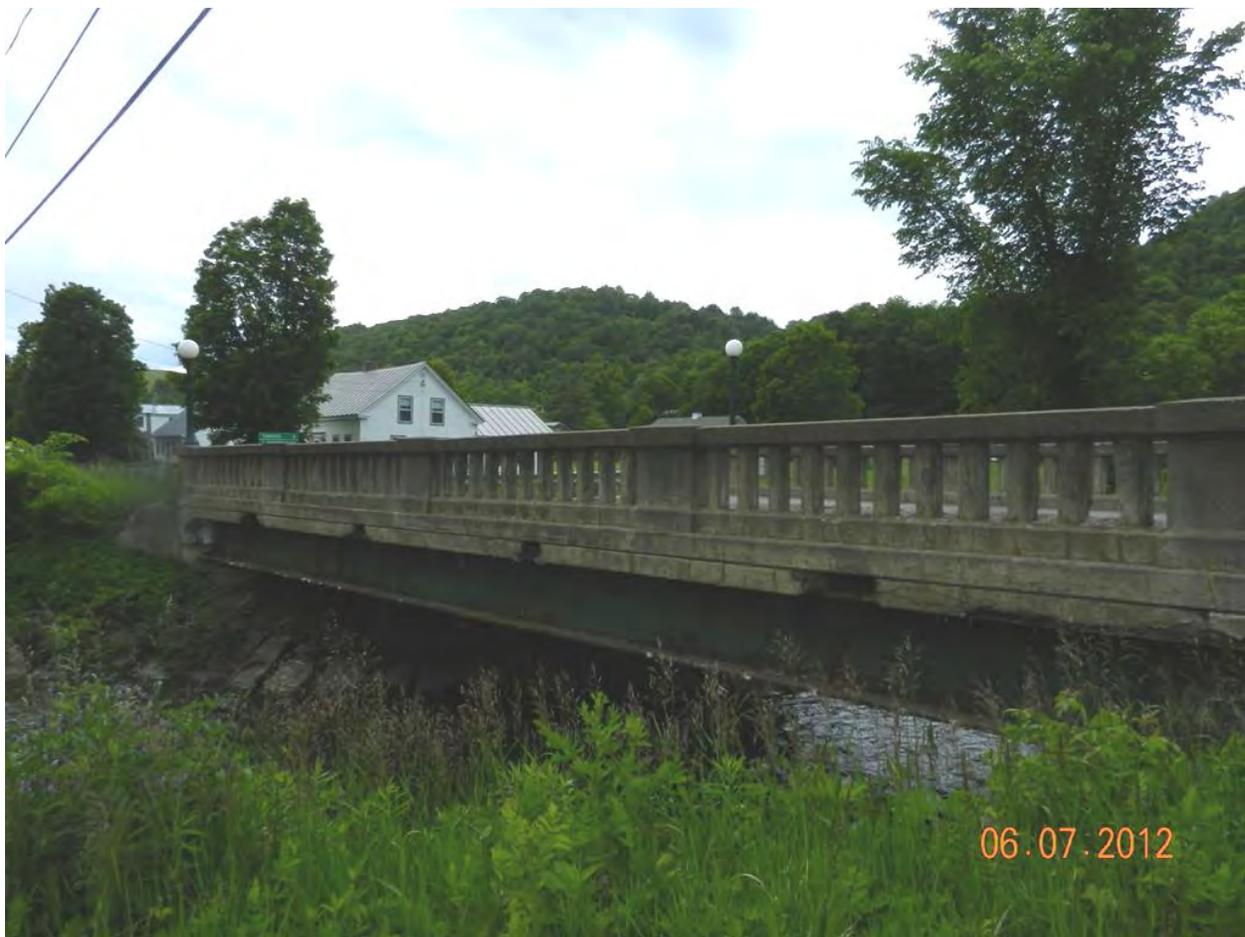
**Figure 3.** View of existing bridge, facing south.

The streambed material consisted of cobbles, with a higher concentration upstream. There were large rectangular rip rap stones lining the channel on either side under the bridge as well as downstream. This condition could cause conflicts with both boring and construction operations.

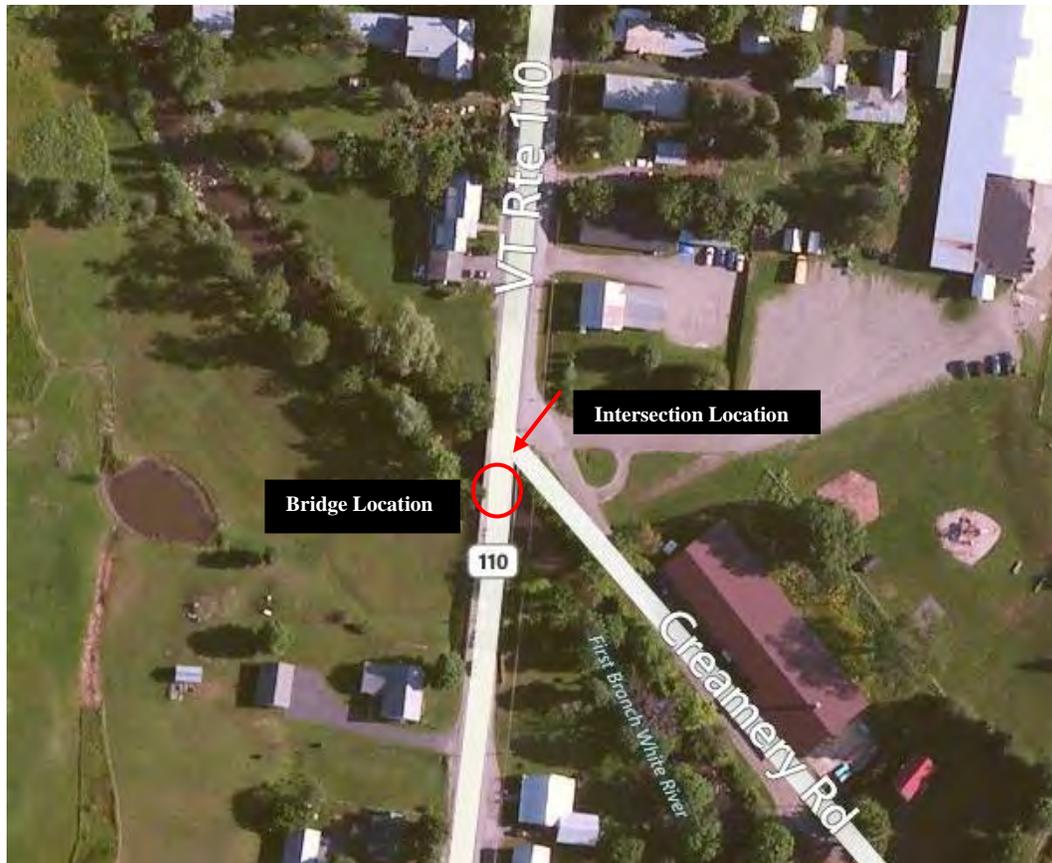
**Figure 4.** Bridge proximity to the Creamery Rd. junction.

When determining appropriate traffic control measures during construction and the drilling operations, consideration should be given to the nearby intersection with Creamery Rd. has poor visibility due to bridge rails obstructing sight distances; see Figure 4.

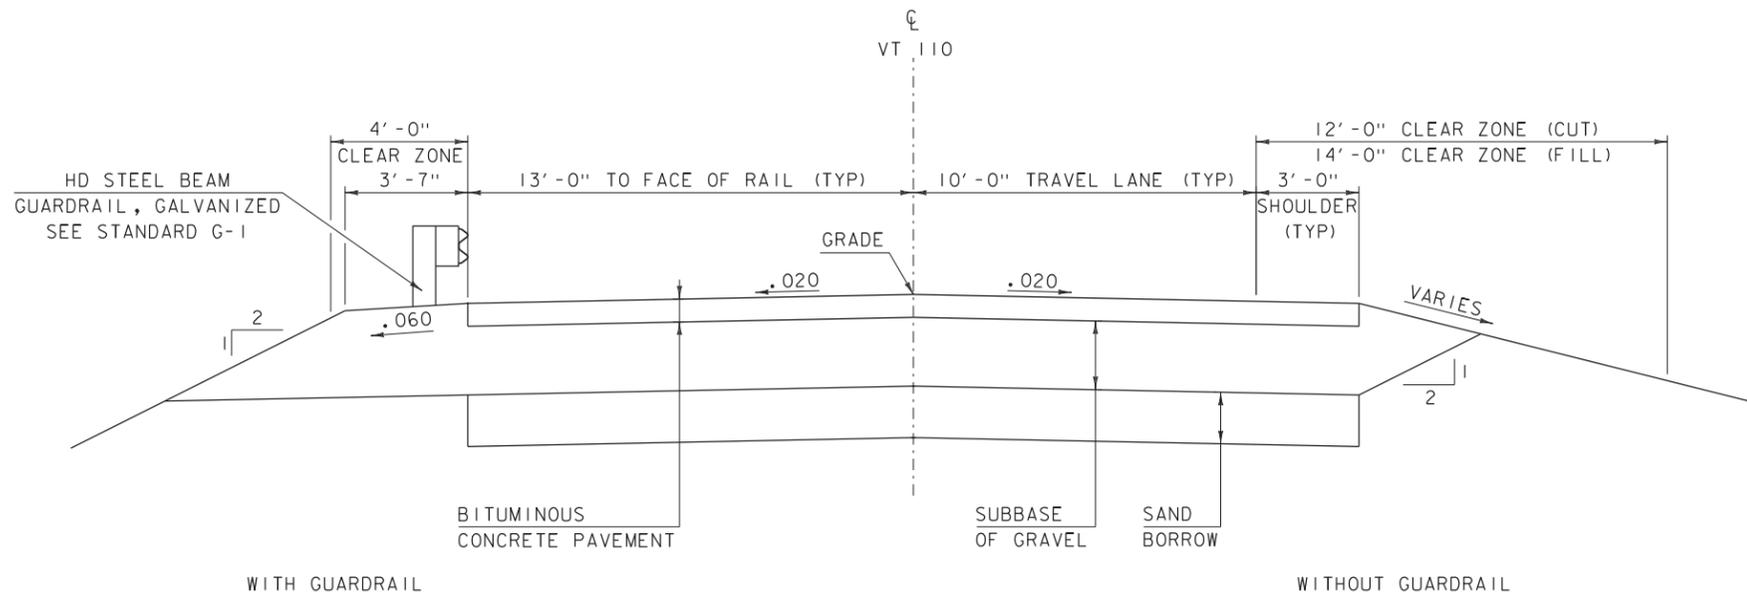
**VT ROUTE 110 TYPICAL ROADWAY SECTION**

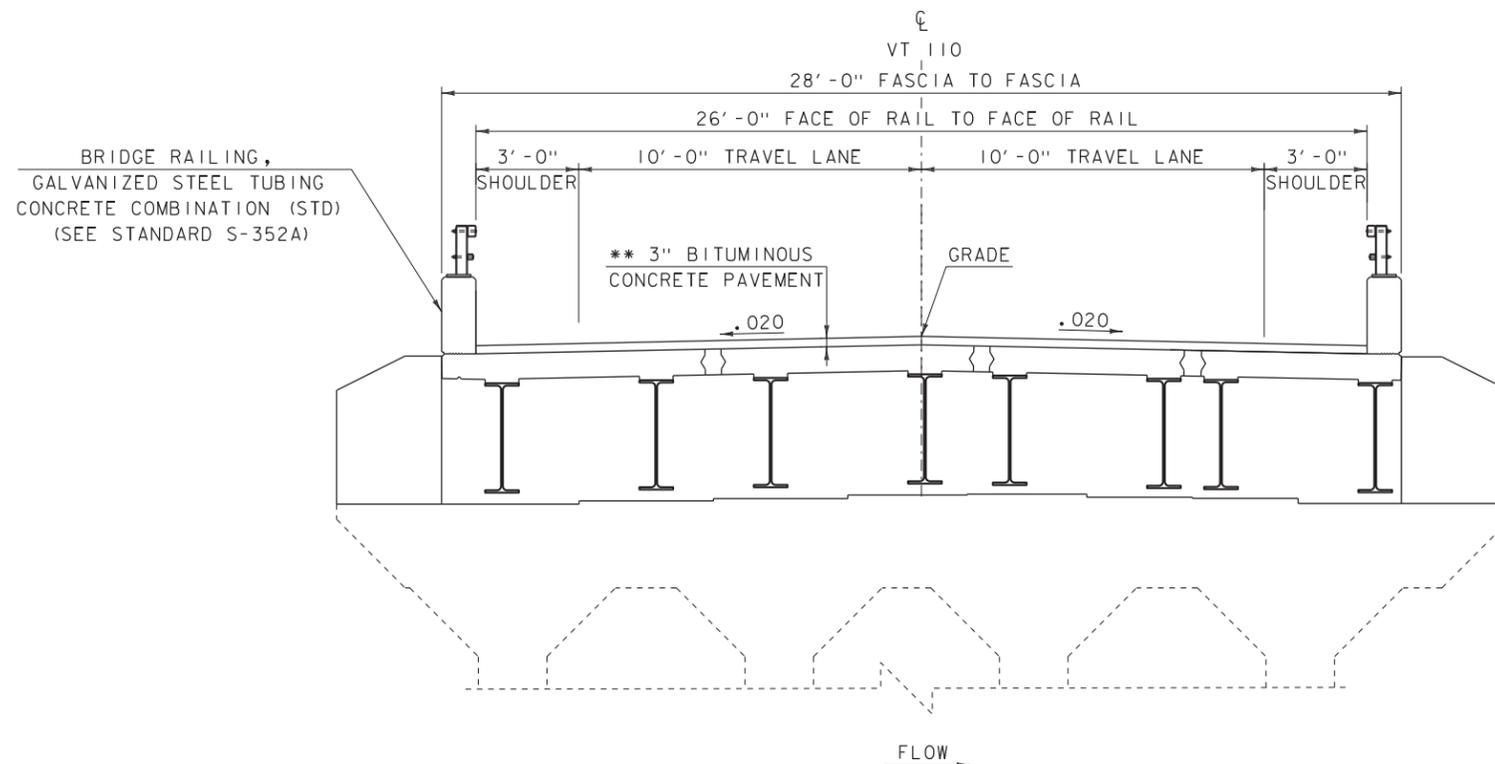
**PROPOSED BRIDGE TYPICAL SECTION**

- An expansion joint is recommended.
- Span would remain at approximately 81 ft.
- Deck width would be 28 ft. total, with lane and shoulder widths of 3-10-10-3.

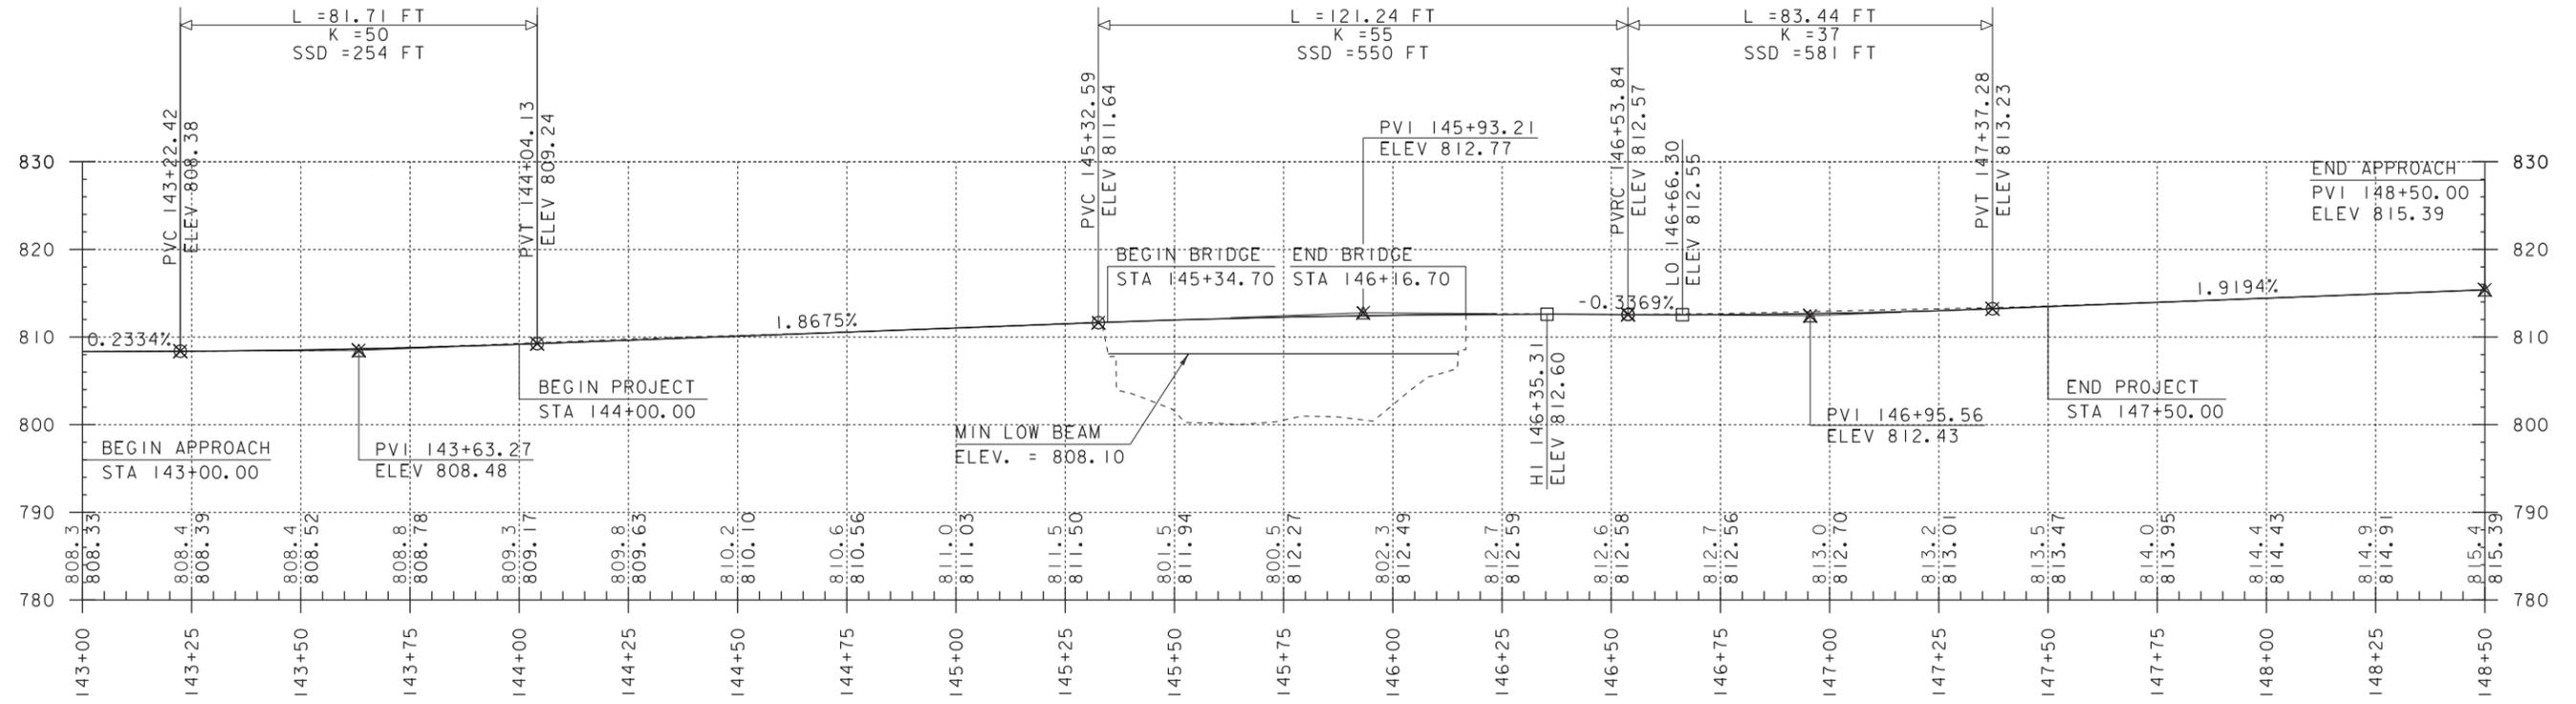
**VT RT 110 PROFILE  
PROPOSED ALIGNMENT 2' UPSTREAM**

GRADES SHOWN TO THE NEAREST HUNDREDTH ARE FINISH GRADE ALONG CL

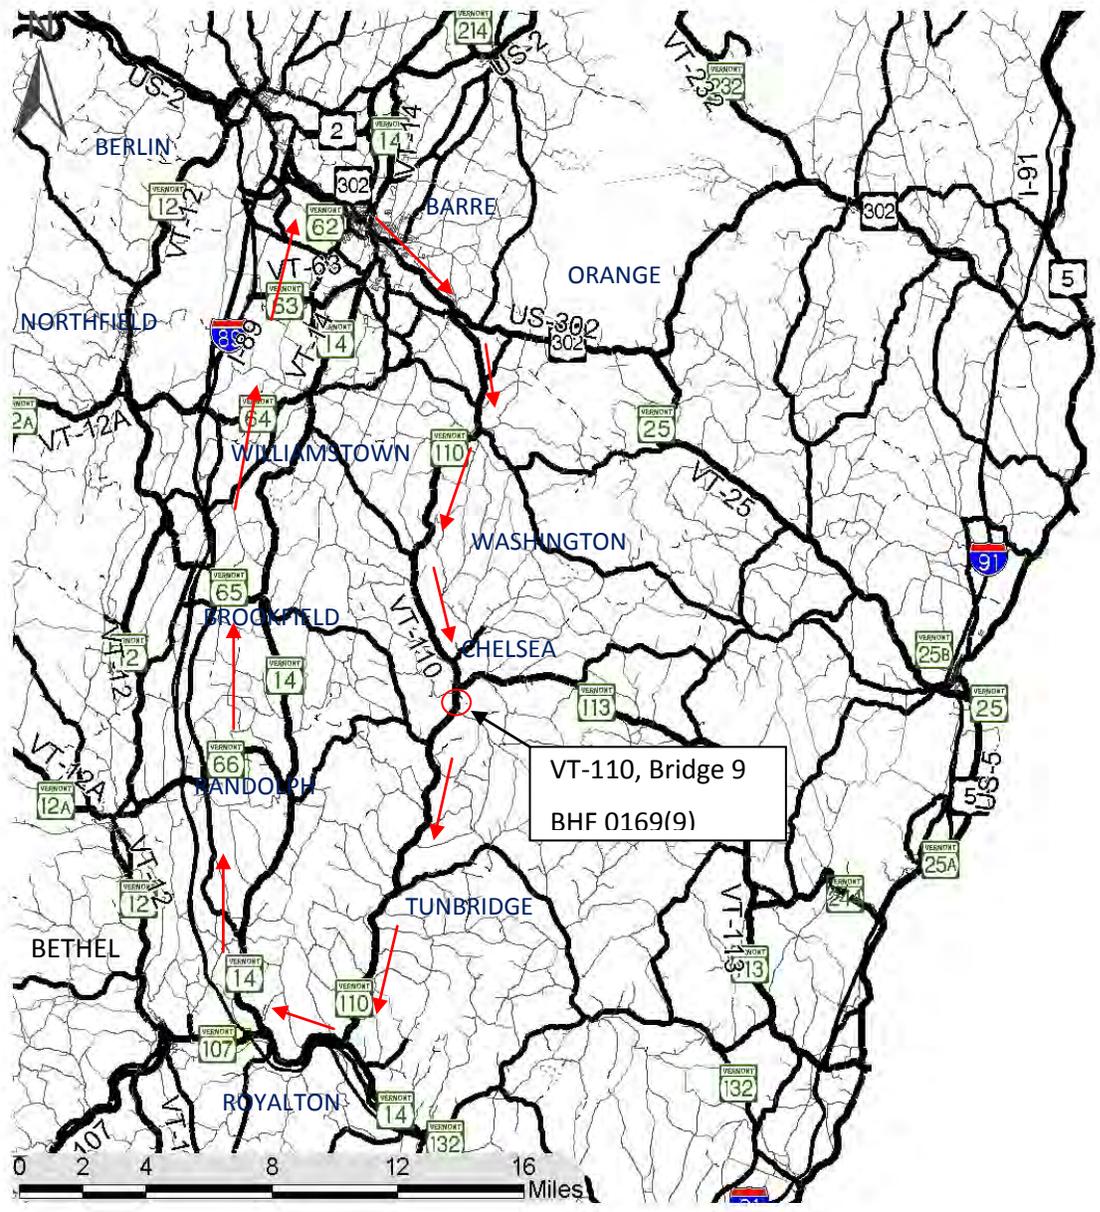
Detour Route: VT 110 to VT 14 to VT 107 to

Interstate 89 North (Exit 3) to Route 62 (Exit 7) to

Additional Distance: 14 miles

End to End Distance: 68 miles

- South on VT 110 to VT 14 or I-89 in Royalton.
- North on VT 14 or I-89 to Barre, where the two routes converge.
- North into the city, then west on US 302, back to VT 110.
- VT 110 south to Chelsea.

This detour adds 14 miles to the through route of 27 miles. The end to end distance is approximately 68 miles. There are no good alternatives to this route due to the lack of Class 1 Town Highways and other State routes in the area.

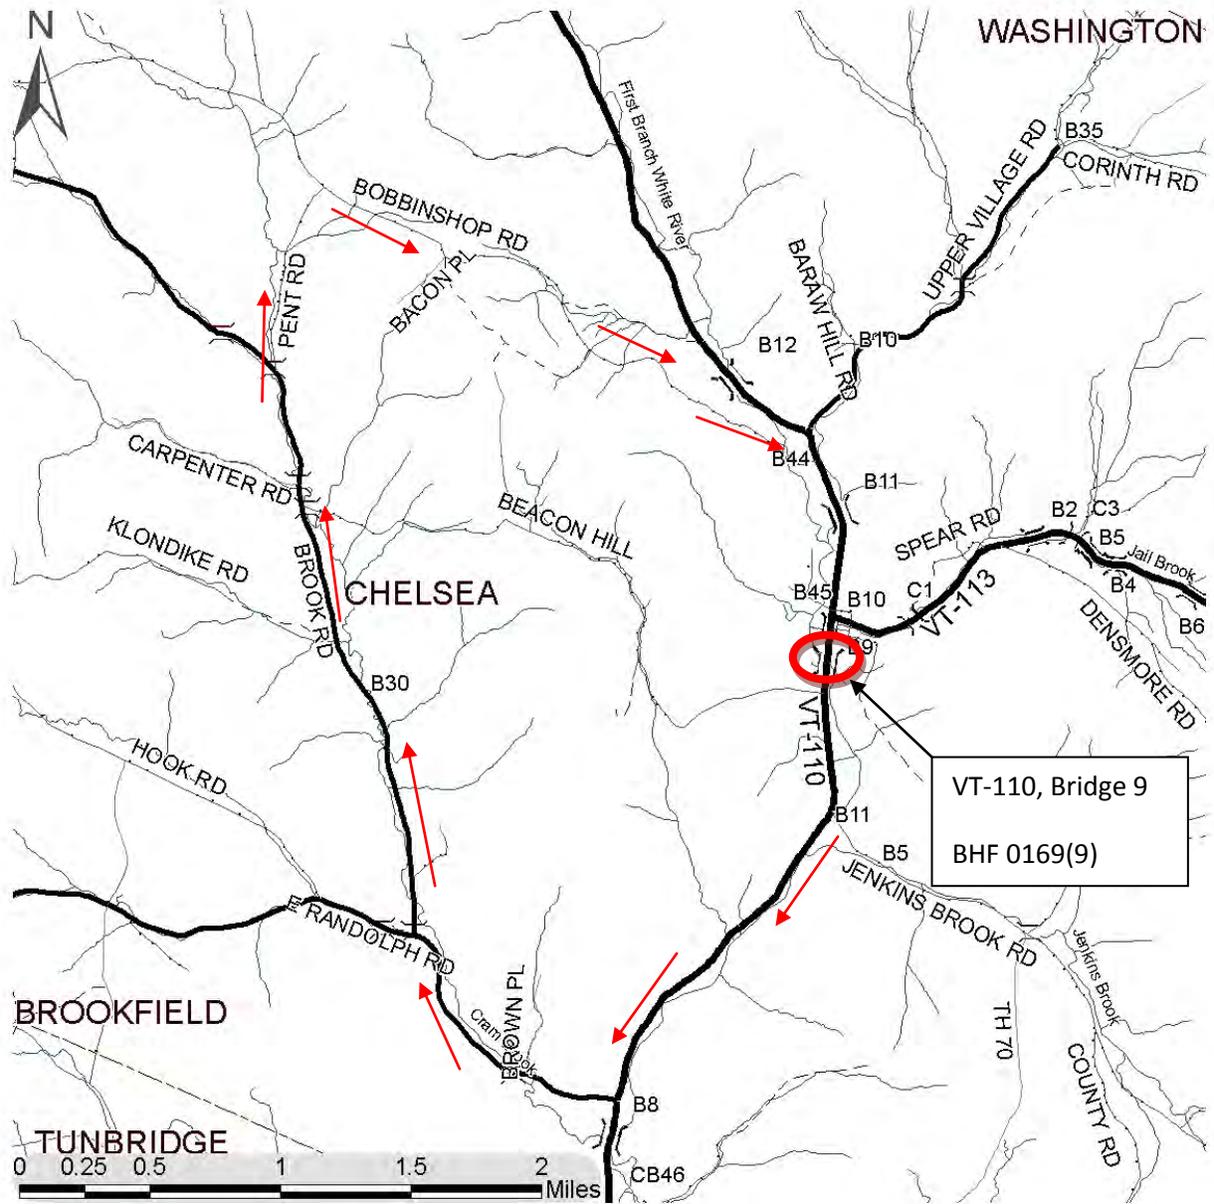
Bypass Route: VT 110 to East Randolph Road (TH-1, FAS 0264, Class 2, Paved) to Brook Road (TH-3, Class 2, Gravel) to Pent Road (TH-33, Class 3, Gravel) to Bobbin Shop Road (TH-4, Class 3, Gravel), back to VT 110.

Distance for	Thru Route:	2.79 miles
	Bypass Route:	6.59 miles
	Additional Distance:	3.80 miles
	End to End Distance:	9.38 miles

Bypass routes are frequently on Town roads. One potential bypass route could be west of Chelsea via VT 110 south, then west on E. Randolph Road (TH-1, Class 2), north on Brook Road (TH-3, Class 2), north on Pent Road (TH-33, Class 3), east on Lyford Hill Road (TH-4, Class3), and back to VT 110. Lyford Hill Road may also be known as Bobbin Shop Road.

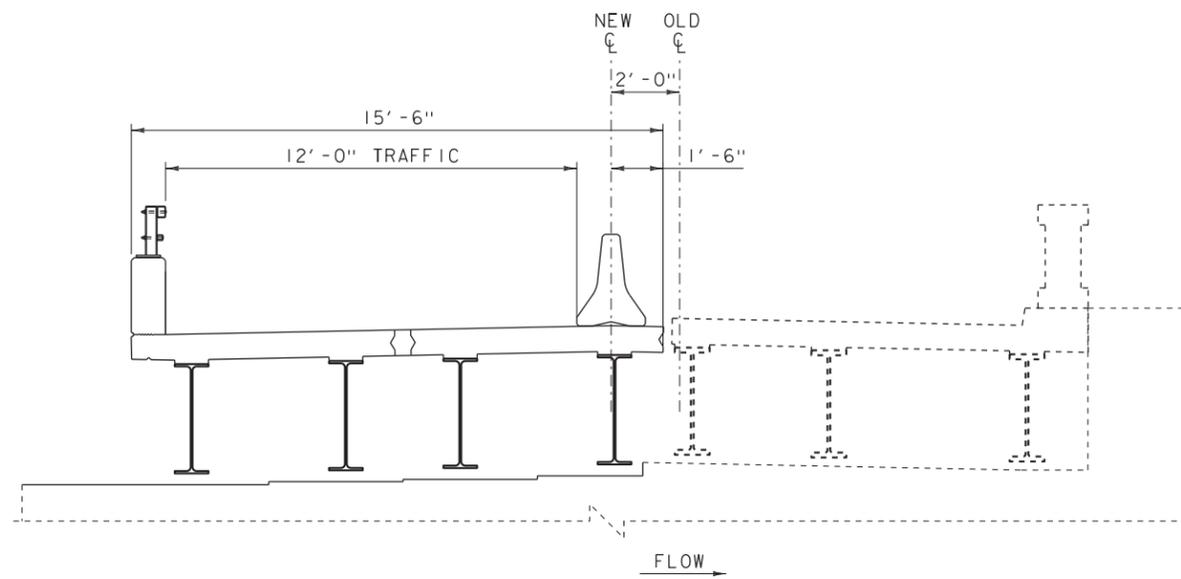
**PHASE #1 TYPICAL SECTION**

BRIDGE WILL BE CLOSED PRIOR TO THIS PHASE

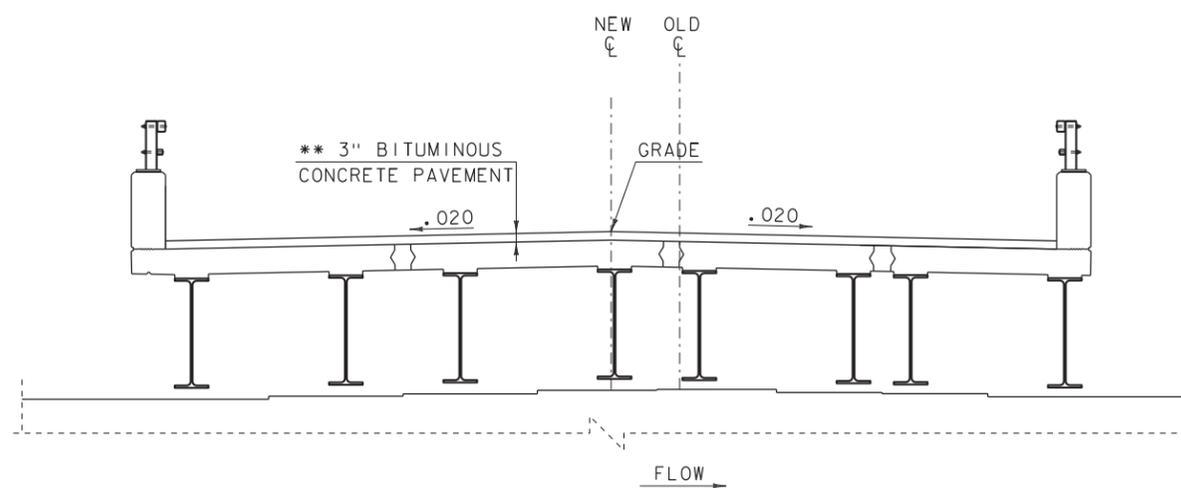
**PHASE #2 TYPICAL SECTION**
