**Clarendon BRO 1443(48)  
Bridge 11 on TH 3 (Walker Mtn. Rd)  
Over Clarendon River  
Alternatives Presentation**

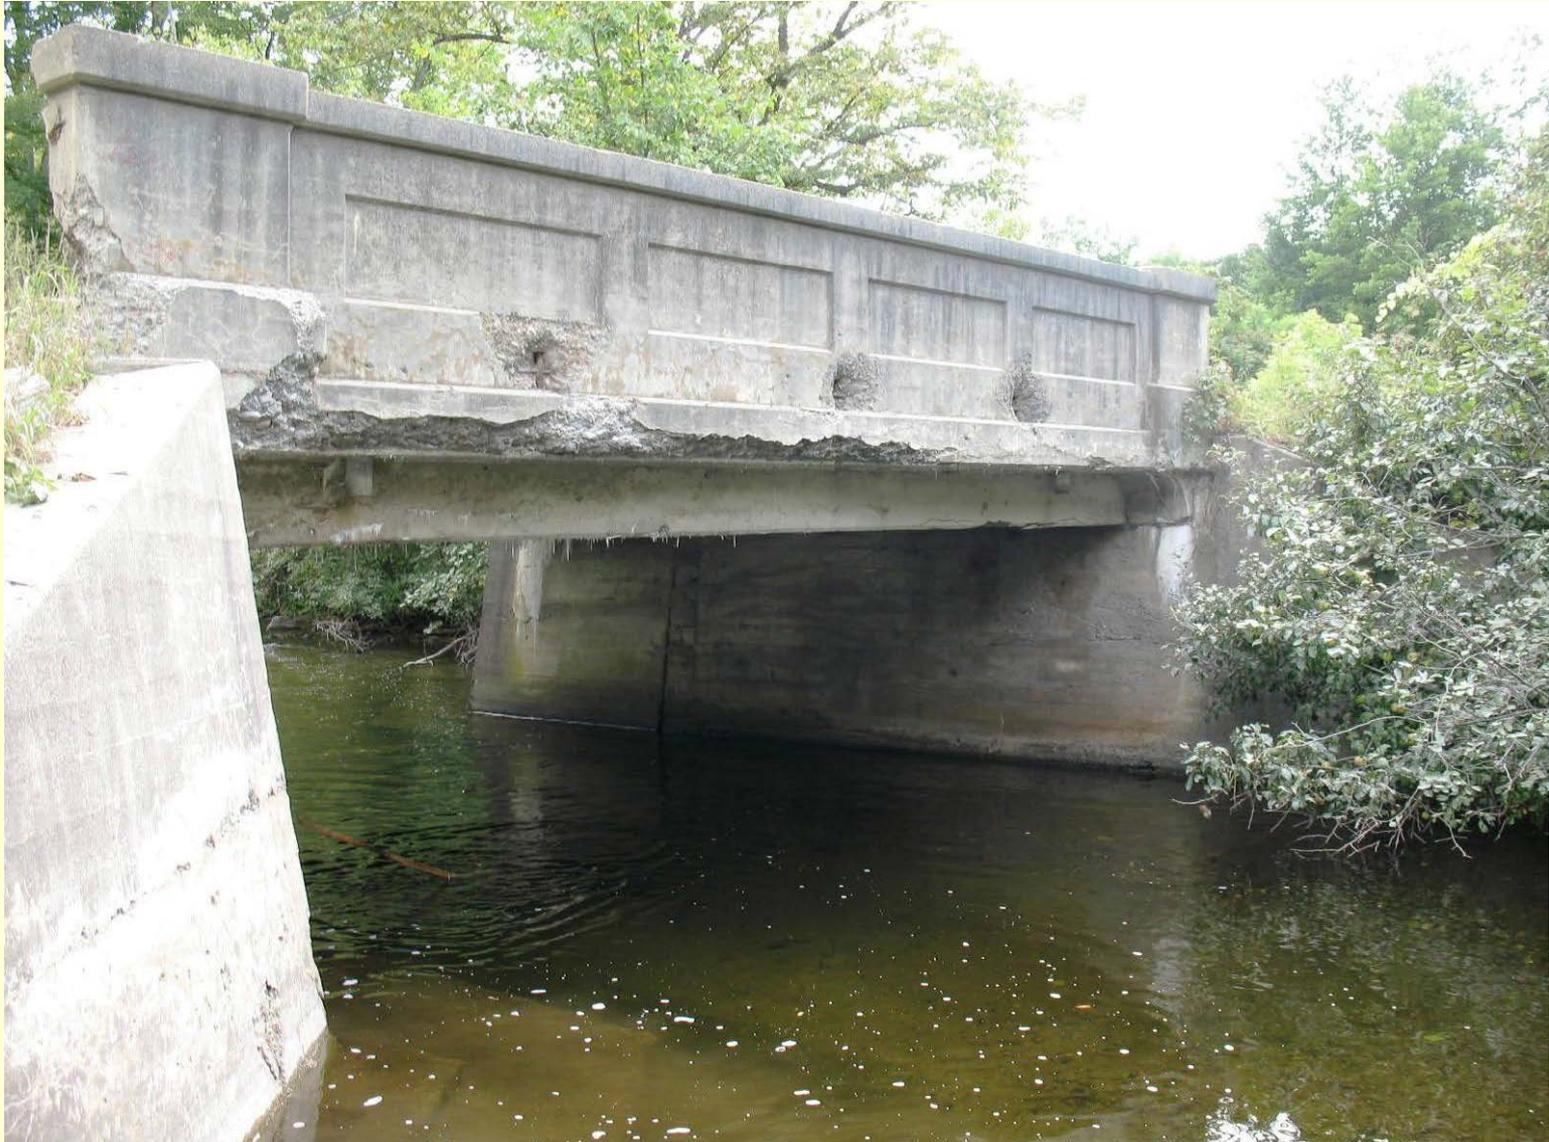
# Bridge Fascia

Deck Rating	4 Poor
Superstructure Rating	4 Poor
Substructure Rating	5 Fair

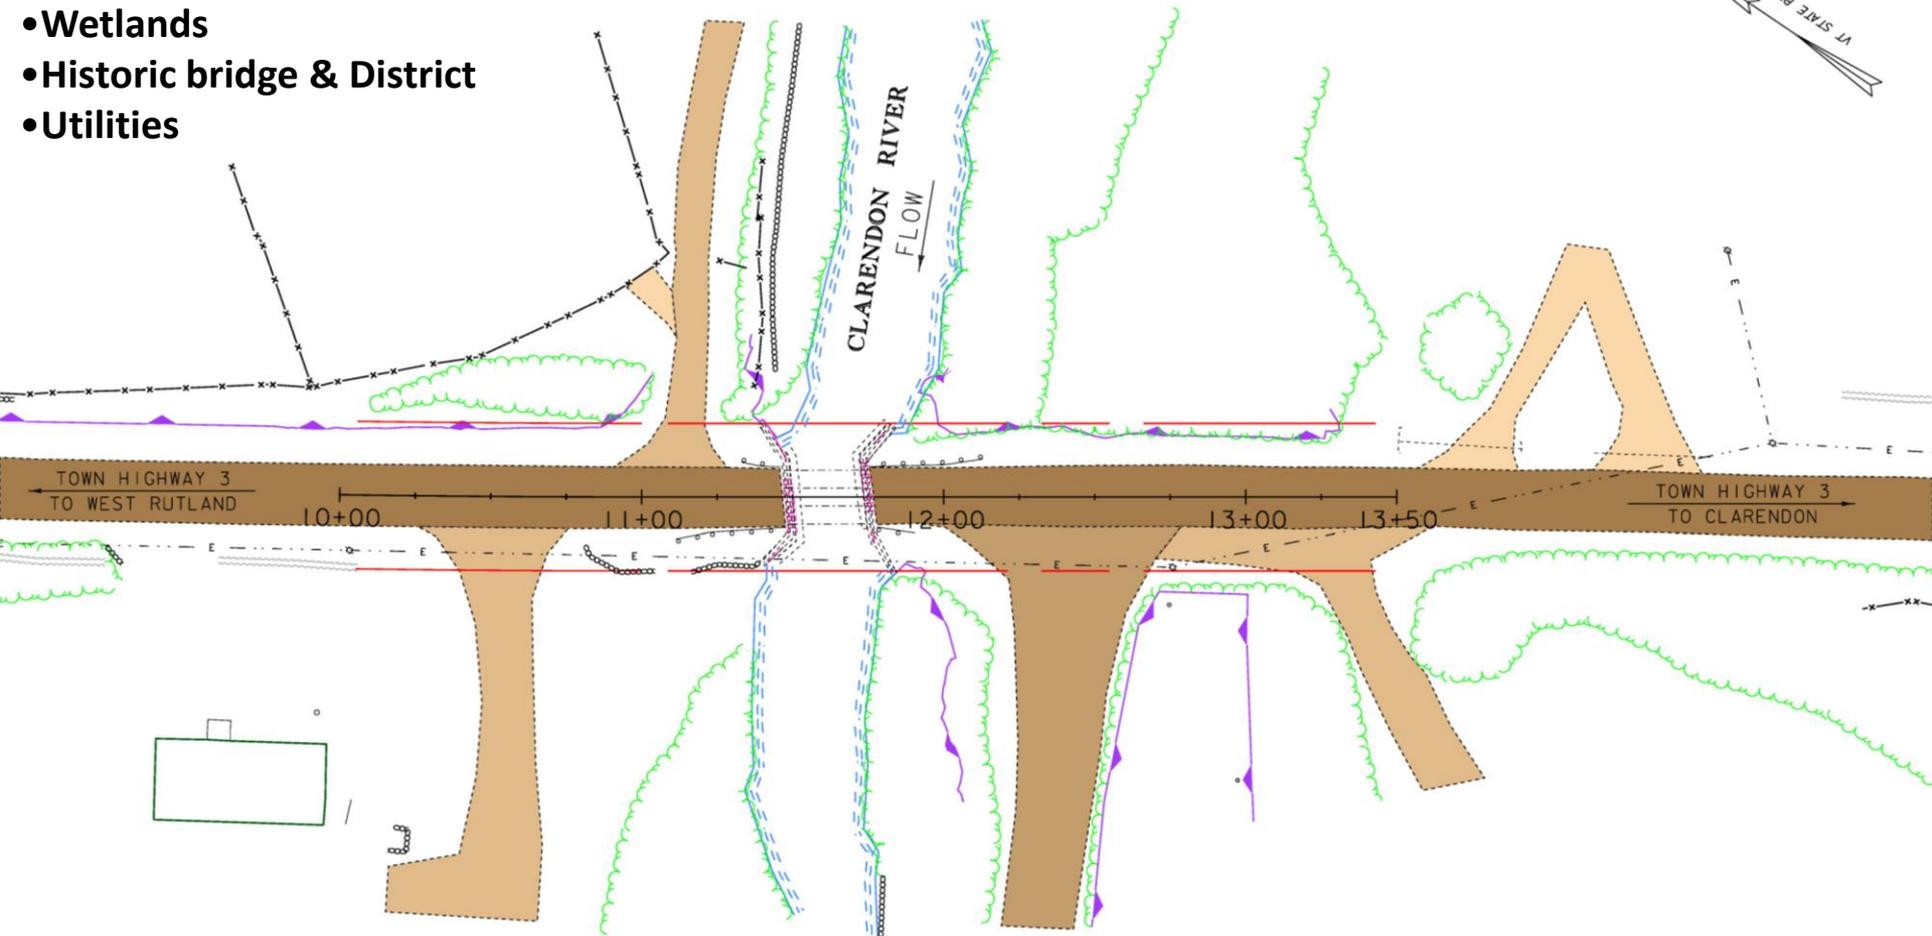
# Layout Showing Constraints

- Right of Way
- Wetlands
- Historic bridge & District
- Utilities

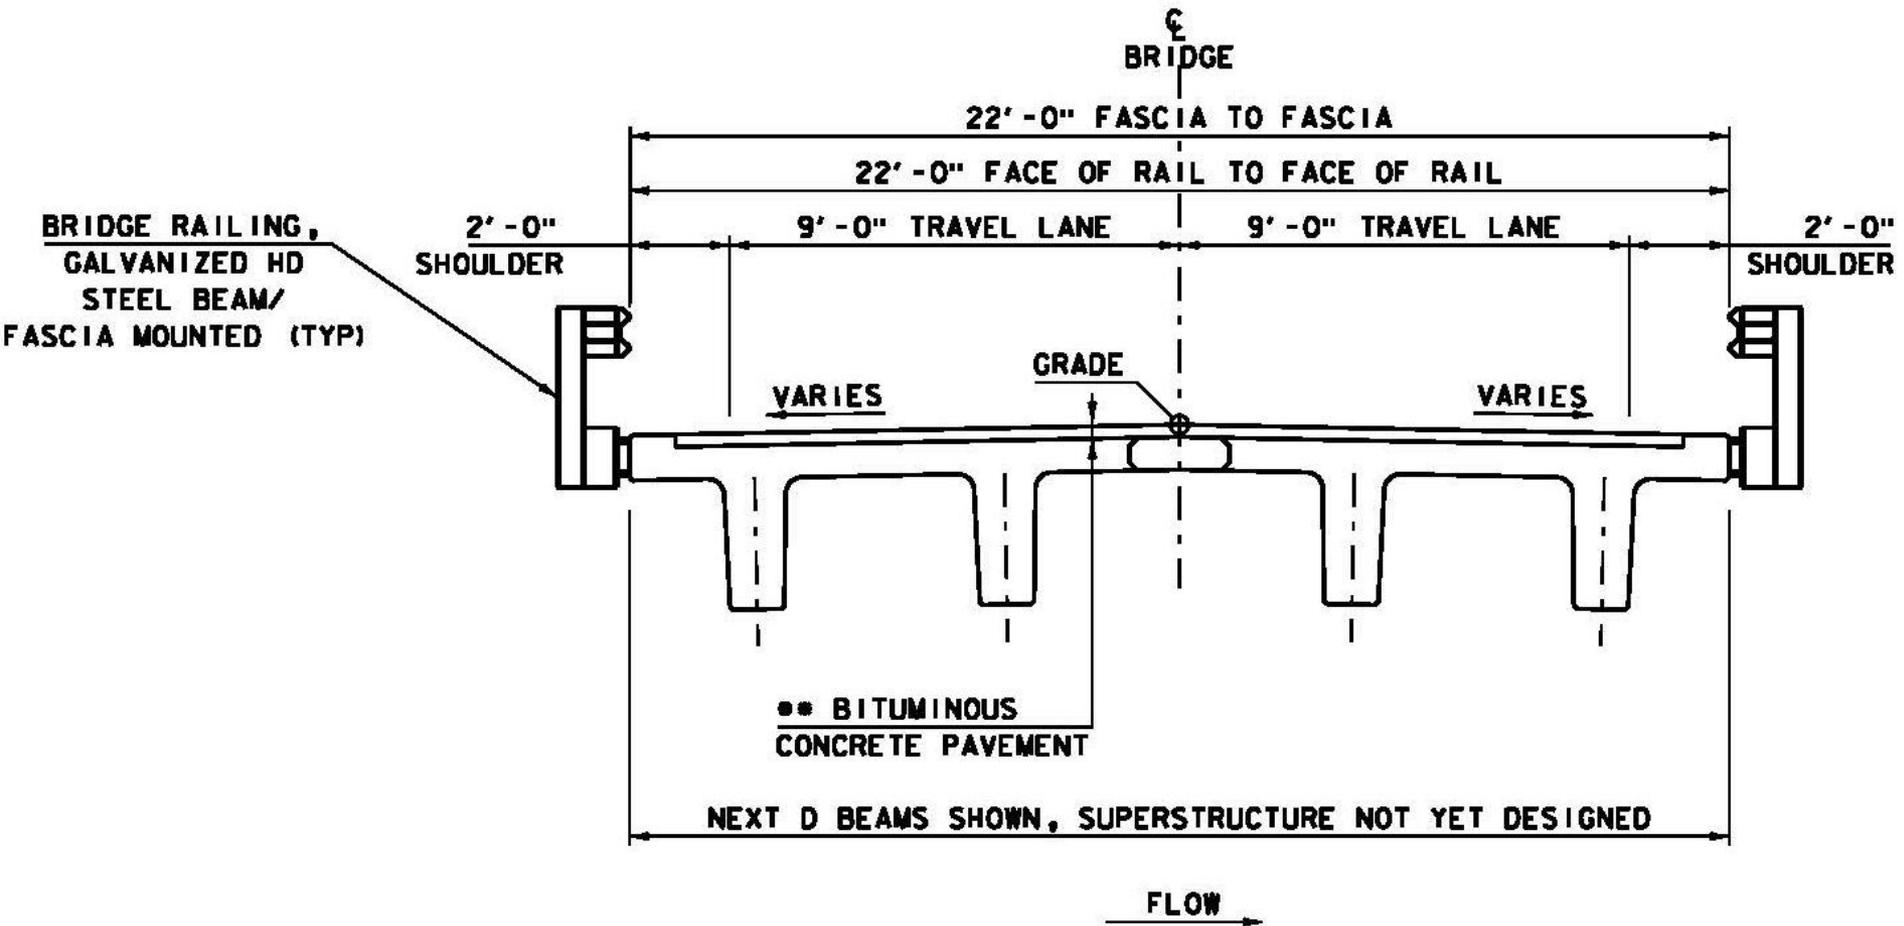
# Bridge Typical Full Replacement

- Complete Bridge replacement
- 70' span w/ substructure on steel H piles
- 22' width between face of rail
- Maintain existing centerline of bridge
- Maintain approximate vertical grade of bridge
- Long term (80 year) solution

**PROPOSED BRIDGE TYPICAL SECTION**

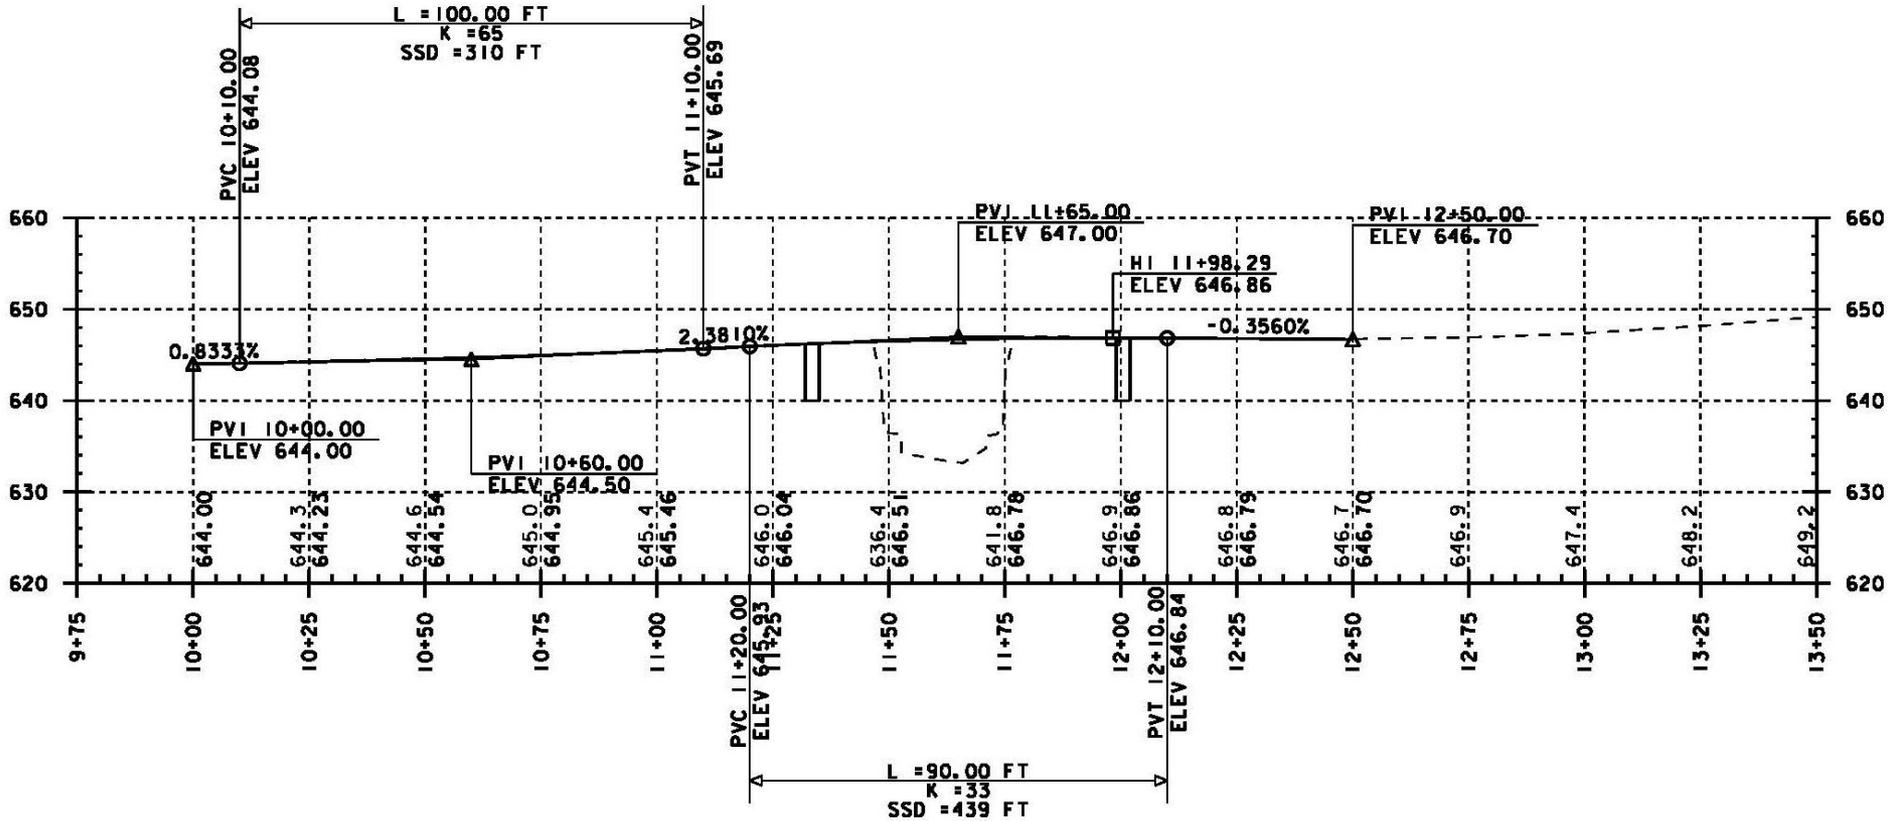
# Full Replacement - Profile

TH 47 PROFILE

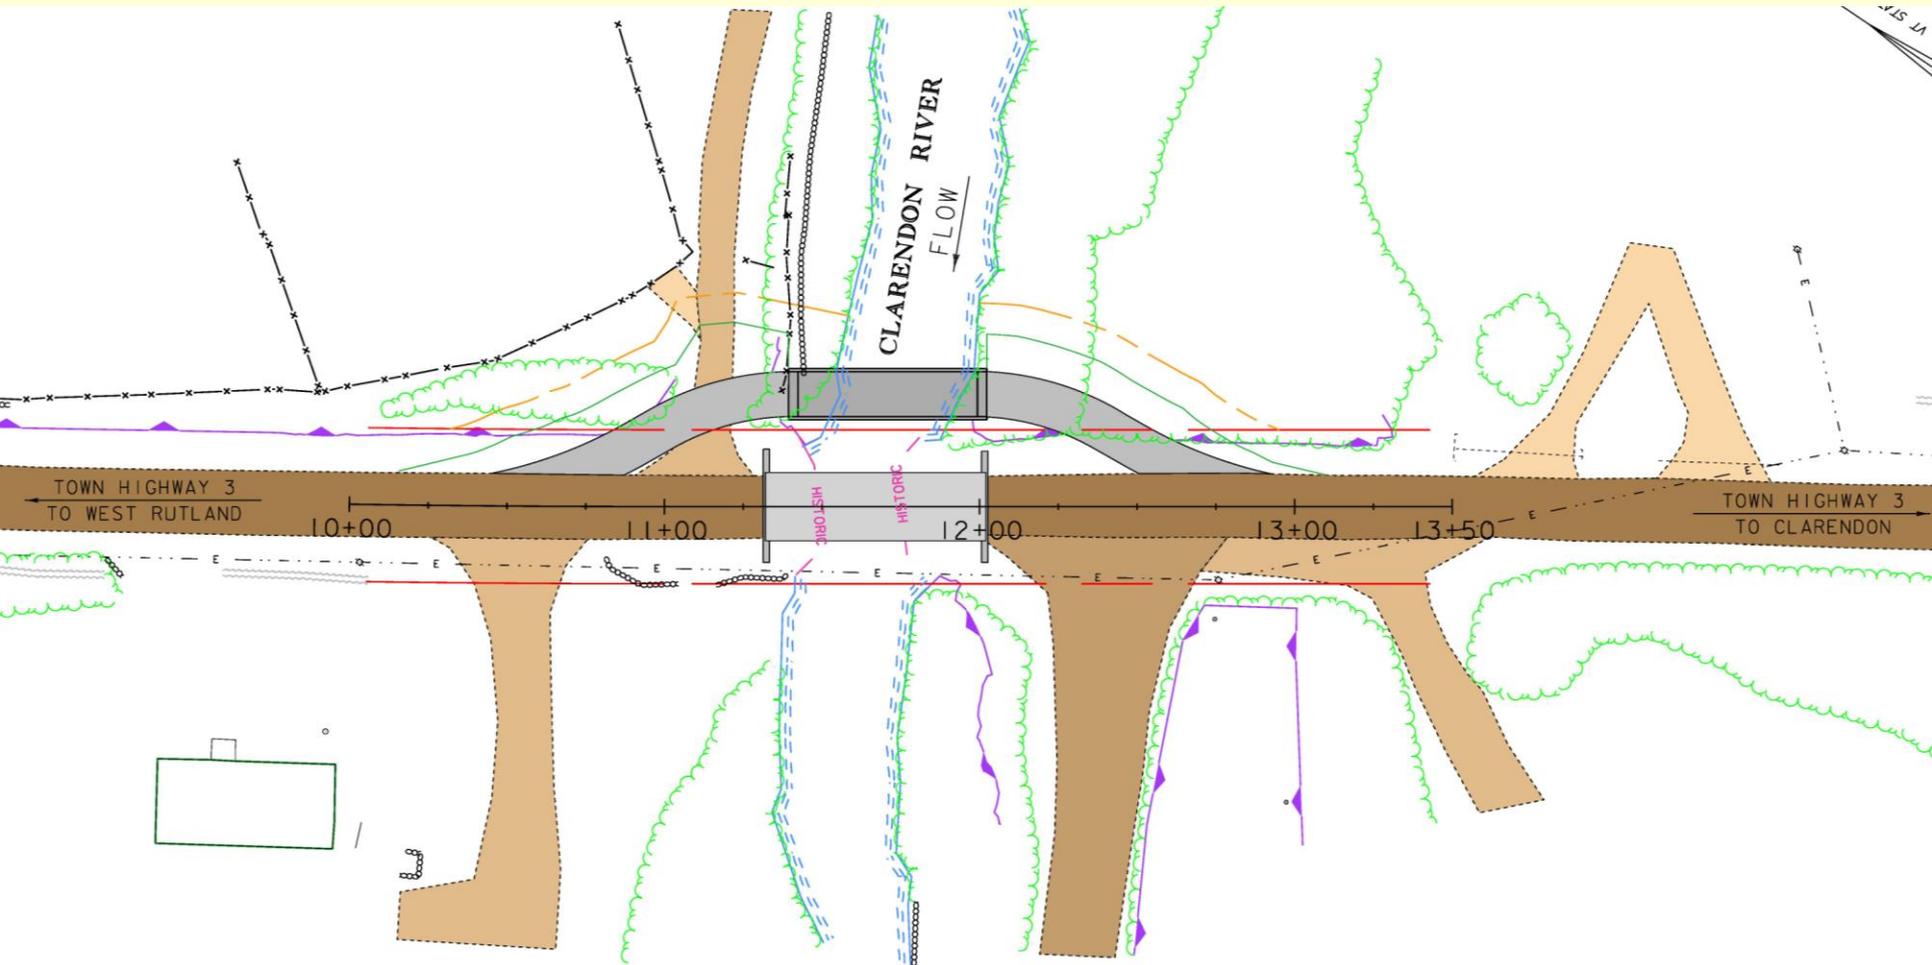
# Temporary Bridge Option

- Temporary Bridge on east side
- Short-term bridge closure with detour
