Bristol

VT Route 116, Bridge 12

Bristol BF 021—1(33)

Project Location: Town of Bristol in Addison County on VT Route 116 over the Baldwin Creek. The bridge is located approximately 0.1 miles north of the intersection of VT Route 17 and VT Route 116.

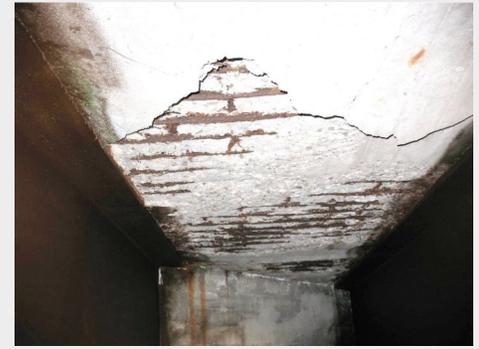
Deterioration of the Deck Underside

The Bridge 12 project on VT 116 in the Town of Bristol consists of the replacement of the existing bridge deck, which is in poor condition, and is considered structurally deficient. The existing bridge is a steel beam bridge constructed in 1955. The existing bridge is 89-feet long and 33.3-feet wide. The superstructure and substructure are in good and satisfactory condition respectively and do not warrant a replacement.

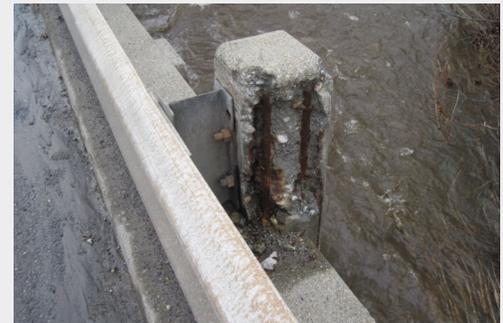
Bridge Railing Post

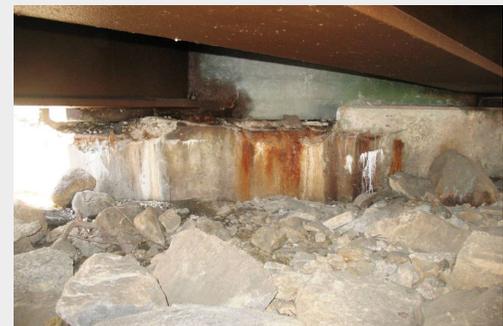
Bridge Seat Deterioration

The new concrete deck will have two 11-foot lanes with 4-foot shoulders to meet the Vermont State Design Standards. This configuration will match the existing geometry in regards to width, vertical, and horizontal alignment. Based on the condition of the substructure there may be potential for widening the bridge as well to accommodate a larger shoulder. In addition to the deck replacement, new bearings will be installed and minor substructure repairs may be necessary.
