Bristol BF 021-1(33)
Regional Concerns Meeting
VT Route 116 – Bridge #12 over Baldwin Creek

April 27, 2015

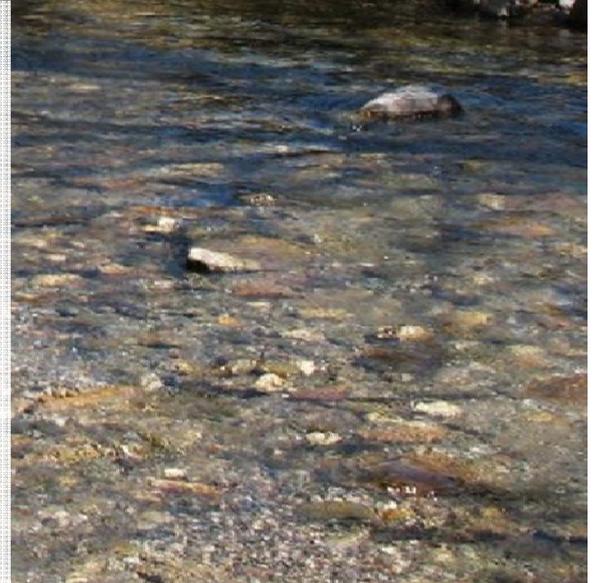
Existing Conditions – Bridge #12

- Roadway Classification – Minor Rural Arterial
- Superstructure – 89' long Steel Beam Bridge
- Substructure – Skeletal Abutments
- Constructed in 1955
- Ownership – State of Vermont

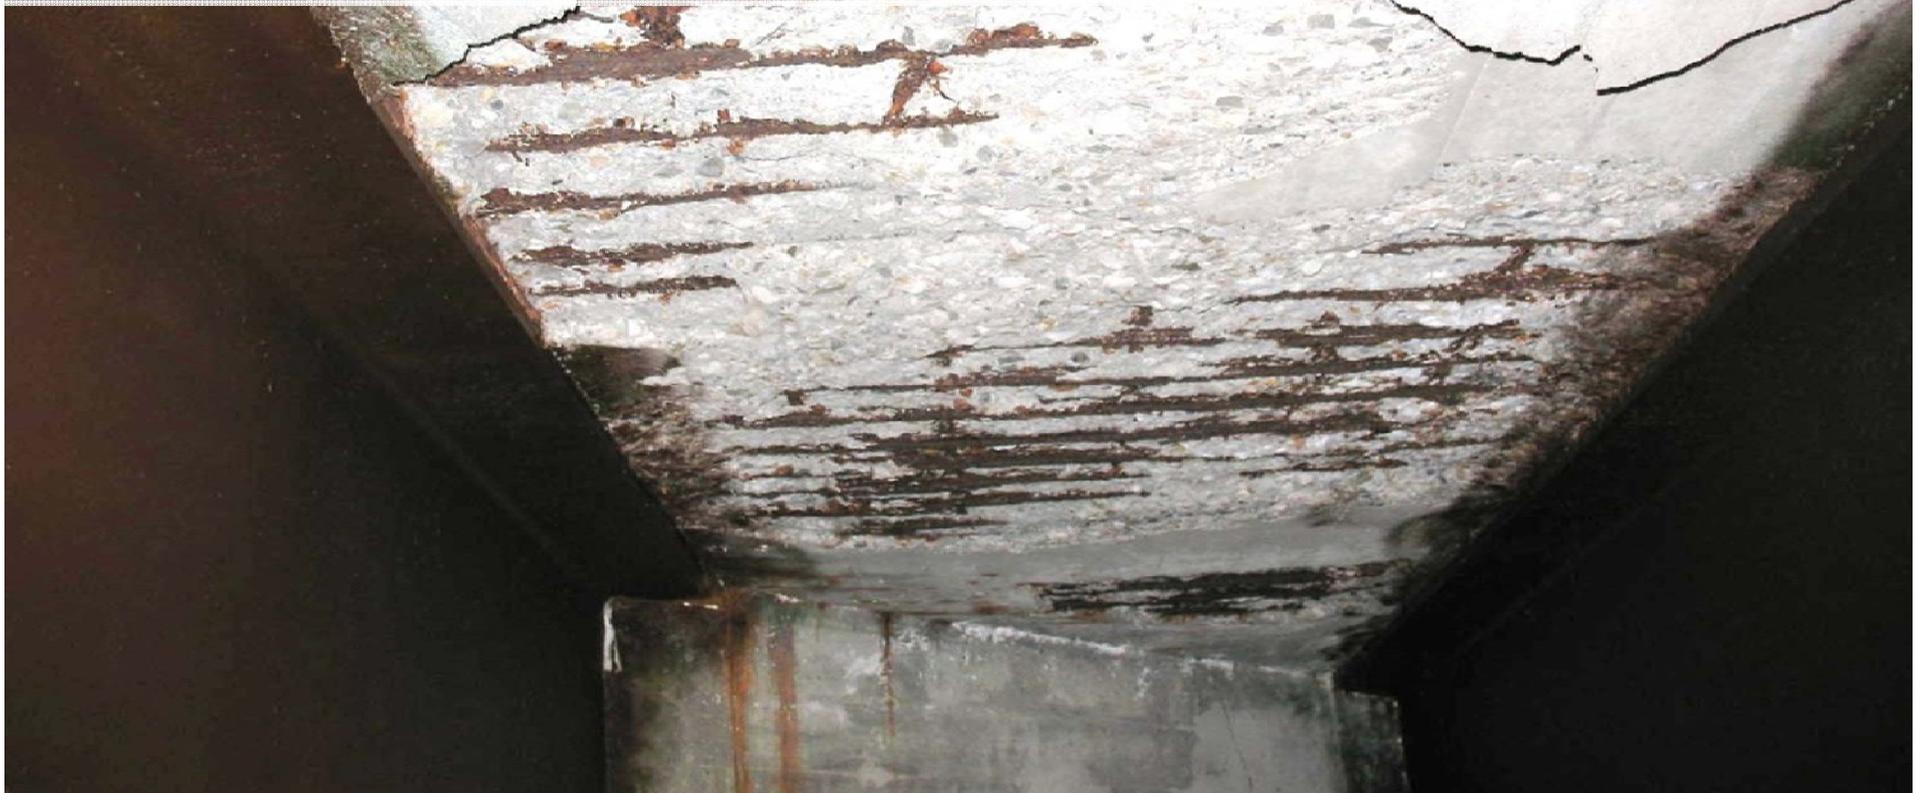
- The existing concrete deck is in poor condition. There have been pop-outs in the past, and future deck pop-outs are possible at any time.
- Deck geometry is substandard.
- The roadway is not banked sufficiently for the horizontal curve present.
- Bridge railing is substandard.

- Deck Rating 4 (Poor)
- Superstructure Rating 7 (Good)
- Substructure Rating 6 (Satisfactory)
- Channel Rating 7 (Good)

Continual deck deterioration with large delaminations and exposed rebar

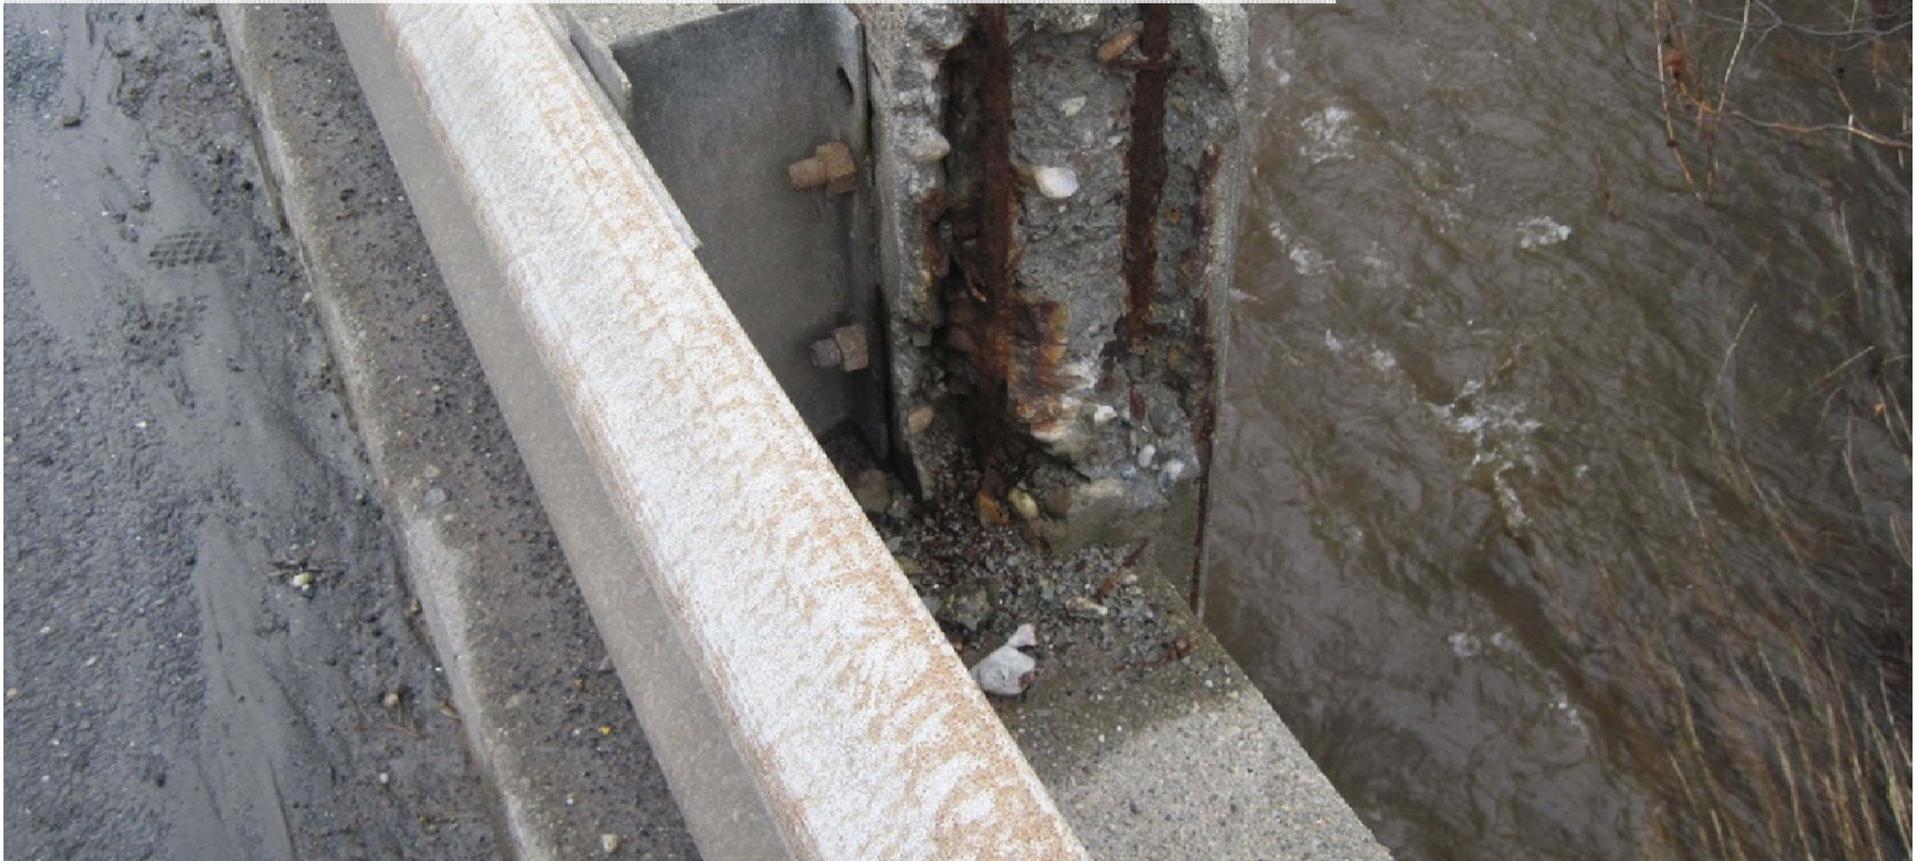
- Bridge Railing
 - Not Crash tested
 - Deteriorated posts, Exposed Reinforcing Steel

Bridge Railing

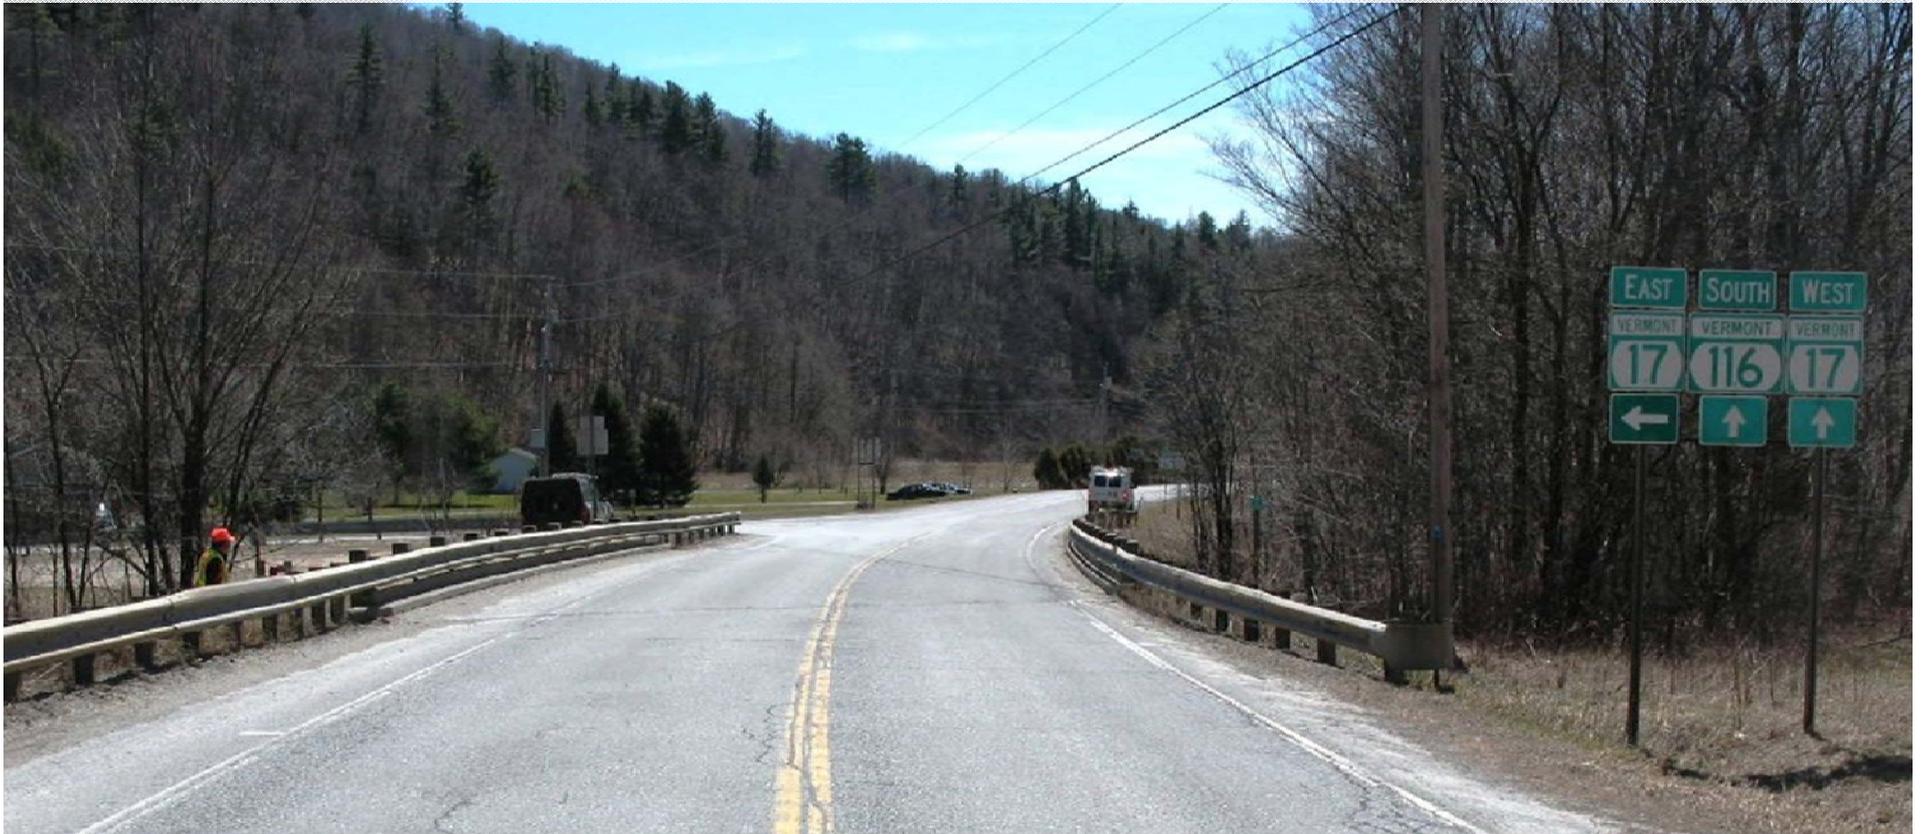
Looking South Over Bridge

- Substandard Horizontal Curve
- Substandard Deck Geometry
 - Existing: 11'4'
 - Standard: 11'5'

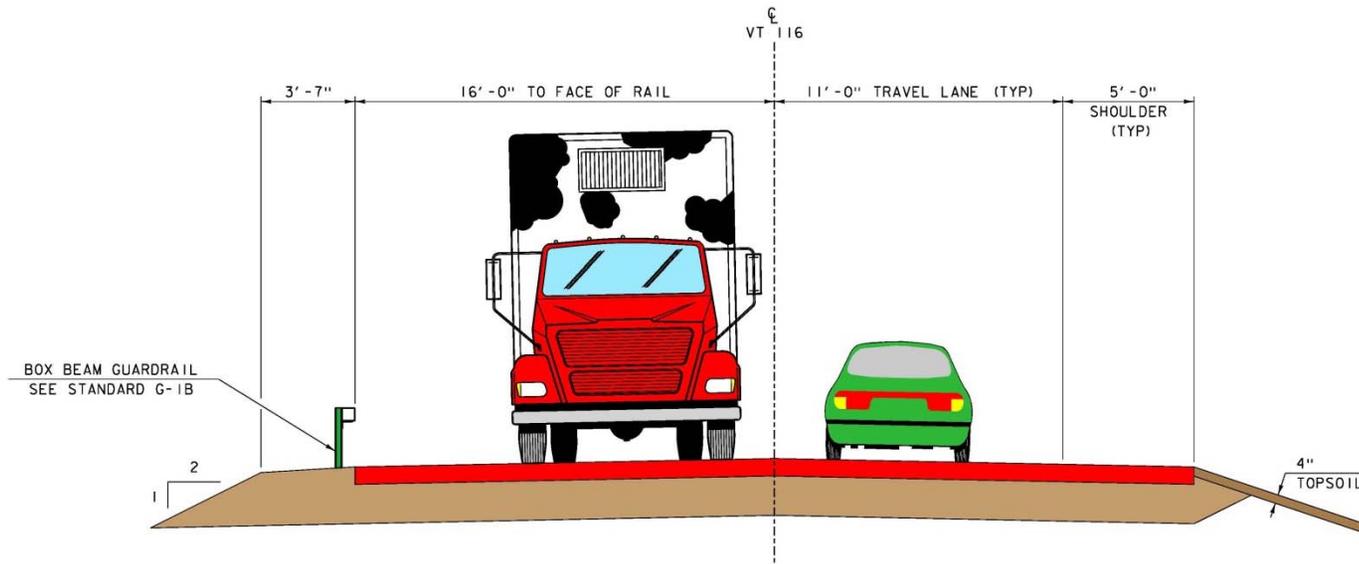
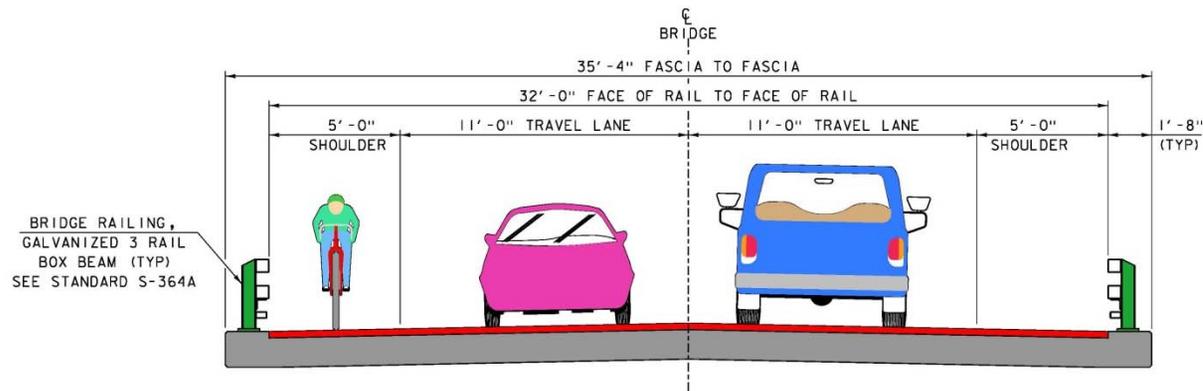
Proposed Typical Sections

- Proposed Bridge Rail to Rail = 32' (Existing is 30')

- Replace existing deck
 - Bridge widened by 1 foot on each side to meet standard
 - New approach railing and bridge railing
 - New joints
 - Meets all geometric criteria
 - 40 year design life
 - Utility relocation will be needed
 - No ROW needed

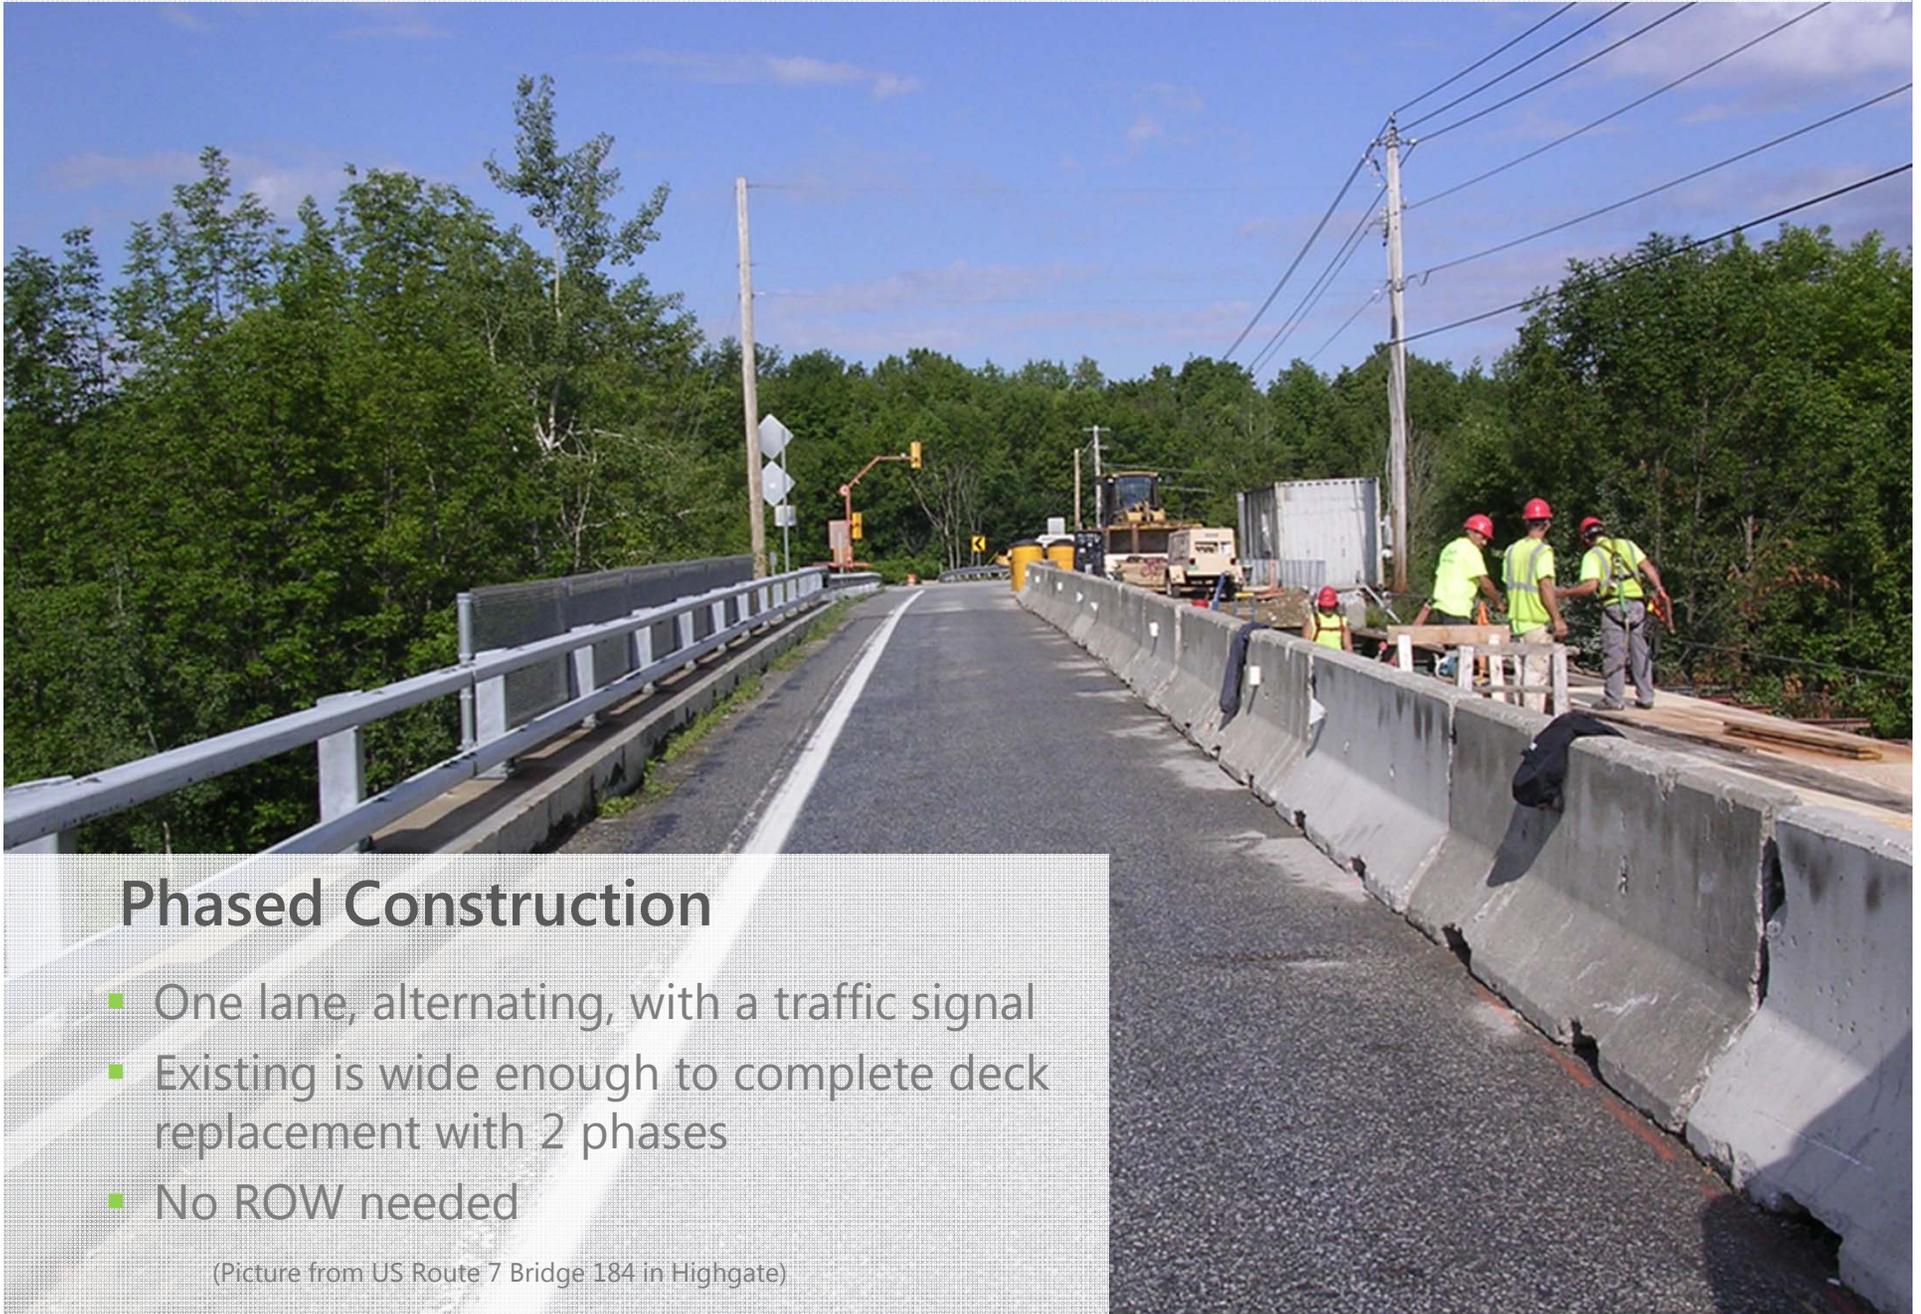
Phased Construction

- One lane, alternating, with a traffic signal
- Existing is wide enough to complete deck replacement with 2 phases
- No ROW needed

(Picture from US Route 7 Bridge 184 in Highgate)
