Pittsford Regional Concerns Meeting

US 7 – Bridge #108

February 18, 2015

Pittsford BF 019-3(59) Questions and Comments

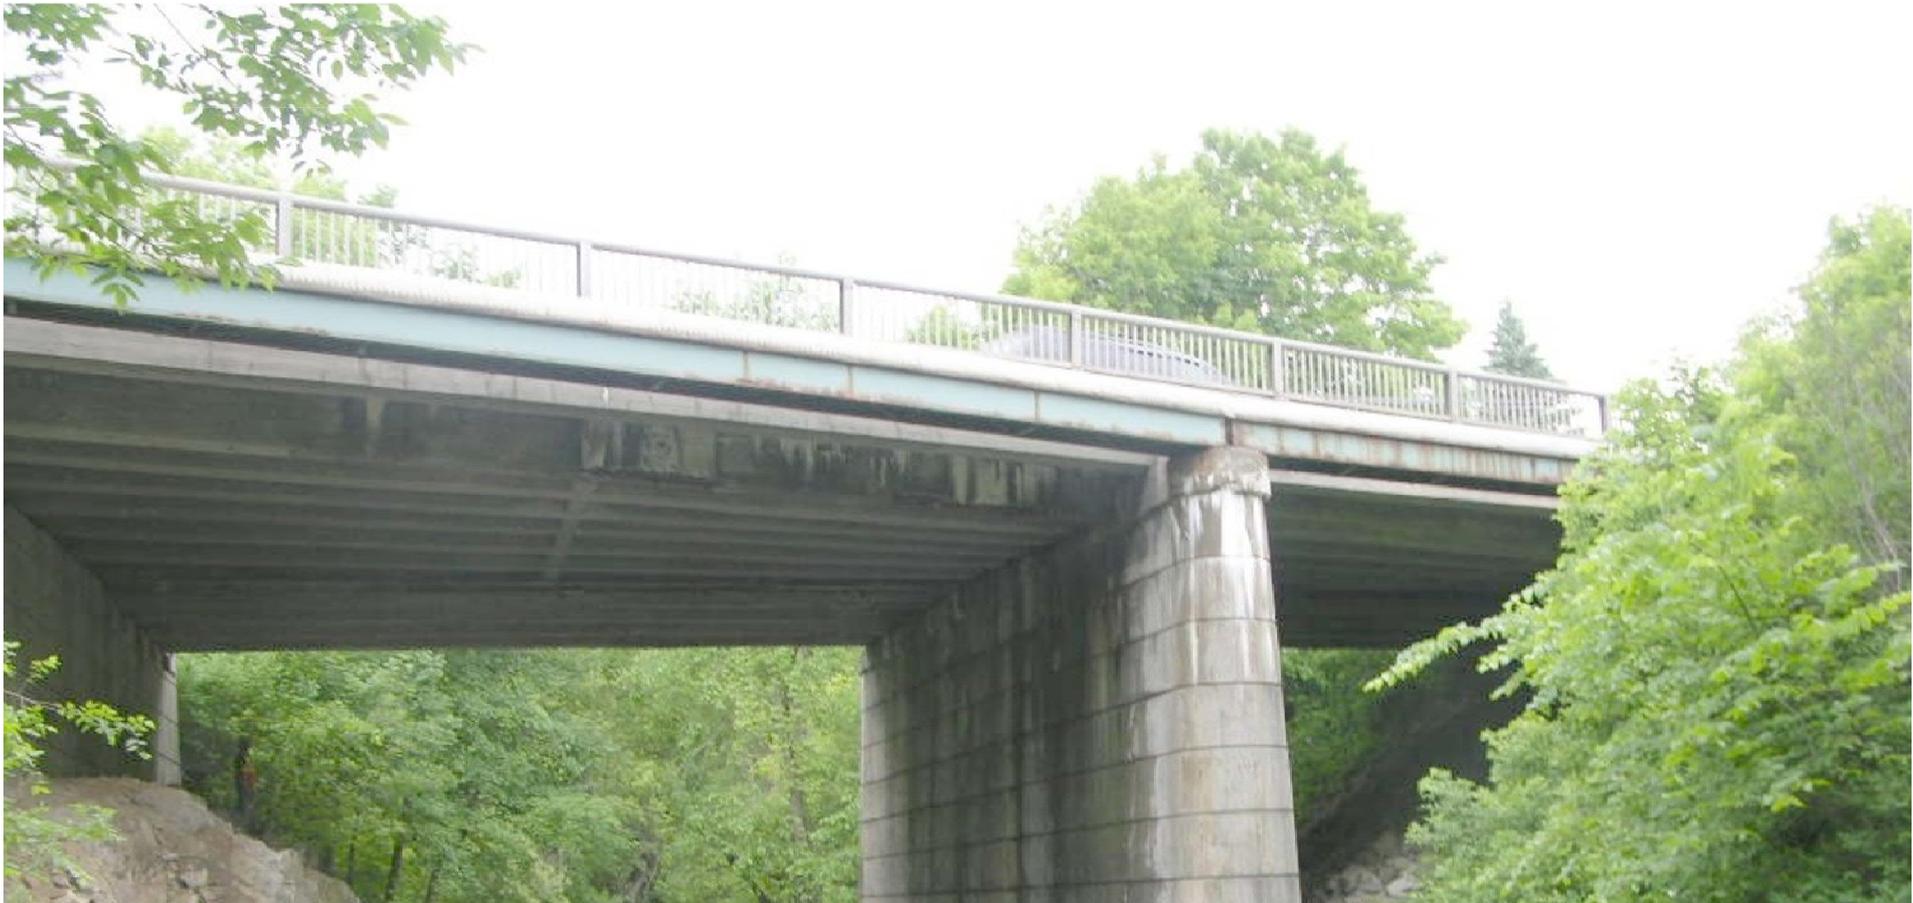
Cross Section of Bridge

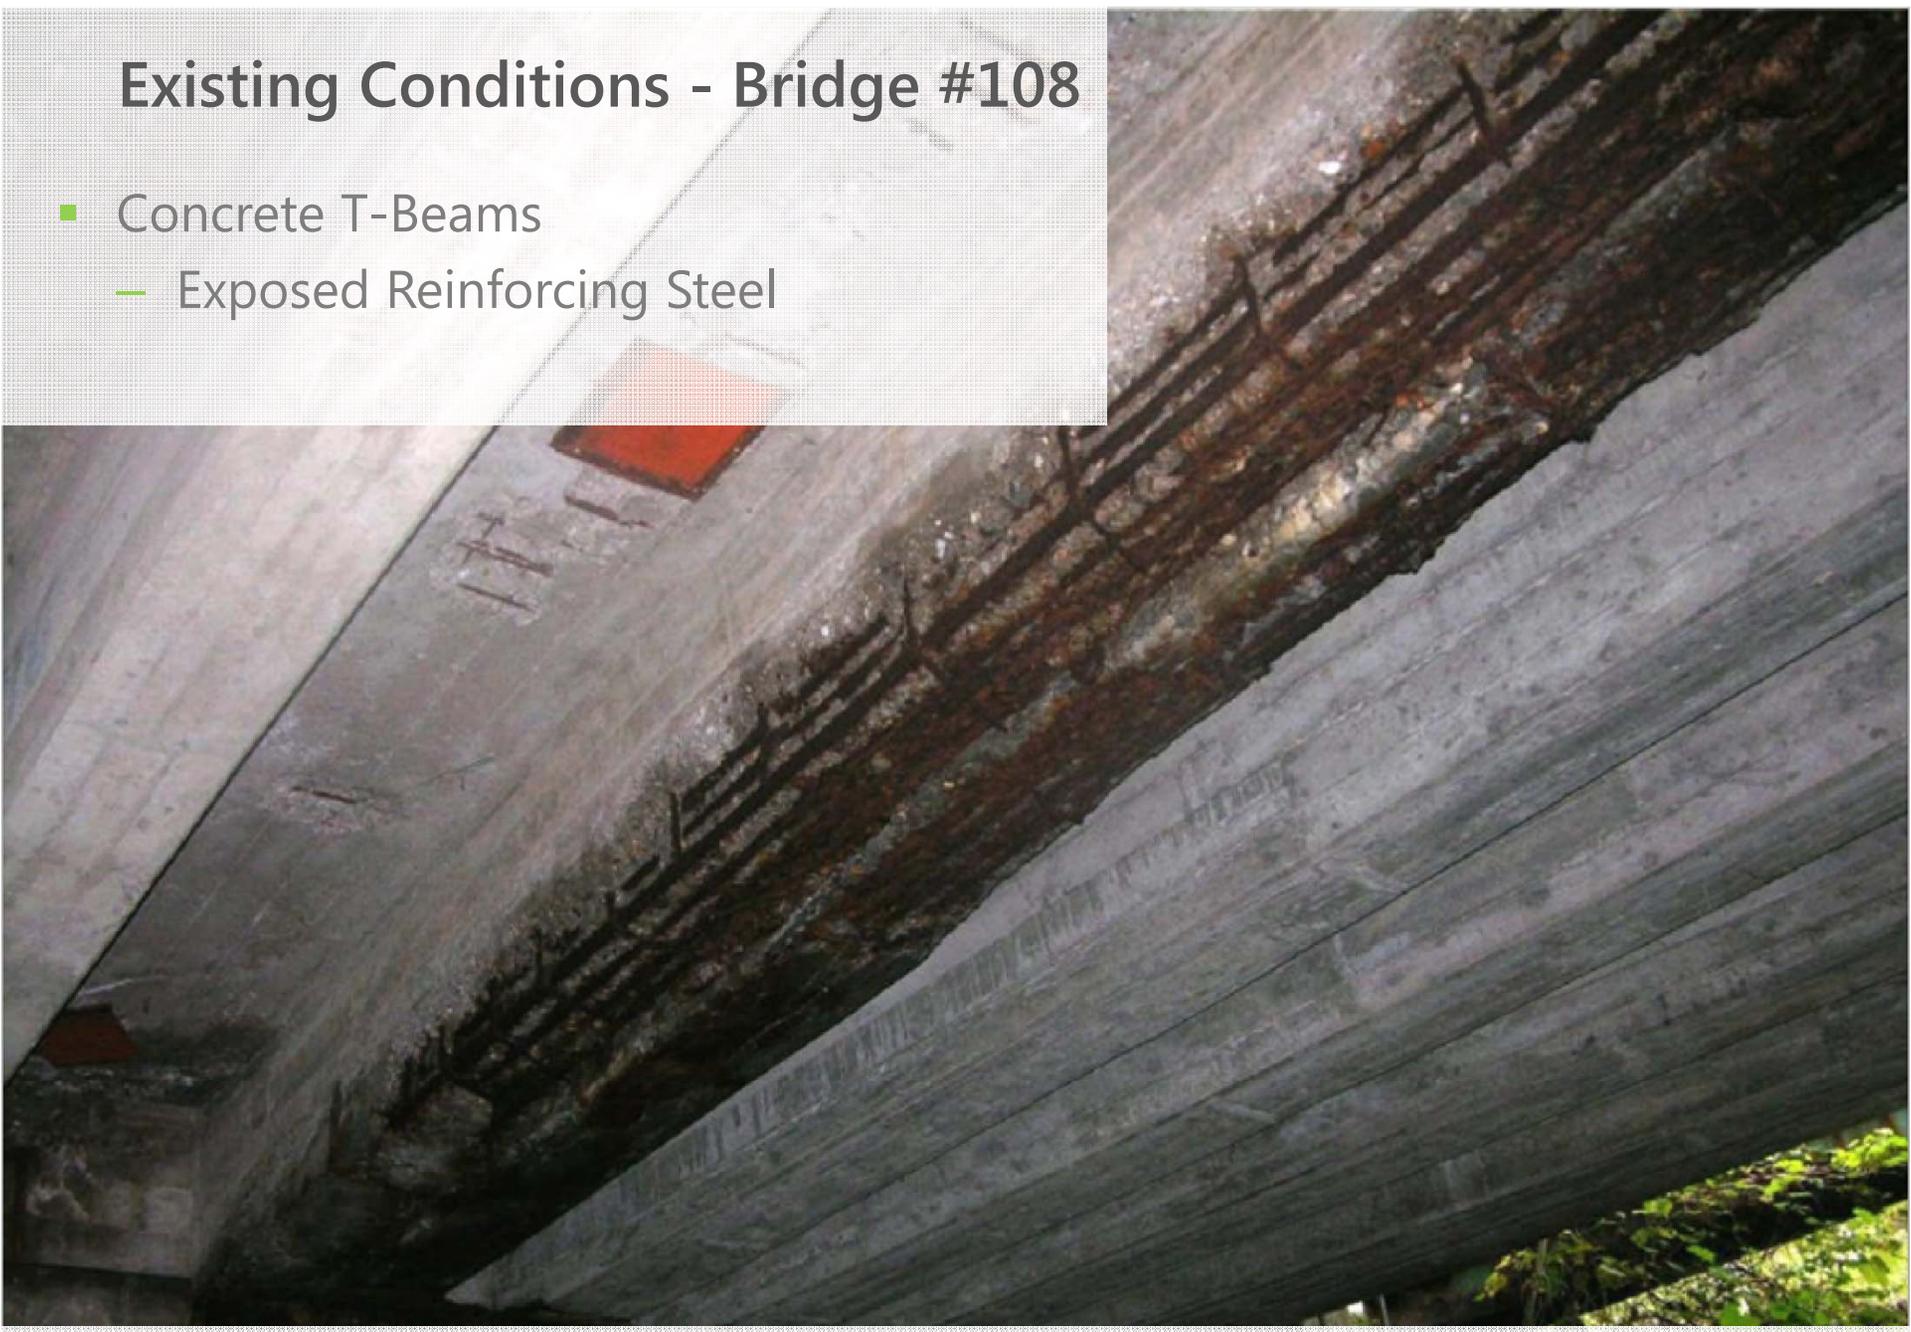
Existing Conditions - Bridge #108

- Concrete T-Beams
- Exposed Reinforcing Steel

Exposed Reinforcing Steel in beam and deck

- Concrete T-Beams have exposed reinforcing steel
- Pot holes throughout the deck surface
- Leaky Bridge Joints
- Sag vertical curve and headlight site distance are substandard
- Deck geometry is substandard
- Bridge railing is substandard
- Utilities attached to bridge

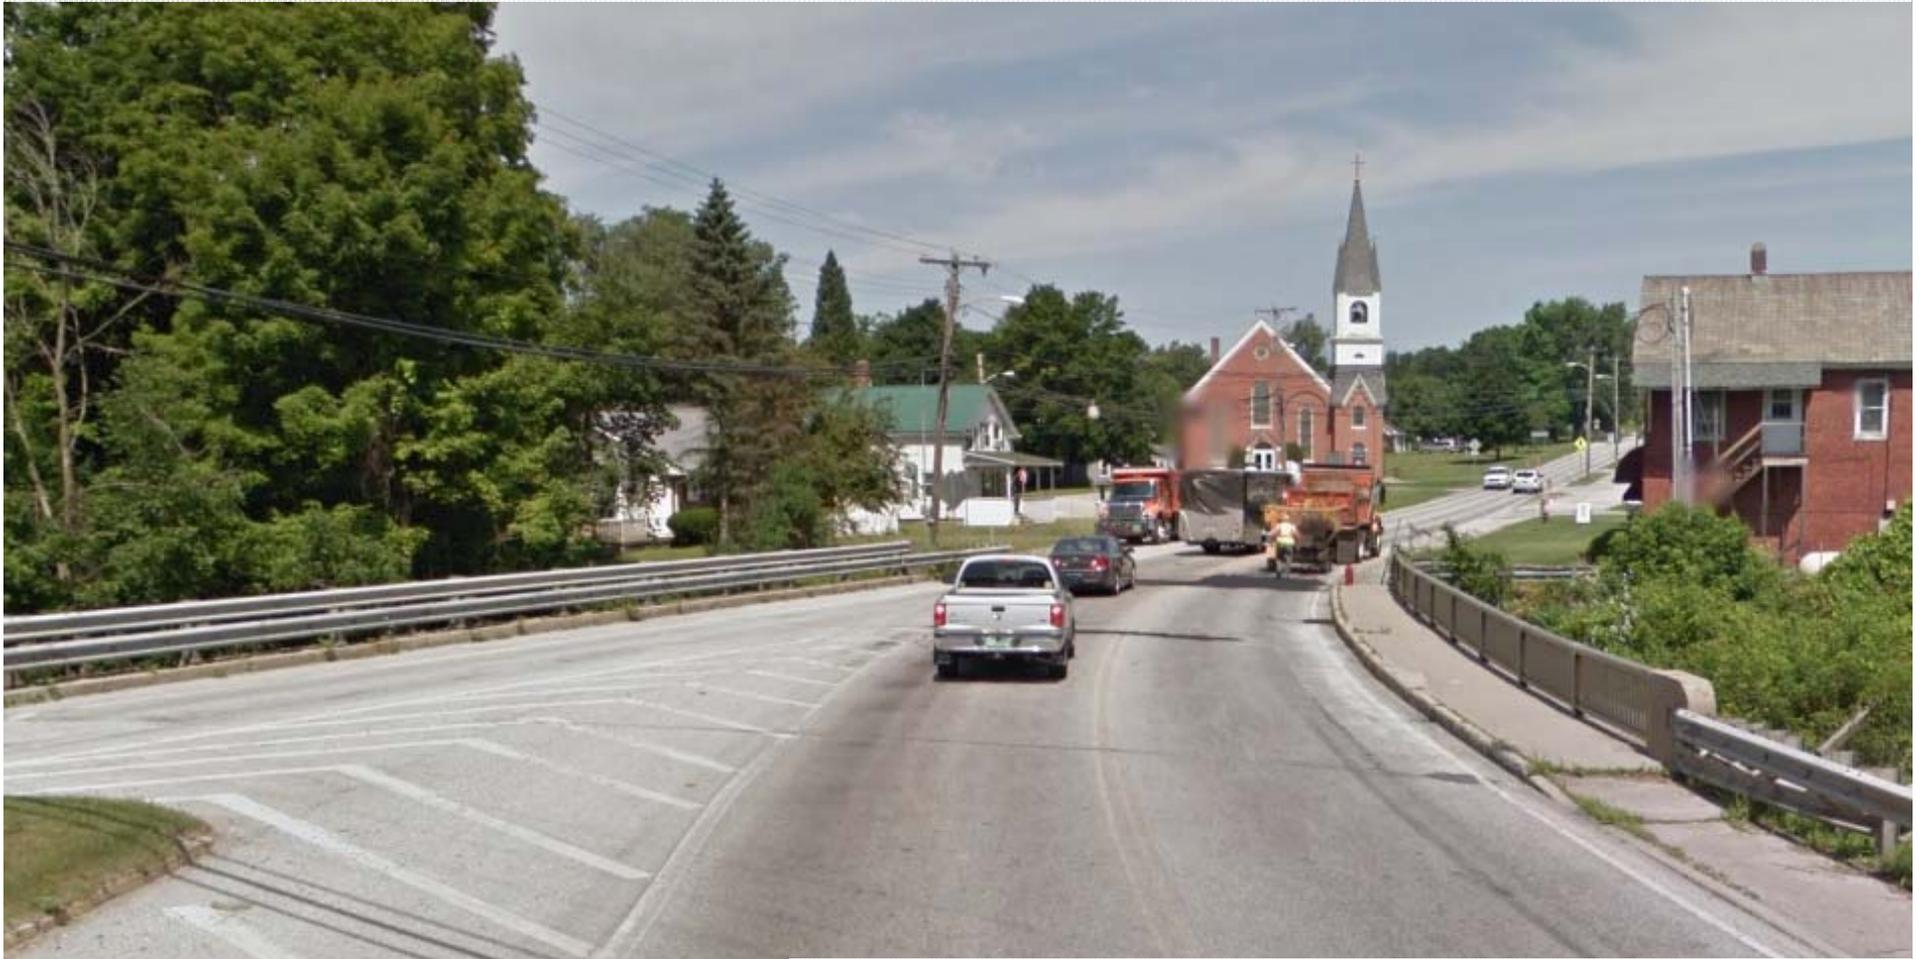
Approach looking north

Existing Conditions - Bridge #108

- Substandard Deck Geometry
- Substandard Railing

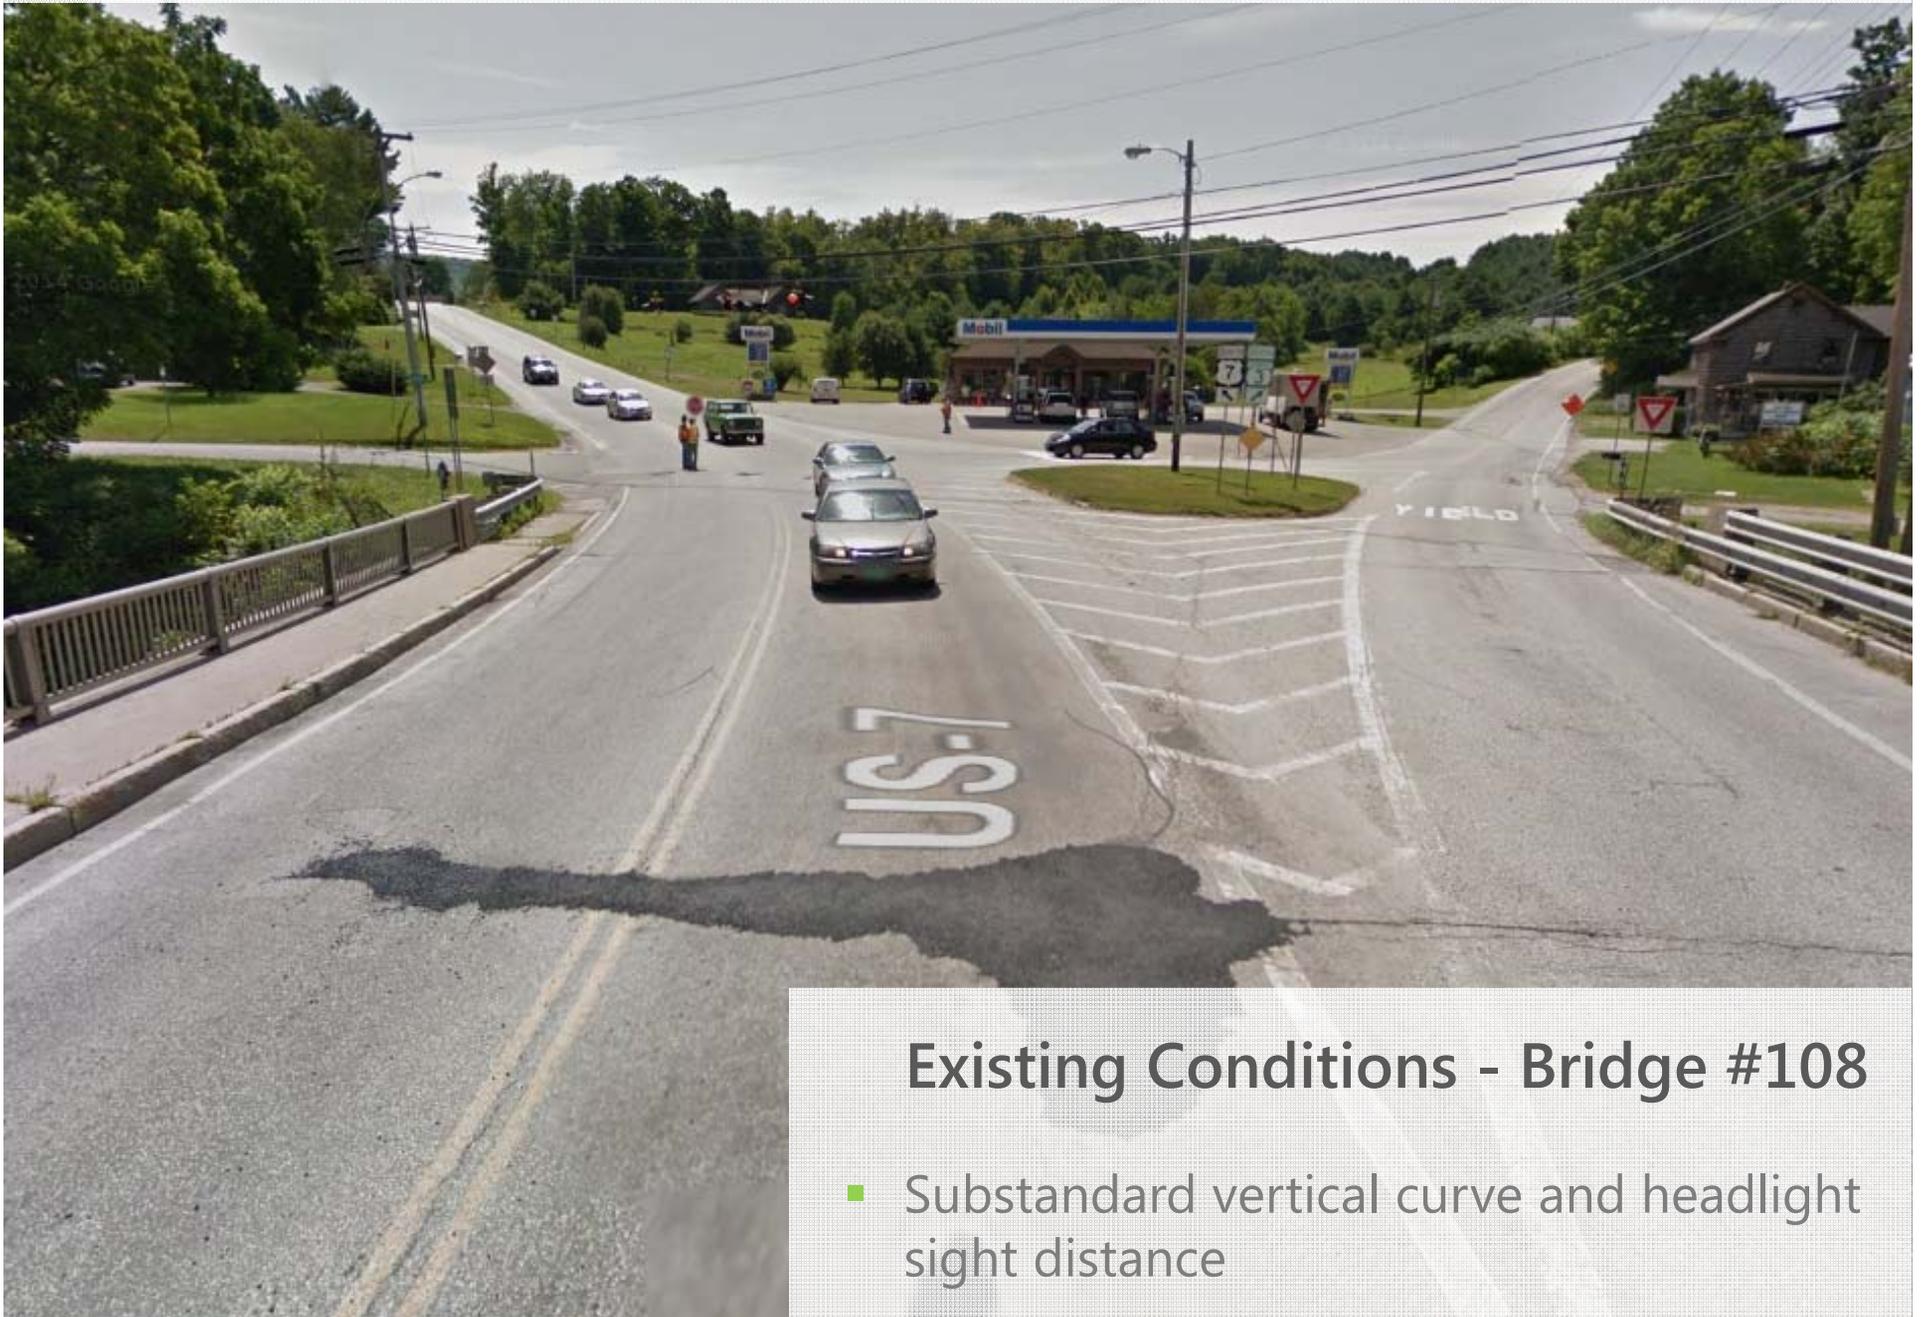
Approach looking south

Existing Conditions - Bridge #108

- Substandard vertical curve and headlight sight distance

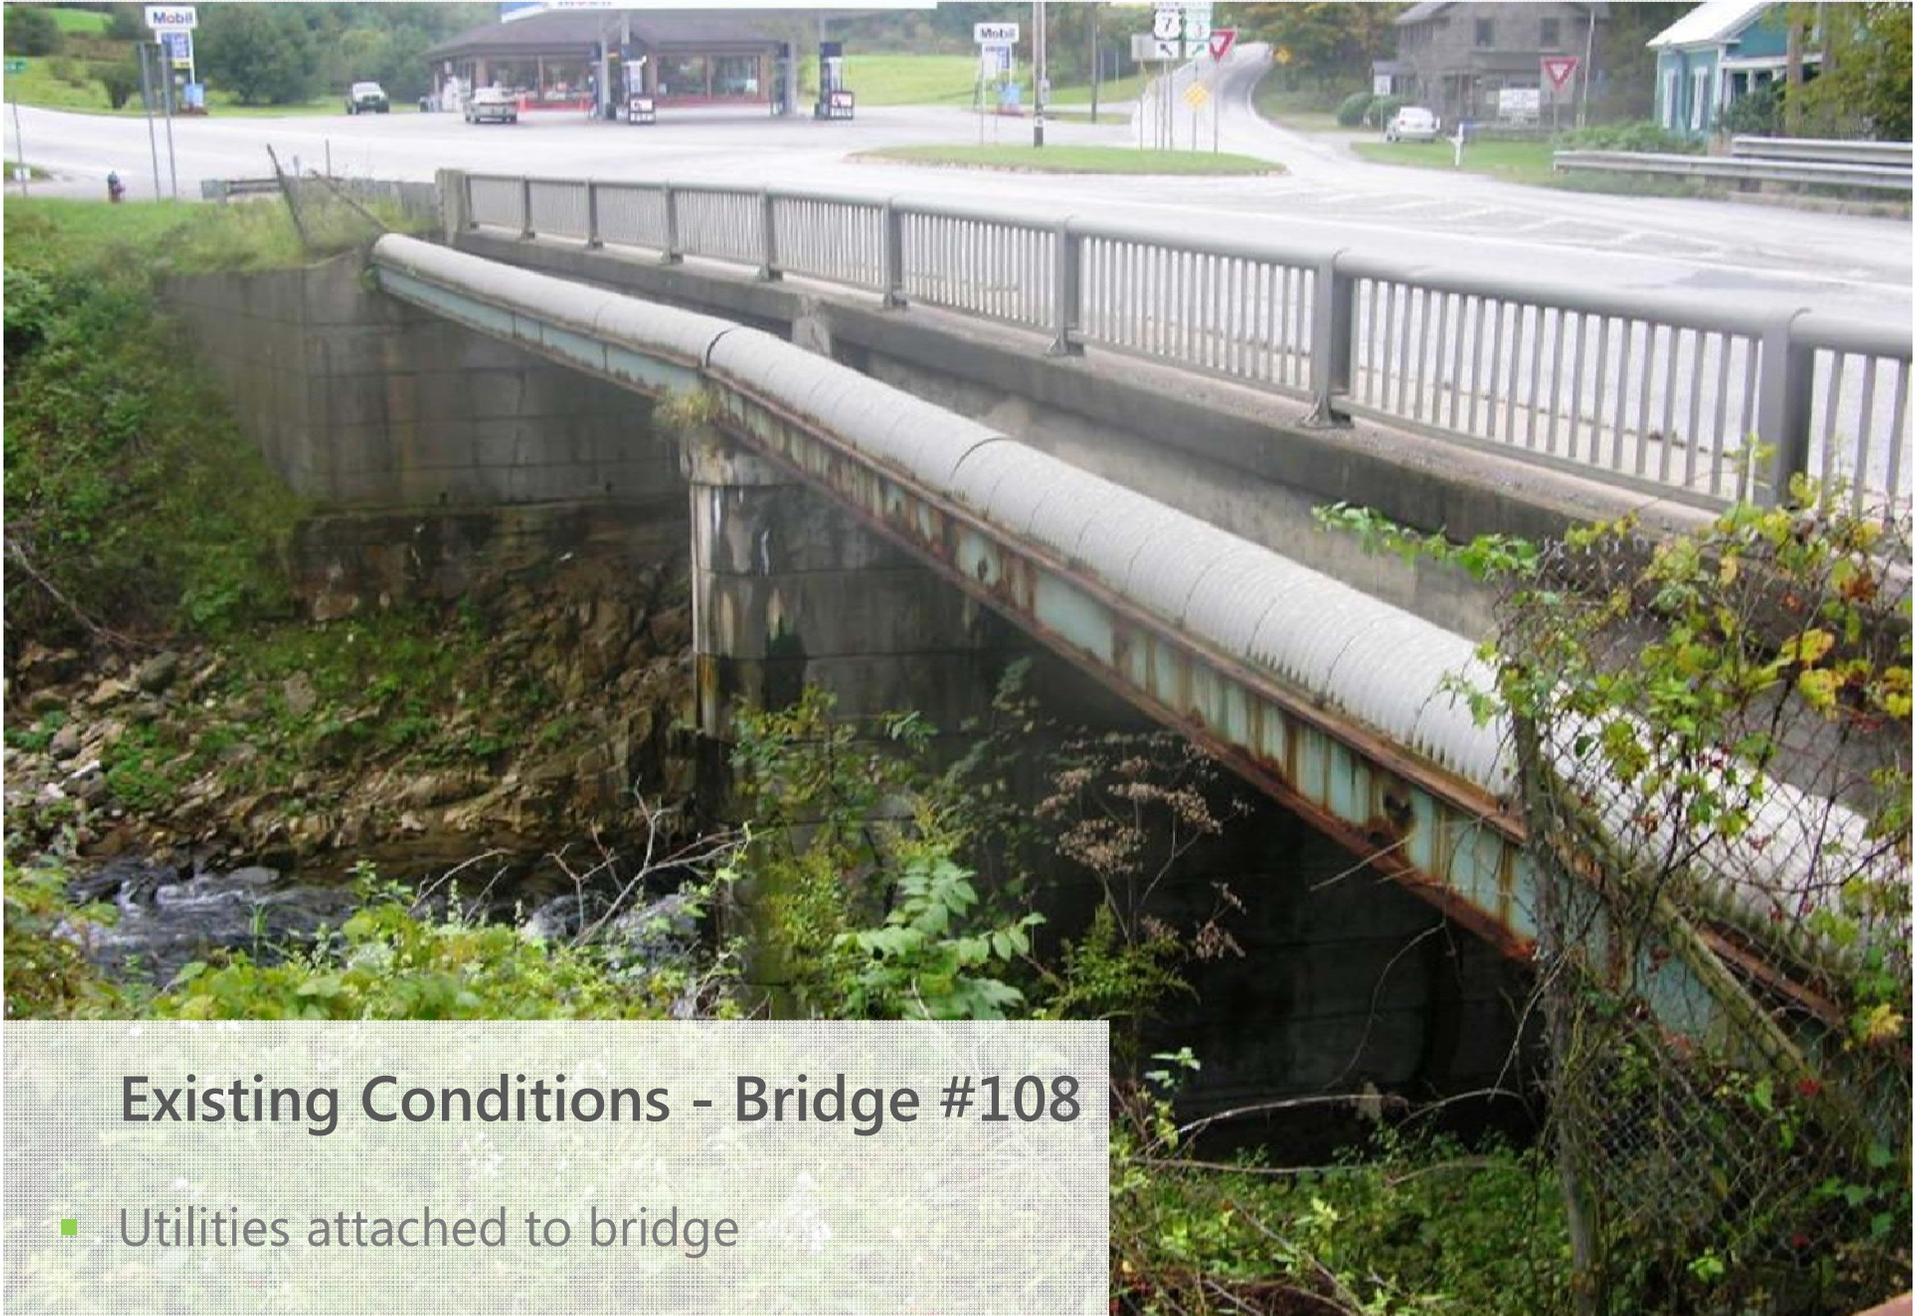
Upstream Fascia

Existing Conditions - Bridge #108

- Utilities attached to bridge

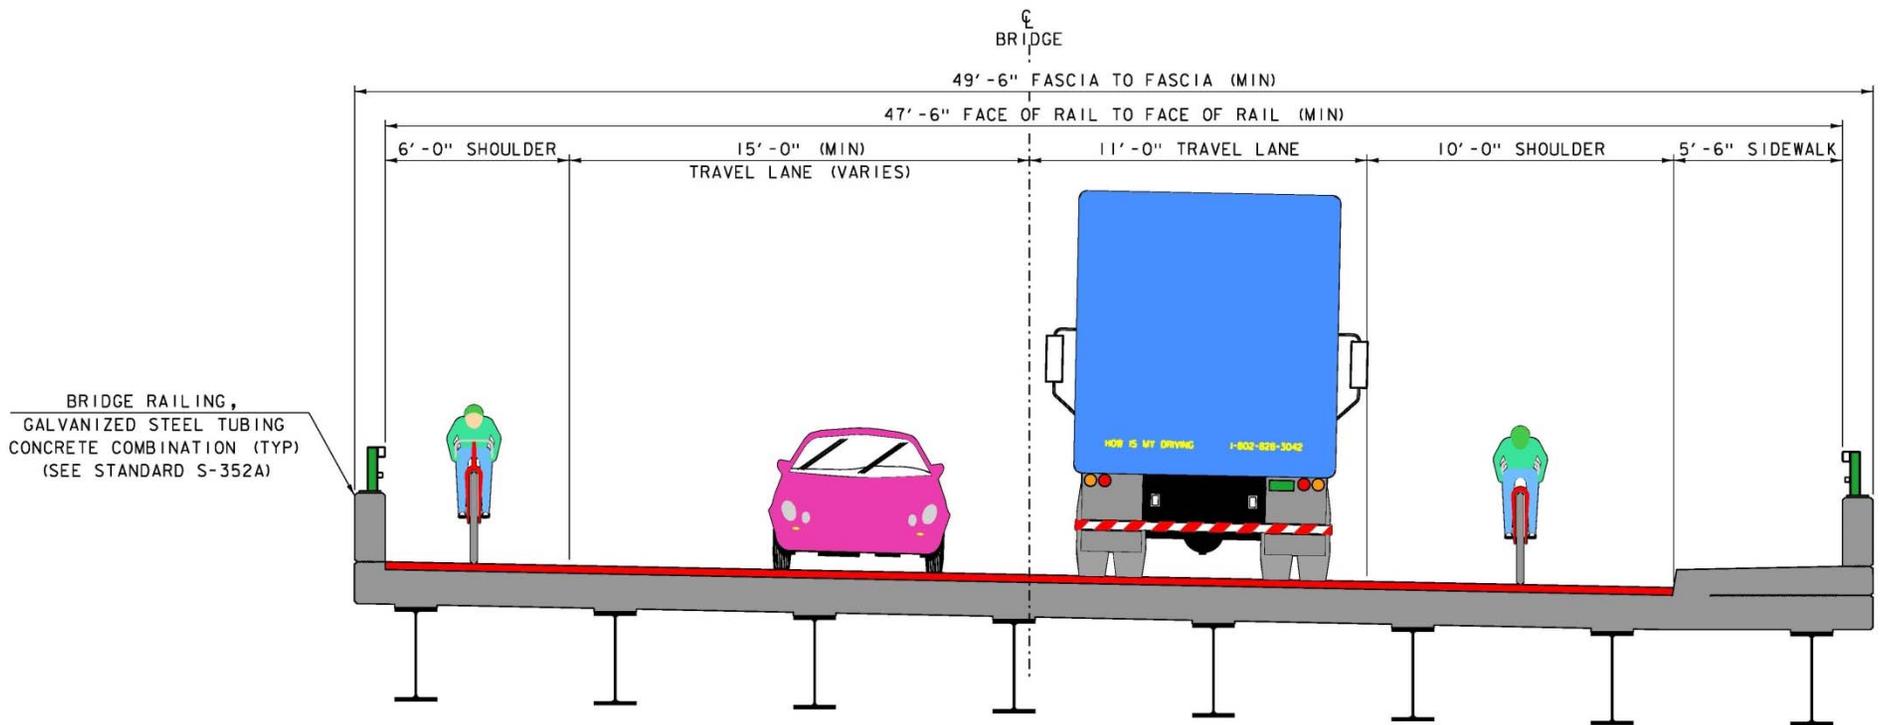
Proposed Bridge Section

- Proposed Bridge Rail to Rail = 47.5' (Existing is 39')
- Proposed Bridge Rail to Sidewalk Curb = 42' (Existing is 34')

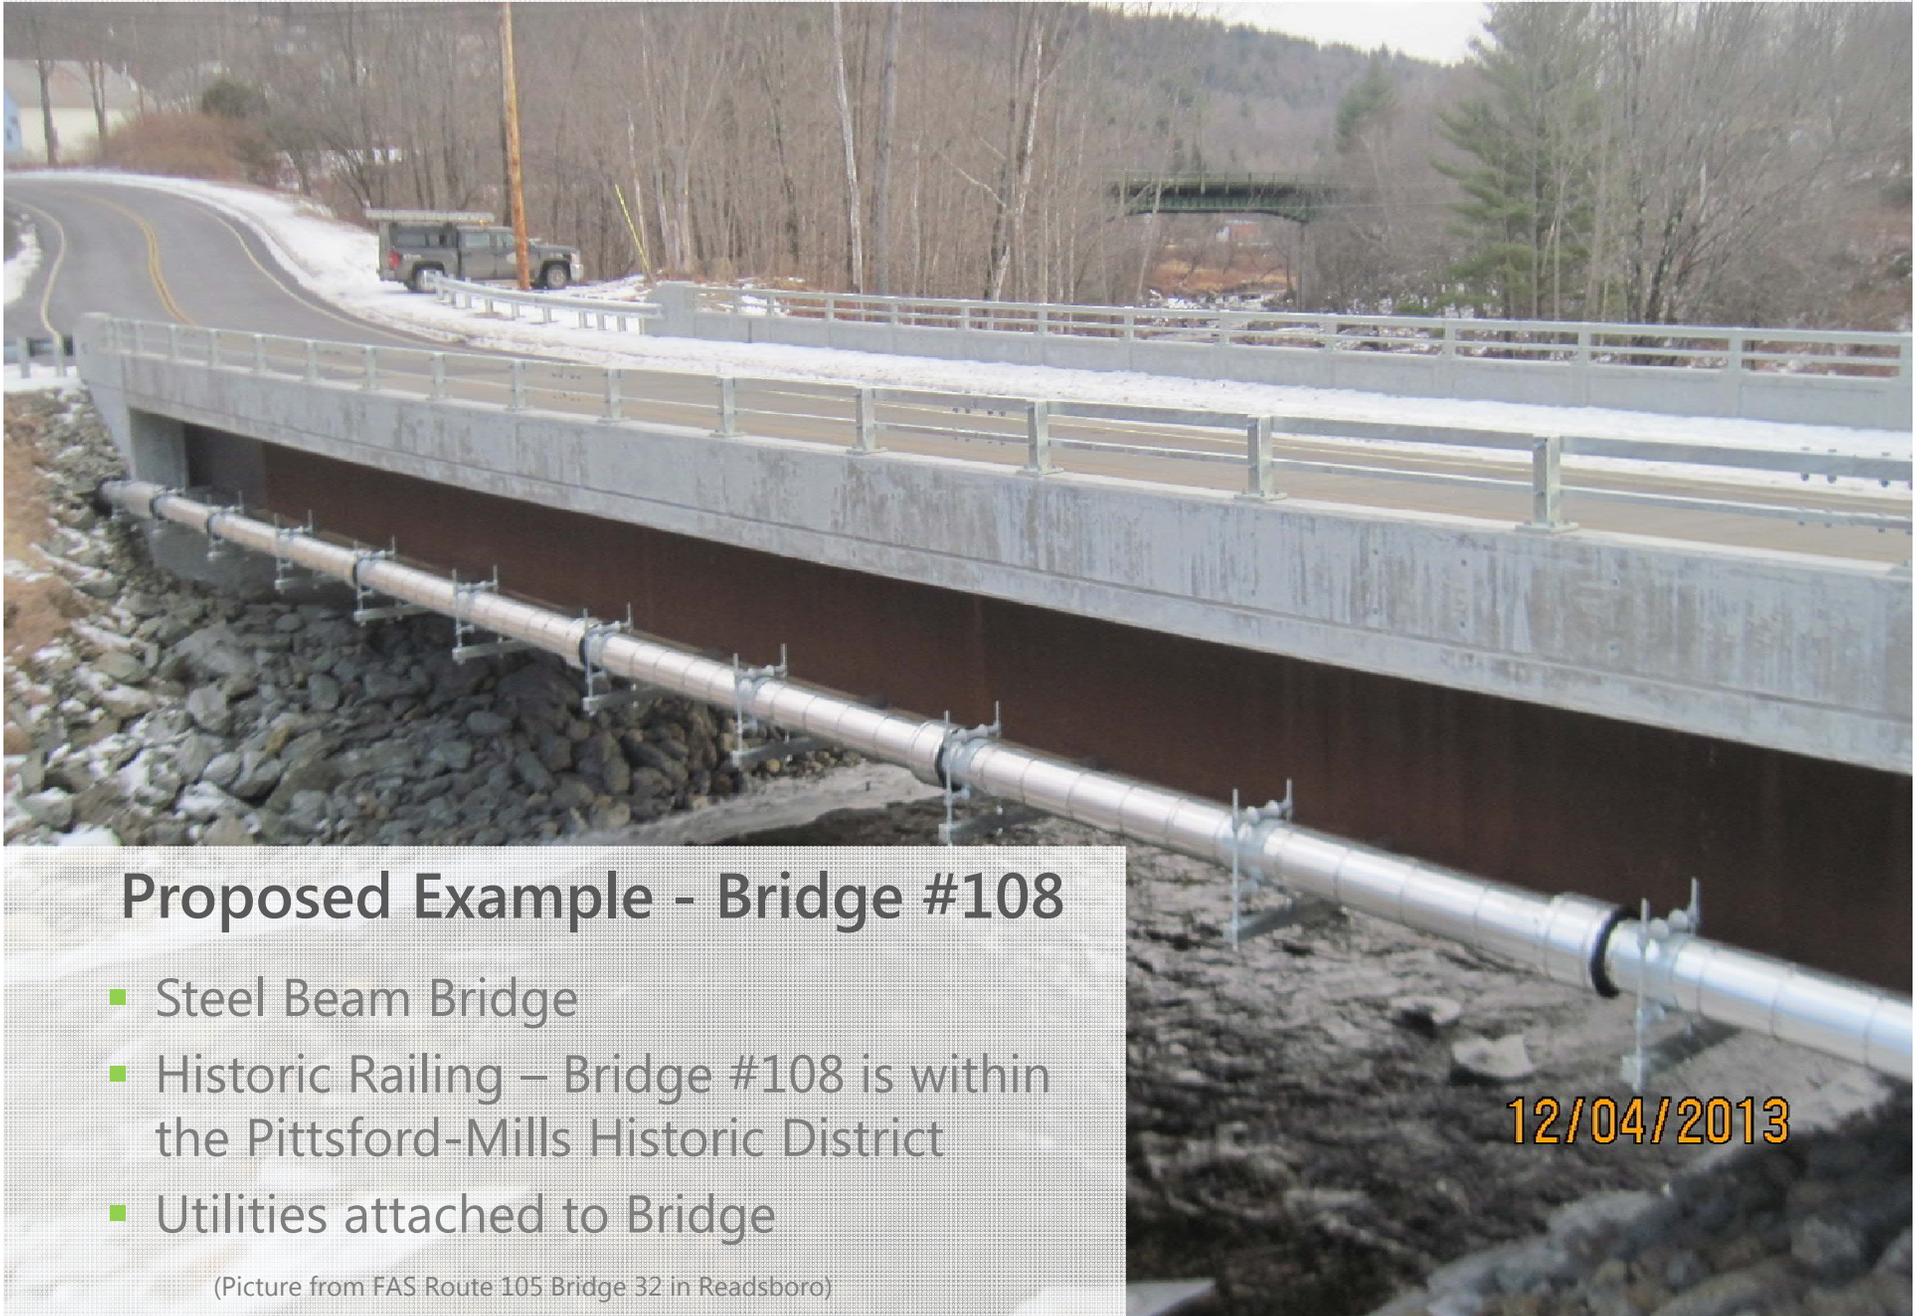
Proposed Example - Bridge #108

- Steel Beam Bridge
- Historic Railing – Bridge #108 is within the Pittsford-Mills Historic District
- Utilities attached to Bridge

(Picture from FAS Route 105 Bridge 32 in Readsboro)

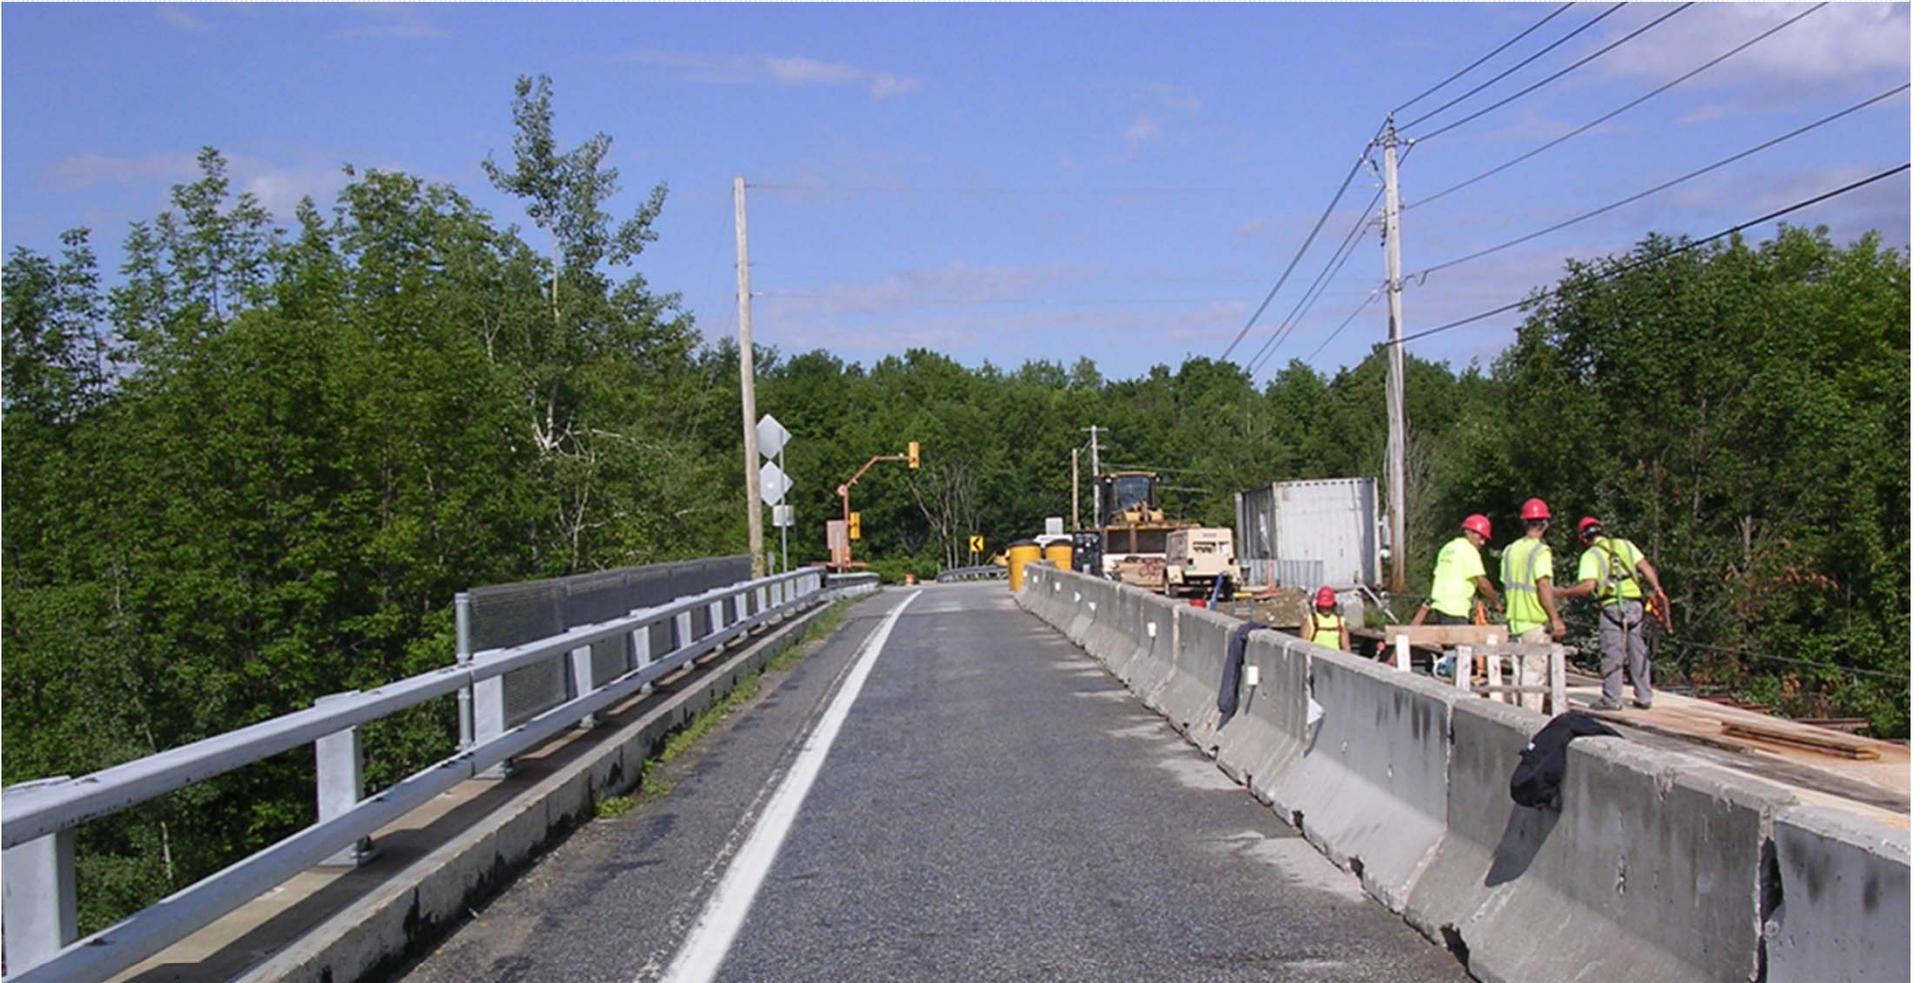
Phased Construction

- 3 Phases with Northbound and Southbound traffic maintained on Bridge 108.
- Pedestrians maintained on an upstream temporary pedestrian bridge

(Picture from US Route 7 Bridge 184 in Highgate)
