**STATE OF VERMONT
AGENCY OF TRANSPORTATION**

Scoping Report

**FOR
Pittsford BF 019-3(59)**

US ROUTE 7, BRIDGE 108 OVER THE FURNACE BROOK

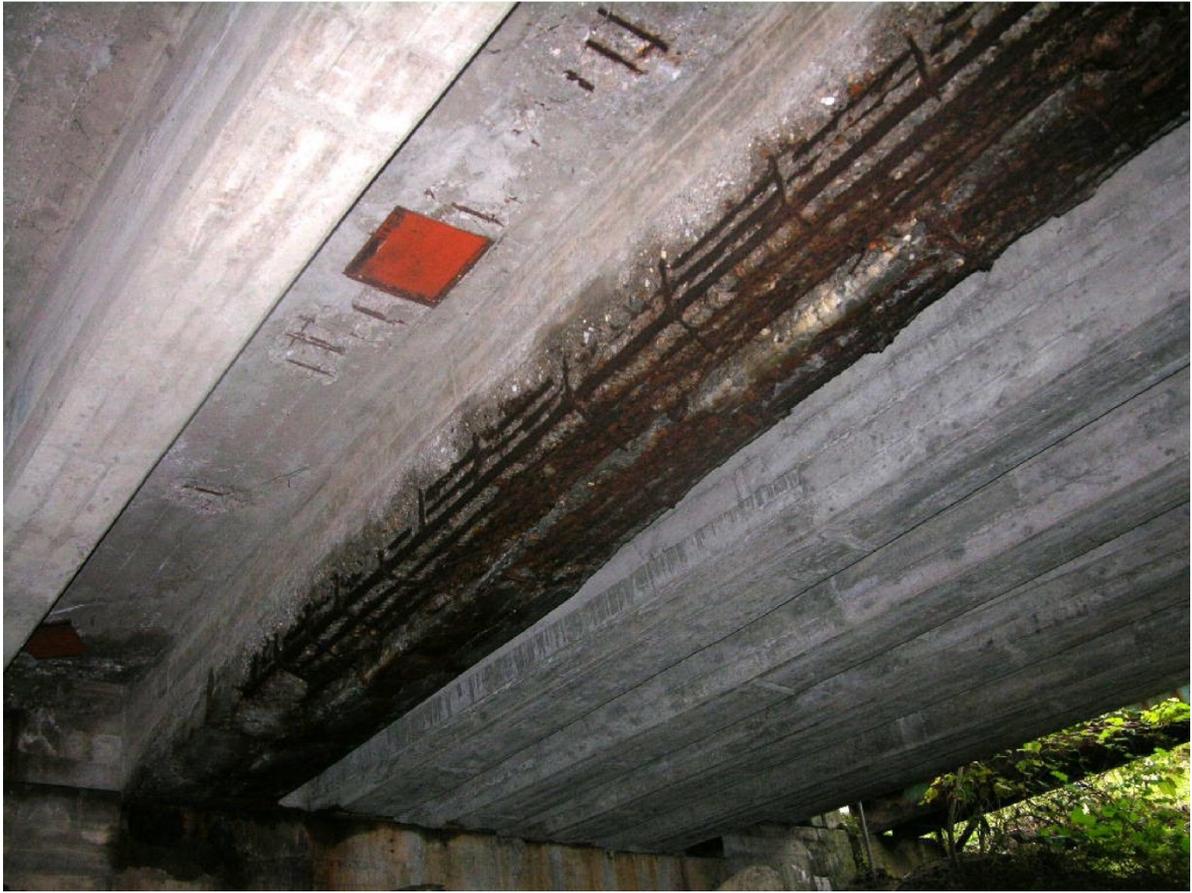
Existing T-beam deterioration

1. The existing T-beams are in fair condition. They have exposed rebar, especially near joints where leakage is taking place. Pot holes throughout the deck surface have needed patching recently.
2. The existing bridge and approach widths are too narrow for the roadway classification and traffic volumes.
3. The bridge railing does not meet crash standards.
4. The sag vertical curve and headlight site distance through the project area are substandard.

- There is no evidence of Alkali Silica Reaction taking place at the substructures. Damage appears to be from chloride attack. Therefore, details for adequate drainage are recommended to keep deicing salts off the existing substructures.
- The outer edges of the pier caps have a significant amount of spalling. The spalled areas on the piers should be prepared for patching, and patched with the appropriate concrete

repair class. Also, anodes should be put in the new concrete to discourage further deterioration.

- The existing bridge seats would be cut down and new bridge seats would be poured to accommodate the new superstructure.
- There is chloride attack along the abutment as evident by efflorescence. This is due to leaky bridge joints. This can be mitigated with minimal type concrete repair, and new bridge joints.

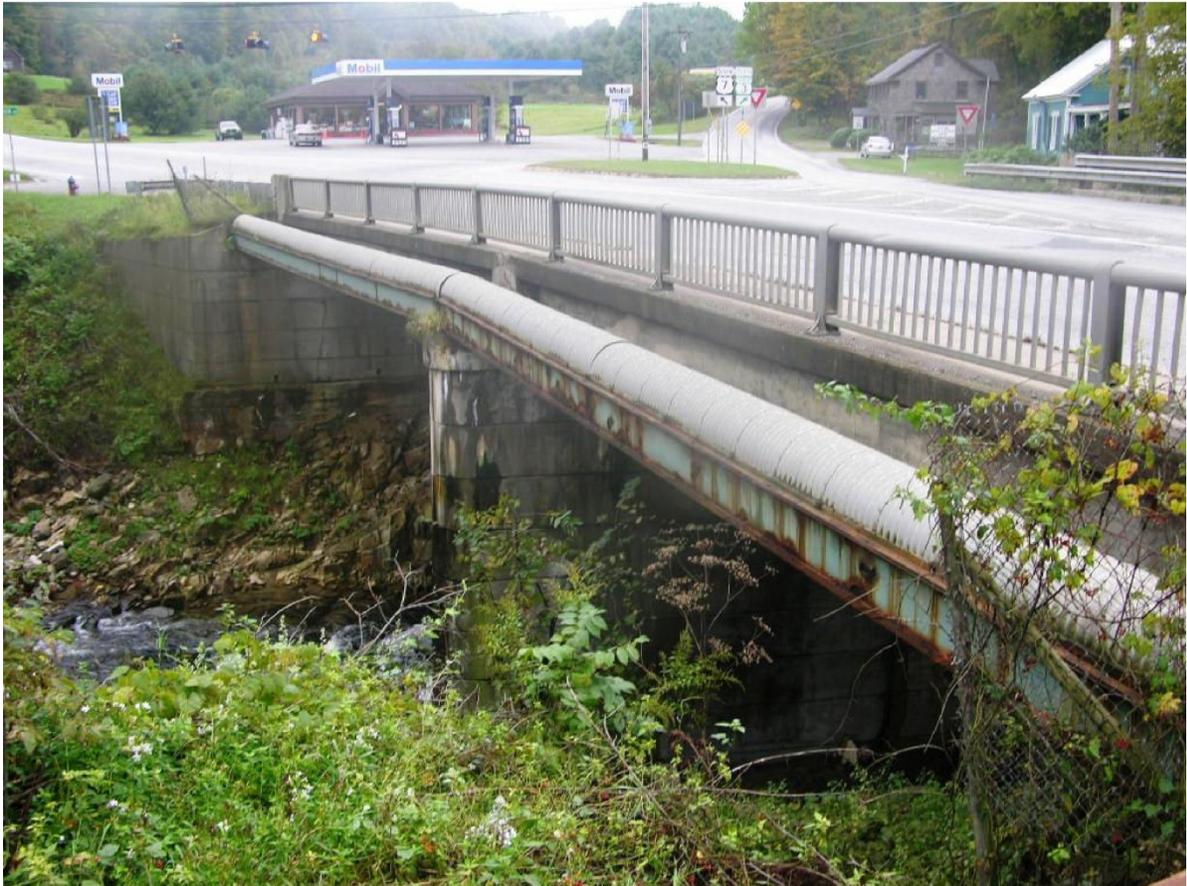
Utility attached to bridge fascia

Early collaboration will need to be made with the utility companies in order to facilitate the move of these utilities. It is recommended that the water main that is attached to the existing bridge is attached to the temporary pedestrian bridge during construction.

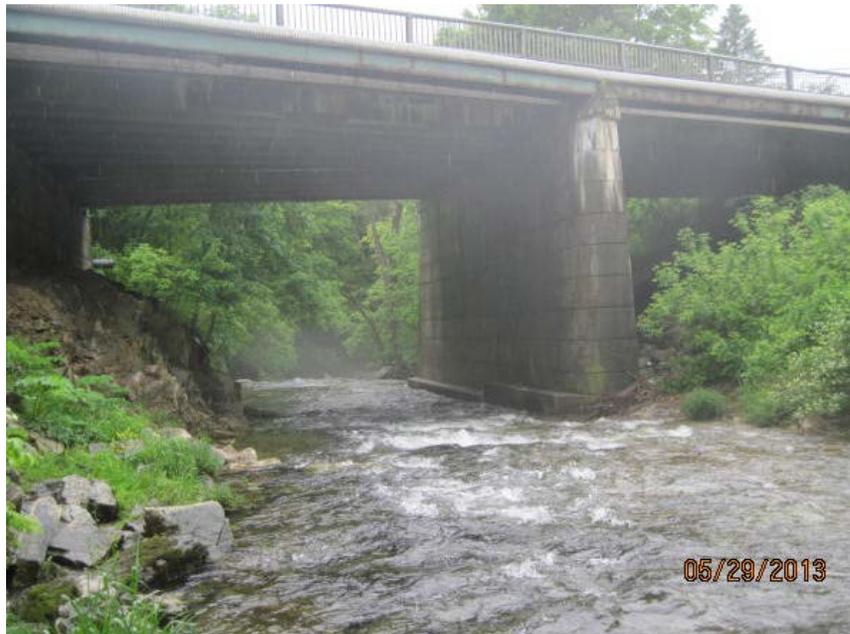
Figure 1 Photograph of Bridge 108. Photograph was taken during 2013 bridge inspection.

The bridge is a two span concrete T-Beam bridge whose abutments and pier rest directly on bedrock. The river channel at this location is floored by bedrock with recent alluvium deposits ranging from sand to boulder in size.

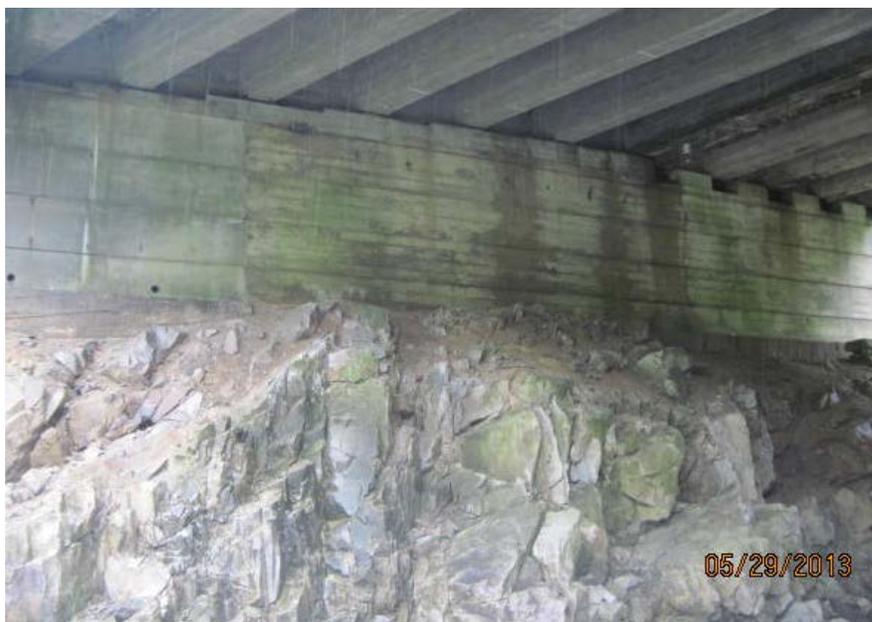
According to the 2012 bedrock map of Vermont, the project area overlies bedrock consisting of “Buff and pink-mottled and massive or light gray, pinkish-gray weathering, and massive to poorly bedded dolostone” of the Dunham Dolostone Formation. Figure 3 shows the rock at the southeasterly abutment of the existing bridge.

Figure 3 Bedrock exposed at Abutment No. 1. Photograph was taken during 2013 bridge inspection.

There is visible bedrock all throughout the project location. Also, both of the existing abutments as well as the pier are founded directly on bedrock. As such, stub abutments on spread footings are recommended. In order to reduce construction time, precast abutments and footings may be used.
