**STATE OF VERMONT
AGENCY OF TRANSPORTATION**

Scoping Report

**Craftsbury BO 1449(34)
Bridge #4 on Creek Rd (TH 4) over the Whitney Brook**

September 12, 2013

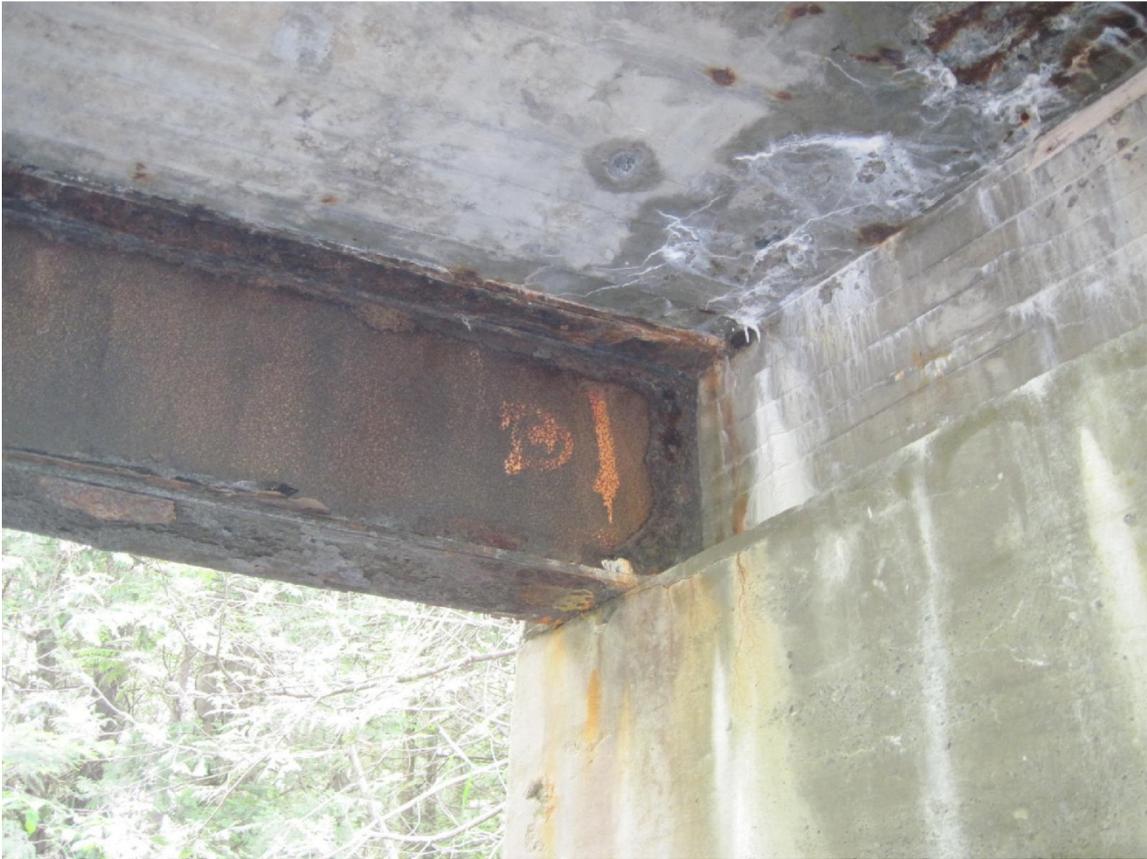
Girder and Deck Deterioration

5/9/2013 The deck and superstructure are in very poor condition due to the full depth hole in the deck between beams 3 and 4 also the major section loss in beams 1 and 2 on abutment#2 sides. Town needs to repair hole in the deck and needs to post for 3ton or even possible closure. ~FRE/DAK

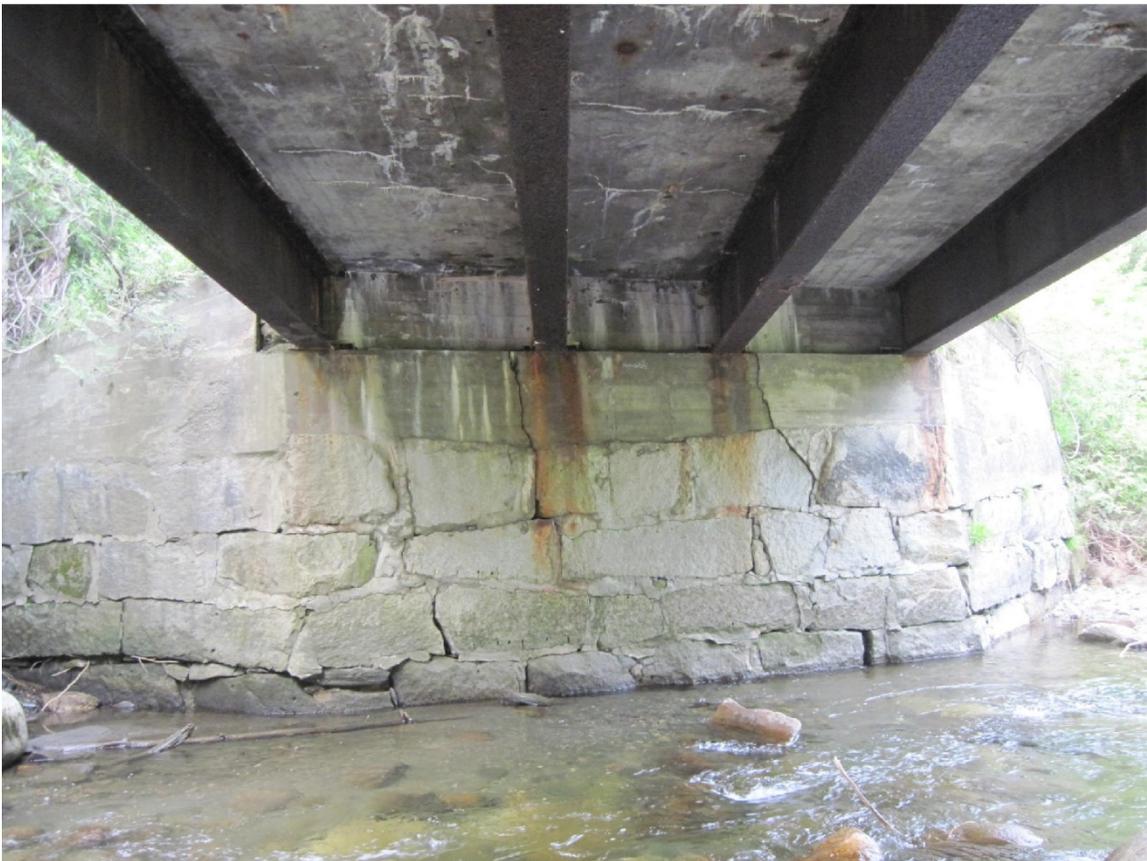
Cracks in the Abutment cap and Gaps in the Stone work

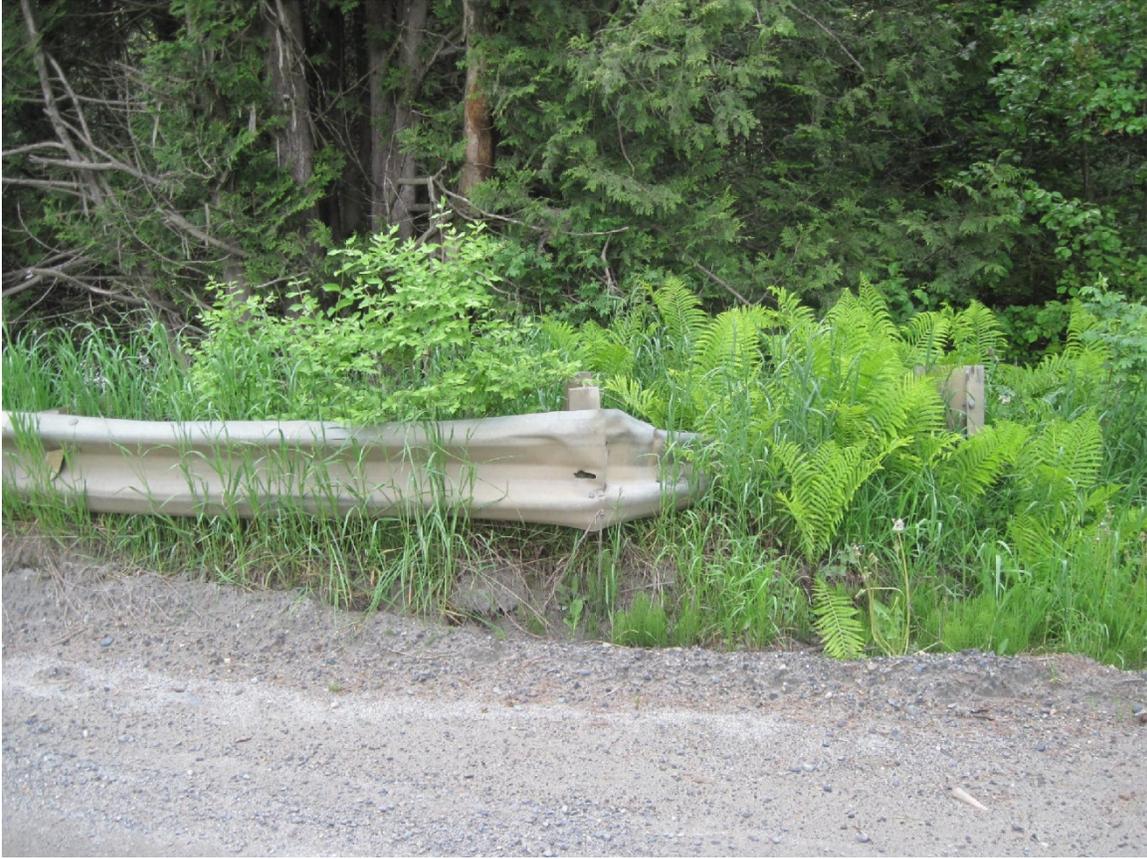
Insufficient terminal section and unrepaired damaged section

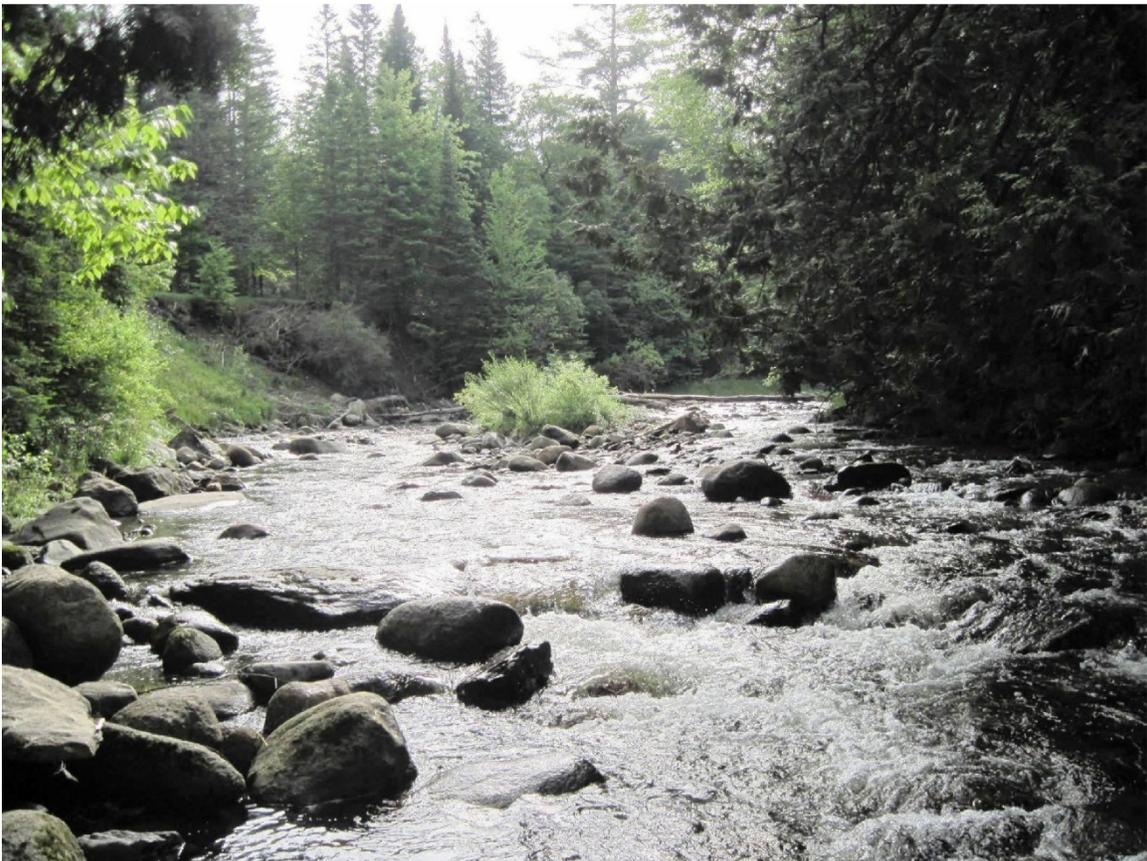
Steep banks and steep channel looking upstream

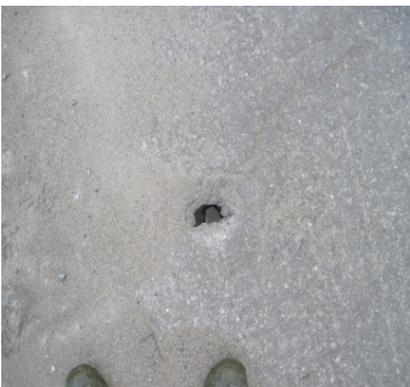
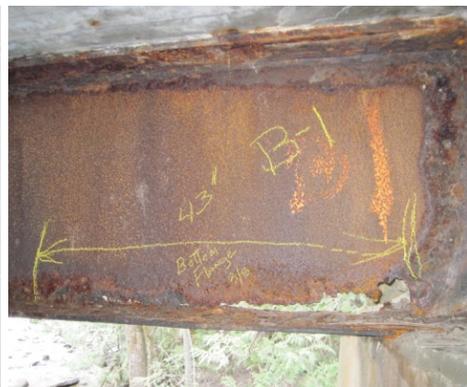
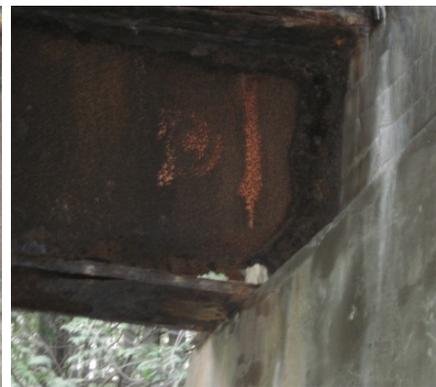
- The deck is in very poor condition. A hole has formed in the deck on abutment #2 side between beams #3 and #4 approximately 6 feet from the abutment. Due to the heavy saturation in the deck more holes could form at anytime.
- The superstructure is in poor condition. There is a hole in the web of beam #1 and 2 on abutment #2 side. There are areas of section loss measuring 43 inches long on beam #1 and 16 to 18 inch long on beam #2. There is also heavy section loss in the bottom flange of both beams in this area.

As discussed with your town road foreman on Friday, May 10th, based on these findings, it is recommended that the hole in the deck be covered with a steel plate as a temporary fix. Also, due to the section loss in beams #1 and #2, that the structure should be legally posted for a maximum gross weight limit of 3 tons and no trucks until beams have been repaired or structure has been replaced.

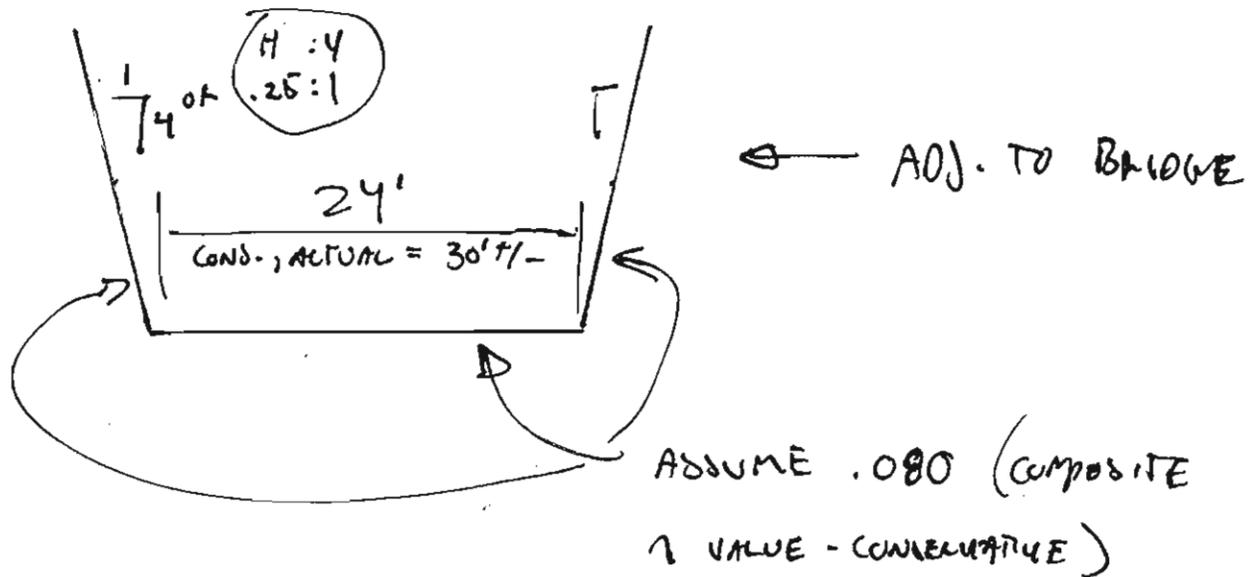
CONSIDER APPROXIMATE CROSS-SECTION @ NORMAL DEPTH
 TO CHECK MAGNITUDE OF HEL-RAS OUTPUT

$$Q = 2000 \text{ CFS}$$

$$d = 7.01'$$

ASSUME CHANNEL SLOPE OF
 4.5% \rightarrow ACTUAL
 SLOPE IS
 GREATER

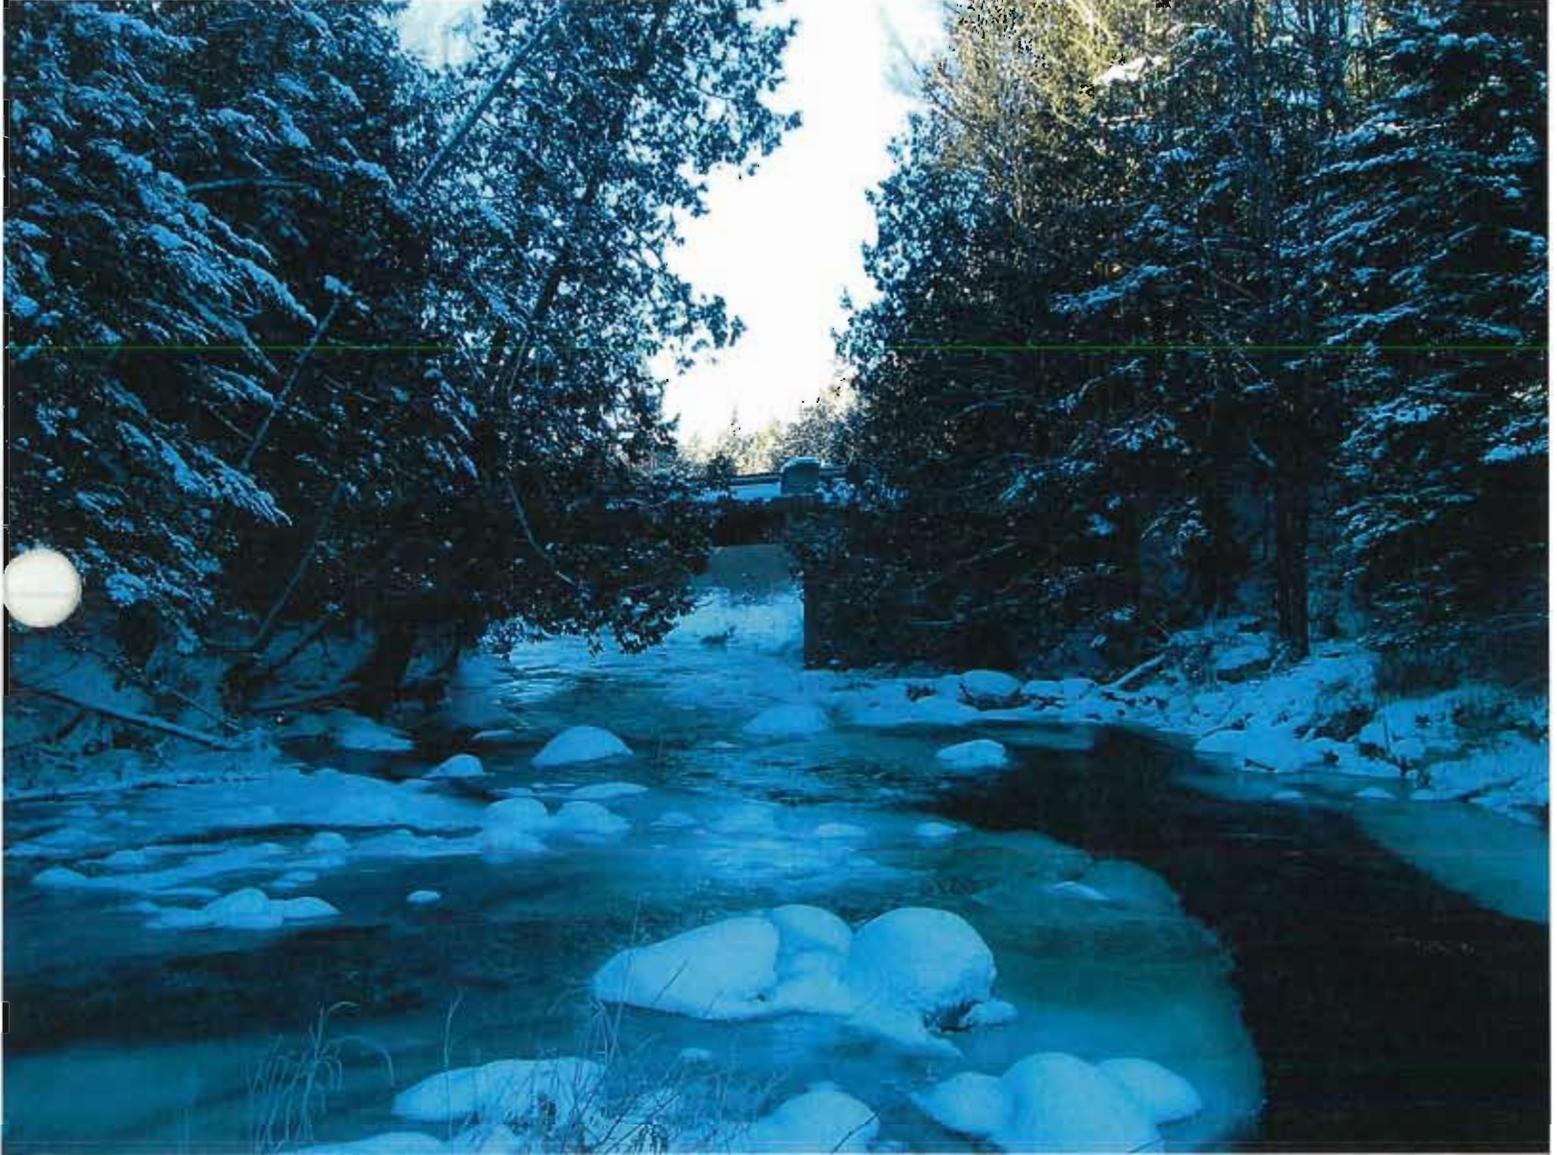
WHITNEY BRK
DN STR. OF CREEK RD

SECTIONS FOR HEC-6AS

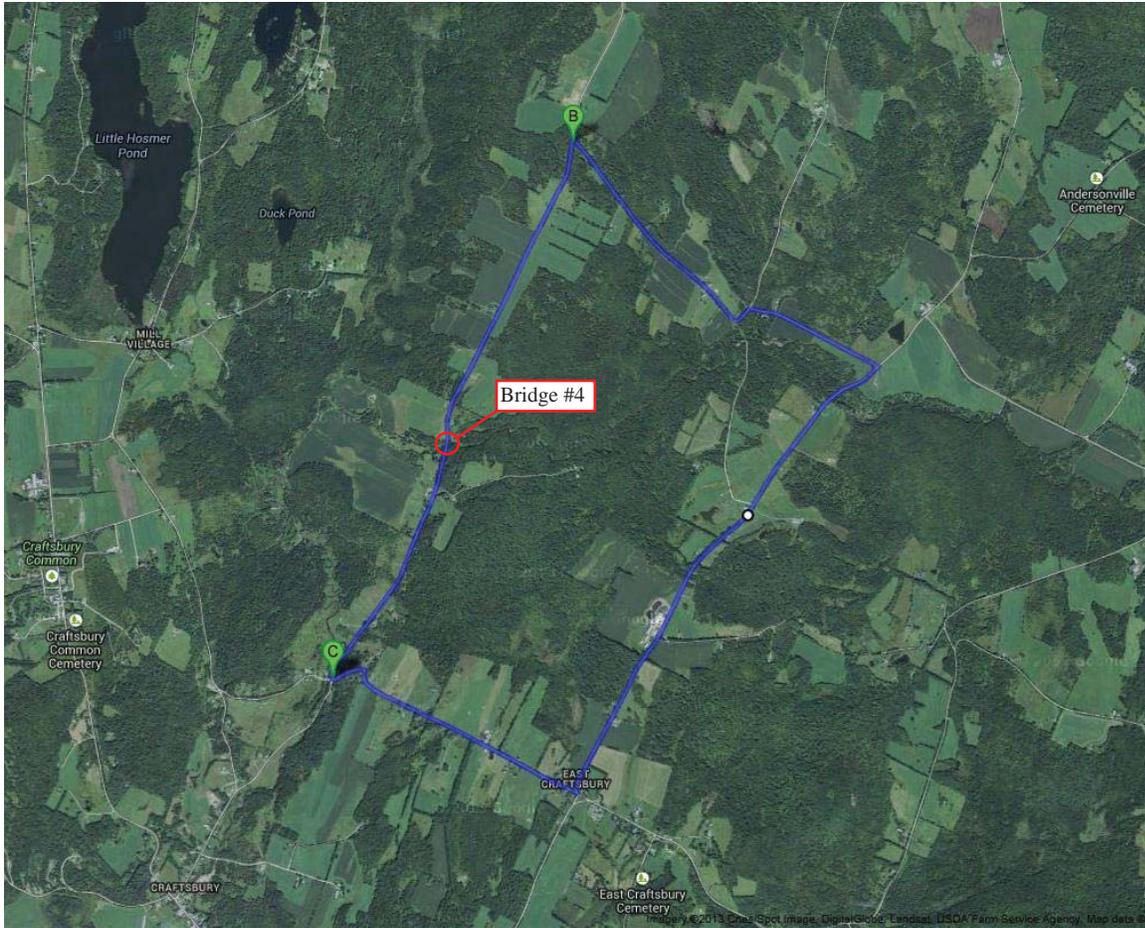
Detour Route – Creek Rd to Seaver Brook Rd to South Albany Rd to Ketchem Hill Rd to Creek Rd

B to C on Through Route: 2.2 Miles (about 5 minutes)

Added Miles: 2.4 Miles

End to End Distance: 6.8 Miles

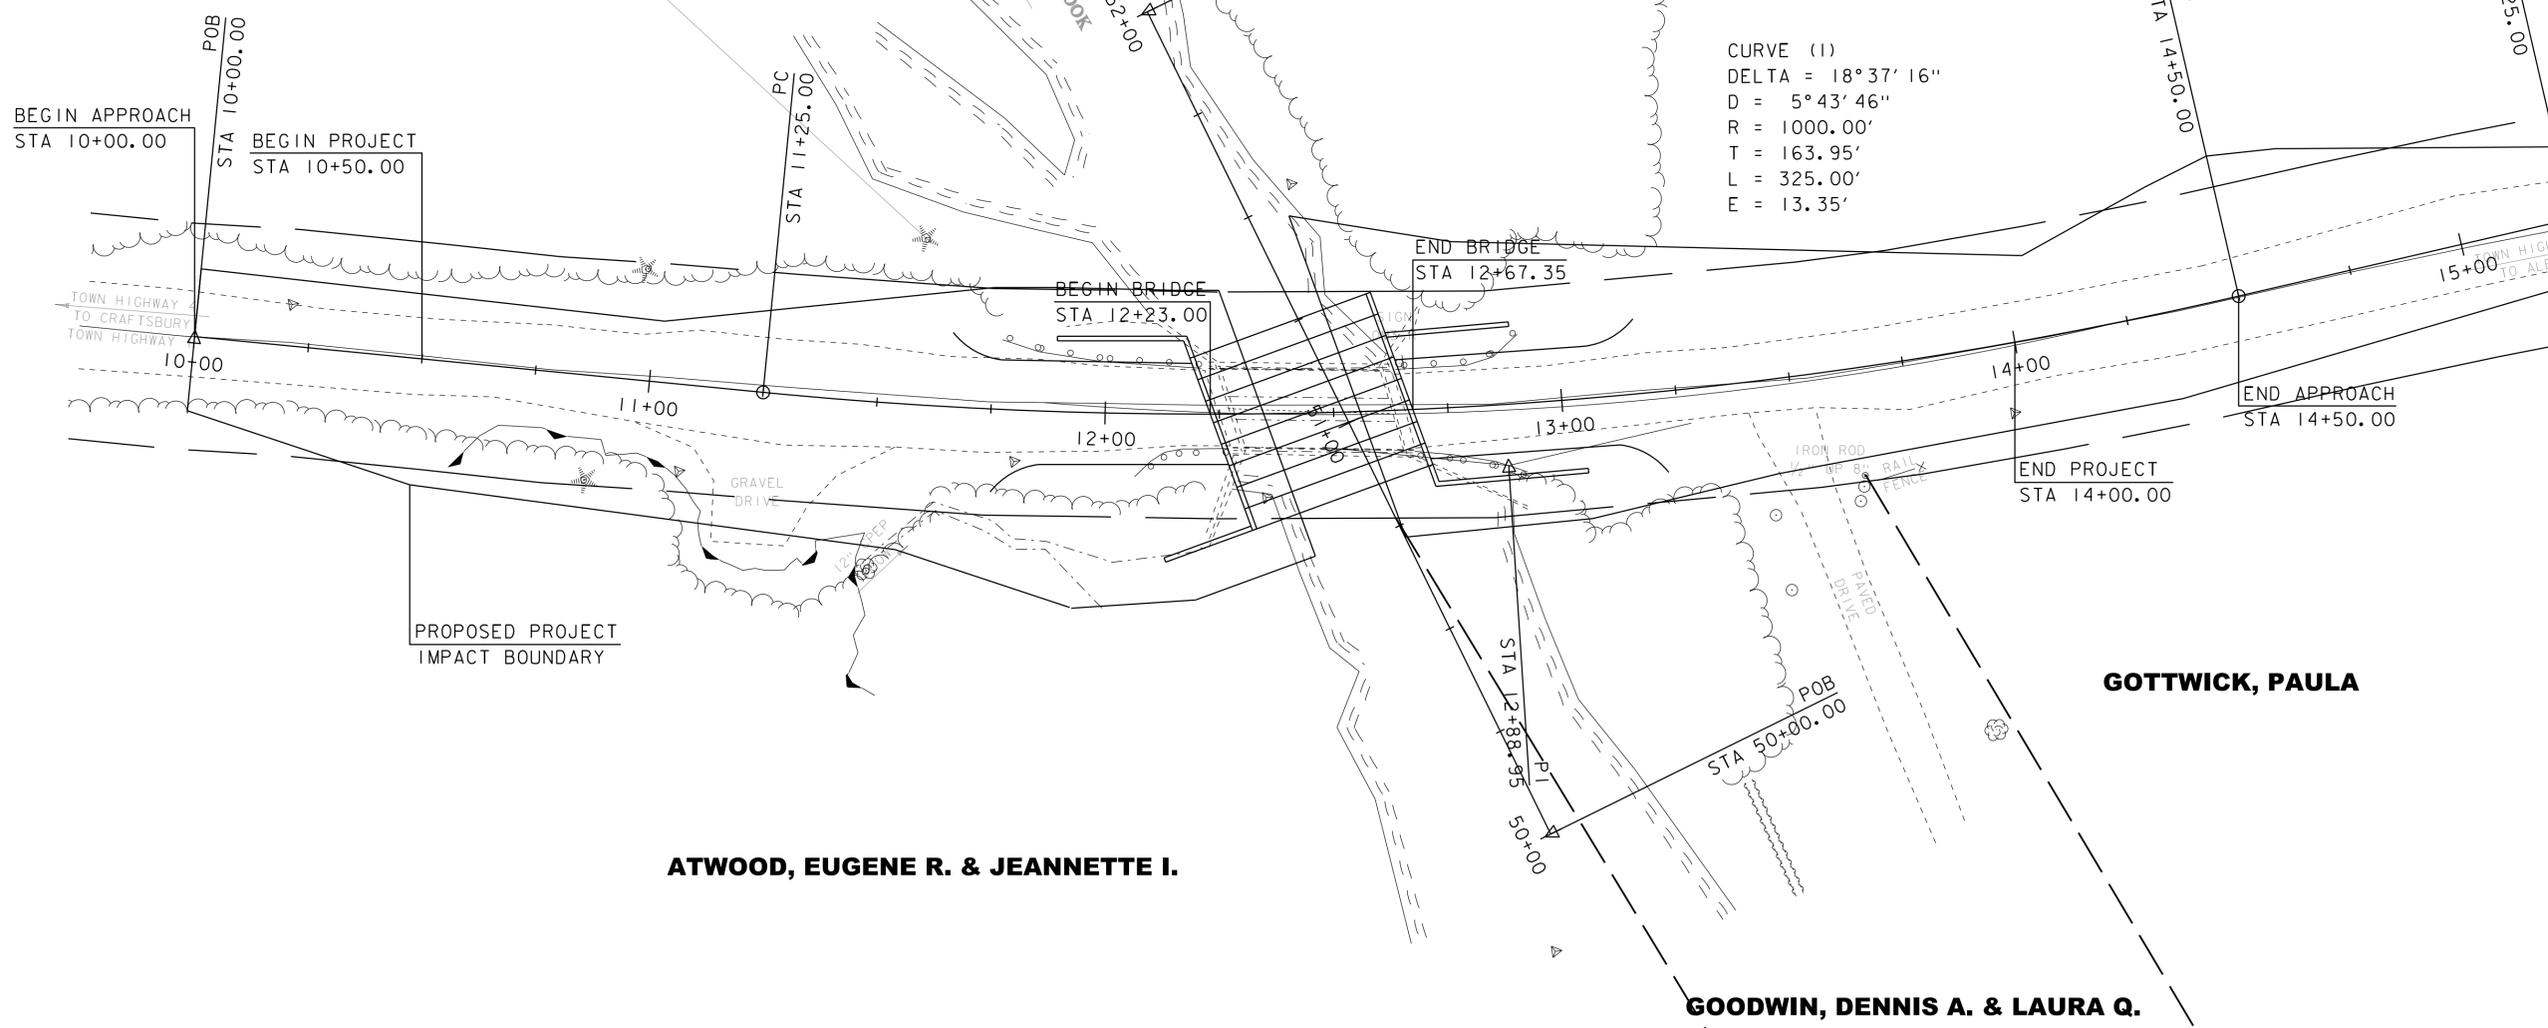
42' BRIDGE LAYOUT
SCALE 1" = 20'-0"
20 0 20

CURVE (1)
DELTA = 18°37'16"
D = 5°43'46"
R = 1000.00'
T = 163.95'
L = 325.00'
E = 13.35'

EXISTING BRIDGE DATA
SINGLE SPAN ROLLED BEAM
BUILT 1929
41' SPAN, 17.7' CURB - CURB

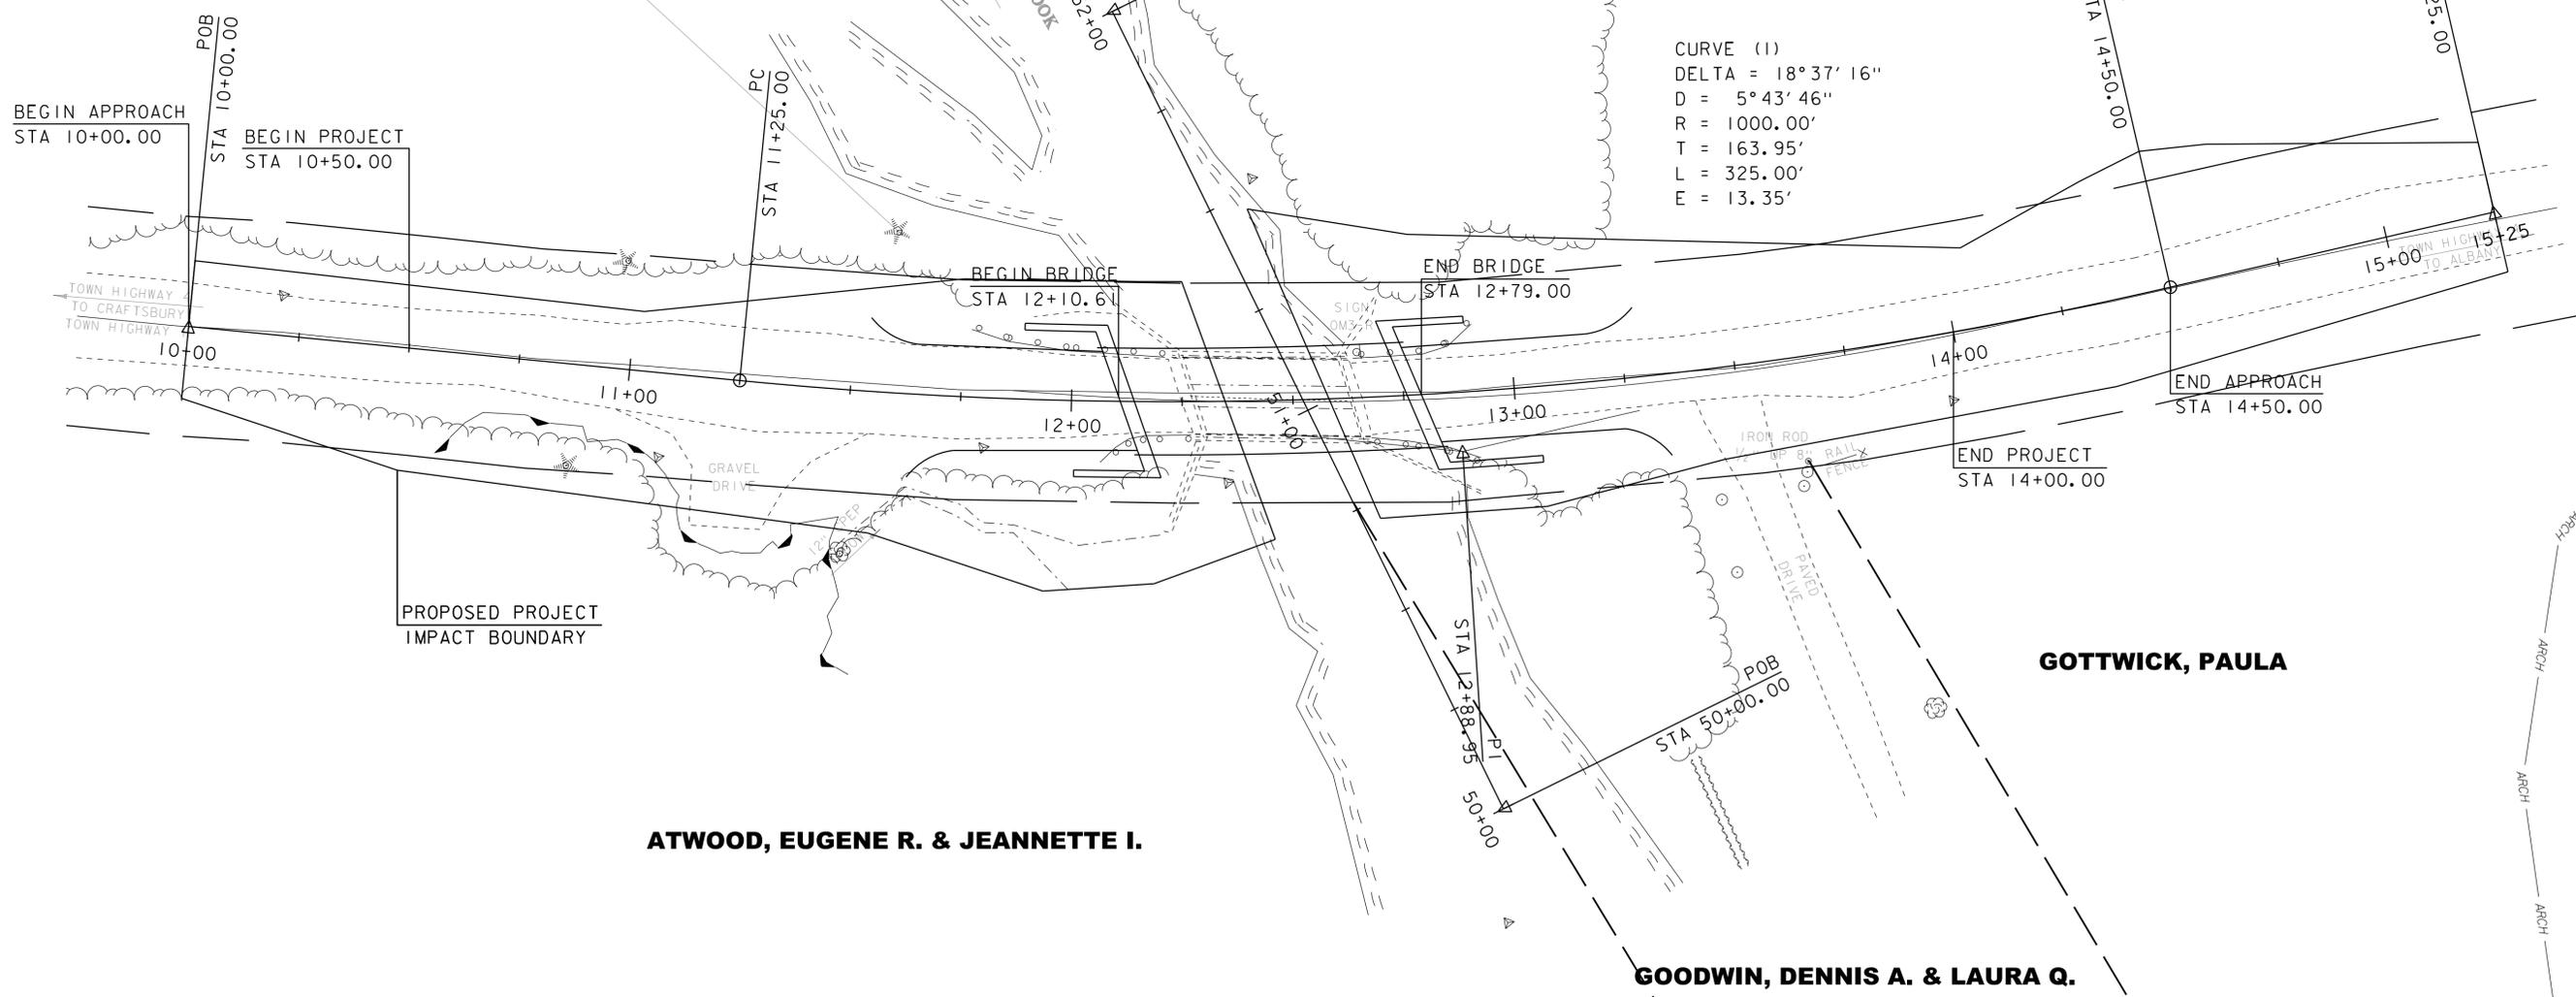
68' BRIDGE LAYOUT
SCALE 1" = 20'-0"
20 0 20

CURVE (1)
DELTA = 18°37'16"
D = 5°43'46"
R = 1000.00'
T = 163.95'
L = 325.00'
E = 13.35'

EXISTING BRIDGE DATA
SINGLE SPAN ROLLED BEAM
BUILT 1929
41' SPAN, 17.7' CURB - CURB

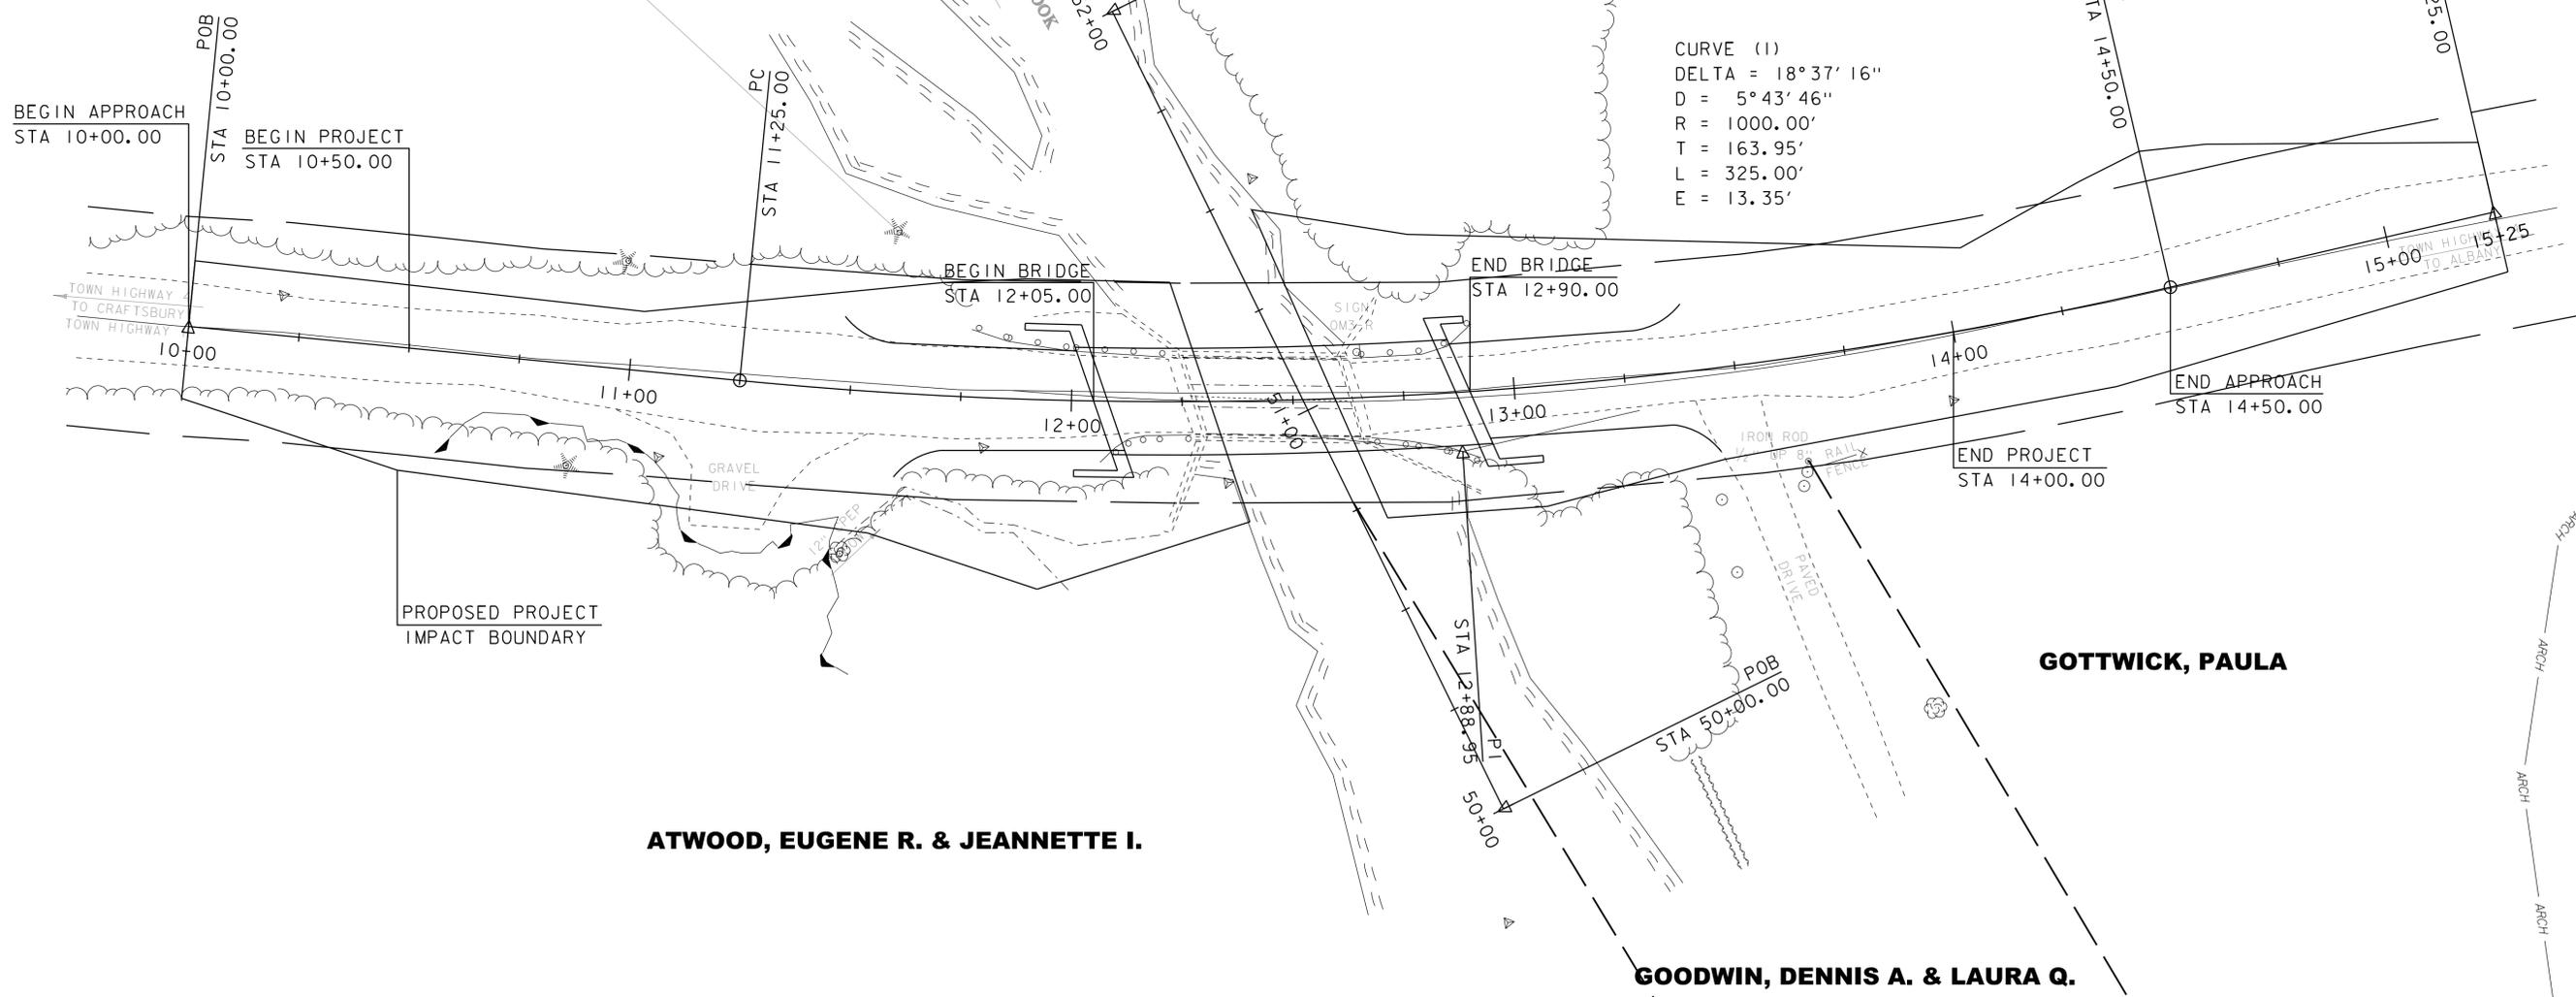
85' BRIDGE LAYOUT
SCALE 1" = 20'-0"
20 0 20

CURVE (1)
DELTA = 18°37'16"
D = 5°43'46"
R = 1000.00'
T = 163.95'
L = 325.00'
E = 13.35'

EXISTING BRIDGE DATA
SINGLE SPAN ROLLED BEAM
BUILT 1929
41' SPAN, 17.7' CURB - CURB
