Danby BF 0130(3)
Alternatives Presentation Meeting
Brook Road (FAS Route 130/TH 1) – Bridge #9 over Mill Brook

March 12, 2015

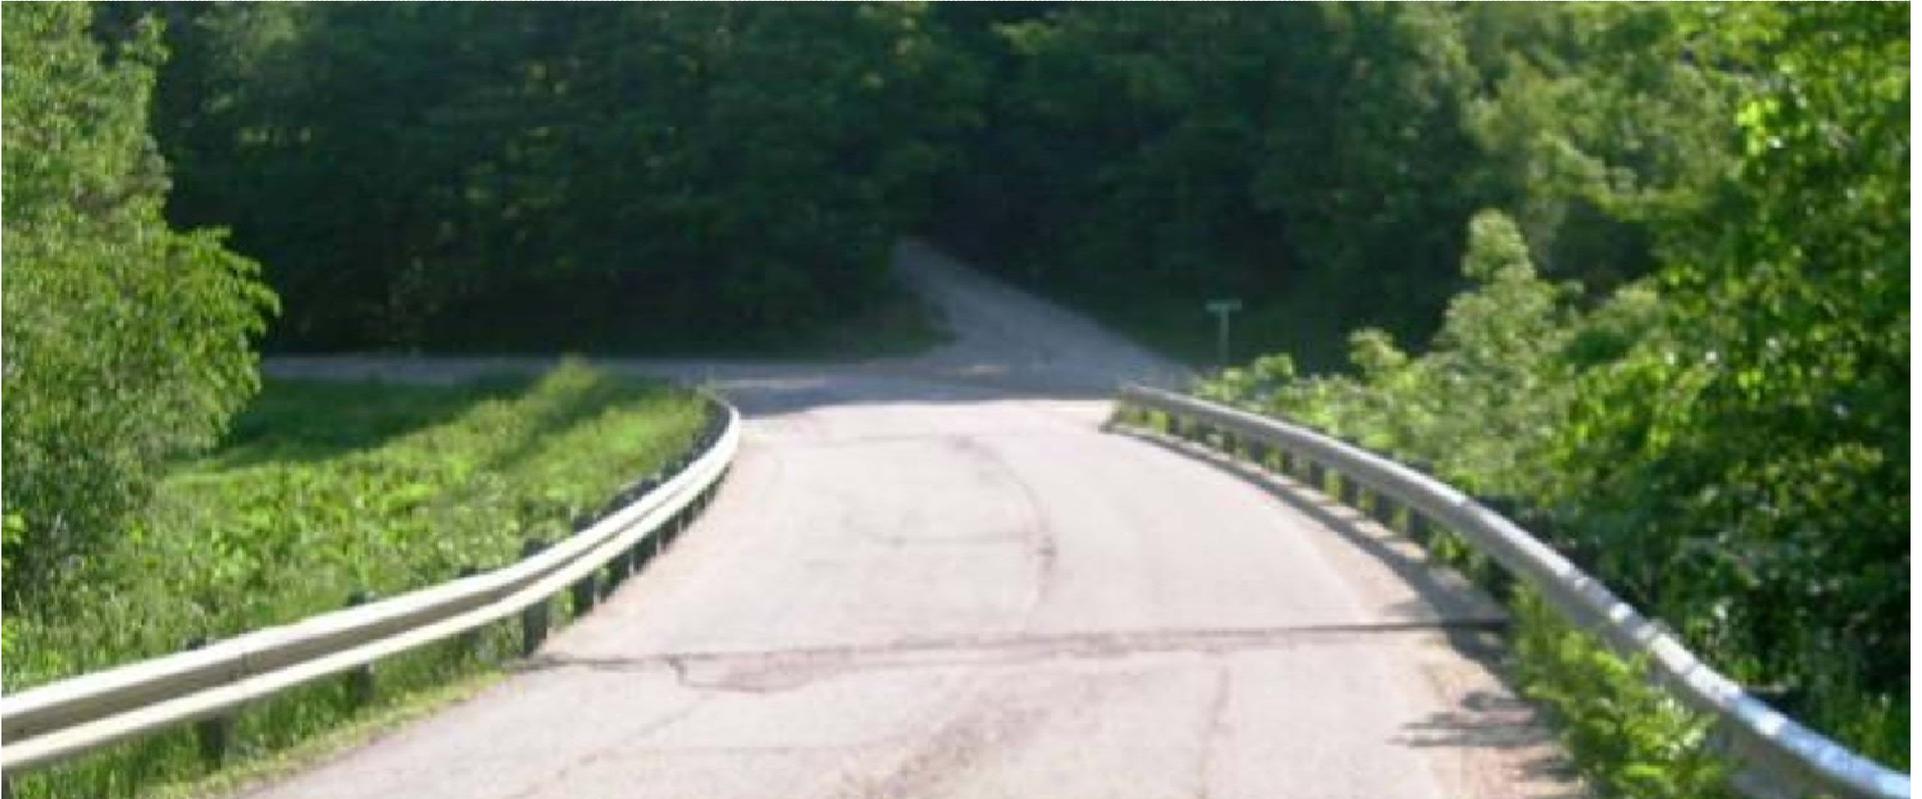
Cross Section of Bridge

Looking East over Bridge

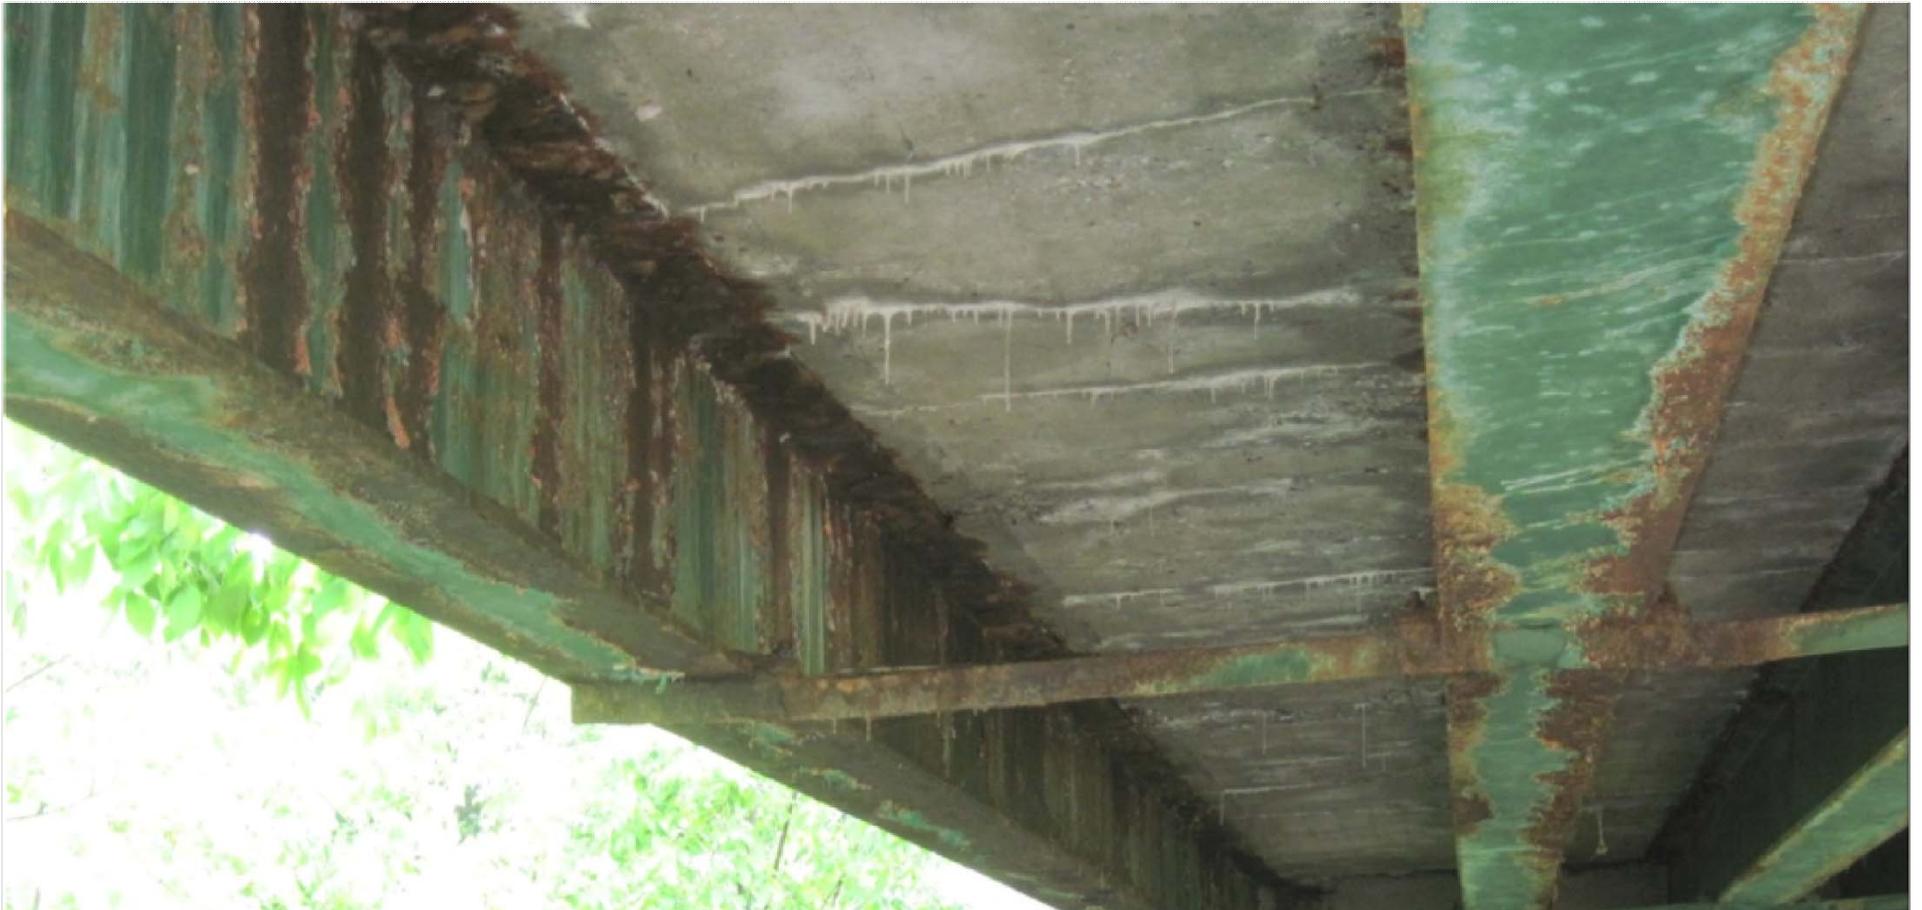
- The rolled beams have significant rust
- There is transverse cracking in the deck
- Leaky bridge joints
- The lane and shoulder widths of the bridge are too narrow
- Horizontal curve is substandard
- The existing vertical alignment through the project location does not meet the current standard

Transverse Cracks in Concrete Deck and Rusting Rolled Beams

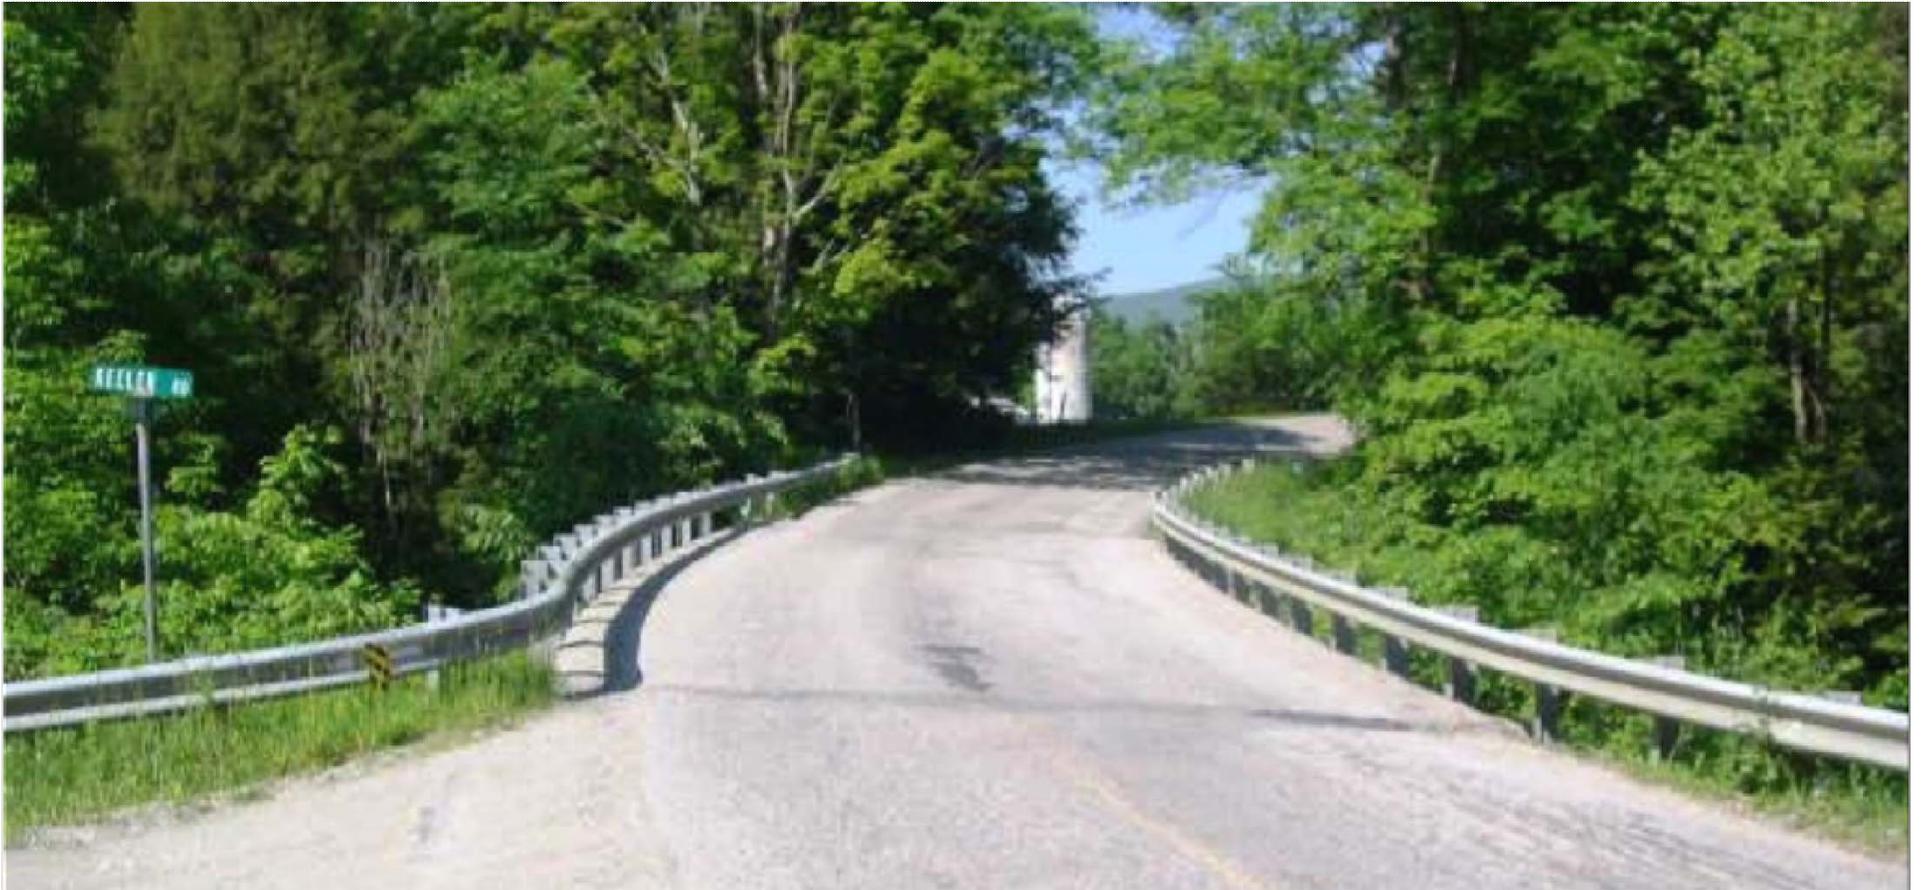
Looking West over Bridge

- Sag vertical curve and headlight site distance are substandard
- Horizontal curve is too sharp
- Bridge is too narrow

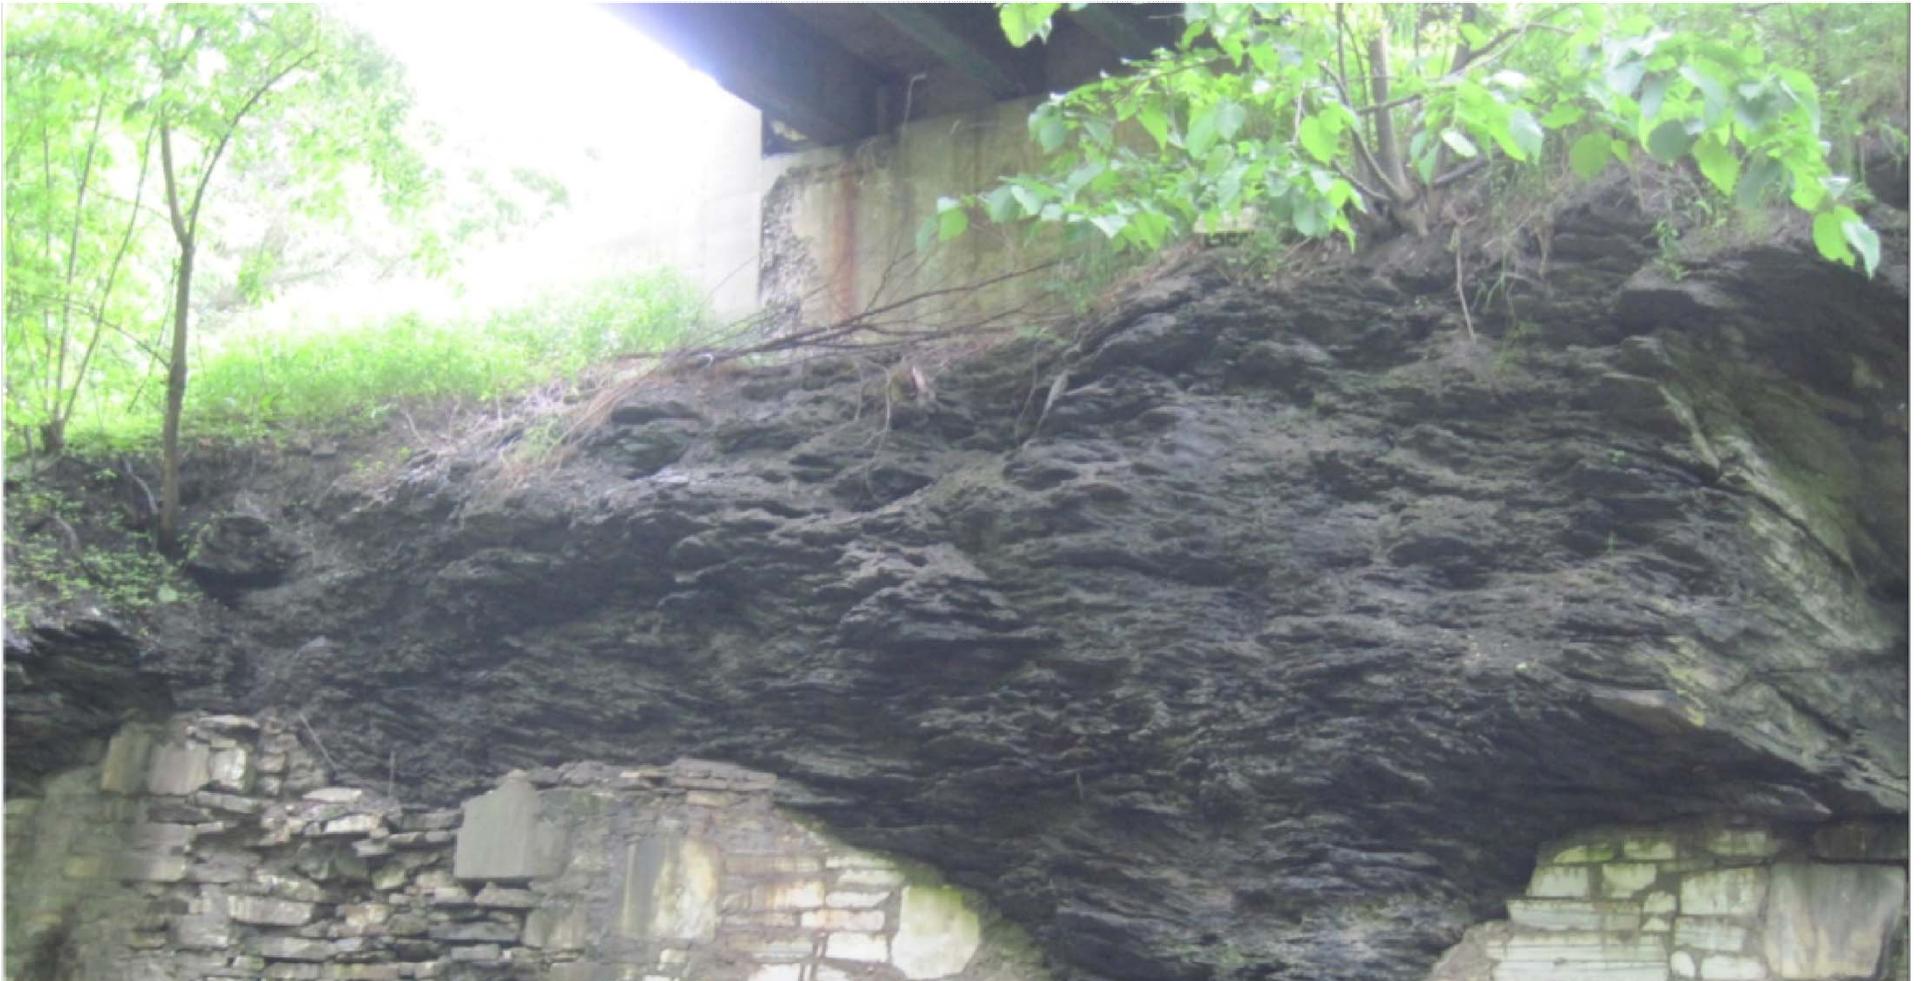
Substructure Condition

- Bedrock overhang with marble block masonry wall support
- Bedrock is instable

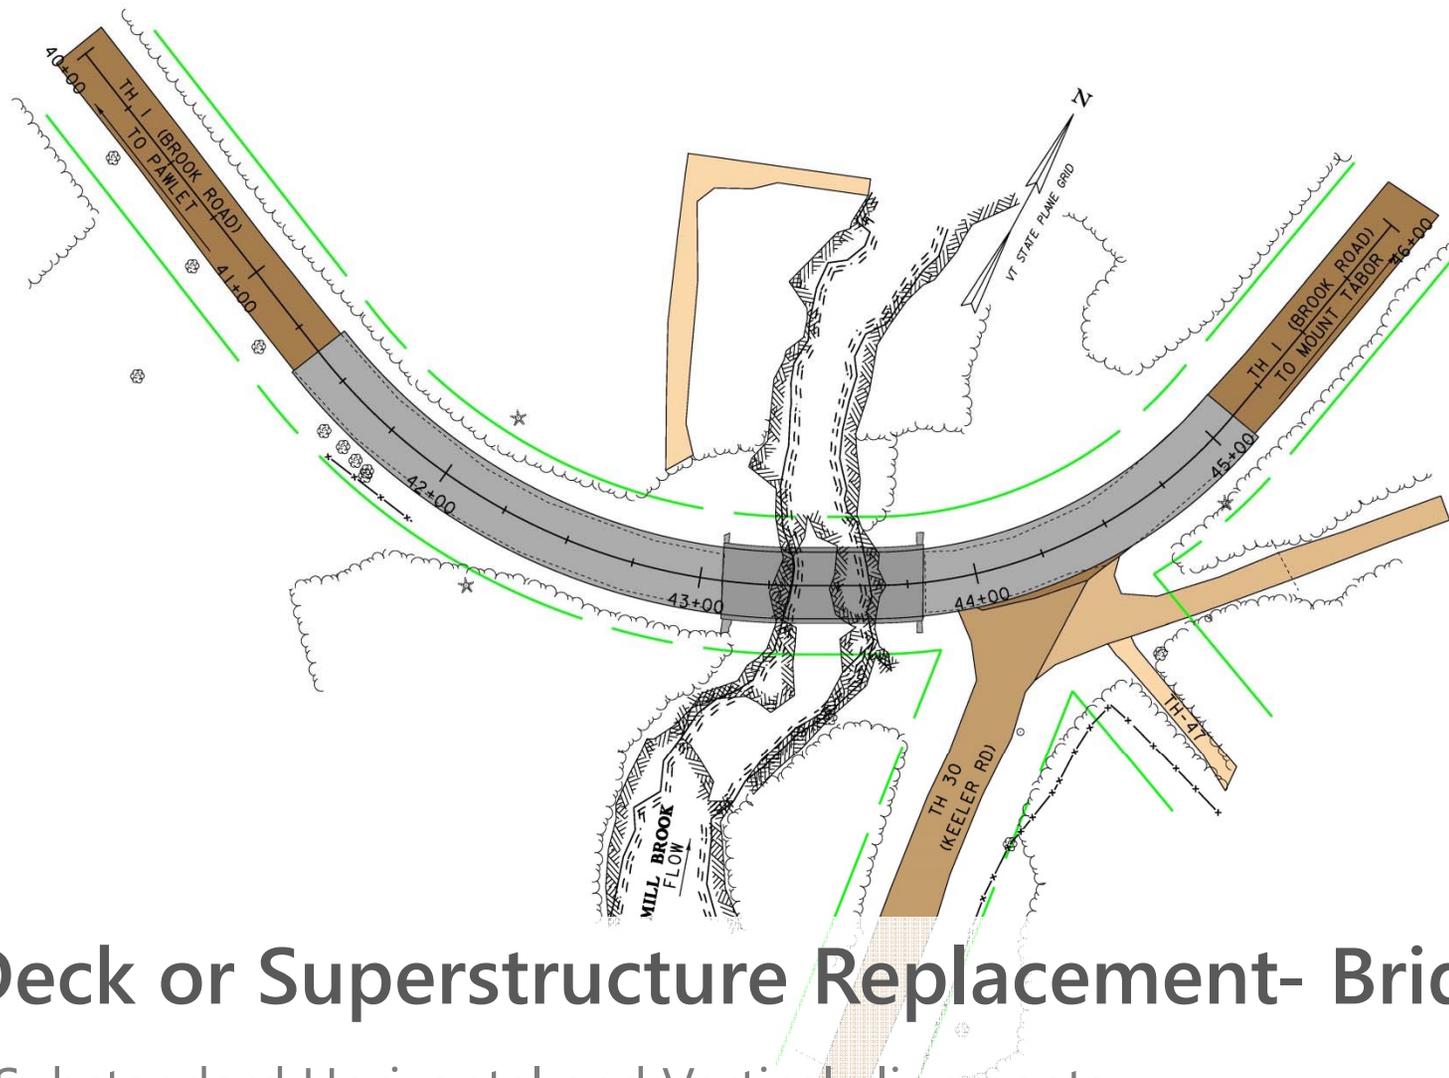
Alternatives 1&2 Layout

Deck or Superstructure Replacement- Bridge #9

- Substandard Horizontal and Vertical alignments

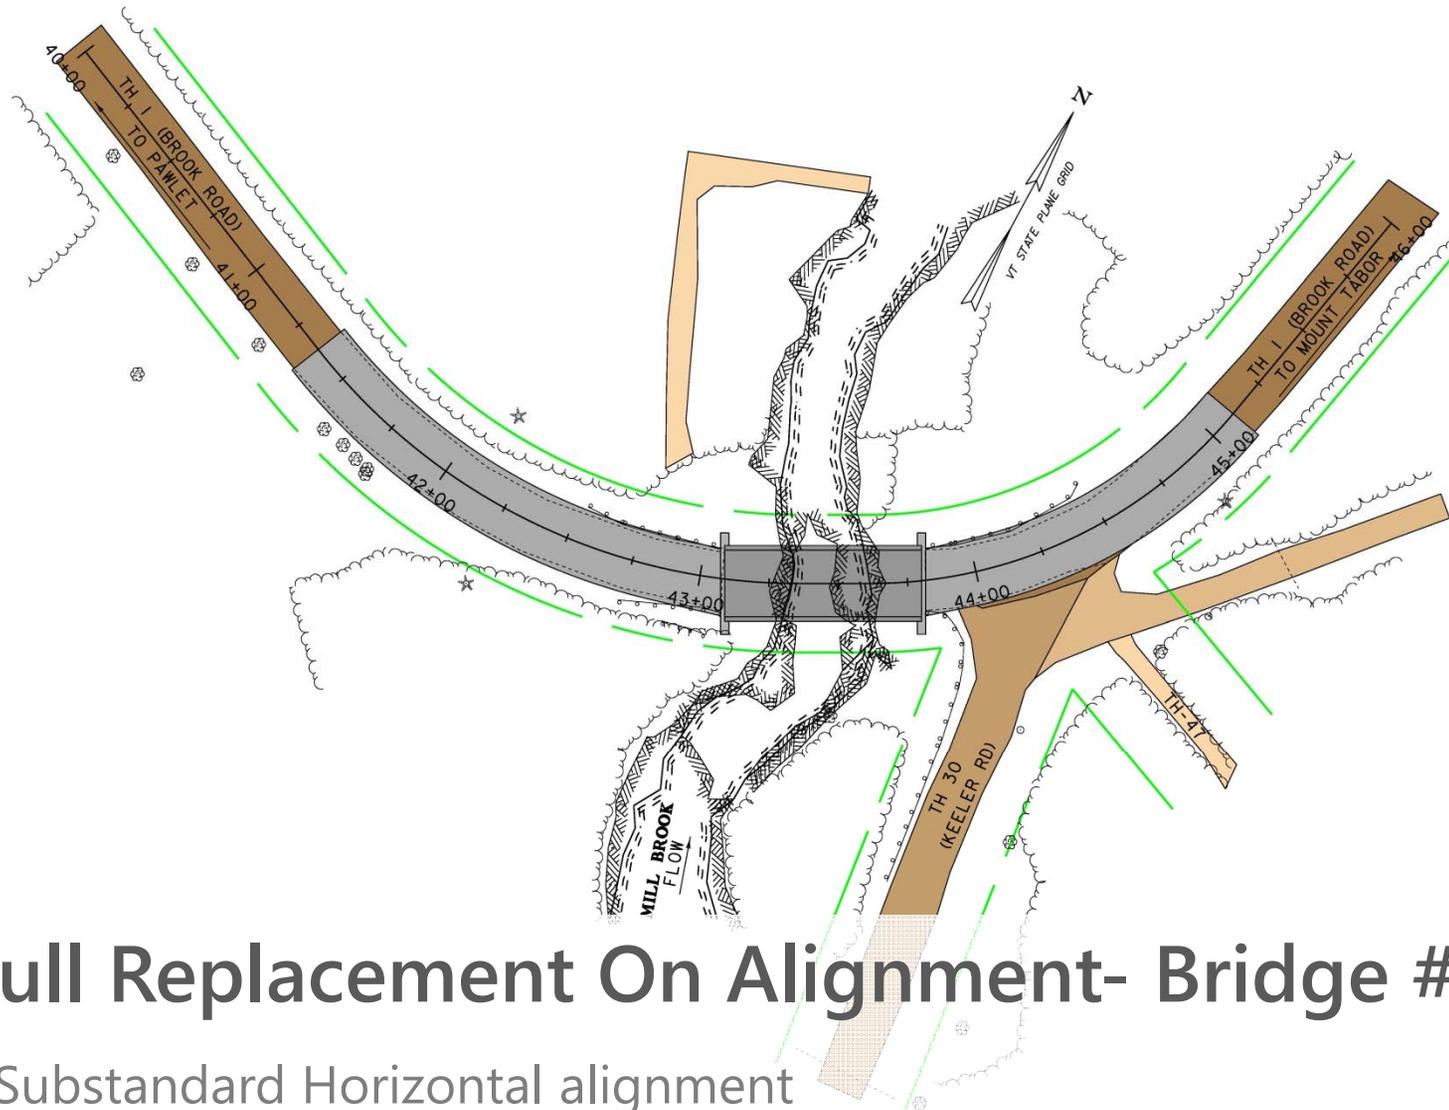
Alternative 3 Layout

Full Replacement On Alignment- Bridge #9

- Substandard Horizontal alignment

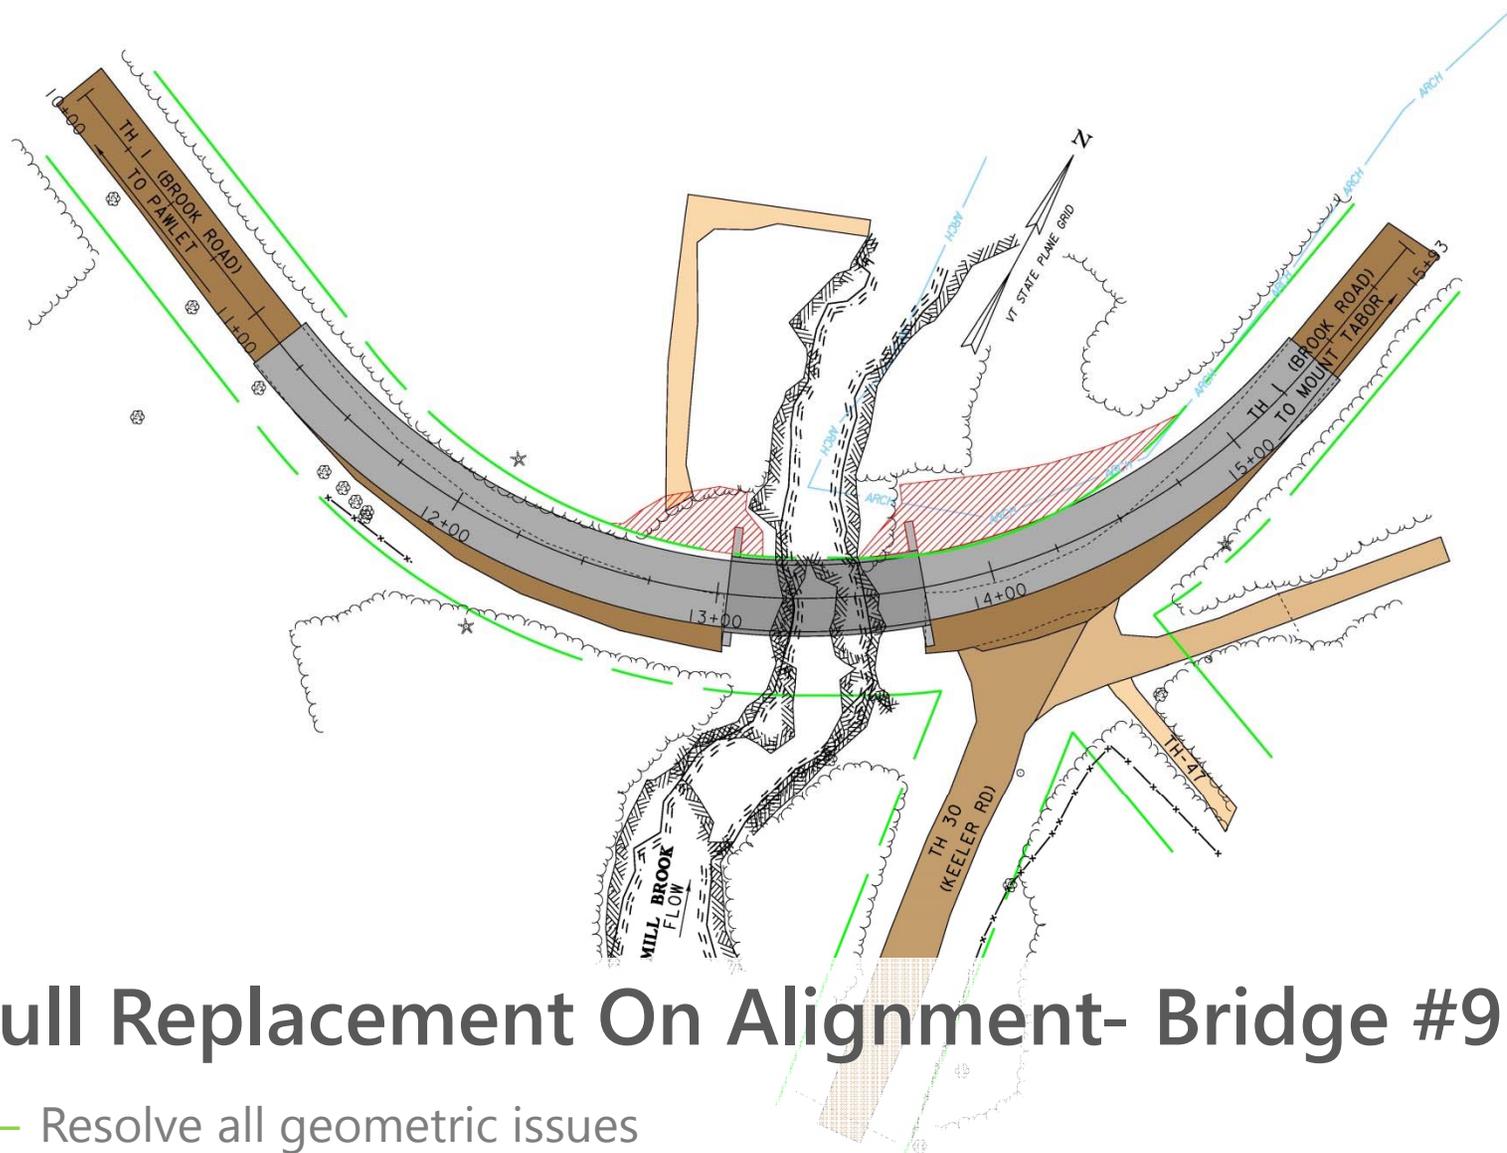
Alternative 4 Layout

Full Replacement On Alignment- Bridge #9

- Resolve all geometric issues

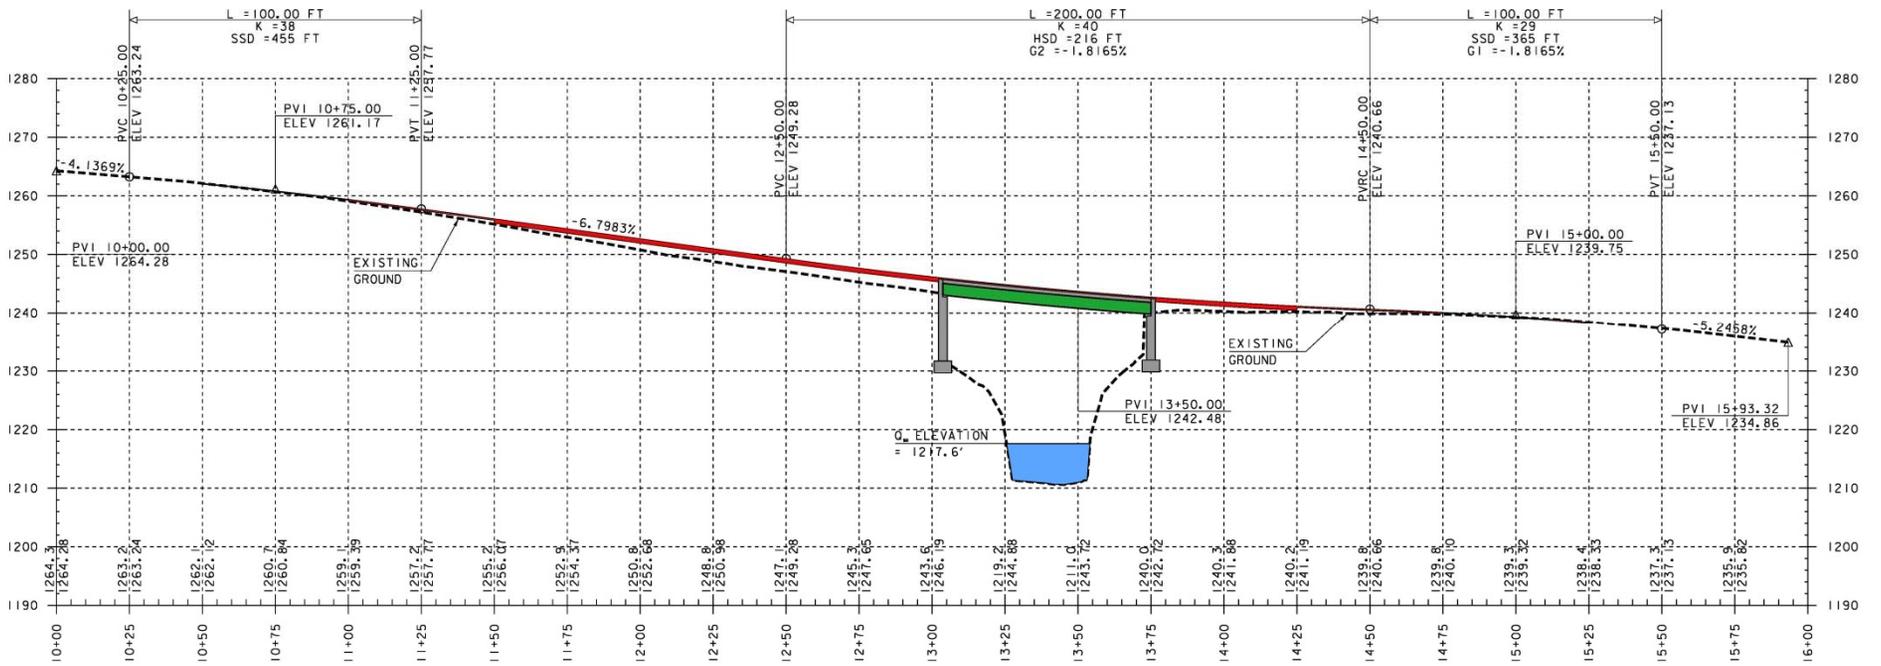
Proposed Profile

- Full Bridge Replacement Off Alignment
 - Replace entire structure on an improved alignment slightly downstream
 - Widen Bridge to 9'/3'
 - Warn curve for 20 mph (no design exception needed as per VSS Section 5.3)
 - Span to be determined out in field by the VTrans Geologist
Approximate length is 70', curved girders
 - Raise vertical grade approximately 2 feet to meet standard
 - No utility relocation
 - ROW needed
 - Approximately 20 week duration closure

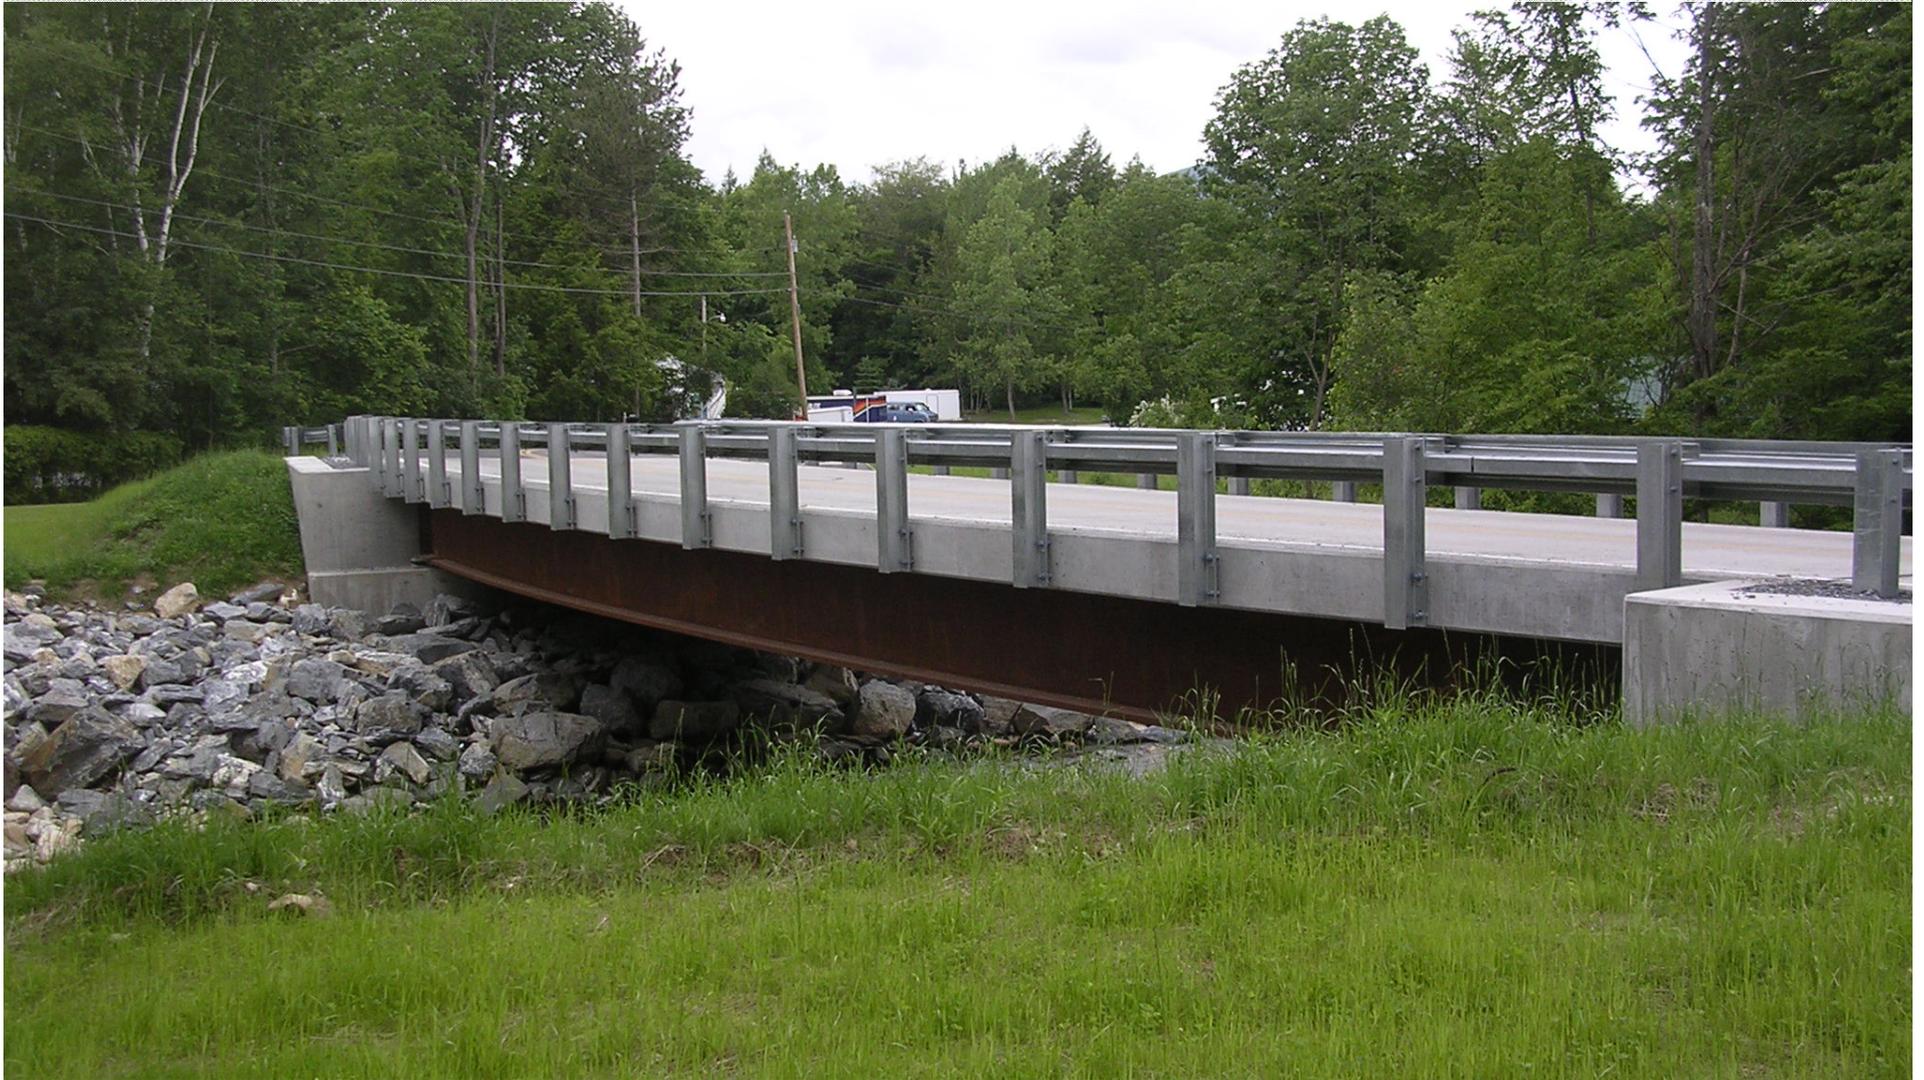
What Will the New Bridge Look Like?

Proposed Example - Bridge #9

- Curved Steel Beam Bridge

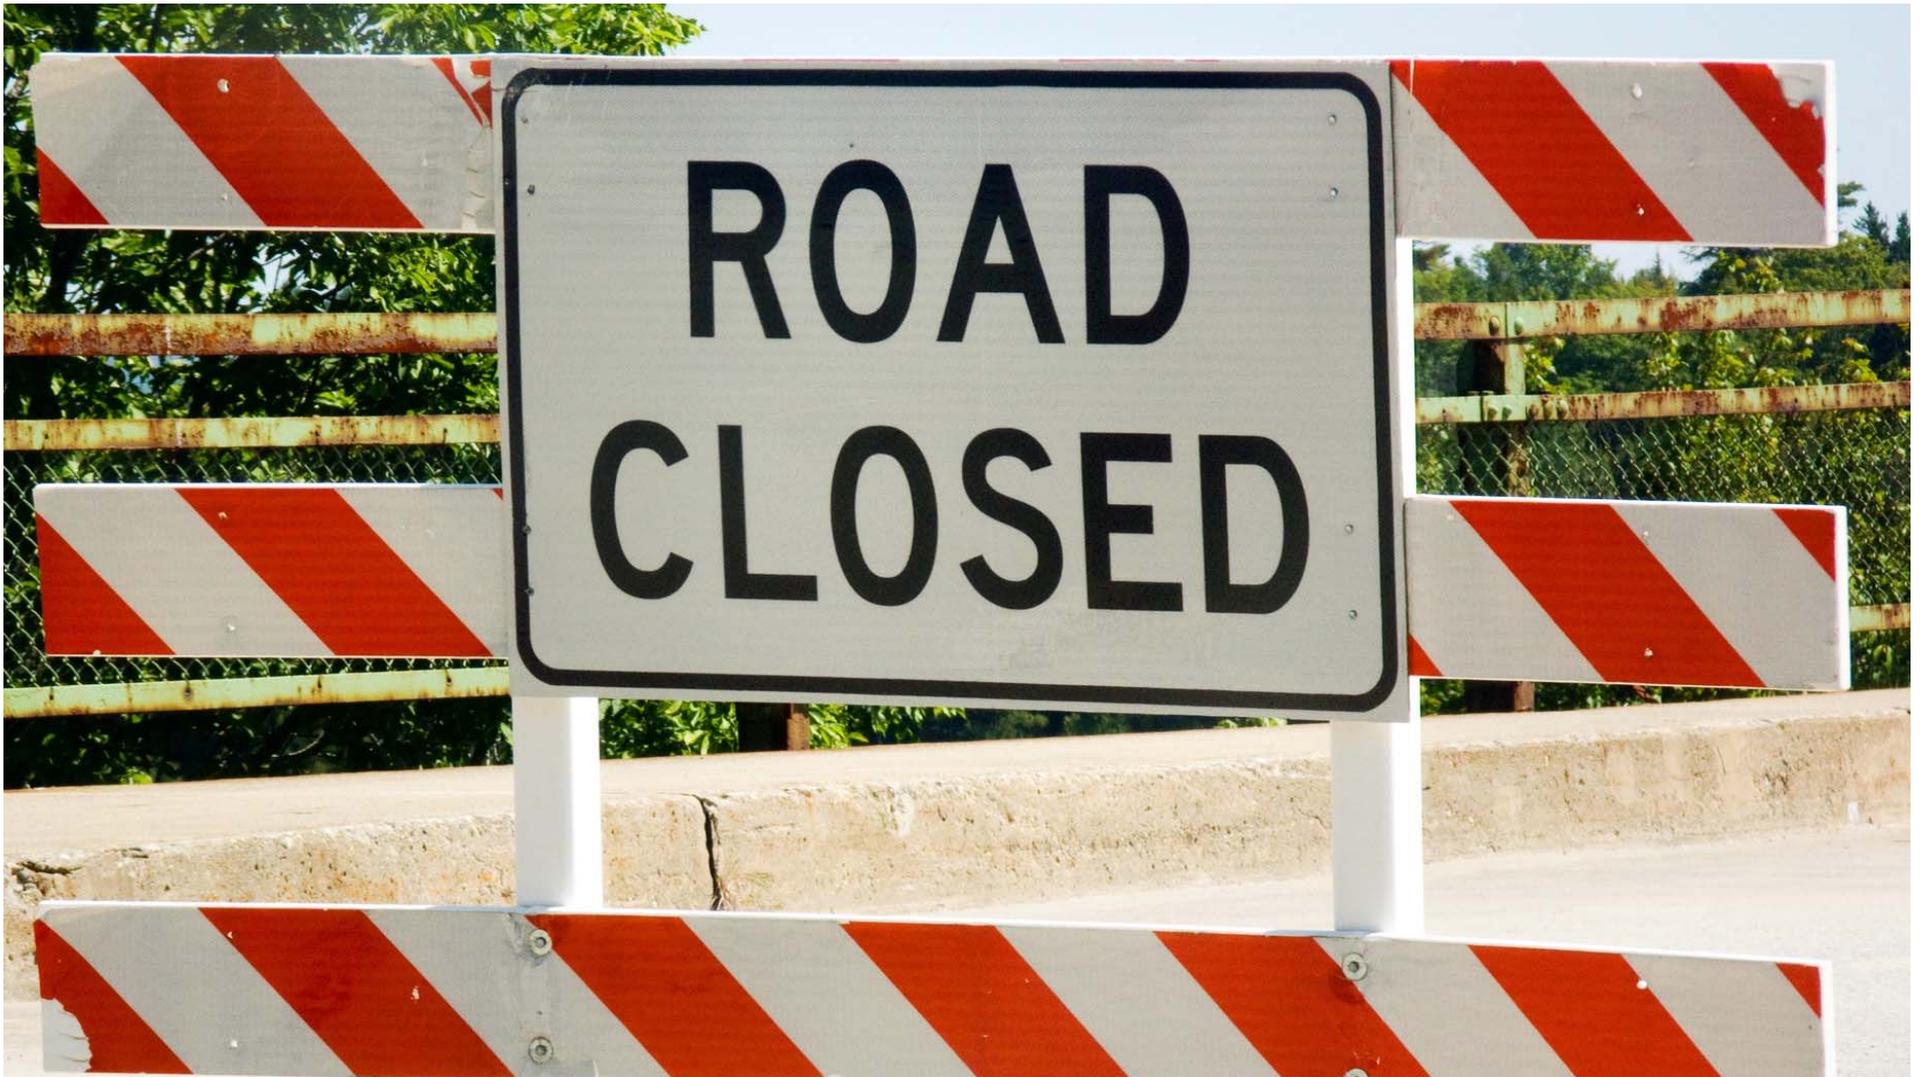
Road Closure

- Approx. 2 or 20 week bridge closure depending on alternative chosen
- **Detour route chosen and signed by town**
- Shortest route available: 1.7 miles end-to-end

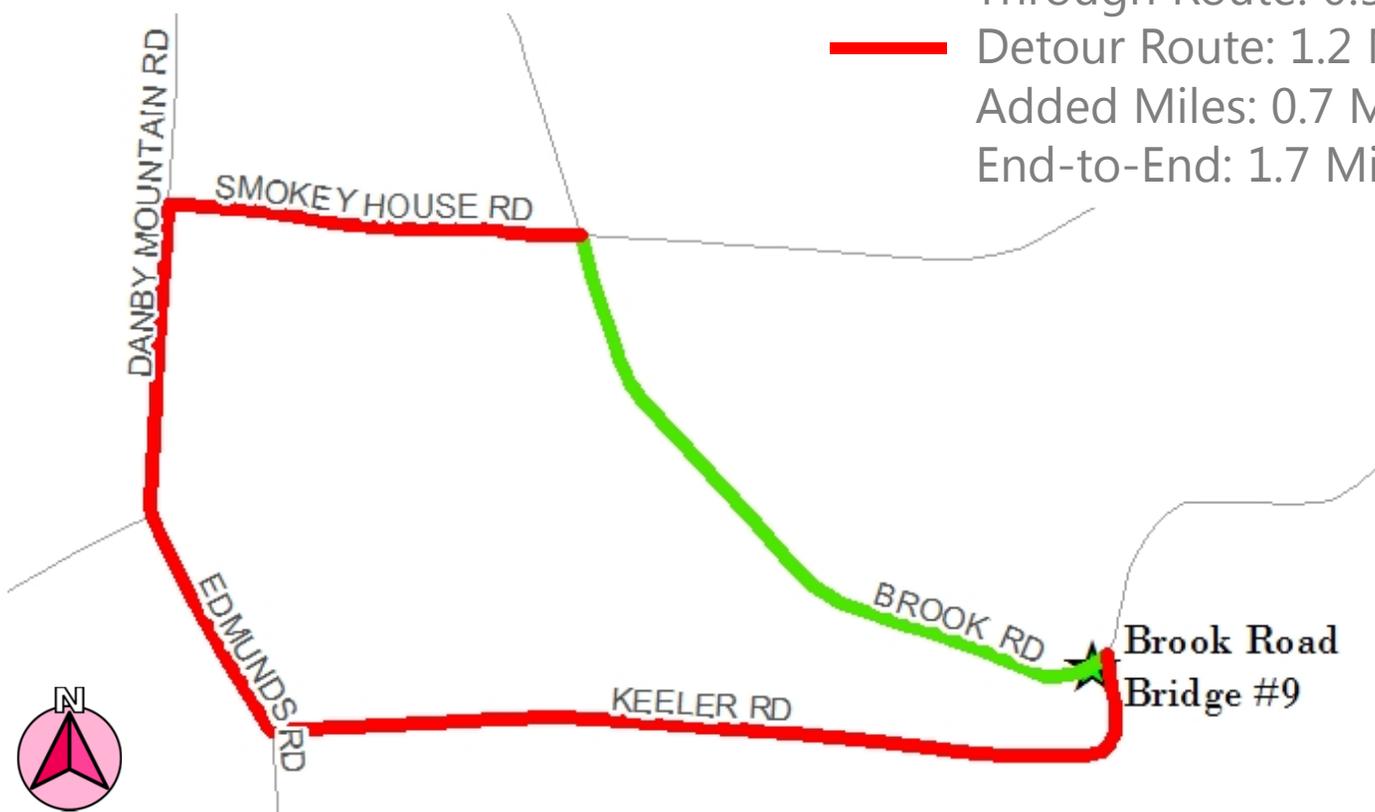
Shortest Possible Detour Route

- Brook Road, to Keeler Road, Edmunds Road, Danby Mountain Road, back to Brook Road

- Through Route: 0.5 Miles
- Detour Route: 1.2 Miles
- Added Miles: 0.7 Miles
- End-to-End: 1.7 Mile

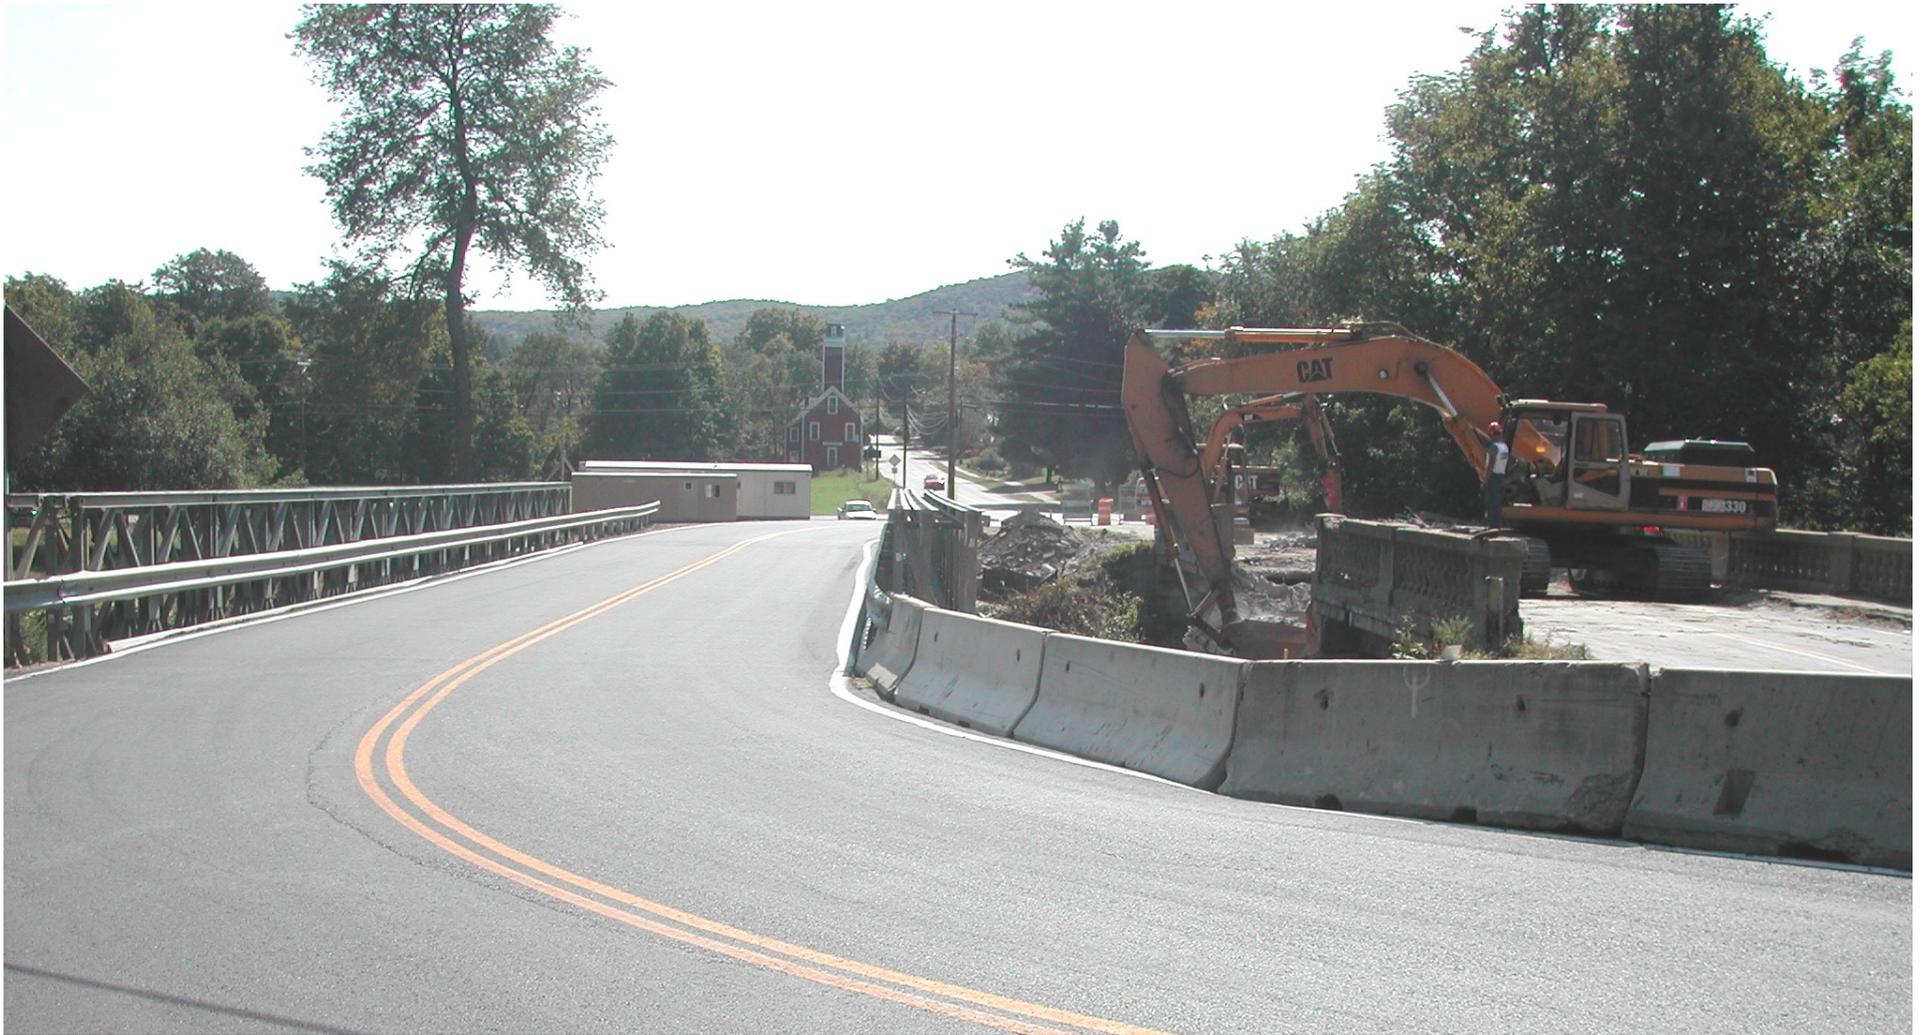
- One Lane Temporary Bridge with Traffic Signal
- Downstream temporary bridge would have impacts to archaeologically sensitive resources
- Both upstream and downstream would require ROW acquisition
