Newfane BF 0106(6)

Alternatives Presentation Meeting

Depot Road (FAS Route 106/TH 2) – Bridge #12 over Rock River

May 18, 2015

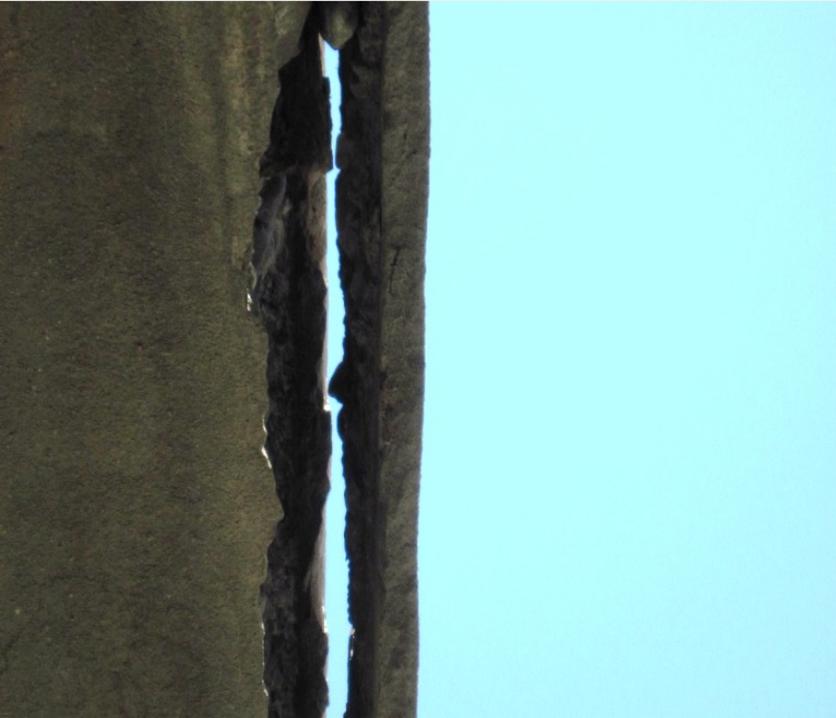
Delaminated Concrete

- The original arch is in poor condition. The foundation has map cracking and efflorescence throughout with major delaminations.
- The existing vertical alignment through the project location does not meet the current standard.
- The lane and shoulder widths of the bridge and approaches are too narrow for the traffic volume, design speed and roadway classification.
- The existing bridge railing has failed.

Spandrel Wall

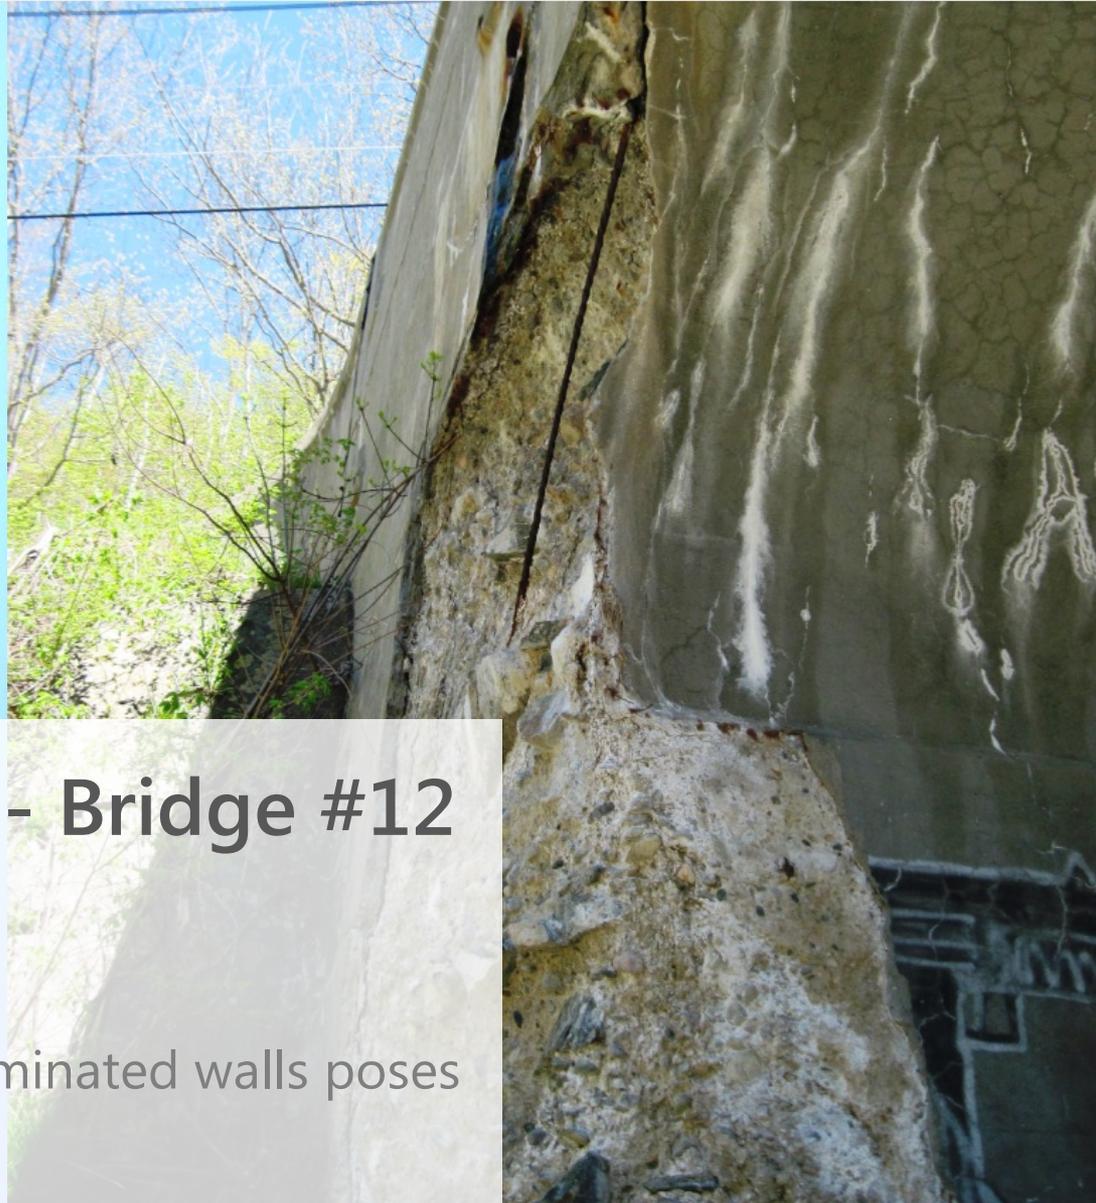
Abutment and Wingwall

- Culvert Rating 4 ("Poor")
- Spandrel walls have failed
- Falling concrete from the delaminated walls poses a risk to swimmers below

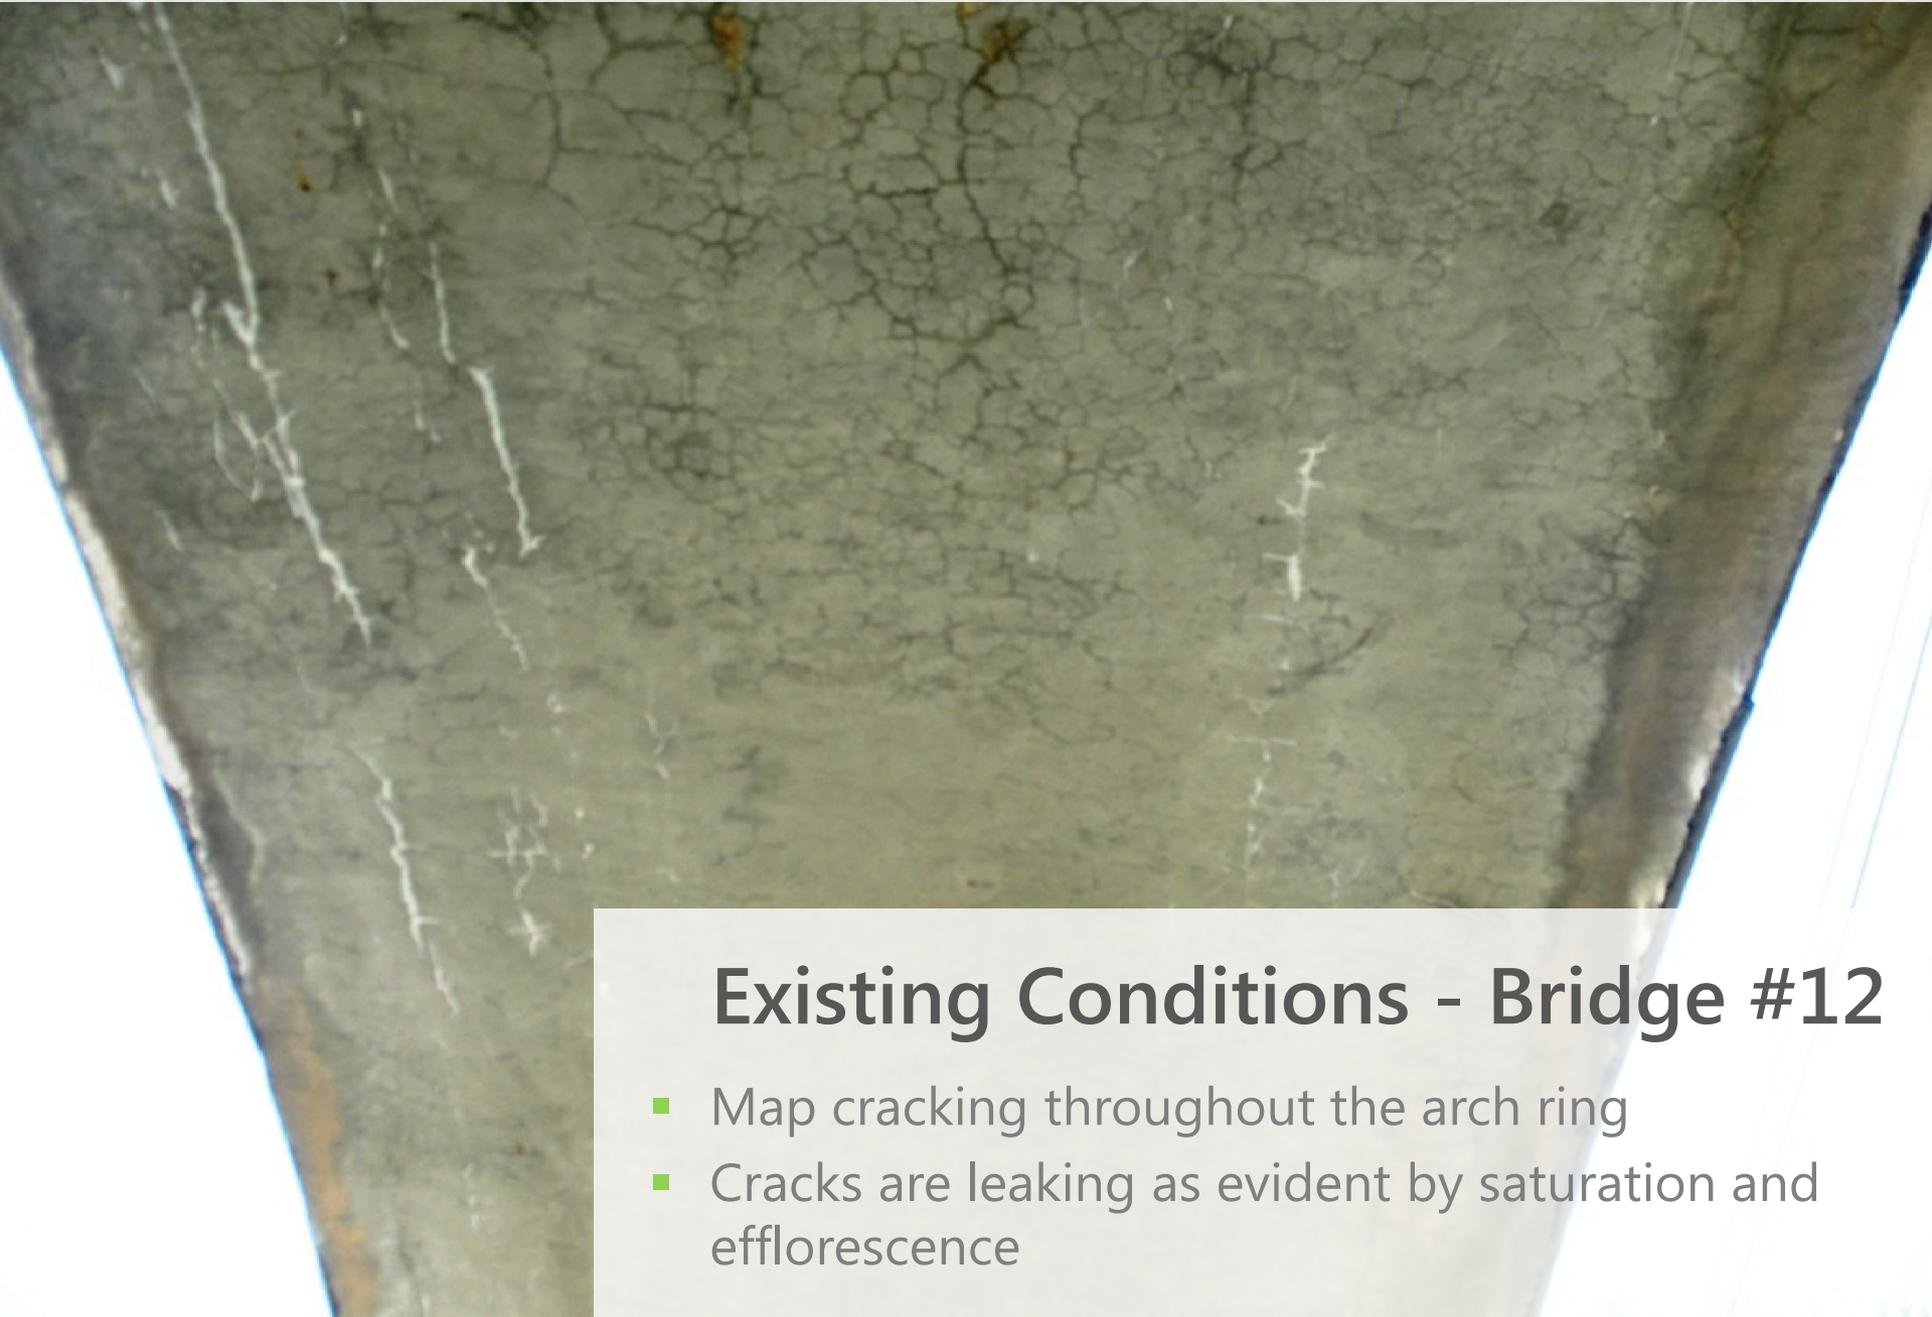
Arch Ring Condition

- Map cracking throughout the arch ring
- Cracks are leaking as evident by saturation and efflorescence

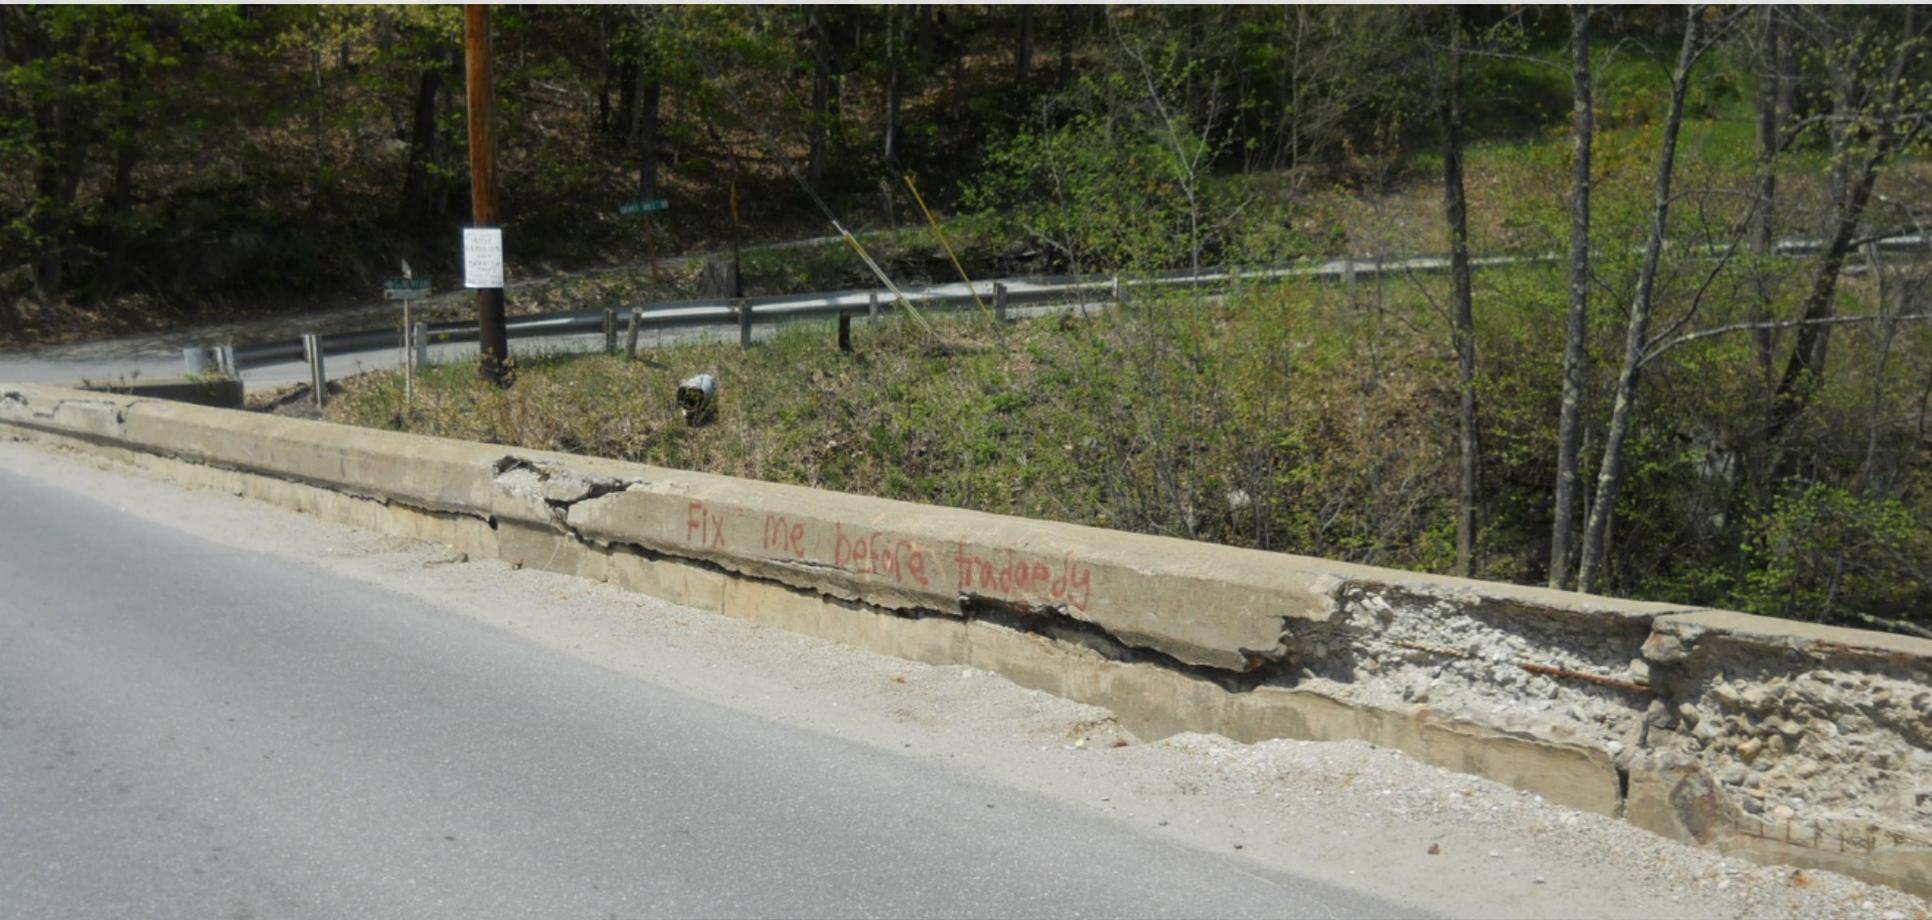
- Failed Bridge Railing
- Substandard height
- Exposed reinforcing steel

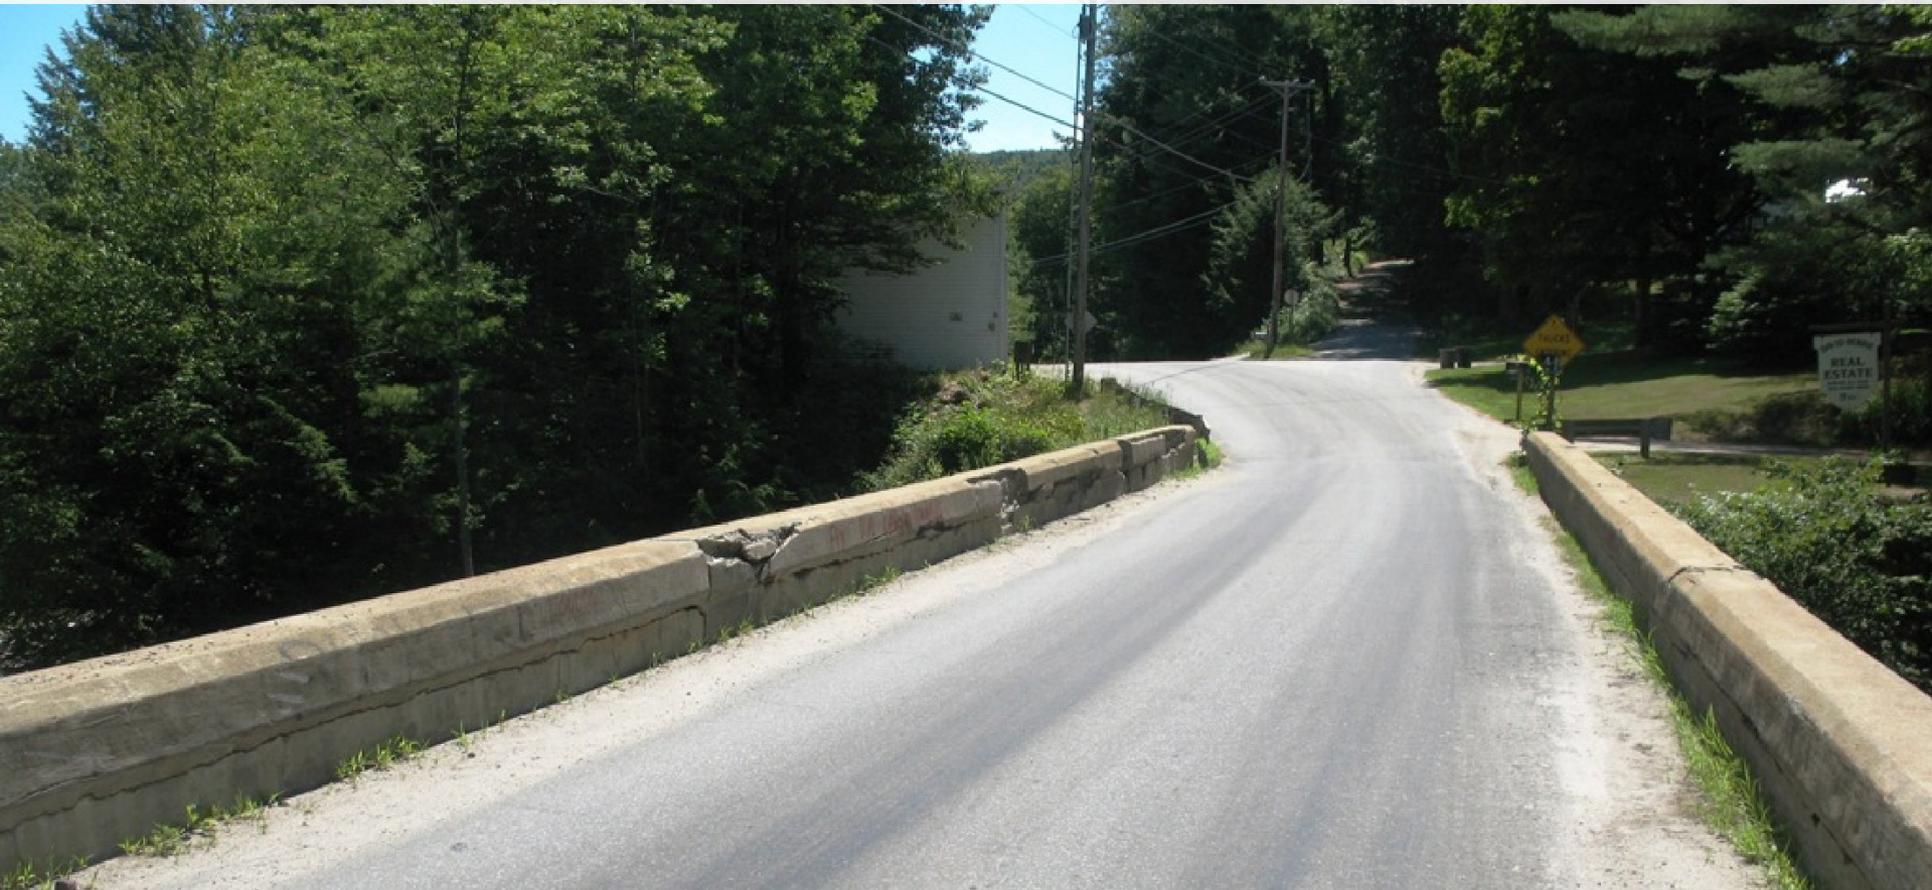
Looking East over the bridge

- Substandard Horizontal Alignment for posted speed
- Substandard vertical alignment
- Substandard Width

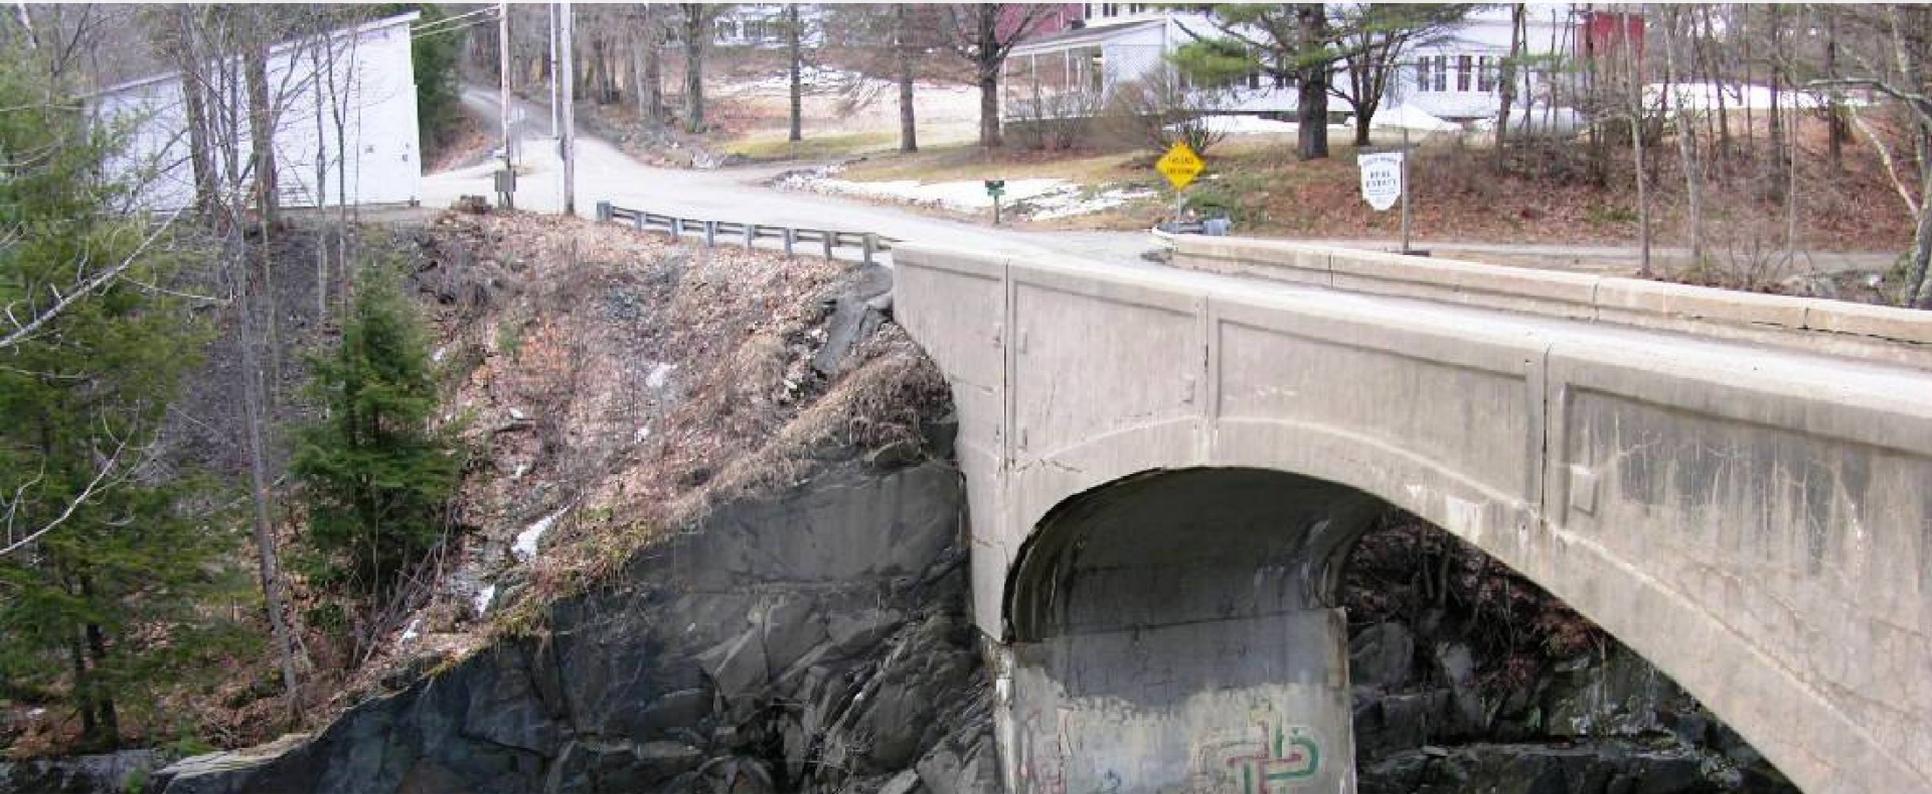
Existing Conditions - Bridge #12

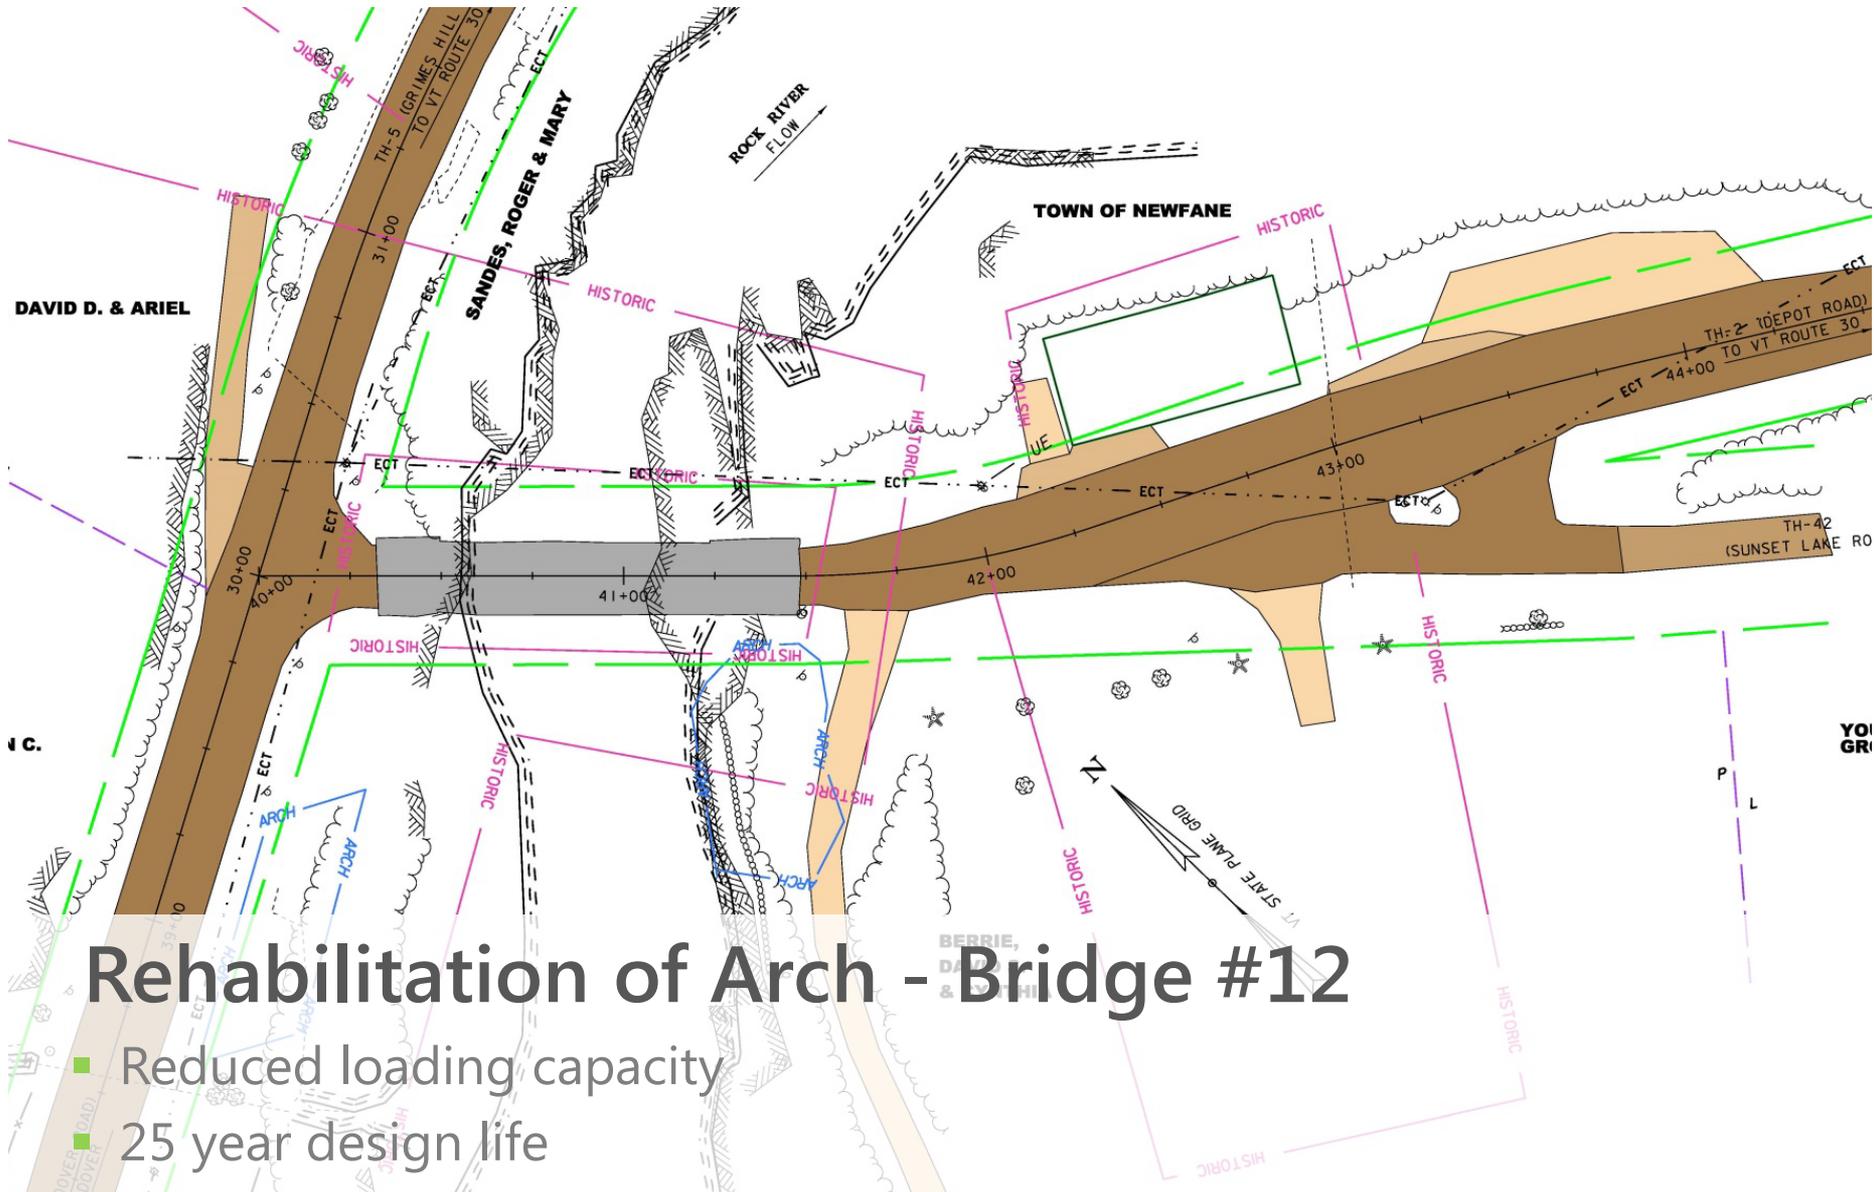
Alternative 1 Layout

- Reduced loading capacity
- 25 year design life

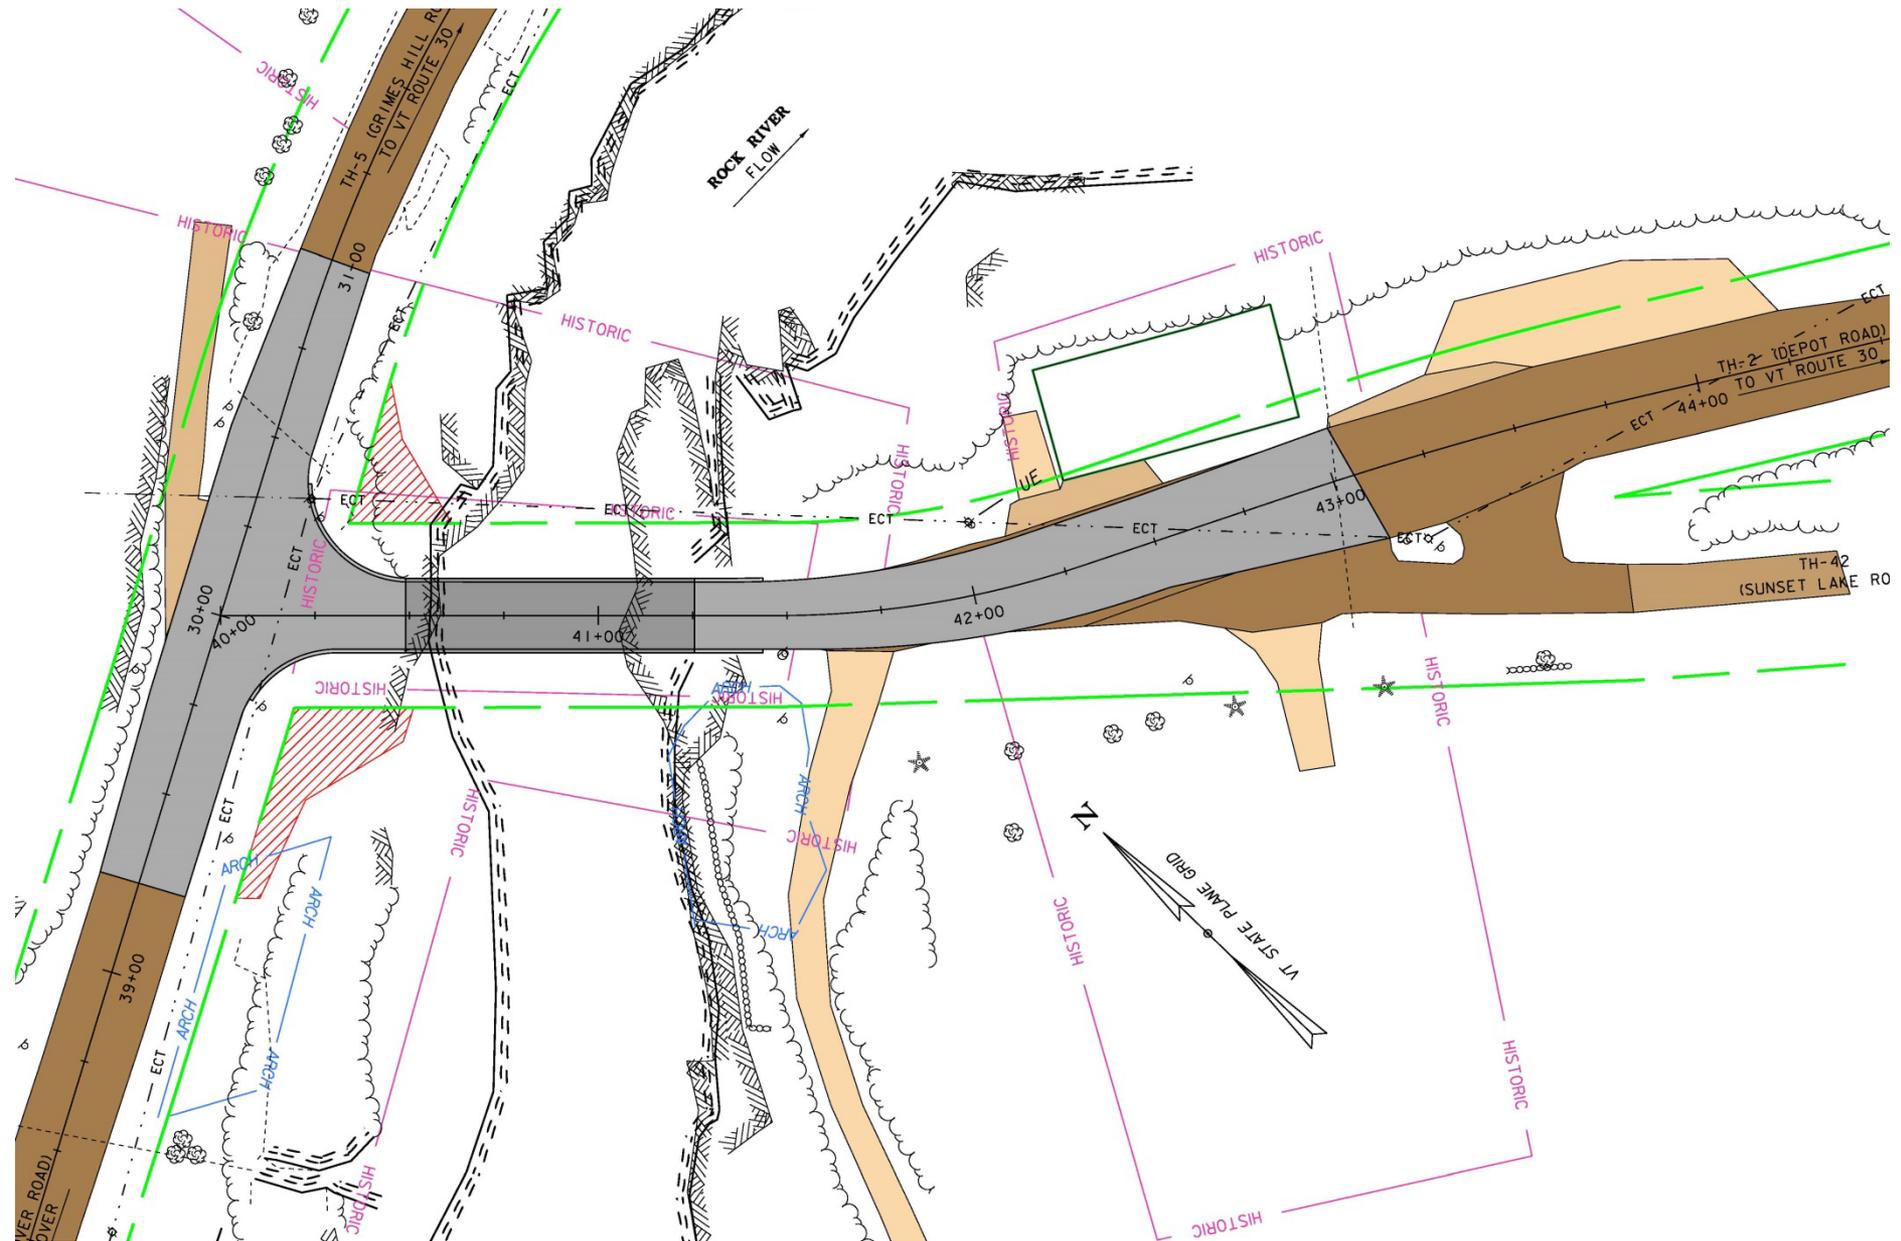
Proposed Layout – 1 Lane

- Full Bridge Replacement
 - Maintain existing travel lane and shoulder widths
 - Town has expressed a desire to keep bridge 12 as a one-lane bridge
 - Slight vertical raise to meet the standard
 - 80 year design life
 - Utility relocation needed
 - ROW needed

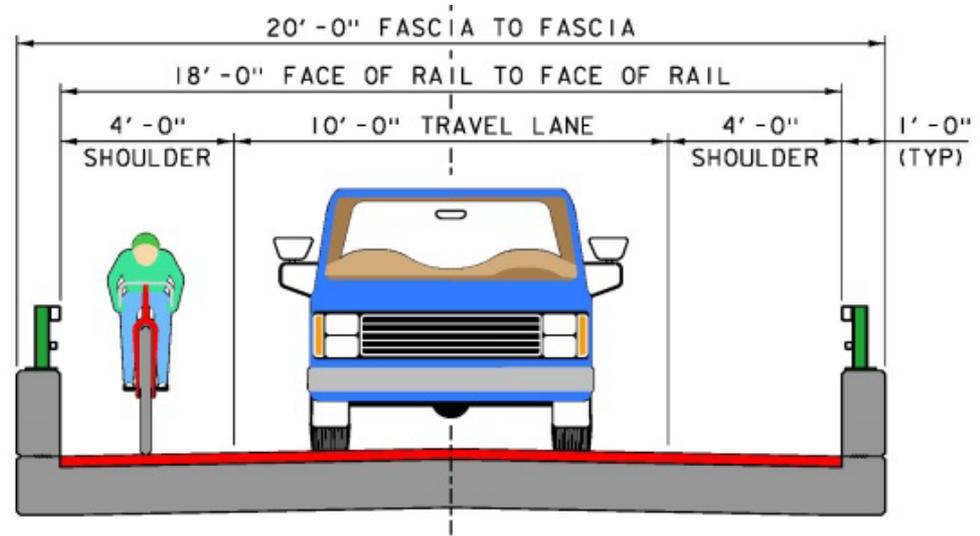
- 1 Lane
- 18' Face-of-Rail to Face-of-Rail

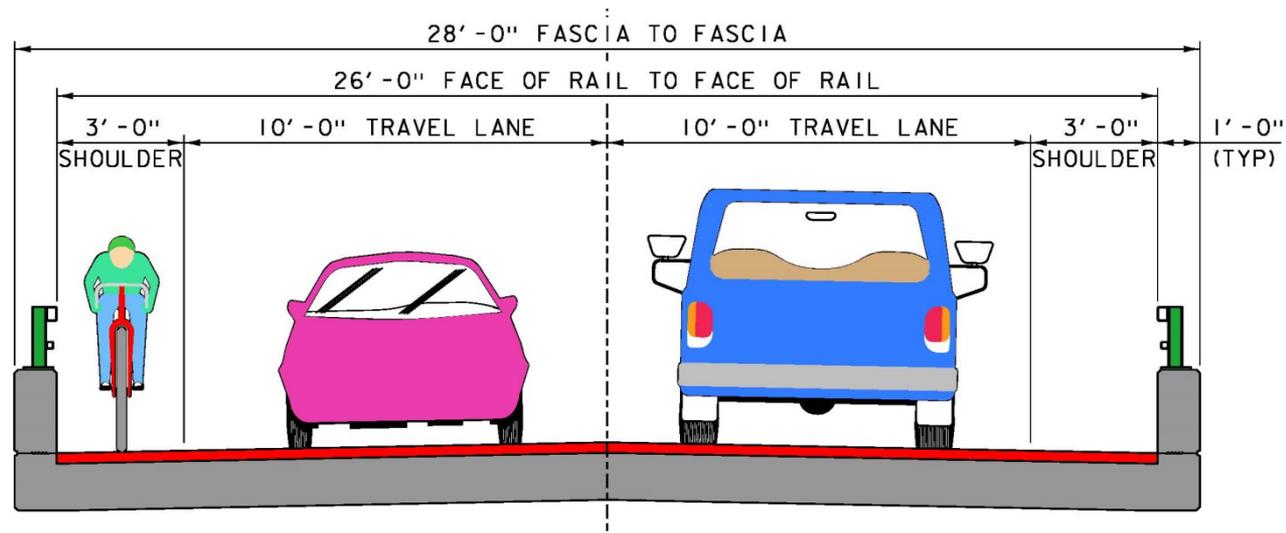
- 2 Lanes
- 26' Face-of-Rail to Face-of-Rail

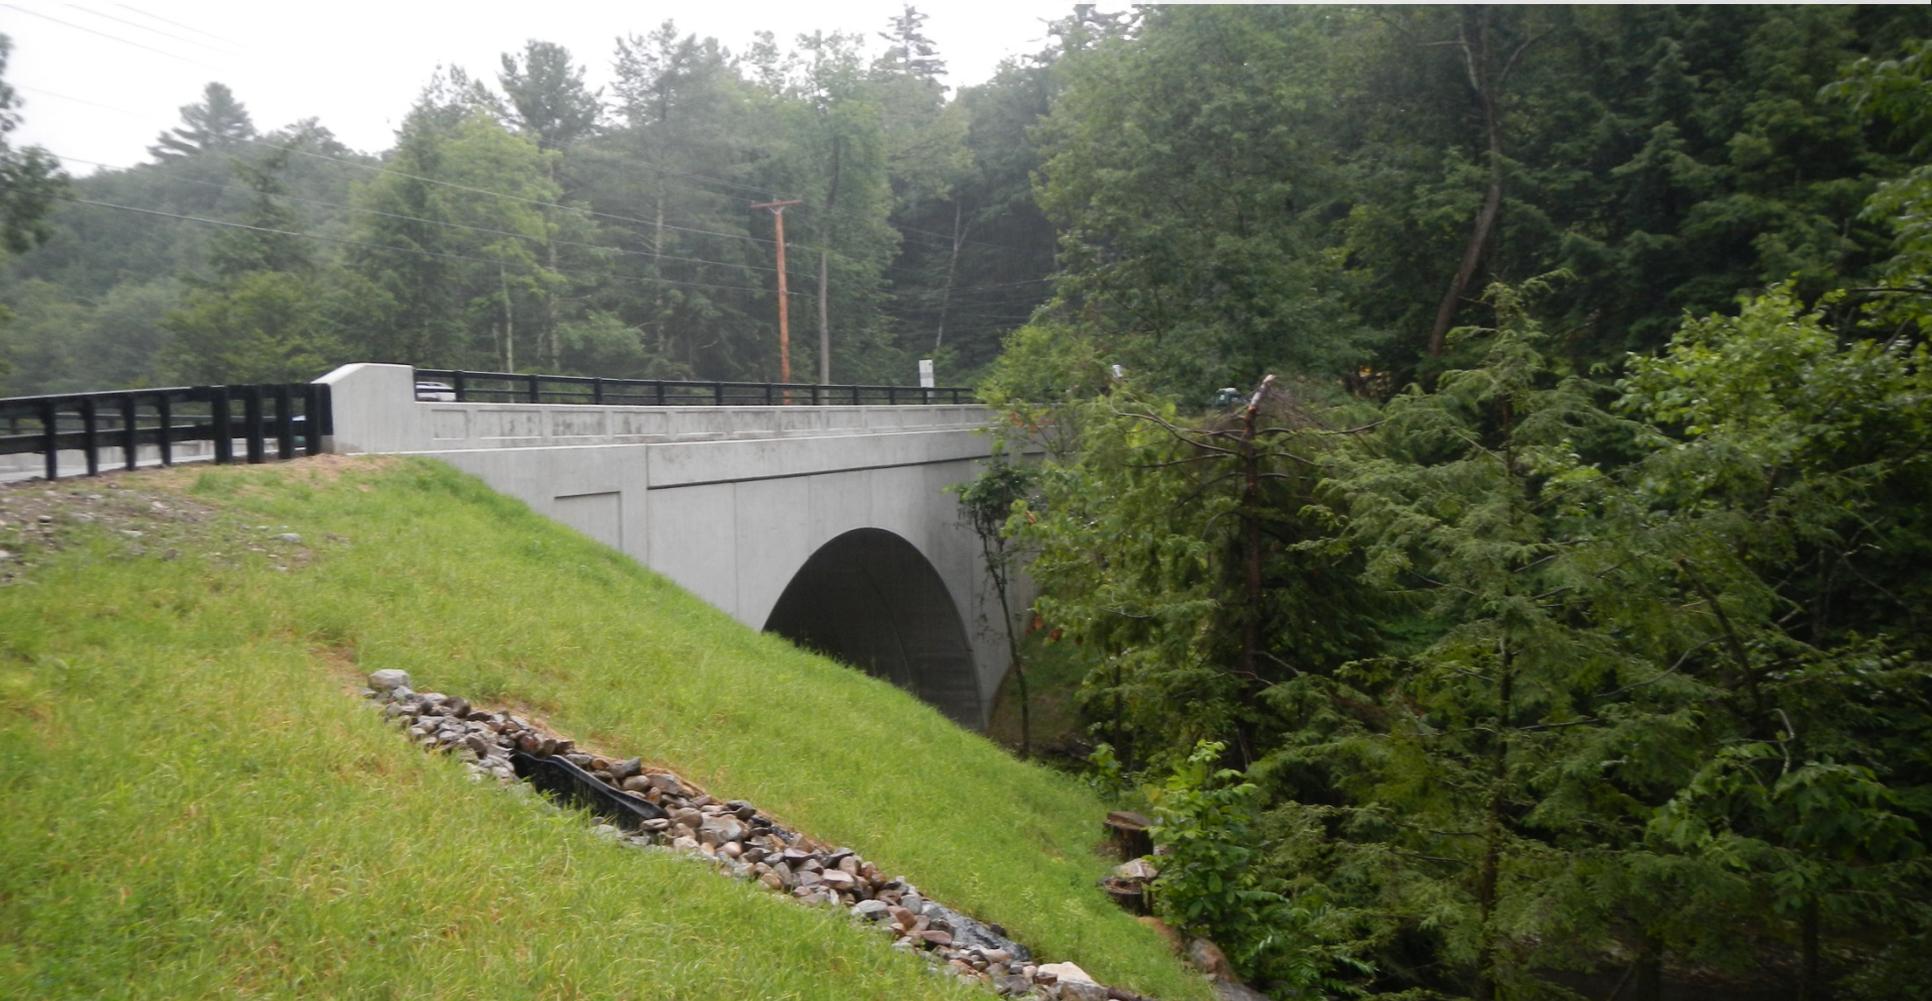
What Will the New Bridge Look Like?

- Concrete Arch – Concrete lines and details to mimic original arch
- Historic Railing

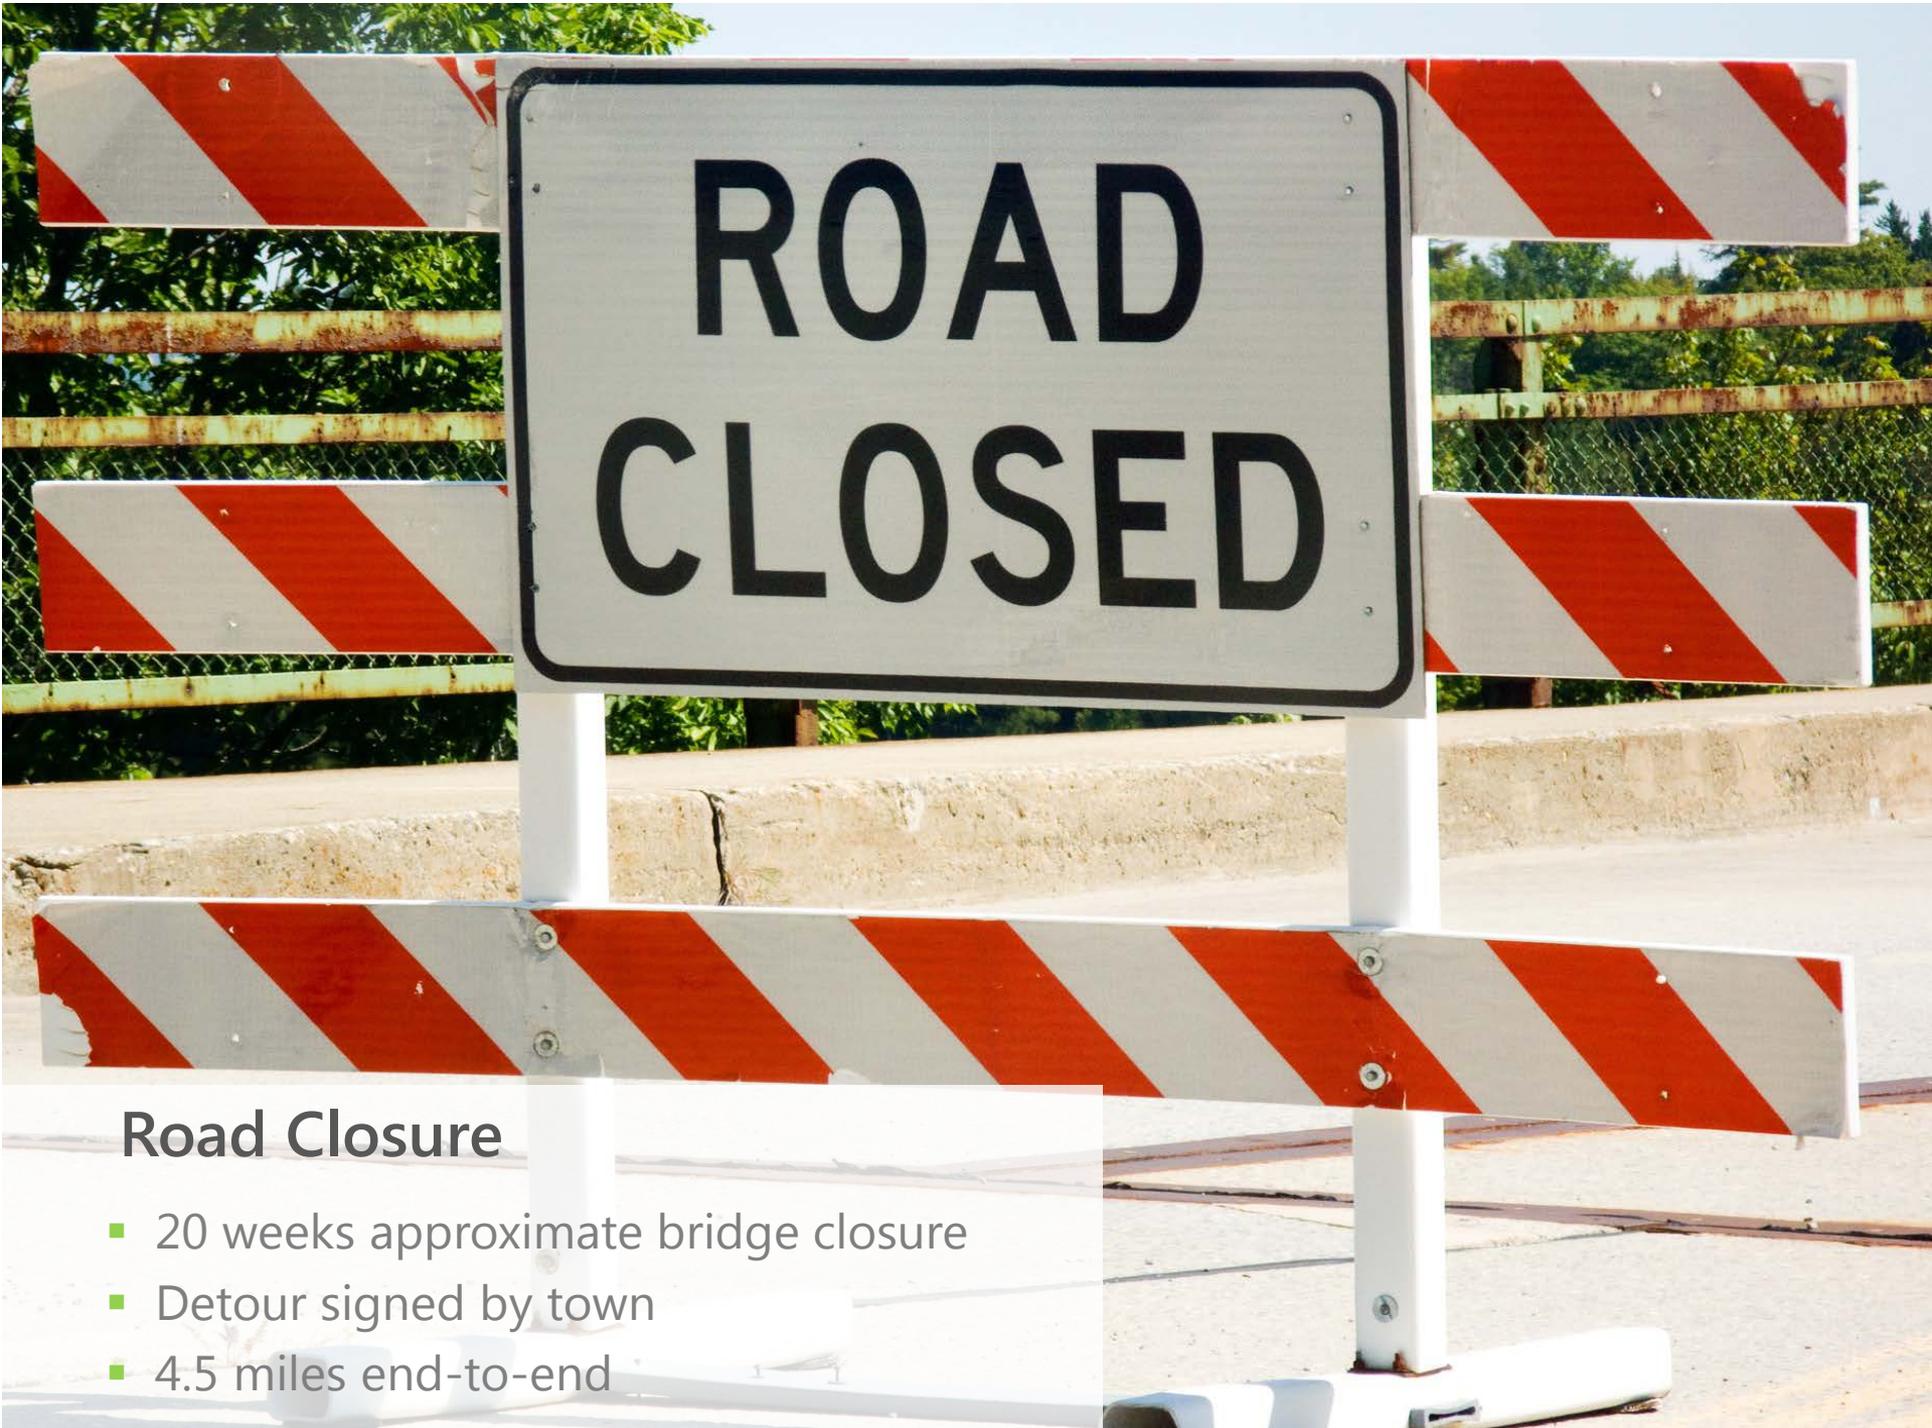
Maintenance of Traffic Options Considered

- Road Closure with Offsite Detour
 - The Town of Newfane has requested a bridge closure
 - By closing the bridge to traffic during construction, the local share is reduced by 50%.

A photograph of a road closure barrier. The barrier consists of several horizontal white panels with red diagonal stripes. A central white sign with a black border and the words "ROAD CLOSED" in large, bold, black capital letters is mounted on two white posts. The barrier is positioned on a paved road, with a concrete curb and green foliage in the background.

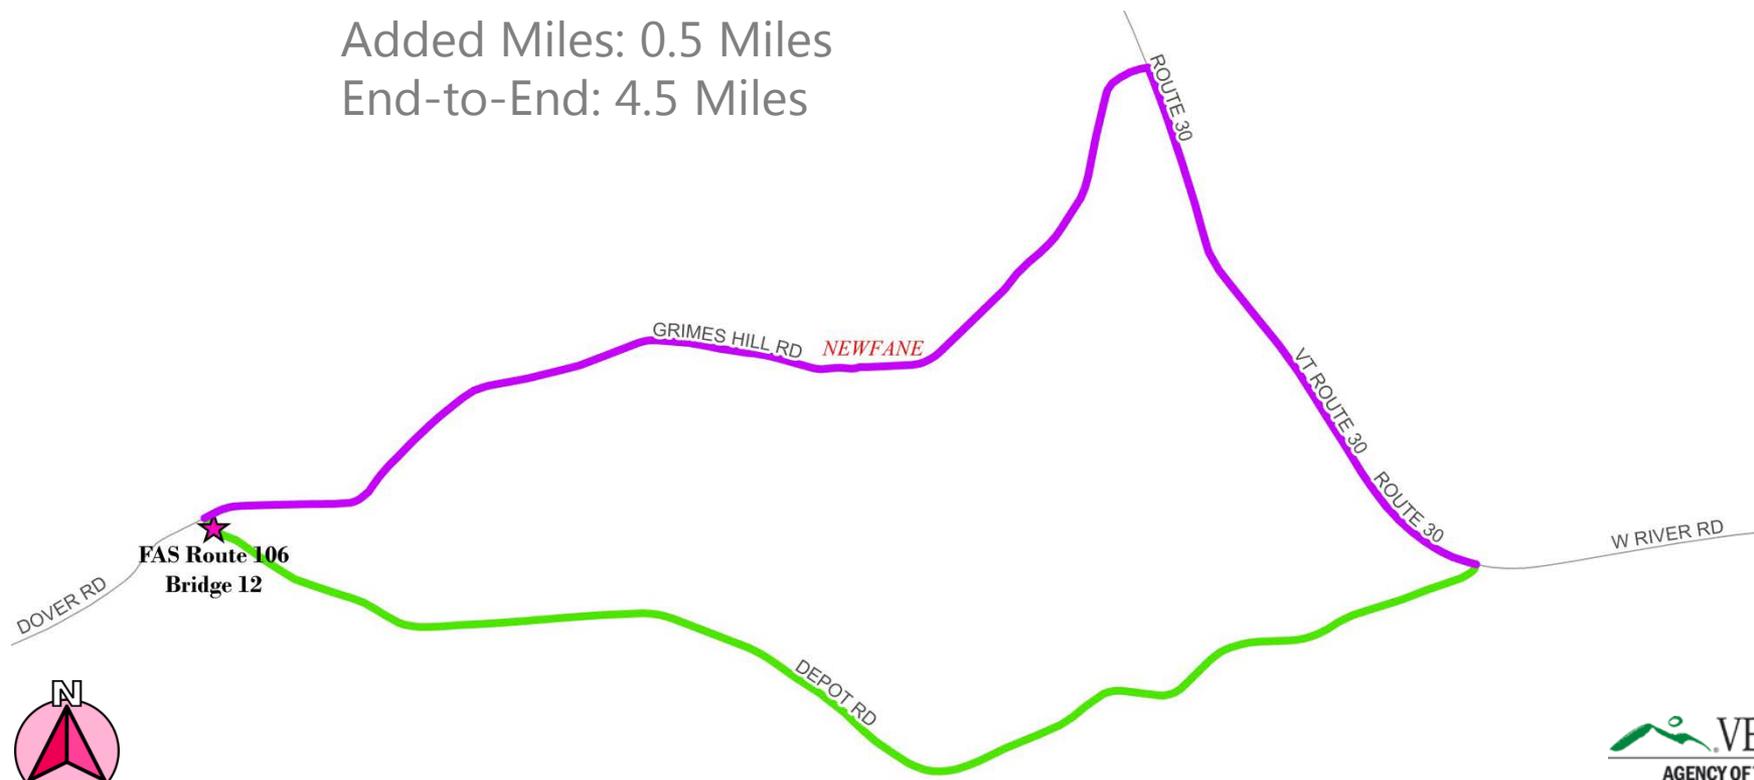
Shortest Possible Detour Route

- Depot Road, to Grimes Hill Road, and VT Route 30, back to Depot Road

- Through Route: 2.0 Miles
- Detour Route: 2.5 Miles
- Added Miles: 0.5 Miles
- End-to-End: 4.5 Miles
