Newfane BF 0106(6) Bridge 12 on Depot Road (FAS 106) over Rock River Public Presentation

**Presented by
Christopher P. Williams, P.E.
Senior Project Manager, Structures Section
Vermont Agency of Transportation
Chris.Williams@State.VT.US**

August 27, 2014

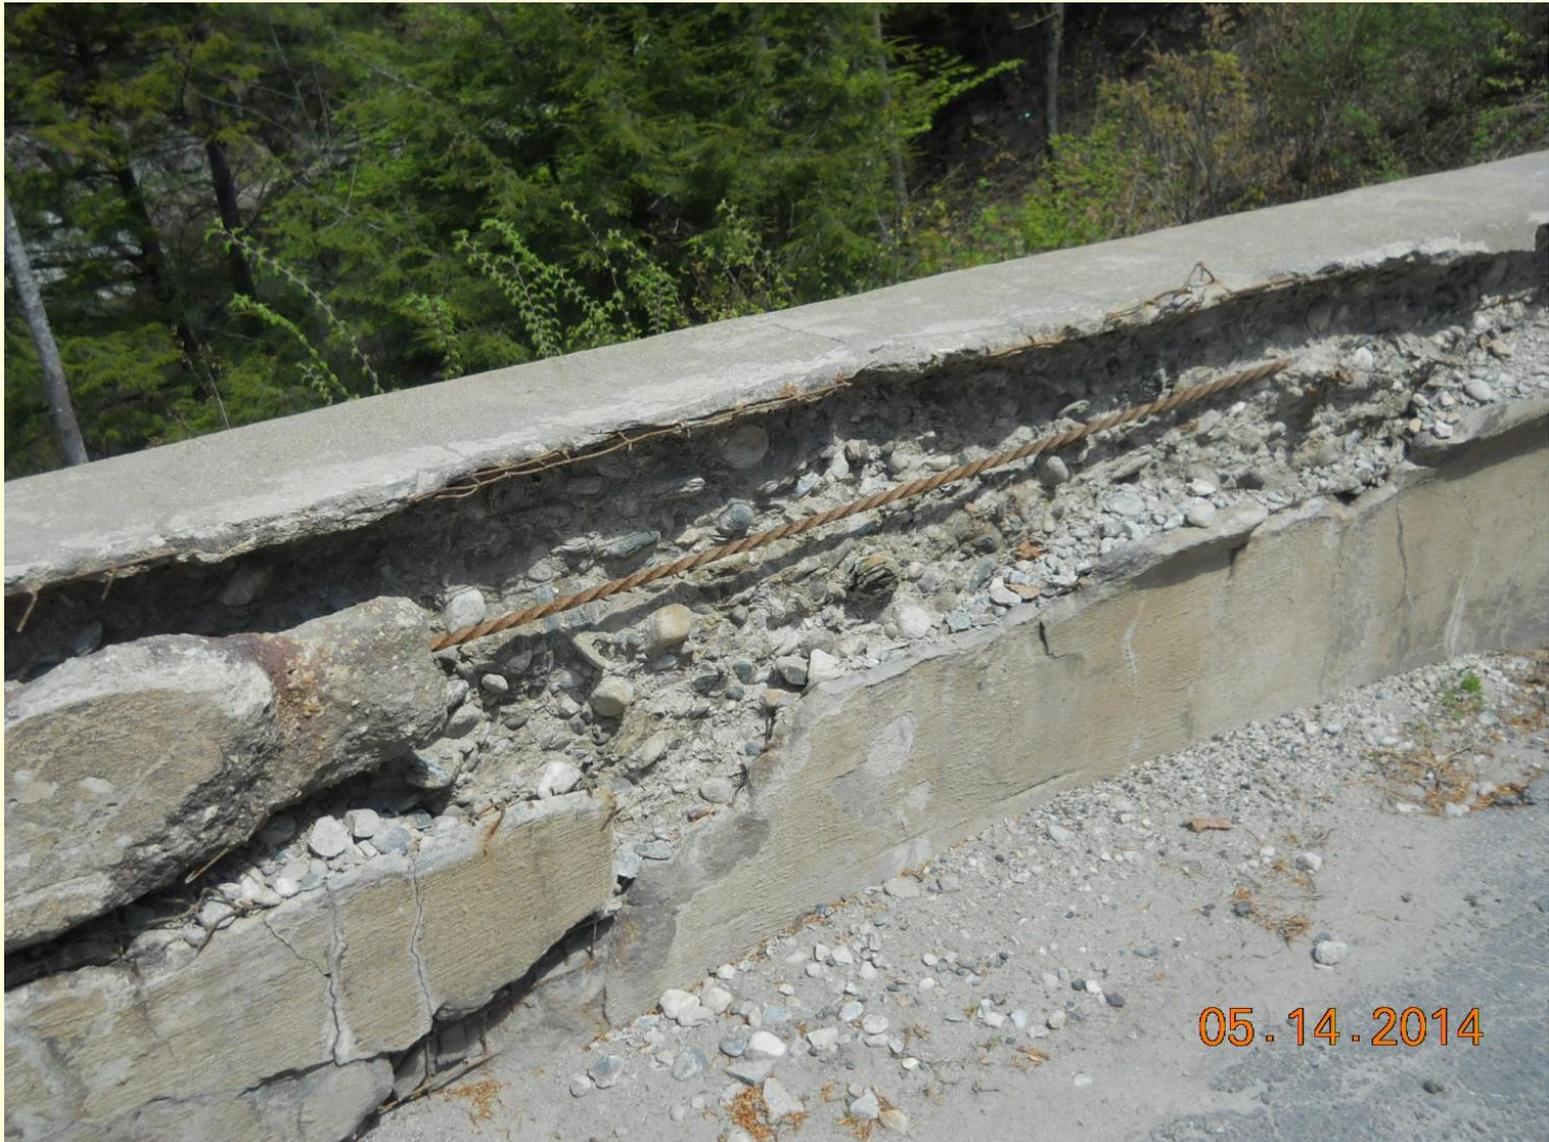
Deteriorated Bridge Railing

- **The bridge is rated 4 (poor) by the Bridge Inspection team and is on a 12 month inspection cycle (reduced from the usual 24 month cycle)**
- **The structure has severe deterioration and delamination throughout**
- **The spandrel walls and arch ring are severely deteriorated where they connect**
- **The spandrel walls, which function as bridge railing, are too low and lack the strength required to properly protect an errant vehicle**
- **The load capacity can not be calculated**

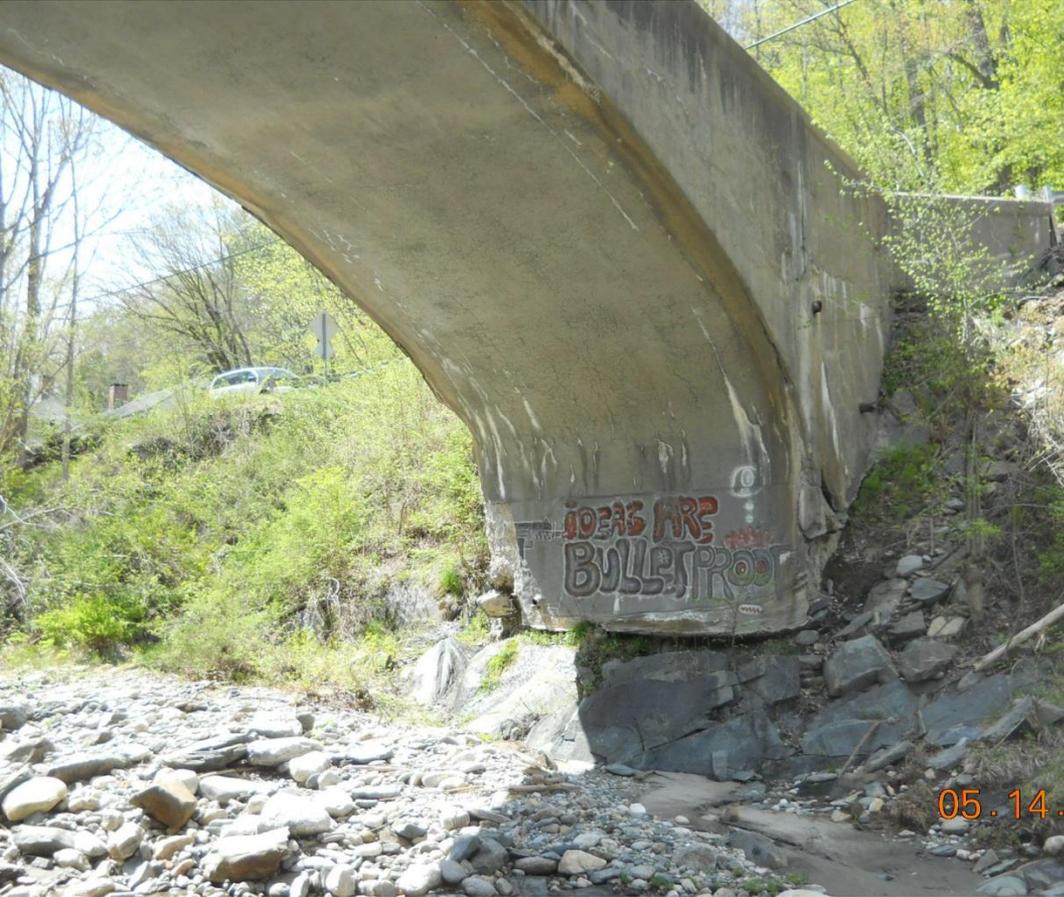
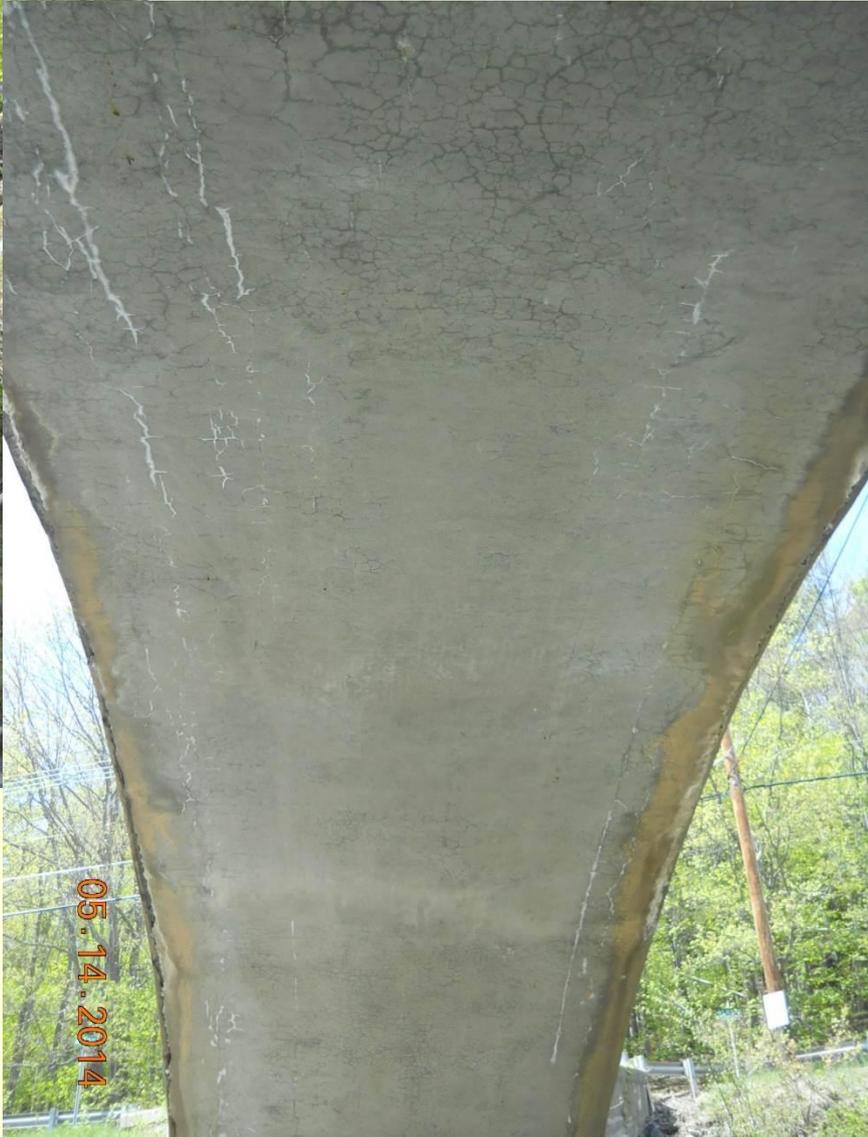
West Abutment & Underside of Arch

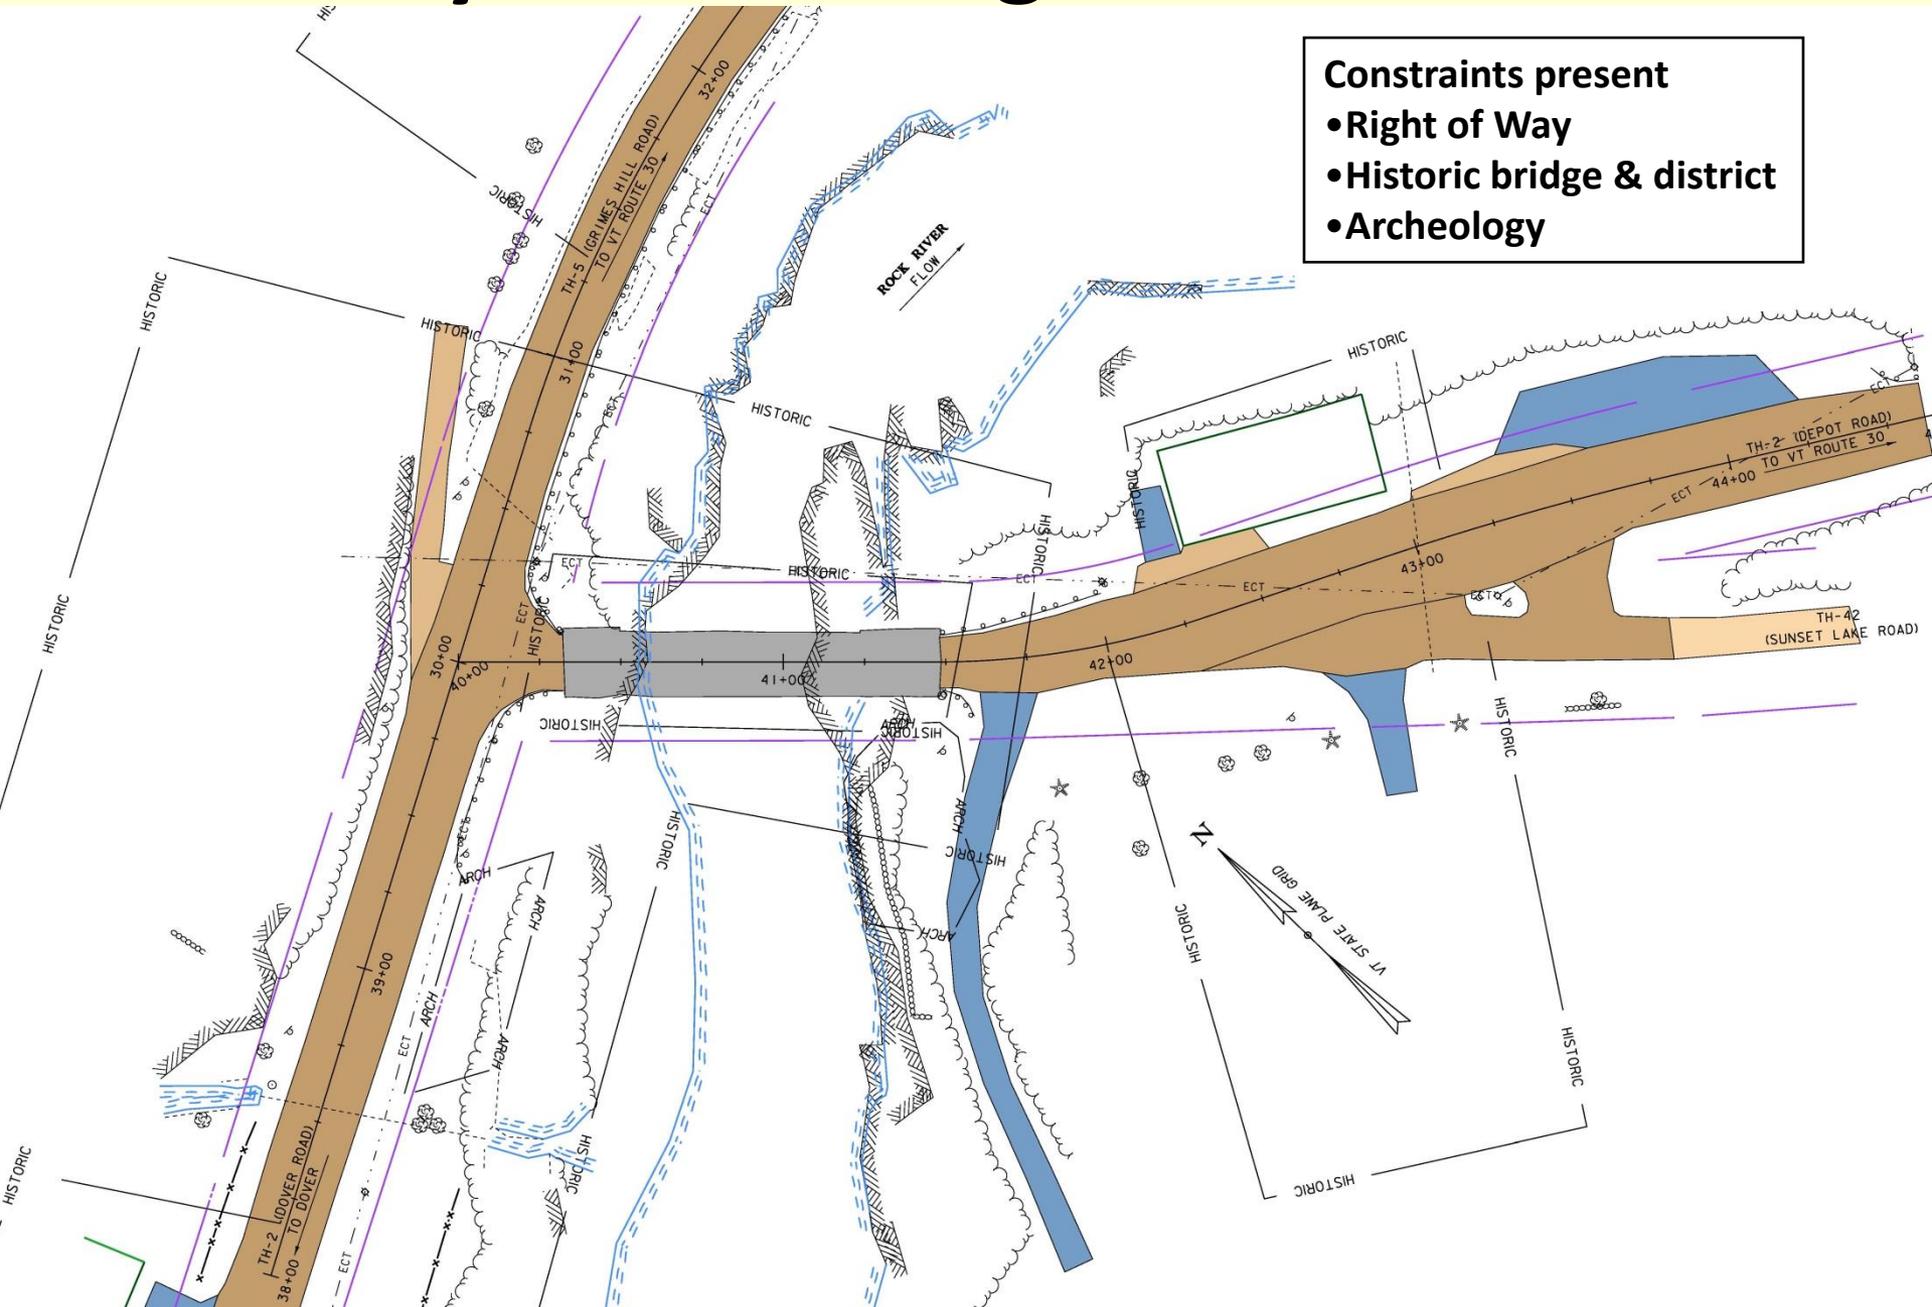
Layout Showing Constraints

Constraints present

- Right of Way
- Historic bridge & district
- Archeology
