Bolton

TH 4 Bridge 51-3

Bolton IM 089-2(45)

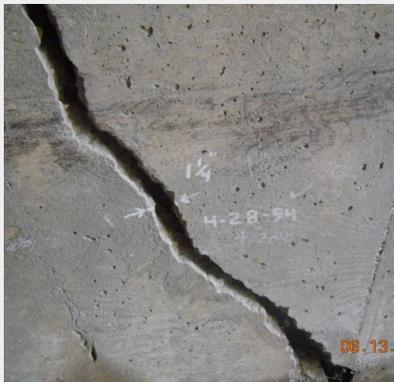
Settlement Crack

The Bolton IM 089-2(45) Bridge 51-3 project will rehabilitate the existing bridge. The existing bridge structure is a four sided concrete box constructed in 1964. It is approximately 150-feet in length and 20-feet wide. The culvert is in fair condition however two large cracks have caused some concern.

The proposed rehabilitation consists of grouting the cracks to fill the void, performing a structural repair using FRP, and then applying a new membrane and pavement to the bottom of the structure as well as treating the concrete with Silane or other similar material. FRP (Fiber Reinforced Polymer) repairs are a new technology in Vermont however it is an inexpensive long lasting material that can be quickly applied to the affected areas. After completion of all repairs, and prior to paving, a 5' wide sidewalk will be installed on the southern side of the culvert to provide permanent pedestrian access.

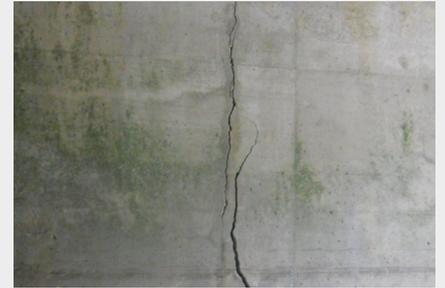
Settlement Crack

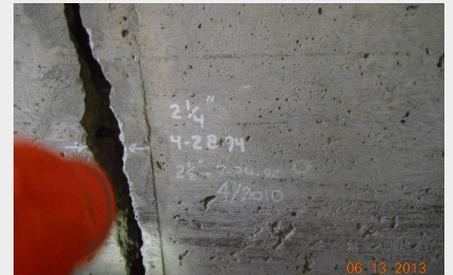
Close Up of Settlement Crack
