**STATE OF VERMONT
AGENCY OF TRANSPORTATION**

**Scoping Report
FOR
Waterford BF 0225(5)**

VT ROUTE 18, BRIDGE 2 OVER UNNAMED BROOK

February 17, 2016

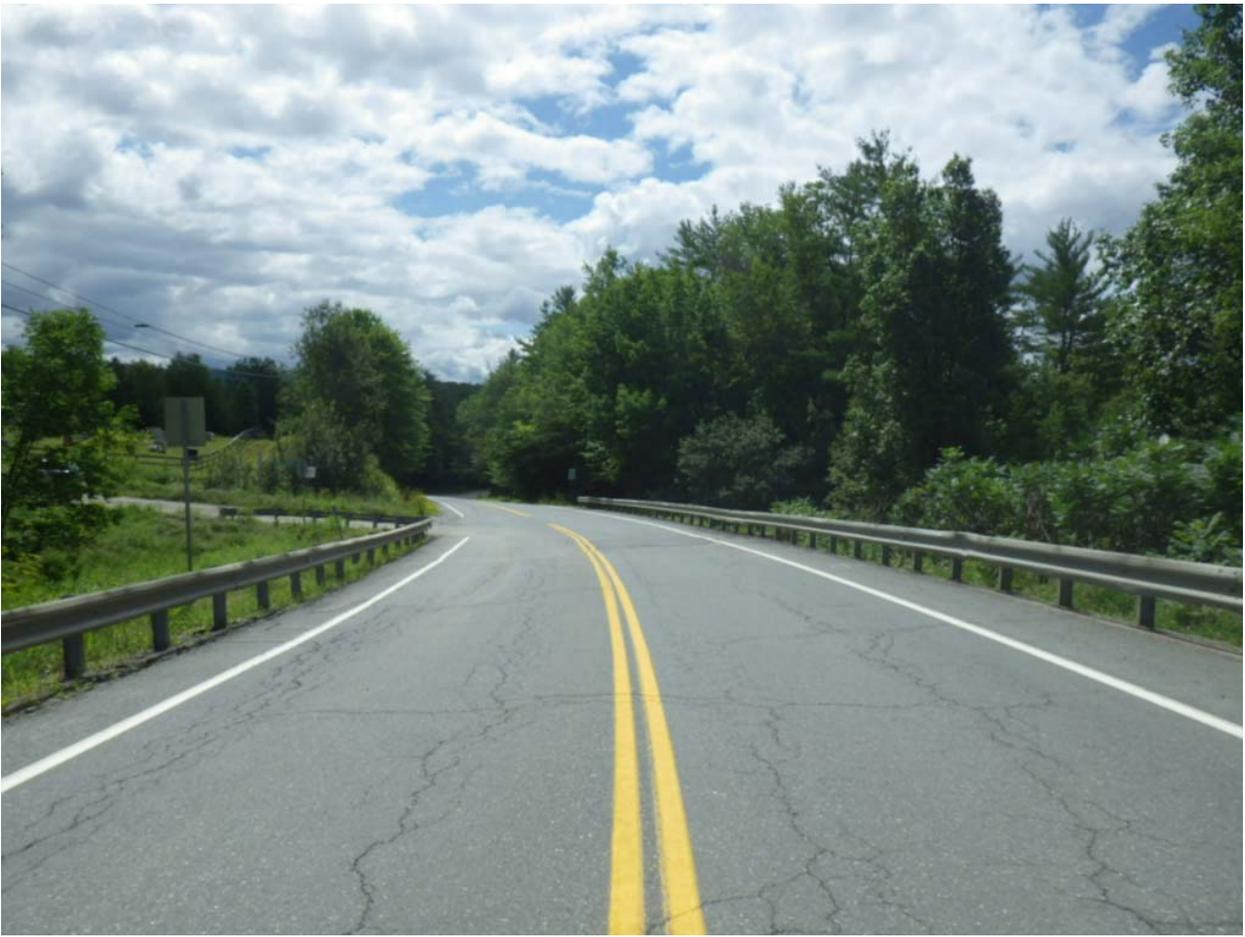
Looking South over bridge

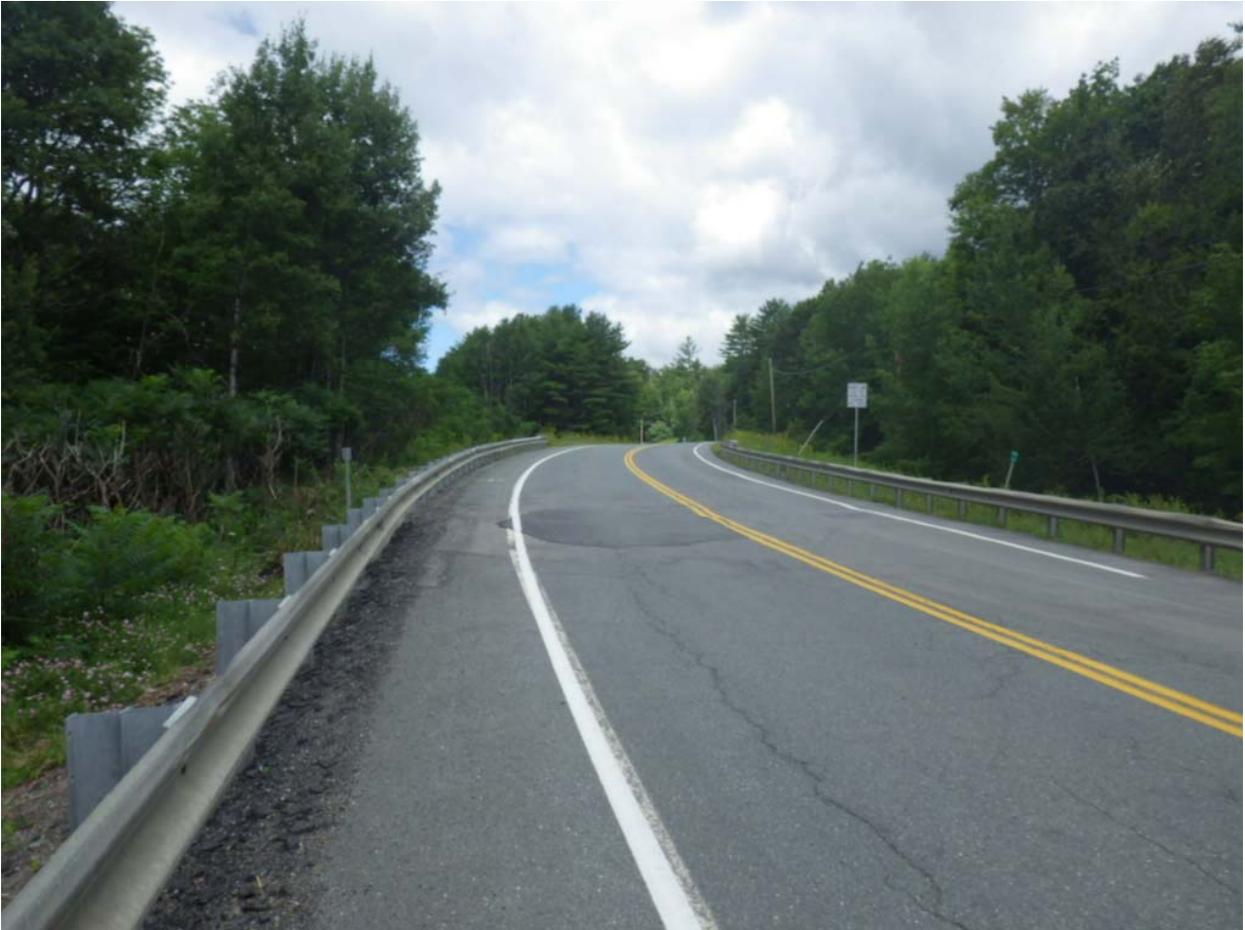
Looking North over bridge

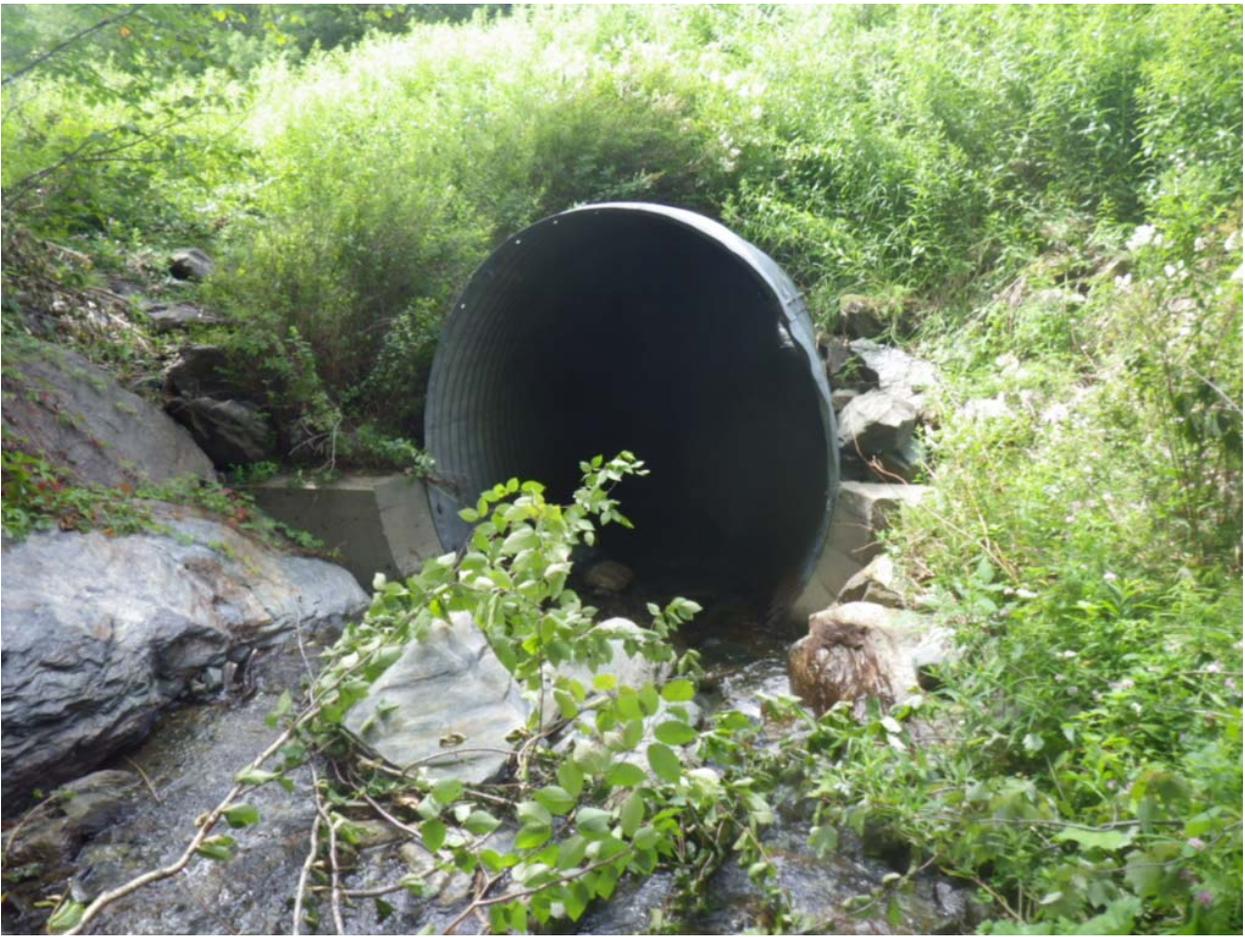
Inlet End

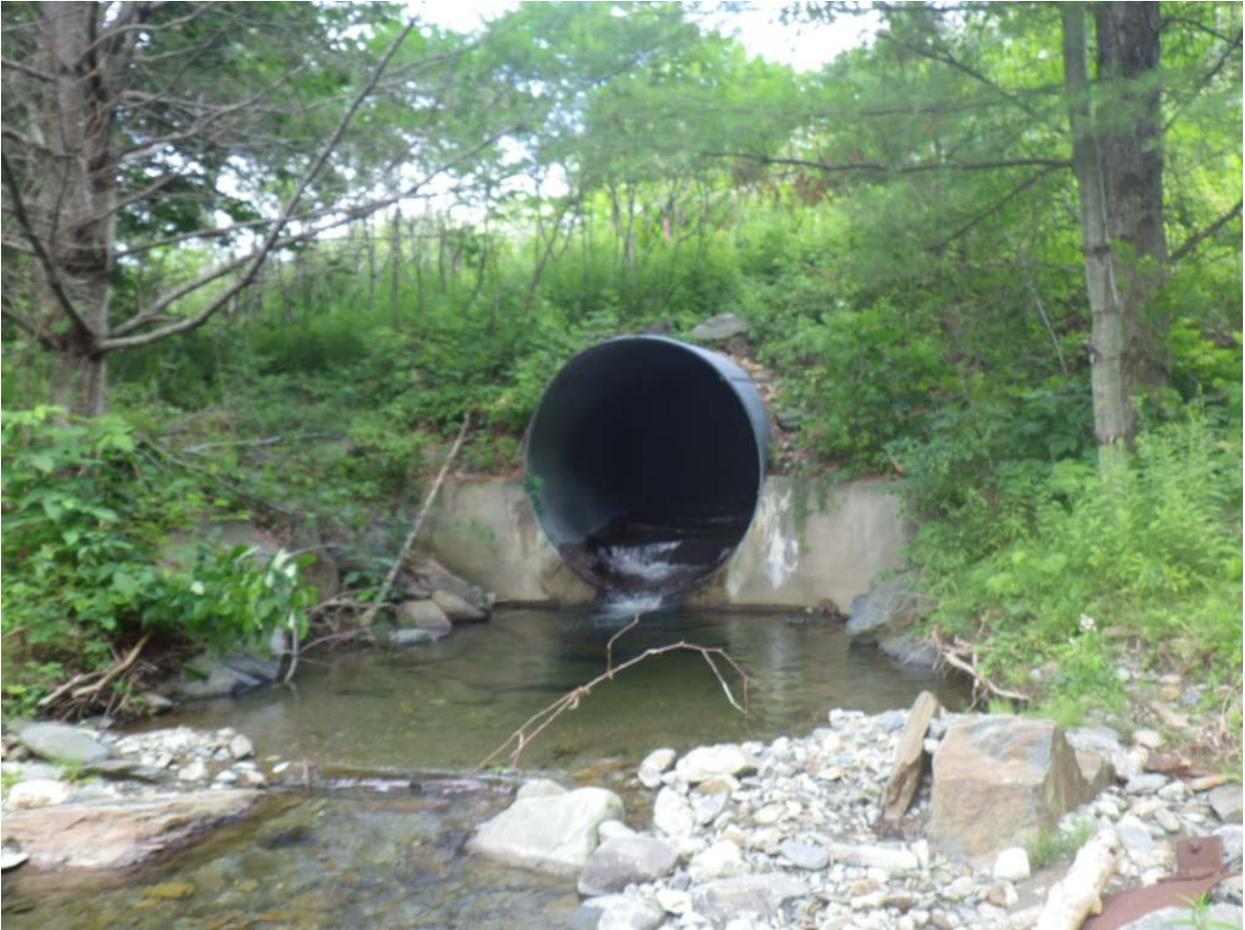
Outlet End

This alternative is not recommended. The culvert is in serious condition, and will continue to deteriorate if no action is taken. Additionally, there is a large drop at the outlet of the culvert making it impossible to pass fish. Something will have to be done to improve this culvert in the near future. Although the culvert does not appear to be in imminent danger of collapse, it will eventually be posted for lower traffic loads. In the interest of safety to the traveling public, the No Action alternative is not recommended. No cost estimate has been provided for this alternative since there are no immediate costs.

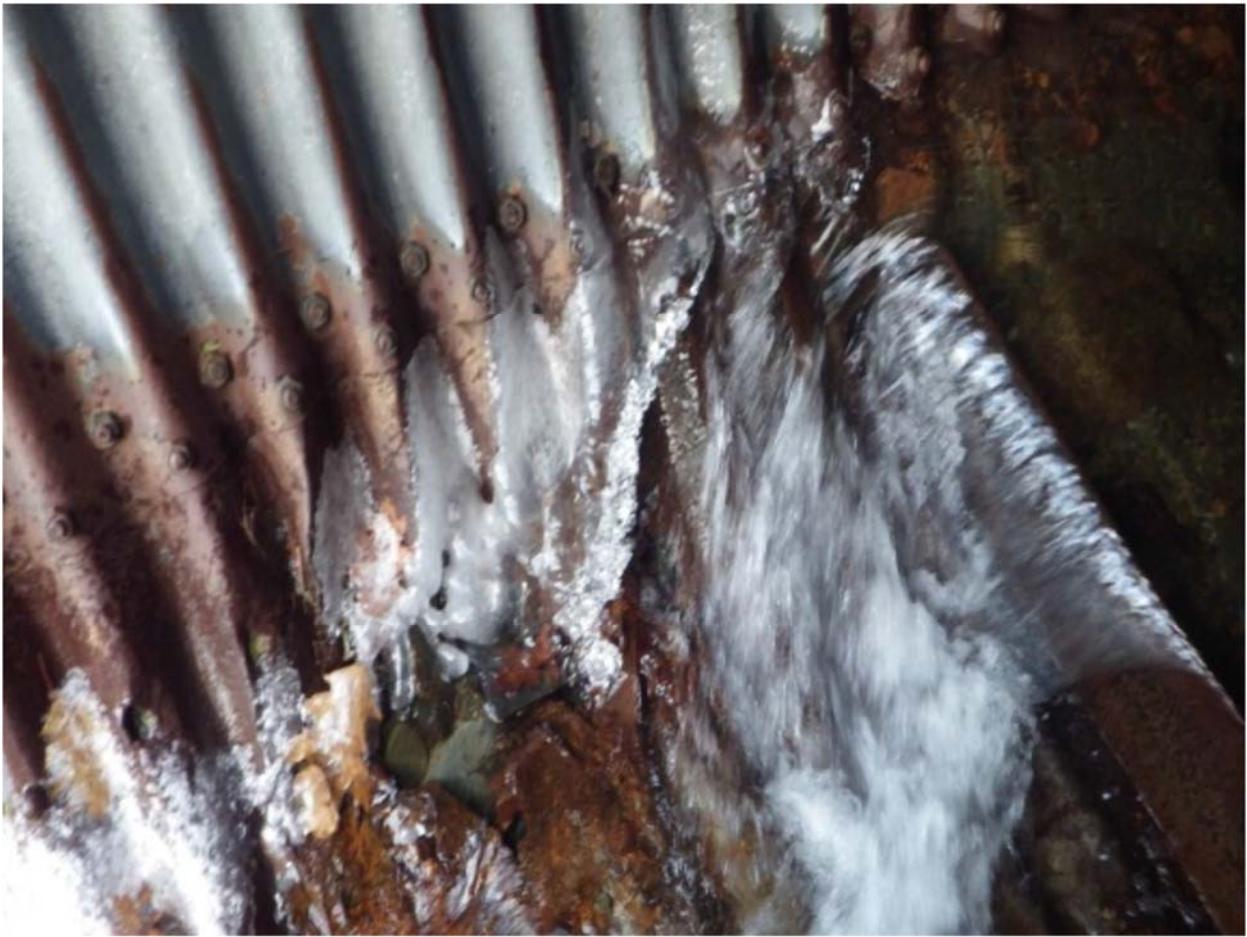
Holes in Corrugated Metal Pipe

1. The culvert is in serious condition. There is severe piping evident by recent patching along the travel lane. There are holes throughout the culvert, with severe holes at the outlet end.
2. The existing culvert does not meet the calculated bank full width.
3. VT Route 18 though the project area is not banked sufficiently for the horizontal curve.

11/20/14 Poor condition, recent patching along travel lane due to severe piping activity that is occurring. Holes are throughout and most severe toward outlet. Pipe needs repairs or replacement. MJK JAS

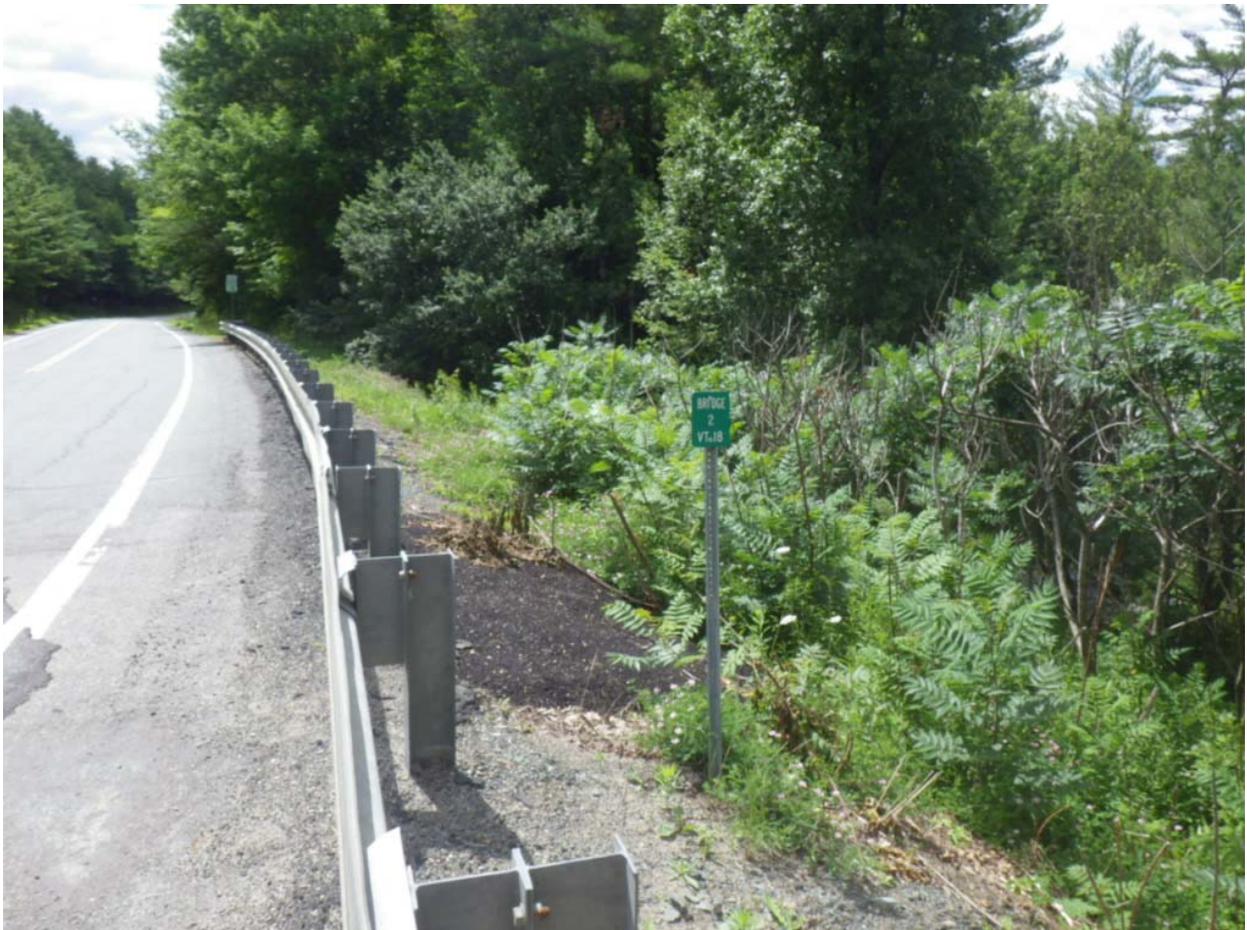
Repaired Sink Hole

1. Your thoughts on the general condition of this bridge and the general maintenance effort required to keep it in service.
The invert of this structure is severely compromised. During high flow events, material around the pipe is pulled through the invert and moved downstream which creates sinkholes at the road surface. District 7 has had to fill sinkholes that have developed over the pipe several times.

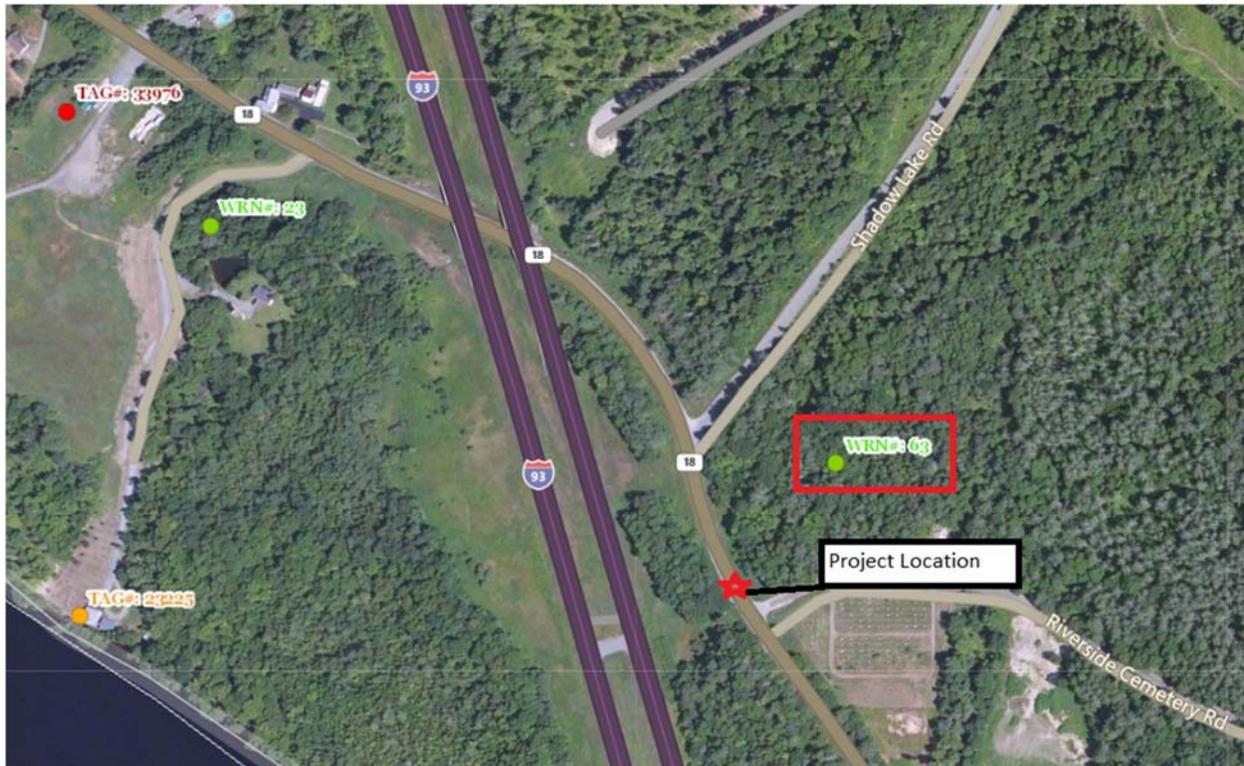
Figure 1. Highlighted well locations near subject project

Figure 1 contains the subject project as well as surrounding well locations found using the ANR Natural Resources Atlas. Published online, the logs can be used to determine general characteristics of soil strata in the area. The soil description given on the logs is done in the field, by unknown personnel, and as such, should only be used as an approximation. One water well nearby the project was used to get an estimate of the depth to bedrock likely to

be encountered for Bridge 3. The specific well used to gain information on the subsurface conditions is highlighted below by red box.

From the single water well used in gathering the surrounding information, located approximately 500 feet away, the depth to bedrock was noted to be 120 feet below ground surface with and the overlying soils consisting of gravels.

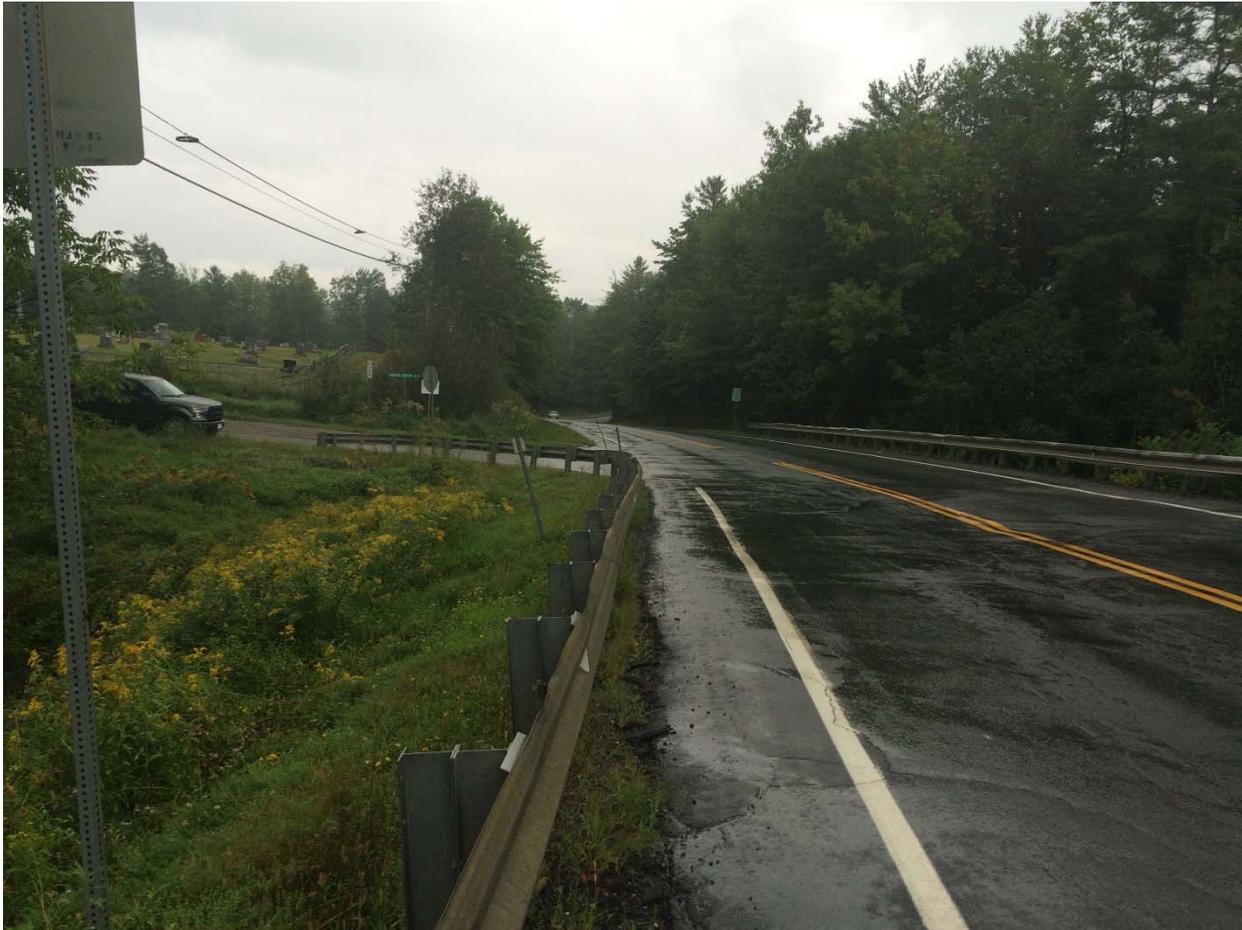
Figure 2: View at Culvert Location Looking South

According to record plans from previous construction and seen during a site visit, the existing foundations are founded on spread footings. No visible bedrock was seen during the site visit. The sides of the stream were armored with stone and the footings helped to prevent undermining, shown in Figure 3. There didn't appear to be any visible bedrock in the stream bed. However there were large amounts of cobbles. There also seemed to be a loss of flow through the culvert due to leaks throughout.
