**Montgomery STP DECK (40)  
Alternatives Presentation Meeting**  
**VT 118– Bridge #19 over Trout River**

March 21, 2016

**Accelerated  
Bridge  
Program**  
VTRANS

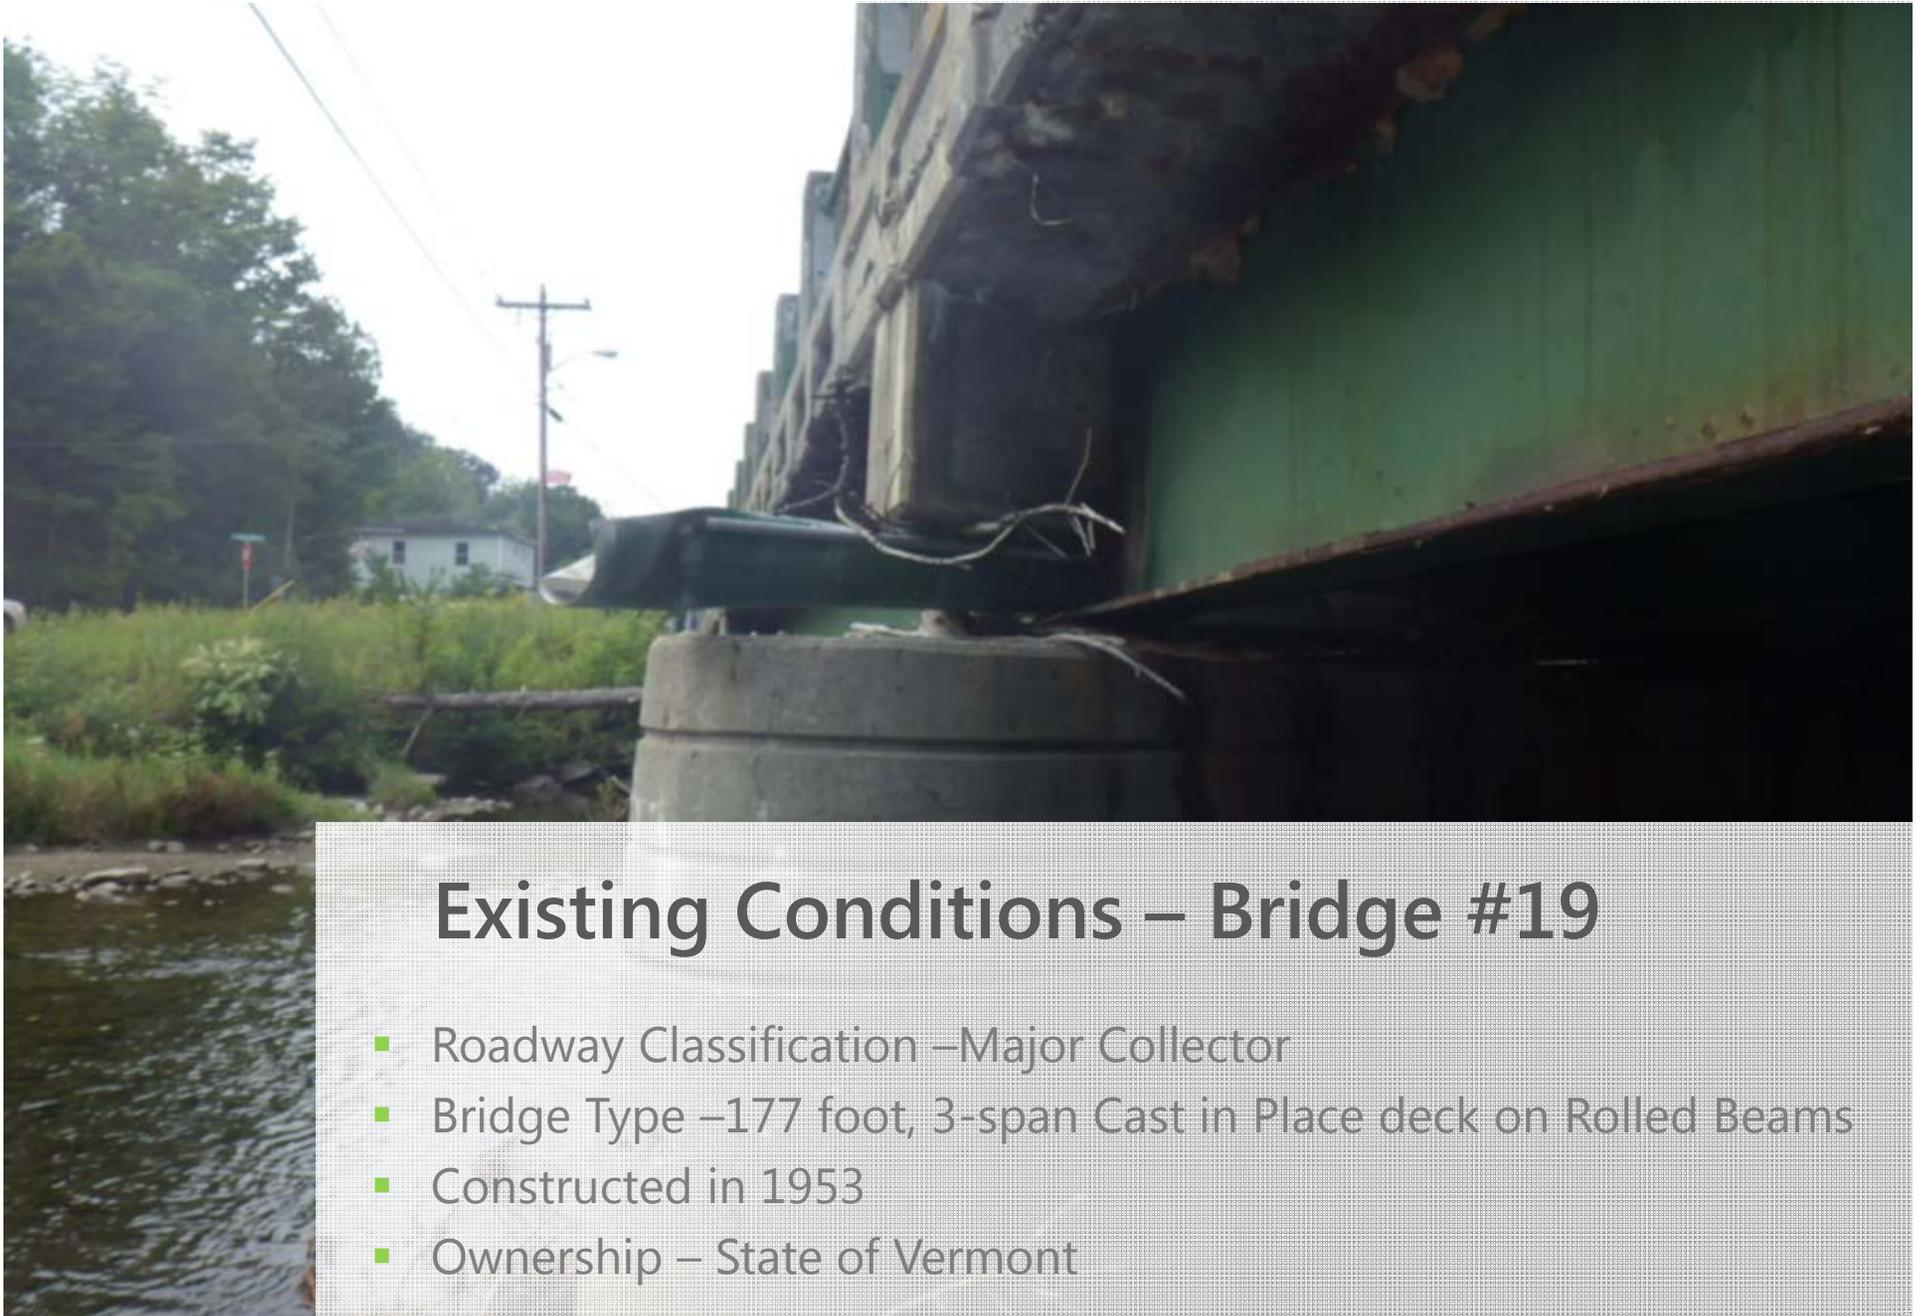
## Existing Conditions – Bridge #19

- Roadway Classification –Major Collector
- Bridge Type –177 foot, 3-span Cast in Place deck on Rolled Beams
- Constructed in 1953
- Ownership – State of Vermont

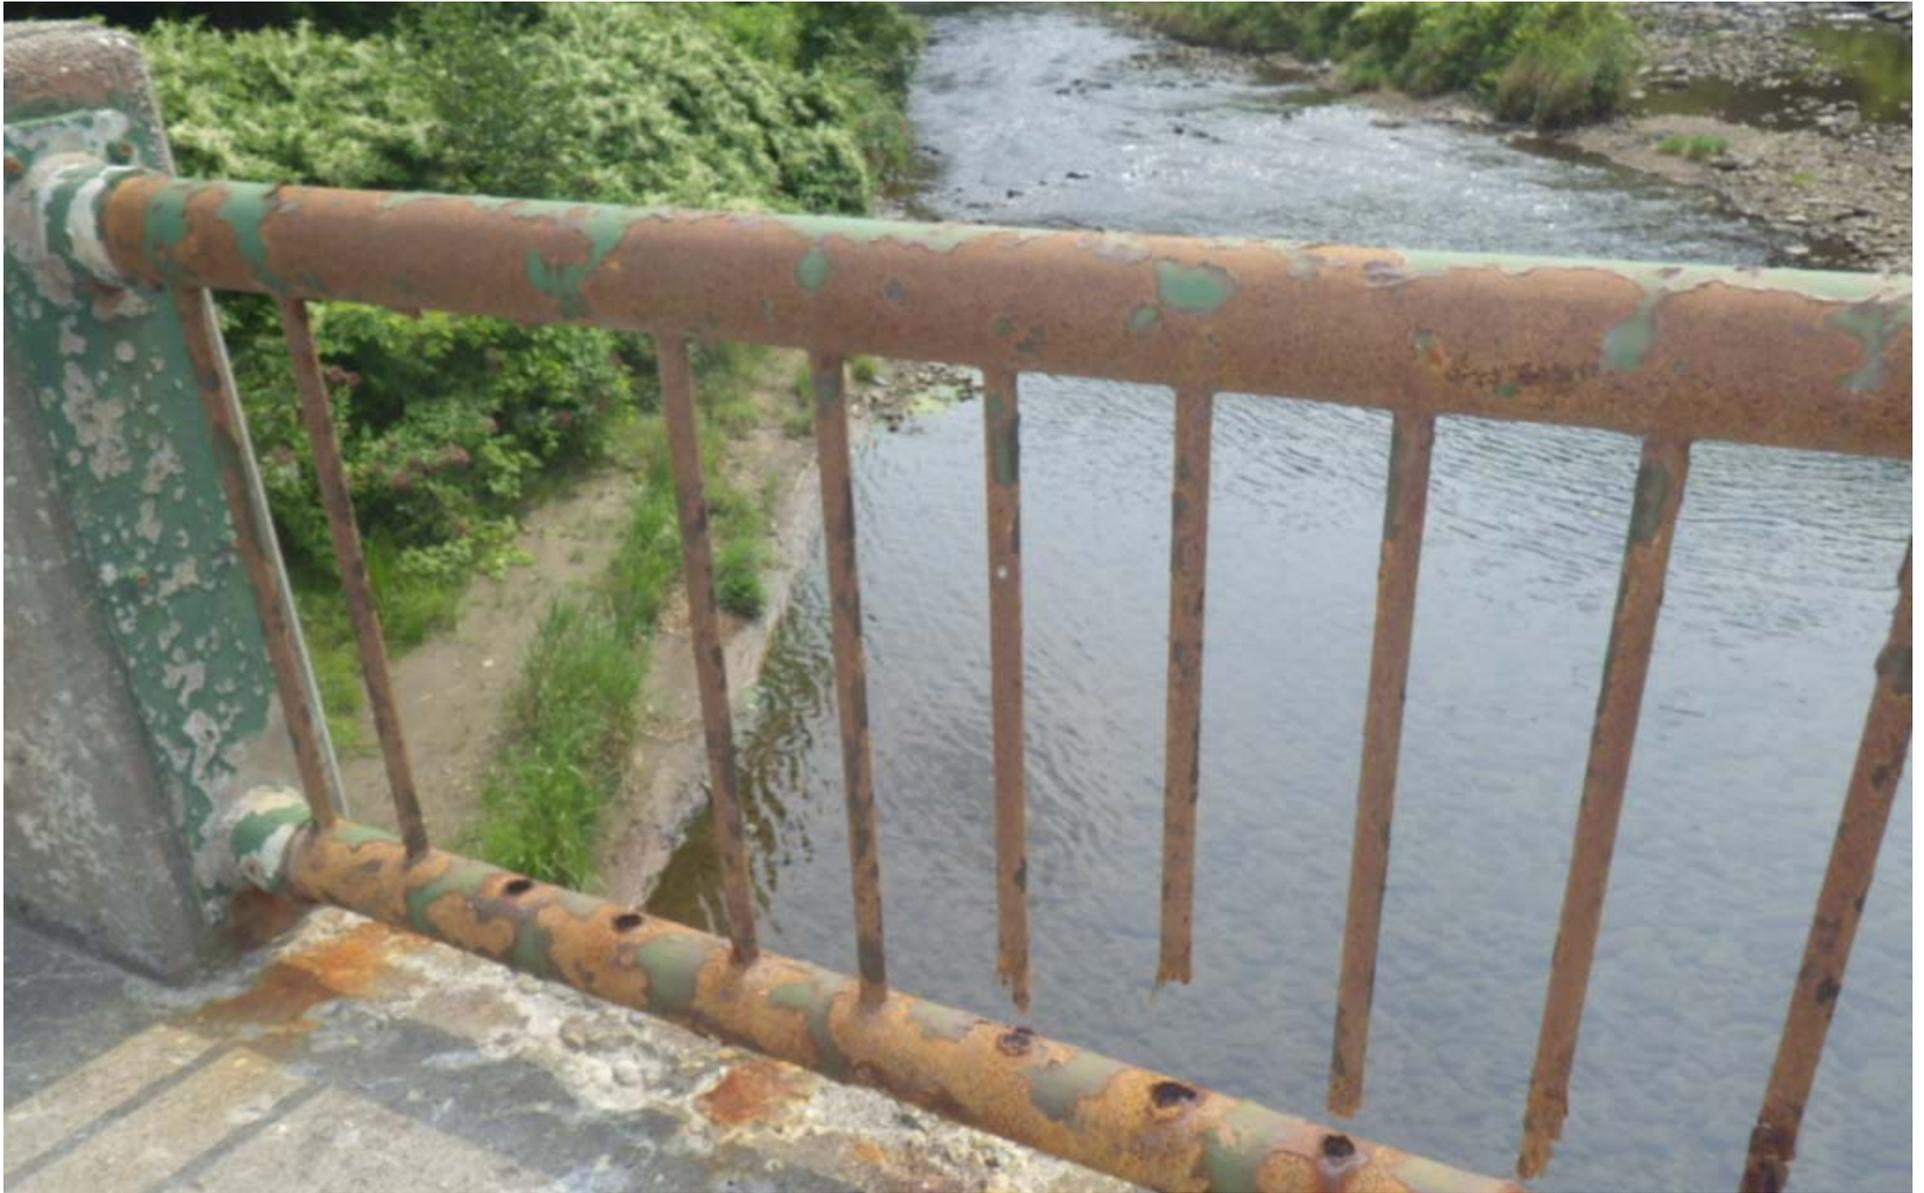
## Existing Conditions – Bridge #19

- Bridge and Approach Rail is Substandard

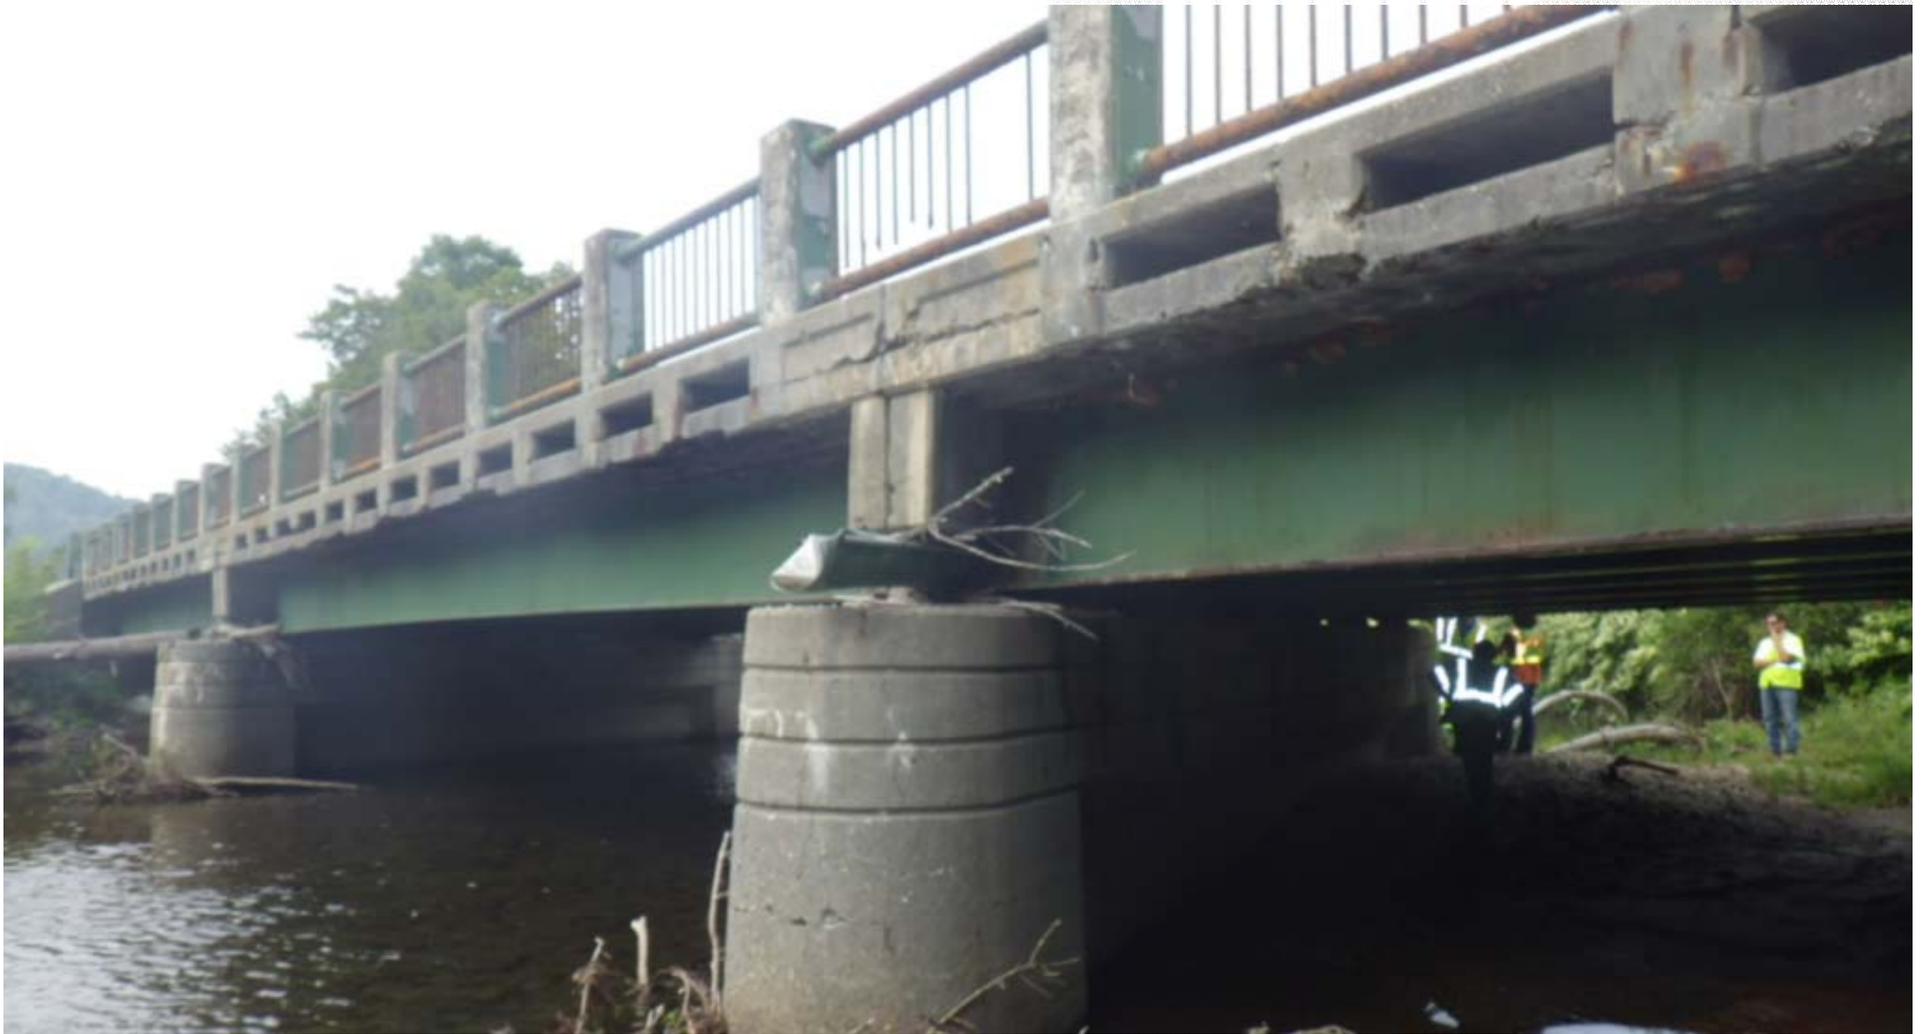
### Existing Conditions - Bridge #19

- Historic Bridge Rail– Concrete Parapet/Metal Railing

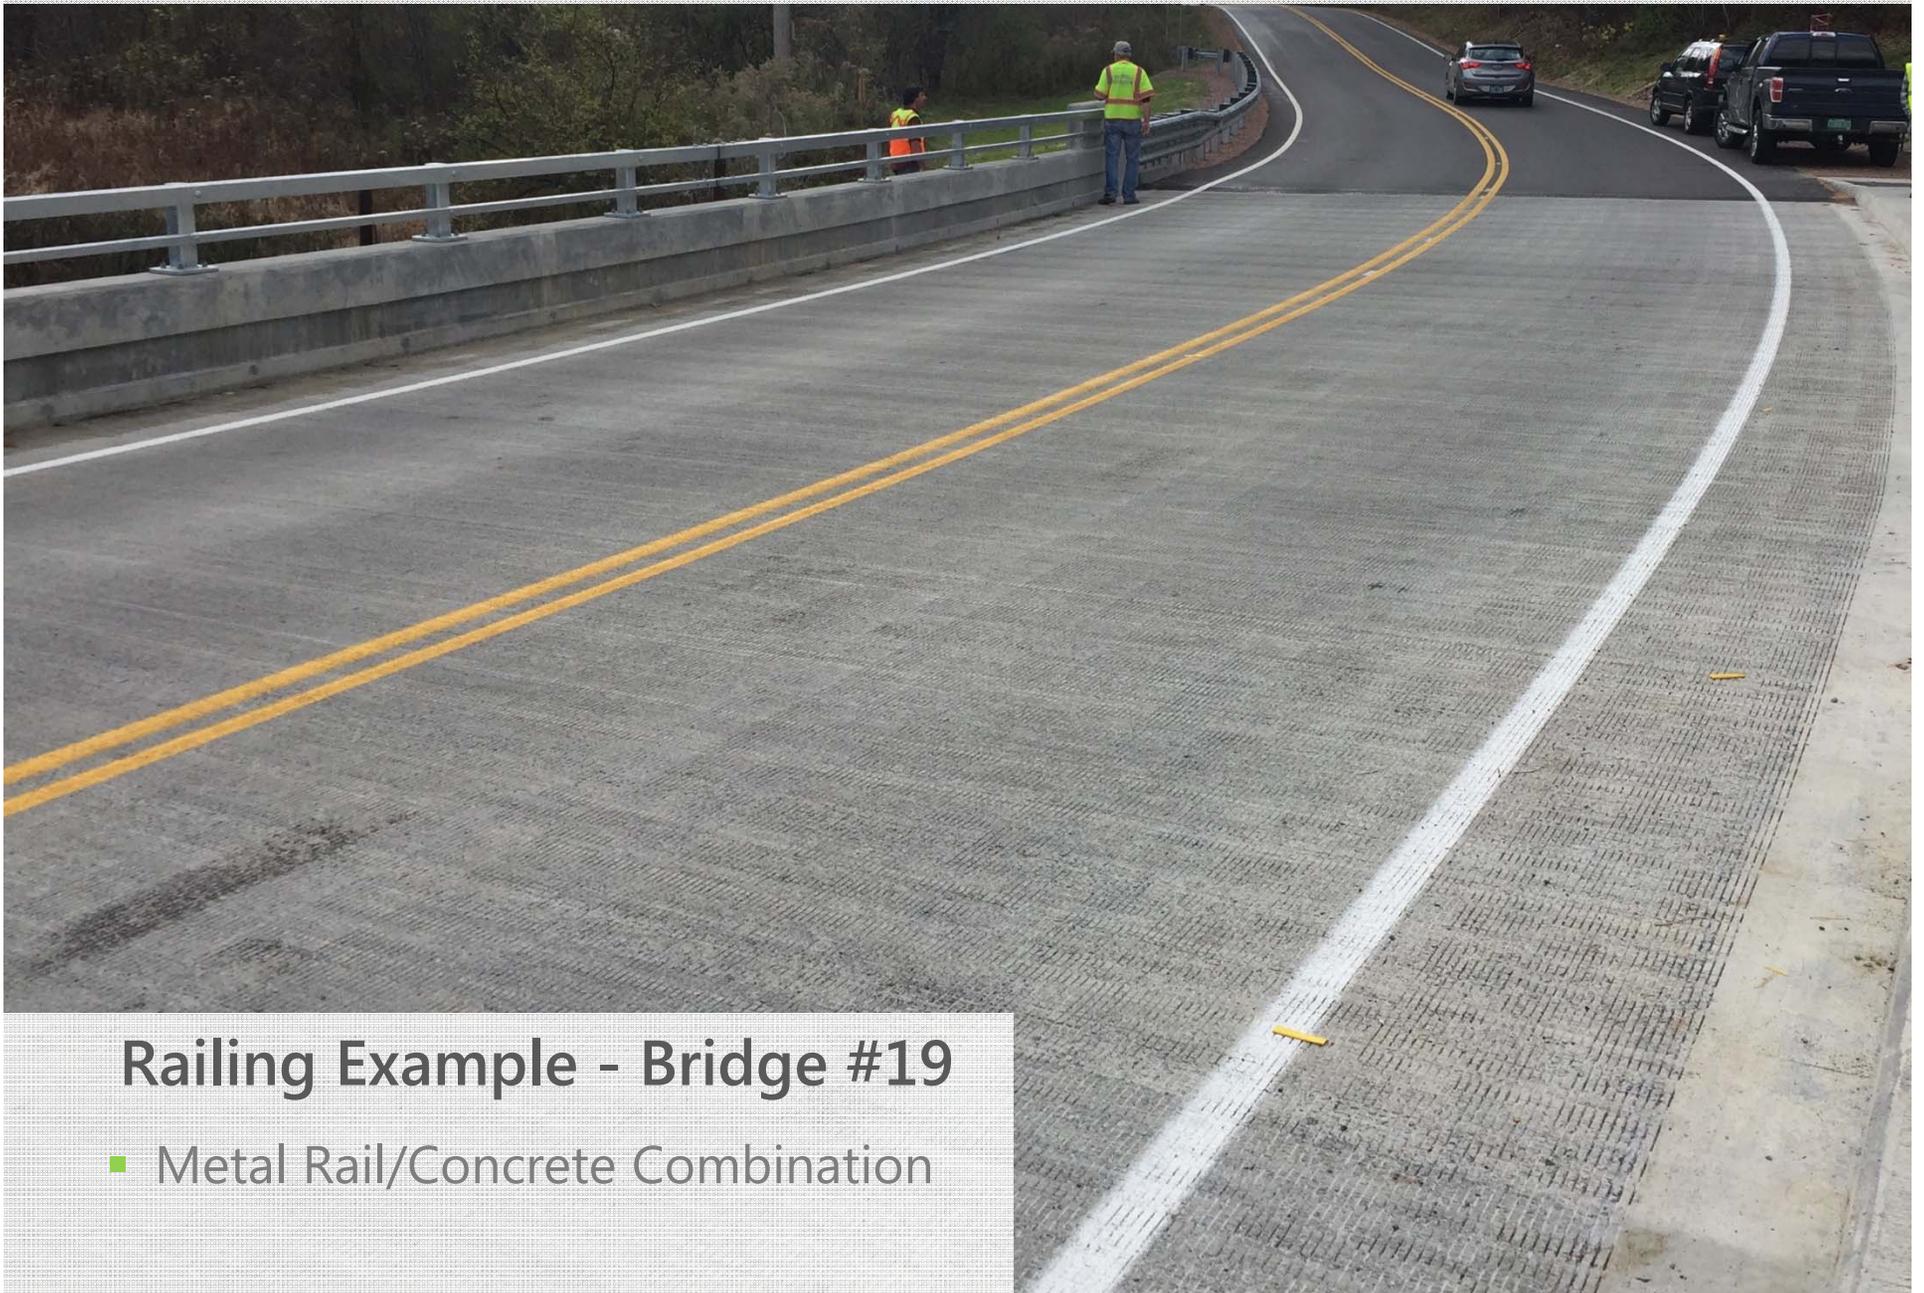
### Railing Example - Bridge #19

- Metal Rail/Concrete Combination

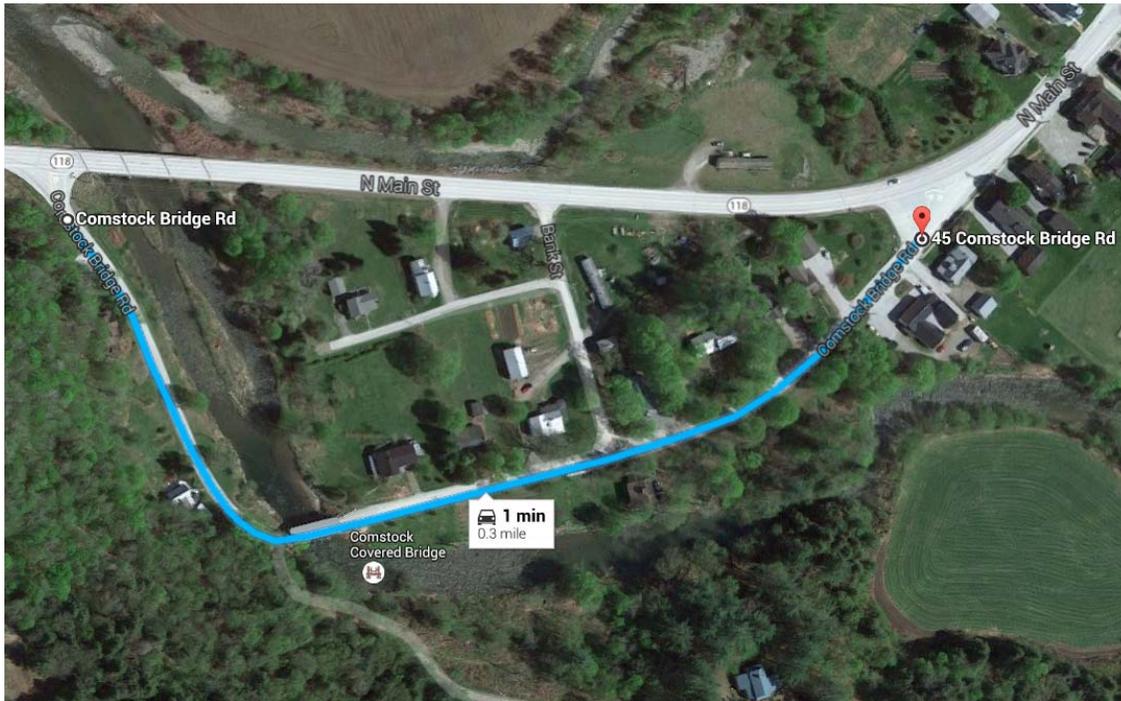
- VT 118, to Comstock Bridge Road, back to VT 118

Through Route: 0.20 Miles

Detour Route: 0.30 Miles

Added Miles: 0.10 Miles

End-to-End: 0.60 Miles

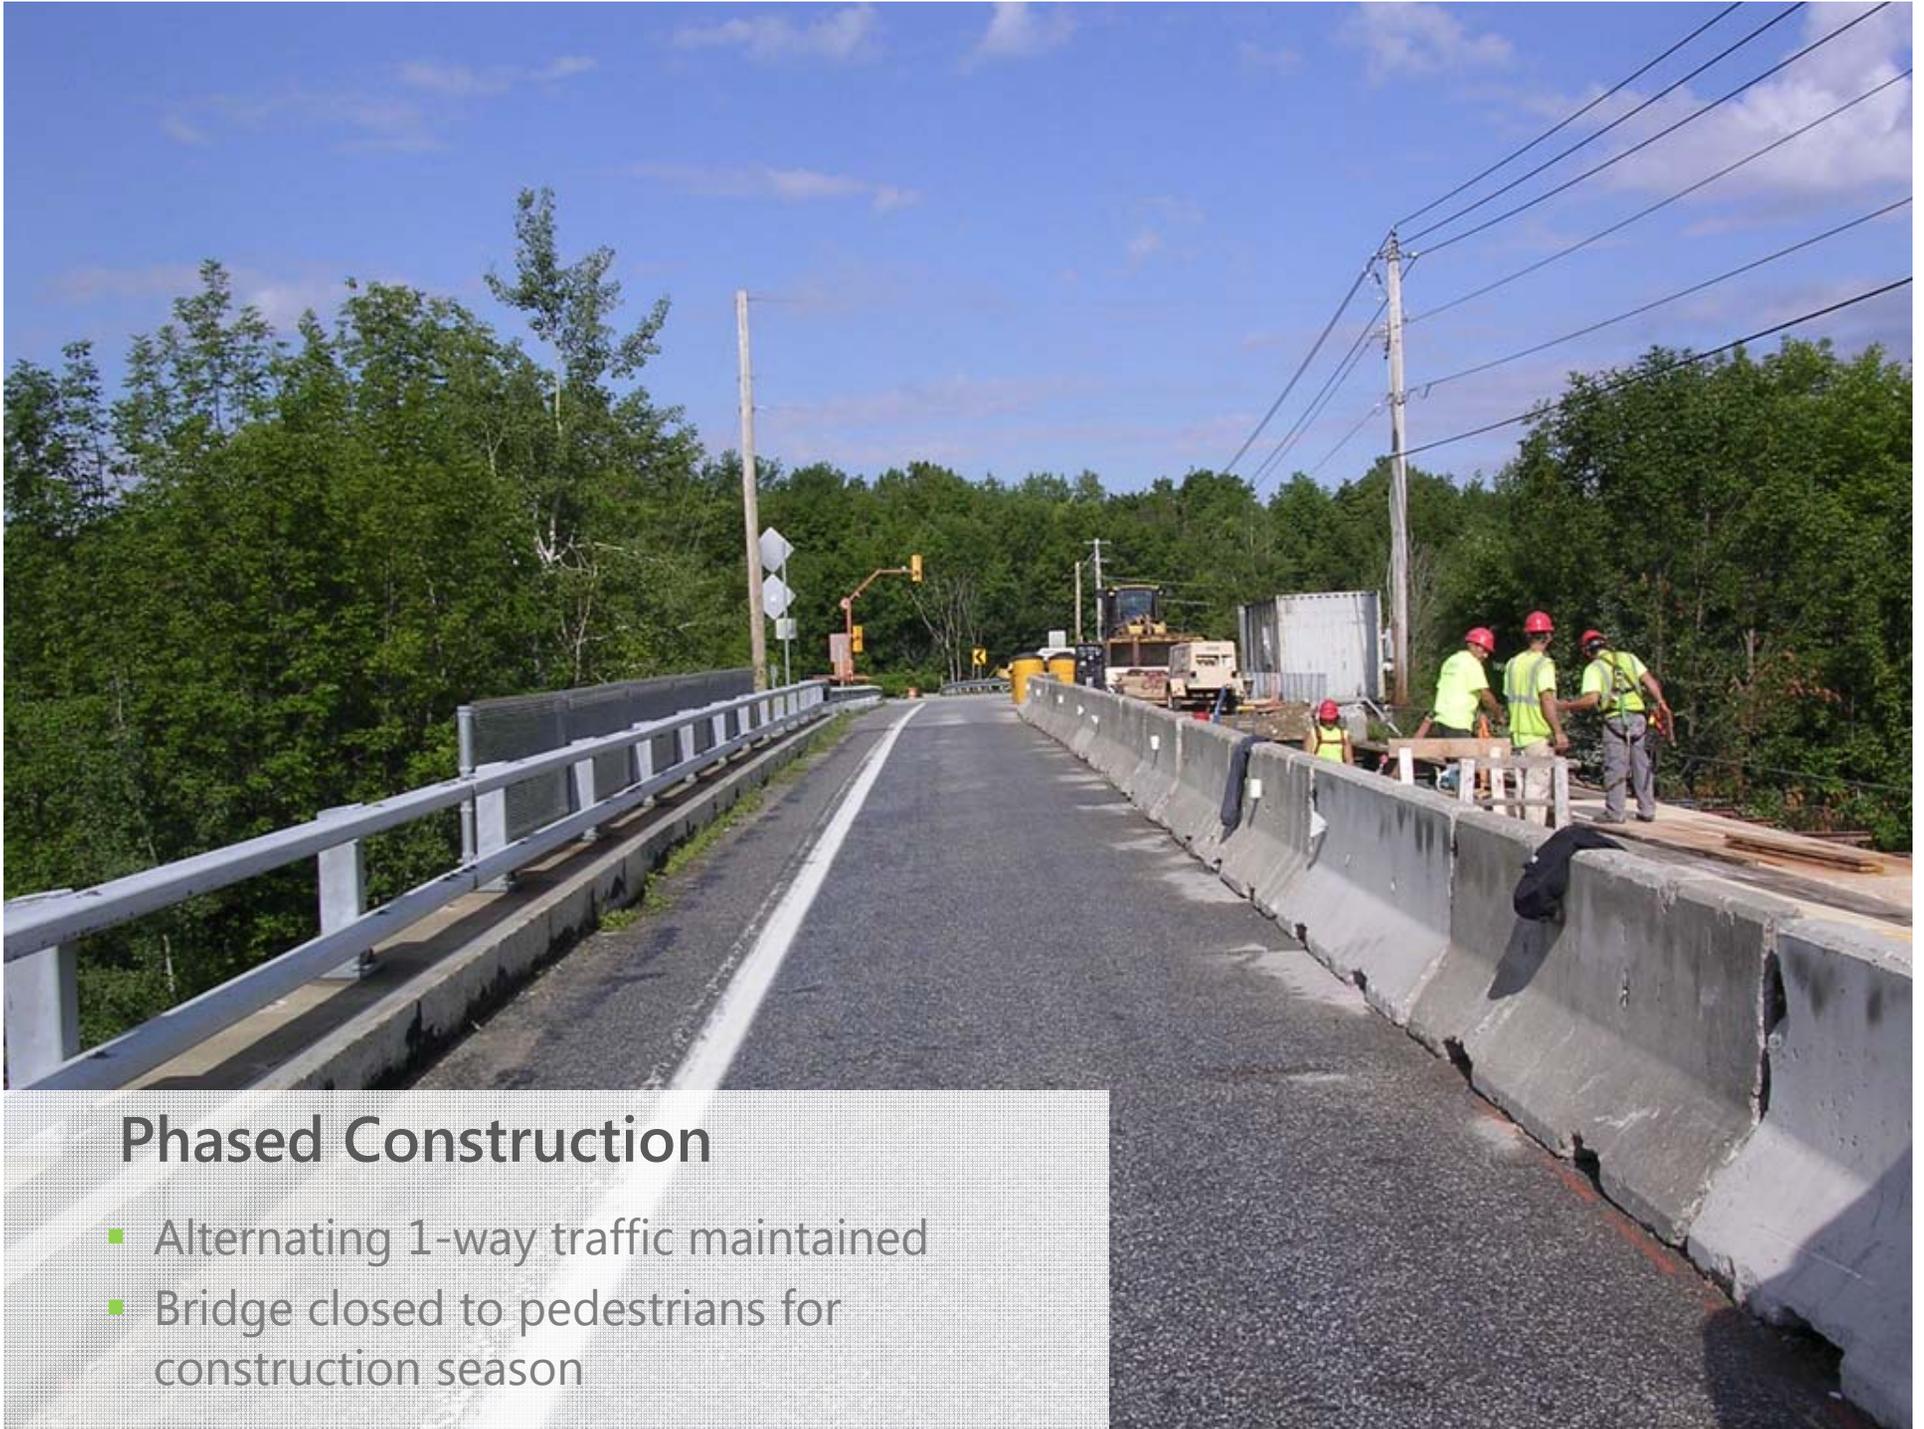
## Phased Construction

- Alternating 1-way traffic maintained
- Bridge closed to pedestrians for construction season

- Replace deck with new cast-in-place concrete deck with traffic maintained onsite using phased construction
  - Maintain Existing Bridge Width
  - Increased Load Capacity
  - New Bridge and Approach Rail
  - No Right-Of-Way Needed
  - Construction – Summer 2017
