Submittal Data Sheet

Project Name: Irasburg IM Deck (46)

Description of Item: Braced Traffic Barrier

Please find attached formal submittal package for the braced traffic barrier for the Irasburg IM Deck (46) project. The below summary of the submittal package identifies each document as it relates to the proposed barrier (Fort Miller Co., Inc. is supplier) and meets criteria set forth for this product:

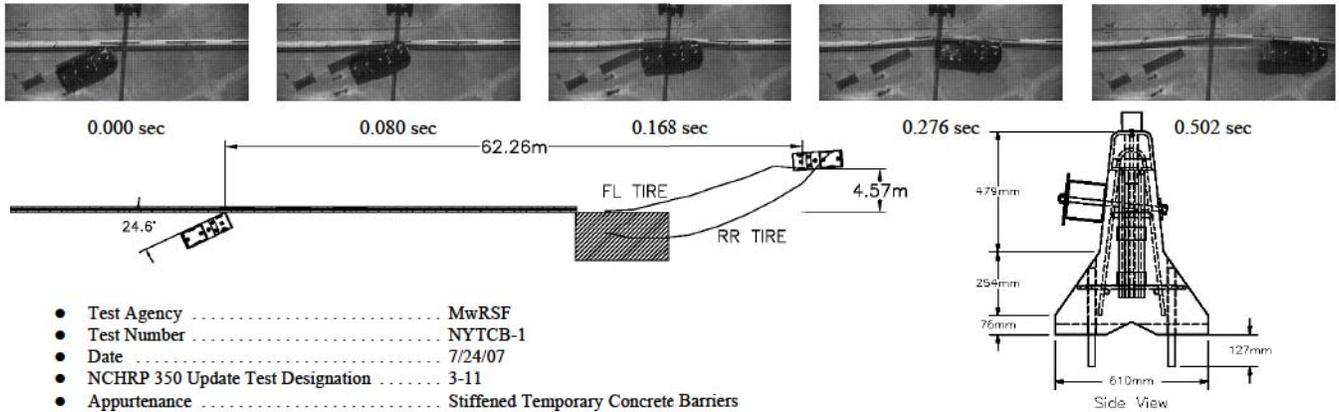
- Test Agency MwRSF
- Test Number NYTCB-1
- Date 7/24/07
- NCHRP 350 Update Test Designation 3-11
- Appurtenance Stiffened Temporary Concrete Barriers
- Total Length 60.96 m

- Key Elements - Barrier
 - Description New York TCB with Connection Keys
 - Length 6,096 mm
 - Base Width 610 mm
 - Height 810 mm
- Key Elements - Anchor Ends

- Make and Model 2002 Dodge Ram 1500 Quad Cab 4x2
 - Curb 2,302 kg
 - Test Inertial 2,275 kg
 - Gross Static 2,275 kg
- Impact Conditions
 - Speed 99.5 km/h

- Exit Conditions
 - Speed 62.9 km/h
 - Angle 7 deg
 - Exit Box Criterion Pass
- Post-Impact Trajectory
 - Vehicle Stability Satisfactory
 - Stopping Distance 62.3 m downstream
4.6 m laterally behind
- Occupant Impact Velocity
 - Longitudinal 4.67 m/s < 12.2 m/s
 - Lateral 6.33 m/s < 12.2 m/s
- Occupant Ridedown Deceleration
 - Longitudinal 4.72 g's < 20.49 g's
 - Lateral 8.36 g's < 20.49 g's
- THIV (not required) 7.45 m/s
- PHD (not required) 8.71 g's
- Test Article Damage Moderate
- Test Article Deflections
 - Permanent Set 660 mm
 - Dynamic 700 mm
 - Working Width 1,311 mm
- Vehicle Damage Moderate
 - VDS¹³ 11-LFQ-3
 - CDC¹⁴ 11-LYEN2
 - Maximum Deformation 38 mm
- Angular Displacements
 - Roll -10.5 deg
 - Pitch -11.4 deg
 - Yaw 28.0 deg

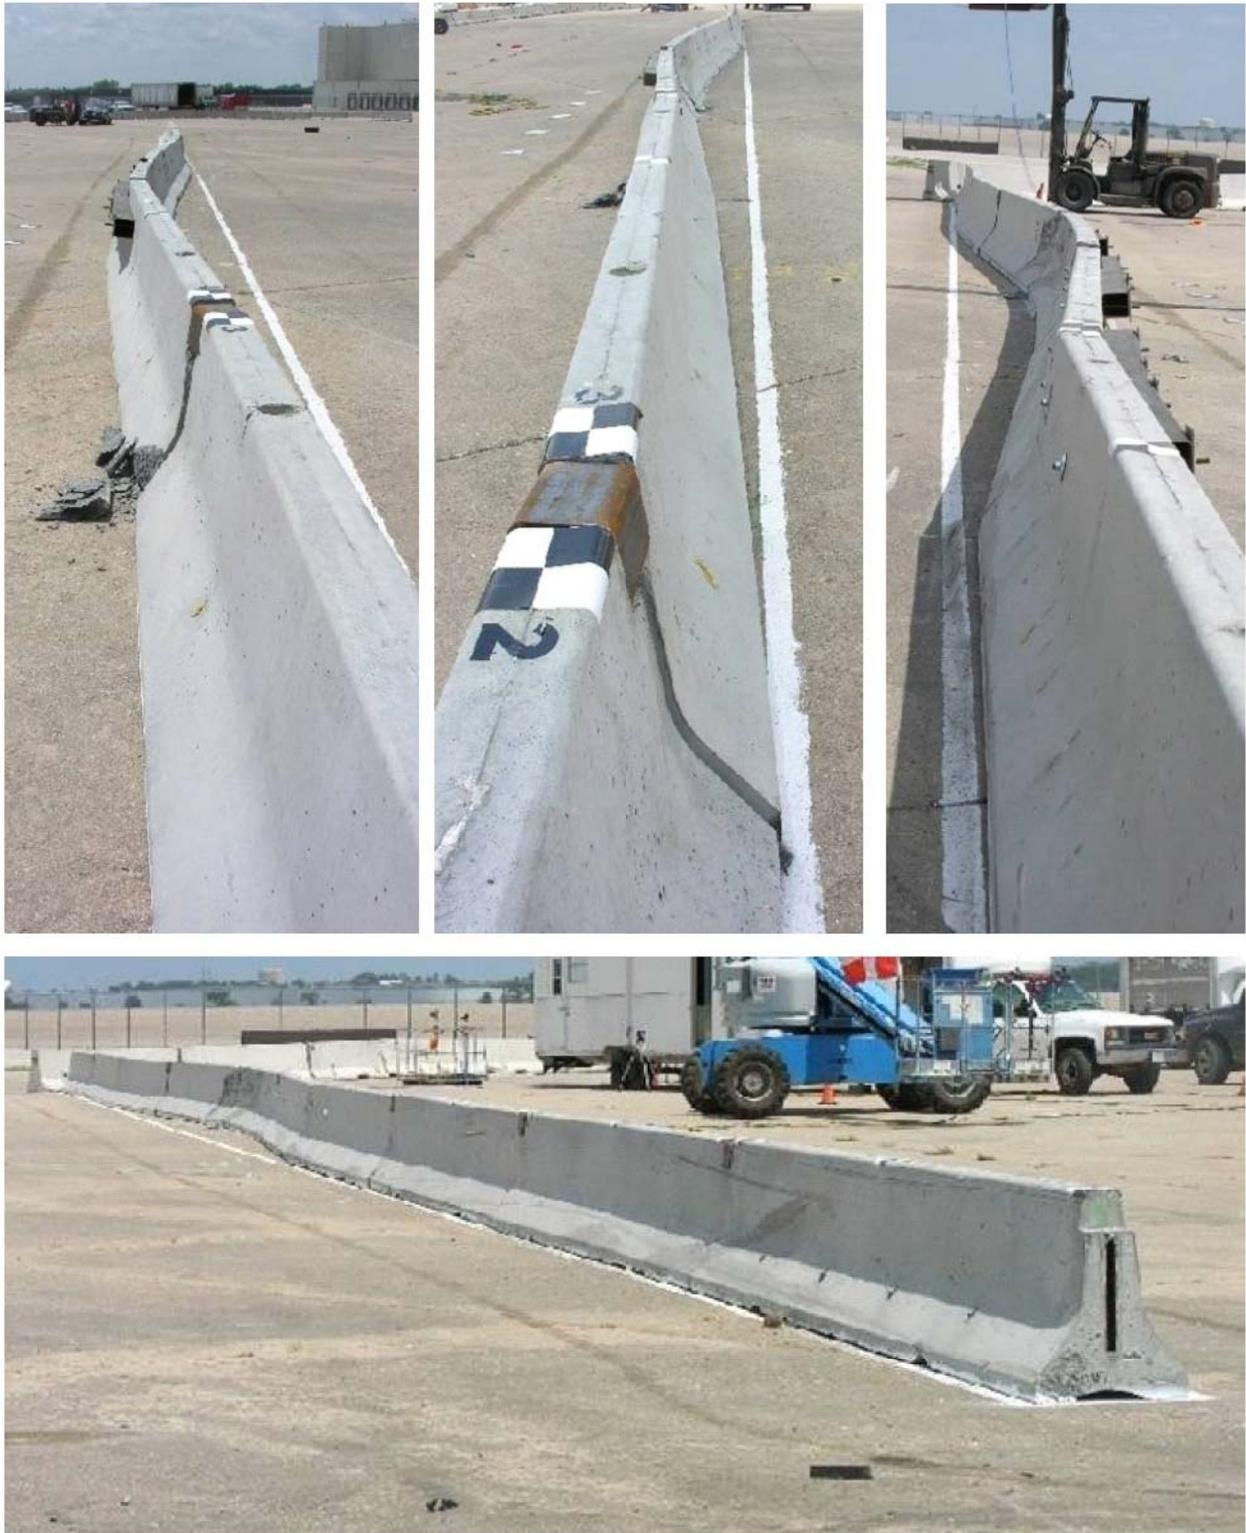
Figure 37. Temporary Barrier Damage, Test NYTCB-1

Damage to the barrier was moderate, as shown in Figures 37 through 41. Barrier damage consisted of contact marks, concrete cracking, barrier spalling, cracks, and deformed box beam sections. The length of vehicle contact along the system was approximately 38.3 m (125.8 ft), which spanned from 1.75 m (5 ft - 9 in.) upstream from the downstream end of barrier no. 4 through the downstream end of barrier no. 10.

The permanent set of the barrier system is shown in Figure 37. The maximum lateral permanent set barrier deflection was 660 mm (26 in.) at the downstream end of barrier no. 4 and the upstream end of barrier no. 5, as measured in the field. The maximum lateral dynamic barrier deflection was 700 mm (27.6 in.) at the upstream end of barrier no. 5, as determined from high-speed digital video analysis. The working width of the system was found to be 1,311 mm (51.6 in.).

Contact and tire marks were visible on the front face of barrier nos. 4 through 10. The back side of barrier no. 3 experienced concrete spalling 152 mm (6 in.) wide and 356 mm (14 in.) in height. The back upstream end of barrier no. 4 experienced concrete spalling 584 mm (23 in.) wide and 254 mm (10 in.) tall. The front downstream edge of barrier no. 4 also experienced concrete spalling 305 mm (12 in.) wide and 178 mm (7 in.) tall. A 381-mm (15-in.) wide by 127-mm (5-in.)

tall area of concrete spalling was found on the back side of barrier no. 5, beginning 762 mm (30 in.) downstream from the barrier's upstream end. The front side of barrier no. 5 also experienced concrete spalling 102 mm (4 in.) wide and 178 mm (7 in.) tall. Concrete spalling occurred on the top-front upstream end of barrier no. 6, measuring 51 mm (2 in.) wide by 76 mm (3 in.) tall. The bottom-front face of barrier no. 6 also experienced concrete spalling at 1,168 mm (46 in.) downstream from the upstream end, measuring 152 mm (6 in.) wide by 76 mm (3 in.) tall. Minor concrete spalling occurred at the bottom-front face of barrier no. 6, measuring 102 mm (4 in.) tall and 1,219 mm (48 in.) long. The back side of barrier no. 6 experienced significant concrete spalling, measuring 102 mm (4 in.) wide by 76 mm (3 in.) tall at the bottom-downstream corner of the barrier. Concrete spalling on the back side of barrier no. 6, measuring 127 mm (5 in.) wide by 76 mm (3 in.) tall, occurred at 838 mm (33 in.) upstream from the downstream end of the barrier. A 178-mm (7-in.) wide by 102-mm (4-in.) tall area of concrete spalling was found on the back side 533 mm (21 in.) downstream from the upstream end of barrier no. 7.

A 76-mm (3-in.) long crack was found on the back side of barrier no. 3 and began 1,219 mm (48 in.) from the downstream end of the barrier. Cracks were found on the back side of barrier no. 4 at 2,997 mm (118 in.), 3,658 mm (144 in.), and 4,699 mm (185 in.) downstream of the upstream end of the barrier. Hairline cracking was found on the back side at the downstream end of barrier no. 4 and at the upstream and downstream ends of barrier no. 5. Cracks were also found on the back side of barrier no. 5 and spanned from the top to the bottom of the barrier and were located 1,295 mm (51 in.), 1,828 mm (72 in.), 2,413 mm (95 in.), 3,073 mm (121 in.), and 3,683 mm (145 in.) downstream from the upstream end of the barrier. Two hairline cracks spanned the height of the front side of barrier no. 6 at 1,803 mm (71 in.) and 3,048 mm (120 in.) downstream of the upstream end of the barrier.

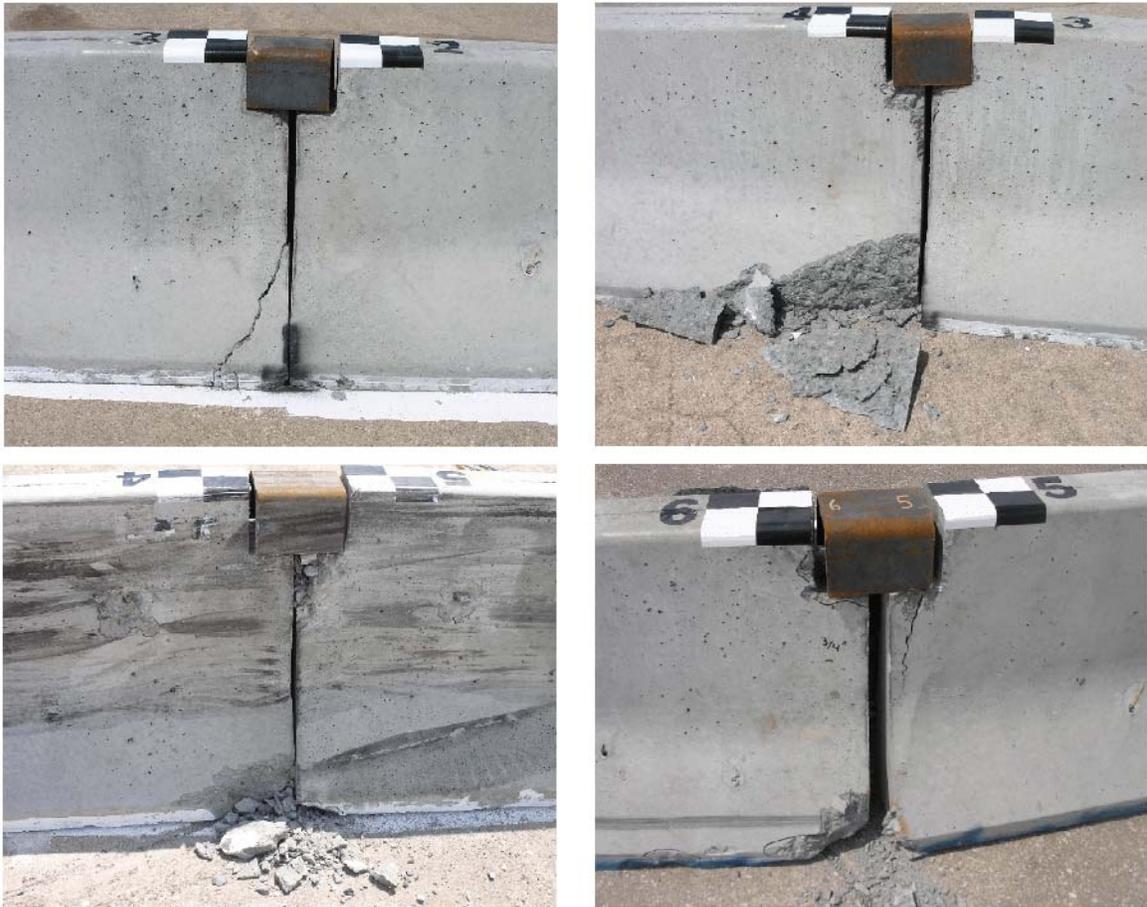
Figure 40. Joint Connection Damage - Joints 2-3, 3-4, 4-5, and 5-6, Test NYTCB-1

The joint between barrier nos. 2 and 3 was observed to have widened from its pre-test width. The joint between barrier nos. 3 and 4 rotated. The box beam stiffeners all experienced minor bending. The box beam rods at the front-downstream end of barrier no. 4 and front-upstream end of barrier no. 5 were sheared off. The downstream box beam rod was bent at the front of barrier no. 5. All connection keys remained undamaged. The anchor rods in barrier nos. 1 and 10 remained undamaged, and these barriers experienced no movement. Minor bending of the plate washers was observed. No buckling of the box beam webs nor bending of the box beam flanges was observed under the plate washers.

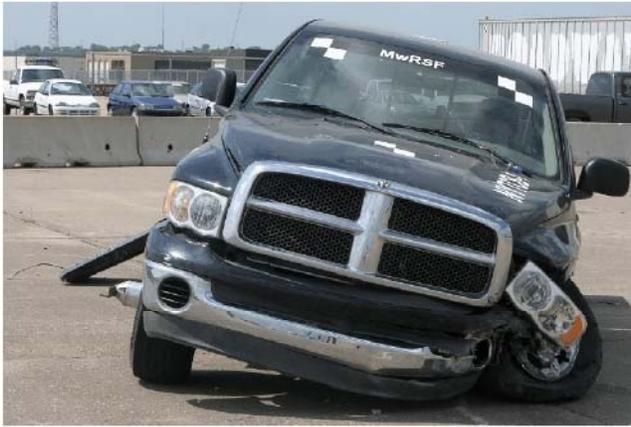
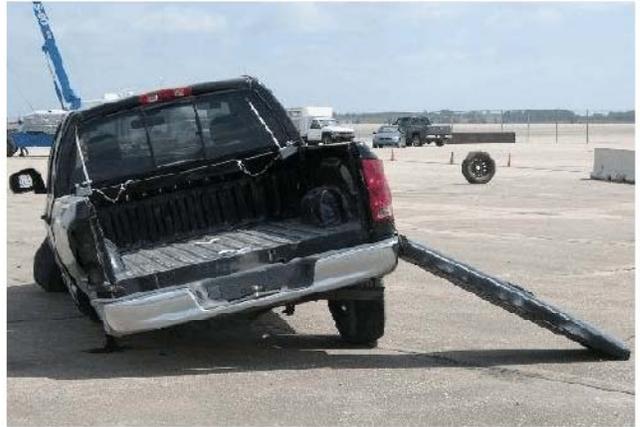
Figure 42. Vehicle Damage, Test NYTCB-1

Exterior vehicle damage was moderate, as shown in Figures 42 and 43. Occupant compartment deformations to the left side and center of the floorboard were judged insufficient to cause serious injury to the vehicle occupants. Maximum longitudinal deflections of 19 mm (0.75 in.) were located near the left-front corner of the left-side floor pan. Maximum lateral deflections of 38 mm (1.5 in.) were located near the left-front corner of the floorboard. Maximum vertical deflections of 32 mm (1.25 in.) were located near the left front of the floorboard. Complete occupant compartment deformations and the corresponding locations are provided in Appendix C.

Damage was concentrated on the left-front corner of the vehicle. The left corner of the front bumper deformed inward and the right side was detached. The left-front tire's side walls were

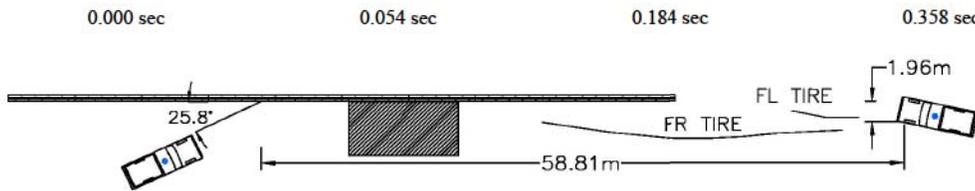
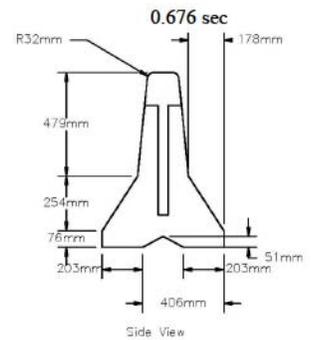
- Test Agency MwRSF
- Test Number NYTCB-2
- Date 7/25/07
- NCHRP 350 Update Test Designation 3-11
- Appurtenance Unstiffened Temporary Concrete Barriers
- Total Length 60.96 m
- Key Elements - Barrier
 - Description New York TCB with Connection Keys
 - Length 6,096 mm
 - Base Width 610 mm
 - Height 810 mm
- Key Elements - Anchor Ends
 - Size 25 mm diameter ASTM A36 rod
 - Length 394 mm
 - Number per Barrier 5 traffic-side, 4 back side
- Type of Soil N/A
- Test Vehicle
 - Type/Designation 2270P
 - Make and Model 2002 Dodge Ram 1500 Quad Cab 4x2
 - Curb 2,245 kg
 - Test Inertial 2,279 kg
 - Gross Static 2,279 kg
- Impact Conditions
 - Speed 98.5 km/h
 - Angle 25.8 degrees
 - Impact Location 1,300 mm upstream from downstream end of barrier 4
- Exit Conditions
 - Speed 72.8 km/h
 - Angle 4.7 degrees
 - Exit Box Criterion Pass

- Post-Impact Trajectory
 - Vehicle Stability Satisfactory
 - Stopping Distance 58.81 m downstream
1.96 m laterally away
- Occupant Impact Velocity
 - Longitudinal -4.84 m/s < 12.2 m/s
 - Lateral 6.32 m/s < 12.2 m/s
- Occupant Ridedown Deceleration
 - Longitudinal -5.44 g's < 20.49 g's
 - Lateral 8.09 g's < 20.49 g's
- THIV (not required) 7.59 g's
- PHD (not required) 8.19 g's
- Test Article Damage Moderate
- Test Article Deflections
 - Permanent Set 1,003 mm
 - Dynamic 1,023 mm
 - Working Width 1,630 mm
- Vehicle Damage Moderate
 - VDS¹³ 11-LFQ-3
 - CDC¹⁴ 11-LYEN4
 - Maximum Deformation 76 mm
- Angular Displacements
 - Roll -12.4 deg
 - Pitch -10.6 deg
 - Yaw 43.1 deg

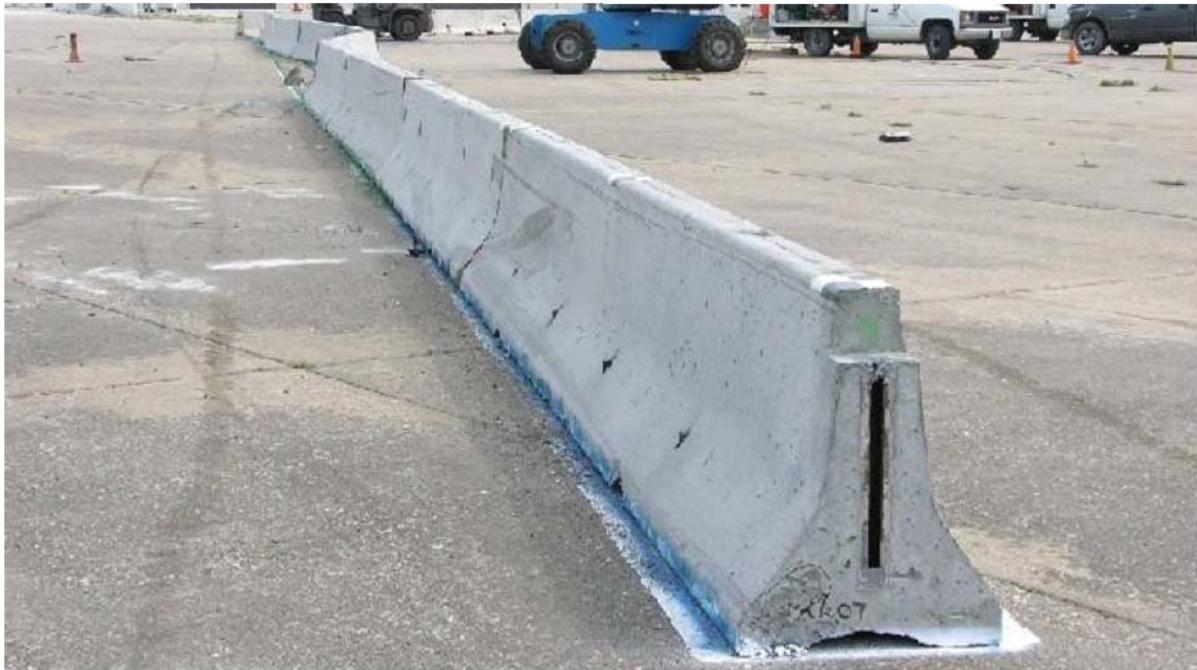
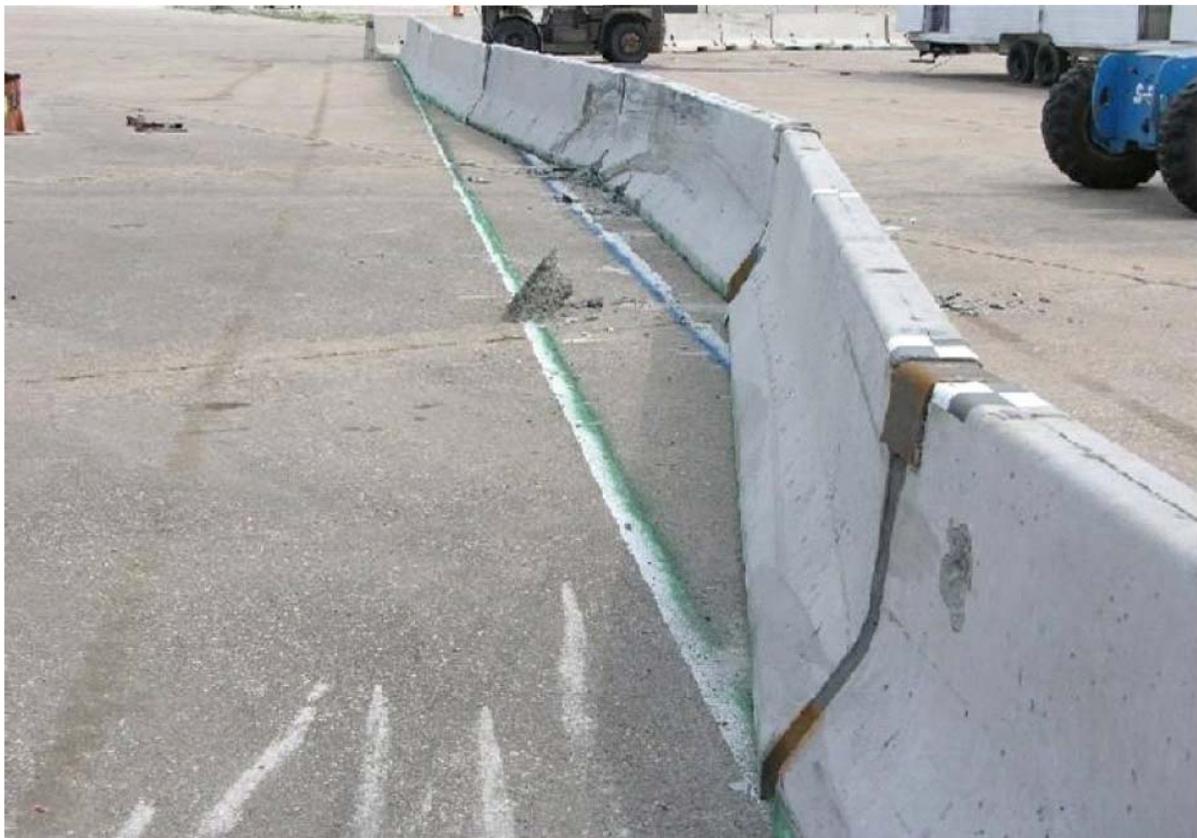
Figure 58. Temporary Barrier Damage, Test NYTCB-2

Damage to the barrier was moderate, as shown in Figures 58 through 61. Barrier damage consisted of tire and gouge marks, concrete barrier cracking, and spalling concrete. The length of the vehicle contact along the system was approximately 13.97 m (45.8 ft), which spanned from 1.78 m (70 in.) upstream from the downstream end of barrier no. 4 through the downstream end of barrier no. 6.

The permanent set of the barrier system is shown in Figures 58 and 59. The maximum lateral permanent set barrier deflection was 1,003 mm (39.5 in.) at the downstream end of barrier no. 4 and the upstream end of barrier no. 5, as measured in the field. The maximum lateral dynamic barrier deflection was 1,023 mm (40.25 in.) at the midpoint of barrier no. 5, as determined from high-speed digital video analysis. The working width of the system was found to be 1,630 mm (64.2 in.).

Contact marks were visible on the front face of barrier nos. 4 through 6. Tire marks were found 1,778 mm (70 in.) upstream from the downstream end of barrier no. 4 and continued through the downstream end of barrier no. 5. Tire marks were also found beginning at the midpoint of barrier no. 6 and continued through the end of barrier no. 6. Blue contact marks were found on barrier nos. 4 and 5.

Cracking was found on the front and back sides of barrier no. 4 from the center of the barrier to the downstream end. Major cracking was found throughout the front and back sides of barrier no. 5. Minor cracking was also found throughout the length of barrier no. 6 and on both the front and back sides.

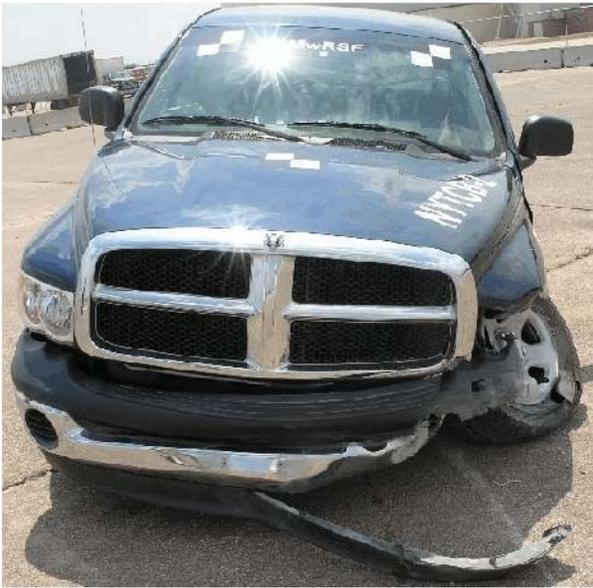
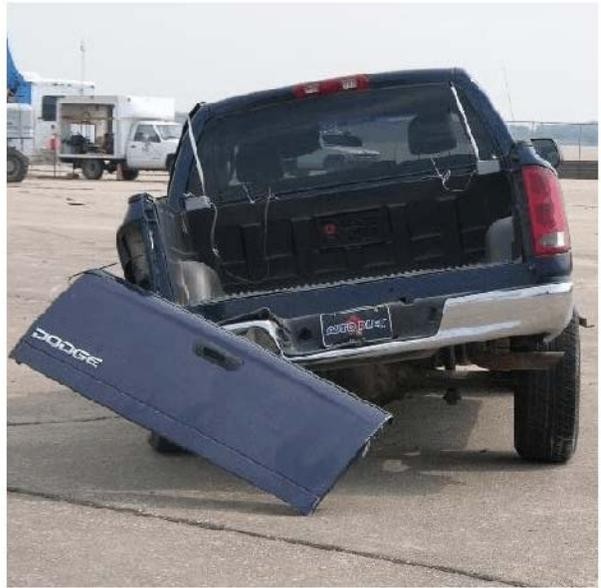
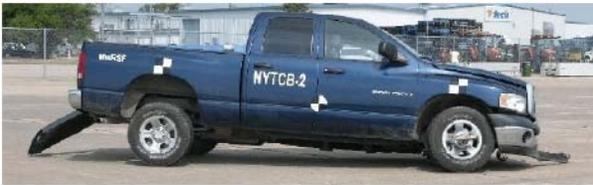
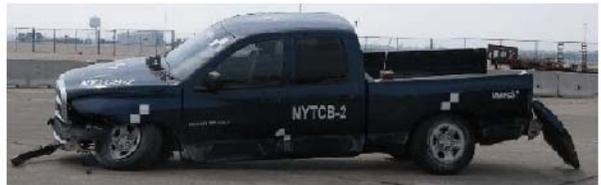
Figure 62. Vehicle Damage, Test NYTCB-2

Exterior vehicle damage was moderate, as shown in Figures 62 and 63. Occupant compartment deformations to the left side and center of the floorboard were judged insufficient to

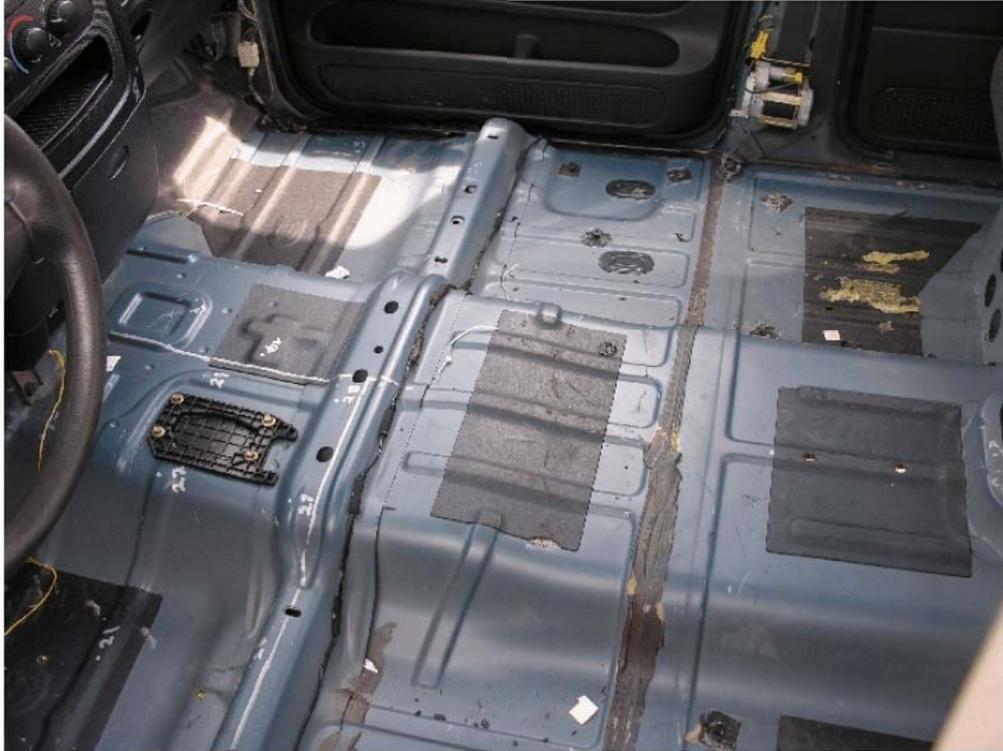
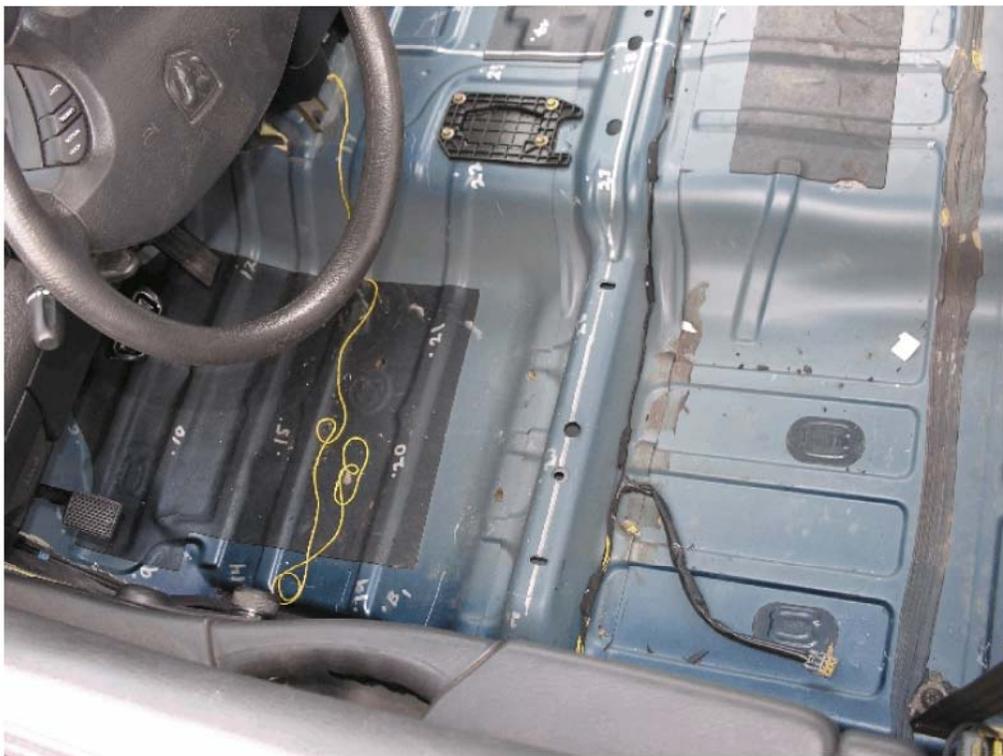
Figure 64. Occupant Compartment Deformation, Test NYTCB-2

cause serious injury to the vehicle occupants, as shown in Figure 64. Maximum longitudinal deflections of 76 mm (3 in.) were located near the left-front corner of the left-side floor pan. Maximum lateral deflections of 25 mm (1 in.) were located near the front center of the left-side floor pan. Maximum vertical deflections of 70 mm (2.75 in.) were located near the middle-front area of the left-side floor pan. Complete occupant compartment deformations and the corresponding locations are provided in Appendix C.
