200 Years of Soot and Sweat

The History and Archeology of Vermont's Iron, Charcoal, and Lime Industries

Addendum A - Update to the 1992 Edition

Victor R. Rolando

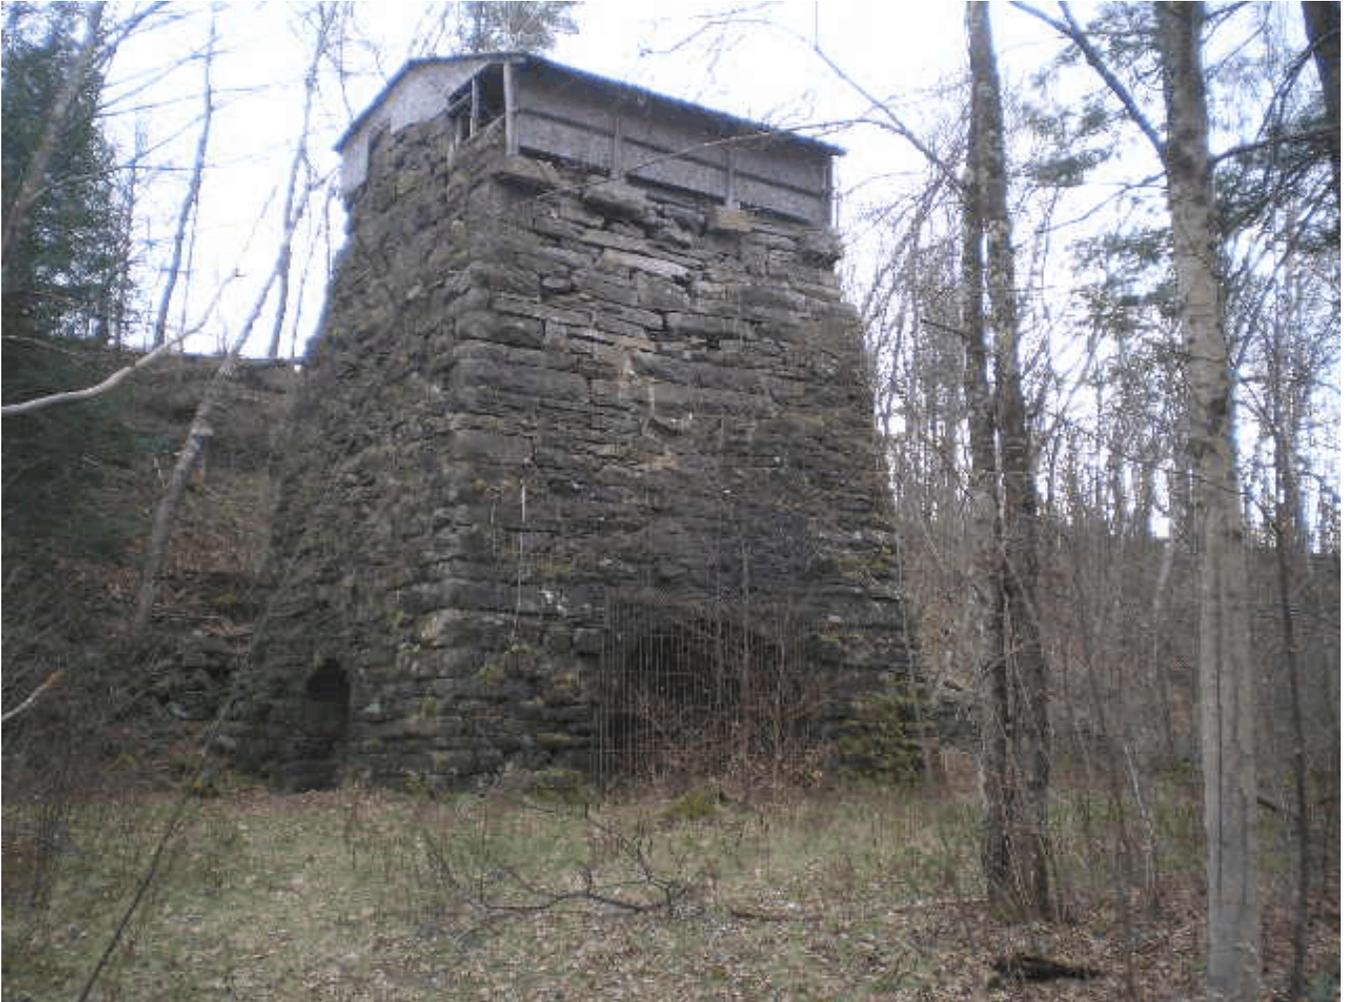
Figure A-1. *The Green Mountain Iron Company blast furnace at Forestdale the fall of 2005. View is from the northeast. Just ten years after its stabilization work the summer of 1995 (see page A-31), the ca1823 stack is holding up well. Compare with the Front Cover of the original 1992 edition showing the work arch fully collapsed. That arch today stands firm and tight except for a few 3- to 4-inch-long stalactites that hang from the ceiling of this and other archways, betraying water seepage into the structure. An iron gate fully guards the work arch from unauthorized exploration. Nature is slowly taking back the grounds; in summer, most of the stack is hidden by renewed tree growth. Rolando photo; November 2005.*

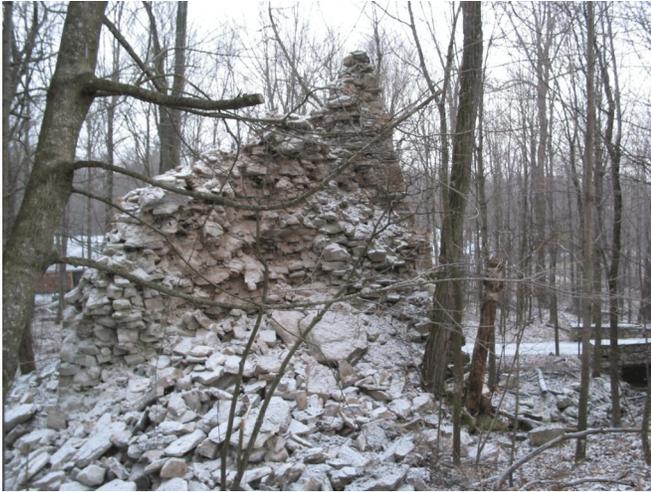
Figure A-3. *The 1822 west stack of the Bennington Iron Works at Furnace Grove the morning of January 16, 2007, a few hours after collapse of the northeast corner.* Margaret Campbell photo.

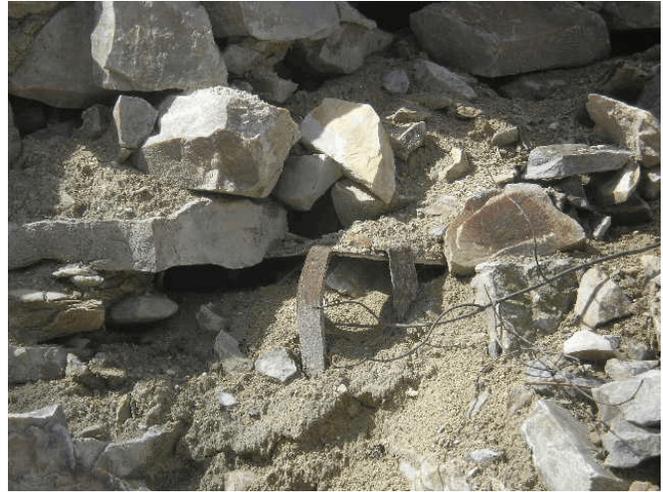
Figure A-4. *A set of flat-iron binders in-situ exposed by the January 15 collapse of the northeast corner, showing the binders were used vertically, and not horizontally as previously thought.* Rolando photo, April 21, 2007.

While inspecting what remained on April 21, 2007, a binder was seen among breakdown in the northeast corner of the stack (figure A-4). Finding this in-situ confirmed an earlier guess as to the use of a piece of hardware found in another part of the breakdown many years ago (see Rolando 1992:26, figure 2-13).

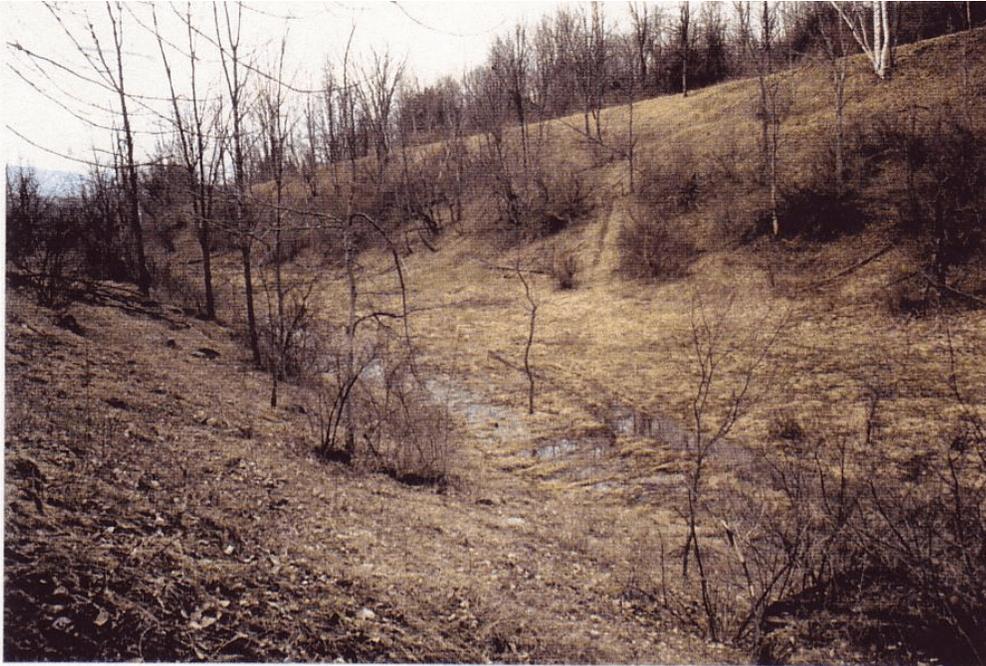
Figure A-7. This trench, 600 feet long, 300 feet wide, and 25 feet deep, was excavated by Burden probably to intercept a rich ore bed 100 yards away (figure A-8, below) that had become too deep to work. Thomas et al., 1979:205; Werner 1995:41, photo 26.

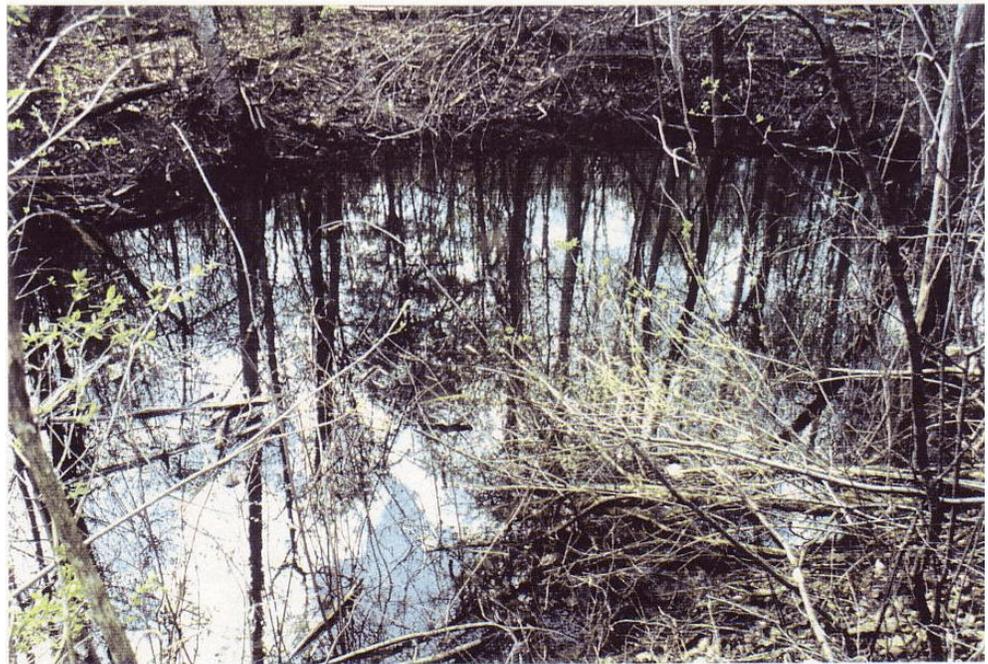
Figure A-8. An ominous pool of dank, dark water fills this historic iron ore pit, 1,800 feet east of Ore Bed Road. About 100 feet in diameter, of unknown depth with steep, slippery sides, it had been mined since the early 1800s. It probably became too difficult to work, thus Burden's "trench" (figure A-7, above) to intercept this ore pit from the north. Werner 1995:32, photo 16.

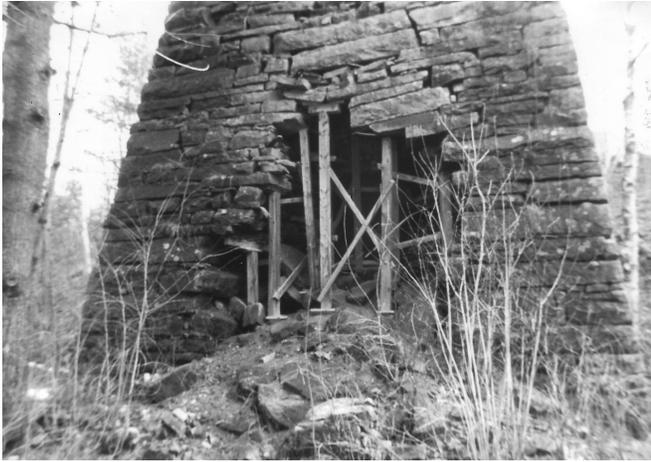
Figure A-13. *The condition of the front of the furnace (casting arch side) on March 16, 1995. Timber supports had been installed in all four archways and a roof atop the stack sometime the fall of 1990. This action slowed, but didn't completely stop the deterioration of the stack, as 'new' stones and bricks were seen accumulating in archways. Rolando photo.*

Through the large hole in the bosh made in 1990 when the piece fell out, workers were able to access the inside of the stack and repair large cracks in the fire brick lining. Material that had fallen from above since 1990 filled the hearth to the top of the bosh, providing a convenient floor for the workers. But someone noticed something hanging out over the edge inside the top of the stack (the top of the furnace is roofed so it’s dark up there). A climb to the top up a 40-foot ladder revealed one of the two large, heavy cast-iron rings had cracked or

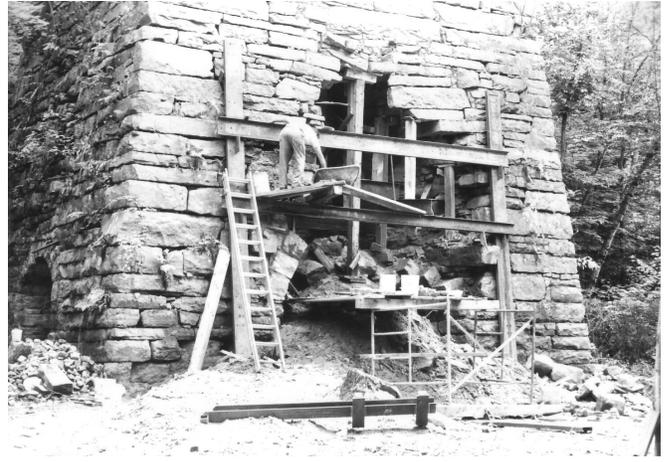
Figure A-14. *First order of action was erecting this iron scaffold to aid in stabilizing the fragile structure while work progressed on July 26, 1995. Note the vertical timbers now rest on inner iron beams, leaving the breakdown free for removal. Work proceeded with cementing the walls "in place" so nothing shifted as timbers were removed. Rolando photo.*

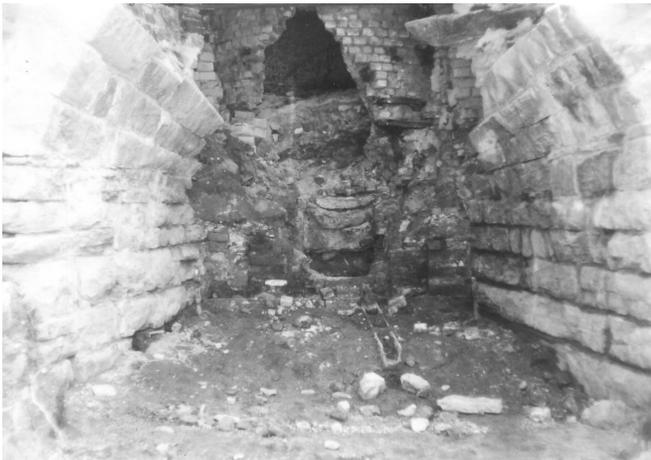
Figure A-15. *The casting arch cleared of breakdown, work commences on rebuilding the arches in this August 8, 1995 photo. The large hole in the stack lining was first noticed May 16, 1990, which prompted the timber supports. Now cleared, certain hardware becomes visible on the casting floor, such as an iron trough (right of center) for guiding the molten iron from hearth to molds. The fore-hearth wall in the rear shows some serious damage. Rolando photo.*

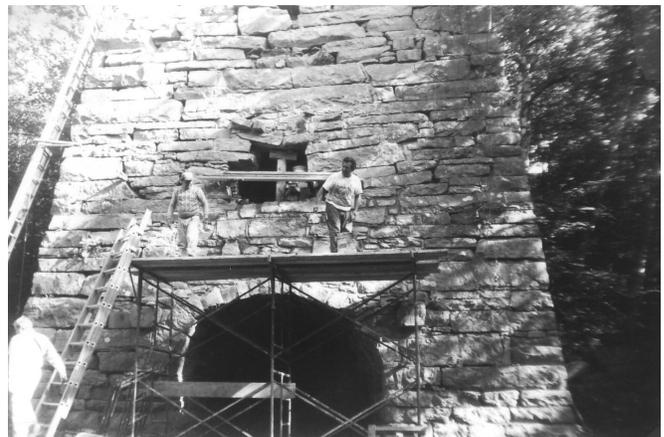
Figure A-16. *As the front wall neared completion, the opening above the work arch grew smaller, in this September 12, 1995 photo. The next day the job was completed - in pouring rain. Note that the large steel I-beam scaffold was replaced by light-weight units, and the supporting timbers remained inside while stones were mortared around them. All other archways were stabilized and pointed, and the casting arch keystone was firmly in place. Rolando photo.*

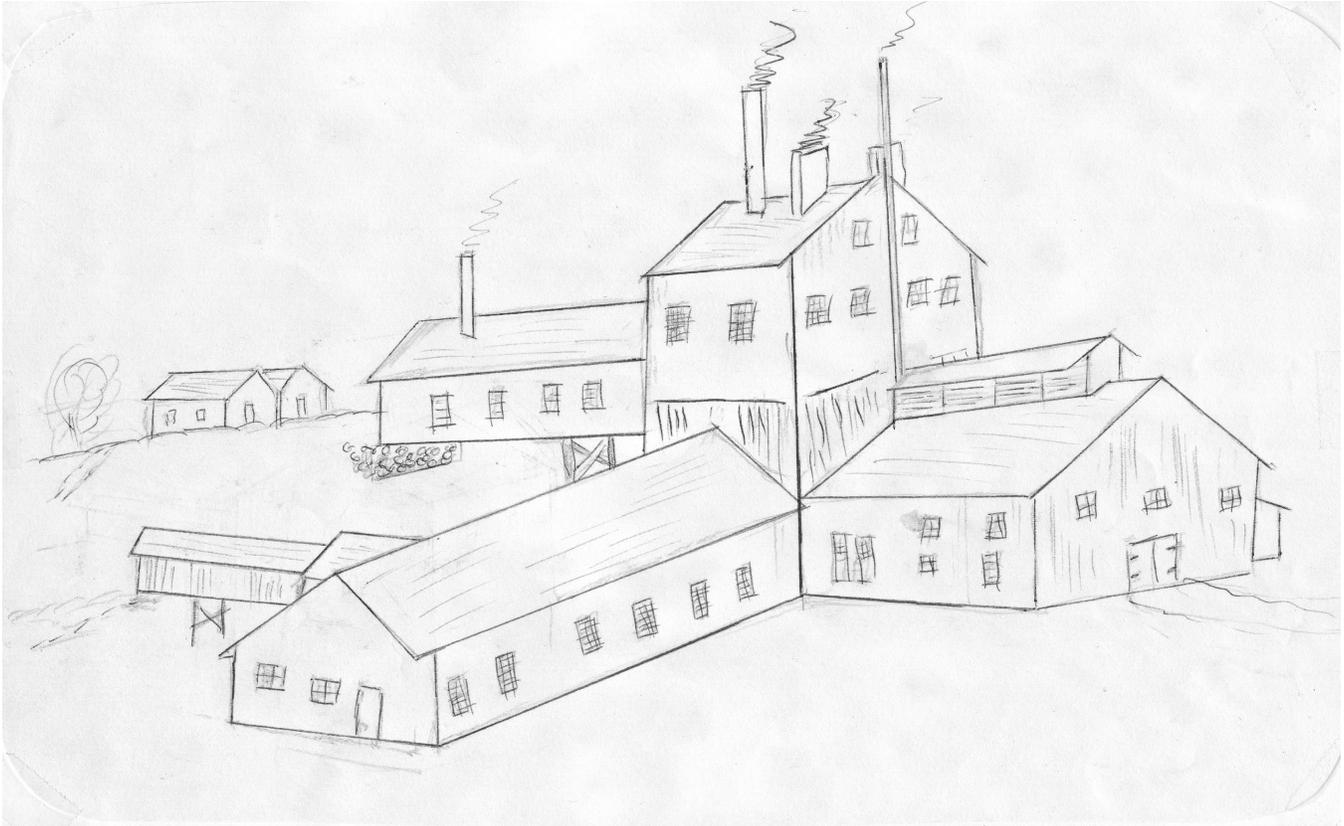
Figure A-17. Conjectured view of how the Green Mountain Iron Company might have appeared when in operation in the 1850s-1860s, based on photographs, drawings, and descriptions of other contemporary ironworks. View is looking southwest. The furnace stack is inside the tall Stack House, the central building with the two chimneys from the regenerative ovens and the main furnace exhaust chimney behind them. Small vertical sections of the furnace walls might or might not have been visible, depending on how well it was insulated by its thick stone walls and rubble fill. The Casting Shed is to the right, with roof-top ventilating monitors. The tall, skinny chimney at the inside end of the shed ventilated the work arch (also known as the casting arch). The waterwheel and blast engines were in the long Bellows House, at left, foreground, with a small bridge behind to convey the head race (water supply) to the waterwheel. The main Charging House is behind the Stack House, to receive charges of iron ore, charcoal, and limestone from Storage Buildings on the upper area. Rolando (very) rough drawing.

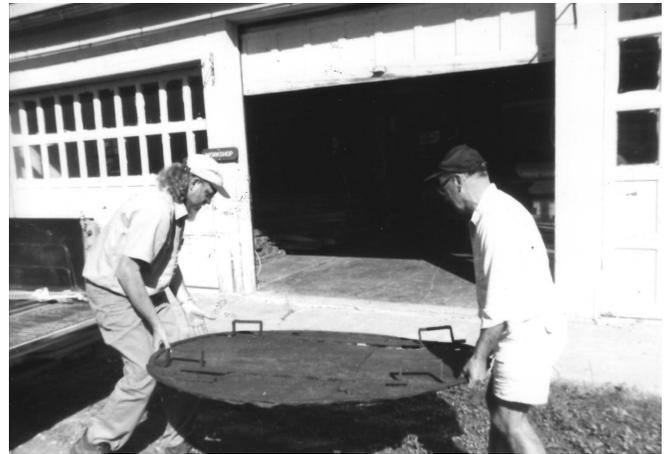
Figure A-18. *Forest Service Archeologist David Lacy (l.) and Bob West (r.) carry the fragile kiln cover rescued from VT-RU-41 charcoal kiln site in Peru into the US Forest Service’s Work Station shed at Mount Tabor for safekeeping. Rolando photo.*

The site was first recorded in 1983 after being led to it by Bob West of nearby Manchester. The rescued hardware is an iron, top-loading kiln cover, which lay flat atop one of the charcoal kilns at the site, closing its top loading hole. The cover is about five feet in diameter, and has four handles and four 2- by 4-inch vent holes. The usual method of draft on kiln covers was to lay bricks flat across the openings. Although a dozen top

loading covers have been found associated with charcoal kiln remains in Vermont, this cover is unique because the vent holes were controlled by little cast iron doors that slid between pairs of recessed mounting plates welded to the cover. Of the four vent holes, only one has its small sliding door still in place (see Rolando 1992:188, figure 6-16, for a closeup of this door and vent).

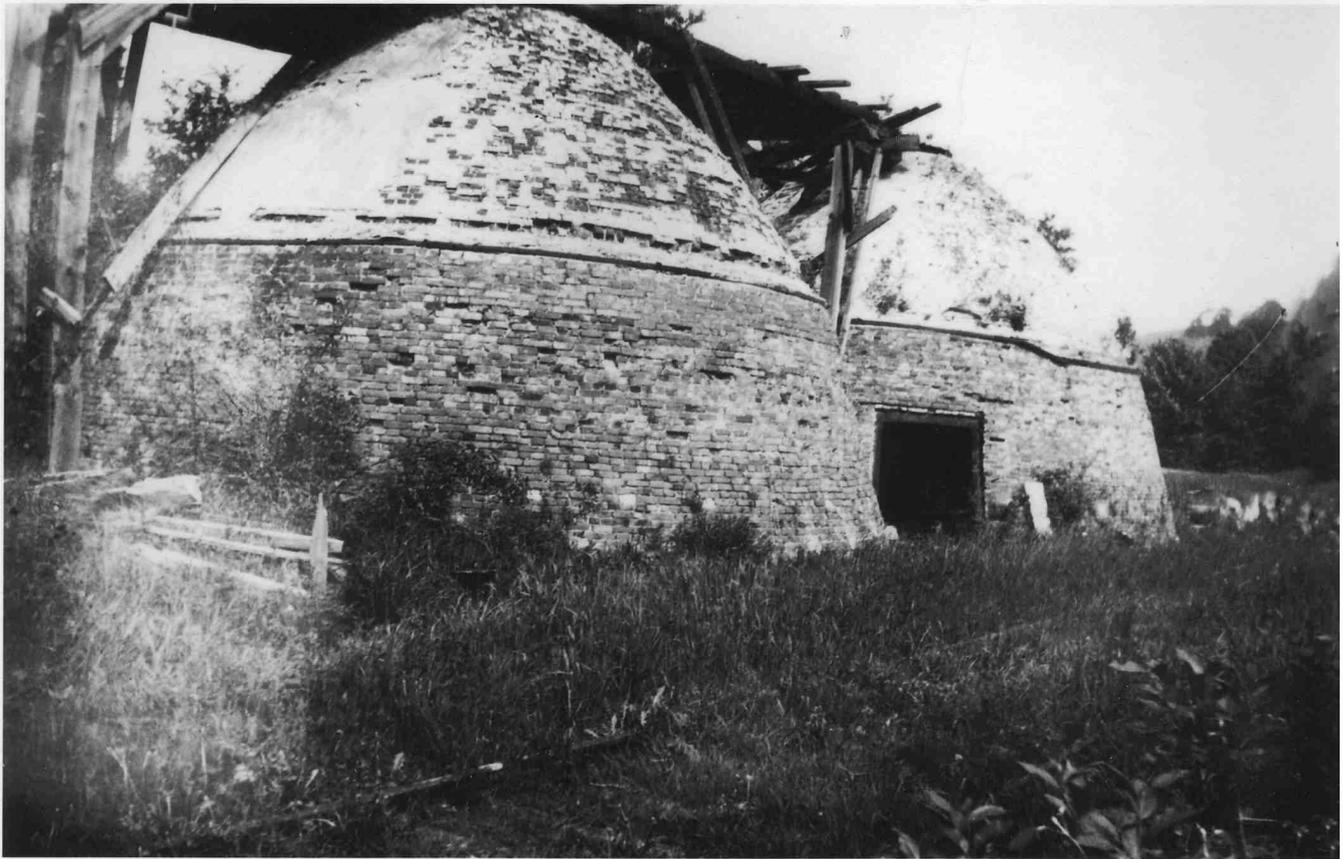
Figure A-19. *The I. N. Hall charcoal kilns along a railroad siding (barely visible in the foreground vegetation) of the M&WRR in Groton. Photo taken in 1920 by Benjamin Haywood, Civil Engineer employed by the M&W. Four kilns stood here; only three are visible in this photo, looking northwest (back to railroad and Wells River). Note loading ramp above the kilns in upper left. What appear to be a series of white bricks about 6 to 7 courses from ground level and girdling the kiln are probably remnants of whitewash residue from sealing the vent holes. Courtesy of Arthur Aldrich; thank you to all Haywood's relatives that could be contacted for permission to use.*

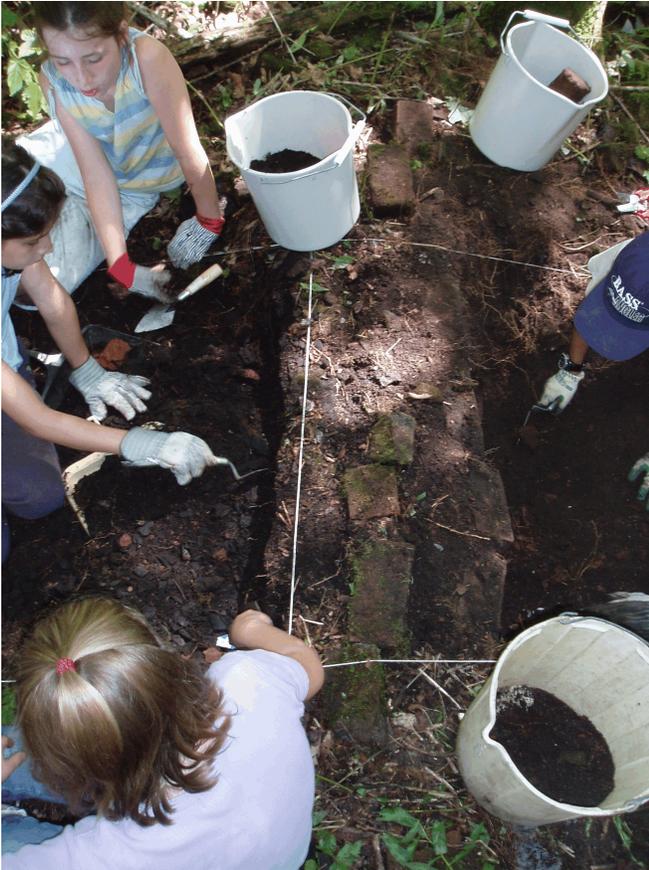
Figure A-20. *Excavating the south-most pair of pits, S1 (l.) and S2 (r.) at the Relics and Ruins program at Old Job in 2005. Many enthusiastic hands and trowels made quick work of getting to the bottom of things. Debra Baasch photo.*

As the excavations proceeded, quite by chance, a vent hole in the brick wall was encountered in pit S1, the "inside" pit, six layers of brick down from the surface. The thickness of the wall measured at the top (the year 2005 surface level) was about 15 inches. Because the brick layers at ground level were not tightly mortared together, but were disarticulated due to weathering and other surface disturbances, the wall thickness was better measured through the vent hole. That measurement, where the bricks were tightly mortared, found the kiln wall to be exactly 13 inches thick.

Excavating pit S2 outside the wall, resulted in exposing the outside end of the same vent hole as found in the inside pit. This excavation reached the original, operating surface ground level at the depth of 22 inches, some 4 inches below the inside floor level. Flat stones, similar in size and deployment to those uncovered inside the bottom of the wall were also encountered along the outside of the wall (figure A-23). This begged the question whether the inside and outside stones were, in fact, long *continuous* stones that extend from about a foot outside the wall, under the brick wall, and extend about a foot inside the kiln? Given the weight of the vertical brick wall and vaulted roof above the foundation, it would make more sense to have long flat stones supporting the weight of all 36,000 bricks plus hardware: reinforcement rings, top loading door ring, discharge doors, etc., - nearly 100 tons supported by the foundation. (The cordwood inside the kiln rested directly on the kiln floor, not the foundation.) No attempt was made to remove or “wiggle in place” any of these stones; no excavation was made below the original ground surface at the bottom of the pit. At the end of the dig the pits were lined with plastic sheet and backfilled.

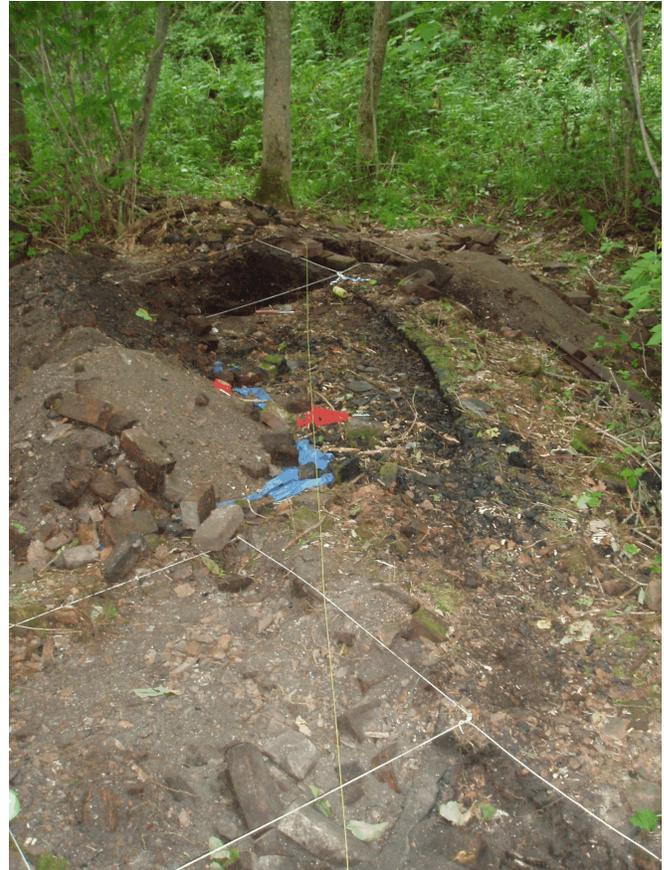
Figure A-21. *Disposition of the two pairs of pits, about three squares apart along the kiln wall. Pits S1 and S2 are at the top; N1 and N2 at bottom. The string connecting the two pair was used for calculating the center point of the kiln. David Lacy photo.*

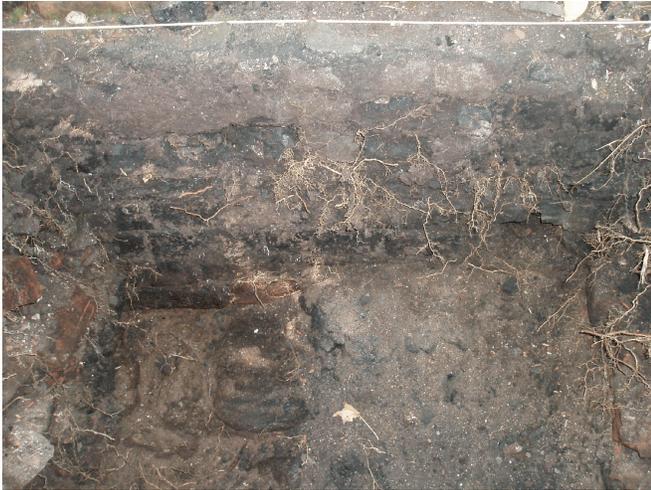
Figure A-22. Pit S1 (inside) excavated to the floor of the kiln, which is coated with a thick layer of brick-hard pitch. Half of the pitch coating was removed to reveal what might be foundation stones under the wall. Note vent hole at middle-right. David Lacy photo.

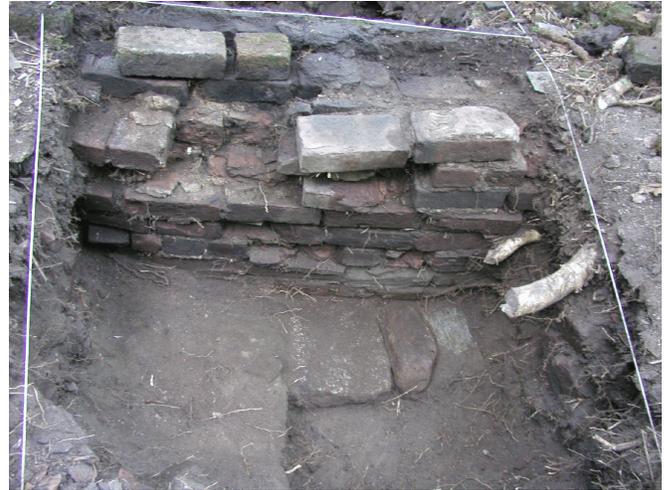
Figure A-23. Pit S2 (outside) excavated to what was ground level during the operating period, showing possible continuation of foundation stones along the outside of the wall. Wall condition was worse outside, possibly for lack of pitch coating. David Lacy photo.

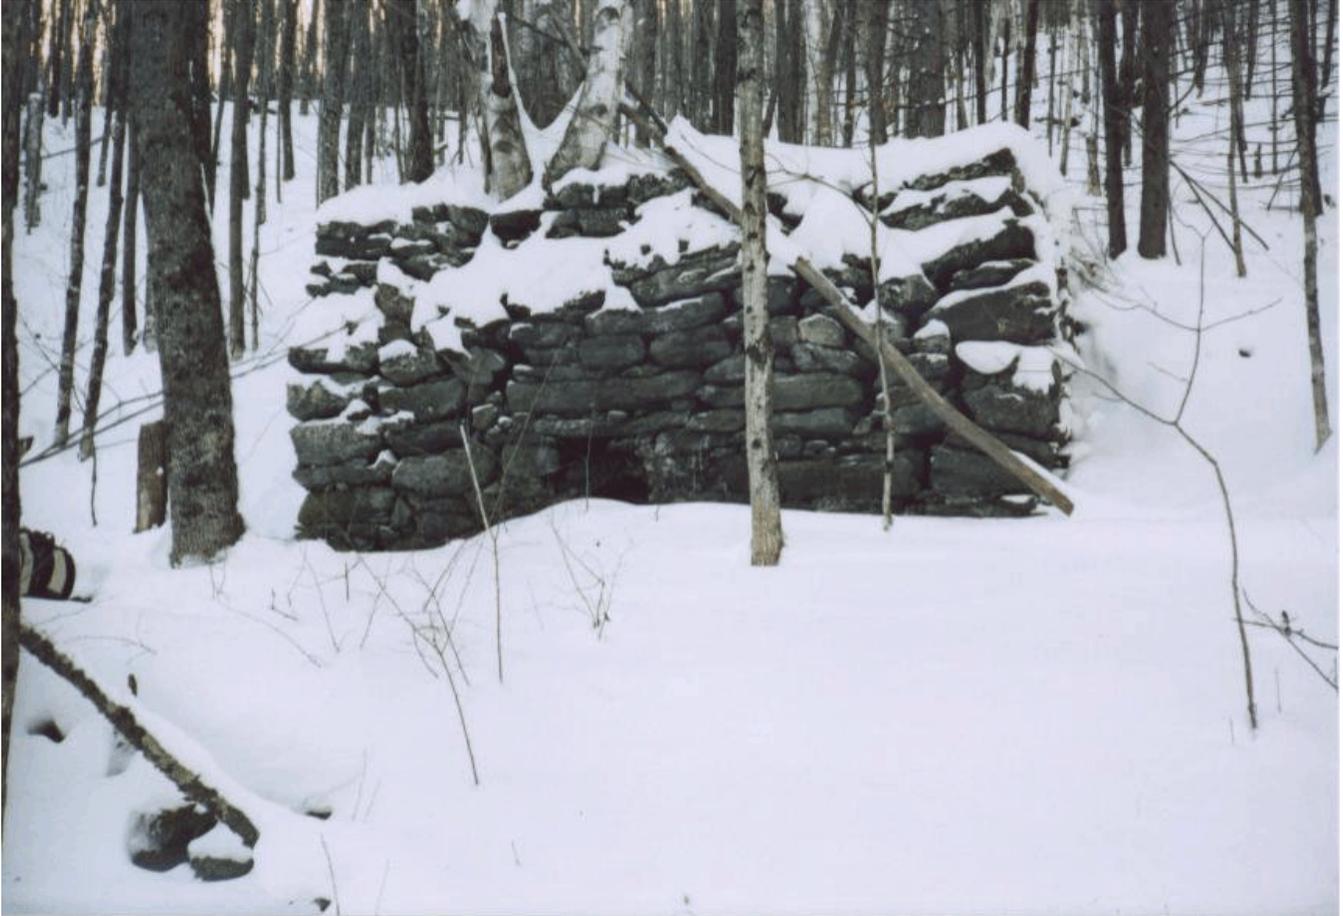
Figure A-29. *The Marsh Farm lime kiln (VT-AD-1355), about a half-mile up the eastern slope of a mountain about a mile southwest of Route 100 and 125 intersection at Hancock village. This photo was taken by hiker-explorer Steve Donovan of Springfield, Vt., in December 2003, while snowshoeing in the area.*

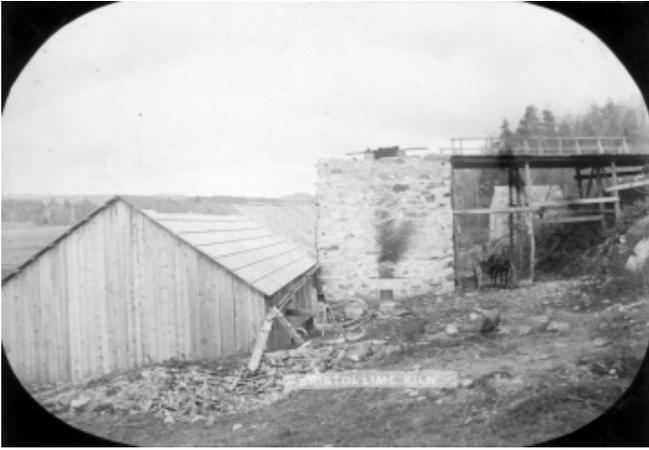
Figure A-30. *The Bristol lime kiln as it probably looked about 1900 (see Rolando 1992:242-43, VT-RU-409); view is to the north toward Route 17.* Courtesy of Ted Lylis and the Bristol Historical Society.

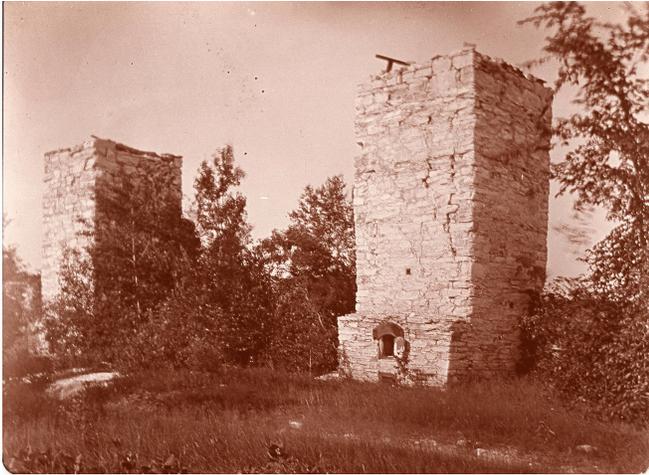
Figure A-31. *Misidentified “Pittsford iron works,” these are definitely mid-19th-C lime kilns and maybe the two 1861 kilns of the Brandon Lime Co.* Courtesy of the Vermont Historical Society.

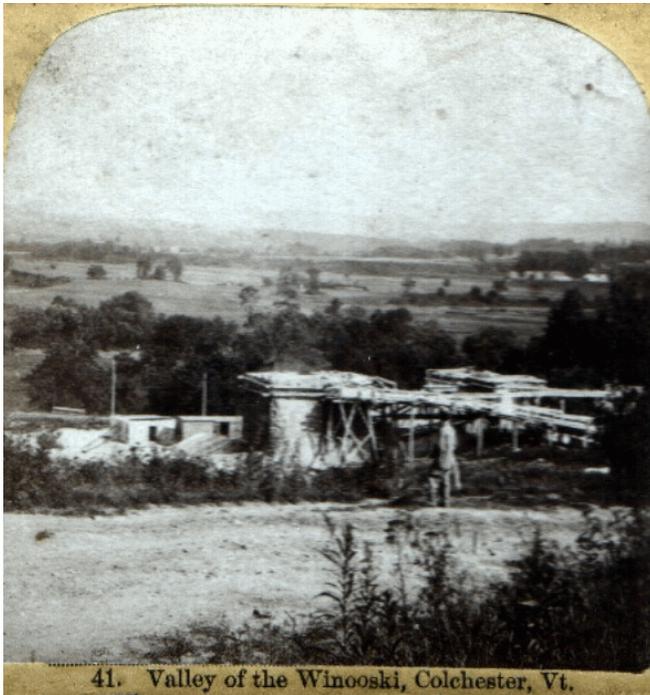
Figure A-33. A “left eye” 1870s stereoscopic photo of lime kilns on the Colchester side of the Lime Kiln Bridge. Photo is by A. F. Styles of Burlington, probably taken from the rise at the southwest corner of Lime Kiln Road and Route 15. These kilns operated until the early 1920s. Courtesy of Gary Irish, Jericho, Vt.

became a major lime manufacturing area after the end of the War of 1812 with the building of lime kilns at the south end of Lime Kiln Bridge (the South Burlington side; VT-CH-282). In the early 1920s the operations were modernized with the construction of a new, poured-concrete building to hold the three huge, high-capacity lime kilns which went into operation in 1926 (VT-CH-284). With the end of a US Government contract for agricultural lime in 1971, the works closed, thus ending over 150 years of lime manufacture at this site..

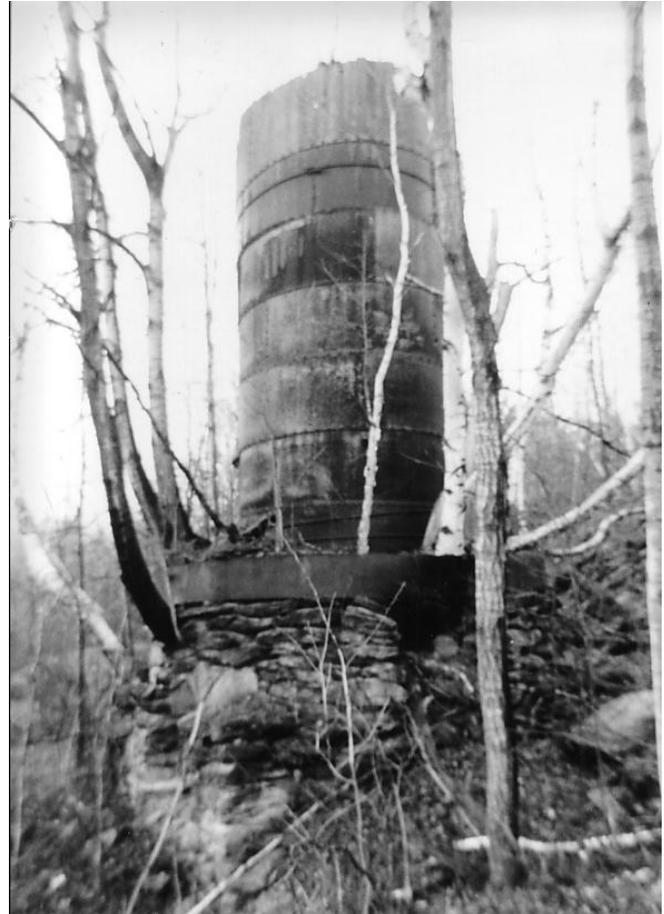
Figure A-34. *Fragile remains of the ca1871 Day lime kiln at Ira, as it was in 1995. View is from the east with oval fireplace seen at bottom center. Rolando photo.*

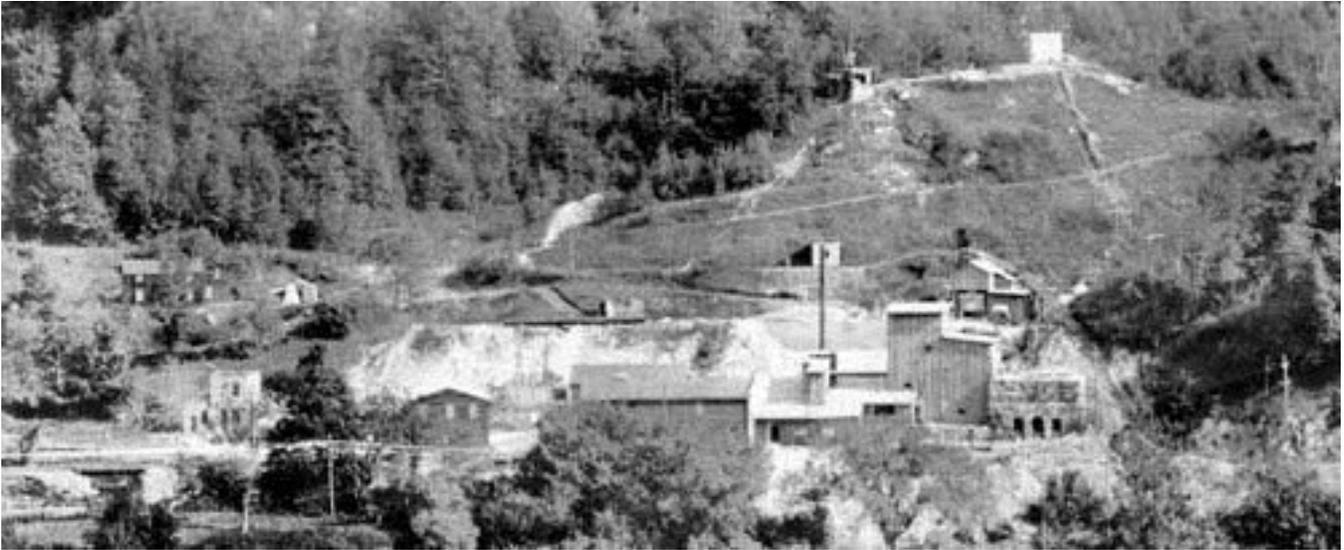
Figure A-36. *The Sherman Carbide Company complex at it appeared sometime before being razed, but possibly after closing (ca1920?). View is looking east from across the Deerfield River before it was flooded. Note one of the two concrete water storage towers at upper right, a building containing three furnaces (three arches) at lower right, and a large, long supply of raw stone in the center, which was drawn from the quarry that is behind the hill off-photo to right. www.alpenwald.com/earlyreadsboro, “Lime Kiln Across River.”*

by 875-foot (north-south) area, bordering the HT&WRR right-of-way, about a half-mile north of the Vt.-Mass. state line. In its site plan, PAL, Inc., identifies 20 structures/remains at the site (Glover et al., 1994:99, Figure 6-8). Someone with an intimate knowledge of early 20th-century carbide manufacture might better describe their uses. There appears to be a material flow from quarry, to furnaces, to railroad siding, but the many other buildings with specialized ovens (figure A-37) that beg other purposes for their existence. Some walls are poured concrete, others, possibly from the earlier Vermont Lime Company era, are mortared stone. One stone wall adjacent a building identified as “furnaces” is 13 feet high.

Three buildings on the plan have the word “furnace” associated with them. One is at the southwest corner of the site, adjacent the railroad right-of-way, showing what appears to be three furnaces. And three granite archways can still be seen here. But what it gong on? Three “furnace fire boxes” are indicated in the building immediately to the north. Four furnaces are indicated at

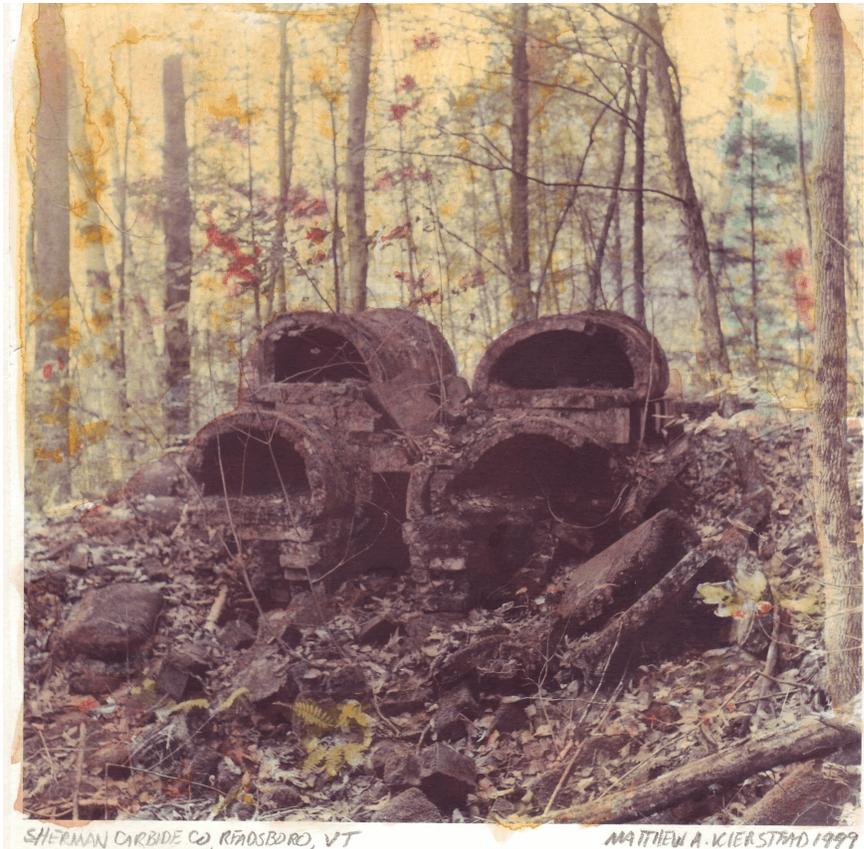
Figure A-37. *Fragile ruins of a stacked group of four heavy duty, industrial refractory ovens manufactured by the Missouri Firebrick Co. of St. Louis, located in near the center of the old Sherman Carbide complex. Quiet reminders of more sooty and hectic days, today they provide shelter for wildlife. Watercolored photo by Matthew A. Kierstead (1999); Rolando collection.*

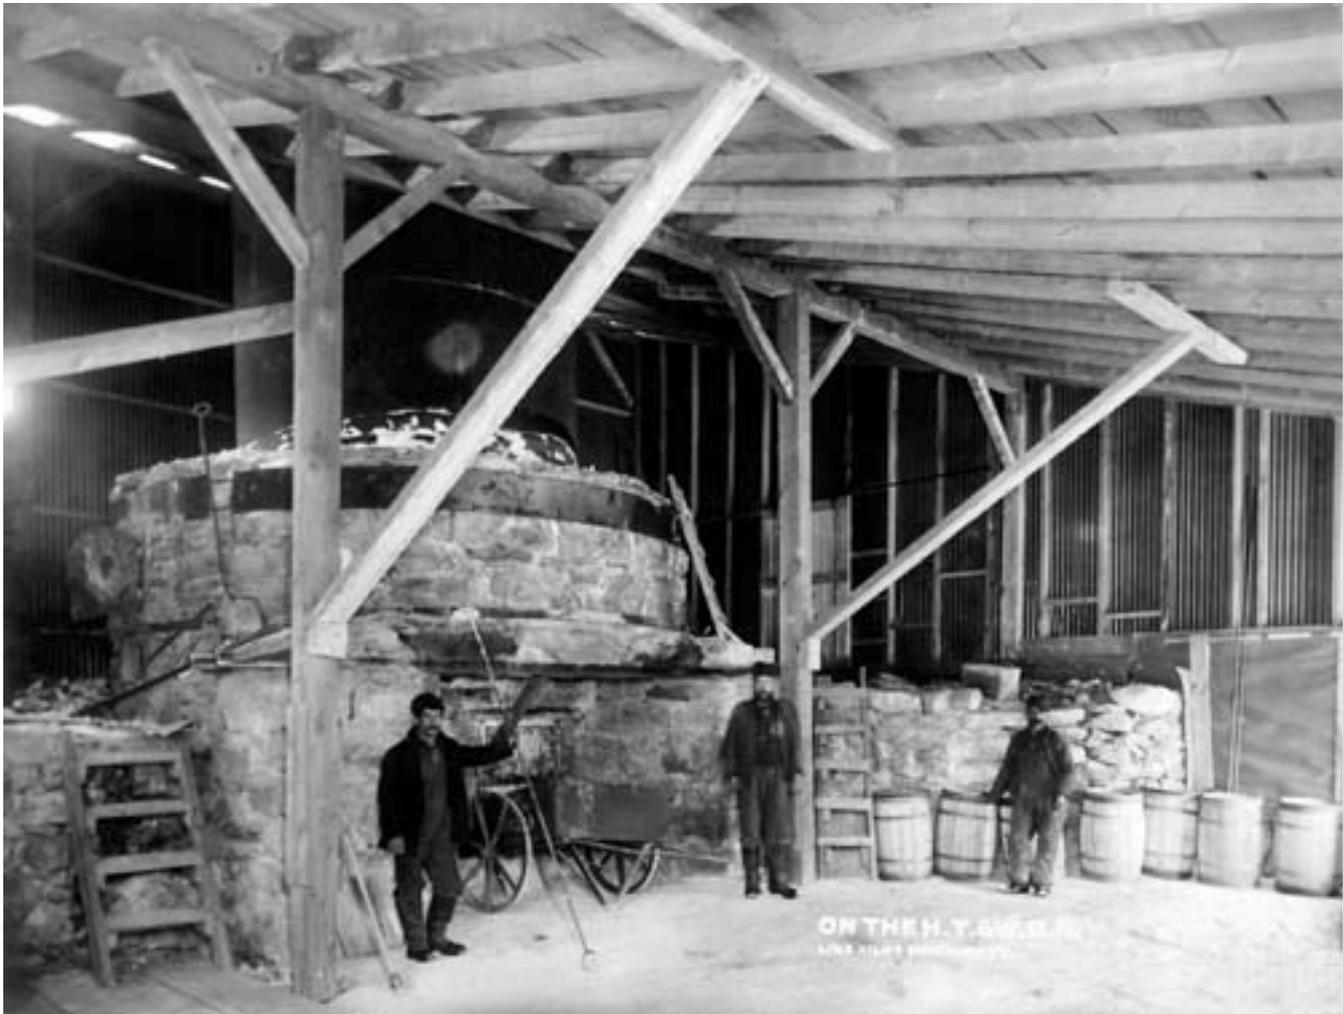
Figure A-38. The caption at lower-right reads “On the H.T.&W.R.R., Lime Kilns Readsboro Vt.” (Note: plural “Kilns”). That these kilns were ever in Readsboro is highly questionable. In addition to interviews with native and long time residents of Readsboro, many inspections of possible locations for this 1880s-1930s-type lime kiln have been made in and around the village area in proximity to the former HT&W tracks without identifying its location. Might this be a transitional kiln of the elusive ca 1905-1915(?) Vermont Lime Company at Lime Hollow, predecessor to the Sherman Carbide Company? www.alpenwald.com/earlyreadsboro, “Lime Kiln interior.”

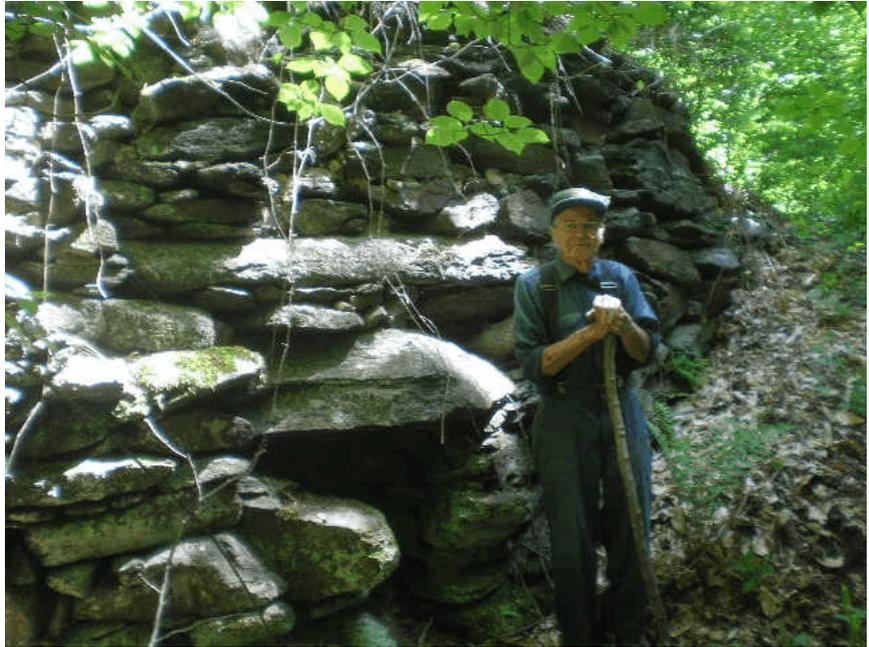
Figure A-39. Robert Hass of Westminster West, standing next to the Goodell lime kiln ruin's draw arch on May 30, 2007. This ruin is in particularly good condition for having survived 175 years. Rolando photo.

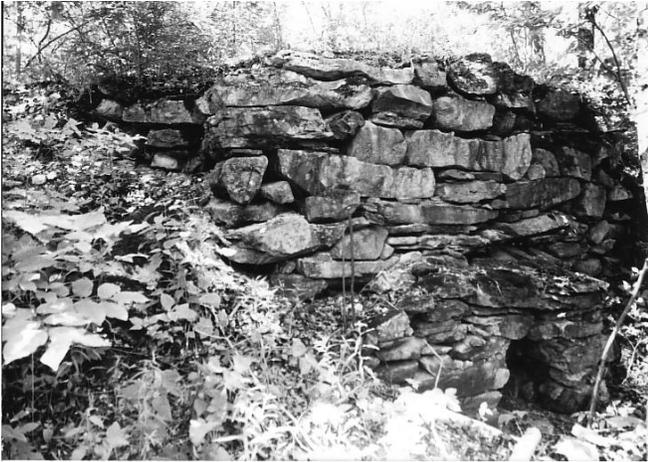
Figure A-40. The “West Twin” of the Black River Twin Lime Kilns in Plymouth. Note small draw arch compared to its twin at right. Rolando photo.

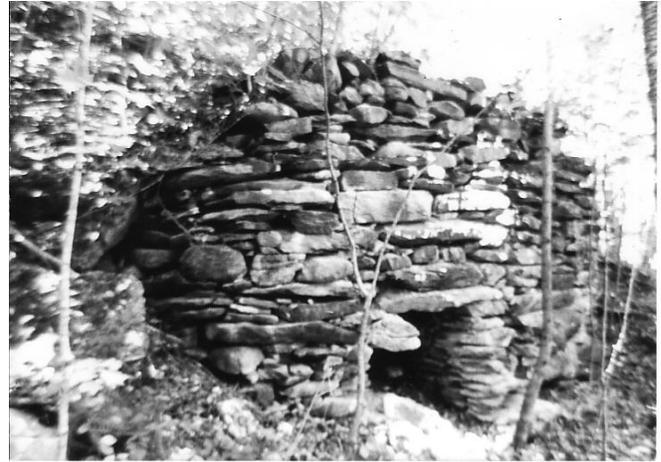
Figure A-41. The “East Twin” of the Black River Twin Lime Kilns in Plymouth. A heavy lintel stone has helped keep this ruin intact. Rolando photo.

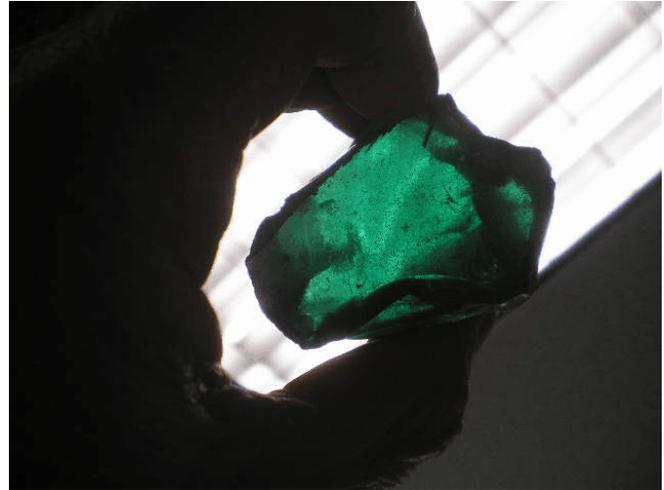
Figure A-42. *About a 2-inch diameter piece of rough waste glass from the vicinity of the Lake Dunmore glass-making site. Rolando photo.*

The new glass works was in full production early in 1833, producing window glass as did its predecessor, but with a difference - thinner and with a light blue hue. Petersen says this could be the result of changing sand supply, importing it from Pittsford, which had less iron than that found locally at Lake Dunmore. (Petersen 2001:90).

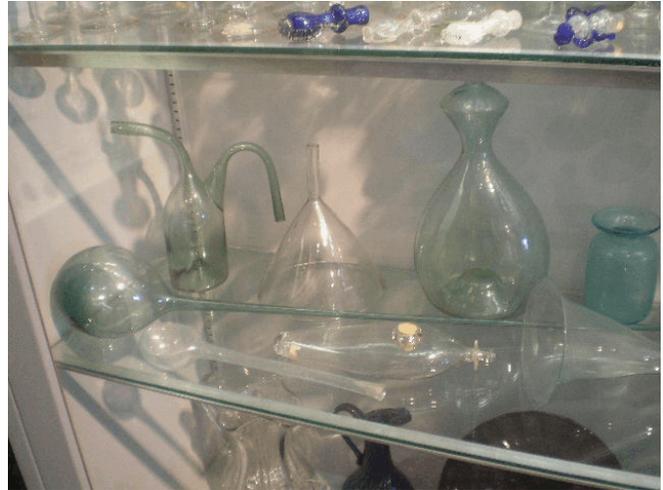
Figure A-43. *Glass tubes on display at the Bennington Museum attributed to the Manchester Glass Factory.* Rolando photo.

This may have been the “glass water pipes” that Art Johnson of Manchester dug up in the ruins of old buildings on the Taylor Farm on Johnny Cake Street in 1946, where Earl Taylor had heard that glass had been blown, per notes by the late Mary Bort, Manchester historian. Mary also noted that the 1929 *Manchester Journal* published a plea for information about the glass factory in 1929 (Judy Harwood to Rolando, August 20,
