DMT Technical Support Inquiry

DMT Serial #: 100140
Agency/Site: Bradford VSP
Date: 11/23/2020
DMT Supervisor: Sean Brennan

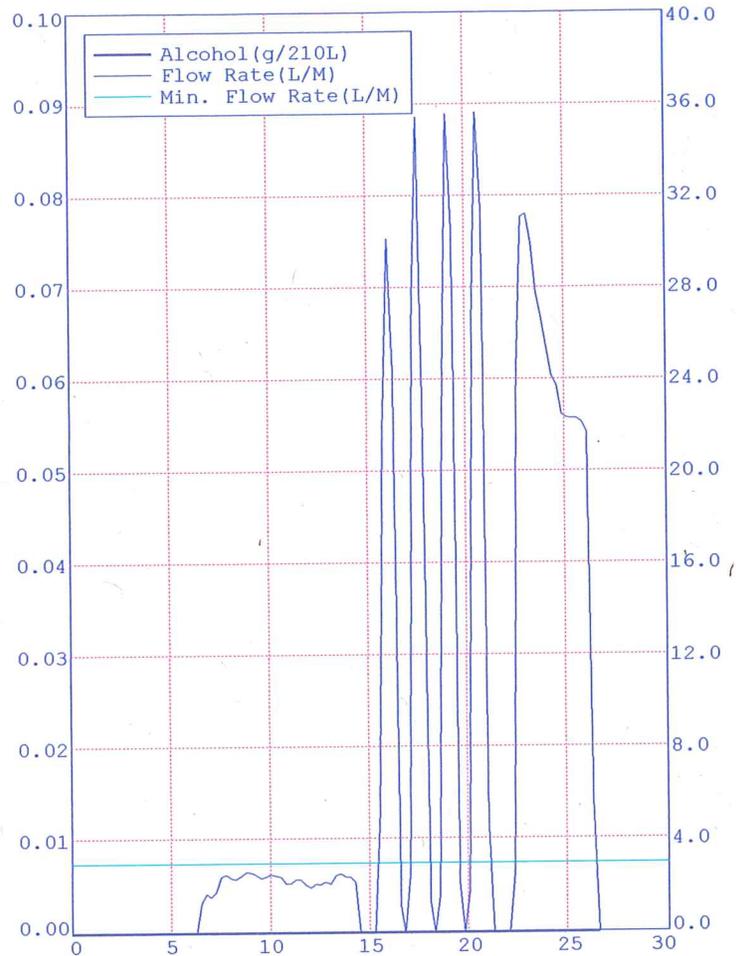
CHECK-IN CONFIRMATION TEST

BLANK TEST	0.000	13:30
CALIBRATION CHECK	PASSED	13:30
Xq = 0.079 (0.44%)		
SIMULATOR VAPOR 34.0°C	0.099	13:31
X[1] = 0.0993 (-0.0010) (-0.0003)		
SUBJECT SAMPLE (Vol=1.6L)	0.000	13:31
X[1] = 0.0000 (-0.0011) (0.0000)		
BLANK TEST	0.000	13:32

All alcohol values reported in g/210L
Sim. Vapor Concentration 0.101
Sim. Vapor Range 0.096 - 0.106
Lot #: 20-10-100

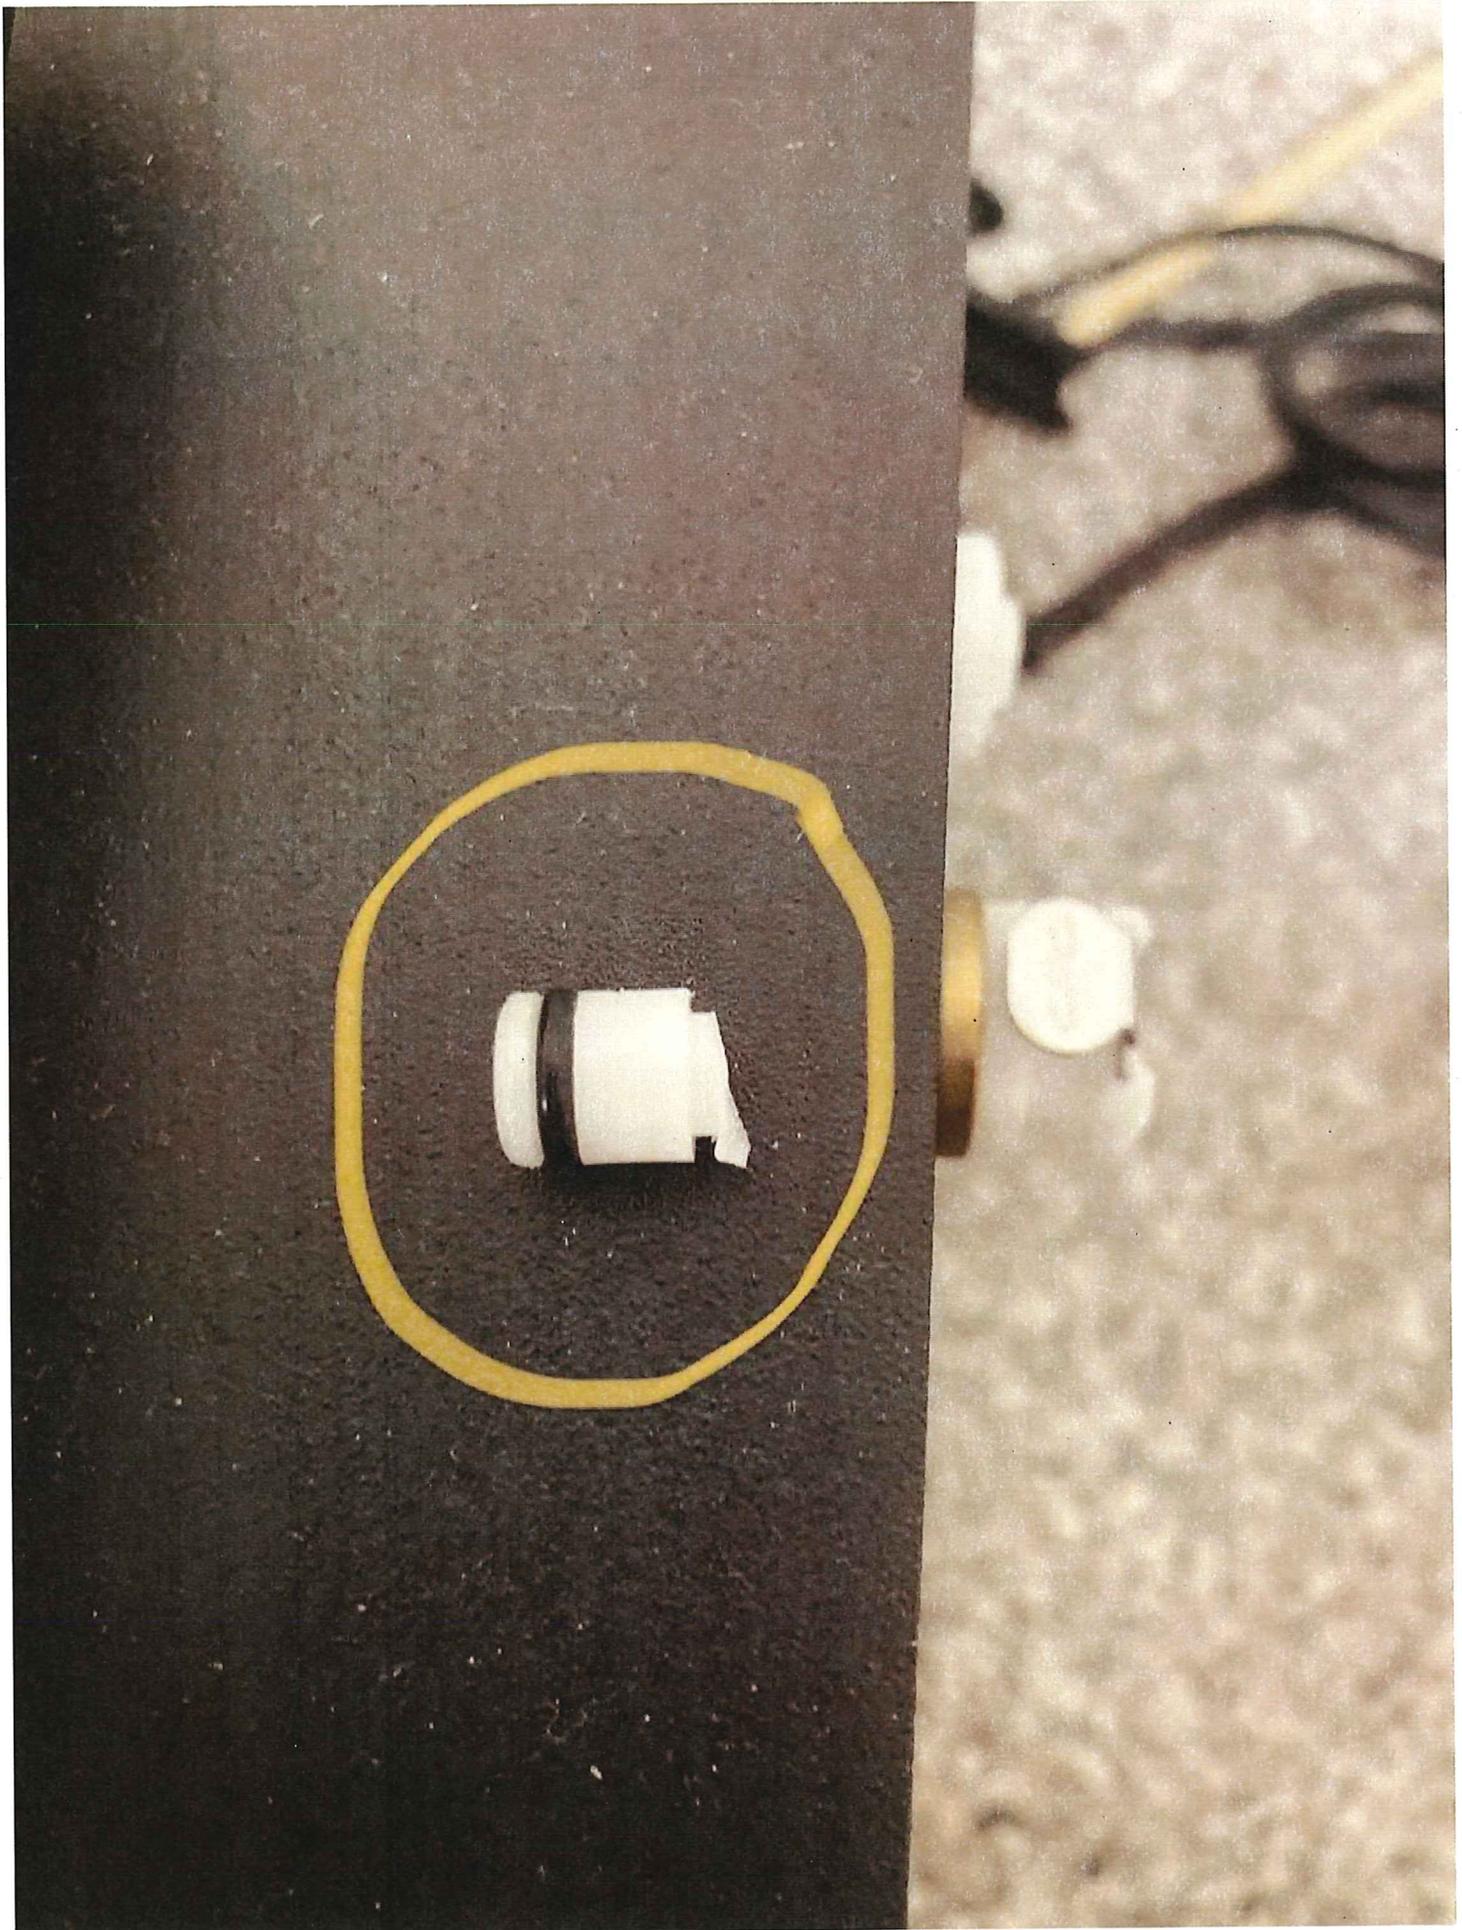
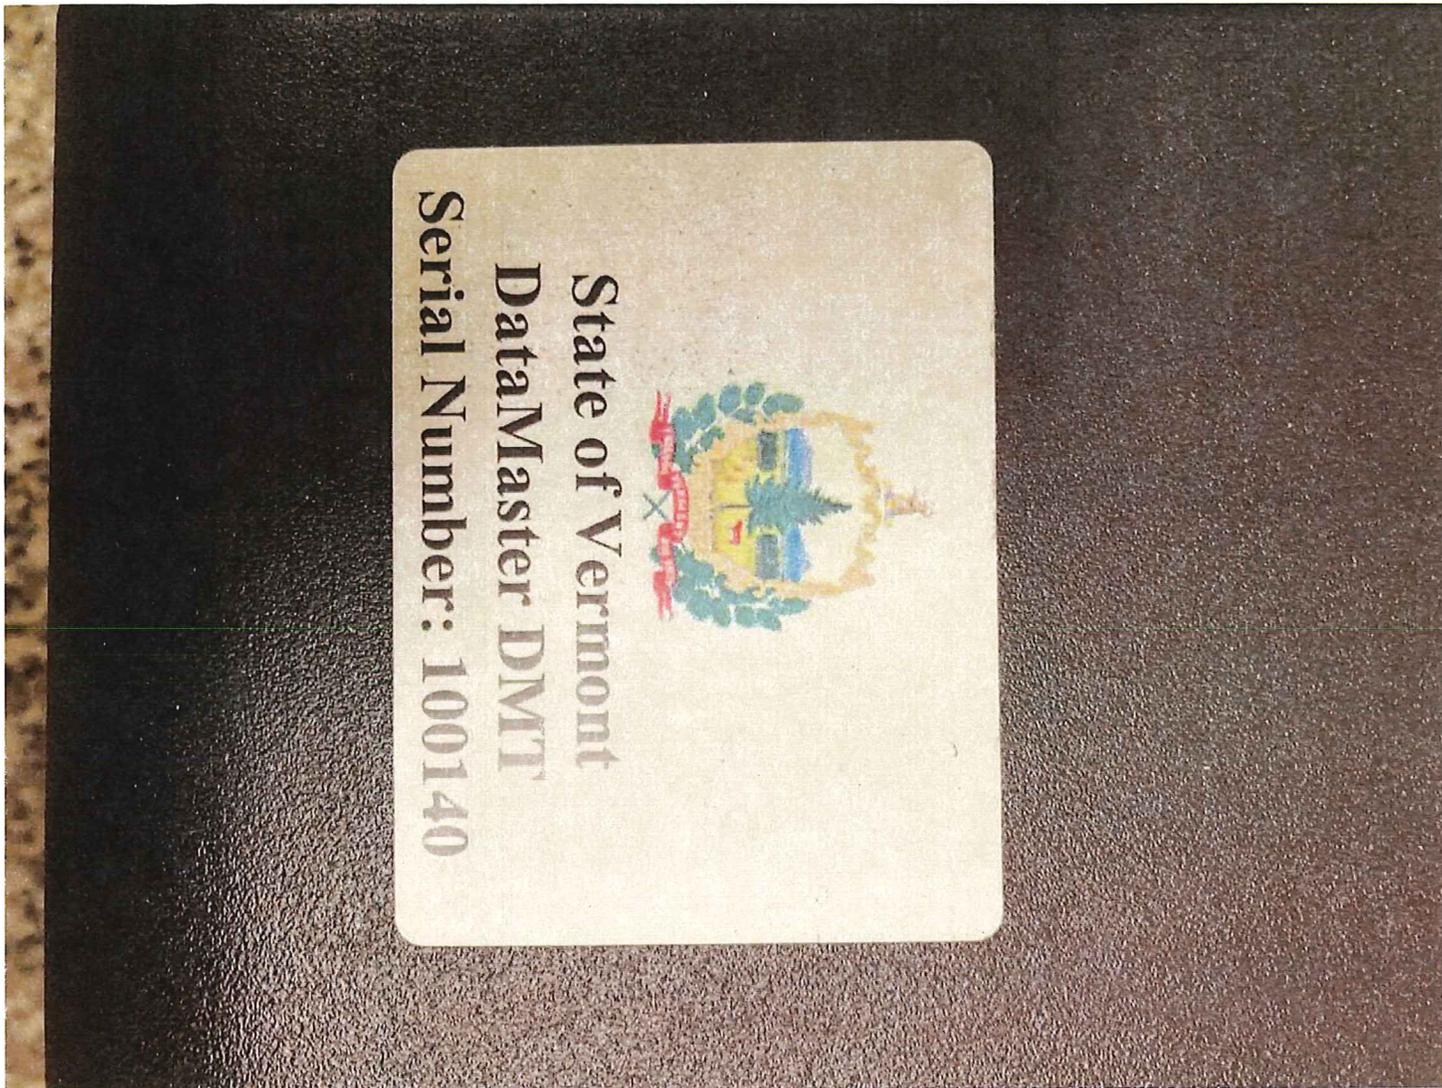
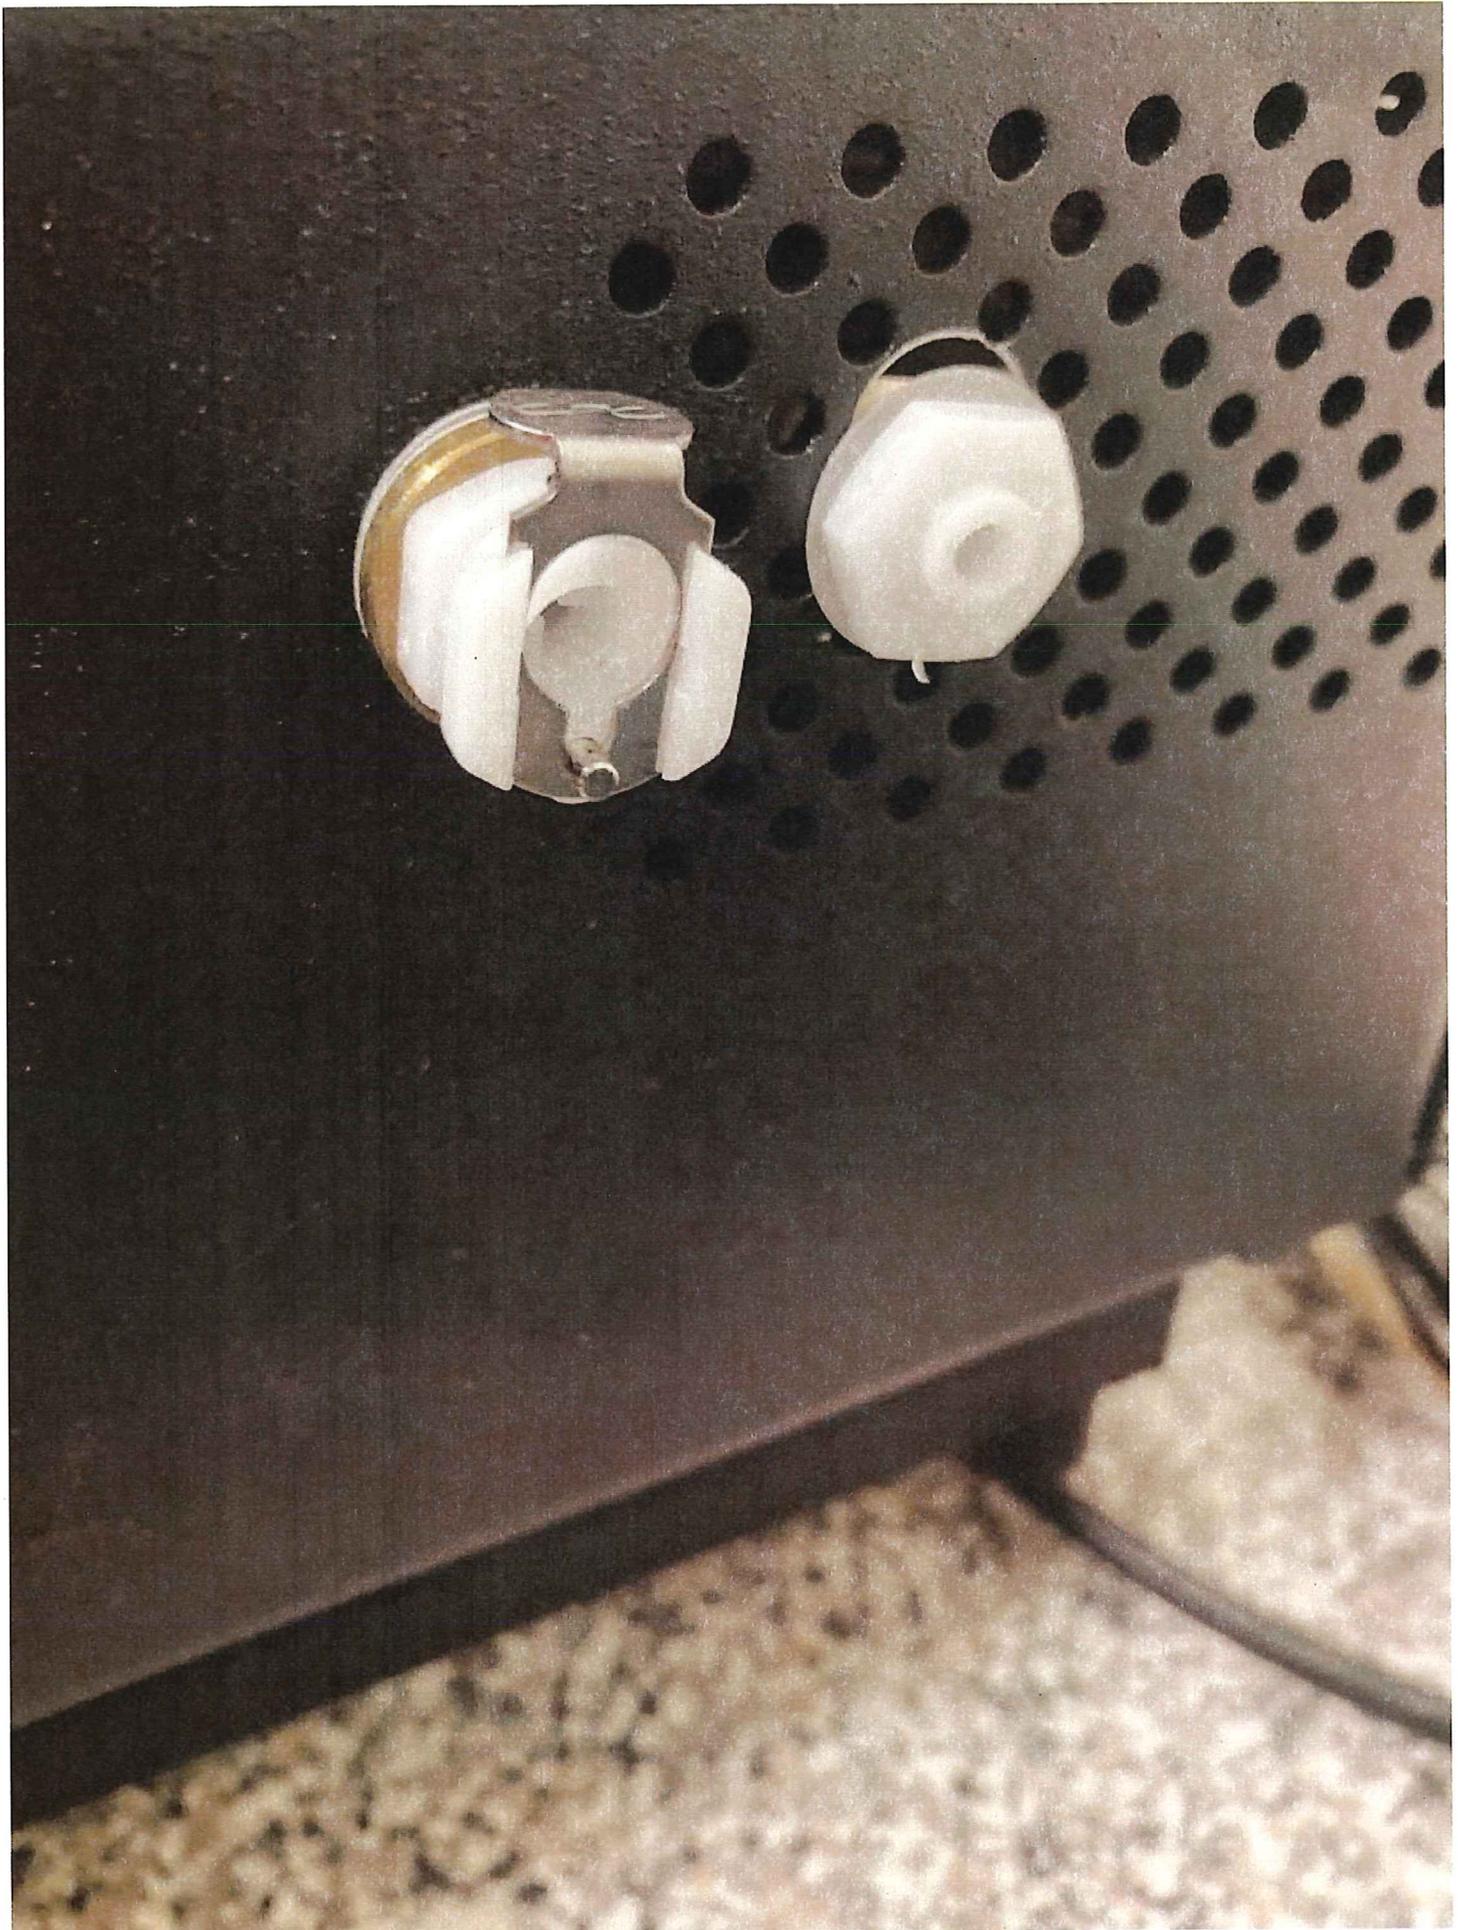
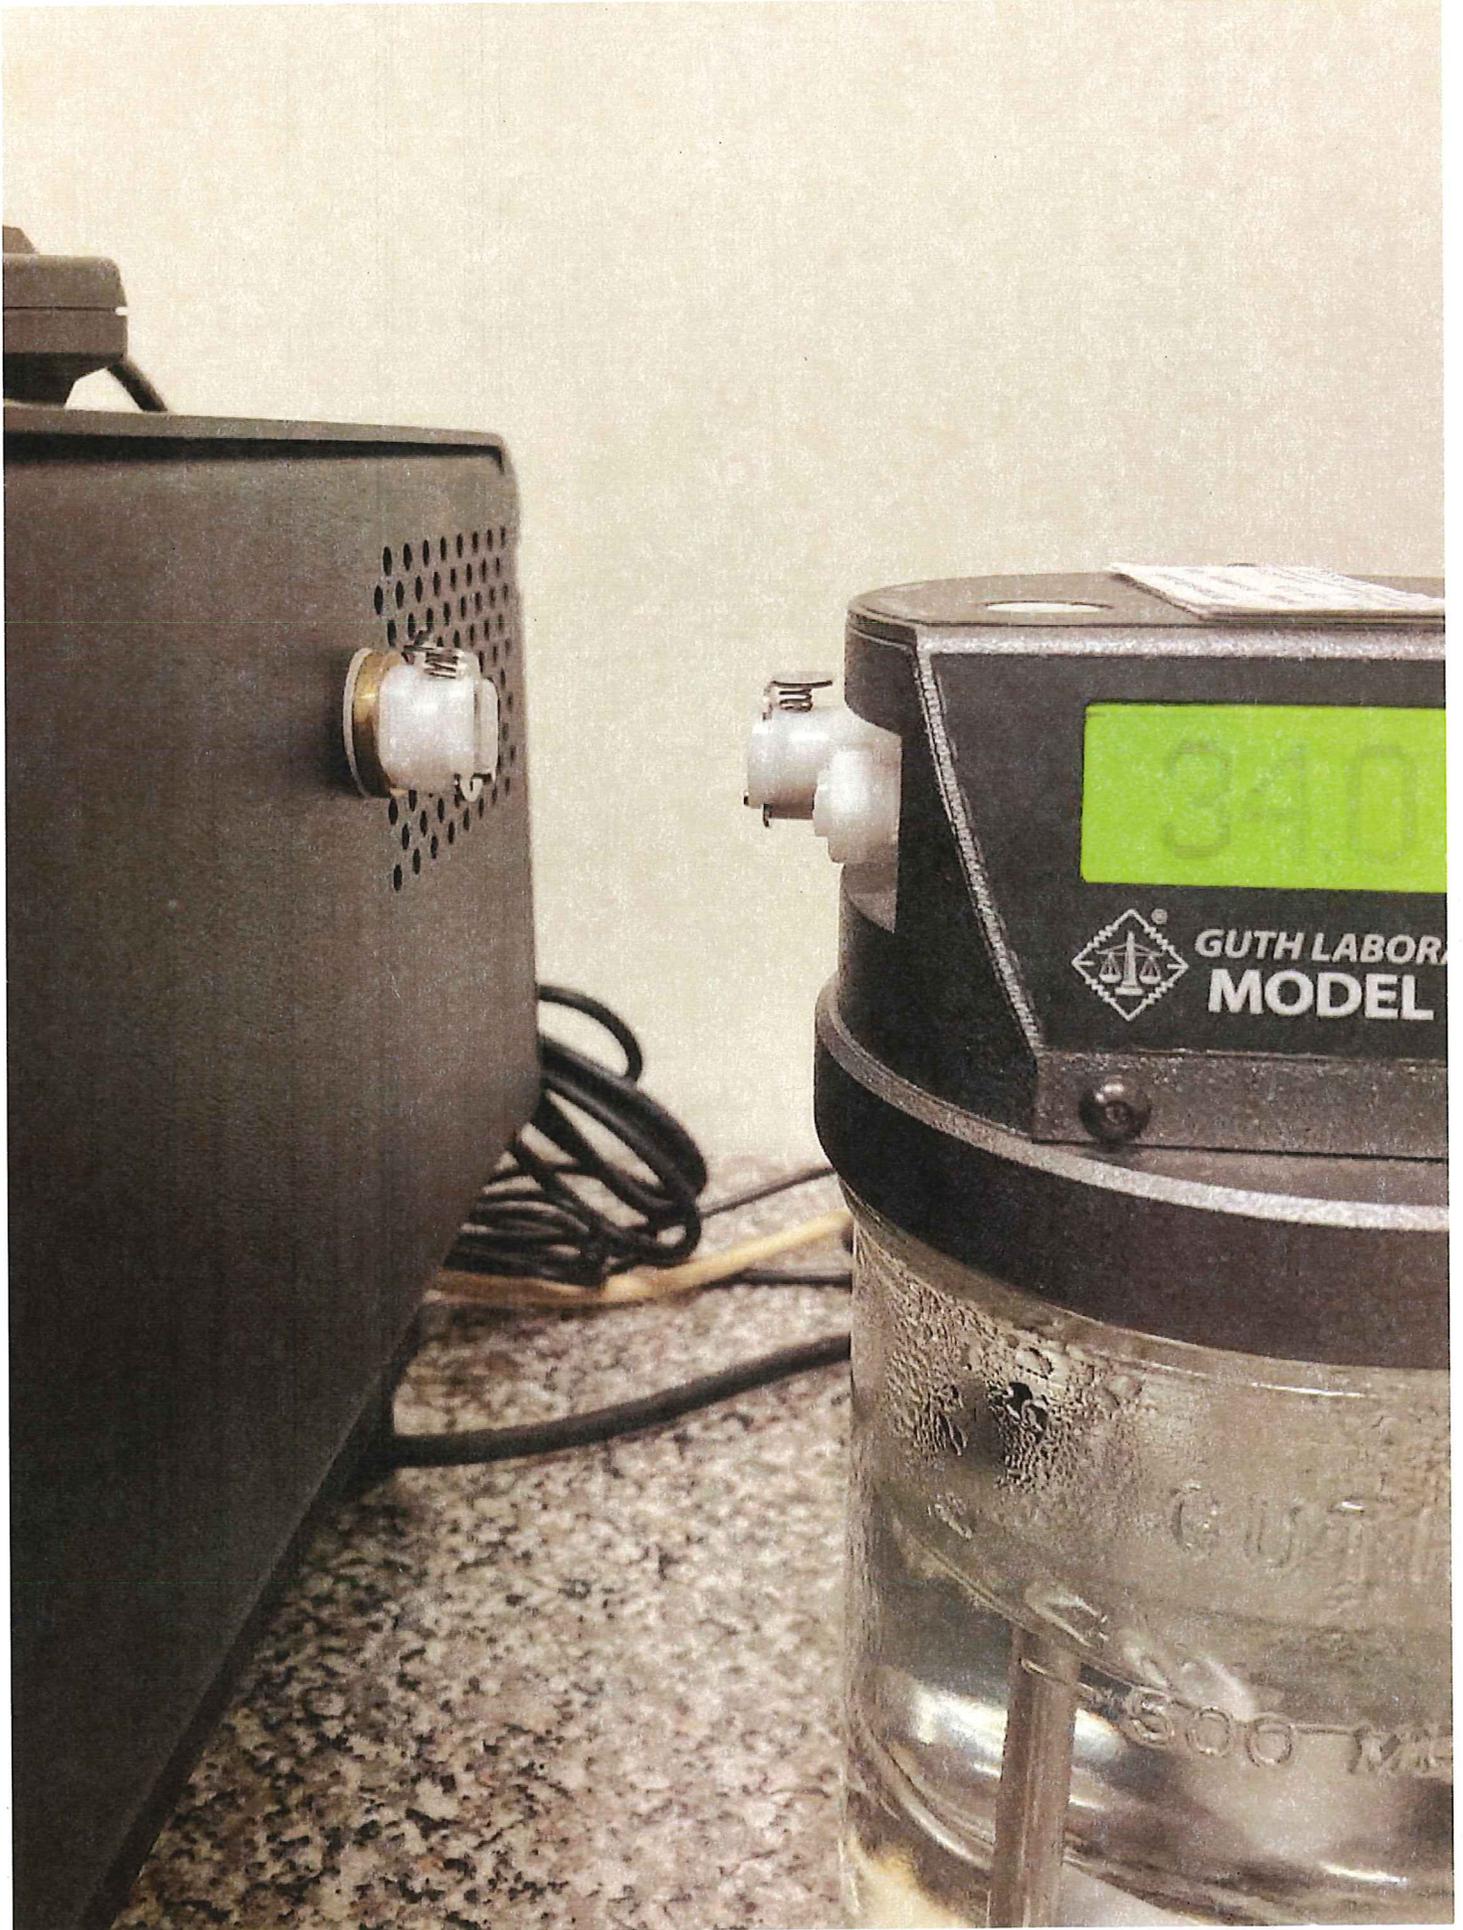
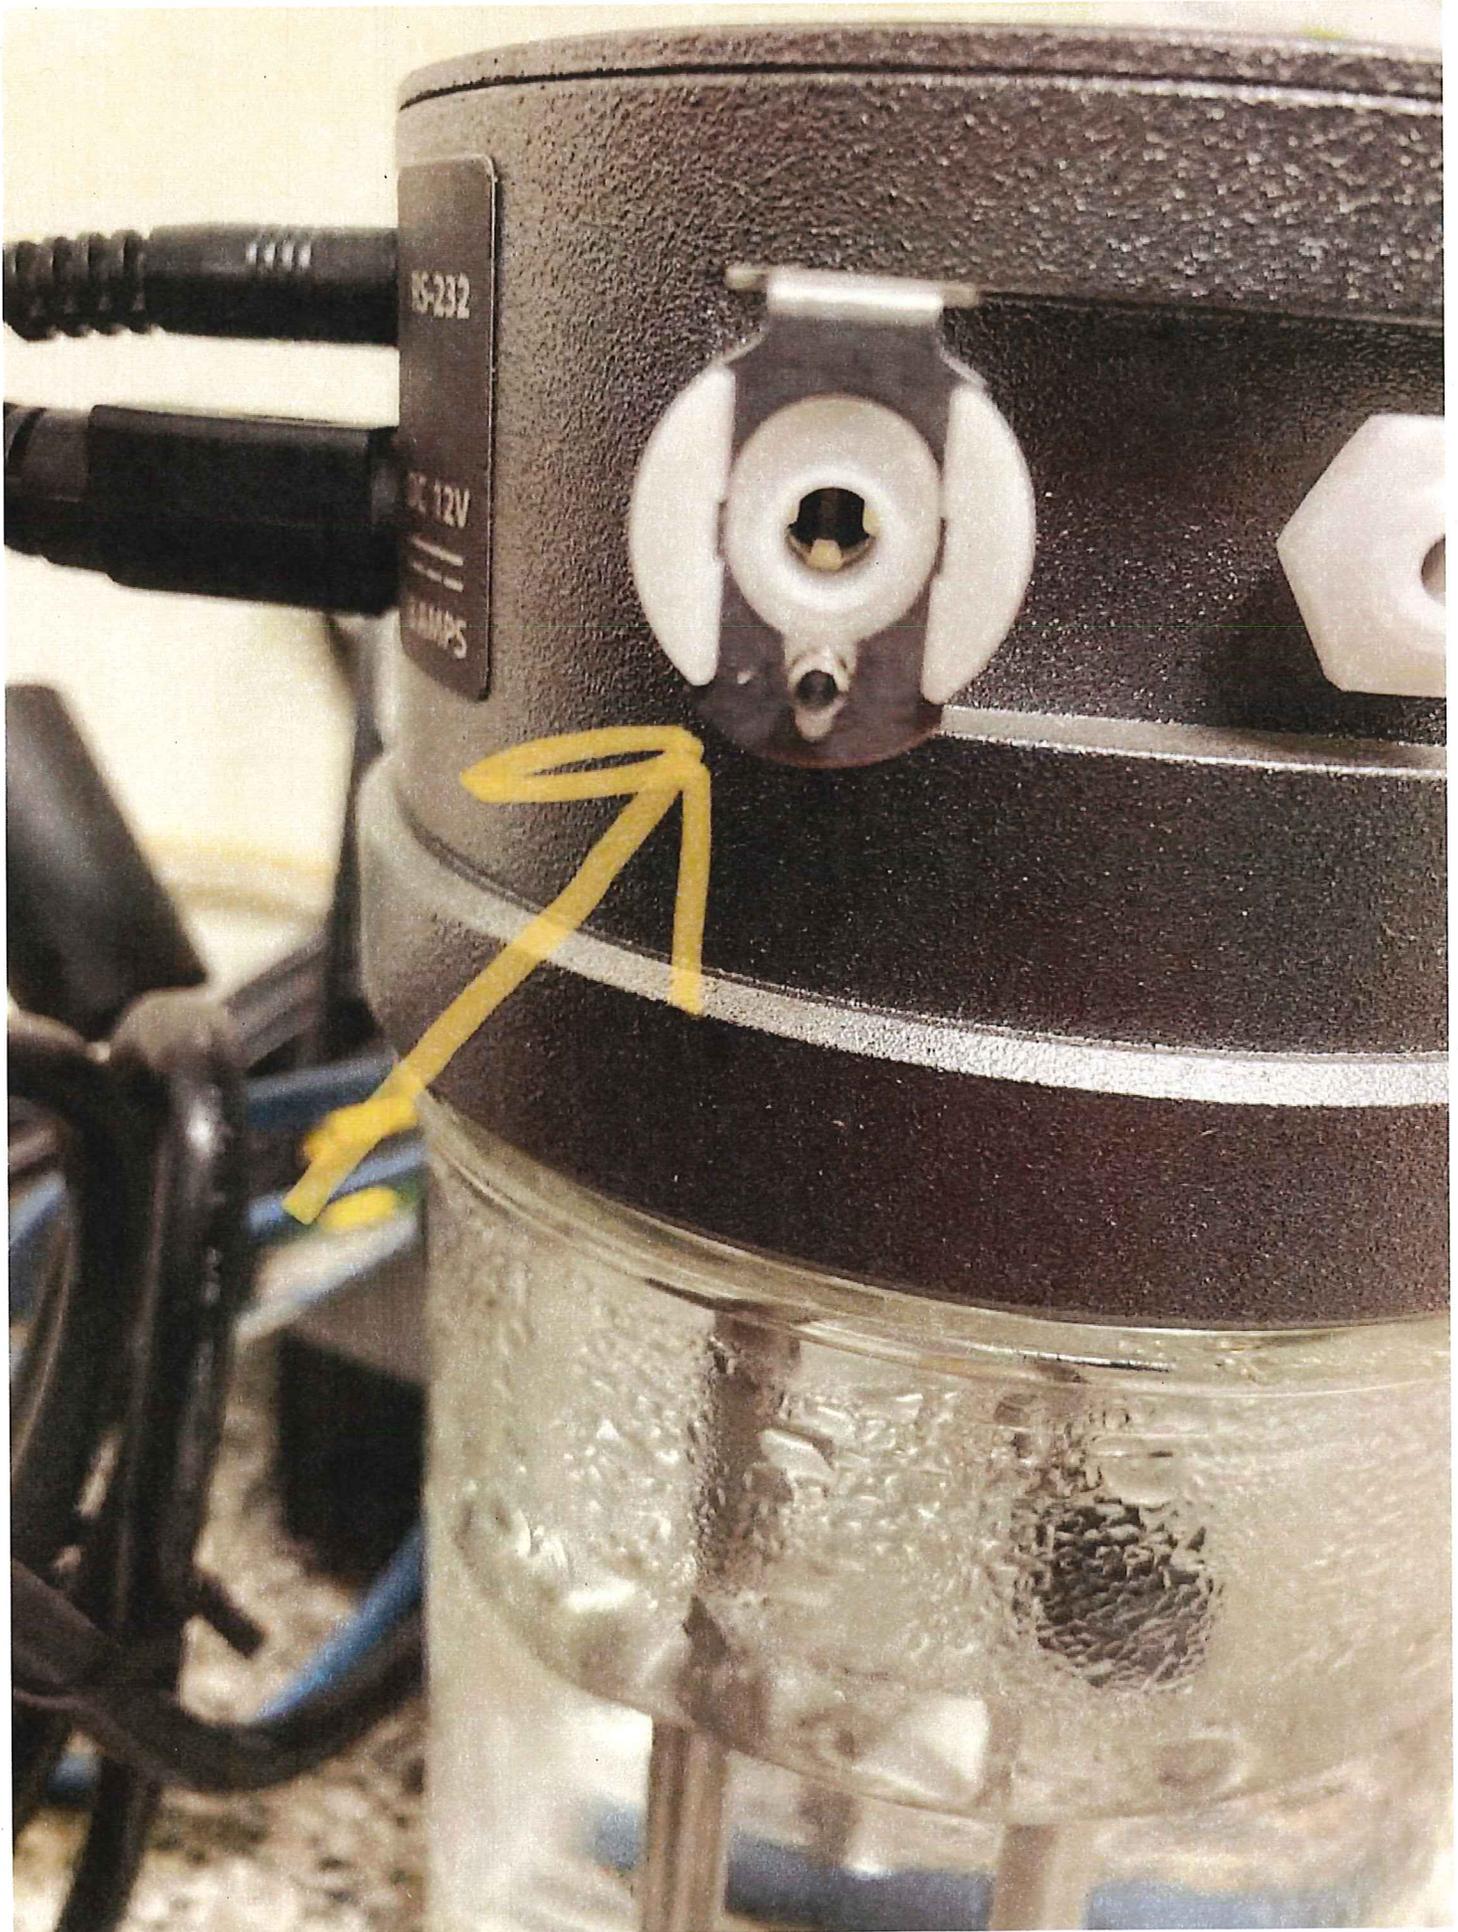
An officer reported that the DMT had been damaged by a detainee. VFL staff responded and discovered that the simulator quick connects were broken. This damage was consistent with the photos provided by the officer.

While the detainee was in the processing room he kicked the DMT. As you can see in the photos, there is a small plastic piece that appeared to be broken off where the fluid vessel connects to the computer part of the machine (apologies for the lack of correct terminology). I was not in the room at the time, but did pull the video and he clearly kicked the machine, causing it to slide across the counter. If you provide your mailing address I can send a copy of the video.

The male quick connects for the simulator were broken and were replaced. One had broken off inside one of the female quick connects so that was also replaced. The simulator was checked to ensure there was no other damage. The interior of the DMT was checked and there was no evidence of simulator solution having spilled into the tubing. The connections were secure. Ran 8 filter wheel cycles without error. The DMT was purged for just over a minute with no significant changes to the filter voltages over this time frame. Ran a diagnostic and found it was consistent with prior diagnostics. Ran an accuracy and precision check (n=5) to check the sim solution. Ran a check-in with no errors. DMT was returned to service.
