STATE OF VERMONT
AGENCY OF TRANPORTATION

Scoping Report

Hartford IM 091-2(79)

I-91, Bridge 43N & 43S over US 5

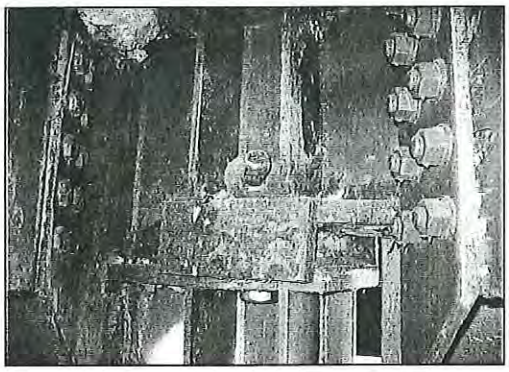
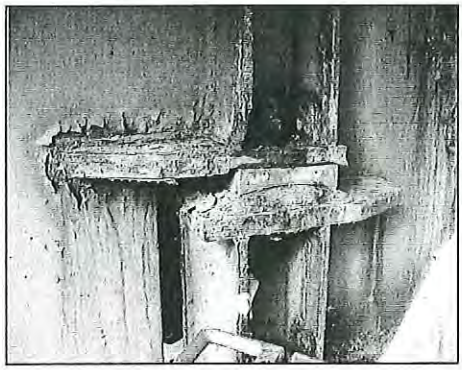
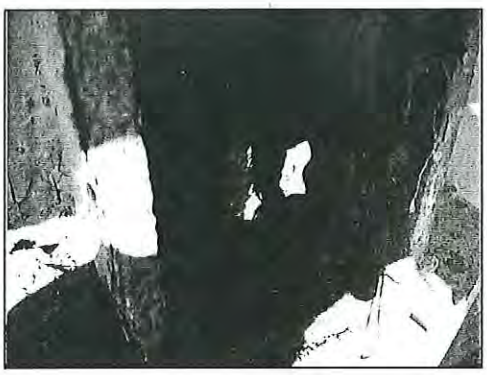
2. Repair/Replace Brg Devices — Swedge bolt busted off at suspended span
   Location:
   Est. quantity - Each:
   Urgency of Repair Coding: Needs to be addressed

Swedge bolt has busted out at beam #4 (west side) at pier #1 in the suspended span bearing. The bolt needs replacing. Broken swedge bolts were also noted in the bearing of beams #3 and #4 (west side) at pier #2 of the same suspended span. There is heavy rust scale in some of the other swedge bolts in both ends of the suspended span. Consideration should be given to replacing these bolts at the same time. There is minor to moderate section loss in members at suspended span which is caused by the leakage of the joints. The beam ends at the suspended spans need extensive cleaning and painting to prevent any further section loss in the members.

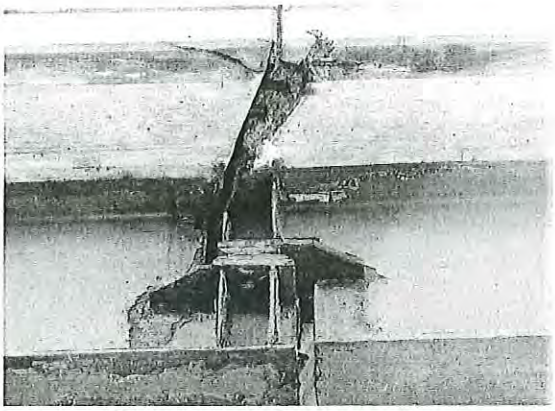
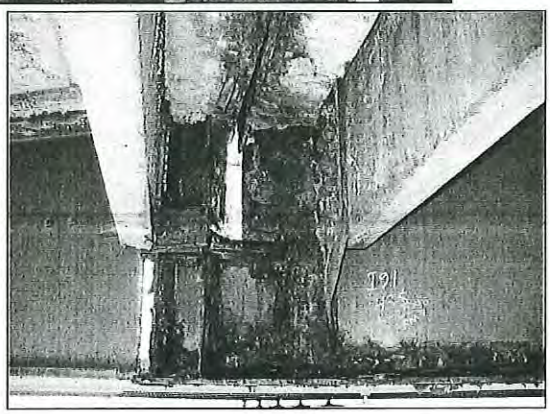
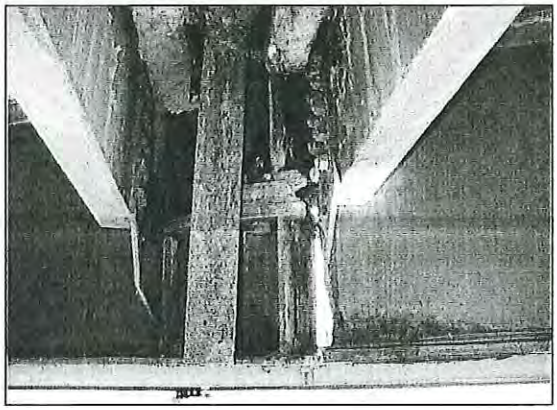
1. Repair Beam/Girder — Heavy rust scale in the beams at splice
   Location:
   Est. Quantity
   Urgency of Repair Coding: Needs to be addressed

2. Repair/Replace Brg Devices — Swedge bolt busted off at suspended span
   Location:
   Est. quantity - Each:
   Urgency of Repair Coding: Needs to be addressed

Some beams have heavy rust scale with section loss in the webs and flanges located on the ends at the suspended spans due to the leakage of the joints. A swedge bolt has busted out at beam #4 (west side) at pier #1 in the suspended span bearing and needs replacing. There is heavy rust scale in some of the other swedge bolts in both ends of the suspended span. Considerations should be given to replacing these bolts at the same time. Beams need extensive cleaning and painting at the suspended spans to deter more deterioration and stop any holes from forming.

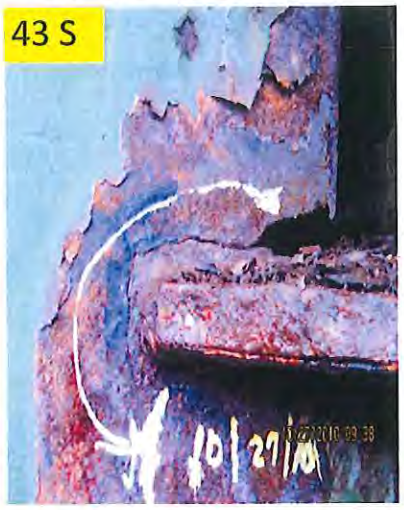
SUPERSTRUCTURE	PROBLEMS FOUND:	ACTION TAKEN:
1. Repair: East exterior Beams	**Reinforce Webs on both 43 N/S**	
Location: Sp.2 So. seat area 43S	**Bot. web of cantilevered Bm No.7.**	
Location: Sp.2 So.seat area 43N	**Bot. web of cantilevered Bm No.6.**	
Est. Quantity 2 beams	**Bm(s). No.7S & 6N (Both in Sp. No.2)**	
Urgency of Repair Coding:	**Critical**	
2. Add or Replace Bolts	**Replace all broken or bent seating bolts.**	
Location: Along all seating areas	**Suspended span**	
Est. quantity - Each:	**28 seats total to check**	
Urgency of Repair Coding:	**Critical**

South Seat Area of Span No.2

North Seat Area of Span No.2

Inspector(s) Comments : **The seat areas in both pictures above are in need of critical and timely repairs. It is suggested that full height reinforcement plates be added to the webs of both these areas. The plate should be shaped to fit between the center bearing stiffener plate to the first full height connection plate of the diaphragm beam (nearest the affected area). Welding and all preparation procedures for these repairs shall conform to field welding manual per Maintenance Division. Shoring of the suspended span should be considered during repair operations.**
