COPIES	NUMBER	DESCRIPTION	CODE
1		FRP Fabrication NCR 7-2 - PE Seal per 8/22/14 Letter	H

August 21, 2014

Brookfield BRF FLBR (2)

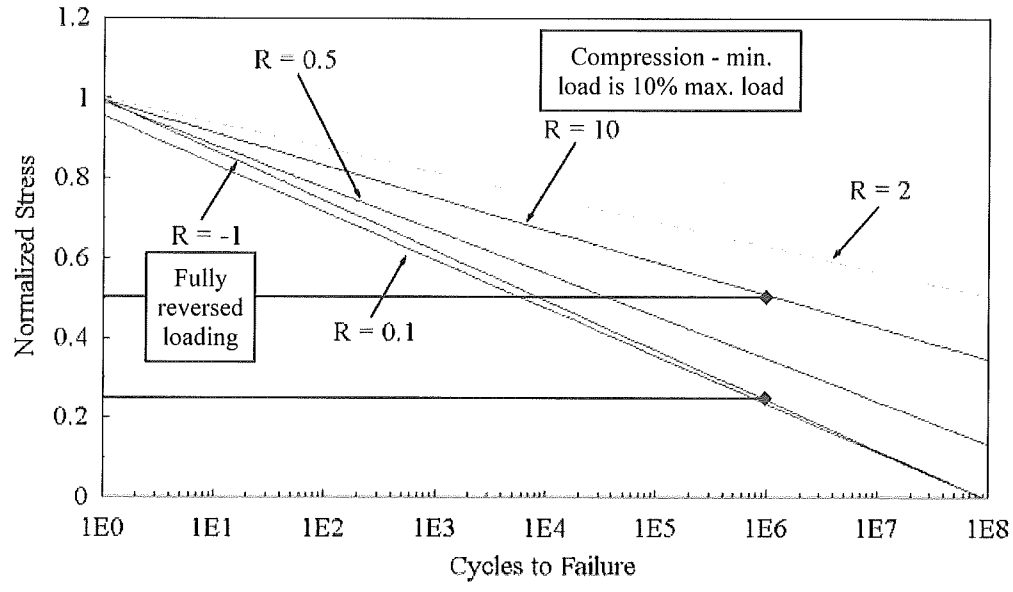
Figure 1 – Constant Amplitude S-N Fatigue Data[1]

In order to empirically evaluate the long term effect of cyclic loading on the durability of the re-infusion, the direction and magnitude of applicable loads must first be defined. After reviewing the design, Kenway has determined that the quantifiable cyclic loads imparted on the repair areas will be due to ice loading where the load is one sided (compression only) or service loads where the load is fully reversed (tension and compression). Figure 1 shows curve fits to data for vinyl ester infused fiberglass specimens that have been exposed to fatigue loading. This shows that the laminate can be exposed to 50% of its ultimate compressive strength (R = 10) and 25% of its ultimate tensile strength (R = -1) and still reach 1 million cycles before failure. By comparison, the primary laminate in way of defects – completely ignoring the secondary infusion – will see 7% of the ultimate tensile strength and 2% of the ultimate shear strength.

Figure 35. Normalized Fatigue Models, Exponential Regression Including All Data.

- Quantifiable quasi-static stresses on the primary infused laminate – ignoring the secondary infusion completely – are well below the allowable design strengths as documented above.
- Quantifiable cyclical stresses on the primary laminate – ignoring the secondary infusion completely – and the anticipated number of cycles in service are orders of magnitude lower than documented S-N curves for vinyl ester/fiberglass laminate.
