VERMONT YANKEE
Seismic Walkdown Submittal Report for Resolution of Fukushima Near-Term Task Force Recommendation 2.3: Seismic

Report Number VY-RPT-12-00019 Rev 0

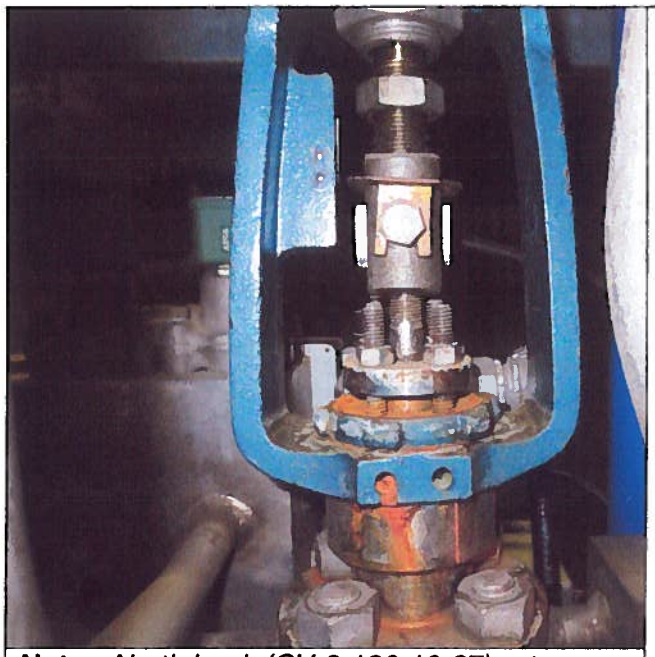
Equipment ID No. *CV-3-126-* Equip. Class[1] *07*

Note: *North bank (CV-3-126-10-27) valve showing surface corrosion.*

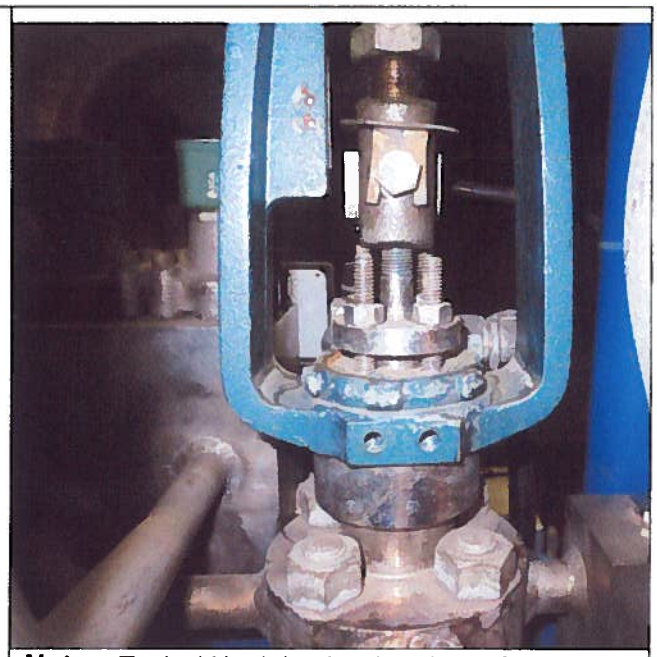
Note: Surface corrosion was observed on valve CV-3-126-10-27associated with HCU 10-27(north bank) at the bonnet and yoke interface (see photos page 5). This surface corrosion does not pose an adverse seismic condition. See CR-VTY-2012-05099.

Note: *Typical North bank valve shown for comparison.*

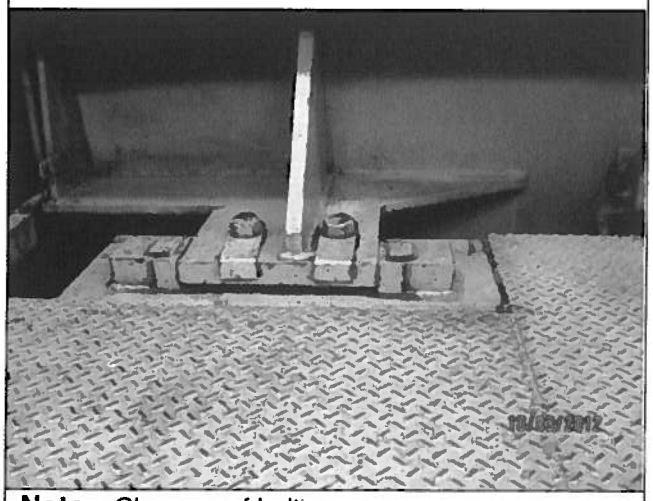
The diesel generator comes attached to the skid. The skid is properly attached to the foundation (see Swel 1-091 and VYEM-0107) and the generator is attached to the skid with 8-1 ¾" diameter bolts. Thus, the generator falls under the rule of the box. Seismically acceptable by engineering judgment.

Note: *Close-up of bolting*

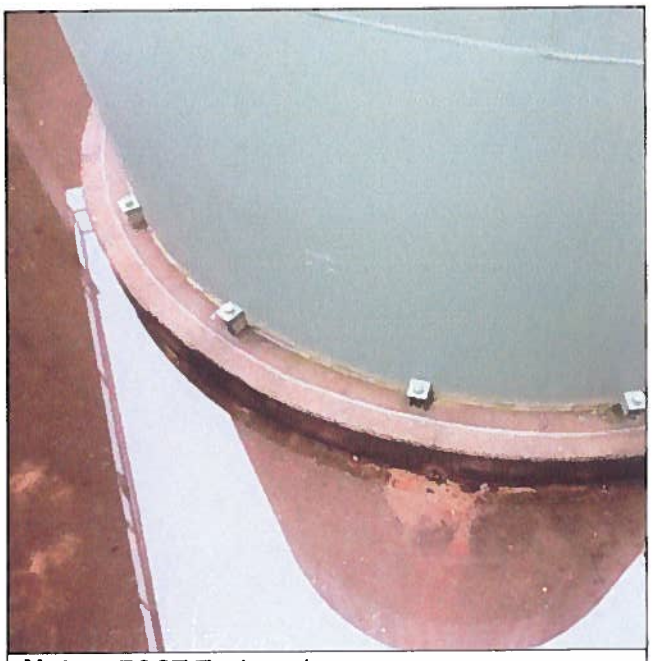
Note: *Hairline crack in concrete.*

Note: *FOST Tank anchorage.*

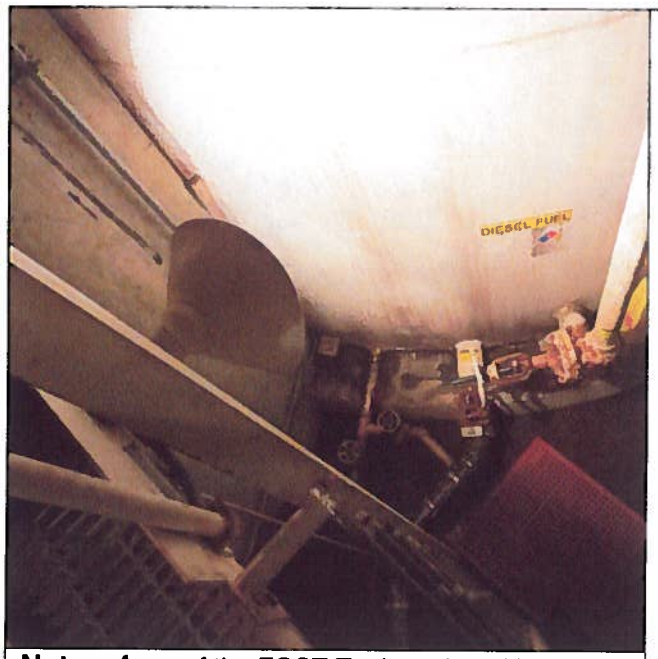
Note: *Area of the FOST Tank enclosed by the pump house.*

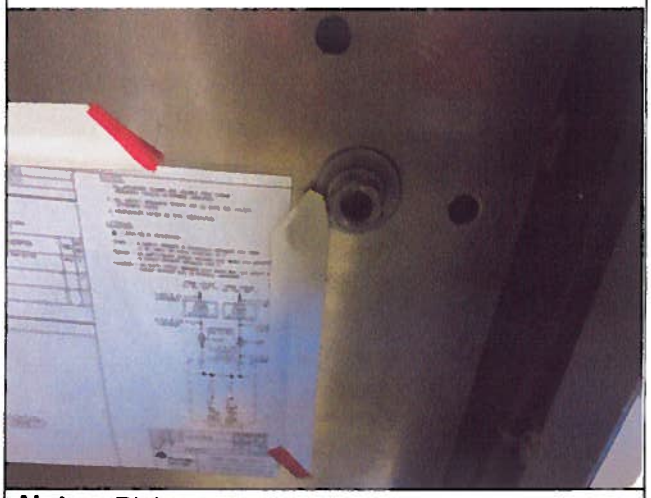
Note: *Cabinet opened 10/11/12 and re-inspection completed. One nut not engaged for 50% of thread. No seismic concerns since 3 nuts are fully engaged.*

Note: *Right upper nut.*

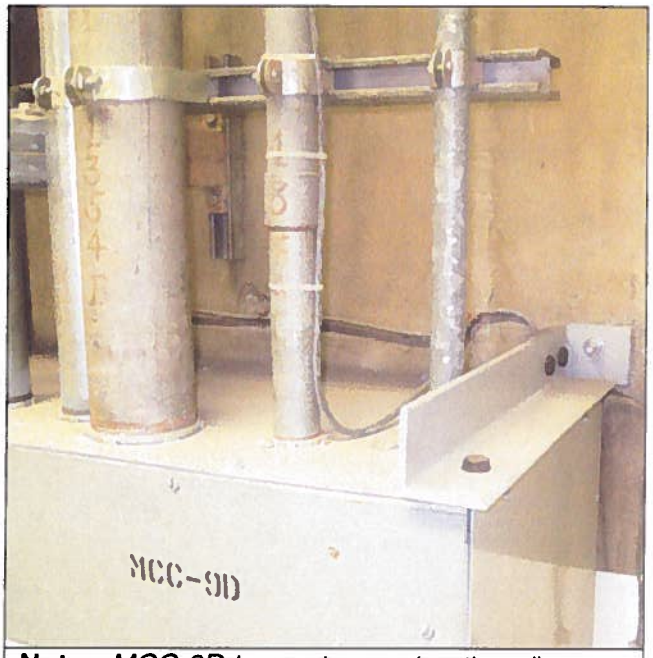
Note: *MCC-9D top anchorage (south end).*

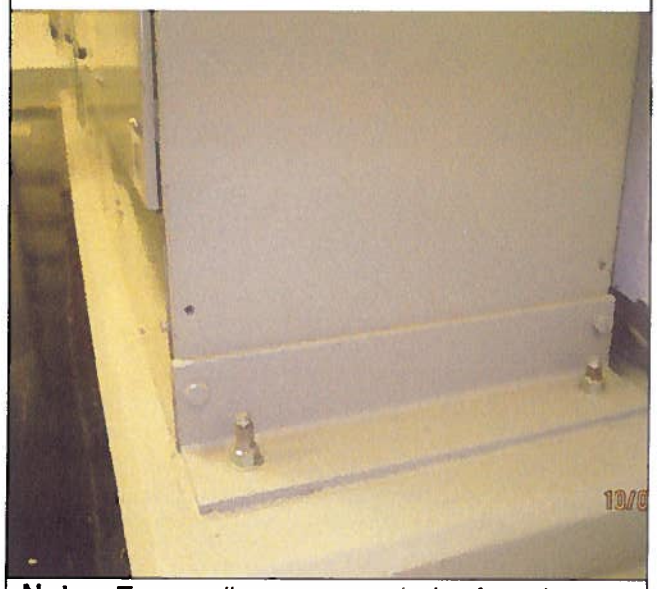
Equipment ID No. *MCC-9D* Equip. Class[1] *01*

Note: *Two small screws are missing from the South end of MCC-9D.See item 1 comment on page 1.*

Note: *Re-inspected 10/11/12 when cabinet panels were opened.*

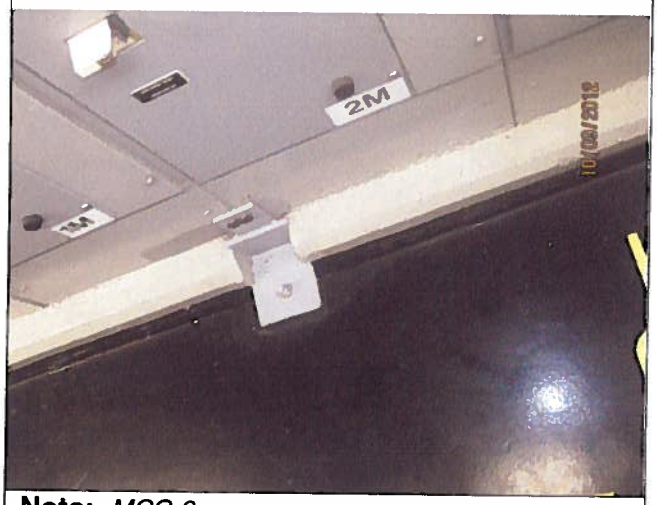
Note: *MCC-9*

Note: *Loose bolts between panels*

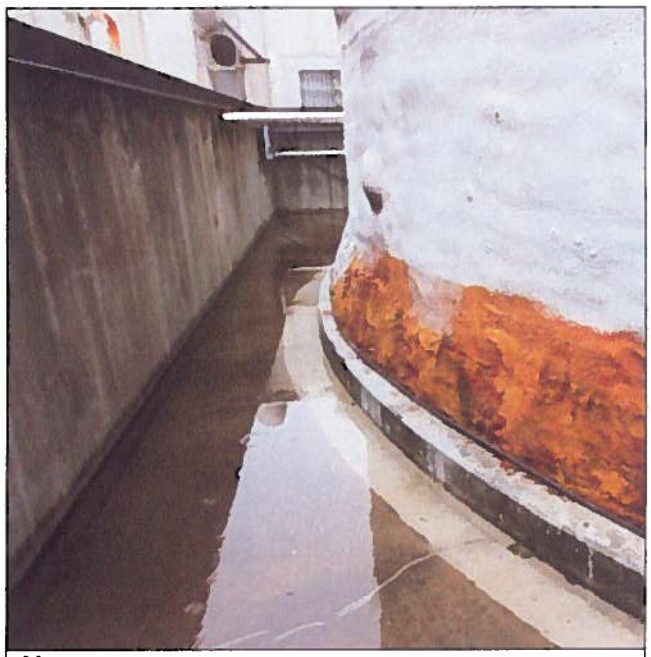
Note: *TK-4-1A*

Note: *Condensate Storage Tank – Anchorage covered by insulation. No visible cracks around the tank foundation*

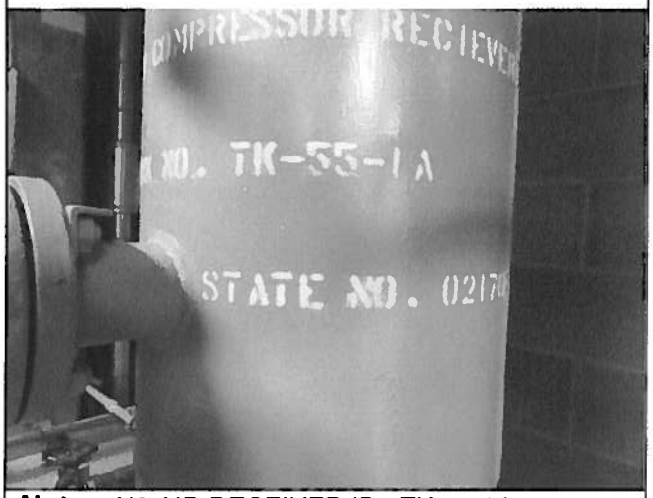
Note: *N2 AIR RECEIVER ID# TK-55-1A*

2. Is the anchorage free of bent, broken, missing or loose hardware? Y☒ N☐ U☐ N/A☐
   One of the bolts on base plate, in extreme left near the wall, is inaccessible due to insulated gaskets around the pipe and scaffolding built around it. All other bolts are found well secured on base plate. No seismic impact.

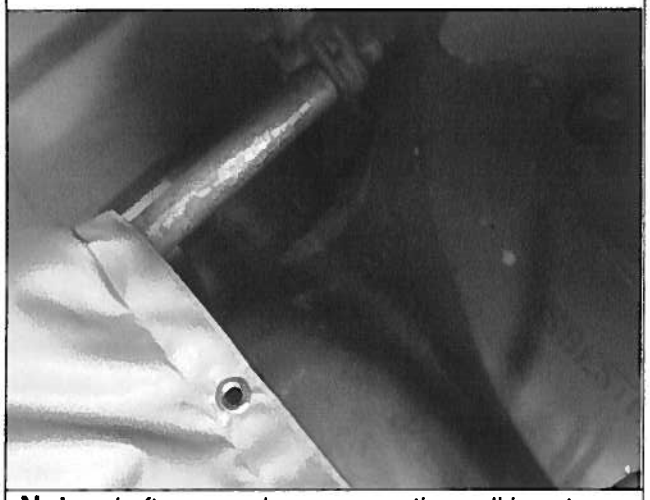
Note: *Left rear anchorage near the wall is not visible.*

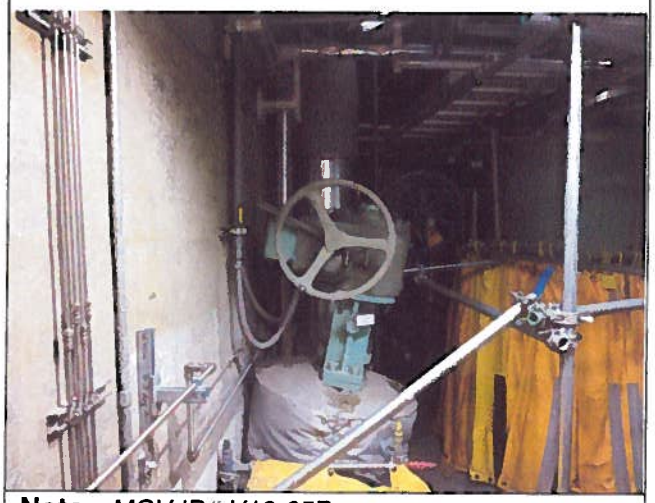
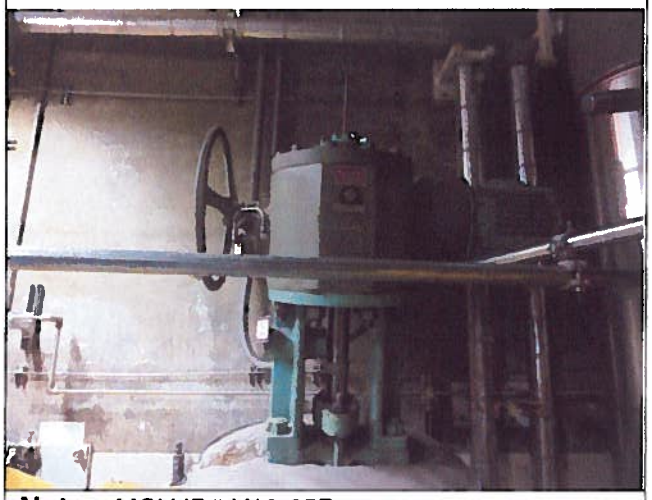
Note: *MOV ID# V10-65B*

2. Is the anchorage free of bent, broken, missing or loose hardware? Y☐ N☐ U☐ N/A☒
   In-line valve, no anchorage.

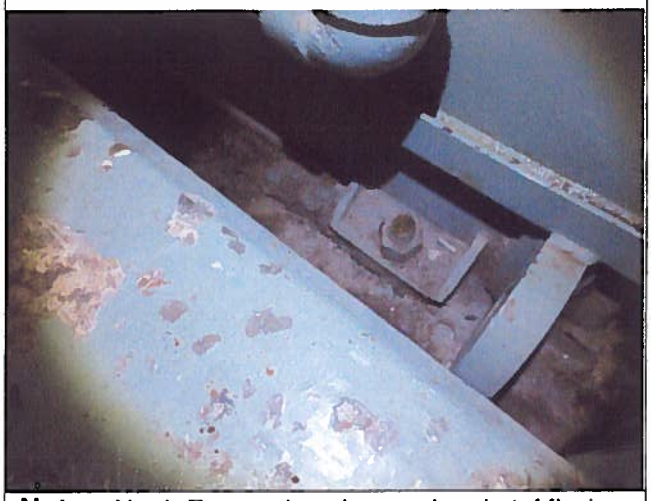
Note: *HPCI-HPCI TURBINE ID# TU-1-1A*

Note: *North East end anchorage bracket. Missing a small amount of grout.*

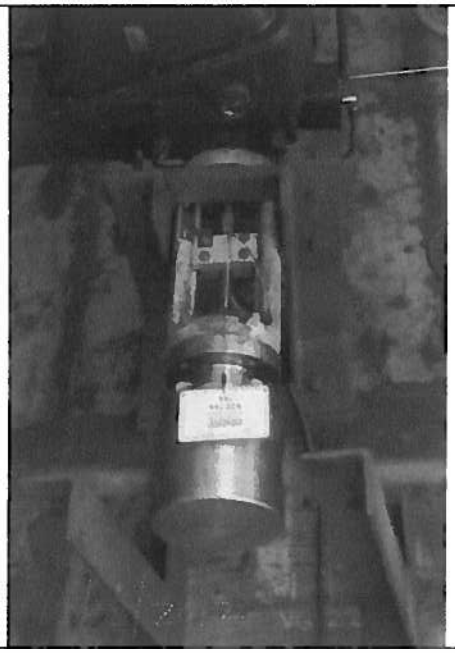
Note: *ID# VG-22A*
Exposed wires are test connection plugs.

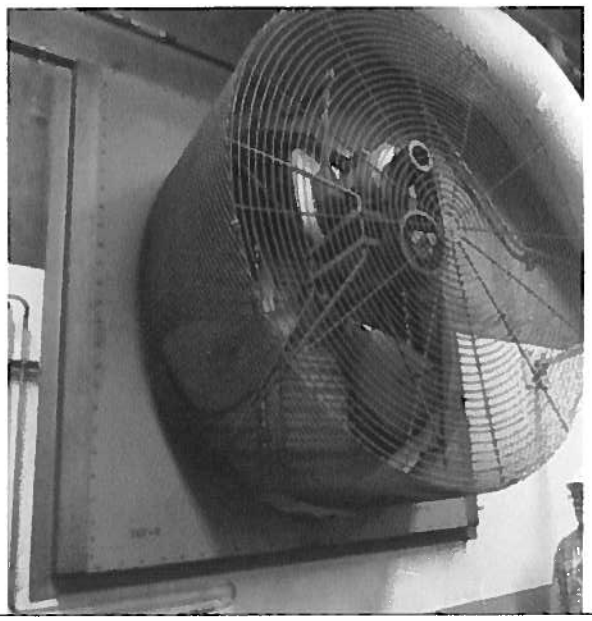
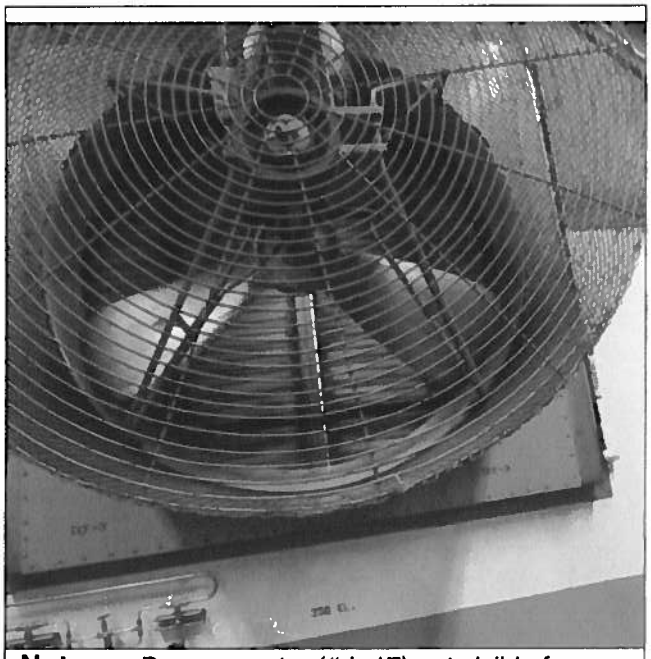
Note: *Damper motor (# L-17) not visible from outside of the fan/shroud assy.*

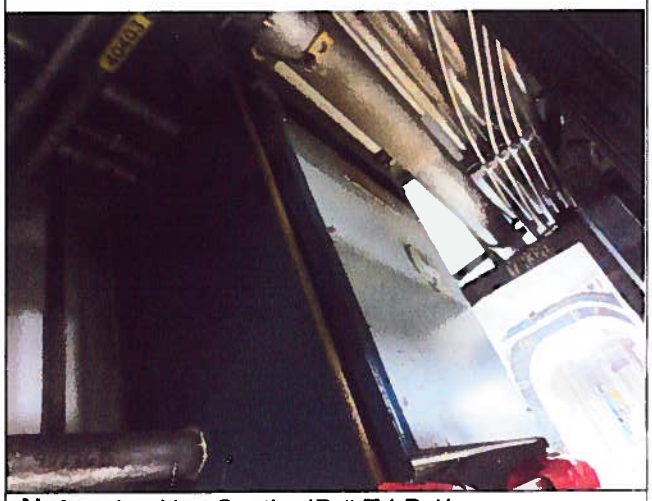
Note: *Looking South. ID # T-LP-1L.*

Note: *Front lower anchorage covered by protective foam and tape. Looking North.*

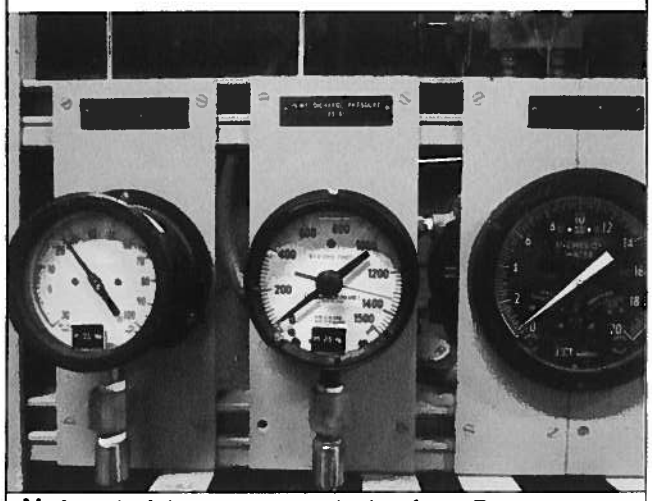
Equipment ID No. *RK25-50B* Equip. Class[1] *18- INSTRUMENTS ON THE RACK*

Note: *Left lower screw missing from Pump Discharge Pressure no. 23-81.*
No seismic impact. See CR-VTY-2012-05118

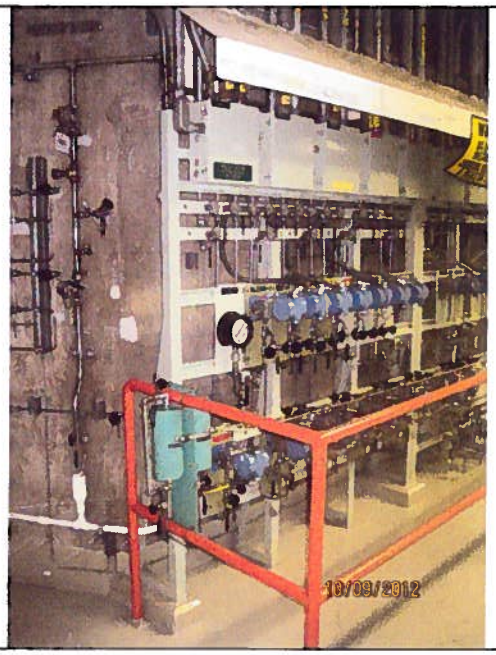
Note: *Instrument rack*

The guard rail is missing anchor bolts. This same issue was brought up in the original SEWS. It is not a seismic issue; the hand rail will not fall over during an earthquake.

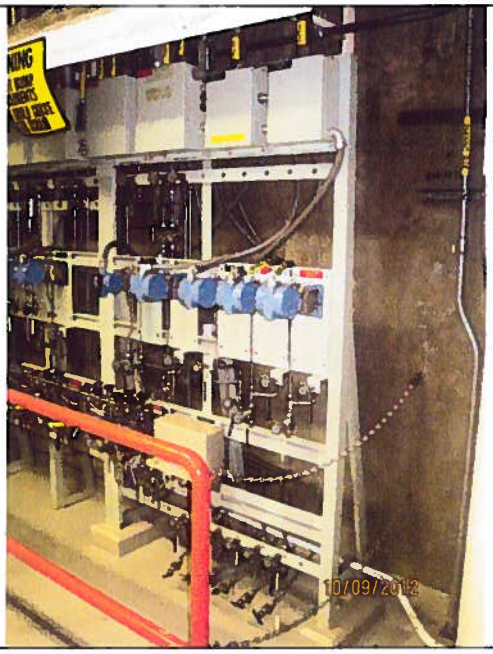
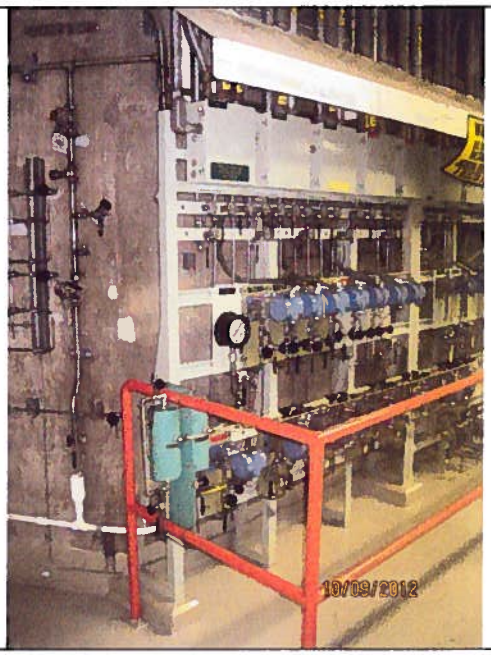
Note: *Instrument rack*

11. Have you looked for and found no other seismic conditions that could adversely affect the safety functions of the equipment? Y☒ N☐ U☐
    A small temporary power supply cart is near by (about 12' away) unchained. Has no seismic impact on any component. See the attached picture.

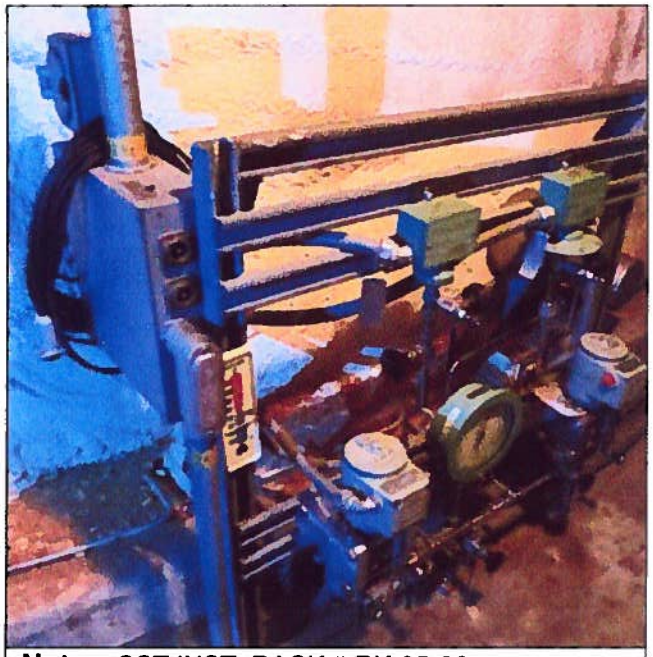
Note: *CST INST. RACK # RK-25-66*

9. Do attached lines have adequate flexibility to avoid damage? Y☒ N☐ U☐ N/A☐
   Rigid connections, however, connection of lines is close to anchorage (near the wall) seismically okay.

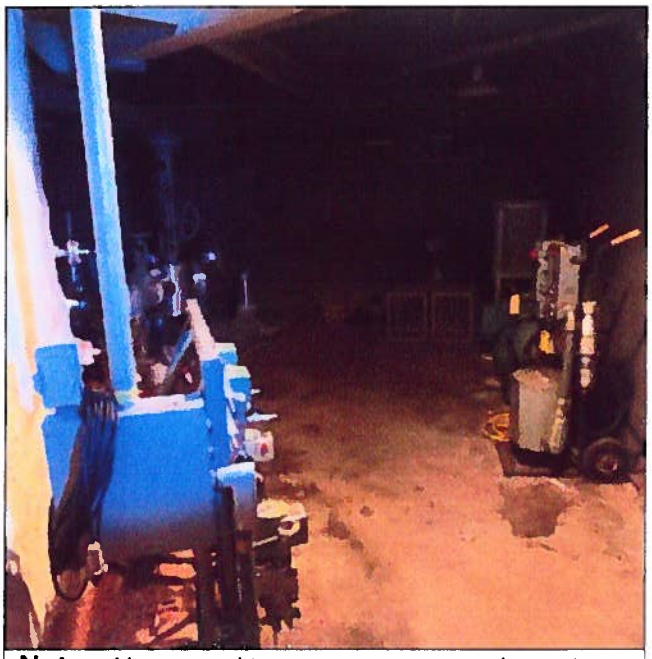
Note: *Unsecured temporary power equipment mounted to wheel car near CST INST. RACK. Not a seismic interaction concern considering its mass, low center of gravity and distance from instrument rack.*

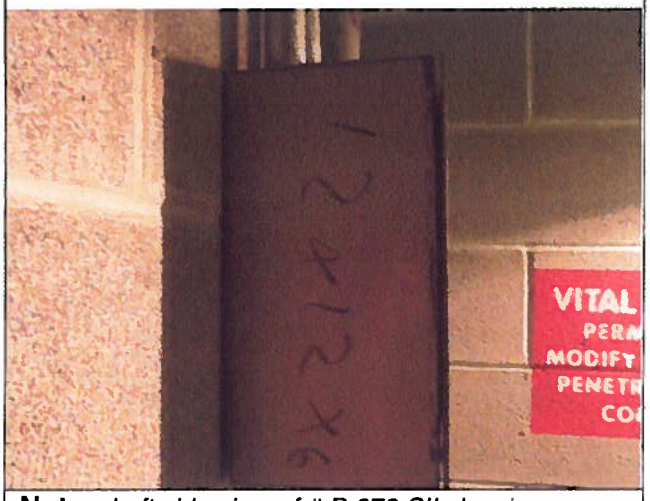
Note: *Left side (top and bottom) screws are missing. Junction box is about 3' from the valve*

Note: *Left side view of # B 679 SII showing gap resulting from missing screws.*

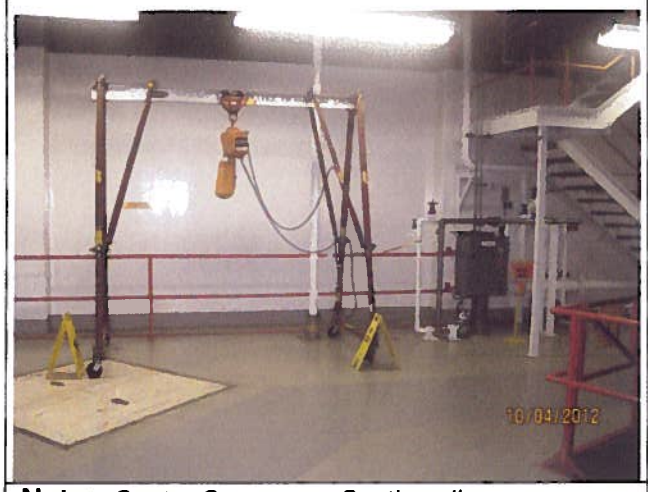
Note: *Gantry Crane near South wall.*	**Note:** *Gantry Crane near South wall.*

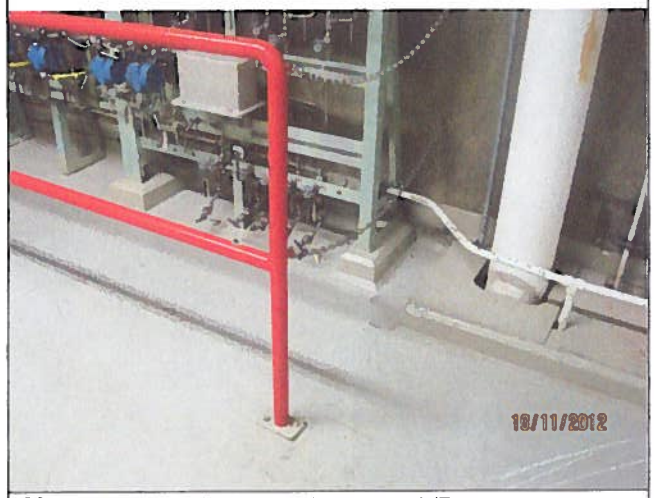
Note: *Railing in front of RK25-6A/B*

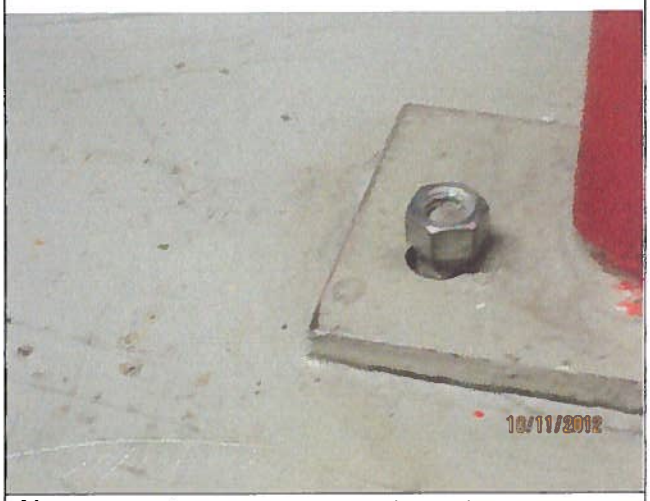
Note: *Detail showing loose bolt on plate*

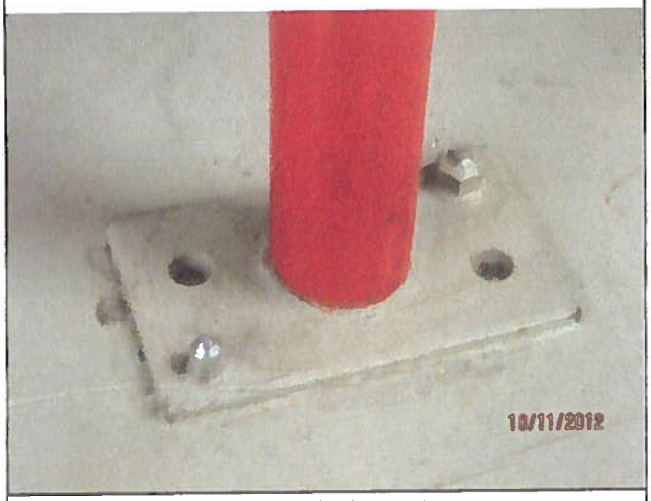
Note: *Railing near RK25-6A/B*

Note: *Detail showing missing nut*

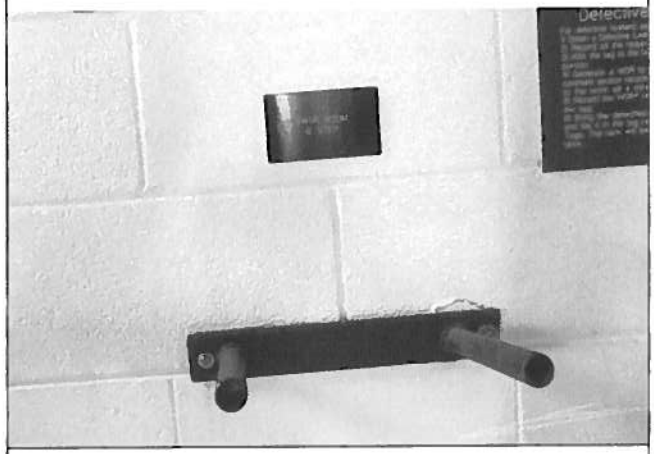
Note: *View of Ladder hanger*

Note: *Ladder hanger detail*

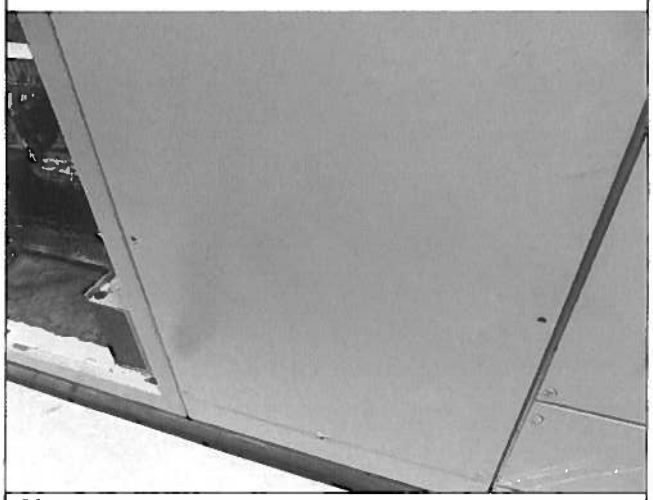
Note: *Two slotted screws missing from access panel for cabinet CRP 9-46 – North side of cabinet*

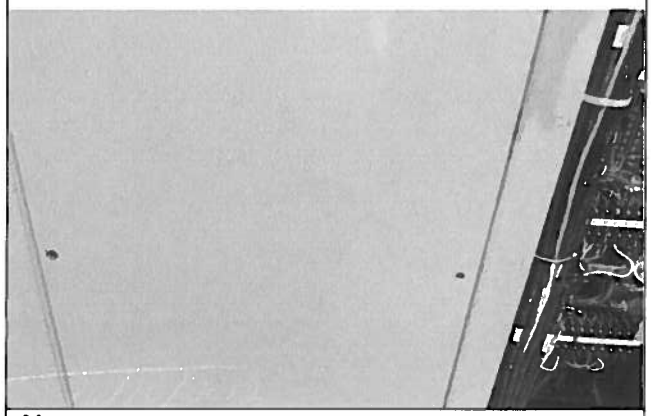
Note: *Two slotted screws missing from access panel for cabinet CRP 9-46 – South side of cabinet*

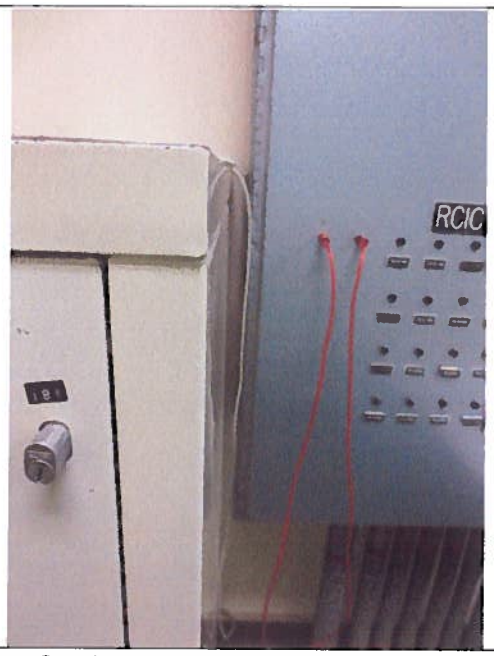
Note: *Filing cabinets in SE corner.*

Note: *Gap between filing cabinets and switch control panel.*

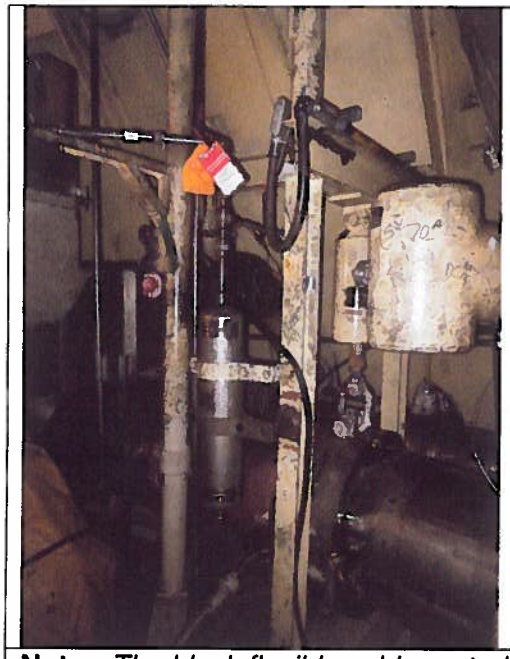
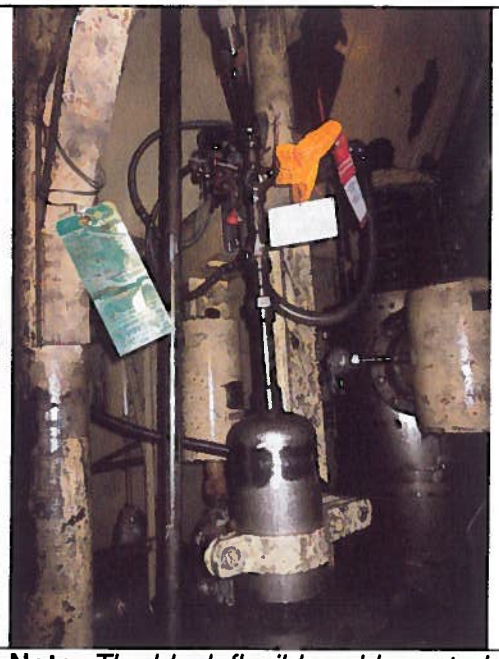
Equipment ID No. *S-2-13A* Equip. Class *21 (Tanks and Heat Exchangers)*

Note: *The black flexible cable routed from behind the tank as seen in the above photo is a temporary power cable which will be removed at the outage completion.*

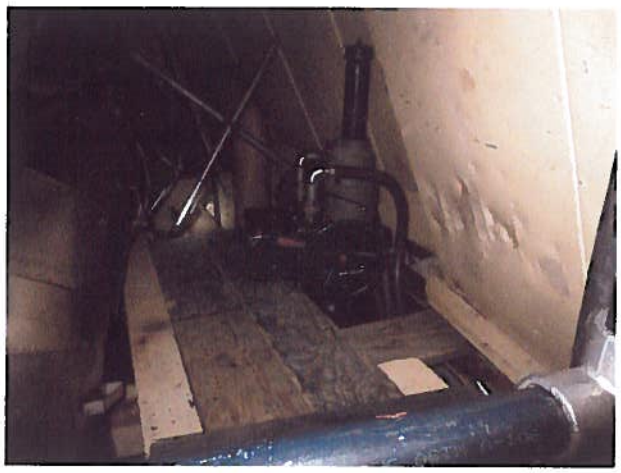
SWEL Components: SWEL1- 029, 055, 057

NO PHOTO
Note: *Temporary scaffolds and tools staged in the area to support the refueling outage. All was removed prior to startup.*	**Note:**
