**Unitarian Property
Burlington, VT**

**Capital Needs Assessment
June 2, 2016**

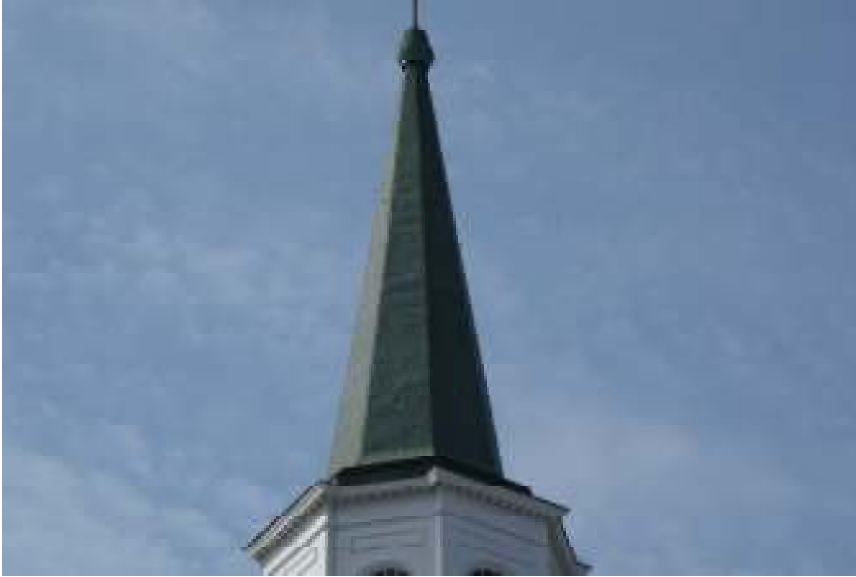
The lantern level windows need to be removed, disassembled, repaired and reinstalled. New, reproduction sash with an identical appearance is a more cost effective option that will be loathed by preservationists.

Southgate also recommends a review and repairs to the lightning protection. The most recent upgrades were in 1999 and it seems reasonable to confirm that it is still working properly. This is an unusual skill and should be performed by a specialist.

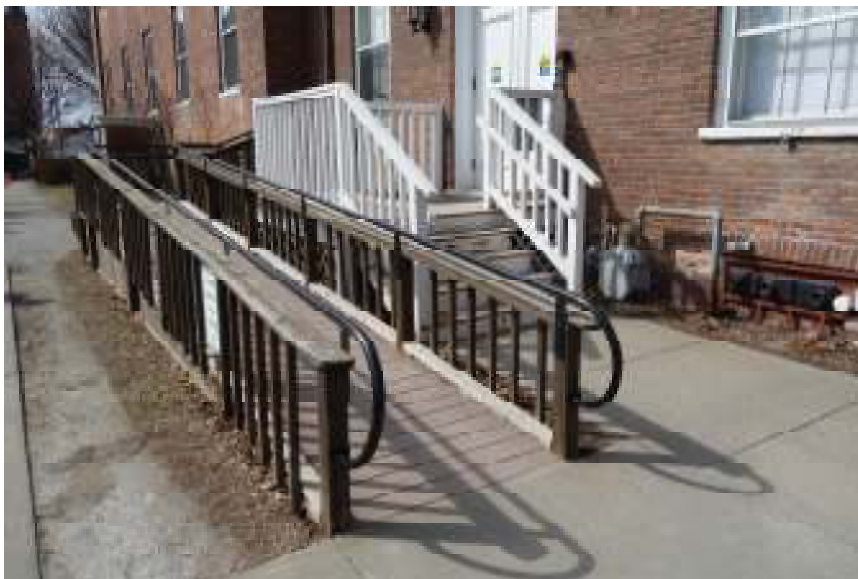
30 Elmwood Ave. – This building has a front porch with a handicap ramp connecting to the deck along the south side of the building. The front porch has some warped and displaced decking. The front steps and deck need paint. The roof ridge cap shingles are starting to disintegrate and should be replaced in year 1. The porch and the adjacent

handicap ramp are otherwise in good condition. The decking on the handicap ramp is composite and does not require maintenance. The porch is budgeted for a full round of repairs in year 12.

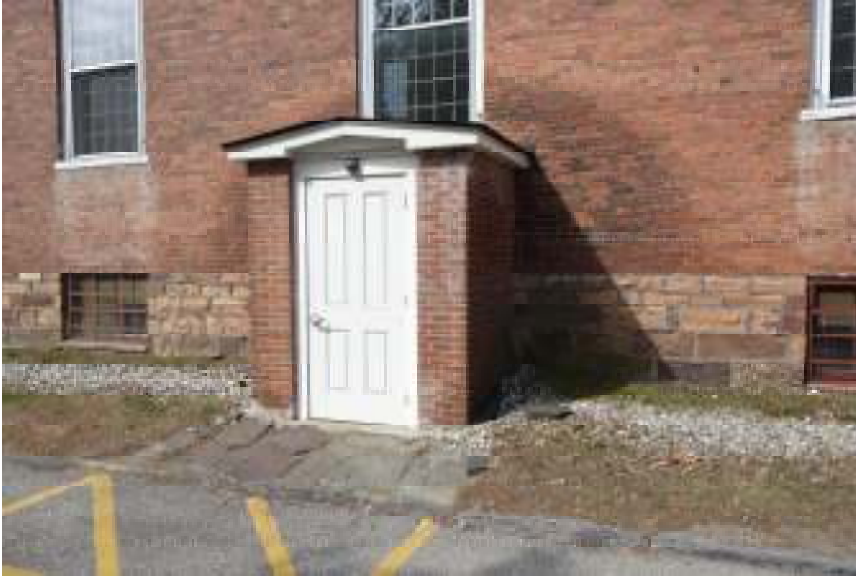
The front steps have new decking since the last report. They look nice and remain in very good condition. There is some rust forming at the base of the handrails and this needs to be painted every year. No capital expenses are budgeted.

The basement entrance was added to meet egress codes from the basement. It has had problems with water entering the structure and draining into the basement. This is partly due to the drainage around the building and to the location of the entrance directly under the drip line of the large main

roof. It has had multiple repairs in the past to correct damage to the structure and leaks. Time to try again. This is budgeted in year 1 and again in year 11.

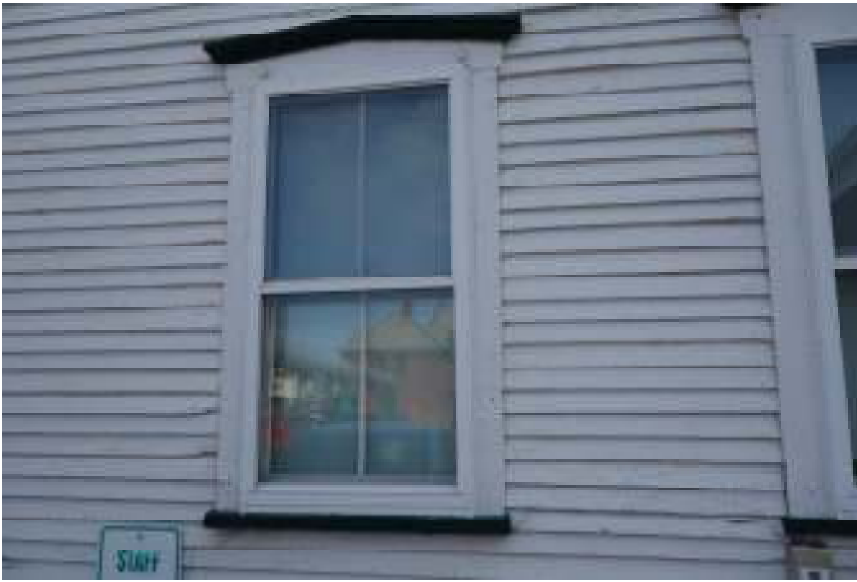
34 Elmwood Ave. – This building has had its windows replaced in some openings. This is roughly speaking the downstairs and not the upstairs. Exceptions to this are that the windows on the north side in the library were not replaced and the front windows in the reception area were not replaced. Window replacement should be considered a must to retain tenants, provide comfortable space and energy efficiency. Replacements are budgeted as part of the insulation package in year 2.

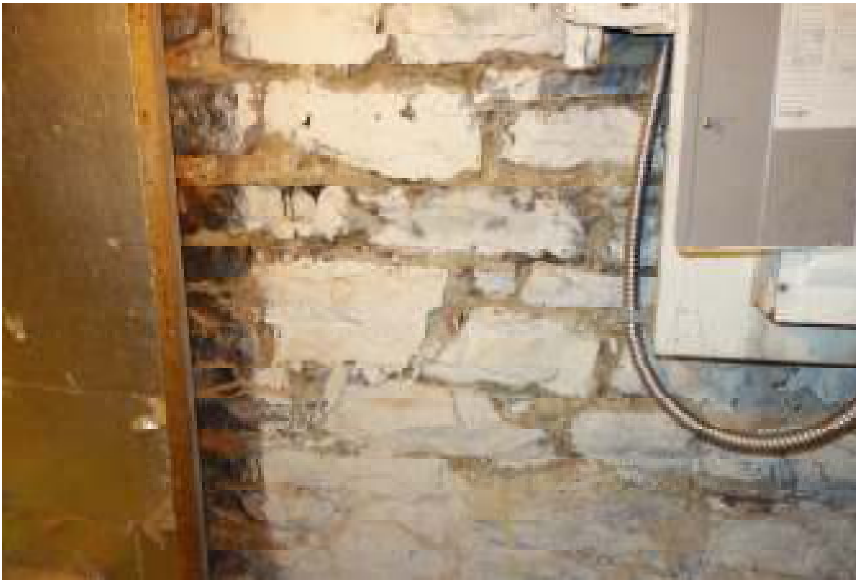
30 Elmwood Ave. – This building has a stone foundation. It is in very good condition. There is older soft mortar in the joints, but they remain sound. No capital expenses are budgeted.

This basement could be cleaned out and used as storage to replace the overloaded attic storage.

Interior spray foam insulation for the foundation is included in the insulation package.

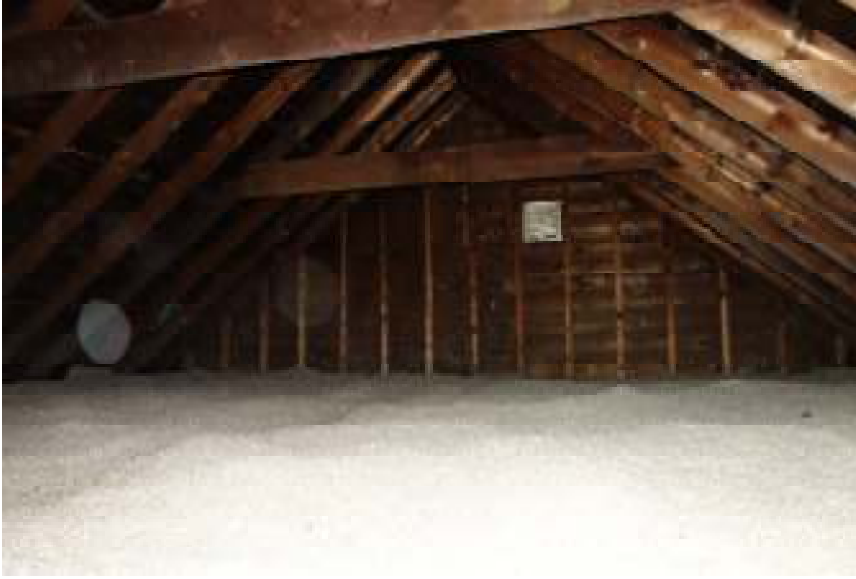
30 Elmwood Ave. – This building was insulated in the 1994 renovations. The approximate depth of the insulation is 9” located under the floor boards. The attic could benefit from substantially more insulation to control fuel costs and be environmentally responsible. Current practice is R-60 insulation in attics or about 18” of cellulose. Adding insulation will either preclude using the attic for storage or require modifications to the attic to have a storage area above the insulation. Additional weatherization work in the stairway to the attic will also benefit the energy efficiency of the building. This is budgeted in year 2.

The current practice for older basements is to spray foam the interior up to the underside of the flooring. This seals the box sill and walls from drafts and provides a moisture resistant insulating layer. It is more effective, more moisture resistant and probably more durable than other

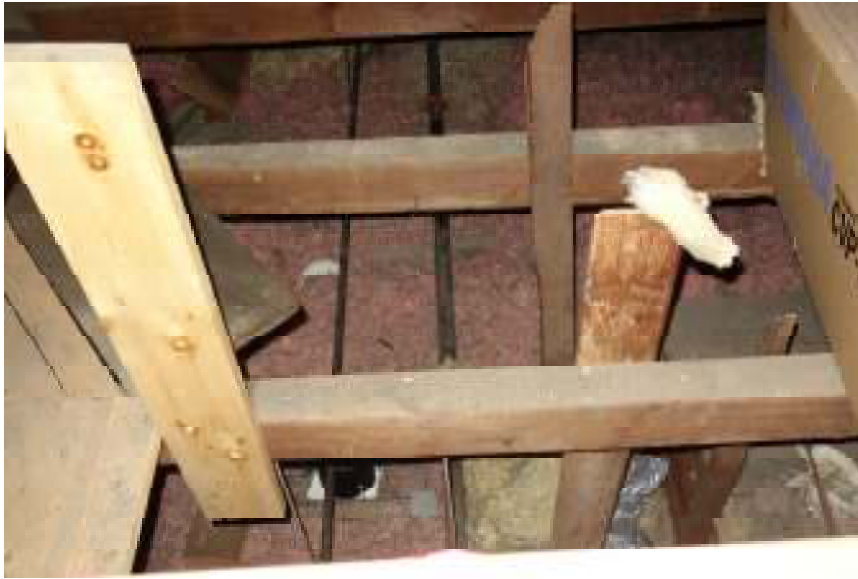
The wall insulation was also not visible. If wall insulation is not present, the walls should be blown in with dense pack cellulose. This work needs to be timed to follow the wiring improvements recommended in the Electrical section.

Meetinghouse – This building has several different attics and wall profiles. The original building has an insulated attic over the main ceiling. It contains a mixture of fiberglass and vermiculite. There is a concern that the vermiculite may

contain asbestos, since it has been found in vermiculite originating in one mine. If it is positive for asbestos you should not disturb this material by adding additional insulation until the vermiculite is abated. If it is negative you should work with a professional insulator to raise the r-value of this attic to at least R-49 and perhaps as high as R-60. That contractor can also help you identify thermal bypasses where warm air is escaping from the building. One obvious one is the recessed lights, but many others probably exist.

This is included in the year 3 improvements to this building and repeats in year 18.

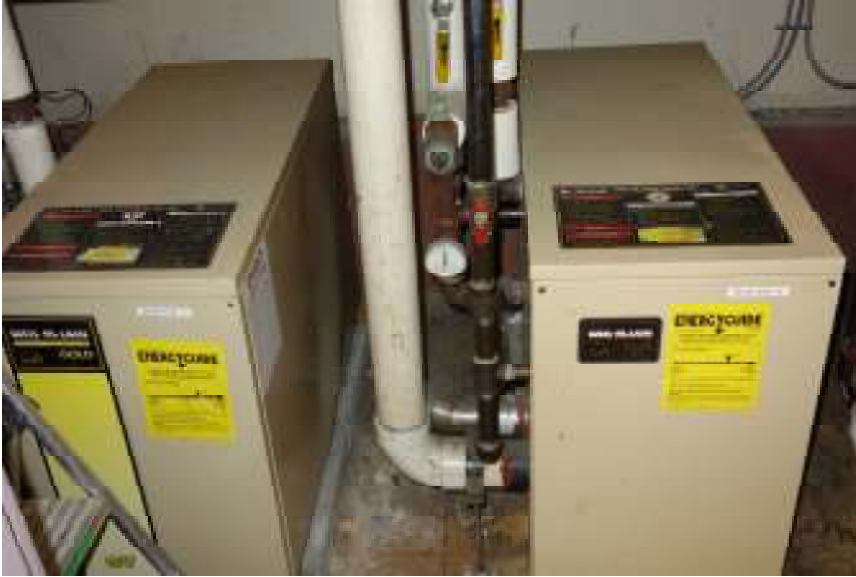
27 Clarke St. – This building has a natural gas hot air condensing furnace (above). It appears to be almost 20 years old. It is an efficient model and no problems were reported. It may require extensive repairs soon to prolong its life. This is budgeted in year 1 and replacement is budgeted in year 11. There is a gas hot water heater. Its age is approximately 14 years. It is budgeted for replacement in years 1 and 16.

The gas hot air heating system may be modifiable to include air conditioning. This would involve installing a compressor outside the building and a heat exchanger in the furnace. As mentioned before, air conditioning is a standard item in offices and should be considered

necessary to attract tenants to this building. It is budgeted in the year 3 improvements. A second round of compressor replacement is budgeted in year 18.

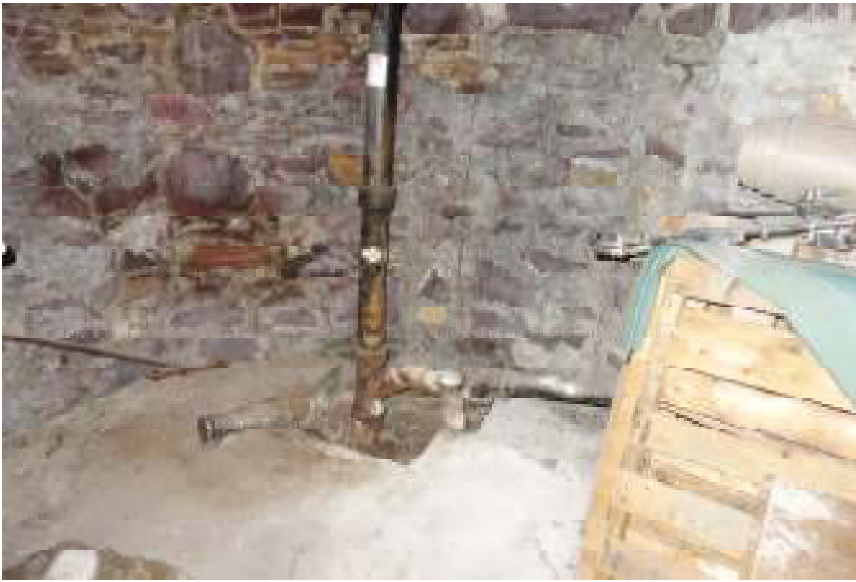
30 Elmwood Ave. – This building has sewer and drain lines that date from before the 1994 renovations. There are extensive hubbed iron drain lines that are over 50 years old (probably over 75 years old) and are prone to failure. These problems may extend beyond the building to the

connection to the sewer main. Replacement of the sewer line (at left) to the main is budgeted in year 12, but could be required at any time or not for decades.

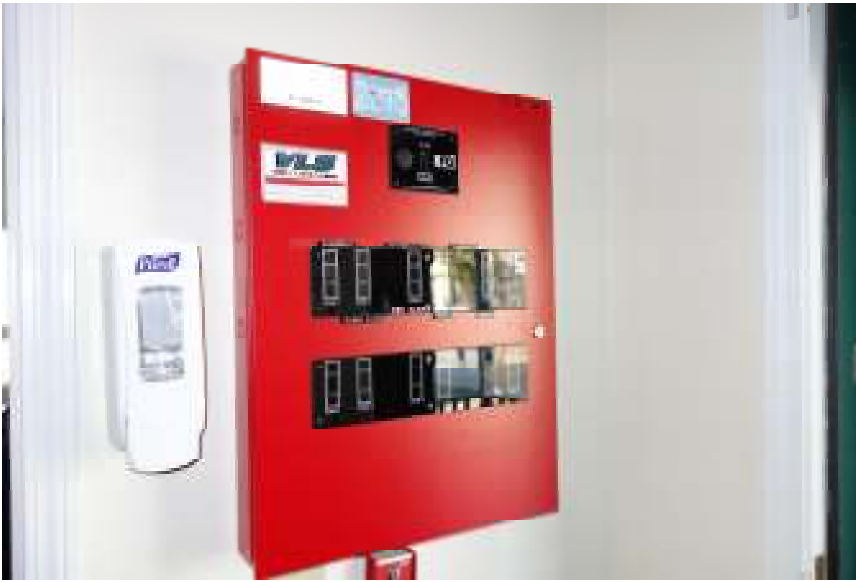
30 Elmwood Ave. – This building had an entirely new electrical system in 1994. Generally, it is wise to assume that there will need to be electrical upgrades and lighting improvements about every 15 years. In this case there is the opportunity to add LED lighting to the building and make improvements to bring the building up to current codes.

Upgrades are budgeted in year 5. Another round of upgrades is budgeted in year 20.

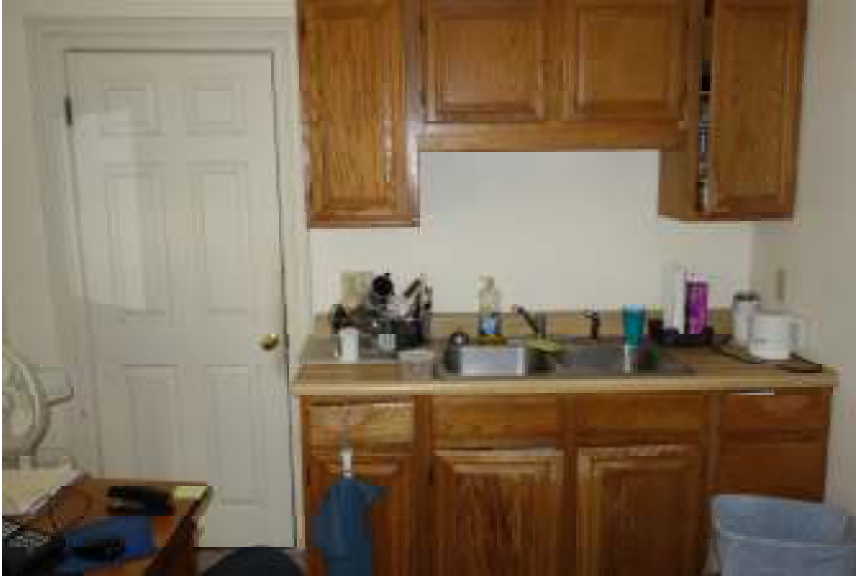
34 Elmwood Ave. – This building (above) has older interiors with the exception of the kitchen and downstairs lavatory. The doors are older panel models. The floors are older hardwood, carpet or vinyl. The interiors are plaster walls and plaster or suspended ceilings.

This building should either receive on-going improvements to retain this tenant or you should plan on significant upgrades when a vacancy occurs. This would include floor refinishing or floor covering replacement, the bathroom described below, modernization of the interior finishes and lighting. This is budgeted in year 6.

If these tenants are likely to stay, you could implement this over a period of several years to keep the building up. This should include floor and carpet on the first floor within a year or two and other upgrades as necessary.

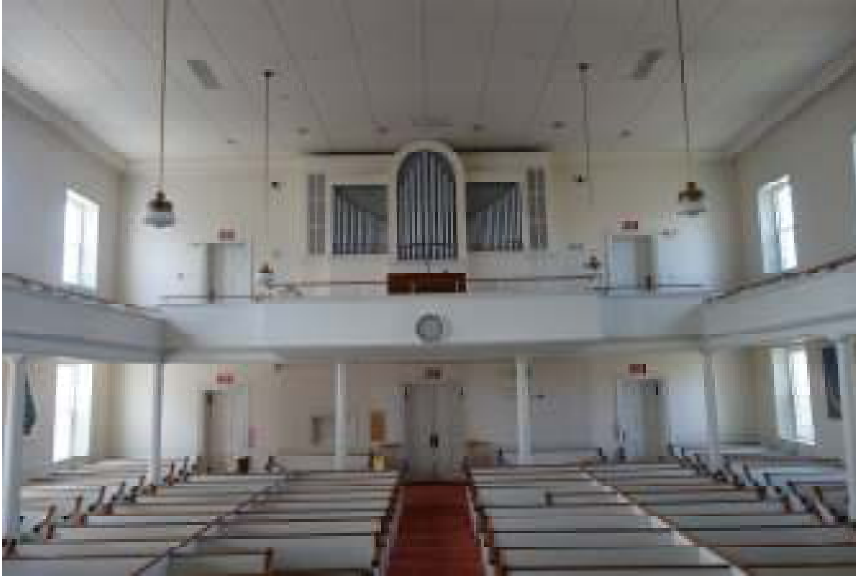
Meetinghouse – This building has numerous areas. There is the Sanctuary and the adjoining entry vestibule, upstairs offices and meeting rooms, first floor parlor, bathrooms and kitchenette, basement kitchen, classrooms, fellowship hall and bathrooms. They have different finish levels, different ages, different purposes and different levels of use.

To rein in the information and make it manageable, I divided the building into 3 parts for painting and carpeting. The Sanctuary and first floor get attention in years 5 and 17. The second floor gets attention in years 1 and 11. The basement gets attention in years 5 and 15, with ceiling
