September 4, 2016

**The Holland Historical Society**

**Holland, Vermont**

**A Preservation Trust of Vermont  
Technical Assistance Survey**

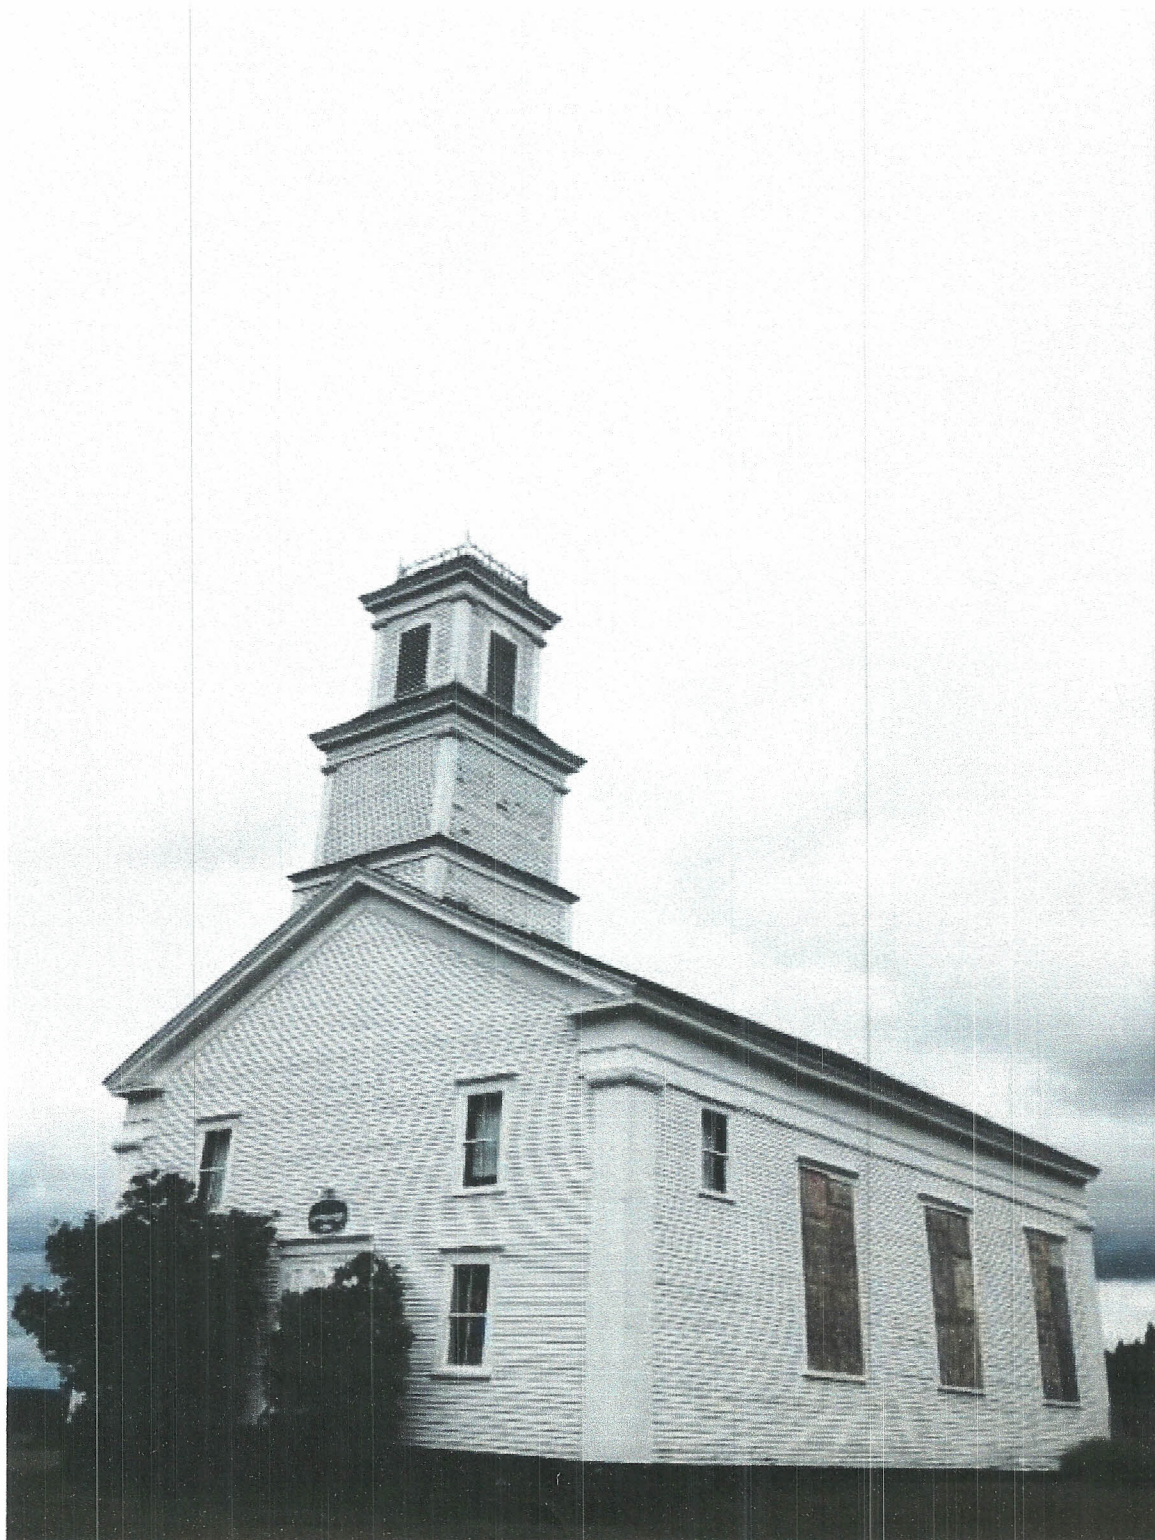
Kingpost Truss

- 2. Framing:** The floor framing appears very good. The wall framing is concealed. The roof frame suffered extensive leakage in the past but damage was restricted largely to the boarding, some of which has been replaced. The exception is the southwest corner of the roof frame, below the steeple, where water and impact have caused 2 broken small rafters, one missing diagonal brace, and some rot to the purlin. When roofing work is done this section should be opened, the 8x9 purlin replaced if necessary and new, larger common rafters, such as 4 x 6 with the 6 inches tall, installed, as well as inserting a diagonal brace where one is missing, perhaps by cutting a lap for one end or using a free tenon on one end of the brace.

- 1. Foundation:** Jack part of the north wall and relay stone with some additional larger stones:  
Cost: \$2000-3000
- 2. Framing:** Repair and replacement of common rafters and diagonal bracing at the SW roof frame. Boarding removed and replaced. Scaffolding in place for roofing not included.
