Pawlet Town Hall Ceiling Restoration Assessment

9/13/16

S·A·fishburn inc.

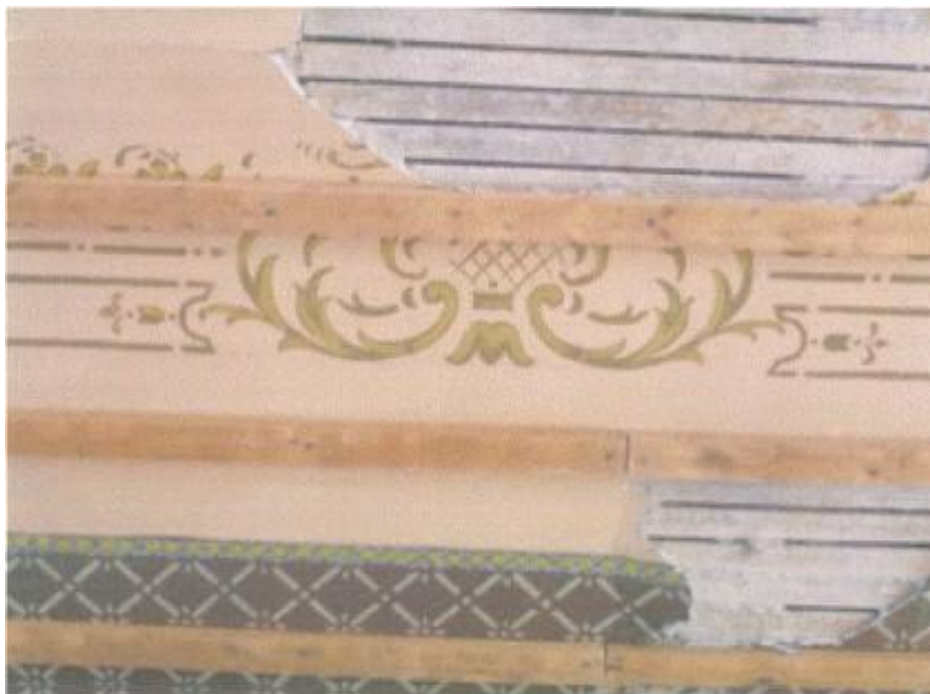
Areas of decorative paints were tested with de-ionized water on q-tips. Paints on the center medallion section of sky and surrounding stencil pattern dissolved rapidly with the introduction of water. Areas of stencil design around perimeter of the room dissolved more slowly but still quickly enough to presume that all decorative ceiling paints are distempers or glue bound paints. Distemper paints always remain hygroscopic and watersoluble. See John Vaughn's report submitted April 3, 2009, which confirm the media present.
